ENVIRONMENTAL SURVEY FOR LEAD BASE PAINT

WAVE RANCH MANUFACTURERS

PW: 8004 / DI: 219020

March 2024

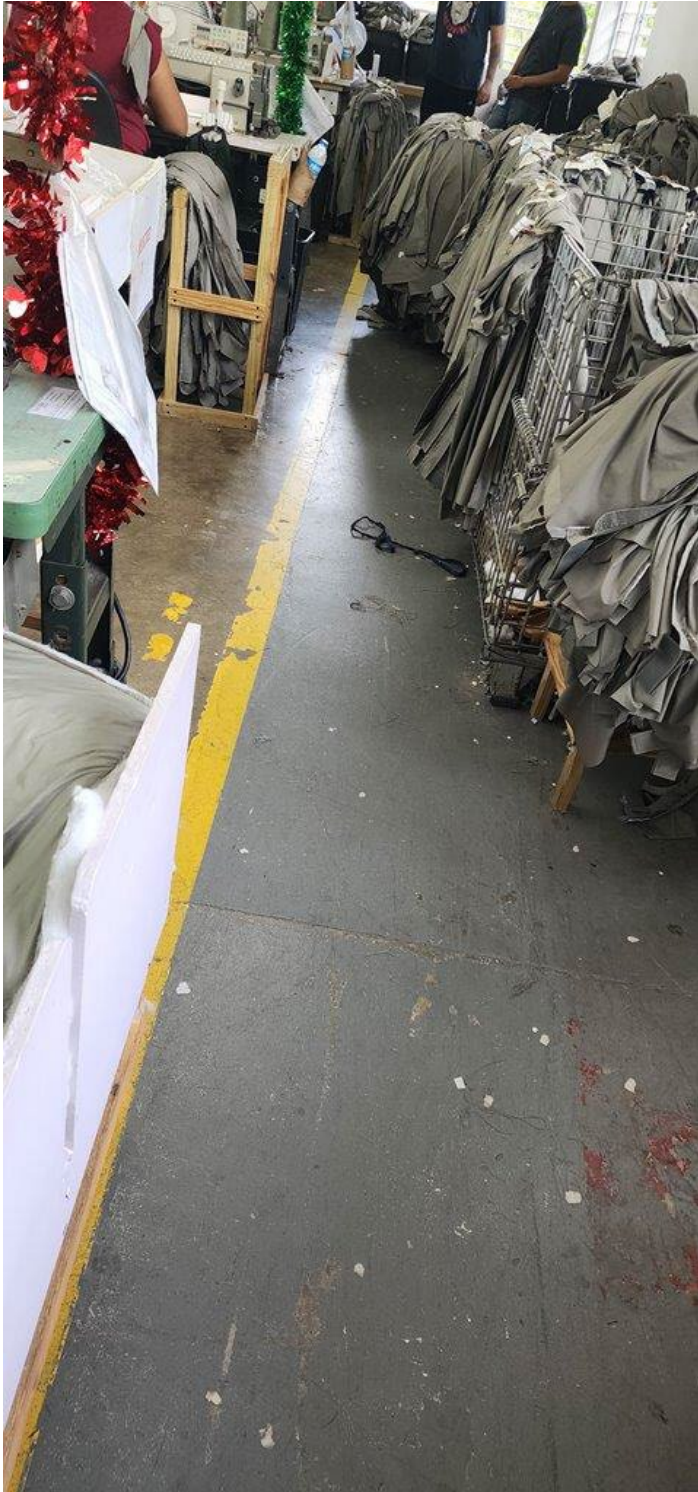
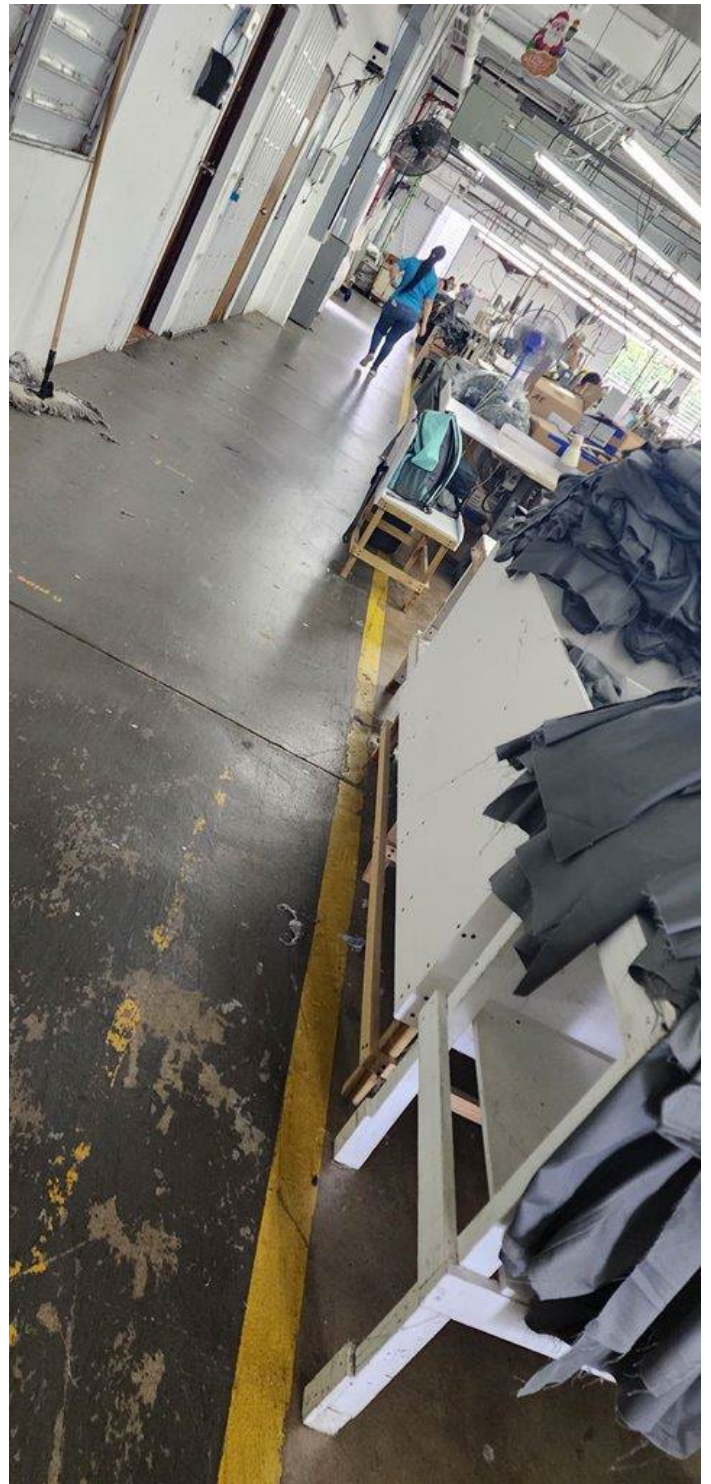
GENERAL VIEW OF POSITIVE INTERIOR, YELLOW, PERIMETER LINES (150 lf total)

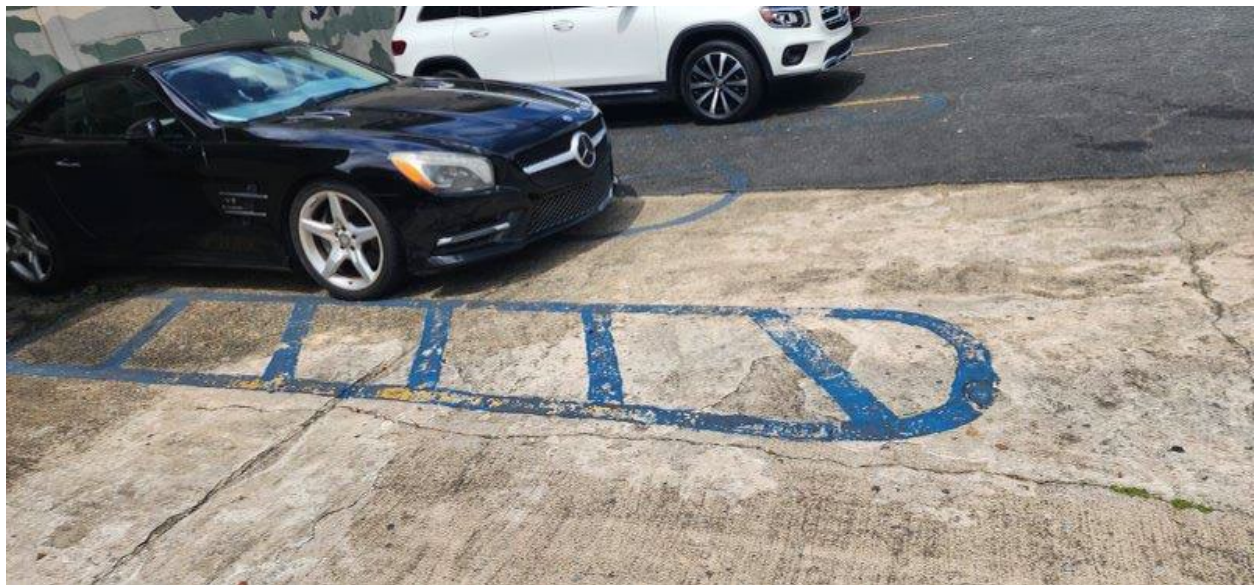
**GENERAL VIEW OF POSITIVE PARKING AREA,
BLUE, DISABLED LINES (400 lf)**

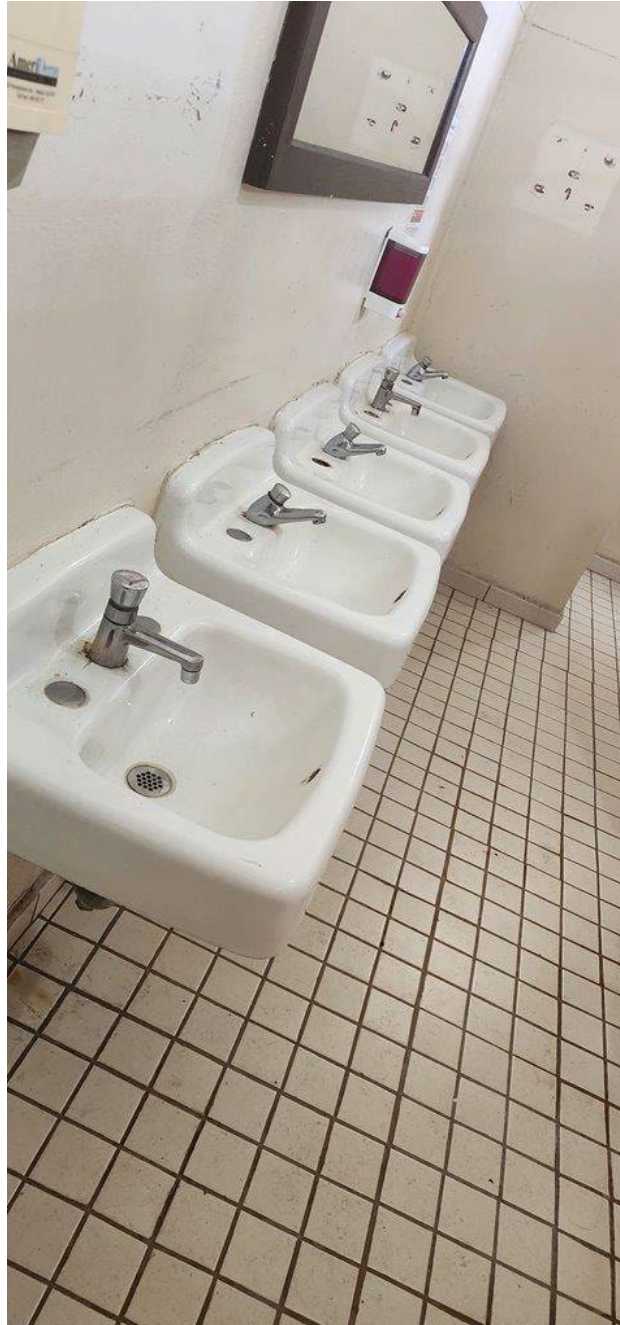
GENERAL VIEW OF POSITIVE MEN BATHROOM, CERAMIC, BEIGE, SINK (4 units total)

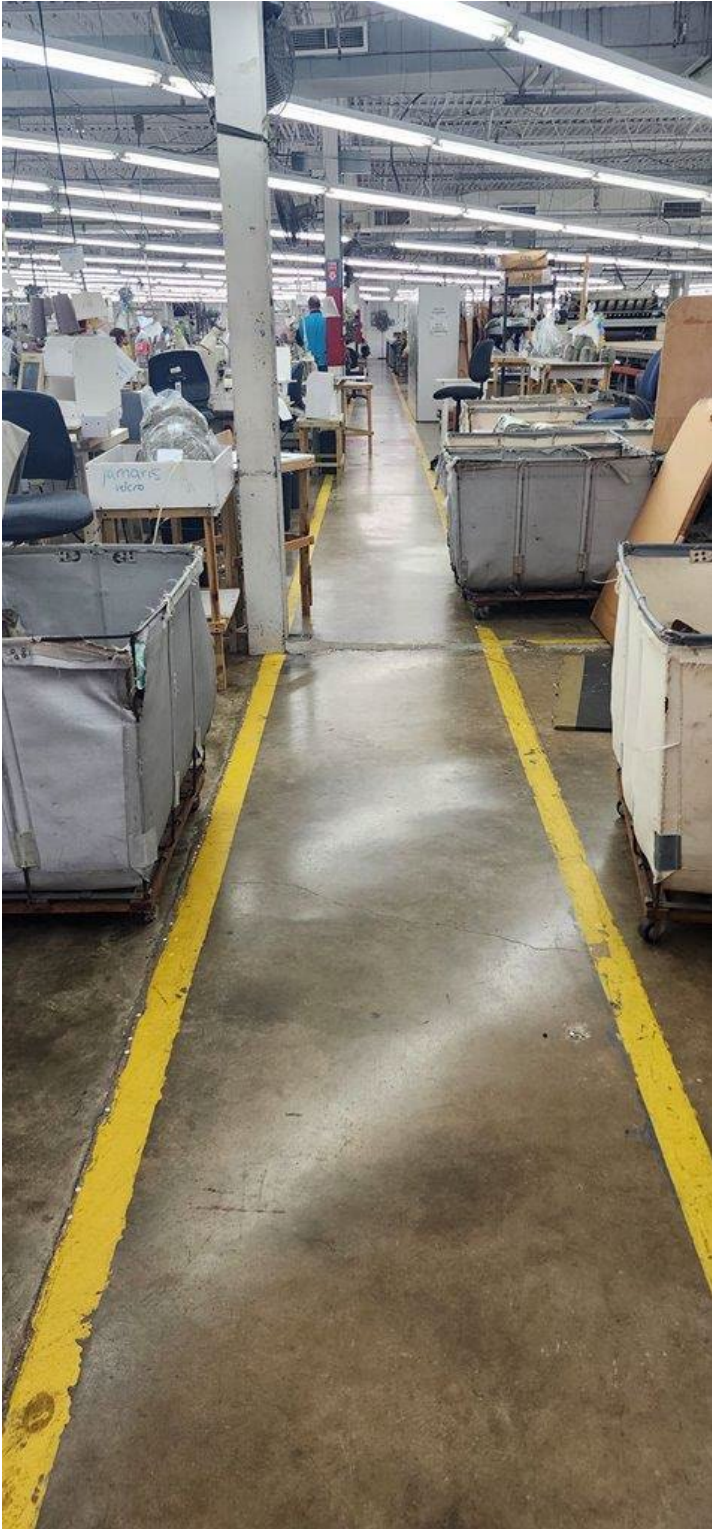
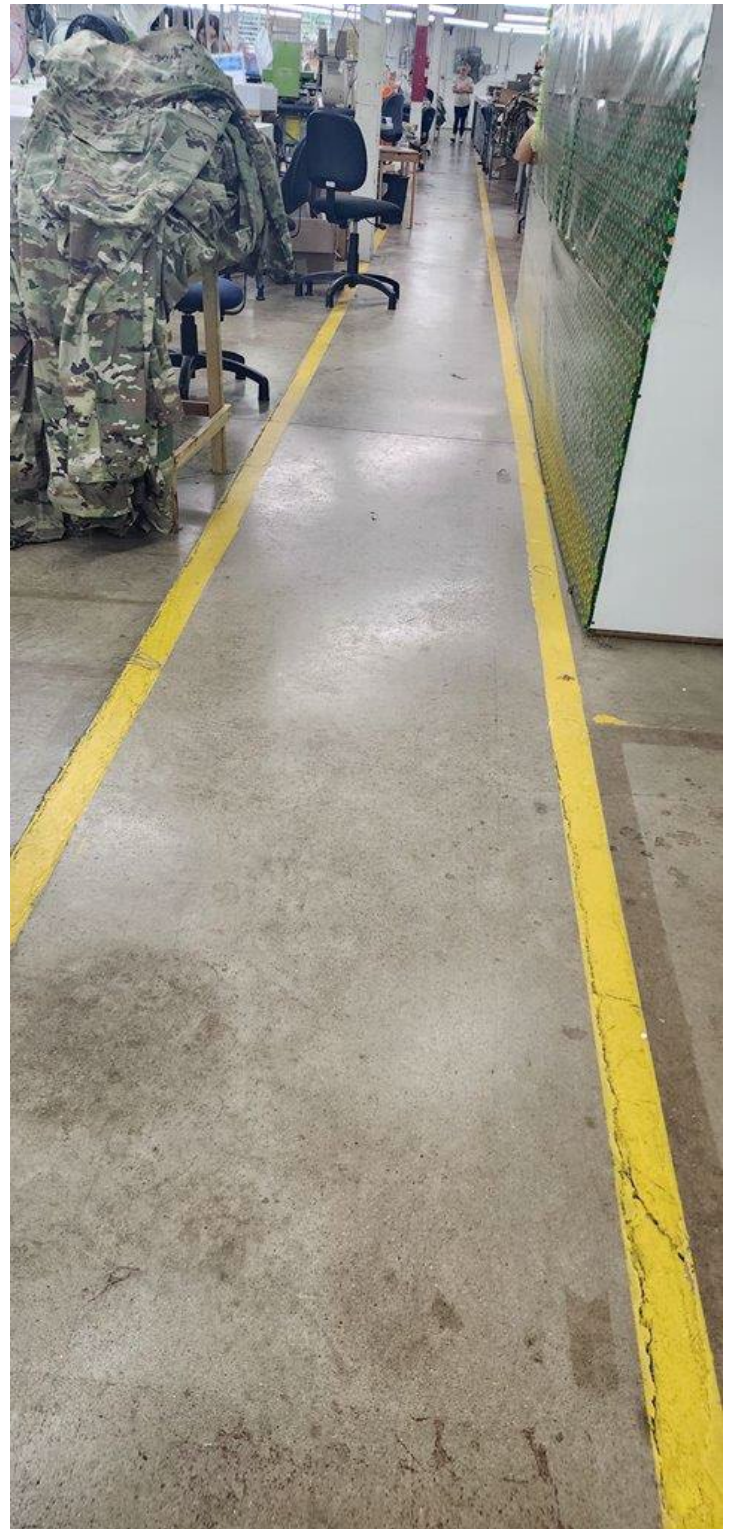
GENERAL VIEW OF POSITIVE INTERIOR, YELLOW, FLOOR GUIDE LINES (300 If total)

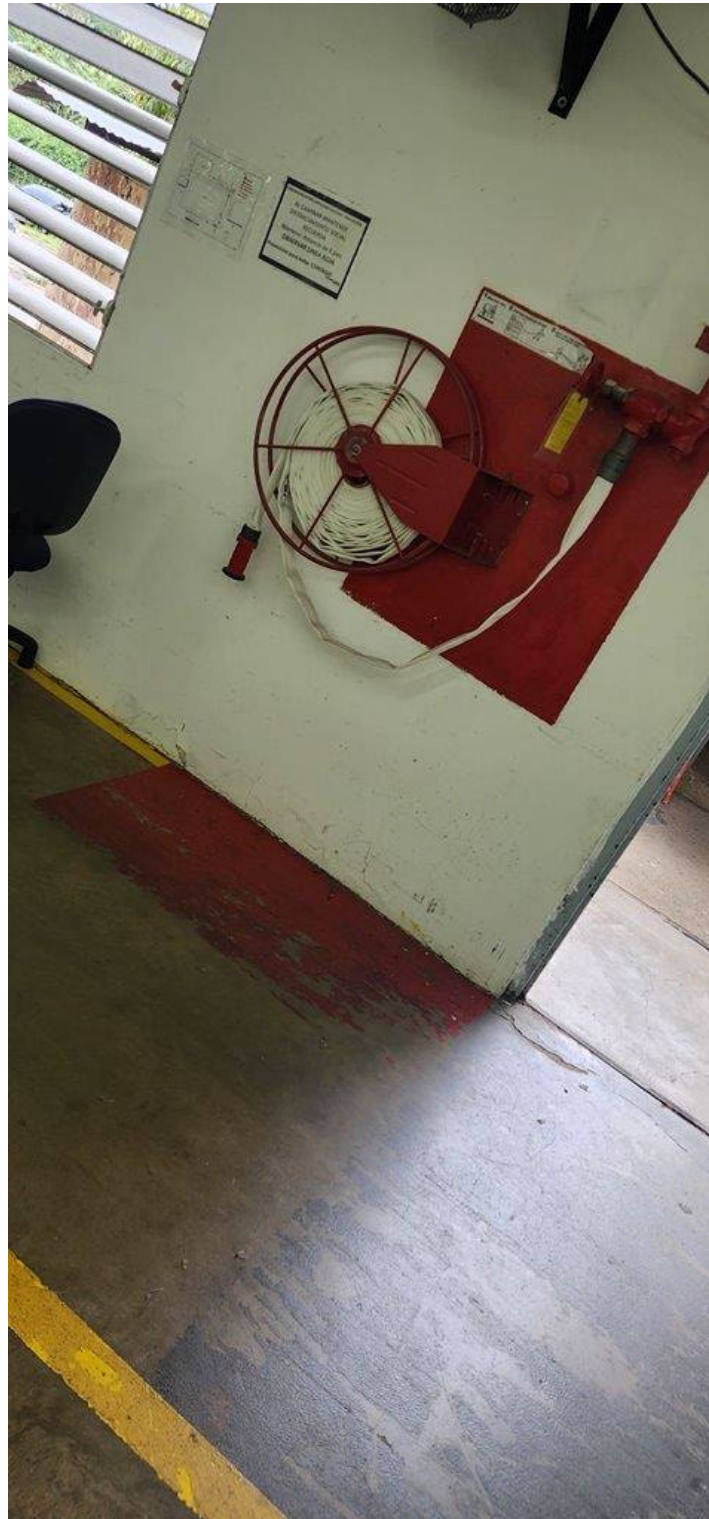
GENERAL VIEW OF POSITIVE INTERIOR, RED, FIRE EXTINGUISHER STATIONS (100 lf)
