Negative Lead & Asbesto Certification

Asbestos Containing Materials Inspection

**SAMPLING CONDUCTED AT:
BUILDING T085506700
(PW-7801) & (DI-219340)
NORTH REGION**

Located at Road PR-2 Km. 100.8 San Jose Ward in Quebradillas, PR

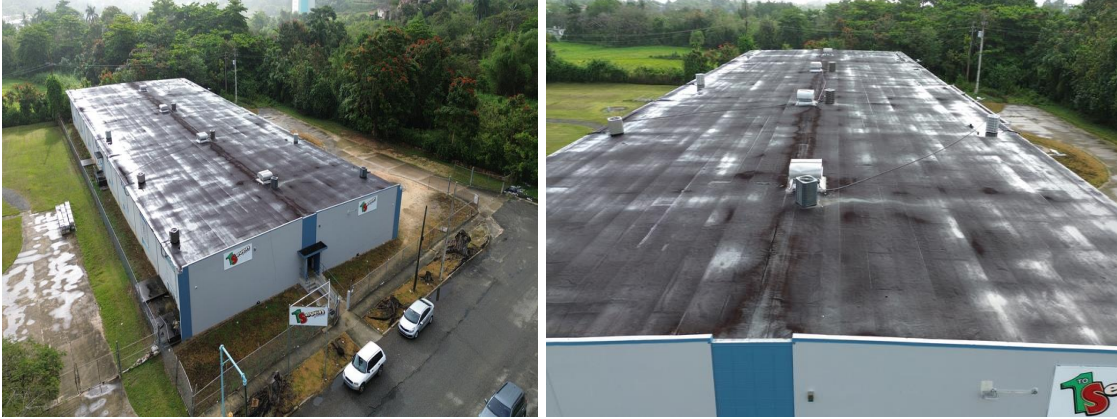
ROOFTOP AREAS -(BUILT TOP OR ROOF TREATMENT) TO THE DATE- NEW CONDITIONS- INSTALLED

NOTE: THE ASBESTOS INSPECTION OF THE EXTERIOR ROOF WAS NOT CARRIED OUT SINCE THE EXISTING MEMBRANE IS UNDER WARRANTY ACCORDING TO THE CLIENT'S INSTRUCTIONS.

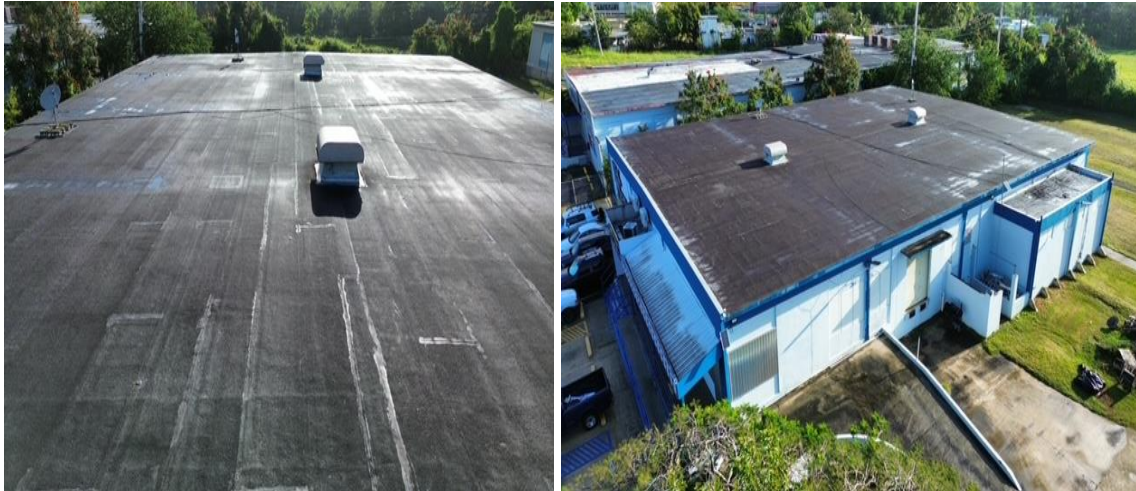
ROOFTOP AREAS -(BUILT TOP OR ROOF TREATMENT) TO THE DATE- NEW CONDITIONS- INSTALLATED

NOTE: THE ASBESTOS INSPECTION OF THE EXTERIOR ROOF WAS NOT CARRIED OUT SINCE THE EXISTING MEMBRANE IS UNDER WARRANTY ACCORDING TO THE CLIENT'S INSTRUCTIONS.

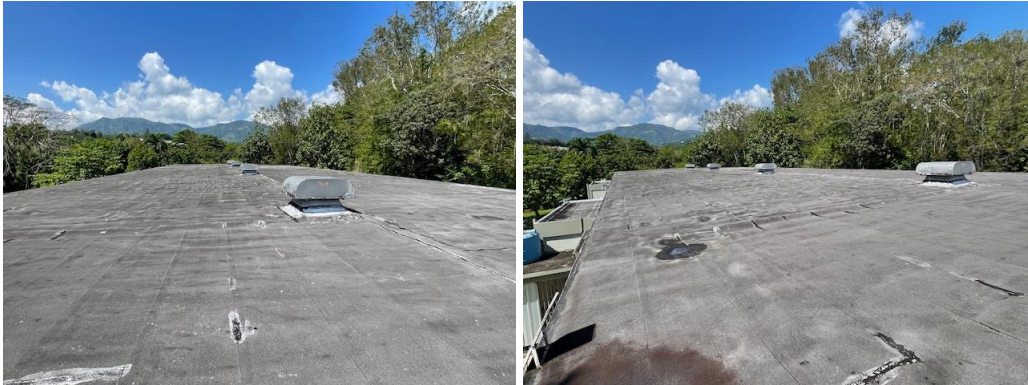
ROOFTOP AREAS -(BUILT TOP OR ROOF TREATMENT) TO THE DATE- NEW CONDITIONS- INSTALLED IN YEAR 2019-2020.

NOTE: THE ASBESTOS INSPECTION OF THE EXTERIOR ROOF WAS NOT CARRIED OUT SINCE THE EXISTING MEMBRANE IS UNDER WARRANTY ACCORDING TO THE CLIENT'S INSTRUCTIONS.

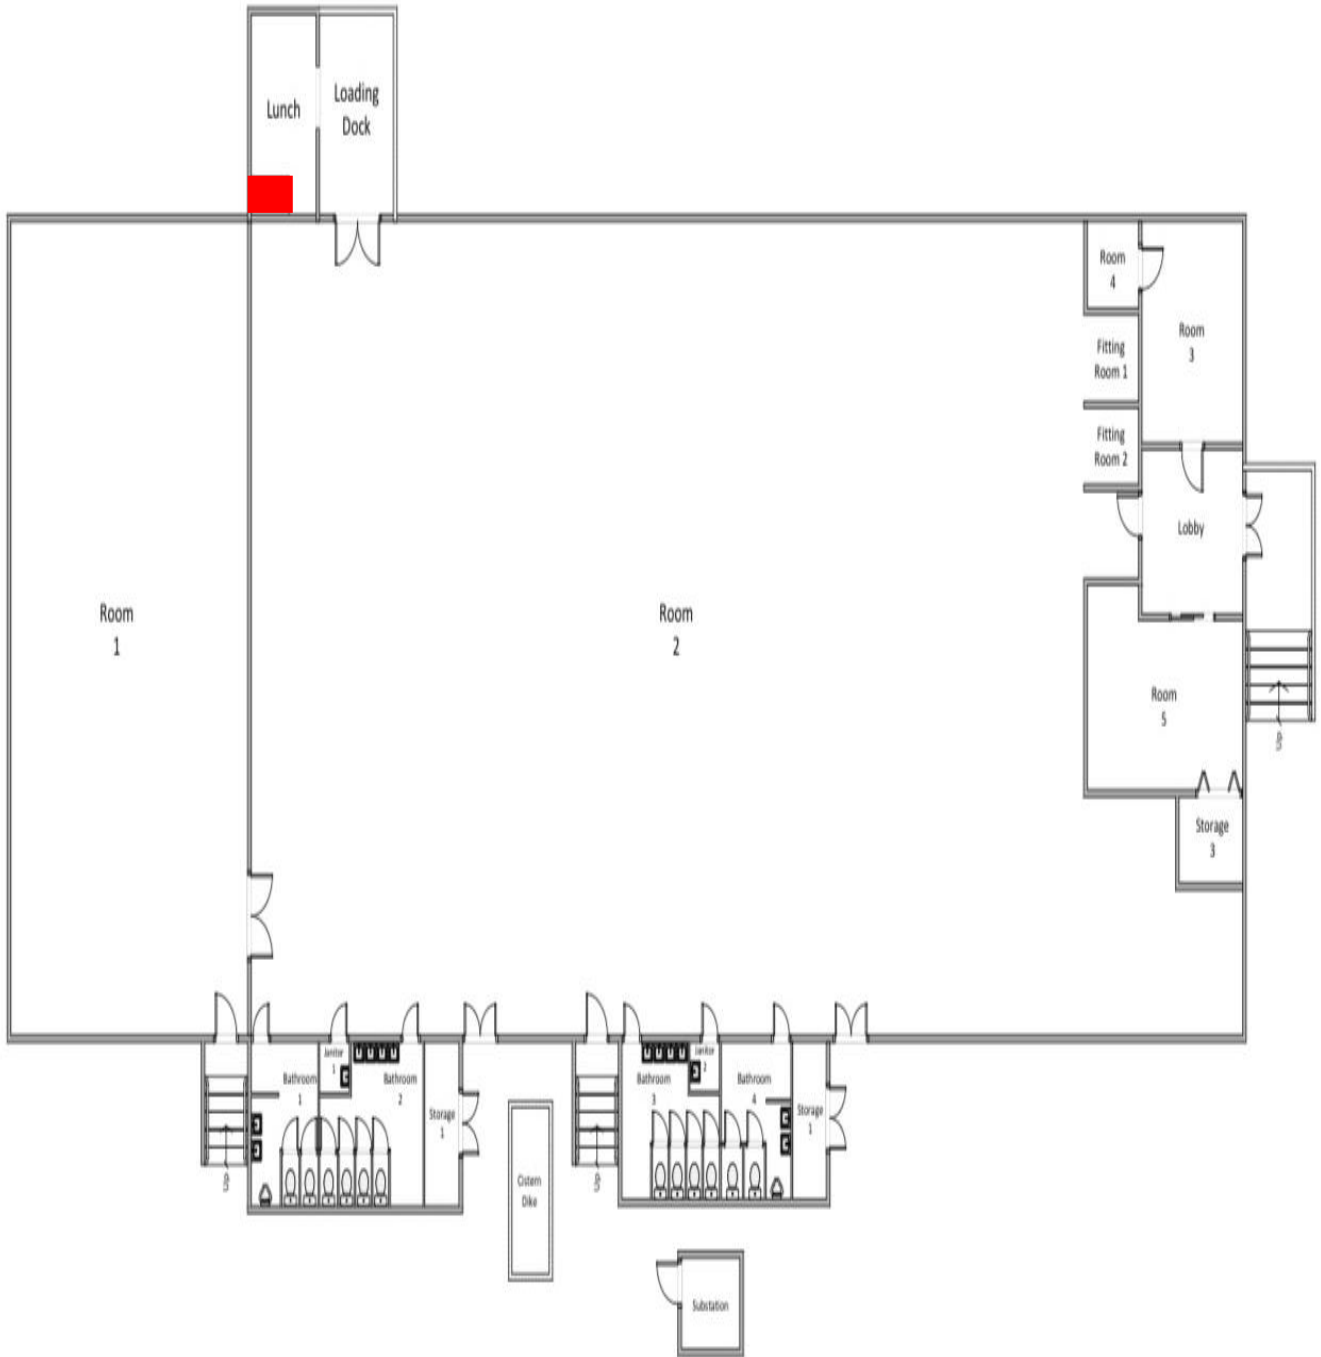
ACM POSITIVE RESULTS LOCATIONS

TABLE 1.0 – SUMMARY OF MATERIALS WITH ASBESTOS			
FUNCTIONAL SPACE	MATERIAL	% WITH ASBESTOS	SQ. FT. APPROX.
Lunch Area	Beige Mastic under sink	1% Chrysotile	4 sq. ft. approx. (1 Unit) (View Appendix VIII)

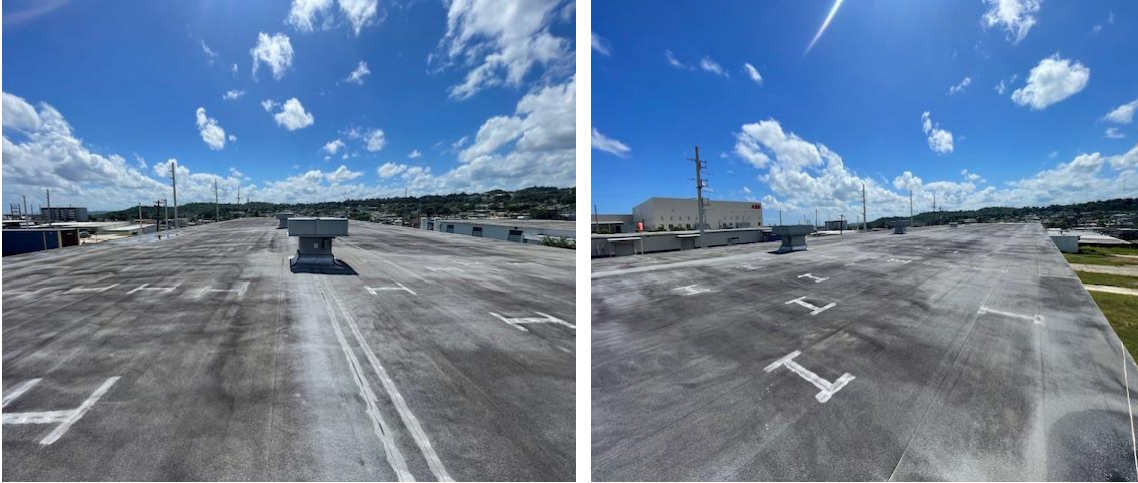
ROOFTOP AREAS -(BUILT TOP OR ROOF TREATMENT) TO THE DATE- NEW CONDITIONS

NOTE: THE ASBESTOS INSPECTION OF THE EXTERIOR ROOF WAS NOT CARRIED OUT SINCE THE EXISTING MEMBRANE IS UNDER WARRANTY ACCORDING TO THE CLIENT'S INSTRUCTIONS.

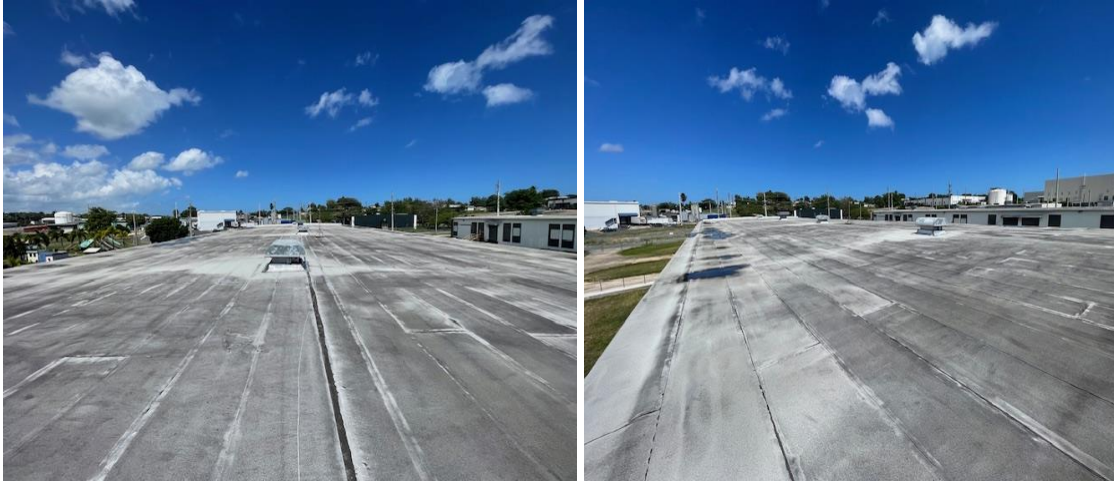
ROOFTOP AREAS -(BUILT TOP OR ROOF TREATMENT) TO THE DATE- NEW CONDITIONS

NOTE: THE ASBESTOS INSPECTION OF THE EXTERIOR ROOF WAS NOT CARRIED OUT SINCE THE EXISTING MEMBRANE IS UNDER WARRANTY ACCORDING TO THE CLIENT'S INSTRUCTIONS.
