# Lead & Asbestos Certification

# **ASBESTOS CONTAINING MATERIALS SURVEY**

**PRAMA Corp. S056506201**

**PW-8329 DI-219206**

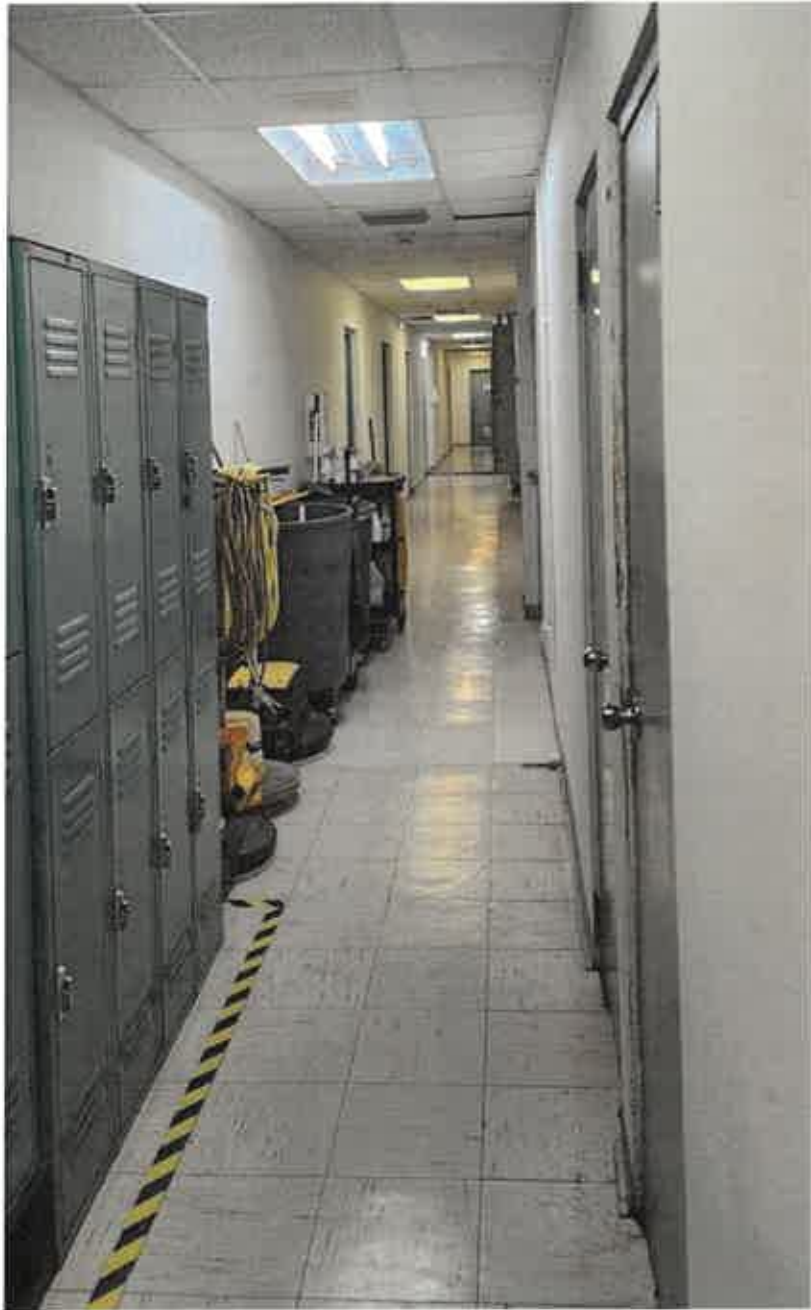
**Main Entrance Foyer, Hallway Floor Vinyl Tile, 800 ft<sup>2</sup>**
