LEAD & ASBESTOS CERTIFICATION

ASBESTOS CONTAINING MATERIALS

T13940861
PW: 8583 / DI: 407866
PR-860 Bo. Las Cuevas
Trujillo Alto, P.R.

PRIDCO

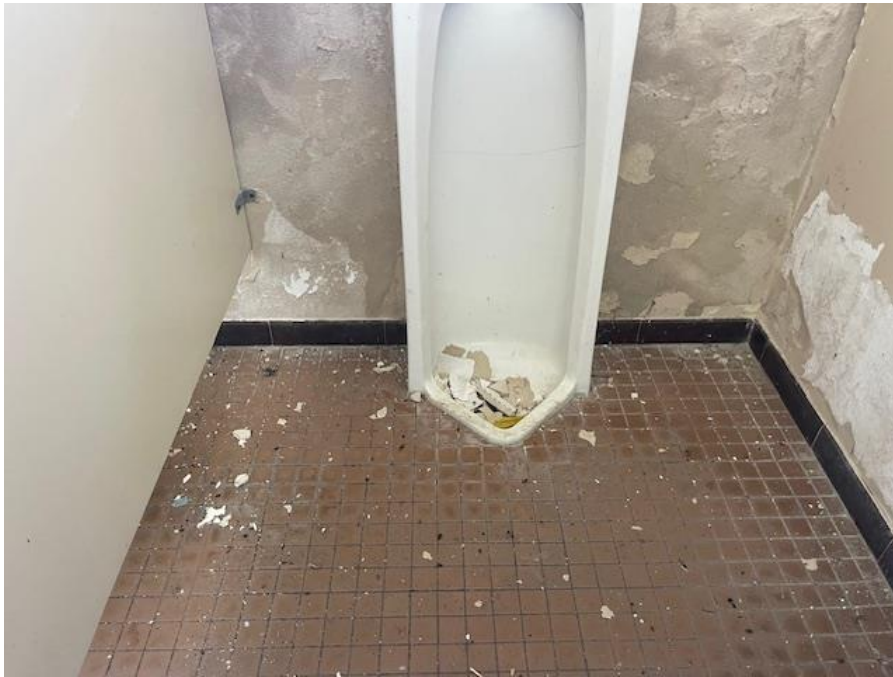
Bathroom 1- Ceramic Baseboards Tiles with Lead Based Paint

Global Environmental Services LLC recommends the owner or representative of owner to hire a Company Certified in the Department of Natural and Environmental Resources (DNER) of Puerto Rico to mitigate and dispose positive areas with Lead Based Paint if is going to touch or demolish the aforementioned areas.

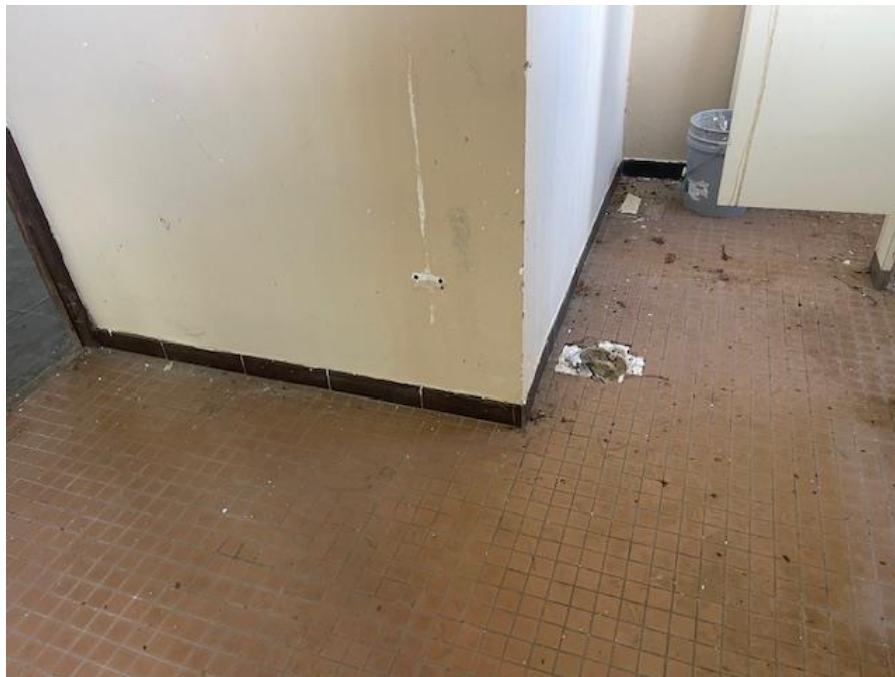
Bathroom 2- Ceramic Baseboards Tiles with Lead Based Paint

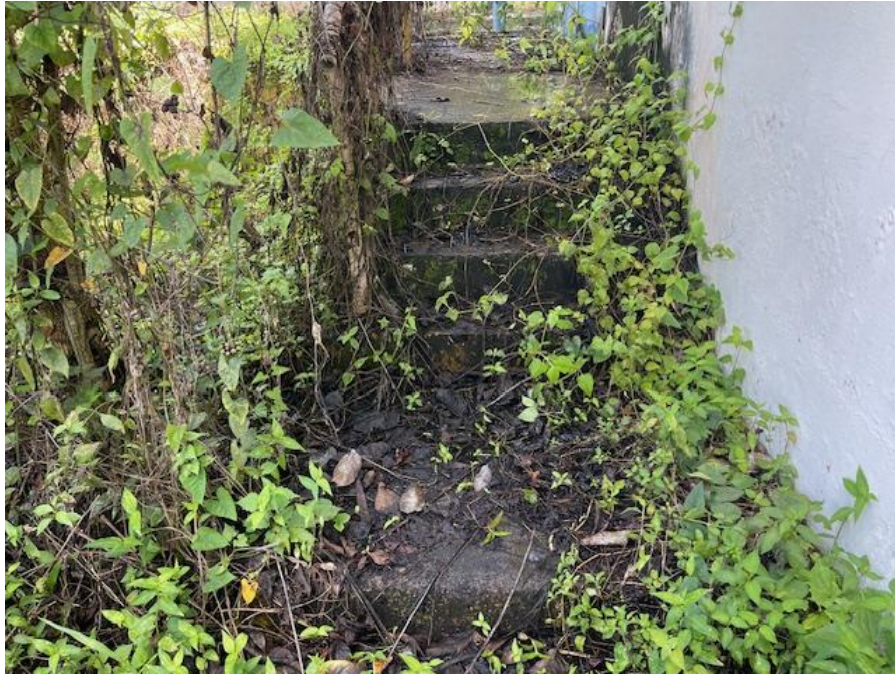
Exterior- Stair- Concrete Floor with Lead Based Paint

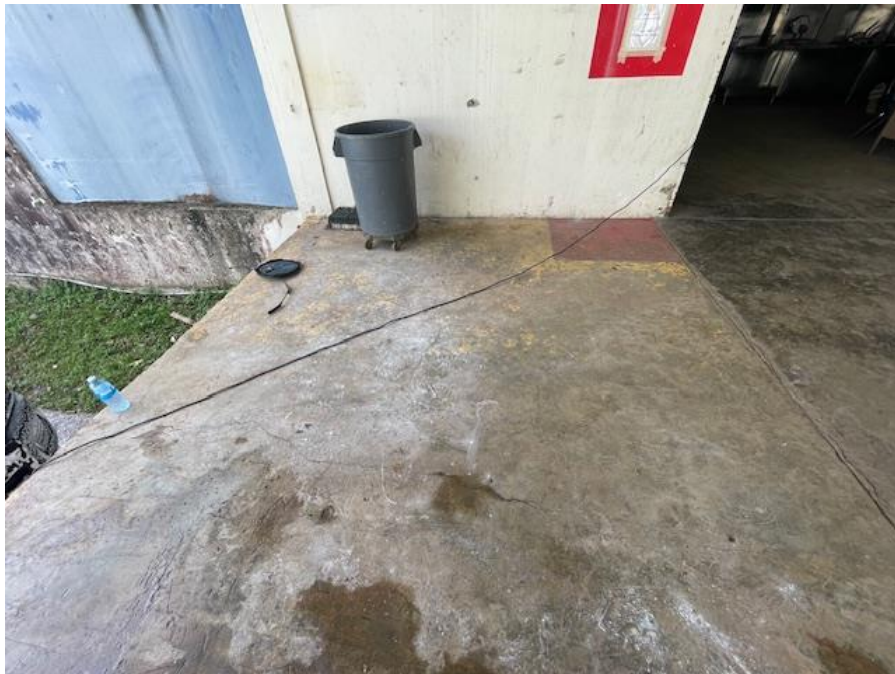
Loading Dock- Concrete Floor with Lead Based Paint

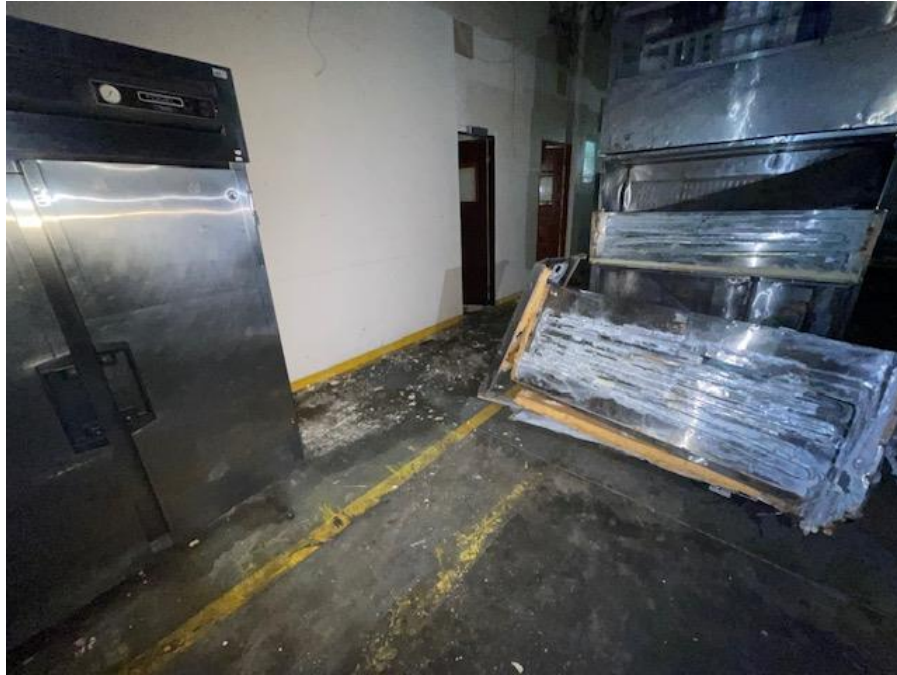
Room 1- Yellow All Floor Lines with Lead Based Paint

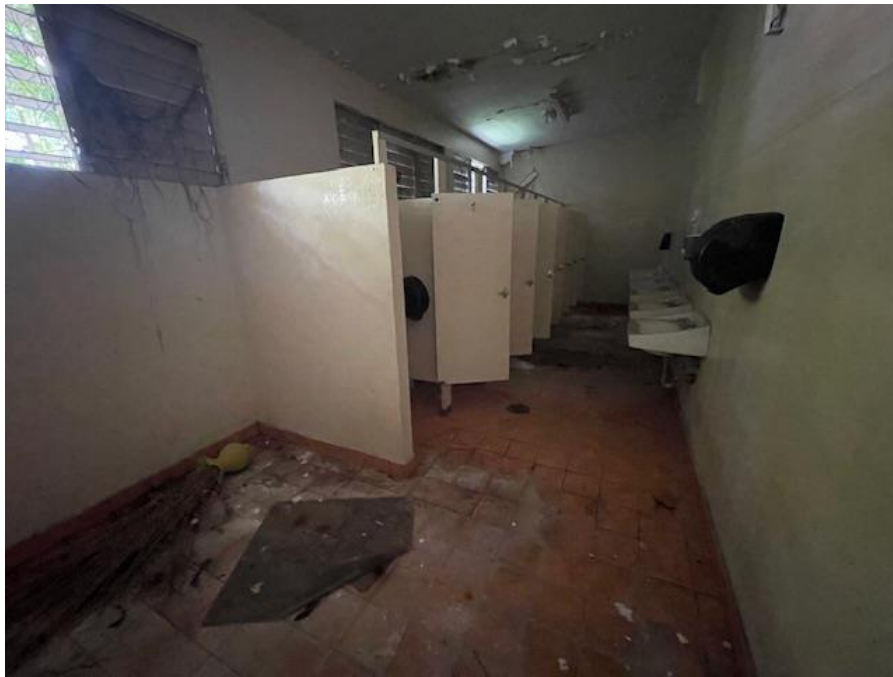
Bathroom 6- Ceramic Floor Tiles & Baseboards Tiles with Lead Based Paint

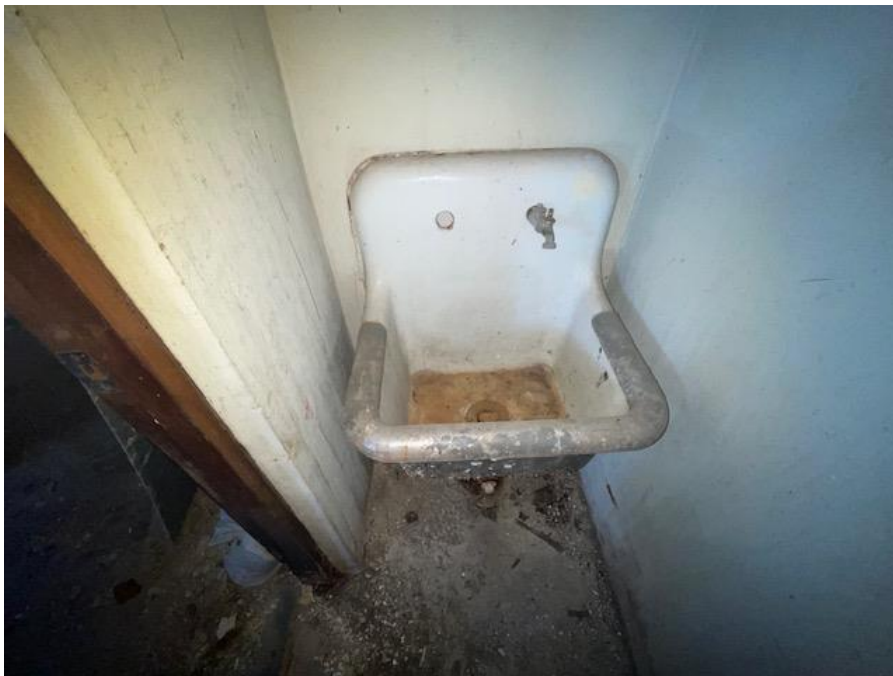
Janitor 2- Ceramic Sink with Lead Based Paint

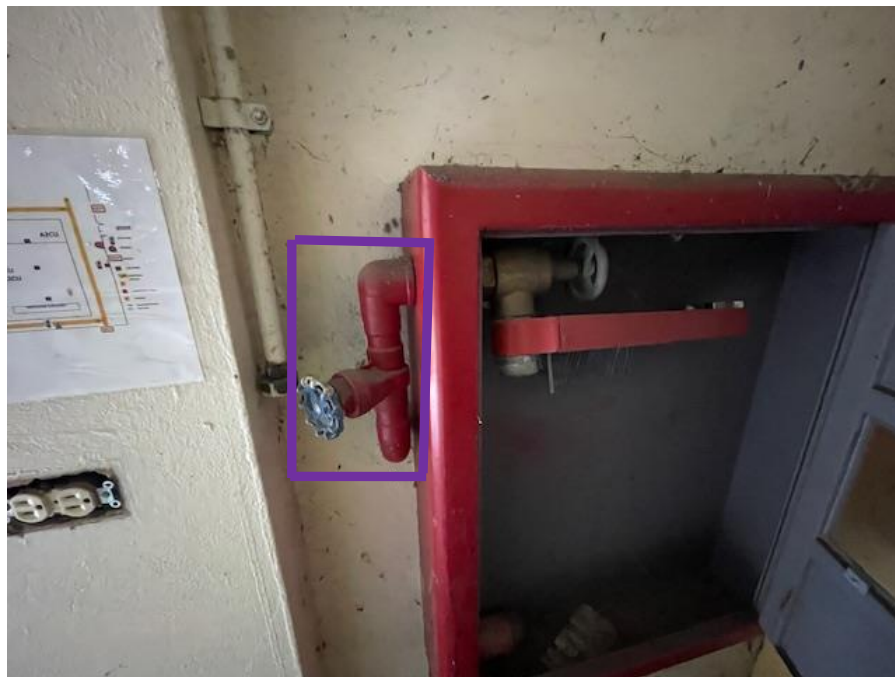
Room 1- Red Metal Pipe with Lead Based Paint

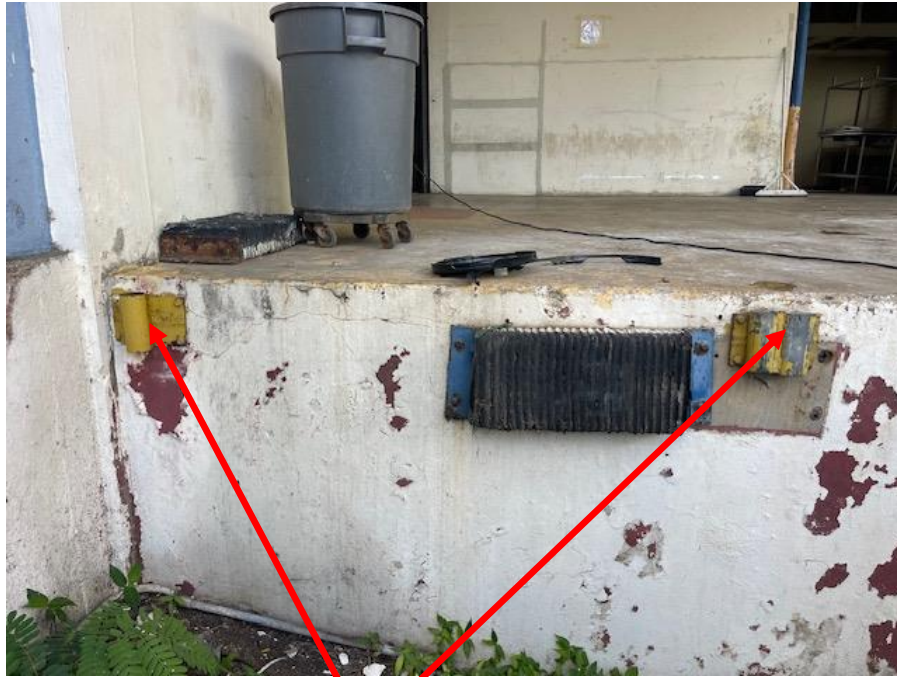
Loading Dock- Yellow Metal Bases with Lead Based Paint
