POLES CONDITION ASSESSMENT REPORT

PROJECT: HURRICANE MARIA DAMAGES REPAIRS
TO ROOSEVELT ROADS ELECTRICAL
SYSTEM (19-1741)

LOCATION: Roosevelt Roads,
Ceiba, PR

DATE: May 17, 2018

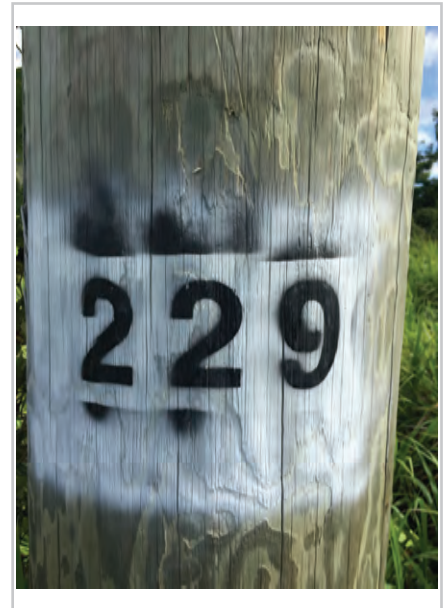
Photo 1: Pole Identification

Comments: ^{ONLY GROUND CONNECTED, MISSING INSULATORS} _____

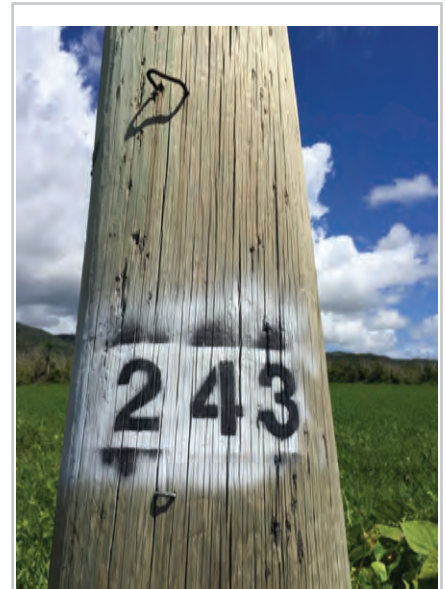
Photo 1: Pole Identification

Comments: ^{PHASE CONDUCTORS AT GROUND, STANDARD BROKEN} _____

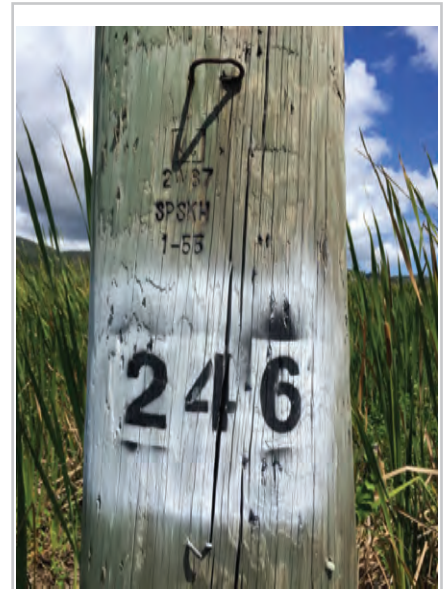
Photo 1: Pole Identification

Comments: PHASES CONDUCTORS AT GROUND, STANDARD BROKEN

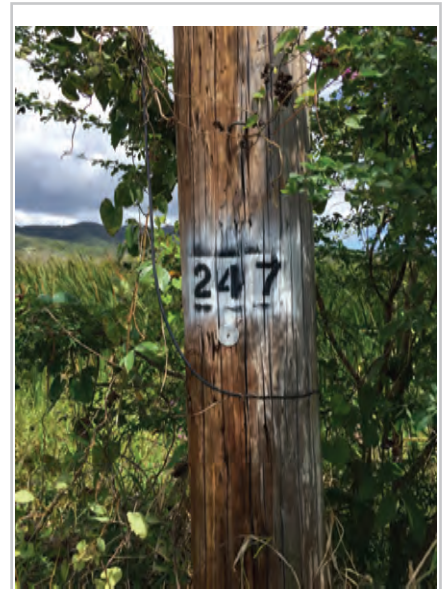
Photo 1: Pole Identification

Comments: ^{PHASES CONDUCTORS AT GROUND, STANDARD BROKEN} _____

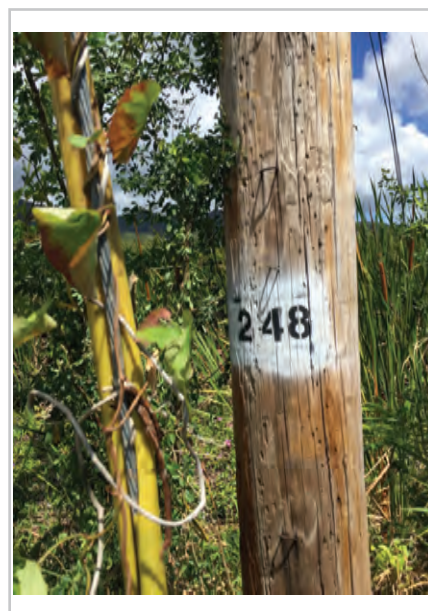
Photo 1: Pole Identification

Comments: ^{PHASES CONDUCTORS AT GROUND, STANDARD BROKEN} _____

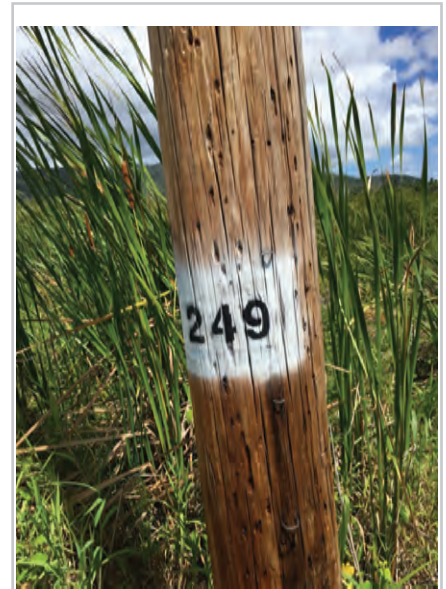
Photo 1: Pole Identification

Comments: ^{PHASES CONDUCTORS AT GROUND, STANDARD BROKEN} _____

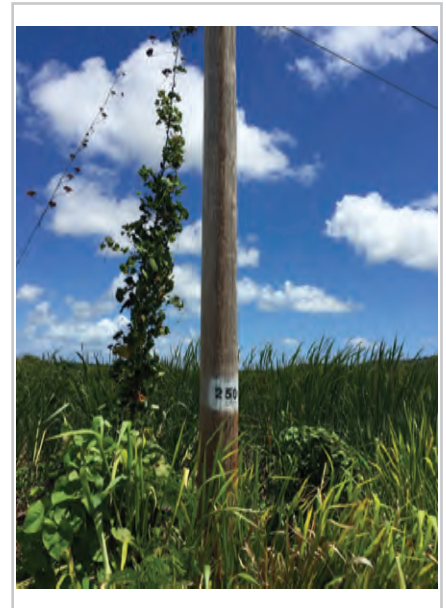
Photo 1: Pole Identification

Comments: PHASES CONDUCTORS AT GROUND, STANDARD BROKEN

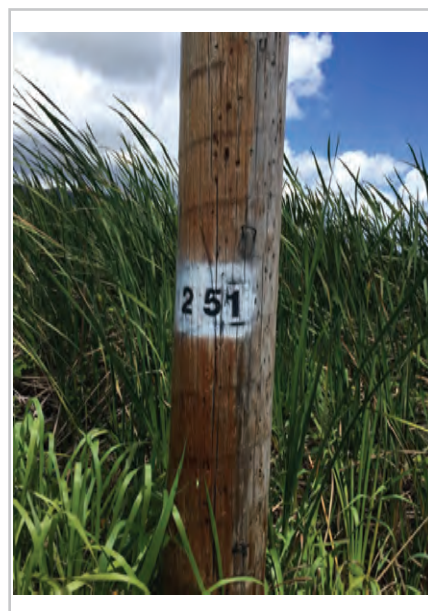
Photo 1: Pole Identification

Comments: ^{PHASES CONDUCTORS AT GROUND, STANDARD BROKEN} _____

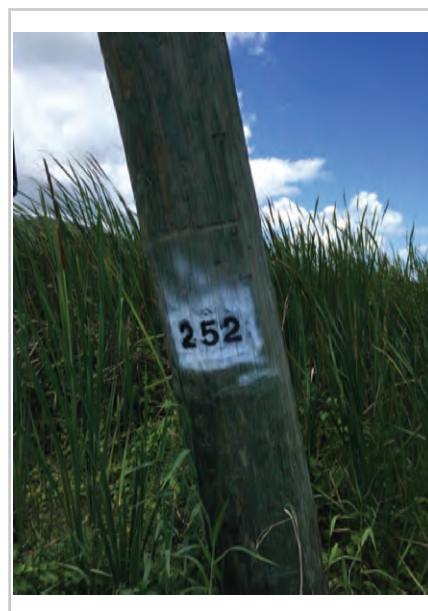
Photo 1: Pole Identification

Comments: ^{PHASES CONDUCTORS AT GROUND, STANDARD BROKEN} _____

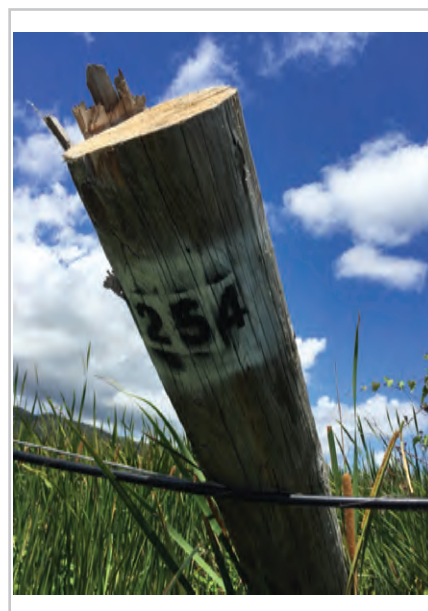
Photo 1: Pole Identification

Condition: ^{BROKEN AT FLOOR} _____

Comments: ^{PHASES CONDUCTORS AND POLE BROKEN AT FLOOR} _____

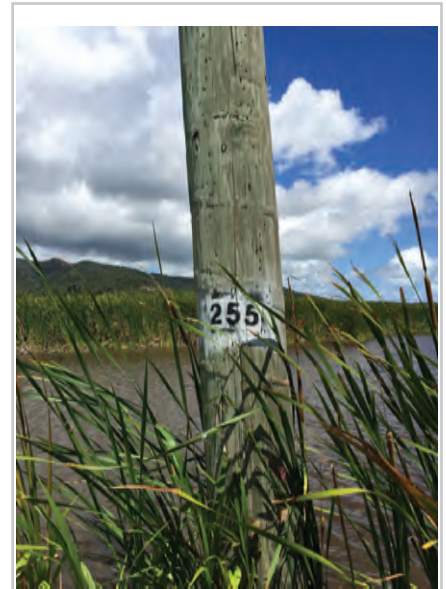
Photo 1: Pole Identification

Comments: ^{PHASES CONDUCTORS AT GROUND, STANDARD BROKEN} _____

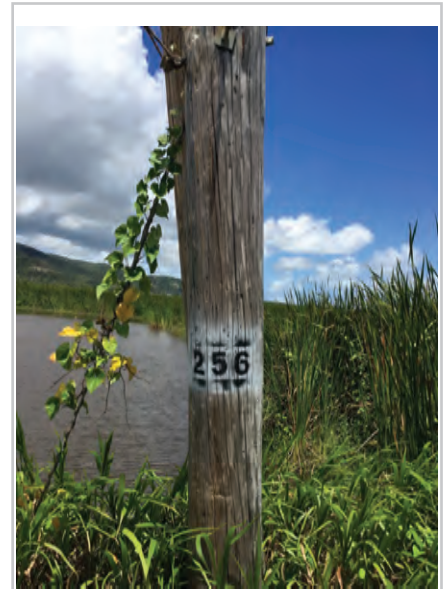
Photo 1: Pole Identification

Condition: ^{BROKEN AT FLOOR} _____

Comments: ^{PHASES CONDUCTORS AND POLE BROKEN AT FLOOR} _____

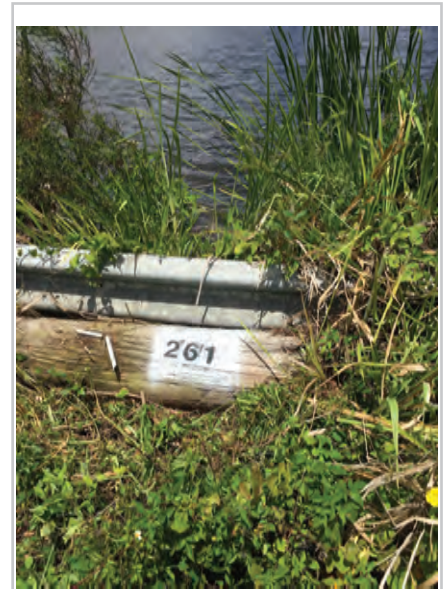
Photo 1: Pole Identification

Condition: ^{BROKEN AT FLOOR} _____

Comments: ^{PHASES CONDUCTORS AND POLE BROKEN AT FLOOR} _____

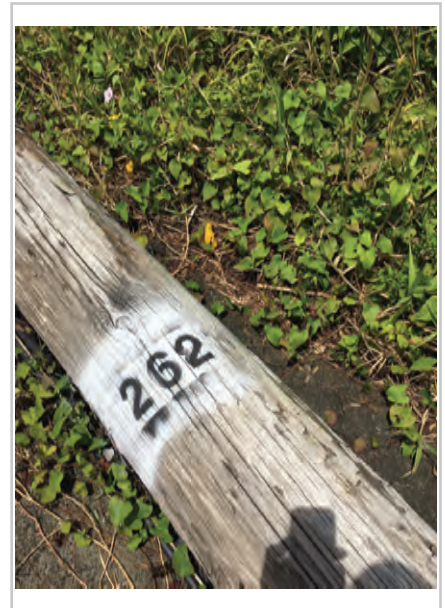
Photo 1: Pole Identification

Condition: ^{BROKEN AT FLOOR} _____

Comments: ^{PHASES CONDUCTORS AND POLE BROKEN AT FLOOR} _____

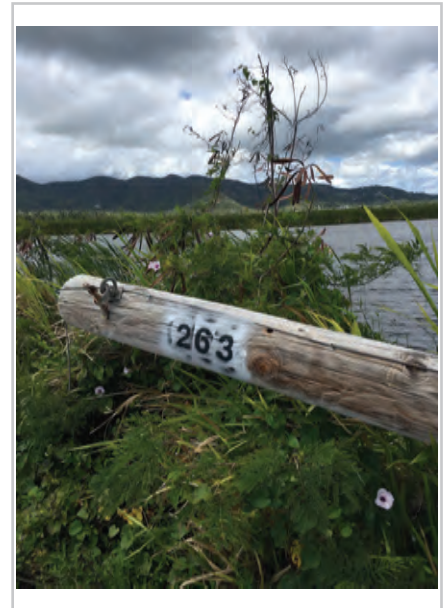
Photo 1: Pole Identification

Condition: ^{BROKEN AT FLOOR} _____

Comments: ^{PHASES CONDUCTORS AND POLE BROKEN AT FLOOR} _____

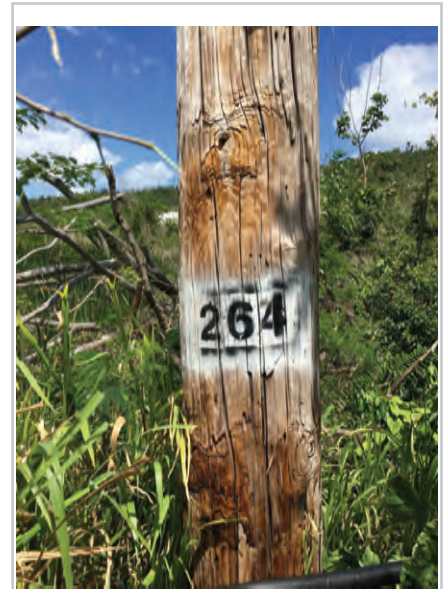
Photo 1: Pole Identification

Comments: ^{PHASES CONDUCTORS AT GROUND, STANDARD BROKEN} _____

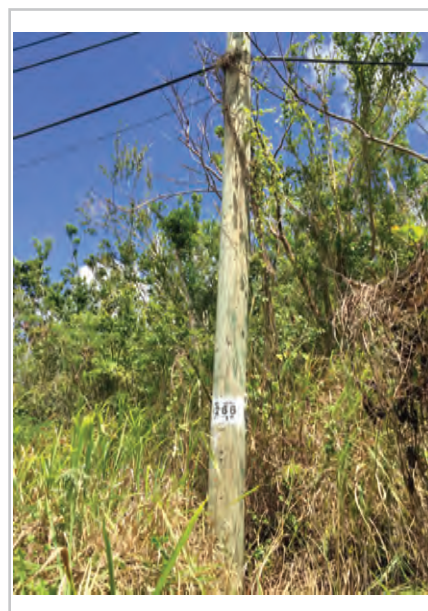
Photo 1: Pole Identification

Comments: INSULATOR BROKEN

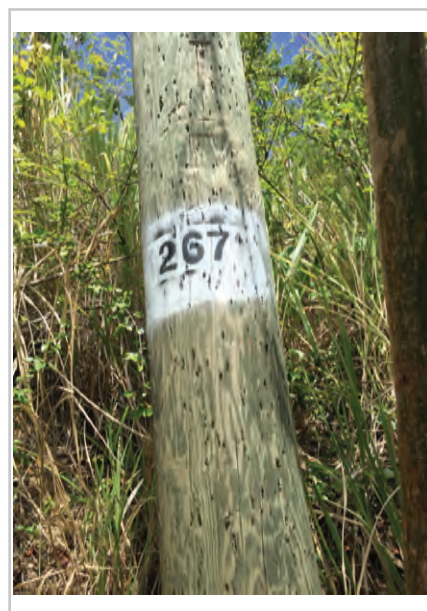
Photo 1: Pole Identification

Comments: ^{STANDARD BROKEN} _____

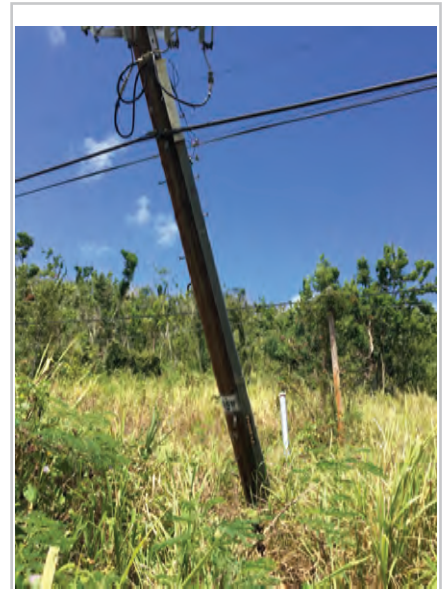
Photo 1: Pole Identification

Condition: BROKEN AT TOP AND BASE, VERY INCLINED

Comments: 38 KV STANDARD BROKEN AND CONDUCTORS AT GROUND

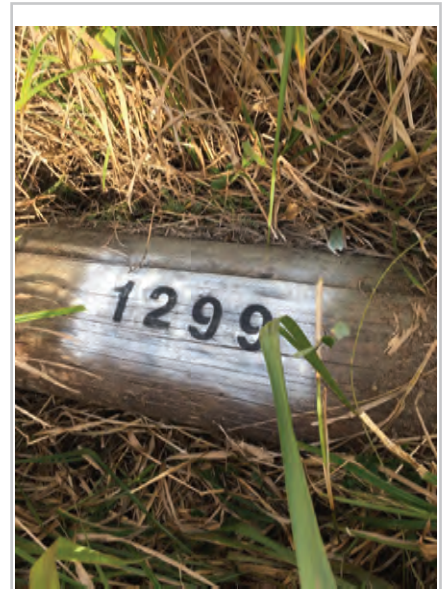
Photo 1: Pole Identification

Condition: ^{BROKEN} _____

Comments: ^{POLE BROKEN, PART OF POLE HANGING FROM LINES} _____

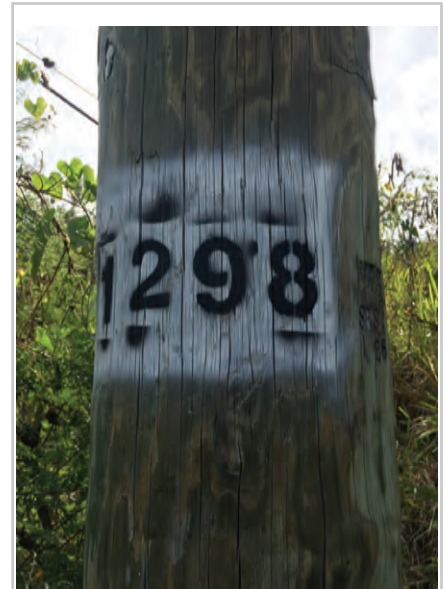
Photo 1: Pole Identification

Comments: ^{POLE BROKEN, PART OF POLE HANGING FROM LINES} _____

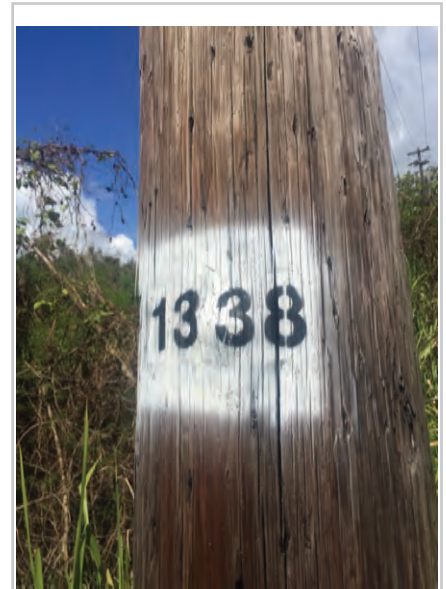
Photo 1: Pole Identification

Condition: ^{BROKEN AT BASE} _____

Comments: ^{NOT ANCHORED STANDARD NOT EXIST, ANCHORED STANDARD} _____

CROOS ARM DAMAGED

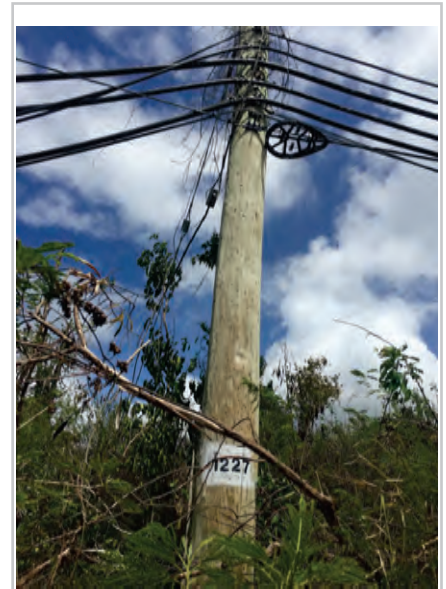
Photo 1: Pole Identification

Condition: BROKEN

Comments: DAMAGE BY LIGHTNING OR FIRE

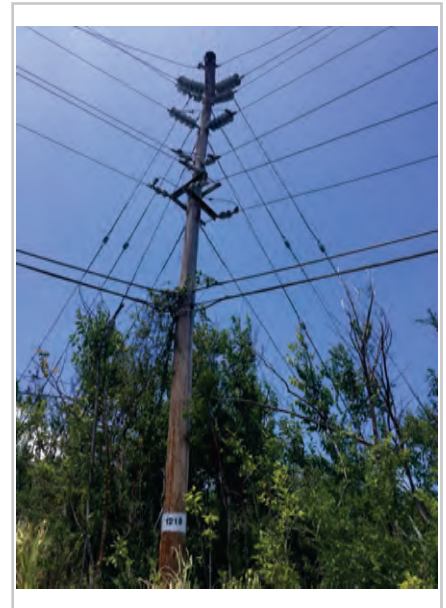
Photo 1: Pole Identification

Comments: ^{BROKEN AT TOP} _____

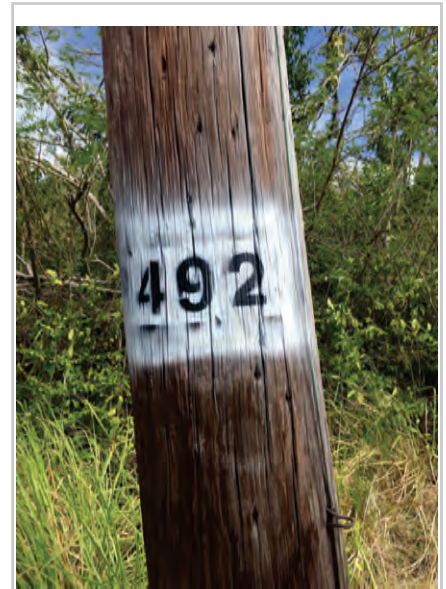
Photo 1: Pole Identification

Comments: BROKEN WOOD CROSS ARMS AND CONDUCTORS FALLEN

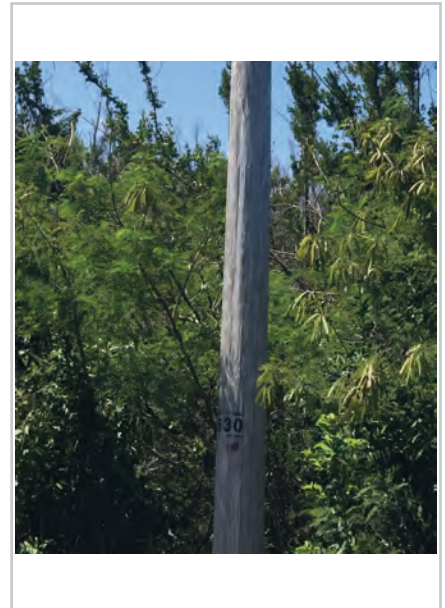
Photo 1: Pole Identification

Comments: CRACKED AT BASE

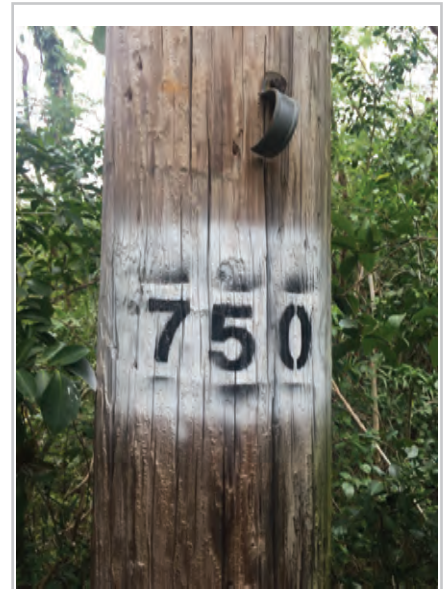
Photo 1: Pole Identification

Comments: ^{CRACKED AT BASE} _____
N/A

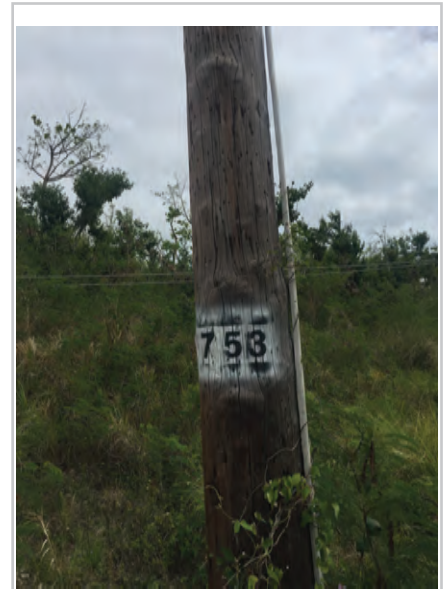
Photo 1: Pole Identification

Comments: ^{SOME CONDUCTORS OUT OF POSITION AND LOOSE CONDUCTORS} _____

DAMAGE CROOS ARMS

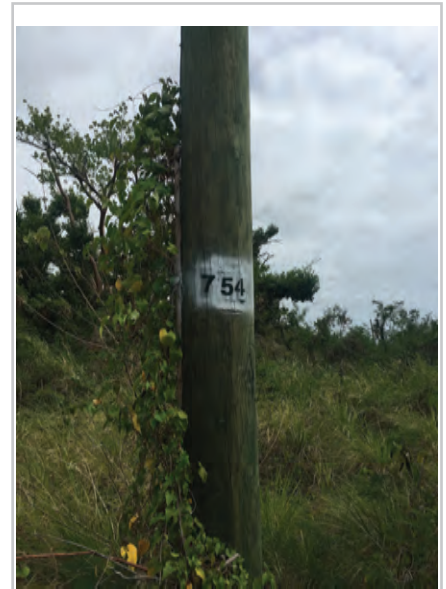
Photo 1: Pole Identification

Comments: LOOSE CONDUCTORS AND FALLEN ONE SIDE GROUND CONDUCTOR

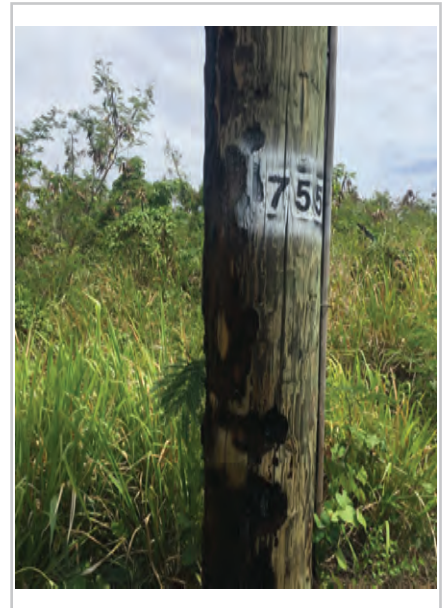
Photo 1: Pole Identification

Comments: ^{FIRE DAMAGE AT POLE BASE}_____

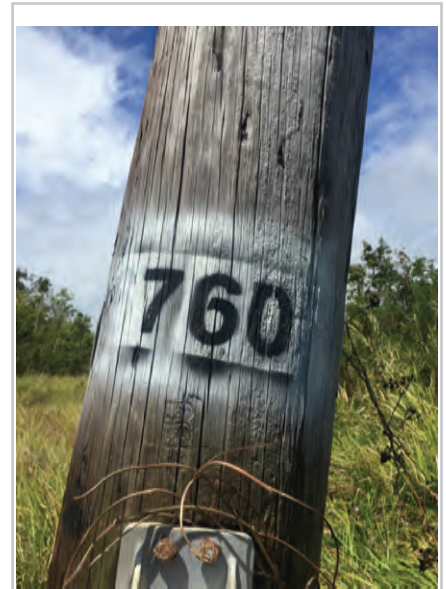
Photo 1: Pole Identification

Comments: ^{CROSS ARMS ARE MIS ALIGNED AND 13.2 LOAD BREAK IS INSTALLED} _____

ON WOOD CROSS ARMS, OPERATING HANDLE NEED REPAIR AND PARTS

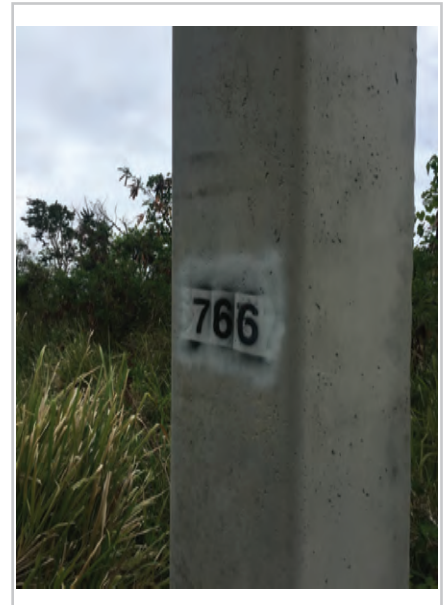
Photo 1: Pole Identification

Comments: ONE SIDE OF OVERHEAD GROUND CONDUCTOR IS LOOSED

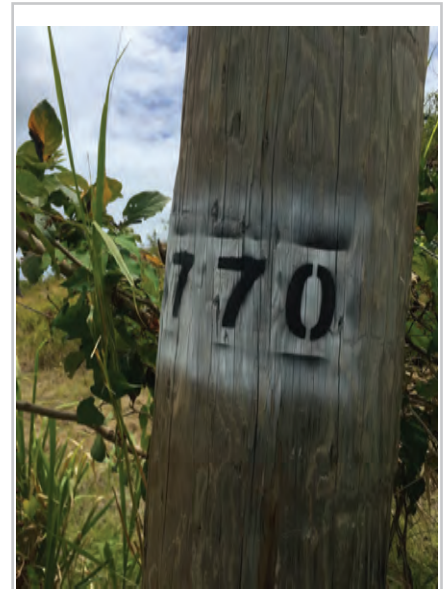
Photo 1: Pole Identification

Comments: ^{BROKEN CROSS ARMS, MIS ALIGNED AND LOOSE CONDUCTORS} _____

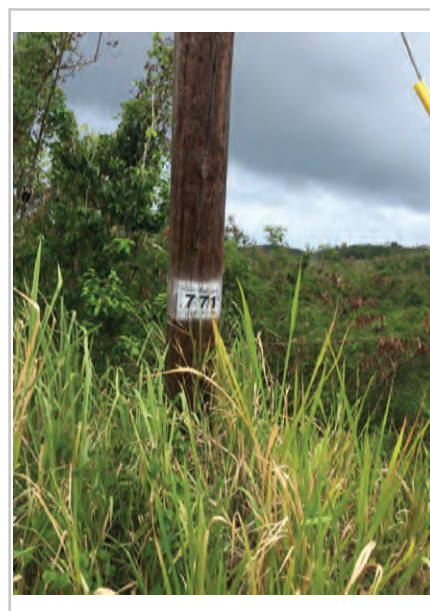
Photo 1: Pole Identification

Comments: ^{OVERHEAD GROUND CONDUCTOR LOOSE OR FALLEN} _____

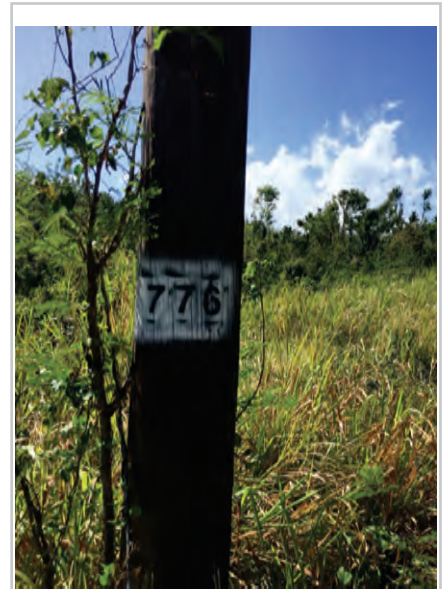
Photo 1: Pole Identification

Comments: ^{CROSS ARMS BROKEN AND MIS ALIGNED, SOME CONDUCTORS} _____

FALLEN OR MISSED

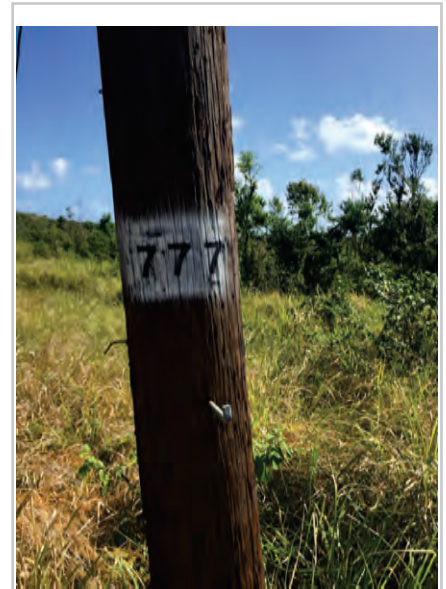
Photo 1: Pole Identification

Comments: CROSS ARMS BROKEN AND MIS ALIGNED, SOME CONDUCTORS

FALLEN OR MISSED

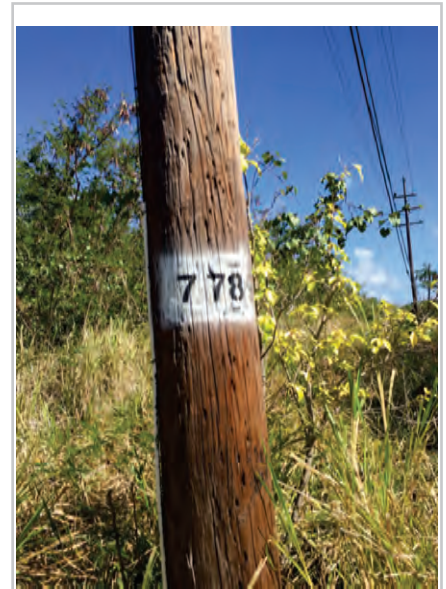
Photo 1: Pole Identification

Comments: ^{CROSS ARMS BROKEN OR MIS ALIGNED, SOME CONDUCTORS} _____

FALLEN OR MISSED

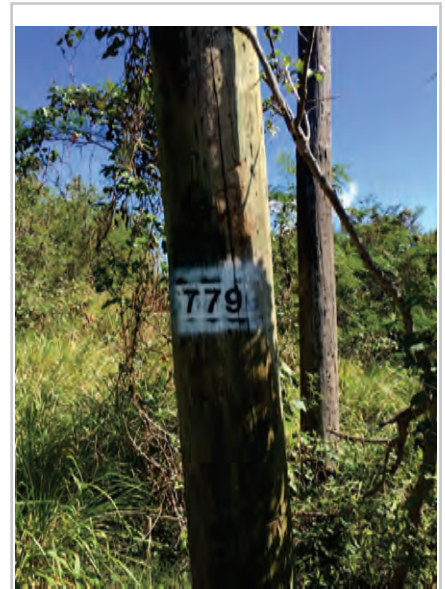
Photo 1: Pole Identification

Comments: NOT EXIST SECONDARY LINES, CROSS ARMS MIS ALIGNED,

38 KV INSULATORS DAMAGED, FUSED CUT OUT FOR TRANSFORMER

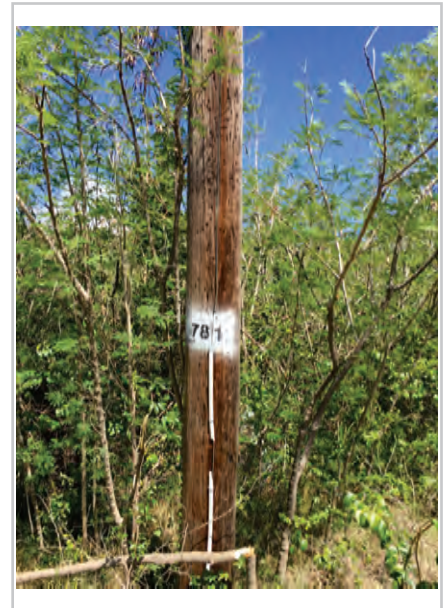
Photo 1: Pole Identification

Comments: ^{ANCHORED WITH WOOD CROSS ARM STANDARD FOR PRIMARY TAP} _____

WITH FUSED CUT OUT, CROSS ARMS BROKEN OR MIS ALIGNED

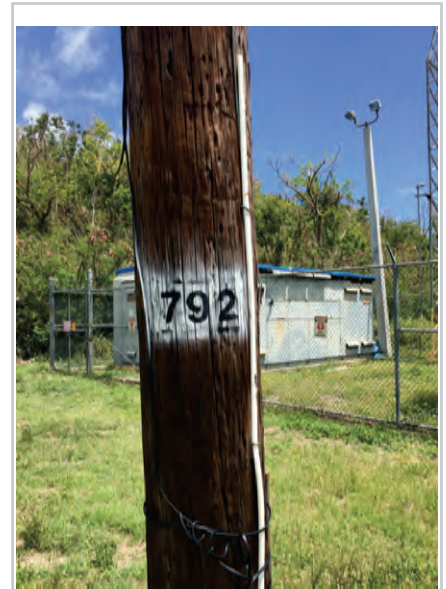
Photo 1: Pole Identification

Comments: ^{CROSS ARMS MIS ALIGNED AND DAMAGED}_____

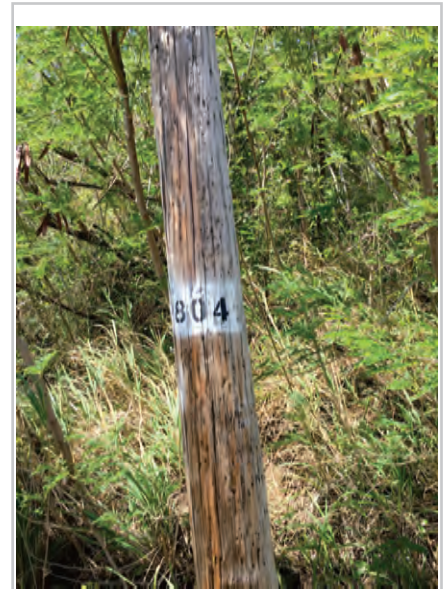
Photo 1: Pole Identification

Comments: ^{CROSS ARM DAMAGED, SOME CONDUCTORS FALLEN} _____
N/A

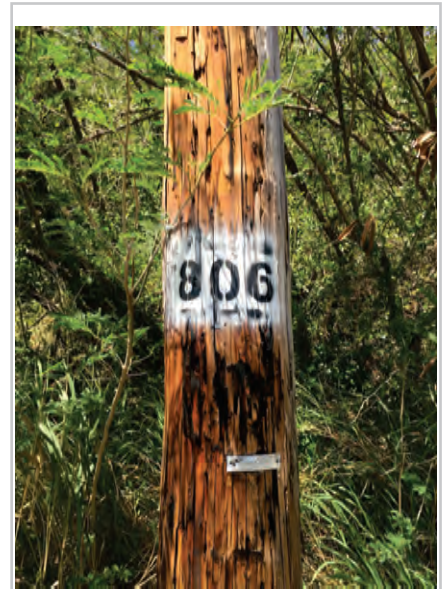
Photo 1: Pole Identification

Comments: CONDUCTORS ARE LOOSED

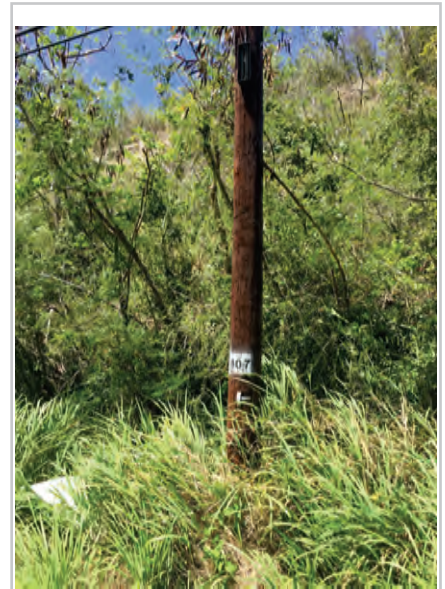
Photo 1: Pole Identification

Comments: ^{CONDUCTORS ARE LOOSED} _____
N/A

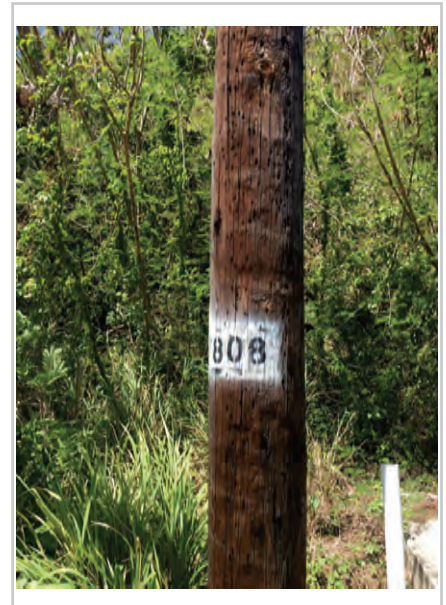
Photo 1: Pole Identification

Comments: ^{CONDUCTORS ARE LOOSED AND LIGHTNING ARRESTER ON WOOD} _____
^{CROSS ARM} _____

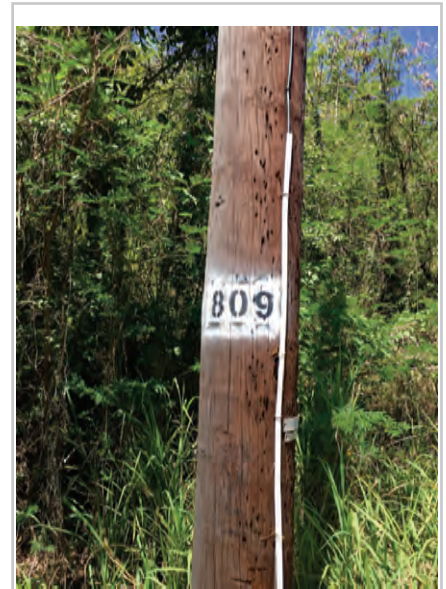
Photo 1: Pole Identification

Comments: ^{CONDUCTORS ARE LOOSED} _____
N/A

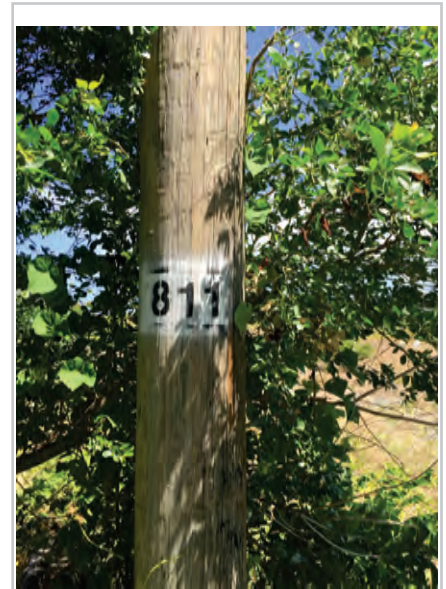
Photo 1: Pole Identification

Comments: ^{CONDUCTORS LOOSED AND OUT OF POSITION} _____
N/A

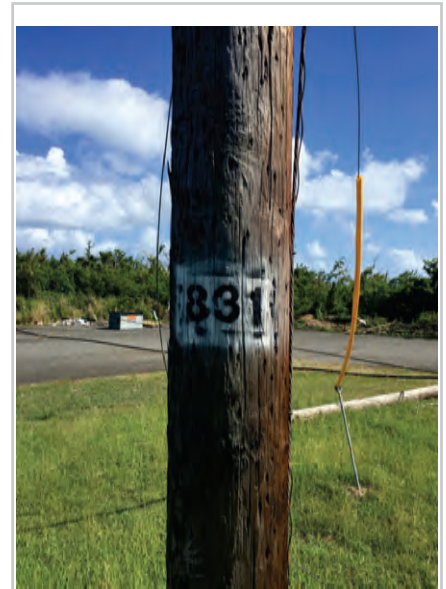
Photo 1: Pole Identification

Comments: FUSED CUT OUT INSTALLED ON WOOD CROSS ARM FOR PRIMARY
LINE, AT ONE SIDE PRIMARY LINES ON GROUND, CROSS ARMS DAMAGED

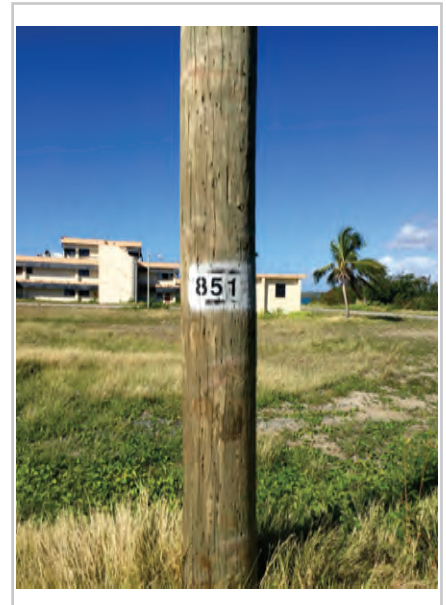
Photo 1: Pole Identification

Comments: ^{38 KV INSULATOR DAMAGED, SOME CONDUCTORS FALLEN} _____

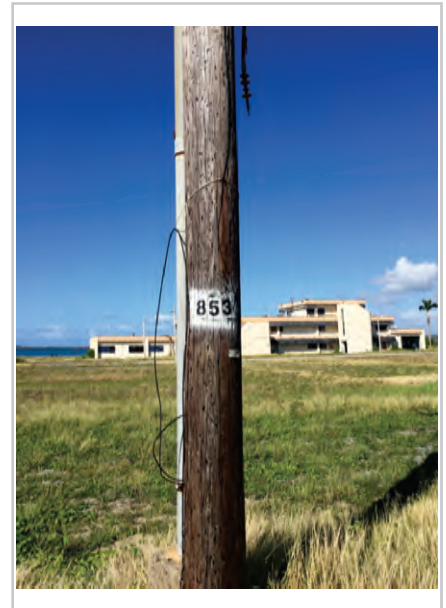
Photo 1: Pole Identification

Comments: FUSED CUT OUT AND LIGHTING ARRESTER INSTALLED ON WOOD

CROSS ARMS FOR PRIMARY RISER, 38 KV CROSS AMRS DAMAGED

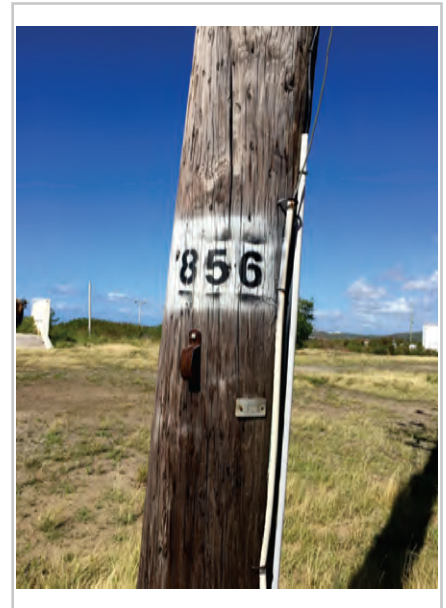
Photo 1: Pole Identification

Comments: FUSED CUT OUT AND LIGHTING ARRESTER INSTALLED ON WOOD

CROSS ARMS FOR PRIMARY RISER, CROSS AMRS AND CONDUCTORS DAMAGED

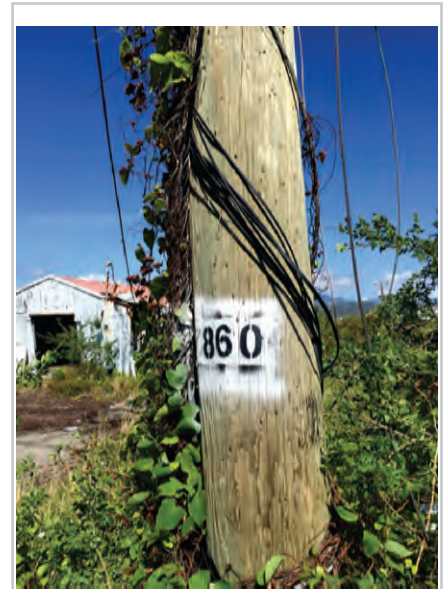
Photo 1: Pole Identification

Comments: ^{FUSED CUT OUT CONNECTED IN LINE WITH 13.2 KV FEEDER ON WOOD} _____

CROSS ARMS, CONDUCTORS FALLEN AND WOOD CROSS ARMS DAMAGED

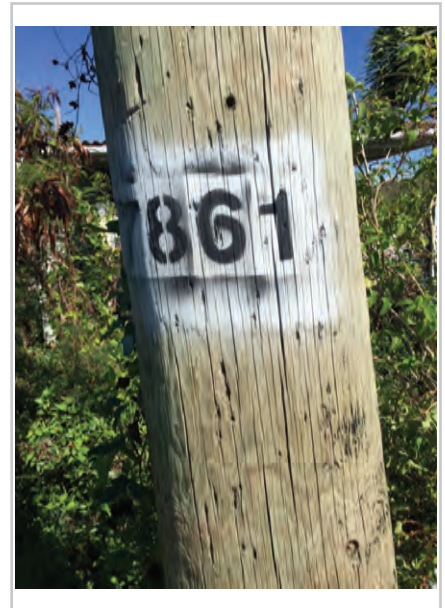
Photo 1: Pole Identification

Comments: FUSED CUT OUT ON WOOD CROSS ARM FOR CONNECTION OF

TRANSFORMER, POLE BURNED AT CROSS ARMS HEIGHT, CONDUCTORS FALLEN

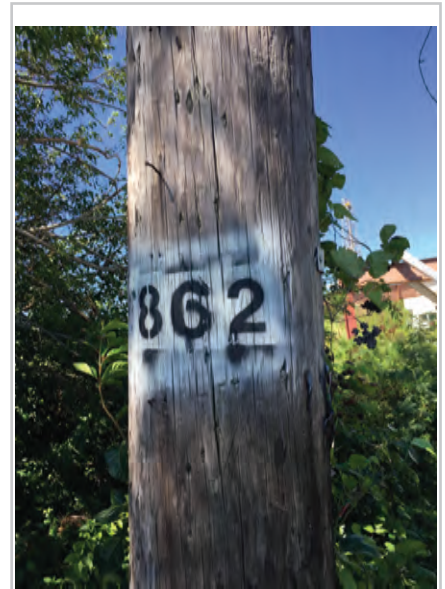
Photo 1: Pole Identification

Comments: DAMAGED AND MIS ALIGNED WOOD CROSS ARM AND CONDUCTORS

FALLEN OR REMOVED

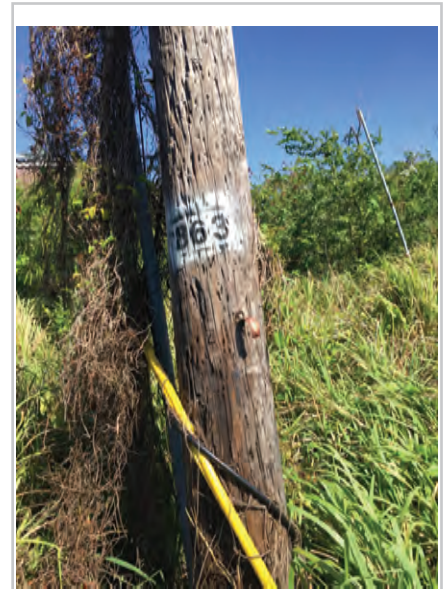
Photo 1: Pole Identification

Comments: DAMAGED AND MIS ALIGNED WOOD CROSS ARM AND CONDUCTORS

FALLEN OR REMOVED. OUT OF SERVICE WOOD CROSS ARMS WITH FUSED CUT OUT

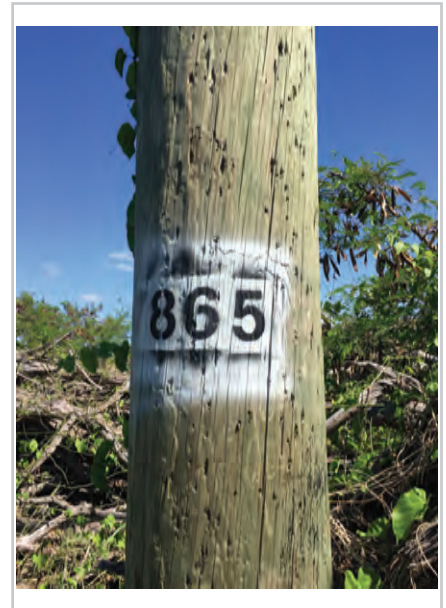
Photo 1: Pole Identification

Comments: ^{DAMAGED AND MIS ALIGNED CROSS ARMS, ALL CONDUCTORS} _____

FALLEN OR REMOVED

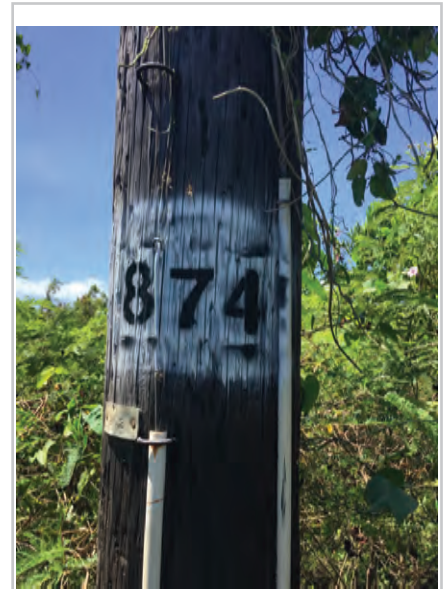
Photo 1: Pole Identification

Comments: ^{CROSS ARMS BROKEN, ALL CONDUCTORS ON GROUND} _____
N/A

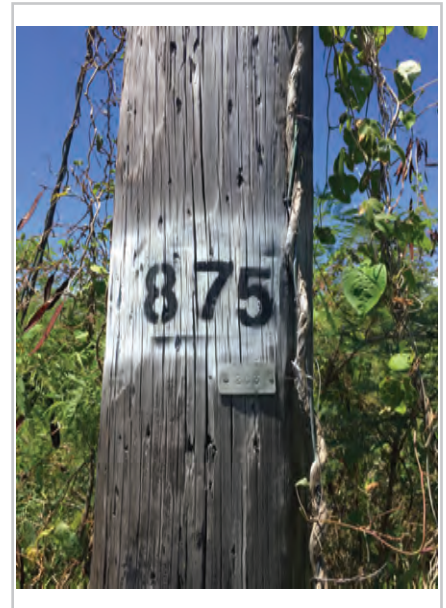
Photo 1: Pole Identification

Comments: CROSS ARMS BROKEN, ALMOST ALL CONDUCTORS ON GROUND
N/A

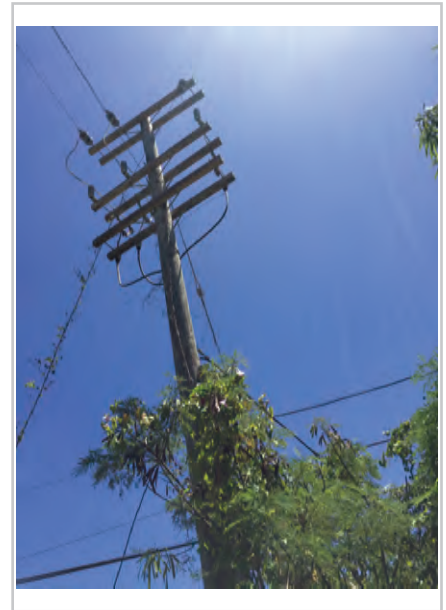
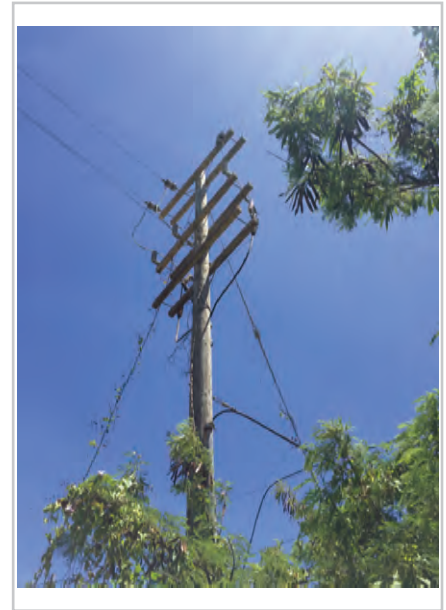
Photo 1: Pole Identification

Comments: FUSED CUT OUTS AND LIGHTNING ARRESTERS INSTALLED ON WOOD
CROSS ARMS FOR PRIMARY RISER, ONE CONDUCTOR FALLEN, NOT LABELED

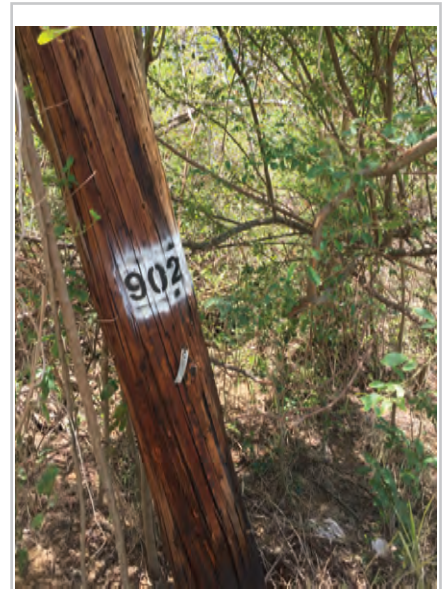
Photo 1: Pole Identification

Comments: POLE CRACKED AT BASE
N/A

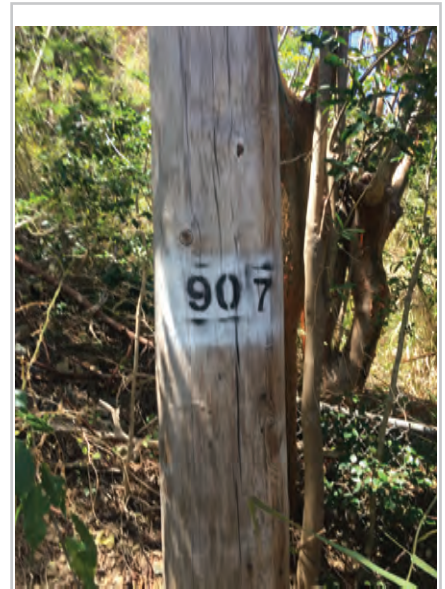
Photo 1: Pole Identification

Comments: FUSED CUT OUT AND LIGHTNING ARRESTER FOR TRANSFORMER
INSTALLED ON WOOD CROSS ARM, SECONDARY CABLES DAMAGED

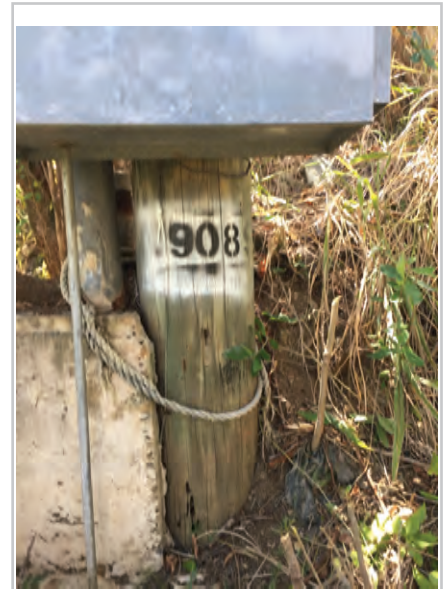
Photo 1: Pole Identification

Comments: FUSED CUT OUT AND LIGHTNING ARRESTER FOR PRIMARY RISER

INSTALLED ON WOOD CROSS ARM, SECONDARY CABLES DAMAGED

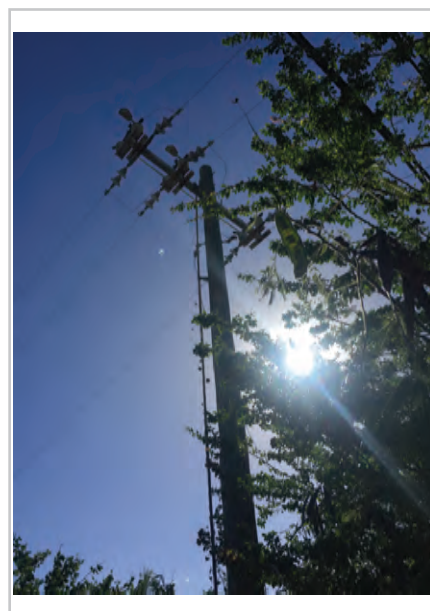
Photo 1: Pole Identification

Comments: LOOSEN CONDUCTORS, NO LABEL, LIMITED ACCESS
N/A

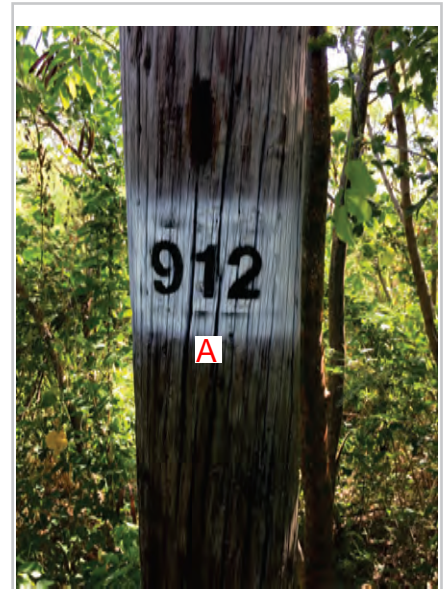
Photo 1: Pole Identification

Comments: INSULATOR DAMAGED

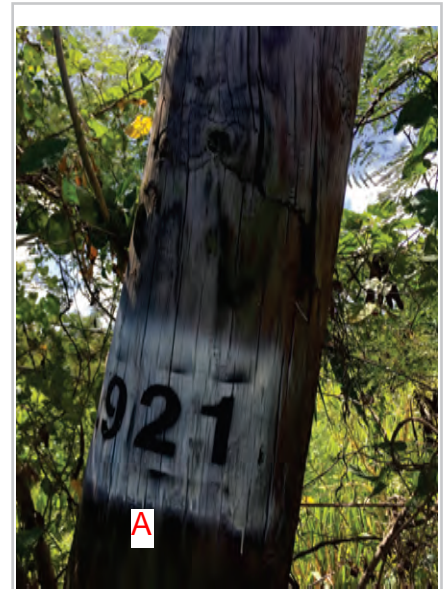
Photo 1: Pole Identification

Comments: ^{INCLINED AND CRACKED AT BASE} _____
N/A

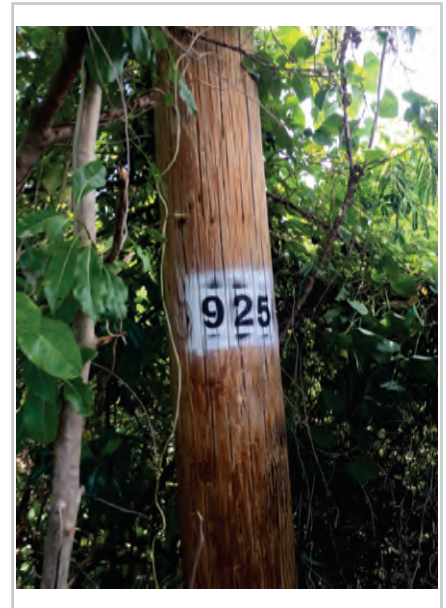
Photo 1: Pole Identification

Comments: ^{ALL CONDUCTORS ON GROUND, CROSS ARM AND INSULATORS} _____
^{DAMAGED} _____

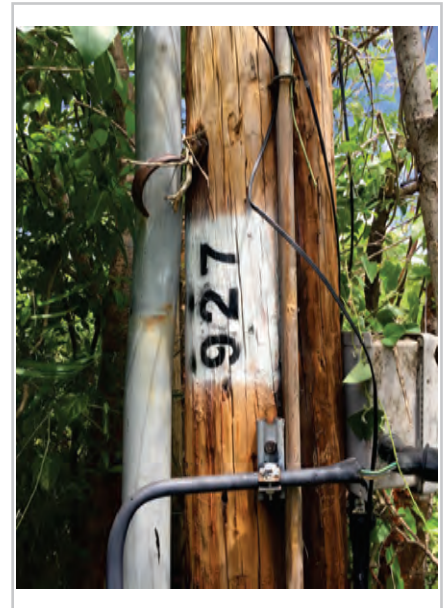
Photo 1: Pole Identification

Comments: POLE BROKEN AT TOP, POLE MOUNTED SUBSTATION AND
SECONDARY INSTALLATION OUT OF SERVICE, ALL CONDUCTORS ON GROUND
