Applicant: Local Redevelopment Authority for Roosevelt Roads		Damage Inventory # 152542	Category G
Work Order # 47591	FIPS # 000-UVI93-00	Date: 17 SEP 2019	GPS 18.223641; -65.634722
Site Inspector: Axel L. Torres		Damage Facility: Coast Guard Pier

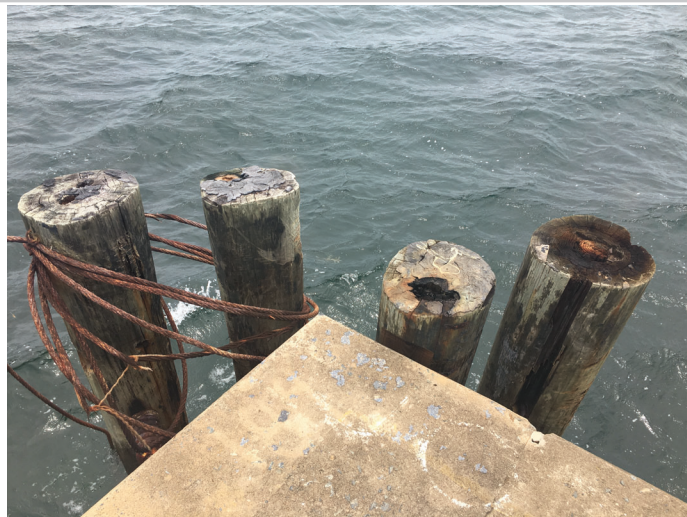
Damage Description	Photo# 4
North-east corner of pier. The photo show the Timber Pile cluster damage.

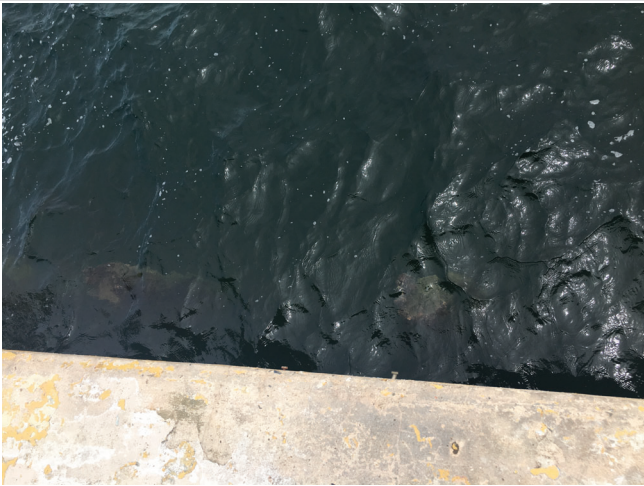
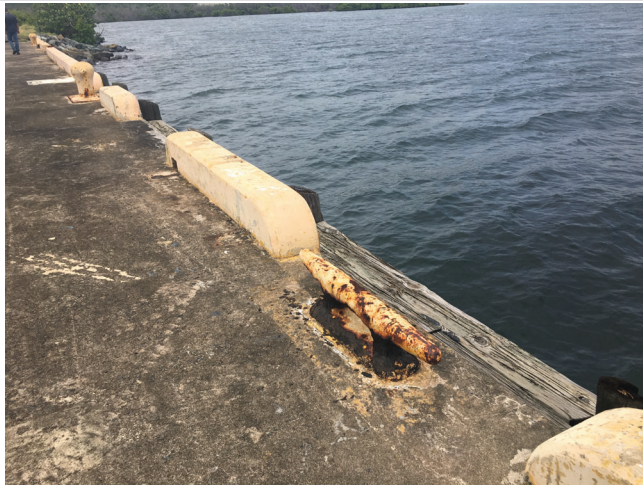
Applicant: Local Redevelopment Authority for Roosevelt Roads		Damage Inventory # 152542		Category G	
Work Order# 47591		FIPS # 000-UVI93-00		Date: 17 SEP 2019 GPS 18.223641; -65.634722	
Site Inspector: Axel L. Torres		Damage Facility: Coast Guard Pier			
		Photo# 5		Photo# 6	
Broken timber piles fenders laid at the bottom of the sea.		Damage Description North side of Coast Guard Pier. The photo show cleat and Timber fenders (wale).

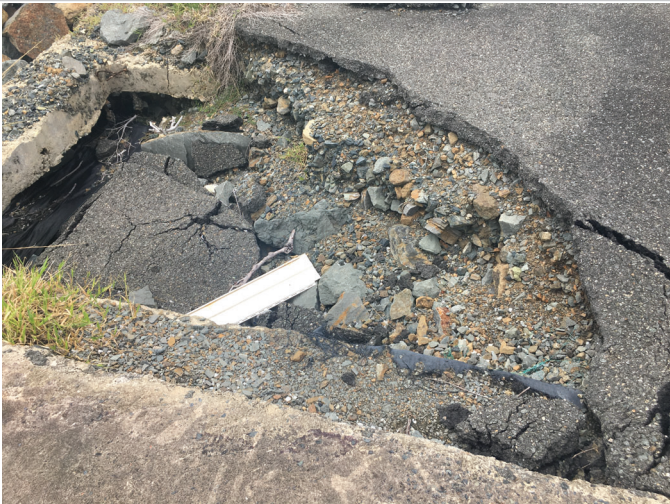
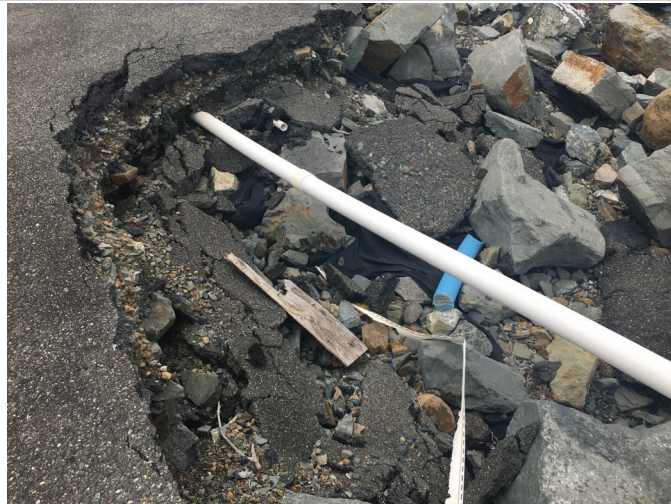
Damage Description:		Photo# 7		Photo# 8	
Washout/scour at the south side of pier approach. As seen from the pier.		Close view of washout/scour at the north side of pier approach. As seen from the pier.

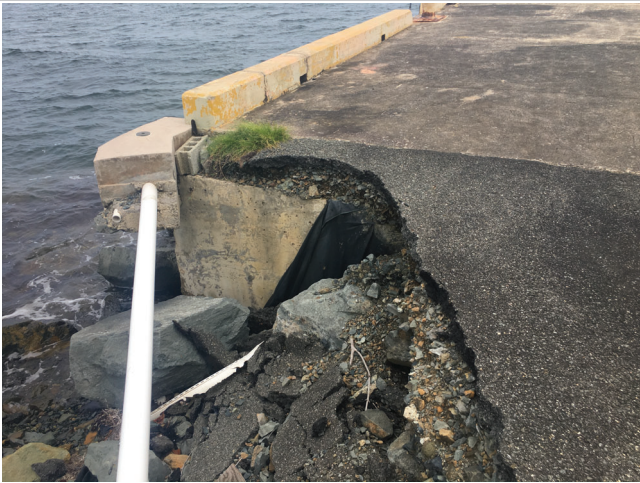
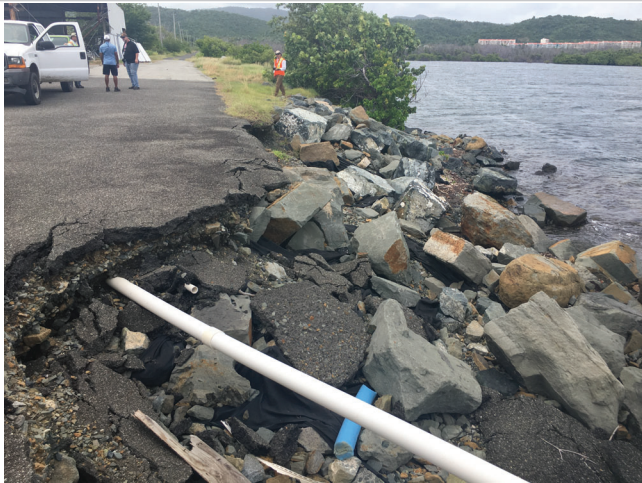
Applicant: Local Redevelopment Authority for Roosevelt Roads		Damage Inventory # 152542		Category G	
Work Order # 47591		FIPS # 000-UVI93-00		Date: 17 SEP 2019 GPS 18.223641; -65.634722	
Site Inspector: Axel L. Torres		Damage Facility: Coast Guard Pier			
		Photo# 9		Damage Description	
Washout/scour at the north side of pier approach, seen from access road.				Wide view of washout/scour and revetment damage at the north side of pier approach, seen from the pier.
