ADDENDUM NO. 3

LOCAL REDEVELOPMENT AUTHORITY FOR ROOSEVELT ROADS REQUEST FOR PROPOSAL RFP 2025-002 NEW APRODEC & EQUINOTERAPIA FACILITIES

Addendum No. 3, dated January 26, 2026, is hereby issued to distribute FEMA DDD, scopes, cost estimates and photos for NEW APRODEC & EQUINOTERAPIA FACILITIES.

Damage # 152174; Building 1211	Equinoterapia Administration Building
Damage # 152336; Building 2296	APRODEC
Damage # 152365; Building 2371	Equinoterapia Multipurpose Building

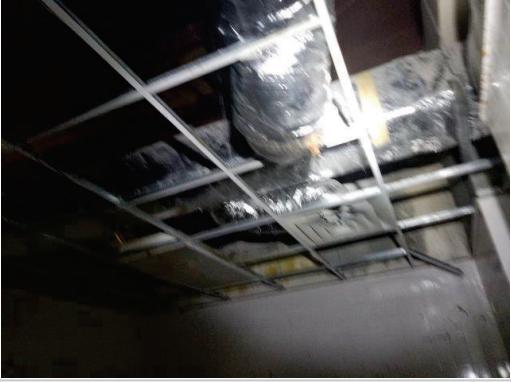
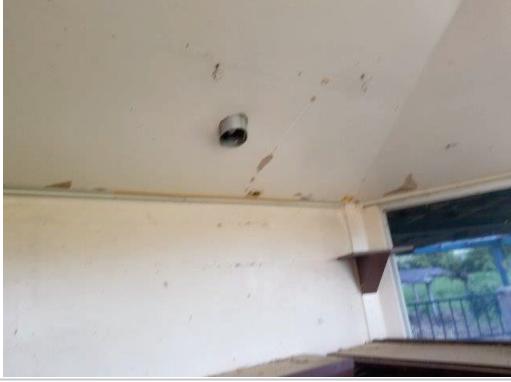
Damage Description	Photo# 100637
Building Interior Ceiling. 4,259 SF of 2 FT x 4 FT panel with noise reduction, water repellent membrane, acoustic ceiling tiles, Water intrusion through roof soaked acoustic ceiling tiles and induced black mold growth.	Damage Description

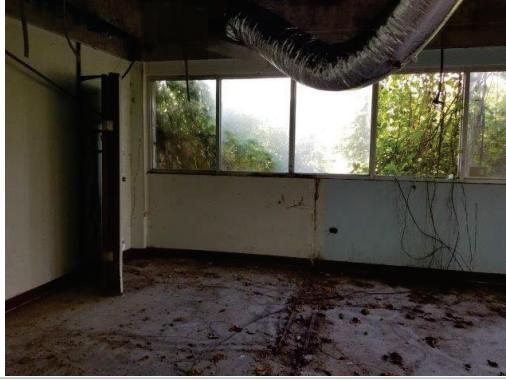
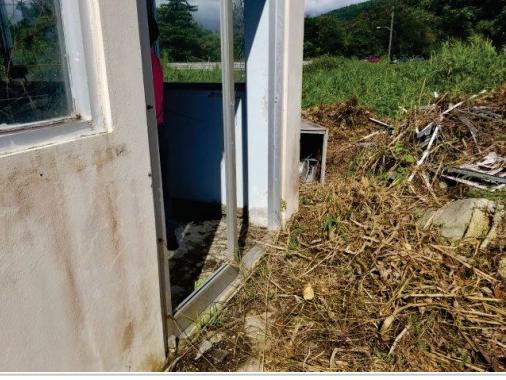
Damage Description	Photo# 095548
Building Exterior Door. 4 each of 40 IN x 86 IN and aluminum frame entrance to comply with astm C1036, all tempered glass shall comply with ASTM C1048 glass w/alum frame door. High winds and wind driven rain impacted, ripped off and damaged	Building Interior Door. 4 each of 40 IN c 86 IN glass UL listed marine frame less metal fire rated doors comply with ansi/ul 10b, ANSI/ul 10c. ANSI/UL 1784, steel hollow, High winds and wind driven rain impacted, ripped off and damaged the door.

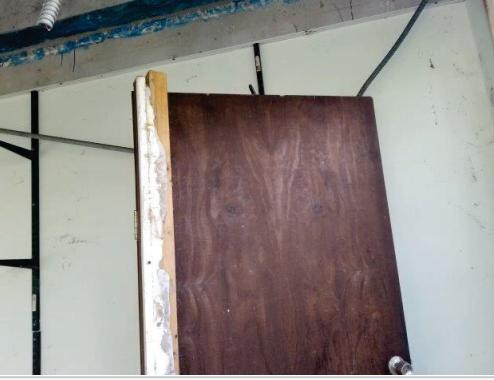
Damage Description:	Photo# 095559
Building Interior Door. 2 each of 40 IN x 86 IN solid core, mahogany, flush wood door, smooth (1-3/4" thick") flush wood door. Water intrusion through roof soaked most of door causing damages due to moisture and induced a black mold growing.

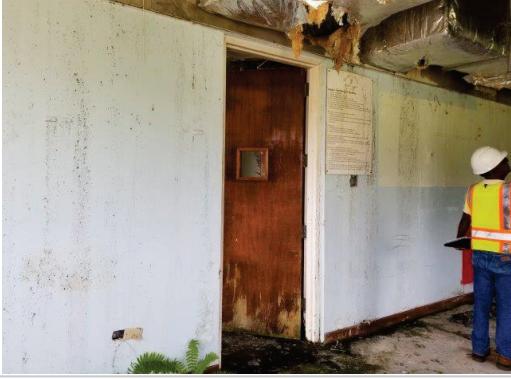
Damage Description	Photo# 095646
Building Interior Door. 2 each of 40 IN x 86 IN solid core, mahogany, flush wood door, smooth (1-3/4" thick") flush wood door. Water intrusion through roof soaked most of door causing damages due to moisture and induced a black mold growing.

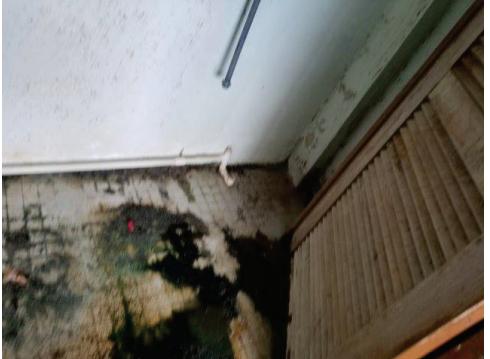
Photo# 095823
Building Interior Door. 1 each of 13 FT x 7 FT solid core, mahogany, flush wood door, smooth (1-3/4"thick") wood accordion door with louver. High winds and wind driven rain impacted, ripped off and damaged the door.	Photo# 095824

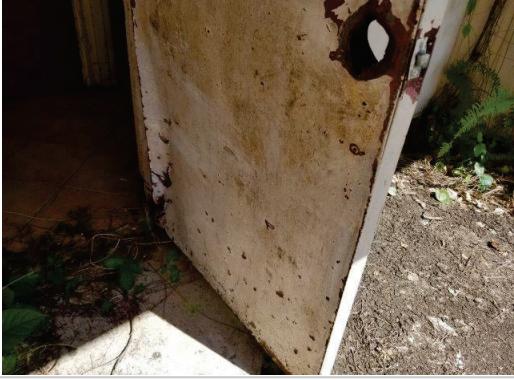
Building Interior Door. 1 each of 72 IN x 86 IN steel hollow double metal, High winds and wind driven rain impacted, ripped off and damaged the door.	Photo# 100140

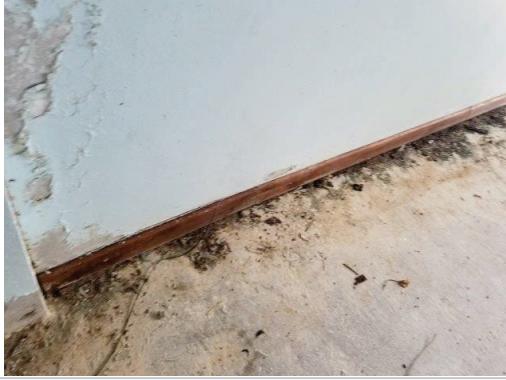
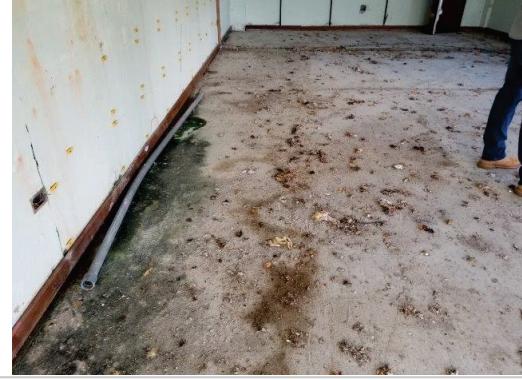
Damage Description:	Photo# 095624
Building Interior Floor. 4,947 SF of 12 IN x 12 IN impervious tile and comply with abrasion resistance- ASTM C1027 ceramic tile to be cleaned. Water intrusion through roof soaked most of ceramic tiles.	Damage Description

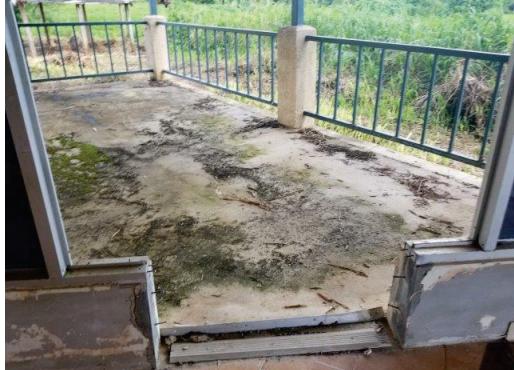
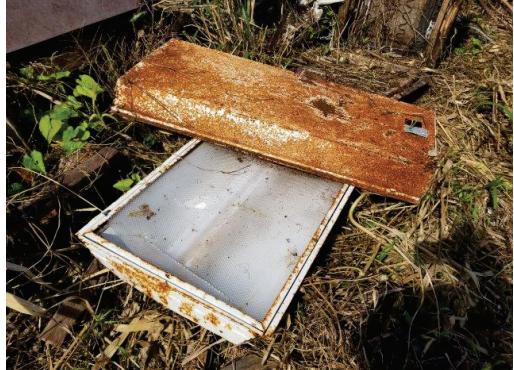
Damage Description:	Photo# 1011131
Building Interior Floor. 6,001 SF of mold remediation floor treatment. Strong winds and wind driven rain detached roof, water intruded through roof the Fungus growth.	Damage Description
Building Interior Light Fixture. 60 each of 2 FT x 4 FT T12, medium bi-pi (G13), 1450 lumen's, 6500k bulb color temp fluorescent, cw lamps, flour 40 watts, Water intrusion through roof soaked and acoustic ceiling tiles and induced black mold growing damaged frame and lamps.	Photo# 094819

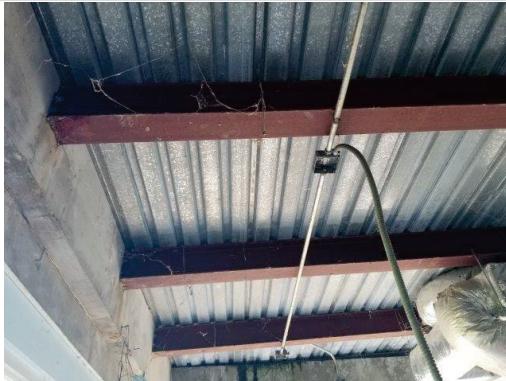
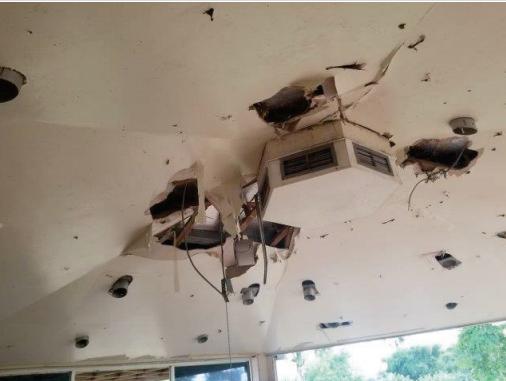
Damage Description:	Photo# 095618
Building Interior Light Fixture. 2 each of 1 FT w x 4 FT T12, medium bi-pin (G13), 1450 lumen's, 6500k bulb color temp fluorescent, cw lamps, two 40 watts. Water intrusion through roof soaked and acoustic ceiling tiles and induced black mold growing damaged frame and lamps.	Damage Description

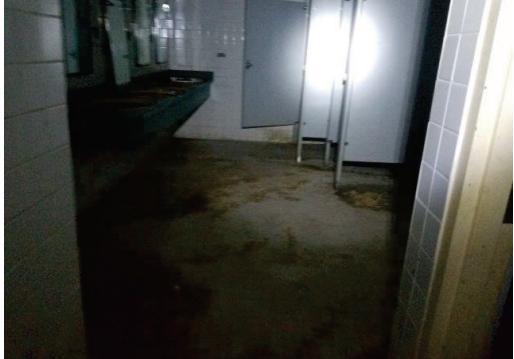
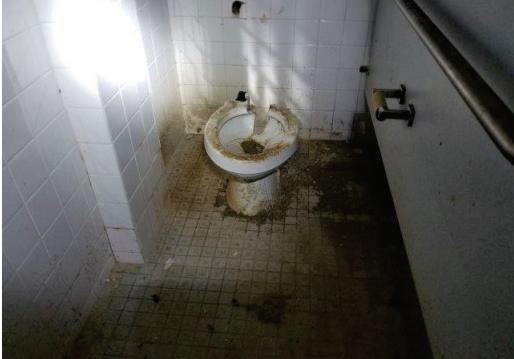
Damage Description:	Photo# 100454
Building Interior Restroom. 100 SF of solid plastic bathroom partition, water intrusion through roof soaked most of bathroom partitions then the partitions was damaged due to moisture and induced a black mold growing.	Damage Description

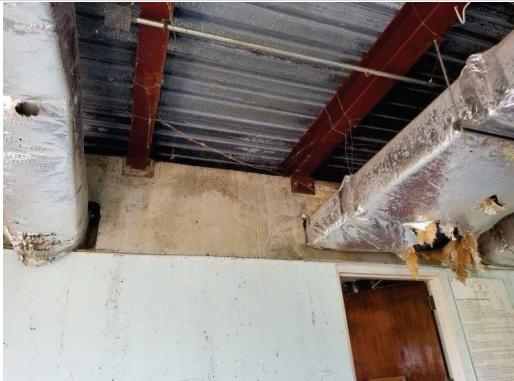
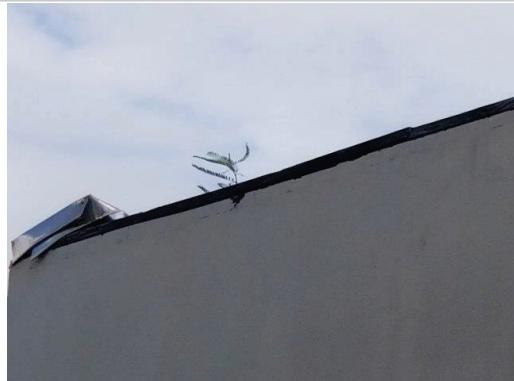
Damage Description:	Photo# 095648
Building Exterior Roof. 2,400 SF of section 07510 - built-up bituminous roofing, section 07540 - thermoplastic membrane roofing, polyvinyl chloride (PVC), astm c 578-01, standard pacification for rigid, waterproofing membrane with insulation deck, strong wind and debris in the air roof, the water to enter through the roof, the soaked the ventilation.	Building Exterior Roof. Aluminum, Ga. 0.032 metal flashing, 179 FT long, High wind and wind driven rain detached metal flashing from edges of roof.

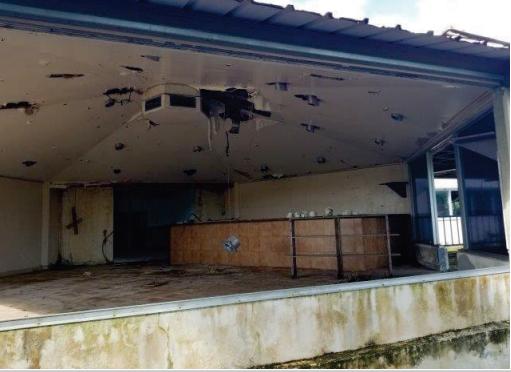
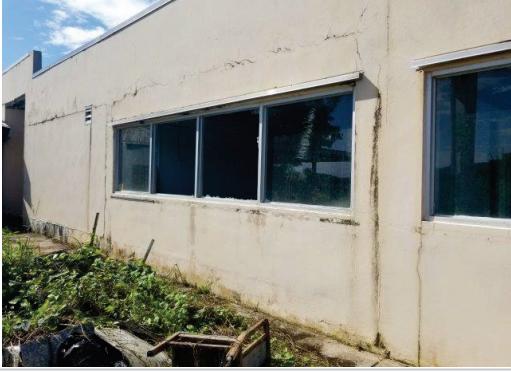
Damage Description:	Photo# 094709
Building Exterior Roof. 484 SF of section 07510 ceramic roof tile. Strong wind and debris in the air lifted and detached the part of roof, this caused the water to enter through the roof, the soaked the ventilation.	Building Exterior Wall. 11,780 SF of water based exterior paint first coat exterior paintwork, high wind and wind driven rain damaged and removed interior paint layers.

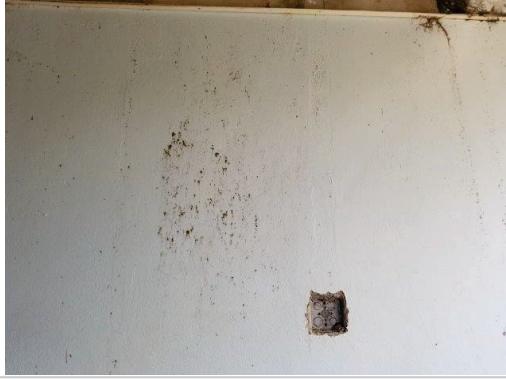
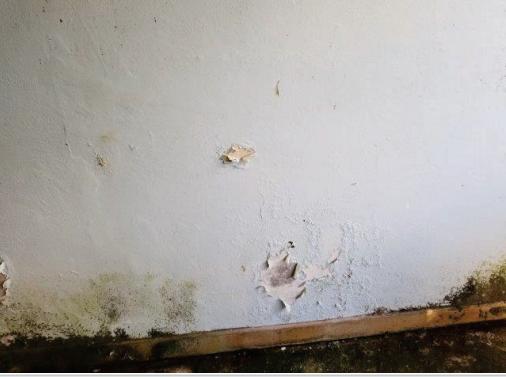
Damage Description:	Photo# 095809
Building Exterior Wall. 24,830 SF of clean wall cleaning. High wind and wind driven rain caused a water intrusion through roof damaged soiled the exterior wall.	Building Exterior Wall. 24,830 SF of clean wall cleaning. High wind and wind driven rain caused a water intrusion through roof damaged soiled the exterior wall.

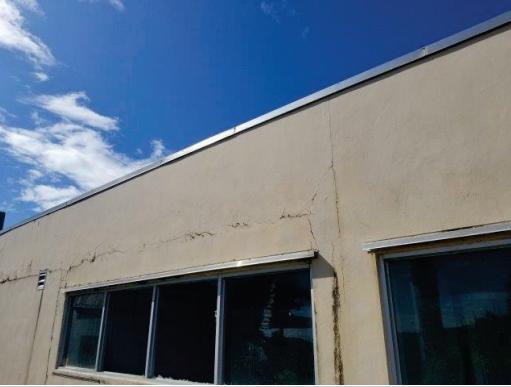
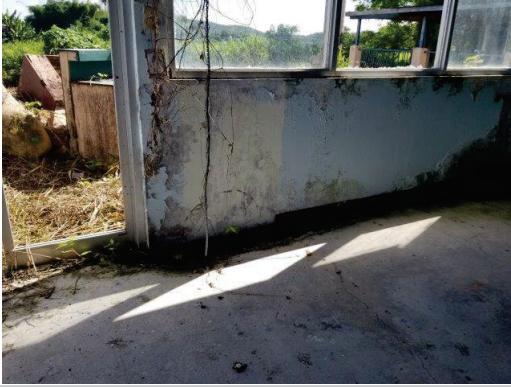
Damage Description:	Photo# 095450
Building Exterior Wall. 138 SF of 0.25 IN thickness cement plastering, high wind and wind driven rain detached cement plaster layer from wall.	Building Interior Wall. 5,320 SF of wall black mold remediation, Water intrusion through roof soaked and acoustic ceiling tiles and induced black mold growing damaged most of wall.

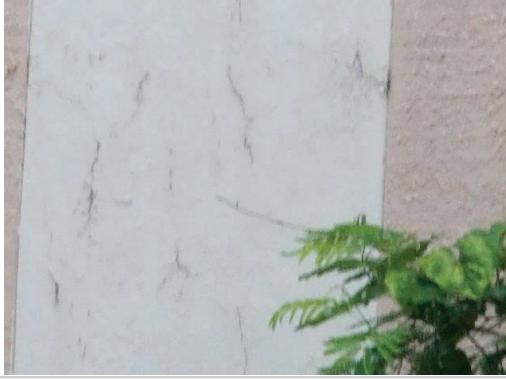
Damage Description:	Photo# 101335
Building Interior Wall. 1,600 SF of 0.25 IN thickness cement plaster, high wind and wind driven rain detached cement plaster	Damage Description

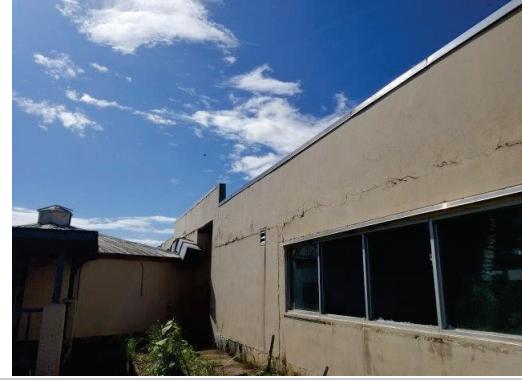
Photo# 095451

Building Exterior Window. 6 each of 4 FT x 4 FT insulated glass to have edge tech warm edge spacer as secondary seal with butyl primary seal, all glass to be glazed with double sided adhesive glazing tape on exterior, retained on interior with snap in glazed bead. Glass thickness to be 1/8 double strength feet fixed glass up to 8 square feet fixed glass aluminum window, High winds and wind driven rain impacted and damaged window glasses lattices.

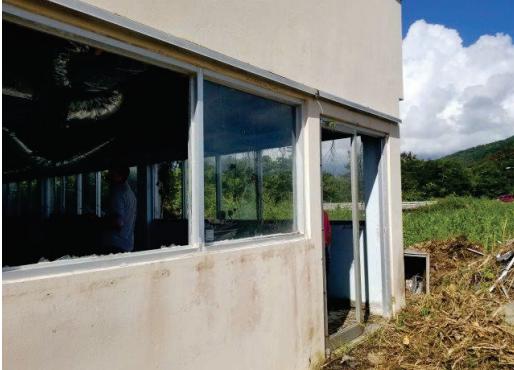
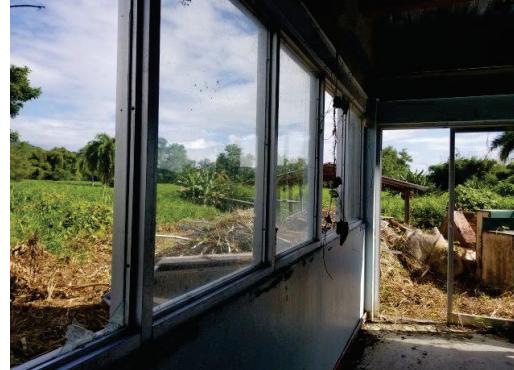
Damage Description:	Photo# 095459
Building Exterior Window. 15 each of 3 FT x 4 FT insulated glass to have edge tech warm edge spacer as secondary seal with butyl primary seal, all glass to be glazed with double sided adhesive glazing tape on exterior, retained on interior with snap in glazing bead. High winds and wind driven rain impacted and damaged window glasses lattices.	Damage Description

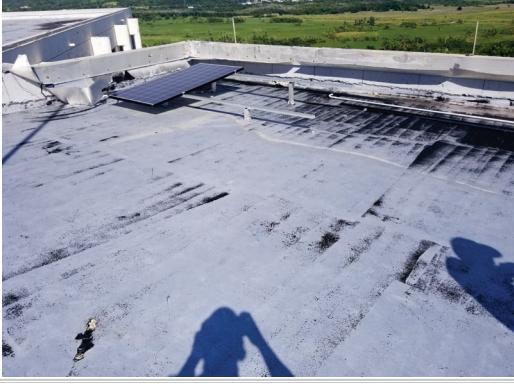
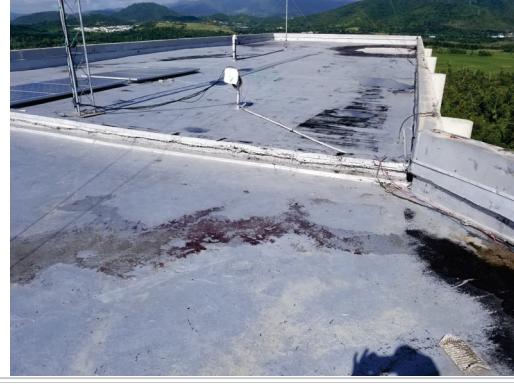
Damage Description:	Photo# 100301
Building Exterior Roof. 3 each of 3 FT x 6 FT, 340 watts solar panels, High wind and wind driven rain impacted the roof, then winds detached all panels.	Building Exterior Roof. 3 each of 3 FT x 6 FT, 340 watts solar panels, High wind and wind driven rain impacted the roof, then winds detached all panels.

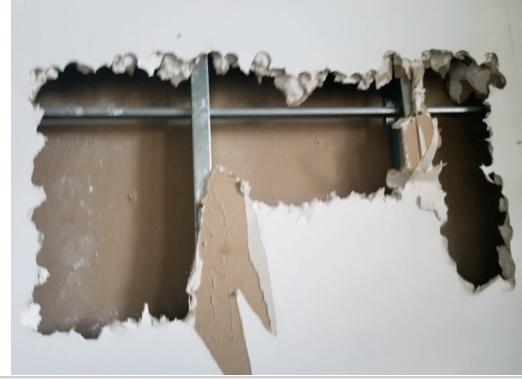
Damage Description	Photo# 114722
Building Interior Wall 1,450 SF of 1/2 IN thick as a standard product, Vinyl covered Durasan panels comply with ASTM Specification C1396 and Federal Specification SS-L-30D. Approved sag resistance equivalent to 5/8 IN Type x wallboard. Surface burning ASTM E 84, Fiberglass Insulation with Galvanized Stud @ 16 IN gypsum Board (Colapsed),

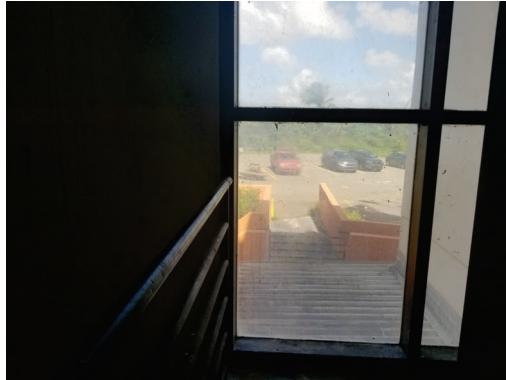
Damage Description	Photo# 111845
Building Exterior Window. 2 each of 10FT x 9 FT Insulated glass to have Edgetech warm edge spacer as secondary seal with Butyl primary seal. All glass to be glazed with double sided adhesive glazing tape on exterior, retained on interior with snap in glazing bead. Glass thickness to be 1/8 double strength up to 18 square feet fix glass aluminum Window

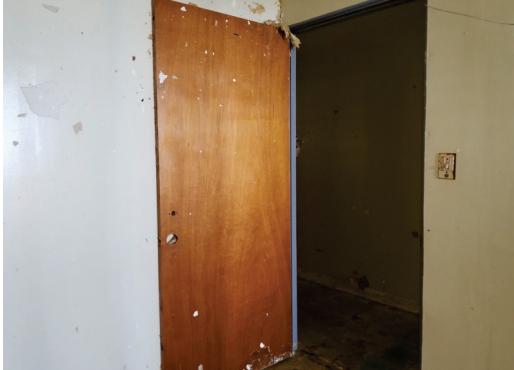
Photo# 102216
Building Interior Door. 2 each of 67 IN x 86 IN hollow Core, mahogany, Flush Wood Door, Smooth (1-3/4 IN Thick) double wood door.	Photo# 102216

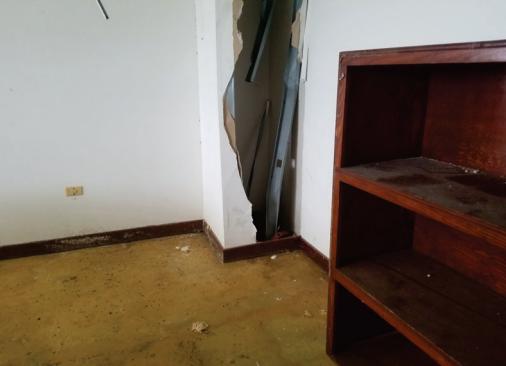
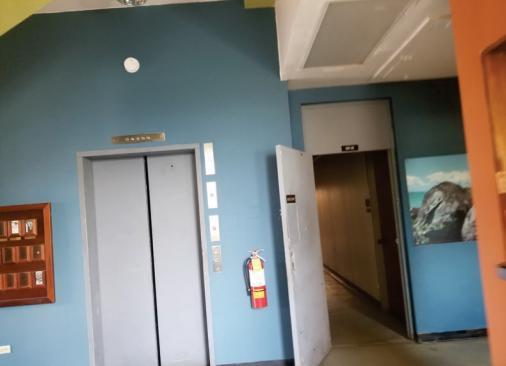
Damage Description:	Photo# 102913
Building Interior Floor. 848 SF of 2FT x 2 Impervious tile and comply with abrasion resistance - ASTM C1027 Damaged ceramic tile.	Building Interior Floor. 2,782 SF of Apply bleach t the stain (using a spray bottle is the most efficient way to apply bleach) vinyl tiles to clean.
