The Secretary of the Interior's Standards  
for the Treatment of Historic Properties

with Guidelines for  
Preserving, Rehabilitating  
Restoring & Reconstructing  
Historic Buildings

Kay D. Weeks and Anne E. Grimmer

U.S. Department of the Interior  
National Park Service  
Cultural Resource Stewardship and Partnerships  
Heritage Preservation Services  
Washington, D.C.  
1995

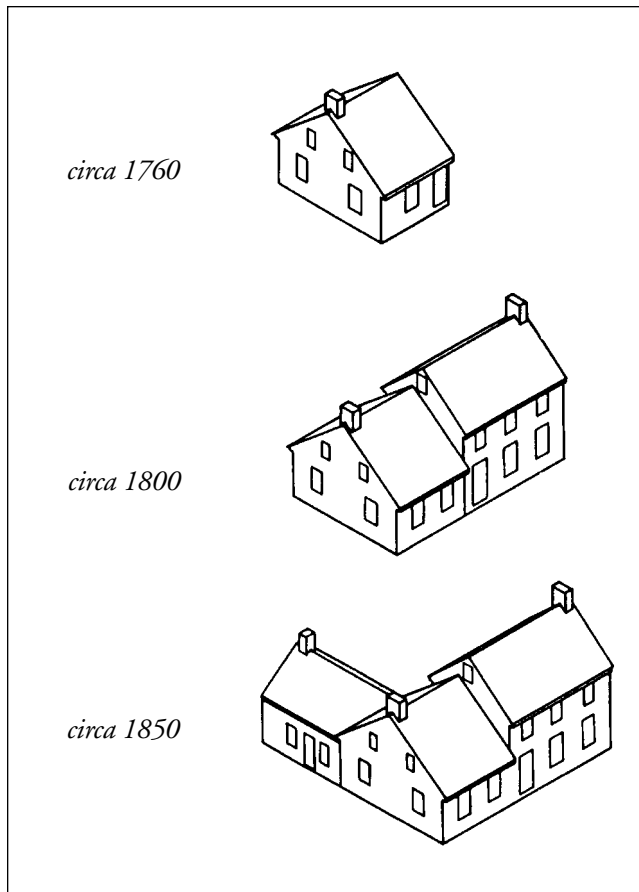
*This three-part drawing shows the evolution of a farm house over time. Such change is part of the history of the place and is respected within the treatment, Preservation. Drawing: Center for Historic Architecture and Engineering, University of Delaware (adapted from Preservation Brief 35: Understanding Old Buildings).*

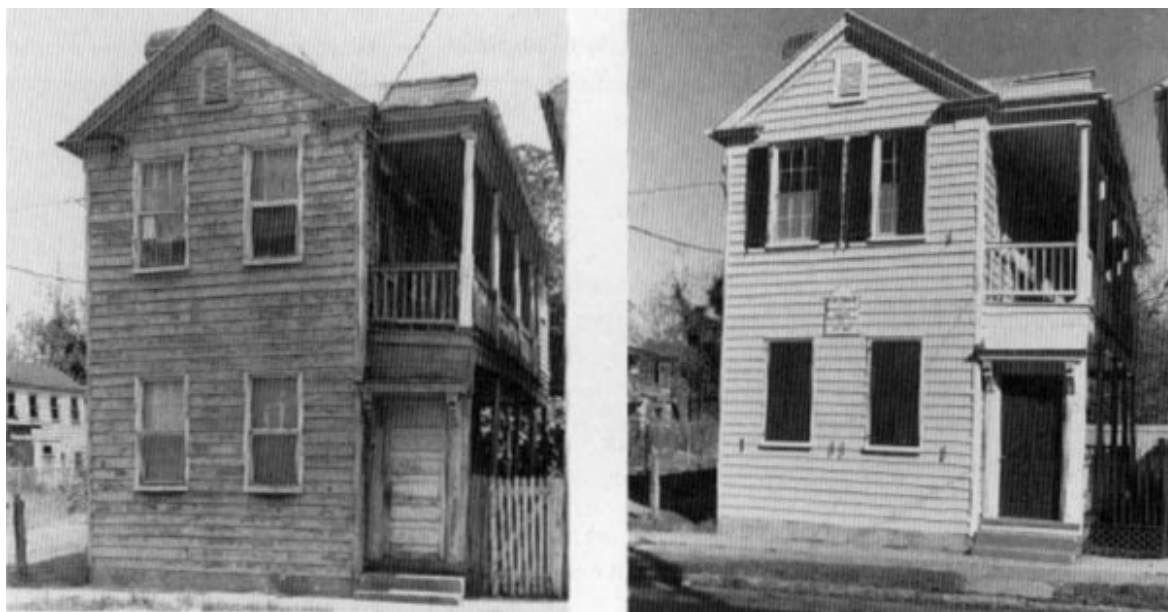
*Maximizing retention of historic materials and features is the primary goal of Preservation as demonstrated here in these “before” and “after” photographs. Aside from some minor repairs and limited replacement of deteriorated material, work on this house consisted primarily of repainting the wood exterior. Photos: Historic Charleston Foundation.*

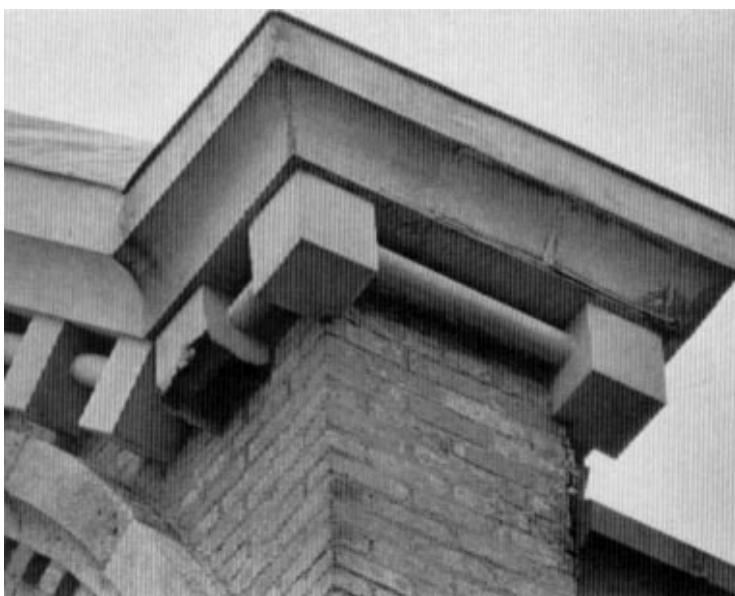
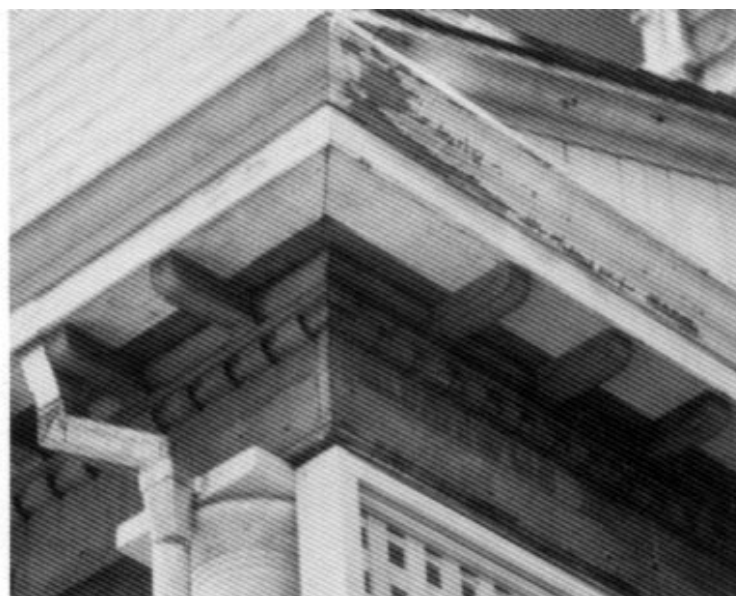
*Two examples of “limited replacement in kind” point out an appropriate scope of work within the treatment, Preservation. (a) One metal modillion that has sustained damage from a faulty gutter will need to be replaced; and (b) targeted repairs to deteriorated wood cornice elements (fascia board and modillions) meant that most of the historic materials were retained in the work.*

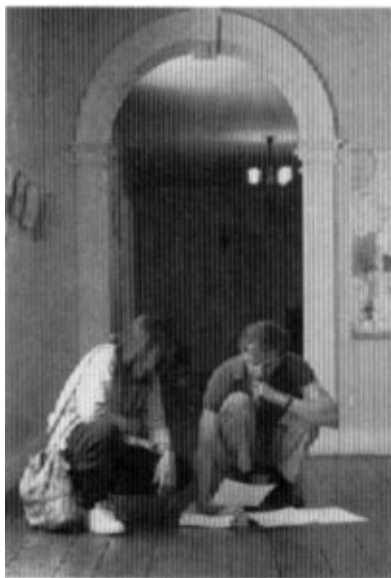
*Careful documentation of a building's physical condition is the critical first step in determining an appropriate level of intervention. (a) This may include relating the historical research to existing materials and features; or (b) documenting a particular problem such as this cracked ceiling. Photo (a): Jean E. Travers; Photo (b): Lee H. Nelson, FAIA.*

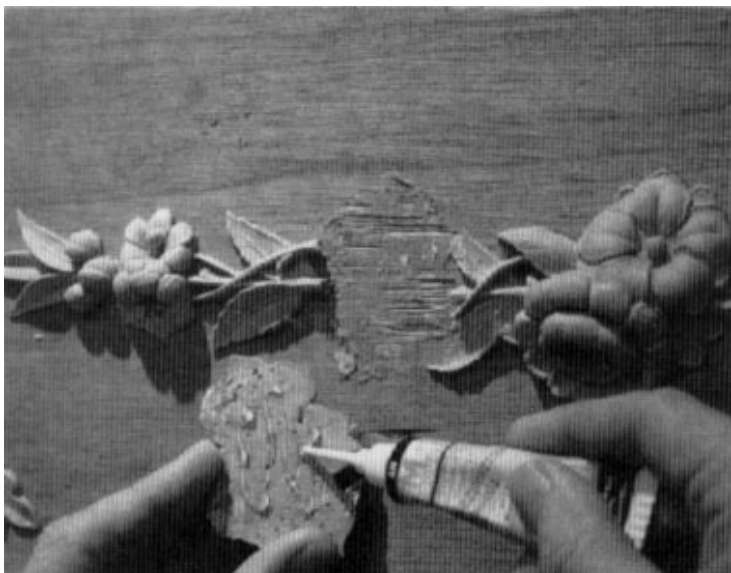
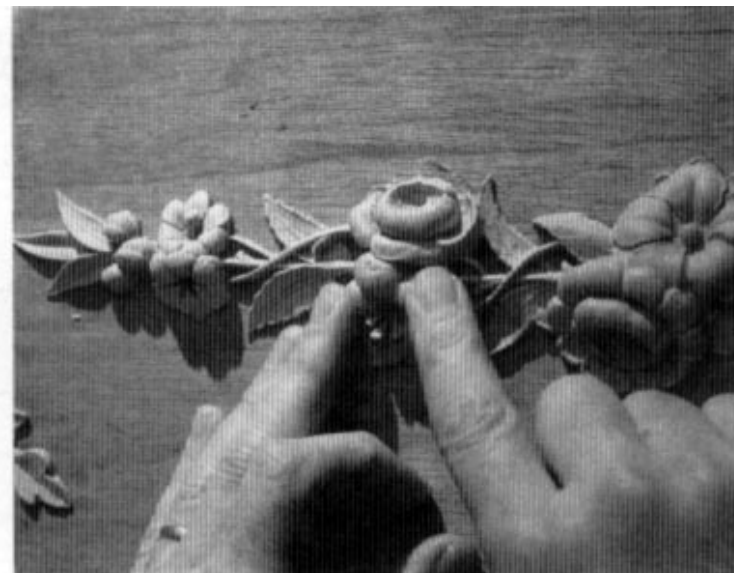
*In Preservation, an appropriate level of intervention is established prior to work in order to maximize retention of historic materials.*

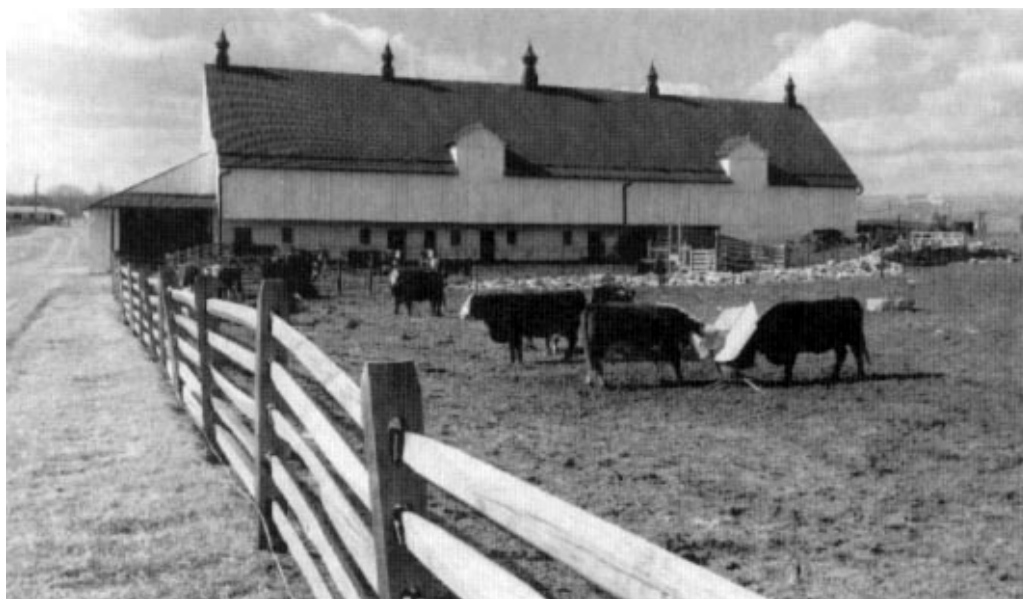
*The goal of Preservation is to retain the historic form, materials, and features of the building and its site as they have changed—or evolved—over time. This bank barn was built in the 1820s, then enlarged in 1898 and again in 1914. Today, it continues its role as a working farm structure as a result of sensitive preservation work. This included foundation re-grading; a new gutter system; structural strengthening; and replacement of a severely deteriorated metal roof. Photo: Jack E. Boucher, HABS.*

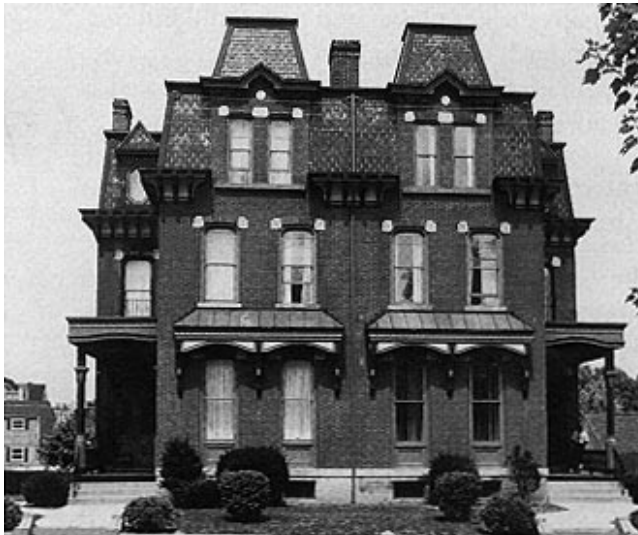
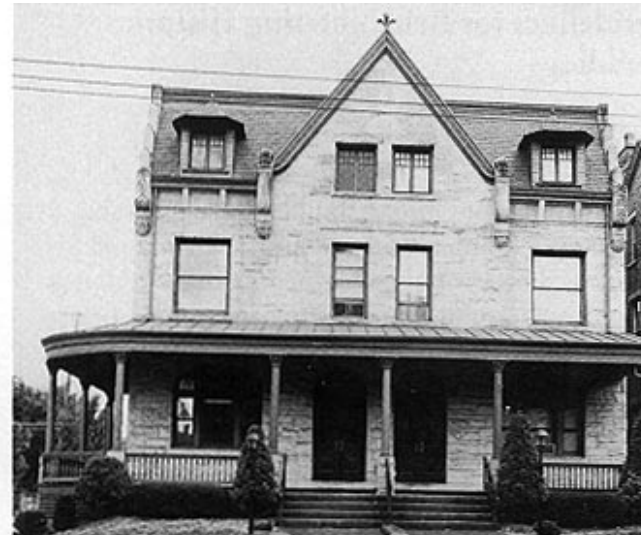
*Originally built as single-family, semi-detached duplexes, these houses were rehabilitated for a new use as rental apartments. While some alteration to non-significant interior features and spaces was necessary in each one, the exteriors were essentially preserved. Photos: Mistick, Inc.*

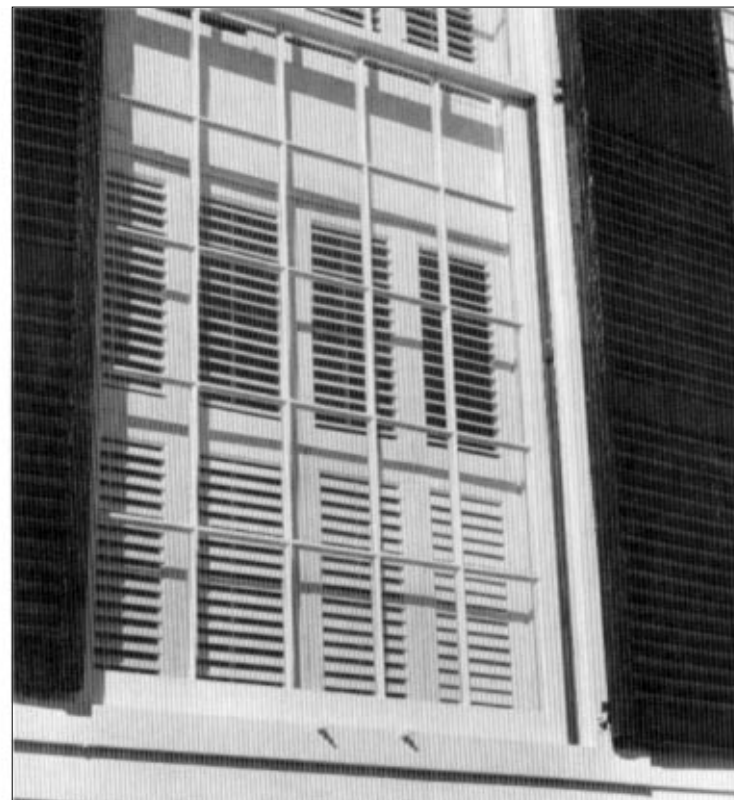
*According to the Standards for Rehabilitation, existing historic materials should be protected, maintained and repaired. In an exemplary project, the windows and shutters of this historic residence were carefully preserved.*

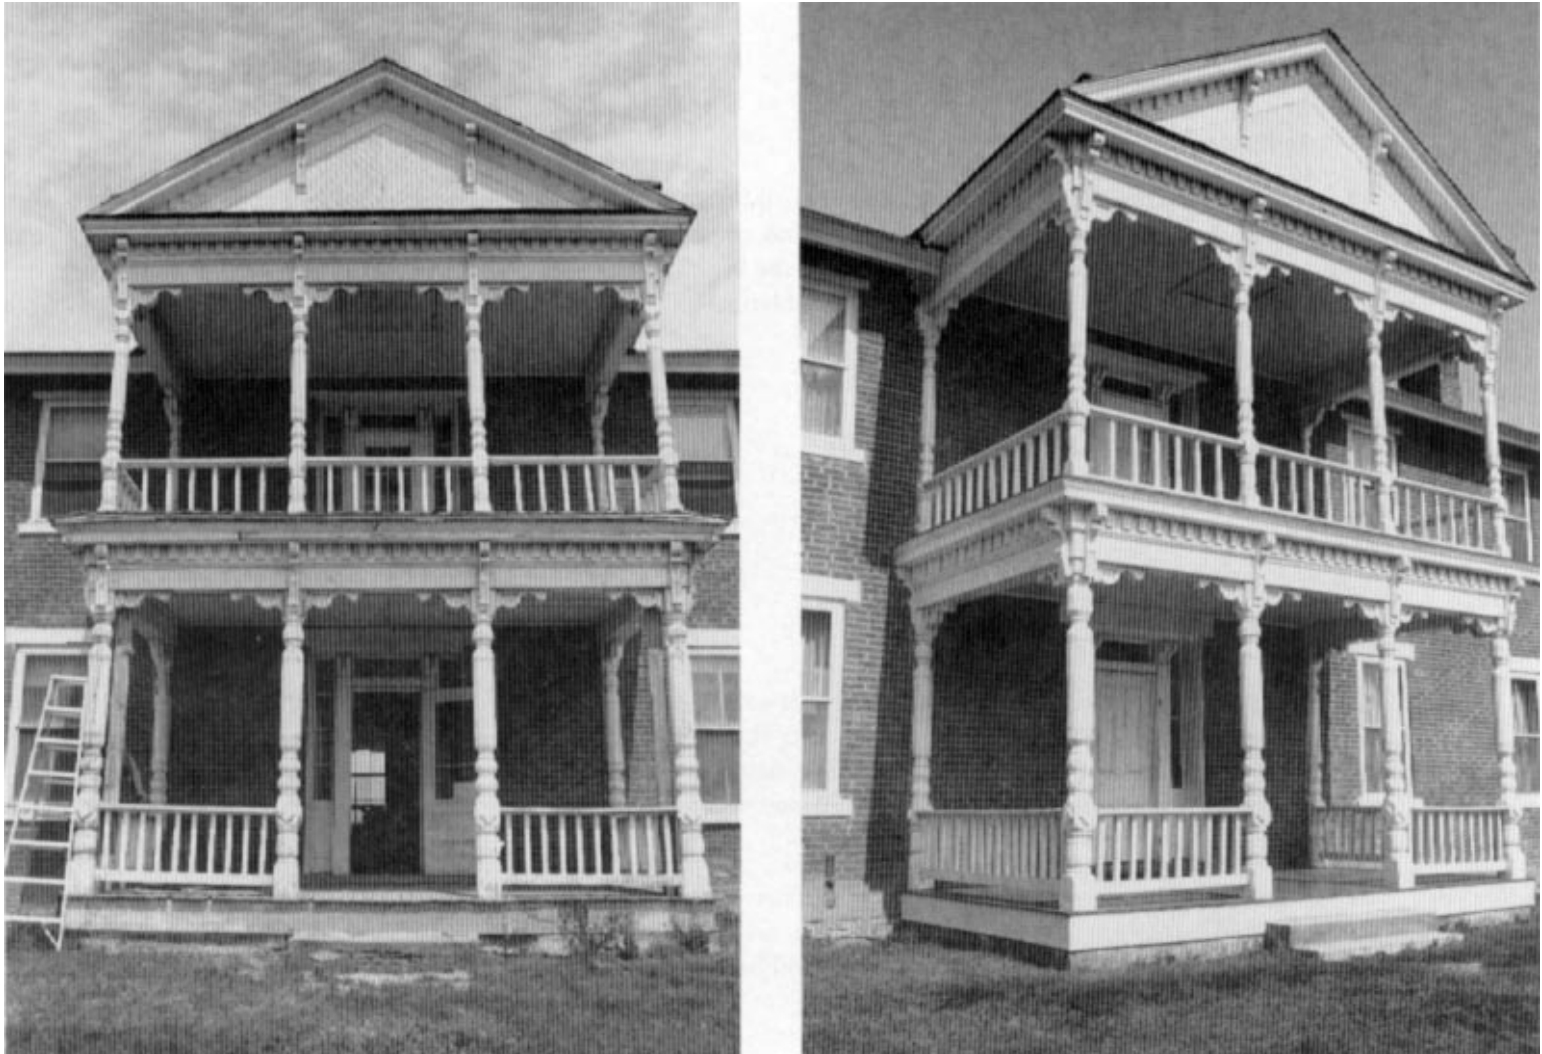
*In Rehabilitation, deteriorated features should be repaired, whenever possible, and replaced when the severity of the damage makes it necessary. Here, a two-story porch is seen prior to treatment (left). The floor boards are rotted out and the columns are in a state of collapse, supported only by crude, temporary shafts. Other components are in varying stages of decay. Appropriate work on the historic porch (right) included repairs to the porch rails; and total replacement of the extensively deteriorated columns and floor boards. Some dismantling of the porch was necessary.*

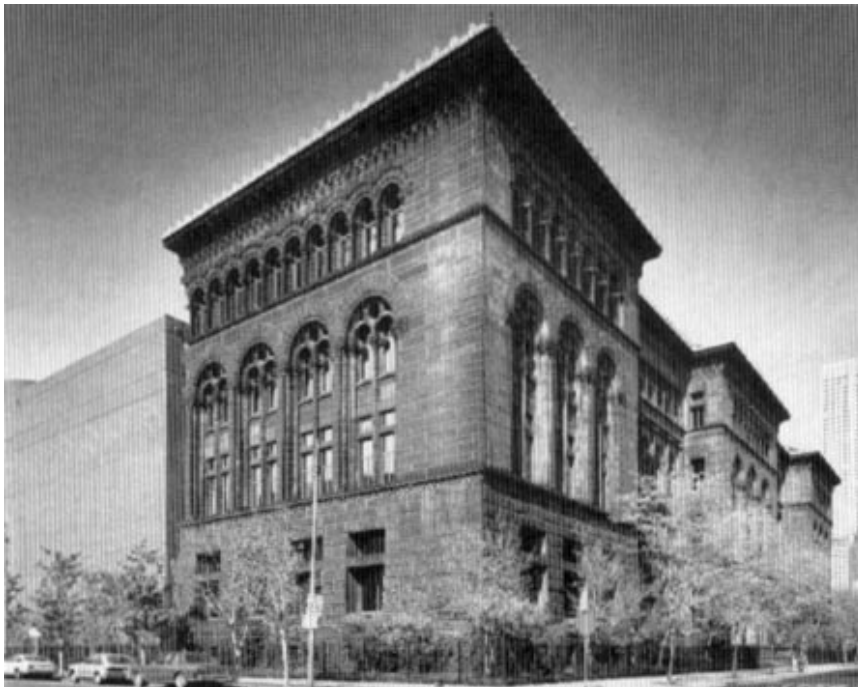
*Rehabilitation, like Preservation, acknowledges a building's change over time; the retention and repair of existing historic materials and features is thus always recommended. However, unlike Preservation, the dual goal of Rehabilitation is to—respectfully—add to or alter a building in order to meet new use requirements. This downtown Chicago library was expanded in 1981 when additional space was required with light and humidity control for the rare book collection. The compatible 10-story wing was linked to the historic block on side and rear elevations. Its simple design is compatible with the historic form, features, and detailing; old and new are clearly differentiated. Photo: Dave Clifton.*

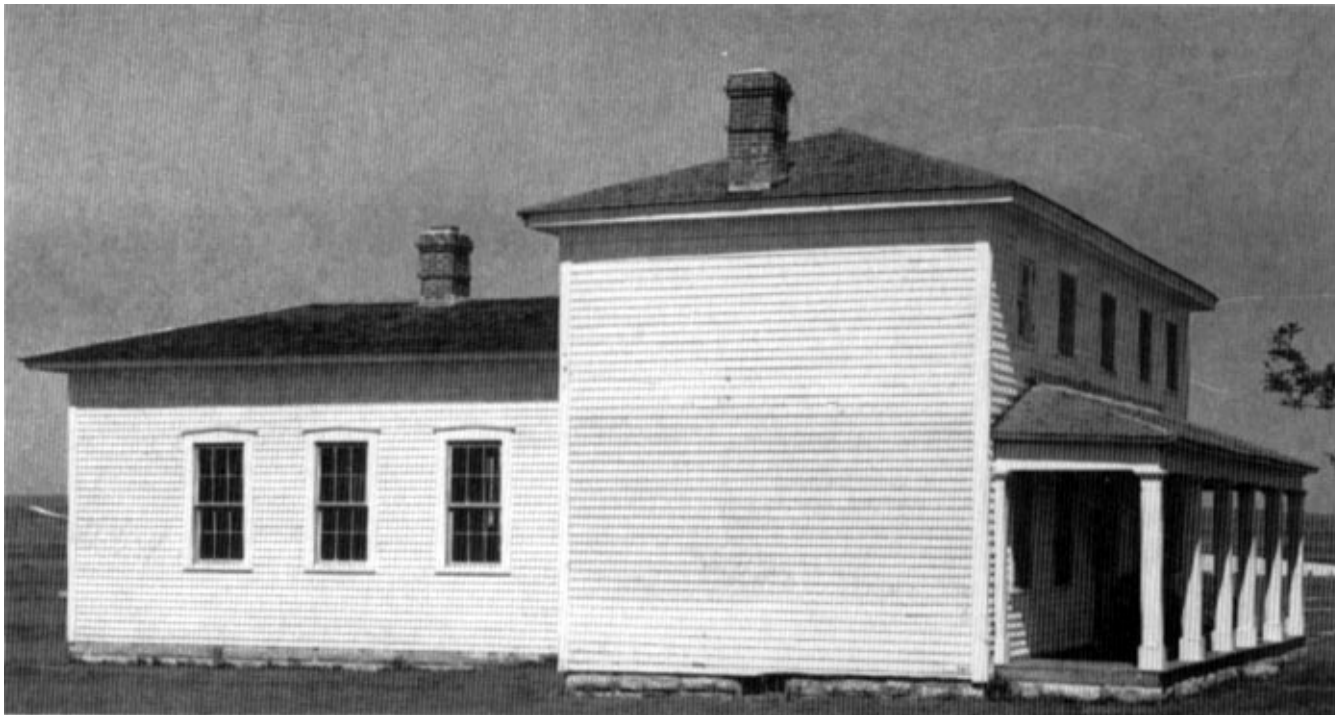
*In a project at Fort Hays, Kansas, the wood frame officers' quarters were restored to the late 1860s—their period of significance. This included replacing a missing kitchen ell, chimneys, porch columns, and cornice, and closing a later window opening in the main block. The building and others in the museum complex is used to interpret frontier history.*

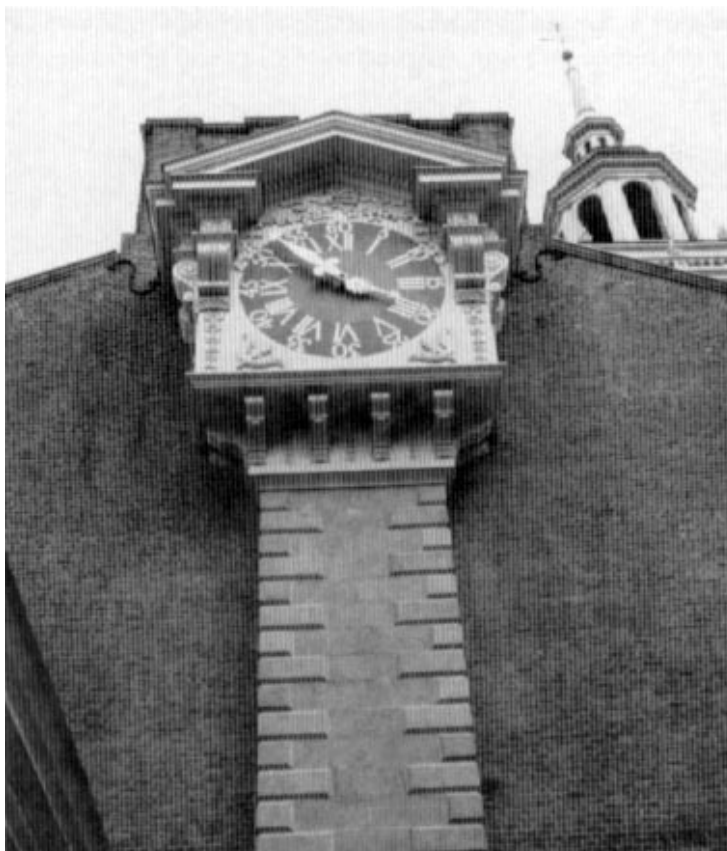
*The Standards for Restoration call for the repair of existing features from the restoration period as well as the re-creation of missing features from the period. In some instances, when missing features are replaced, substitute materials may be considered if they convey the appearance of the historic materials. In this example at Philadelphia's Independence Hall, the clock was re-built in 1972-73 using cast stone and wood with fiberglass and polyester bronze ornamentation. Photo: Lee H. Nelson, FAIA.*

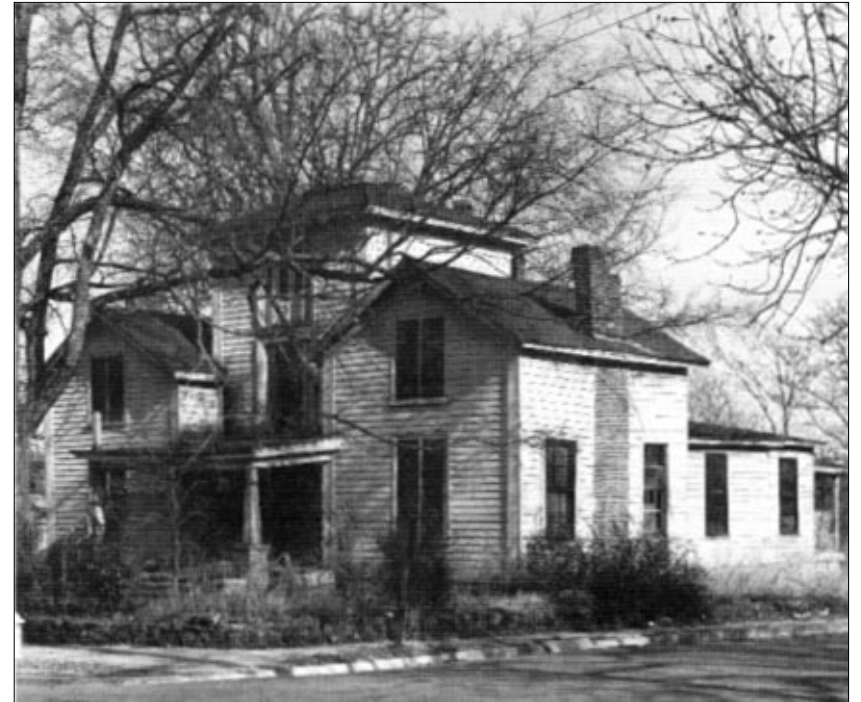
*This ca. 1900 photograph (left) would be invaluable to guide restoration of the deteriorated house (right) to its documented earlier appearance, complete with decorative trim, shutters, polychromed exterior, and fencing. Photos: Courtesy, North Carolina Department of Archives and History.*

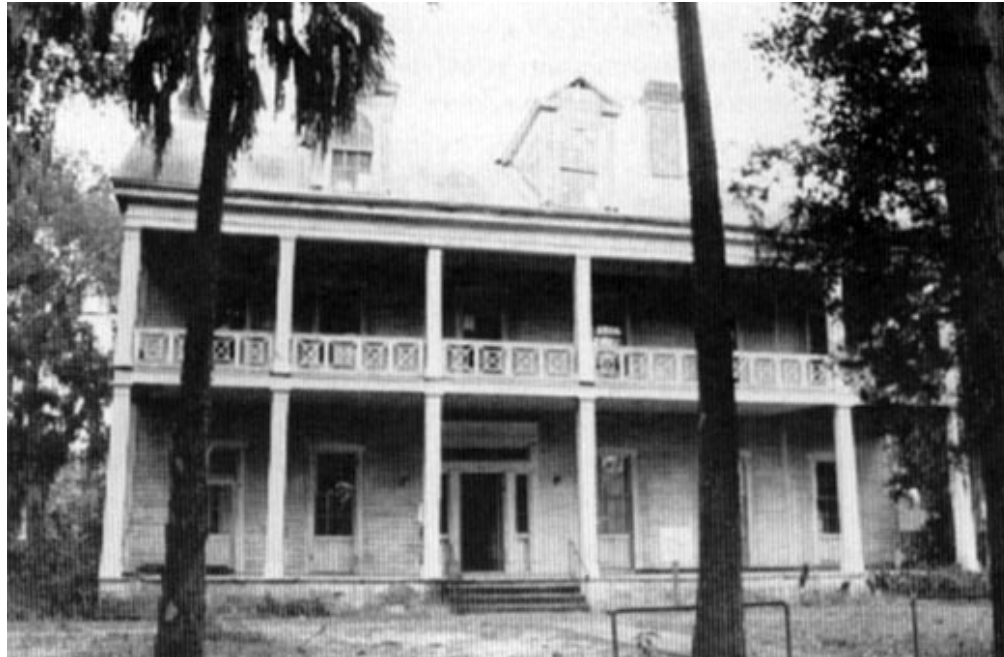
*The Bronson-Mulholland House in Palatka, Florida, ca. 1845, is shown (a) before and (b) after the treatment, Restoration. Over the years the east (far right) side of the veranda had been filled in as a sixth bay. During the restoration, this later infill was removed and the east veranda, together with its flooring, stairs, and foundation, restored. Photo: City of Palatka, Community Development Department.*

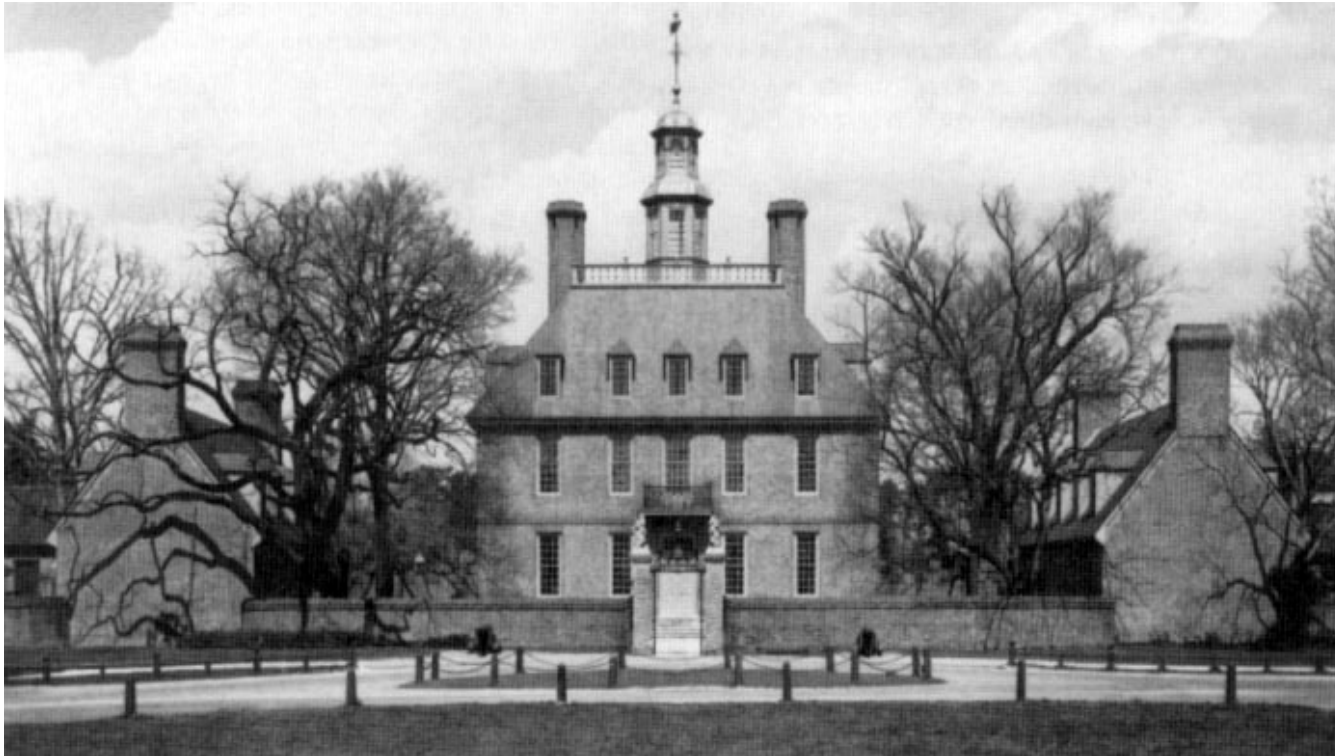
*In the 1930s reconstruction of the 18th century Governor's Palace at Colonial Williamsburg, Virginia, the archeological remains of the brick foundation were carefully preserved in situ, and serve as a base for the reconstructed walls.  
Photo: The Colonial Williamsburg Foundation.*

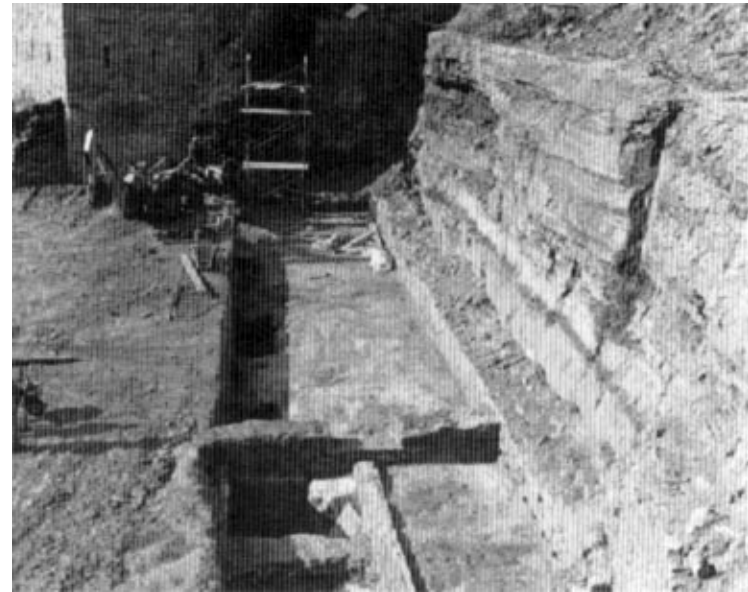
*Reconstruction should generally be based on an extensive archeological investigation, as was done here to re-create a non-surviving commissary building at Fort Snelling.*

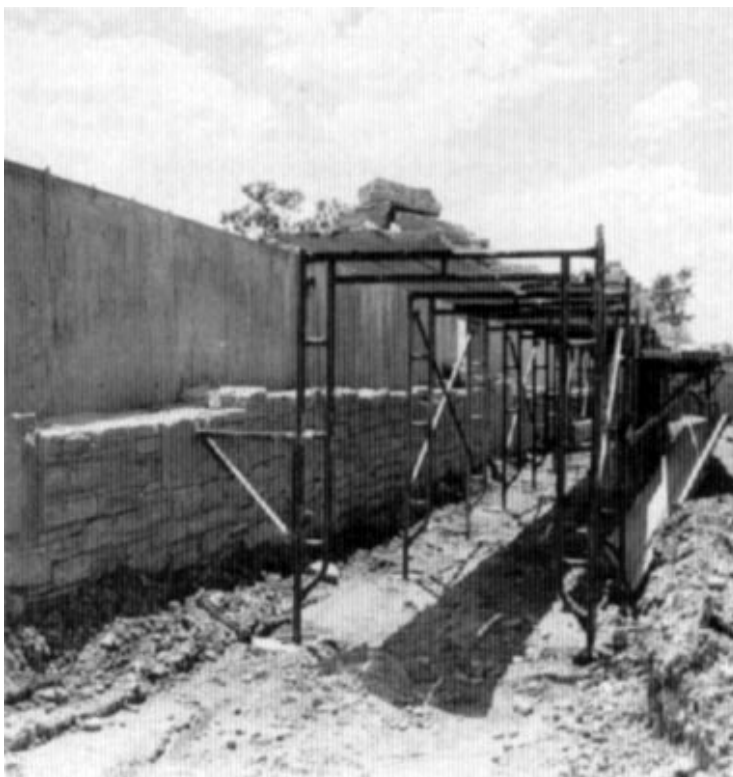
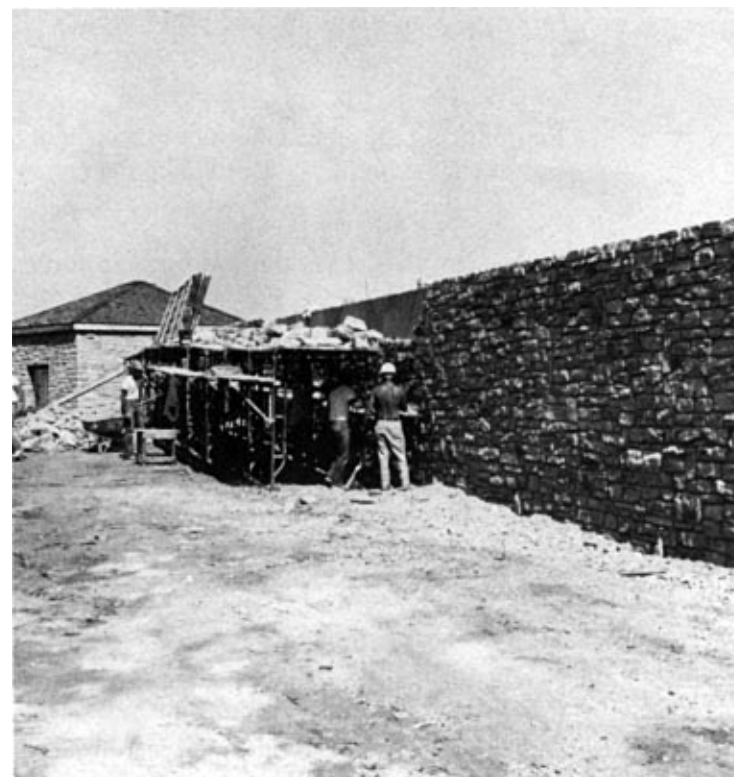
*(a) and (b). Two photos illustrate the use of contemporary construction materials and techniques within the treatment, Reconstruction. Because Reconstruction is employed to portray a significant earlier time, usually for interpretive purposes, substitute materials may be appropriate if they are able to convey the historic appearance.*

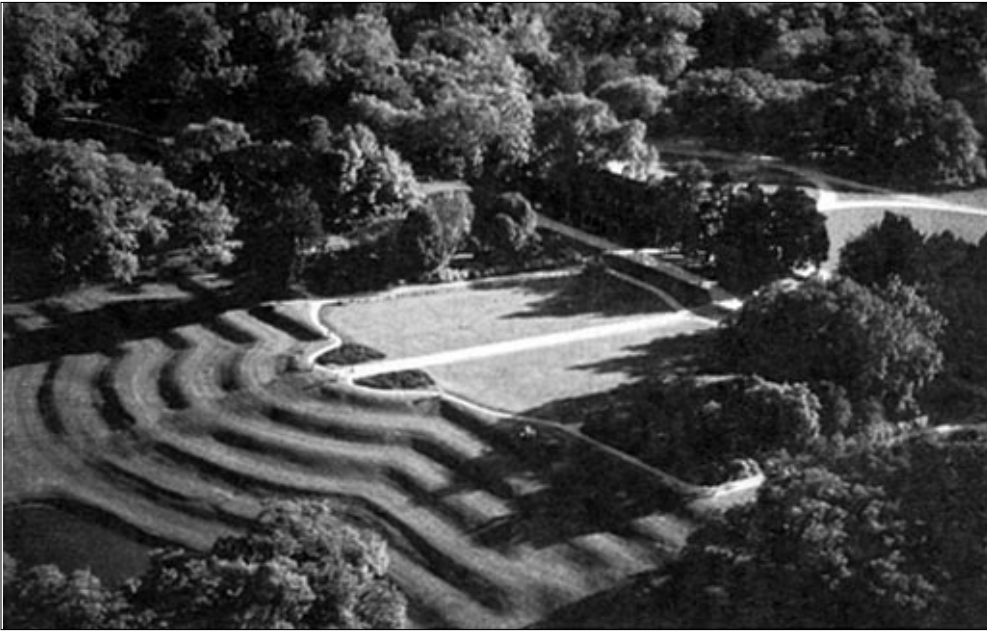
*The spacious grounds at Middleton Place, near Charleston, South Carolina, constitute the first landscaped garden in America. The molded terraces, originally constructed in the 18th century, were largely reconstructed in the early 20th century based on extant remains and other documentary evidence. Photo: Middleton Place.*

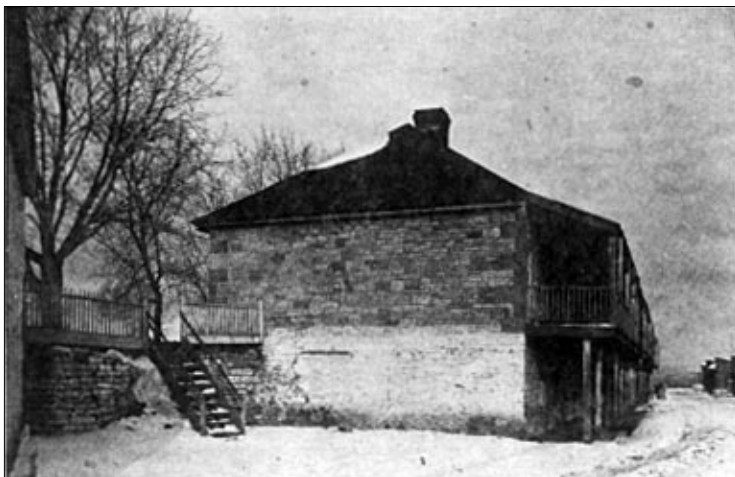
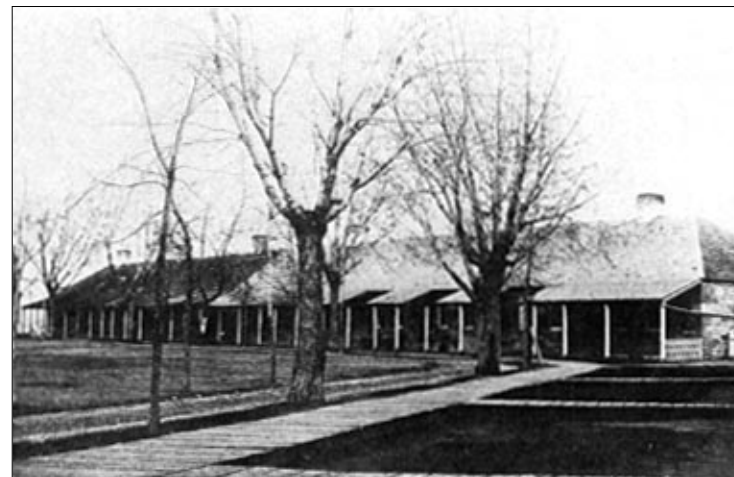
*(a) and (b). Two views of the Officers' Quarters at Fort Snelling (ca. 1885 to 1900) not only provide information on the materials and form of the historic block, they document the wooden walkways and other landscape features such as stairs, railings, and tree placement. Historical and pictorial evidence would need to be combined with specific physical evidence in order to make the case for Reconstruction as a treatment.*

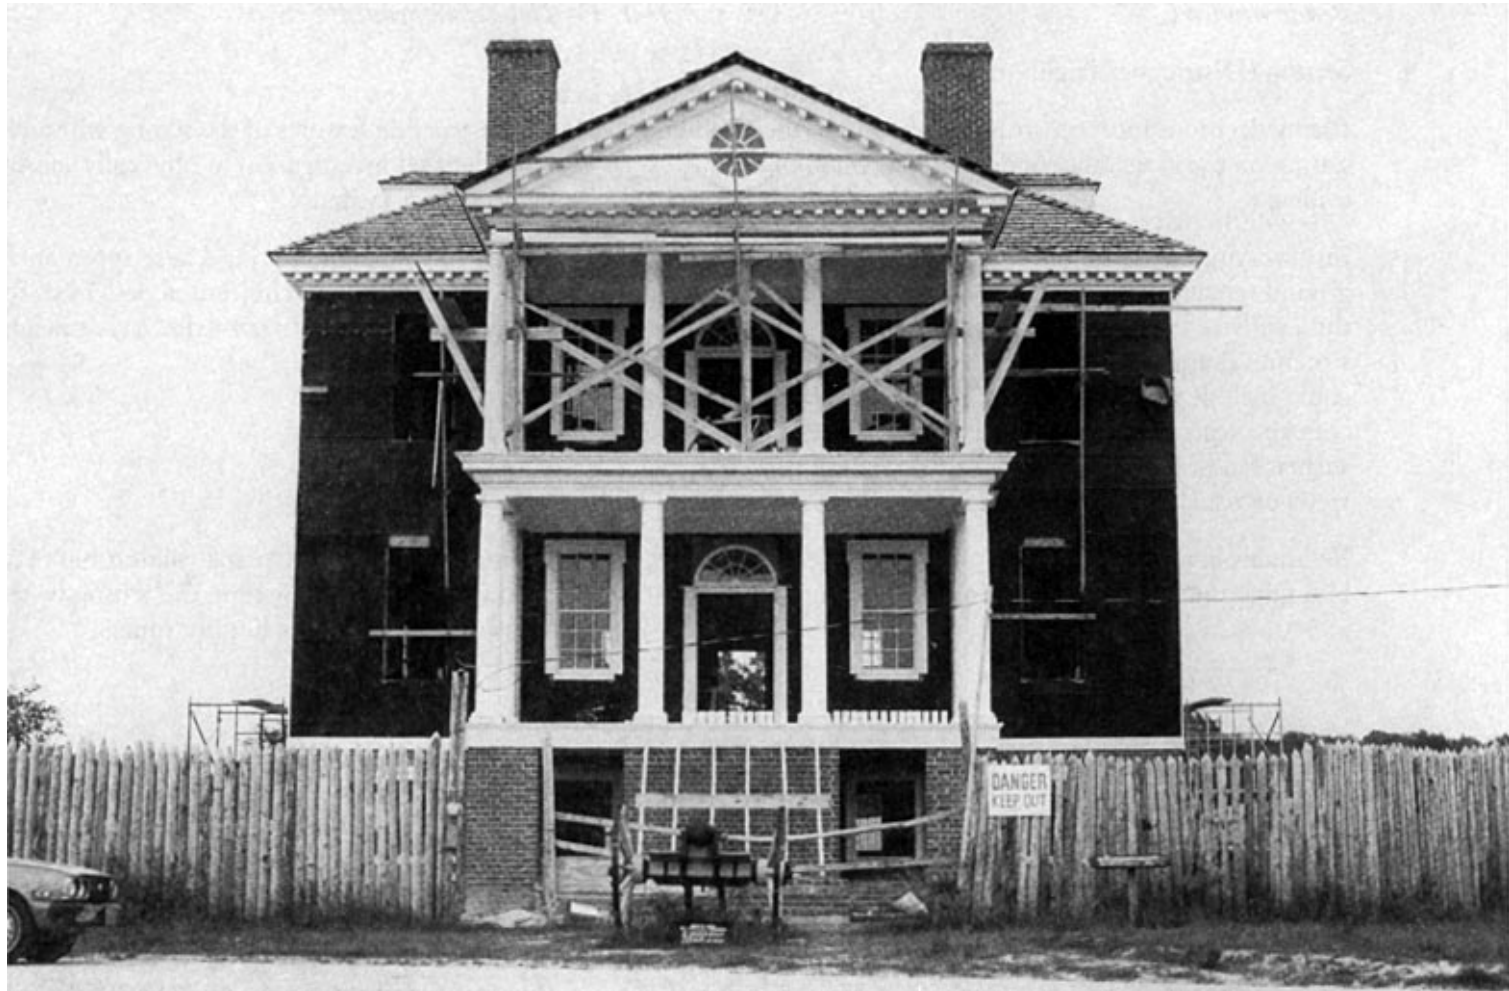
*The 1778 Kershaw House, which served as British Headquarters during the Revolutionary War, was burned by Union troops in 1865. In the early 1970s, the house was reconstructed as part of Camden Battlefield, Camden, South Carolina. Built expressly for interpretive purposes, it serves as an illustrative reminder of a past event of national significance. The Standards for Reconstruction call for any re-created building to be clearly identified as a contemporary depiction. This is most often done by means of an exterior sign or plaque, or through an explanatory brochure or exhibit. A guide may inform visitors as well. Photo: Richard Frear.*
