THE SECRETARY  
OF THE INTERIOR'S  
**STANDARDS FOR  
THE TREATMENT  
OF HISTORIC  
PROPERTIES**

WITH  
**GUIDELINES FOR  
PRESERVING,  
REHABILITATING,  
RESTORING &  
RECONSTRUCTING  
HISTORIC  
BUILDINGS**

U.S. Department of the Interior  
National Park Service  
Technical Preservation Services

2017

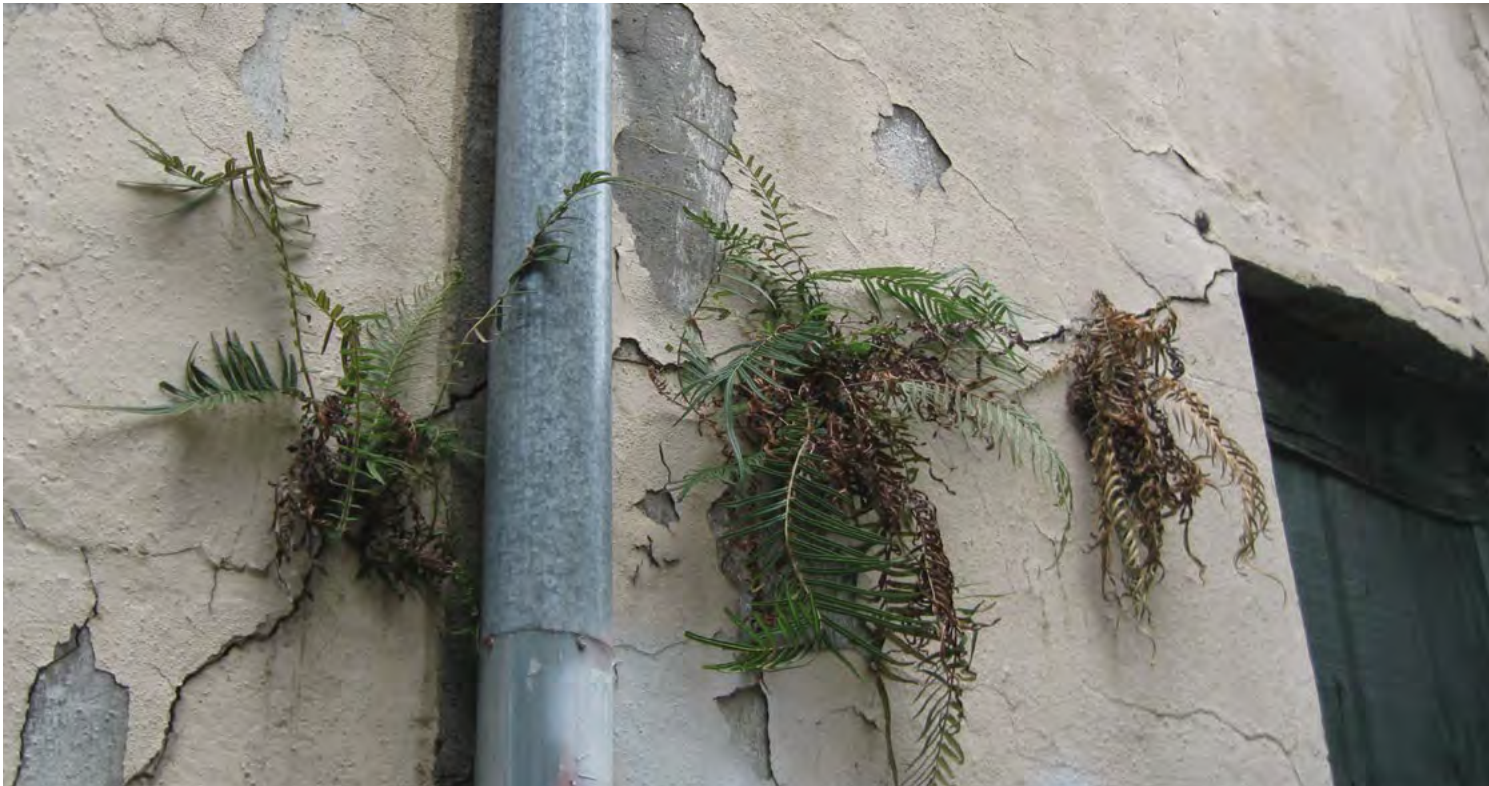
[3] **Not Recommended:** Cracks in the stucco have not been repaired, thereby allowing ferns to grow in the moist substrate which will cause further damage to the masonry.

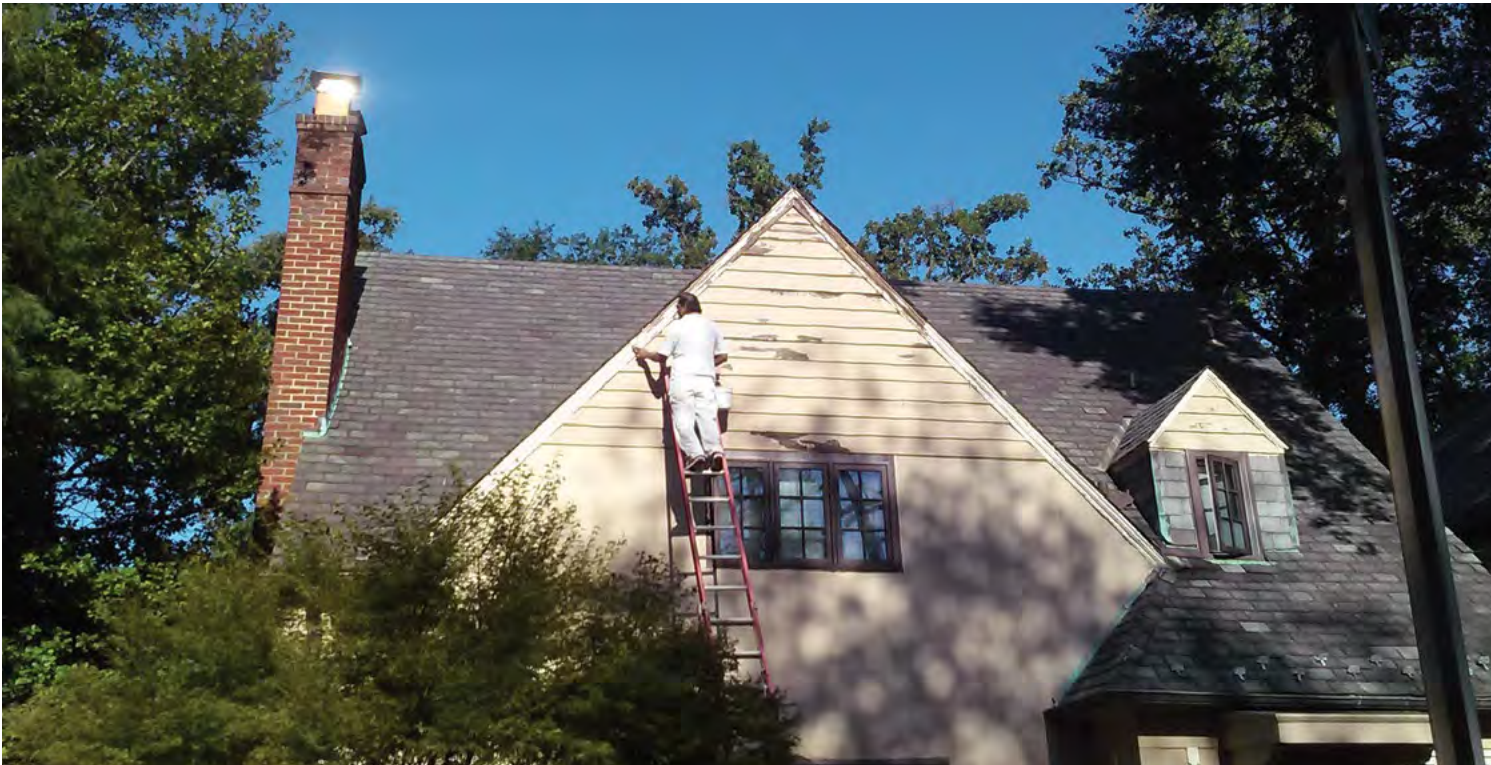
[4] Hand scraping to remove peeling paint from wood siding in preparation for repainting is an important part of regularly-scheduled maintenance.

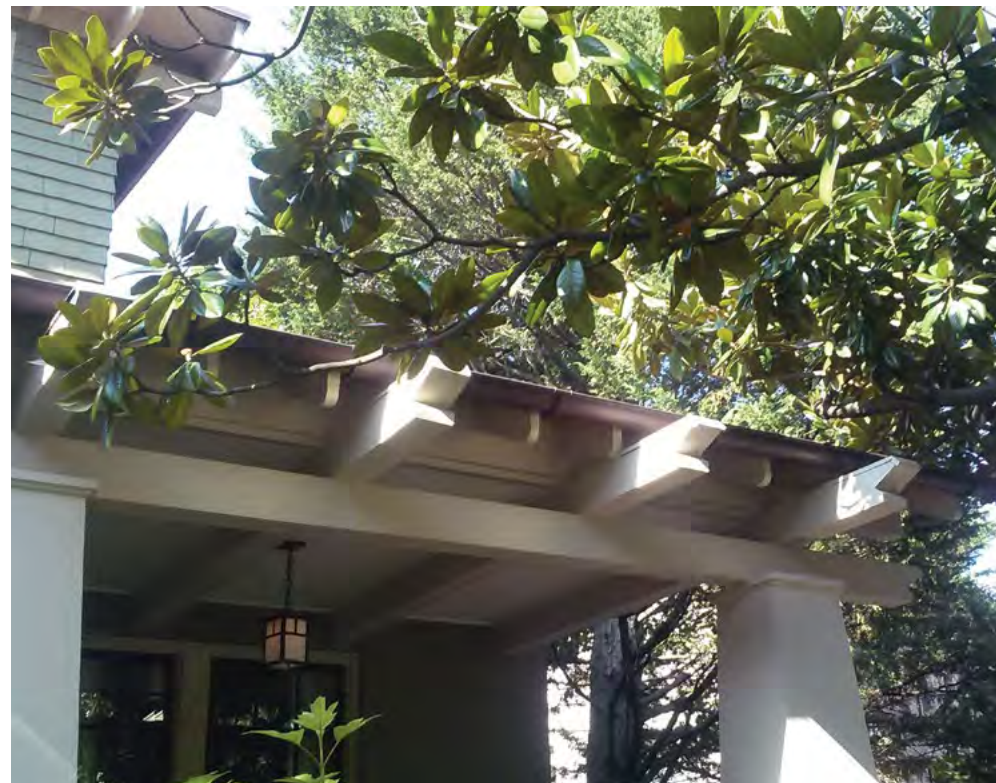
[12] Repair and limited replacement in kind to match deteriorated wood porch features is always a recommended preservation treatment.

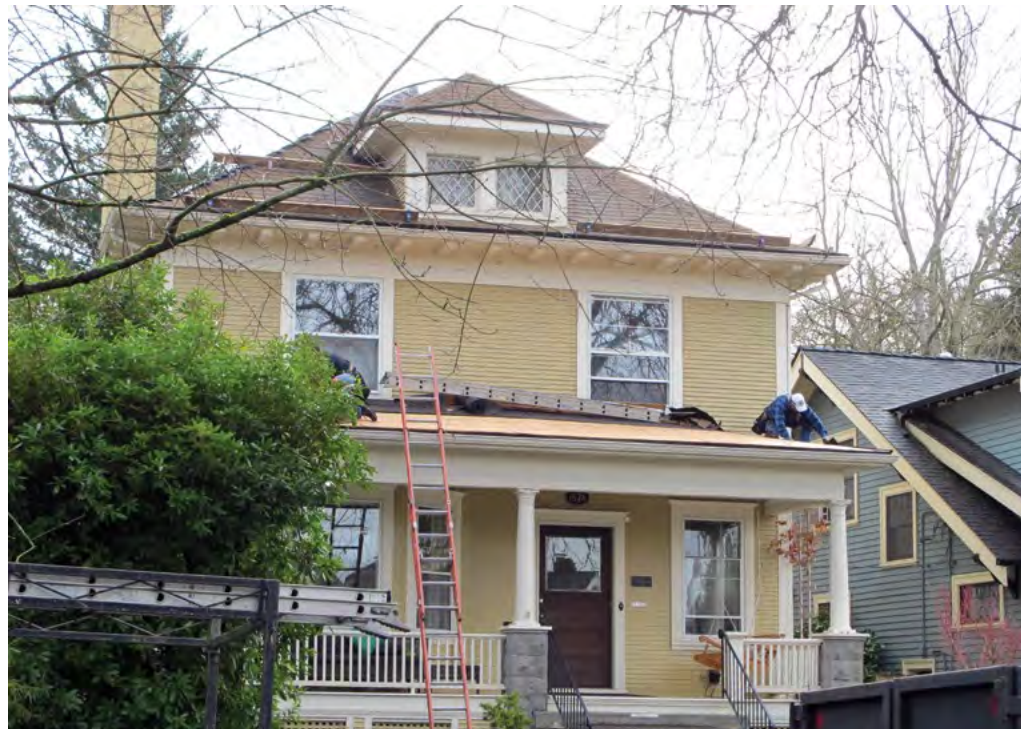
[16] The deteriorated asphalt shingles of this porch roof are being replaced in kind with matching shingles.

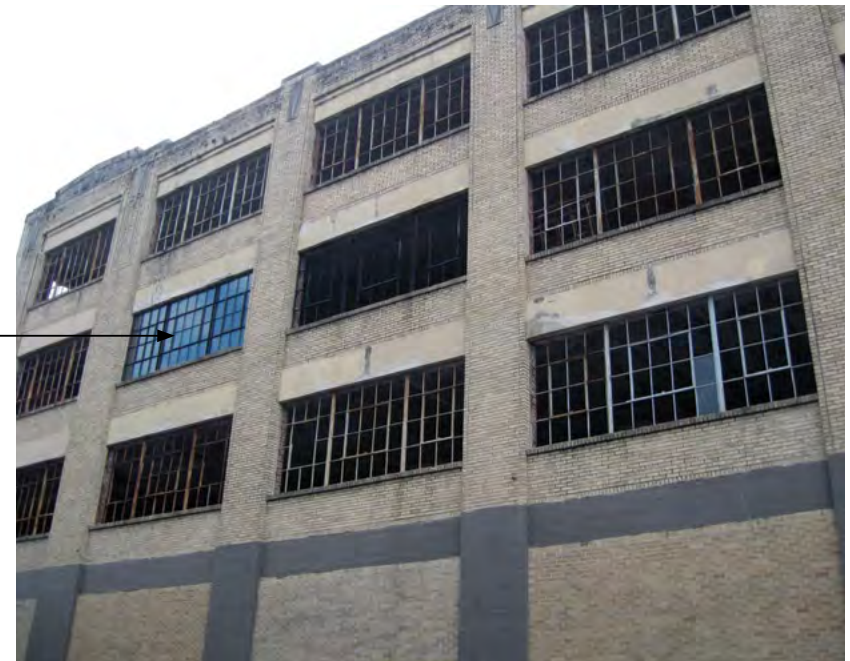
[19] Installing a mockup of a proposed replacement window can be helpful to evaluate how well the new windows will match the historic windows that are missing or too deteriorated to repair.

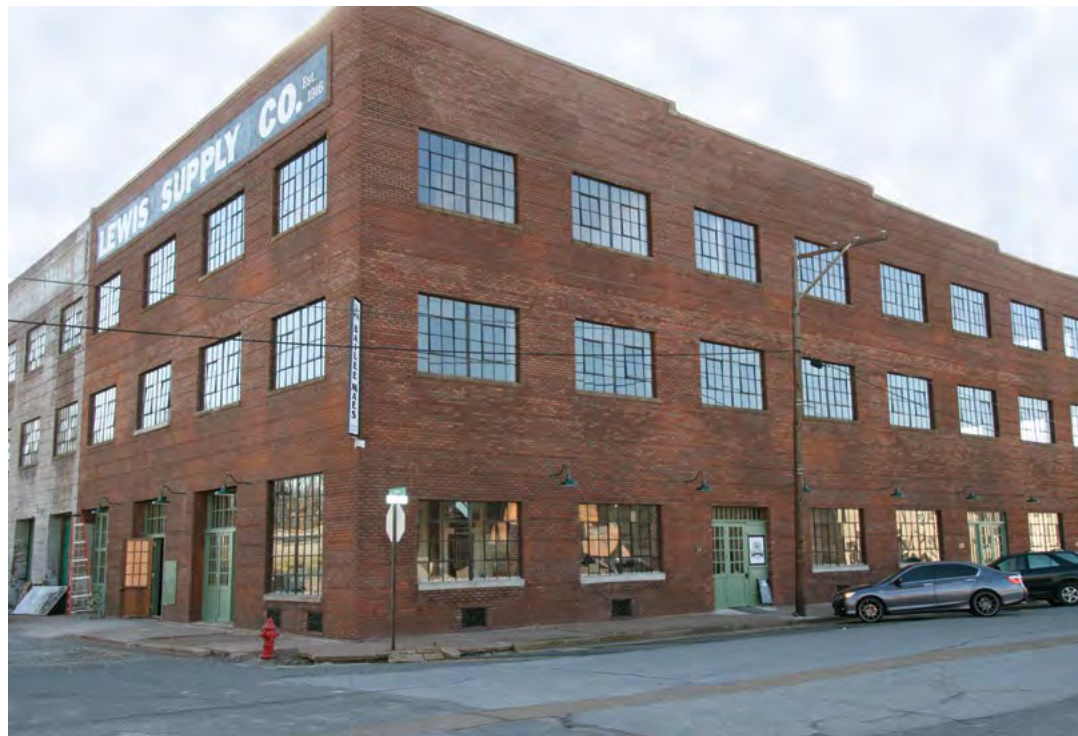
[20 a-d] The original steel windows in this industrial building were successfully repaired as part of the rehabilitation project (left).

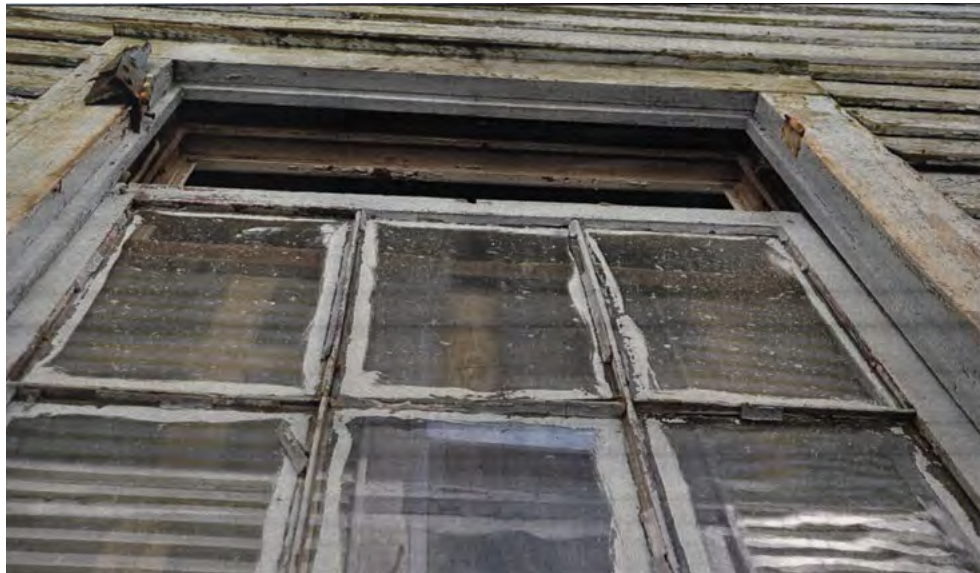
[23] (a) This deteriorated historic wood window was repaired and retained (b) in this rehabilitation project.

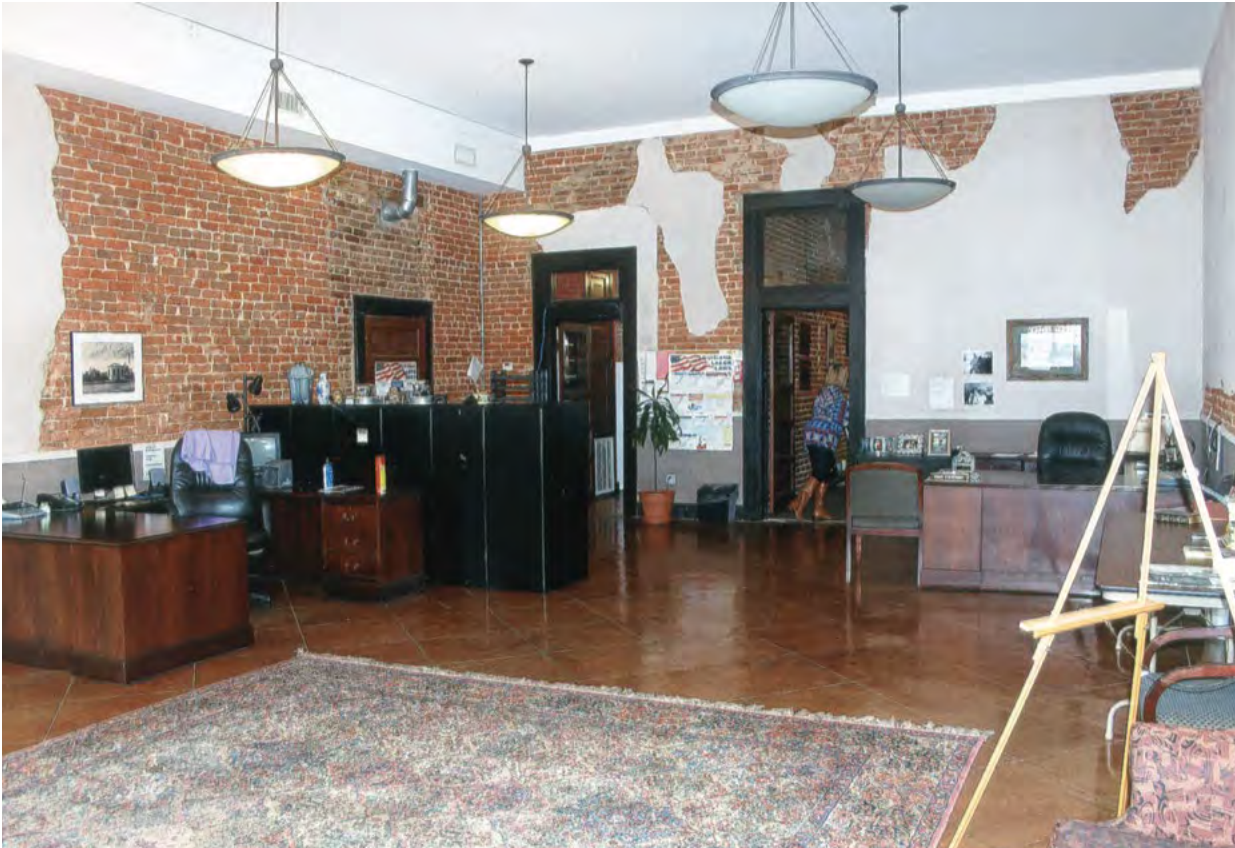
**[41] Not Recommended:**  
Leaving fragments of deteriorated or "sculpted" plaster is not a compatible treatment for either finished or unfinished interior spaces.

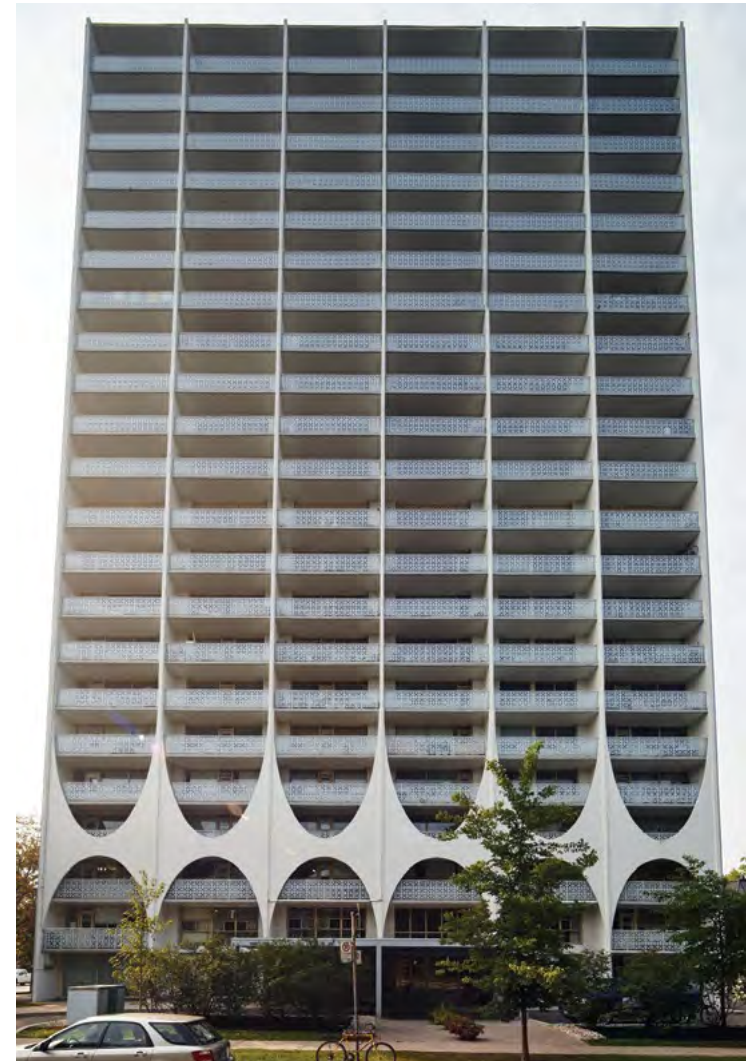
[59] (a-b) The decorative concrete balcony railings on this 1960s building did not meet life-safety code requirements. They were replaced with new glass railings with a fritted glass pattern matching the original design—a creative solution that satisfies codes, while preserving the historic appearance of the building when viewed from the street (c-d). Photos: (a, b, d) ERA Architects, Inc.; (c) Nathan Cyprys, photographer.
