**BORRADOR DE DECLARACIÓN DE IMPACTO AMBIENTAL**  
**ESENCIA, BOQUERÓN, CABO ROJO**

**ENERO 2025**

**TOMO 1 DE 2**  
**Borrador DIA + Anejos 1-5**

**TÍTULO DE LA ACCIÓN PROPUESTA:** Esencia, Boquerón, Cabo Rojo

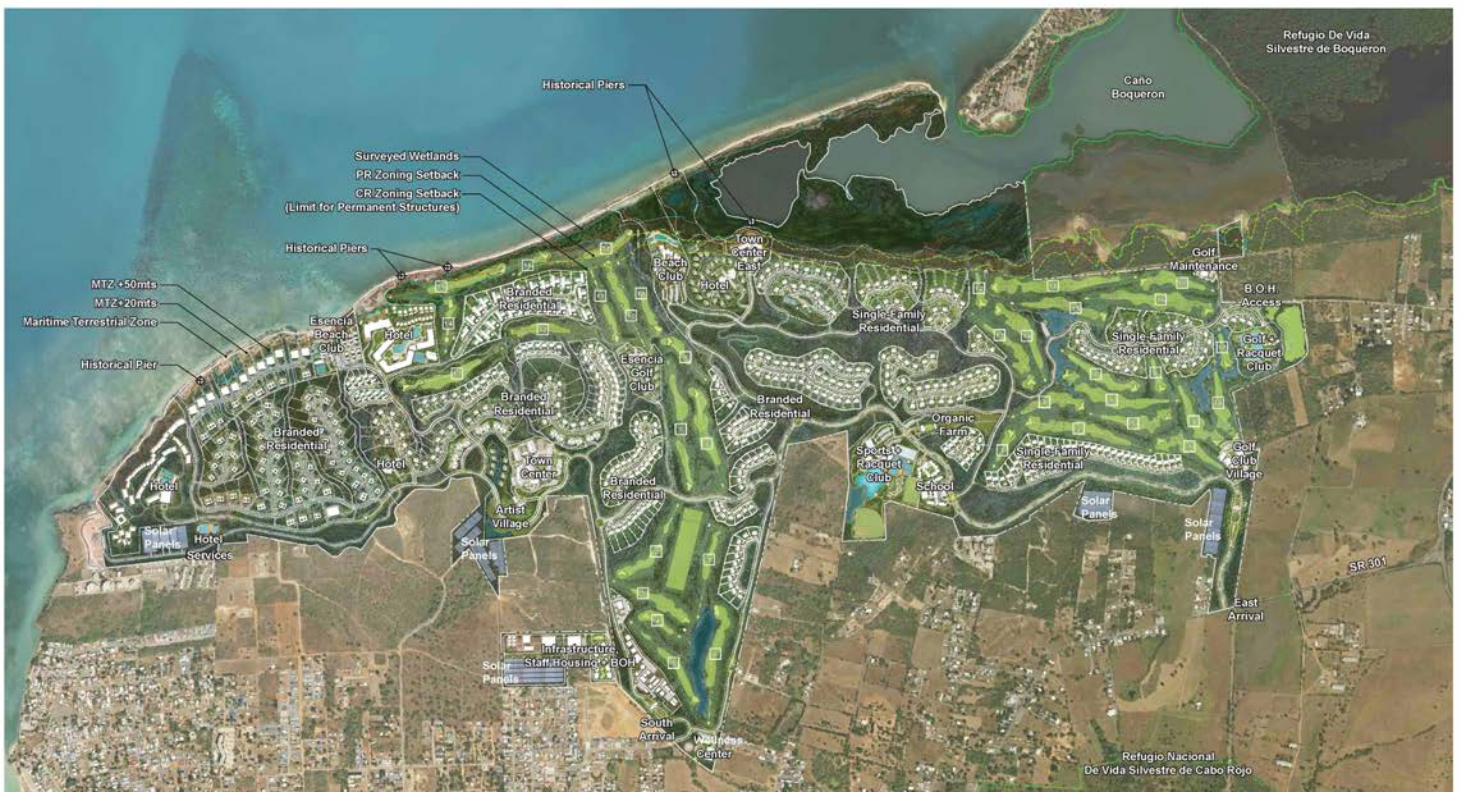
### Figura 3: Plan Conceptual

#### CONCEPTUAL PLANNING ILLUSTRATIVE PLAN - FULL PARCEL VERSION

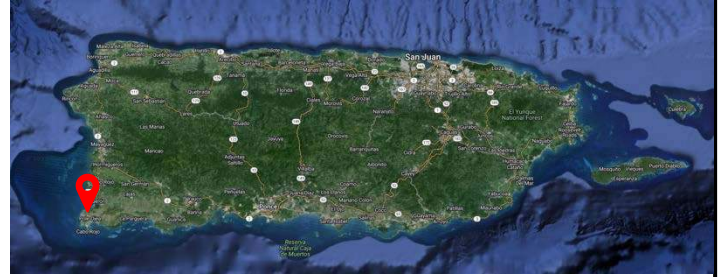
# Figura 16: Mapa de Inundación - FIRMette

FEMA Flood Insurance Rate Map (FIRM)  
 Escencia - Cabo Rojo, PR  
 Date: 12/19/2023

Según el Mapa de Inundación de la Agencia Federal para el Manejo de Emergencias (FEMA, por sus siglas en inglés), Hojas 72000C1540J, 72000C1545J, 72000C1905J y 72000C1910J con vigencia del 18 de noviembre de 2009, el área donde se realizará el proyecto ocupa las siguientes zonas (Ver [Anejo 1, Figura 16: Mapa de Inundación de FEMA](#)):

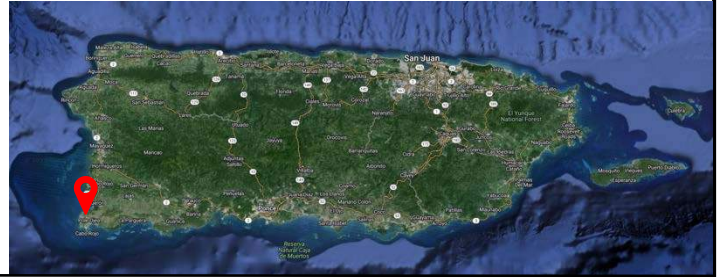
# Figura 24: Mapa Geológico del Área del Proyecto - Geologic Map of the Puerto Real Quadrangle

GEOLOGIC MAP OF THE PUERTO REAL QUADRANGLE, SOUTHWEST PUERTO RICO  
 By Richard P. Volkman  
 1984

Las formaciones geológicas que se encuentran en el área, según el Mapa Geológico del Cuadrángulo de Puerto Real y Parguera del NRCS (Ver [Anejo 1, Figura 24: Mapa Geológico del Área del Proyecto](#)) son las siguientes:

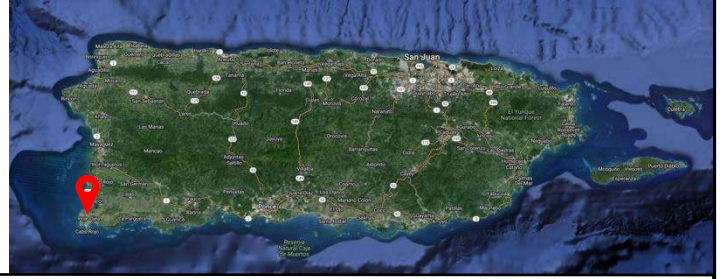
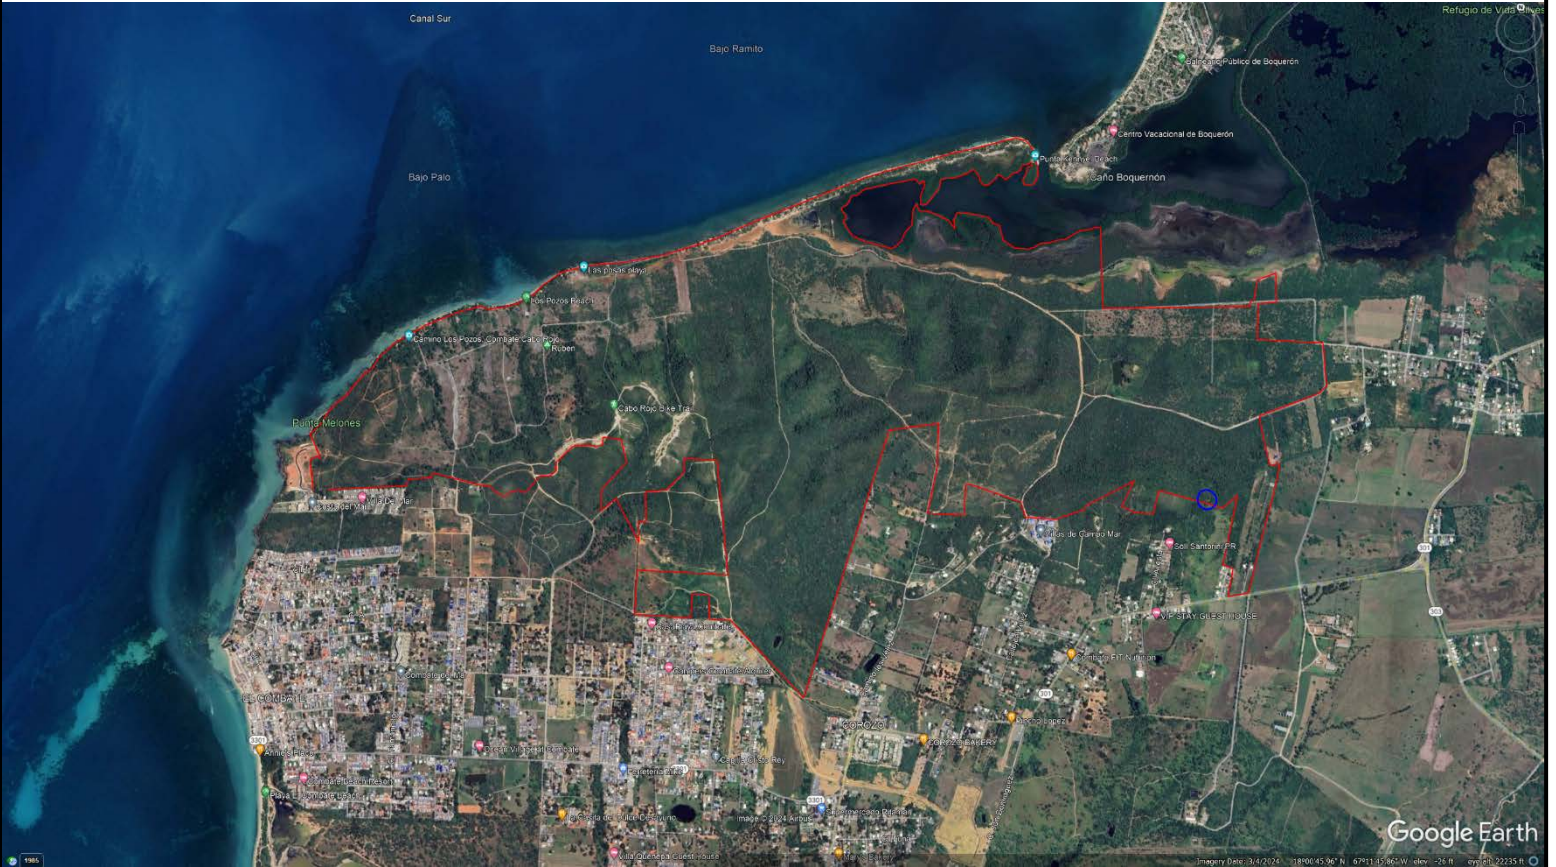
## Figura 25: Sistema de Cuevas en el Proyecto

- Area del Proyecto
- Sistema de Cuevas

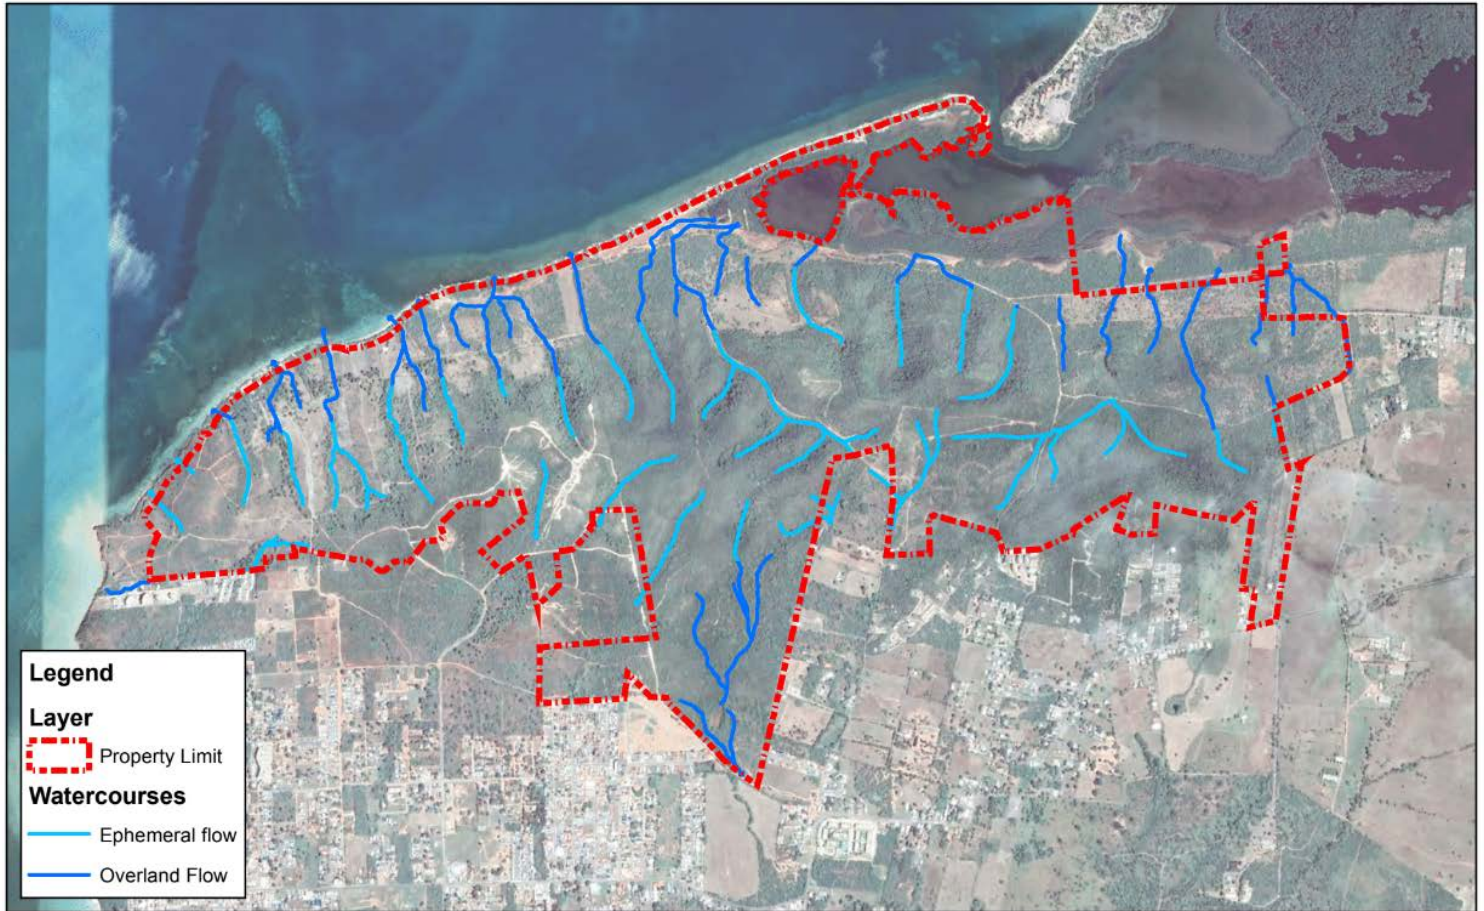
# Figura 28: Aguas Superficiales

<p><b>Water Courses - Existing Condition</b></p> <p><b>Esencia - Cabo Rojo, PR</b></p>	<p>Date: 5/15/2024</p>	
--	--	------------------------	--

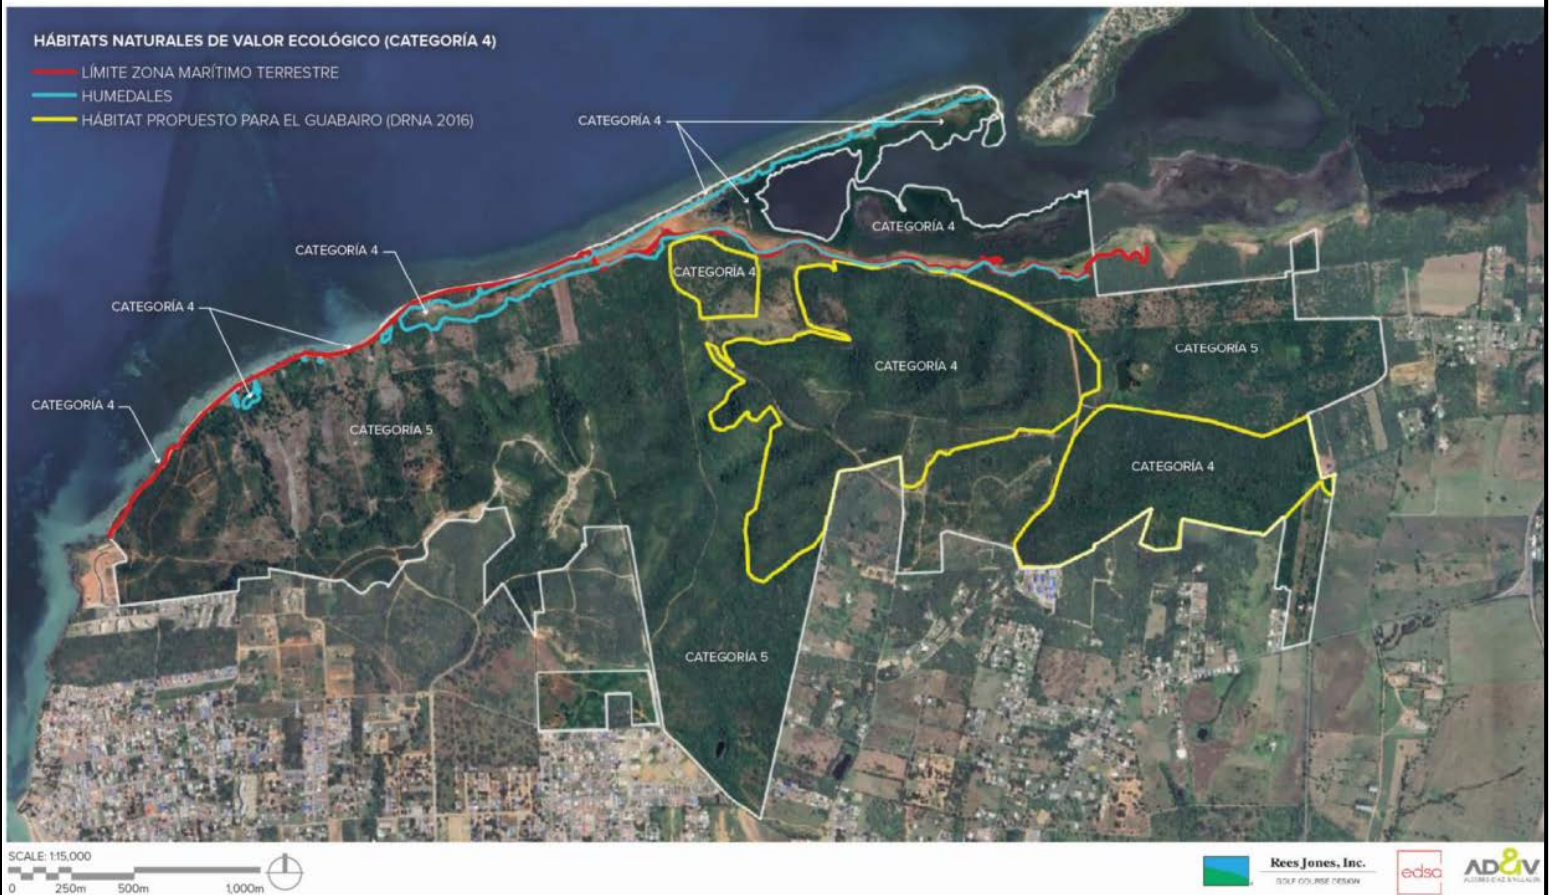
## Figura 35: Categorización de Hábitat

Fuente: *Solicitud para Certificación de Categorización de Hábitats Naturales para la Vida Silvestre Esencia*,  
Álvarez-Díaz & Villalon (AD&V) y Ambienta, Inc.  
Compañía: AVA Environmental Consultants, Inc.

Según los estudios realizados, el área de acción se entiende estaría clasificada como Habitat Categoría 4 y 5<sup>150</sup>. Las medidas de mitigación requeridas para compensar por impactos a hábitats bajo estas categorías son las siguientes (Ver [Anejo 1, Figura 35: Categorización de Hábitat](#)):

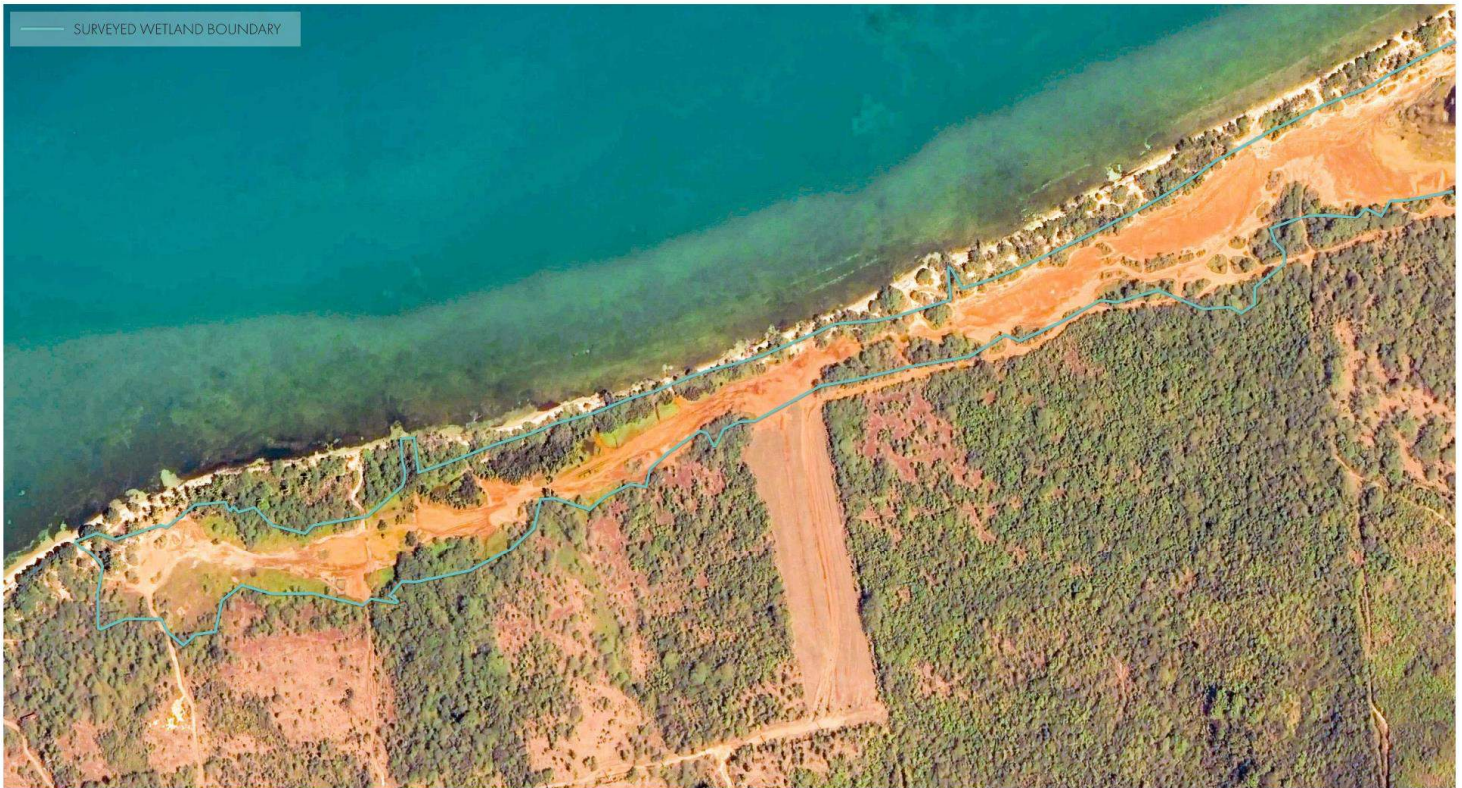
# Figura 39: Impacto a Humedales en el Proyecto 1996-2024

## FOCUS AREA - EXISTING CONDITIONS AERIAL IMAGE + WETLAND BOUNDARY

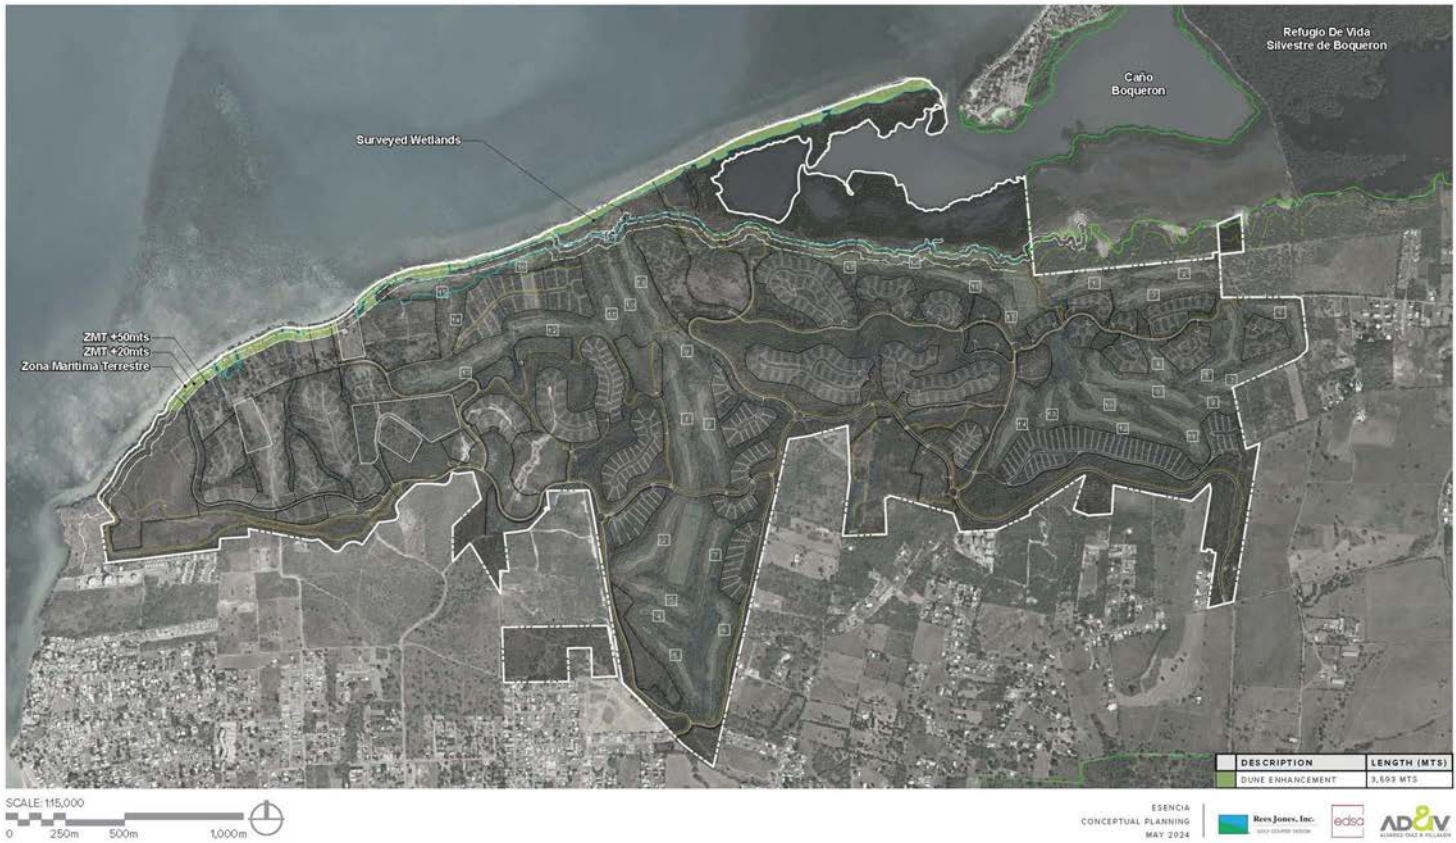
# Figura 41: Área de Mejoras de Dunas

## LAND USE DIAGRAMS DUNE ENHANCEMENT PLAN

Como parte del proyecto y el compromiso de proteger y fomentar la regeneración y revegetación de aproximadamente 2.2 millas de duna (Ver [Anejo 1, Figura 41: Área de Mejoras de Dunas](#)). Según se menciona en la Sección B.3.a.8)b) y B.3.a.8)c), se llevó a cabo un Estudio de Caracterización y Evaluación de la Vegetación de las Dunas en el área del proyecto ([Anejo 21](#)) para determinar sus condiciones actuales y recibir recomendaciones de cómo proteger y, en caso de ser recomendado, mejorar las dunas. De igual manera, en

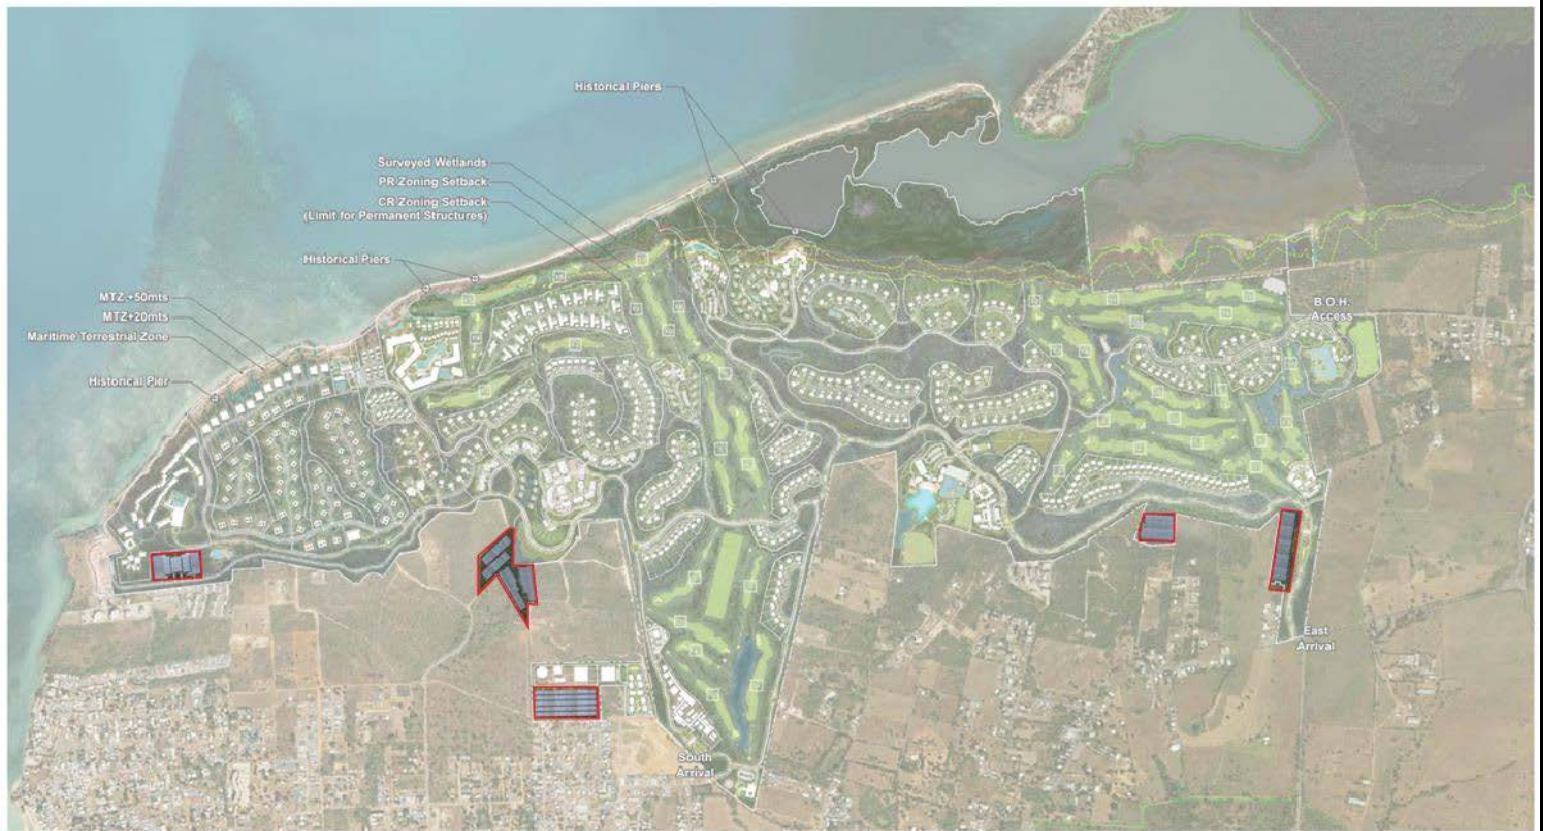
## Figura 42: Localización de Paneles Solares en el Proyecto

### CONCEPTUAL PLAN FULL CONCEPT VERSION

Para la primera fase del proyecto, el consumo se estima en 4MW, en su uso pico. Basado en esta necesidad, se entiende que la generación solar necesaria para suplir esta demanda será de 12.8MW. Para proveerla, se instalarán paneles fotovoltaicos en 26.2 cuerdas que ubican dentro del área del proyecto (Ver [Anejo 1, Figura 42: Localización de Paneles Fotovoltaicos](#)). Se proveerán además 12 Sistemas de Almacenamiento de Energía en Baterías (BESS, por sus siglas en inglés) para proveer energía eléctrica durante la noche y cuando las condiciones no sean óptimas para los paneles generar energía<sup>153</sup>. Se anticipa se necesitarán 68 MW, para suplir la demanda total del proyecto una vez completadas todas sus fases. También se instalarán los BESS necesarios para estas etapas.

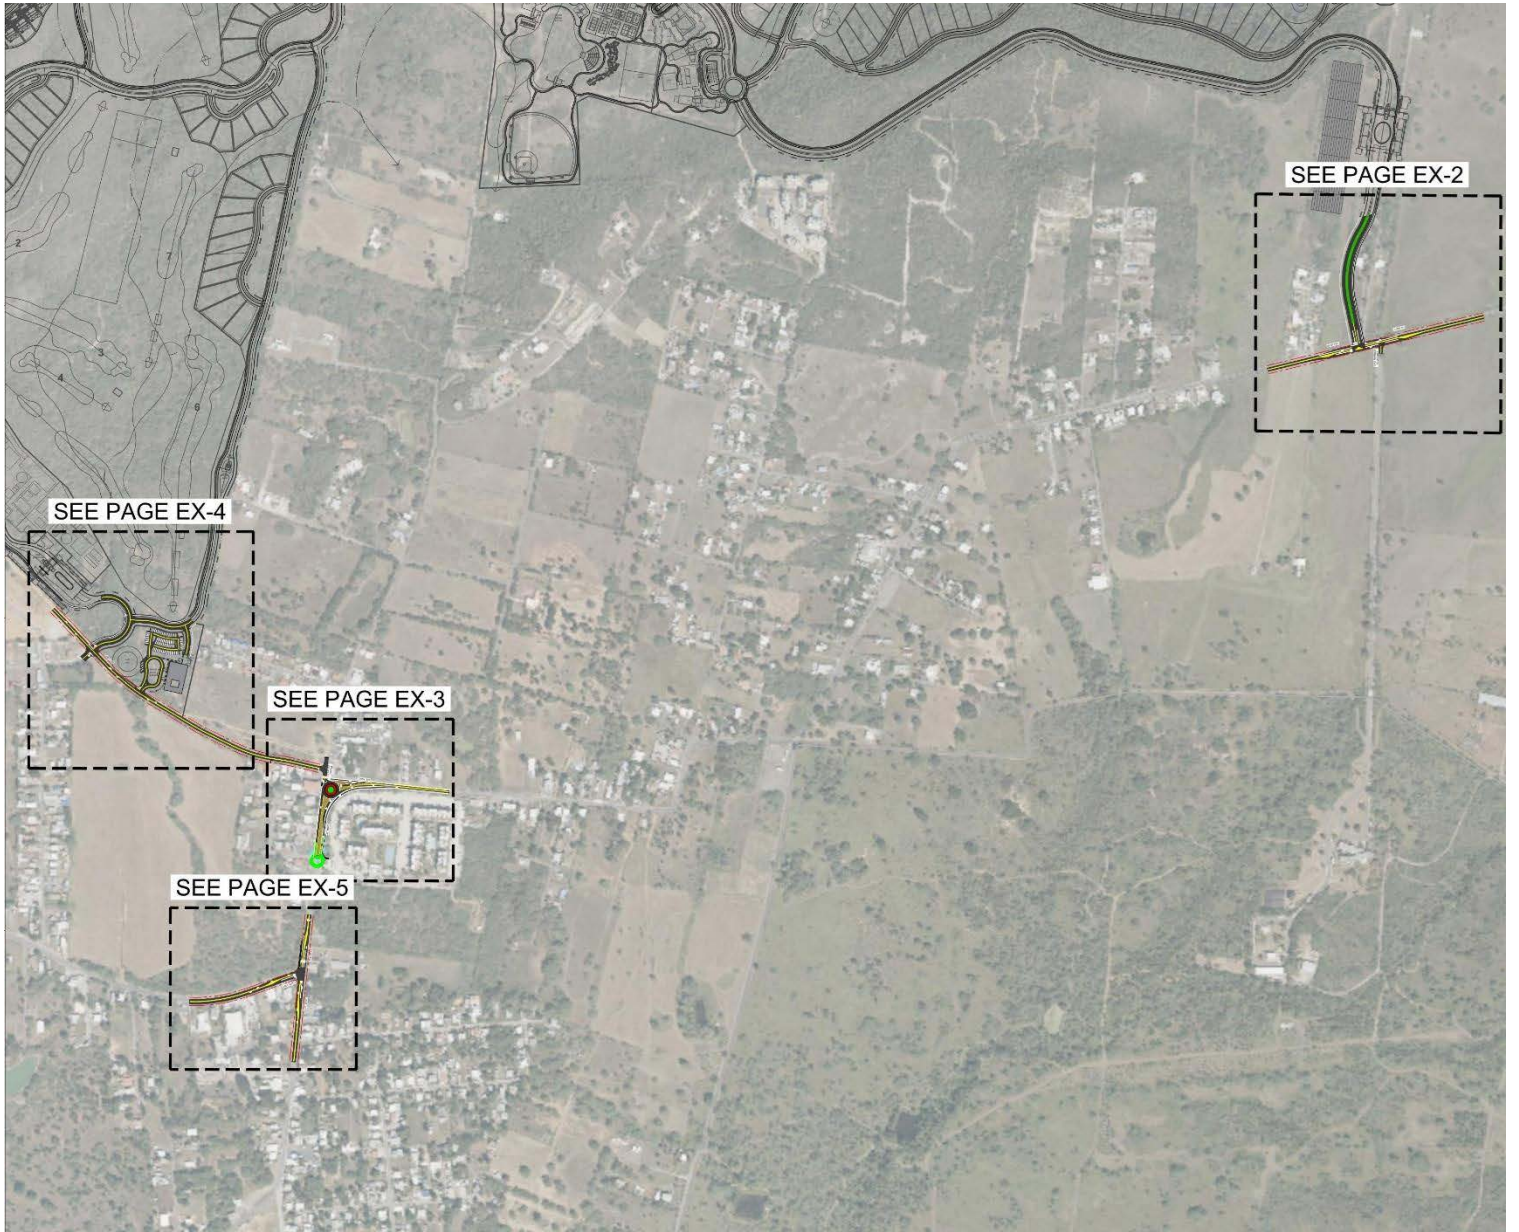
# Figura 43: Plano Conceptual de Mejoras de Vías

Fuente: *Traffic Impact Study*, VAG Transportation Engineering Consultants, PSC  
Compañía: AVA Environmental Consultants, Inc.

por un pare en la boca oeste. La PR-301 incluye dos carriles, uno en cada dirección, más paseos a cada lado y el Camino Monte Carlo incluye dos carriles, uno en cada dirección. Se recomienda proveer rotulación nueva (pare) en el Camino Monte Carlo y línea de pare para controlar el tráfico saliendo de este hacia la PR-301 (Ver [Anejo 1, Figura 43: Plano Conceptual de Mejoras de Vías](#)).

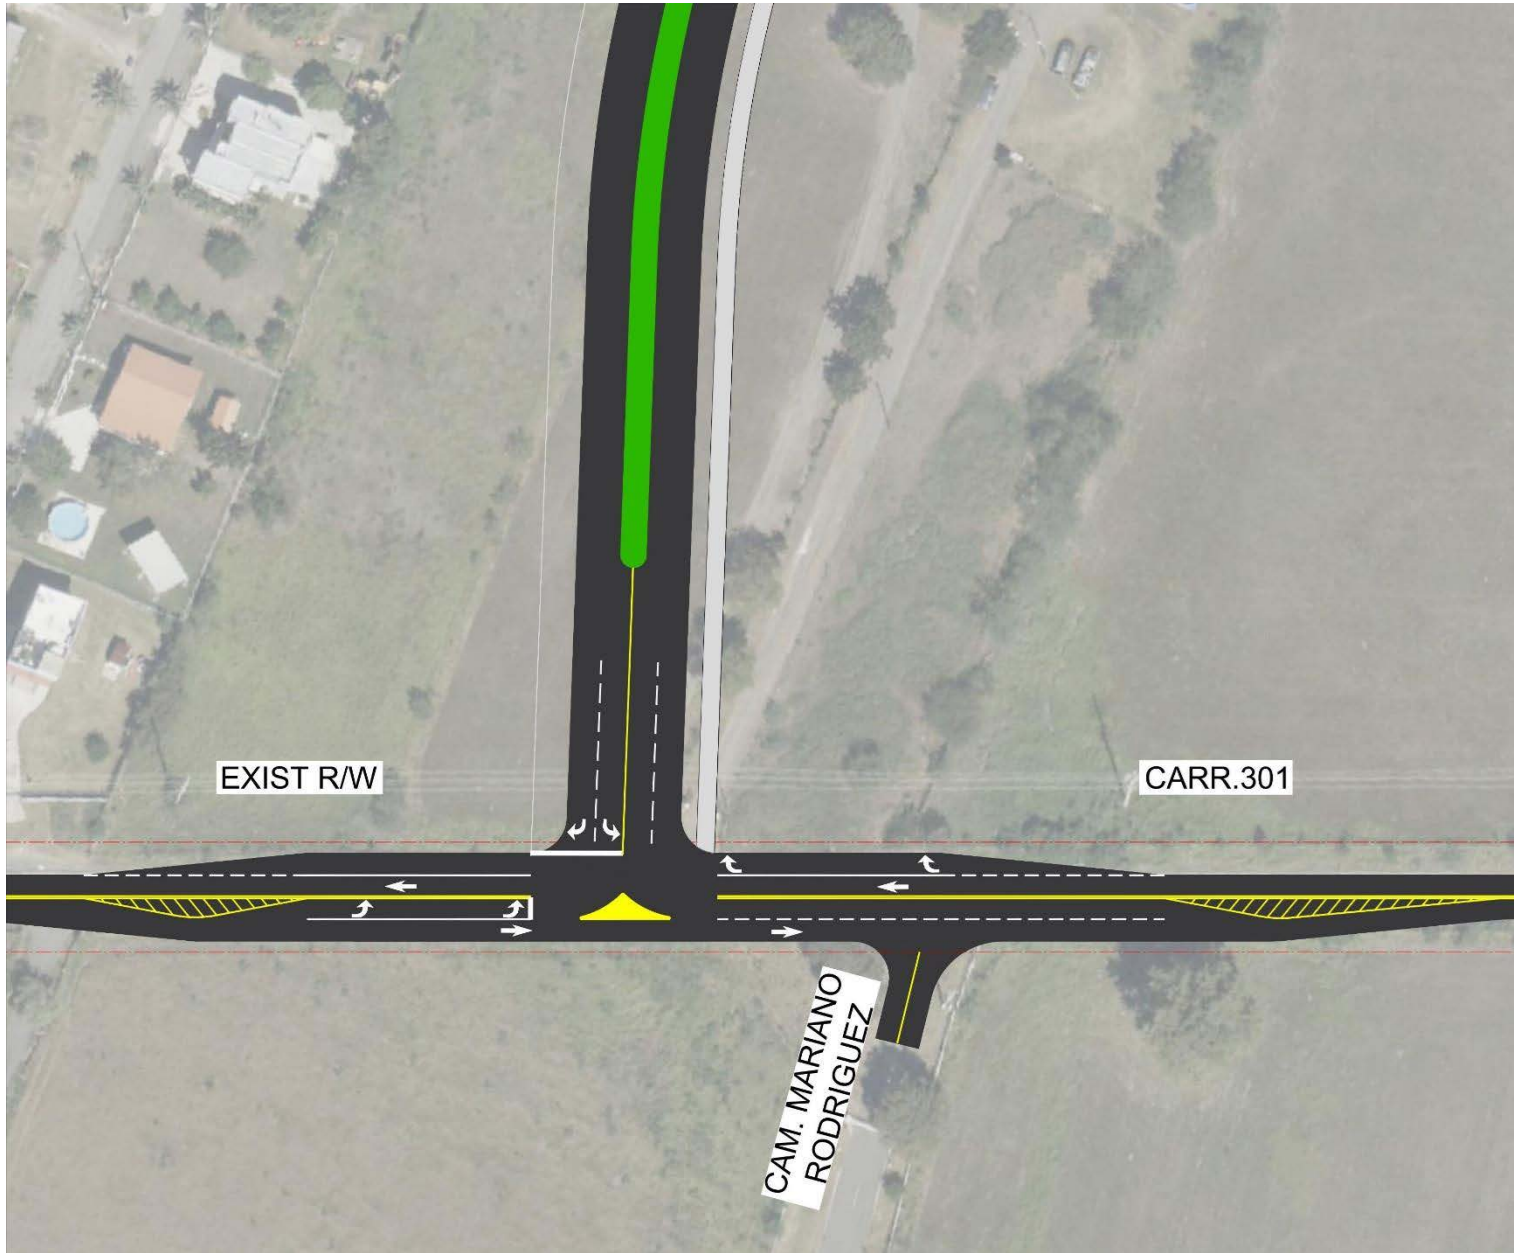
### Figura 43: Plano Conceptual de Mejoras de Vías EX-2

Fuente: *Traffic Impact Study*, VAG Transportation Engineering Consultants, PSC  
Compañía: AVA Environmental Consultants, Inc.

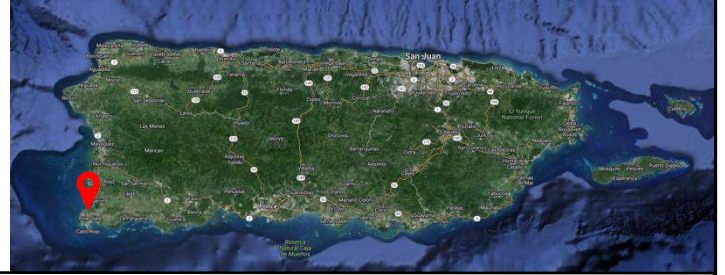
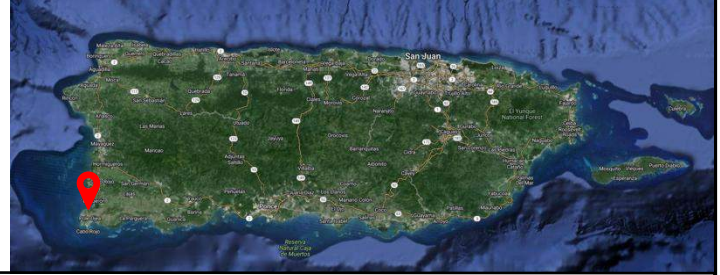
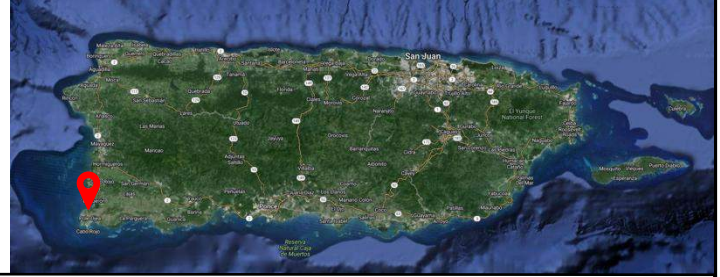
# Figura 44: Suelos Agrícolas del Área del Proyecto

Farmland Classification—San German Area, Southwestern Puerto Rico

Los suelos del área donde se llevará a cabo el desarrollo son en su mayoría terrenos no aptos para la agricultura (aproximadamente 82%). También se encuentran terrenos identificados como agrícolas de primera, si se irrigan (aproximadamente 14%) y agrícolas de importancia, si se irrigan (aproximadamente 3%) <sup>72</sup> (Ver [Anejo 1, Figura 44: Suelos Agrícolas](#)).

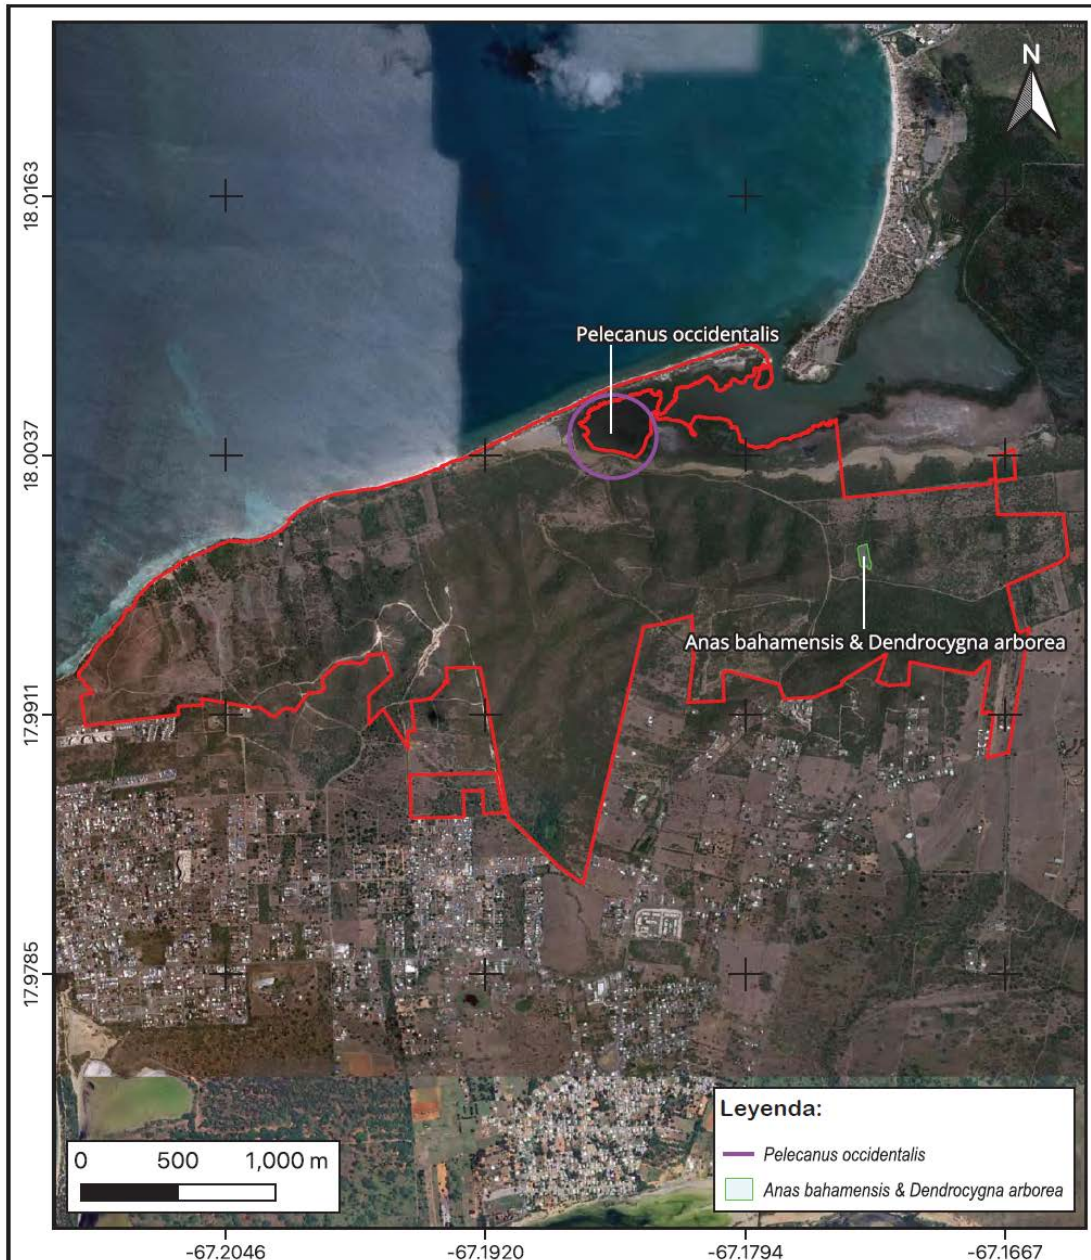
**Figura 45: Presencia confirmada de *Pelecanus occidentalis*, *Anas bahamensis* & *Dendrocygna arborea***

**Figura 8: Presencia confirmada de *Anas bahamensis*, *Dendrocygna arborea* y *Pelecanus occidentalis* Esencia, Cabo Rojo, Puerto Rico**

La [Figura 19: Localización del Guabairo \(Anejo 1\)](#) muestra las localidades donde se encontró la especie *Antrostomus noctitherus* (Guabairo de Puerto Rico). La [Figura 20: Localización de la Mariquita \(Anejo 1\)](#) muestra las localidades donde se encontró la especie *Agelaius xanthomus* (Mariquita de Puerto Rico). La [Figura 45: Fauna \(Anejo 1\)](#) muestra las localidades donde se encontraron las especies *Anas bahamensis* (Pato quijada colorada), *Dendrocygna arborea* (Chiriría Antillana) y *Pelecanus occidentalis* (Pelícano Pardo).

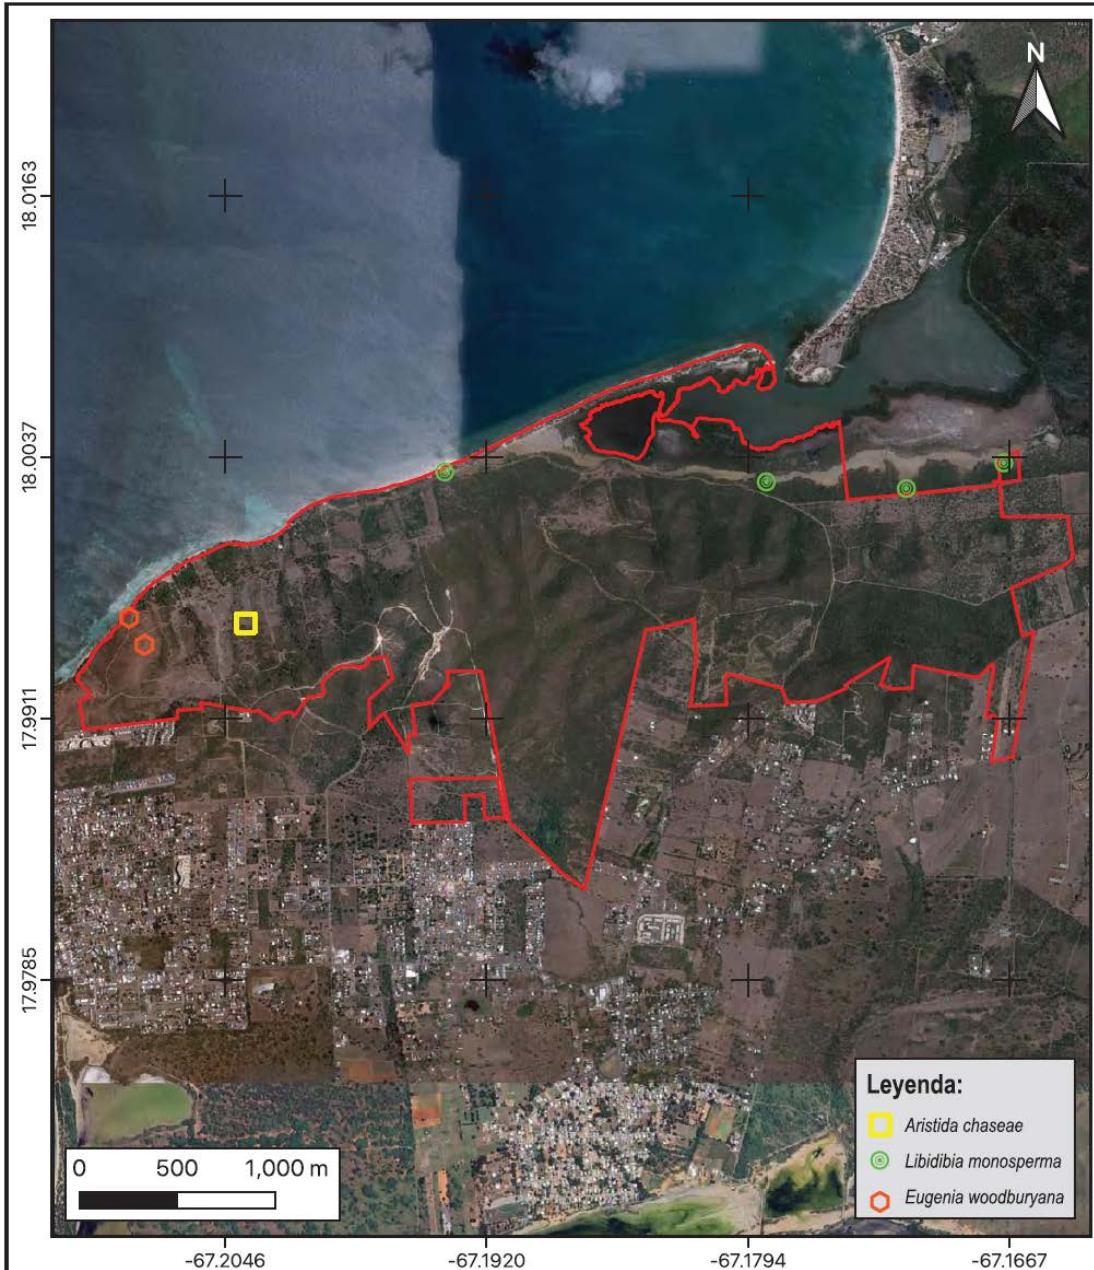
**Figura 46: Presencia confirmada de las Especies de Flora Listadas por el DRNA y USFWS**

**Figura 5: Presencia confirmada de las Especies de Flora Listadas por el DRNA y USFWS**  
**Esencia, Cabo Rojo, Puerto Rico**

- Especies Listadas por el DRNA y USFWS: (especies designadas como vulnerables, amenazadas o en peligro de extinción) (Ver [Anejo 1, Figura 46 – Flora](#)):

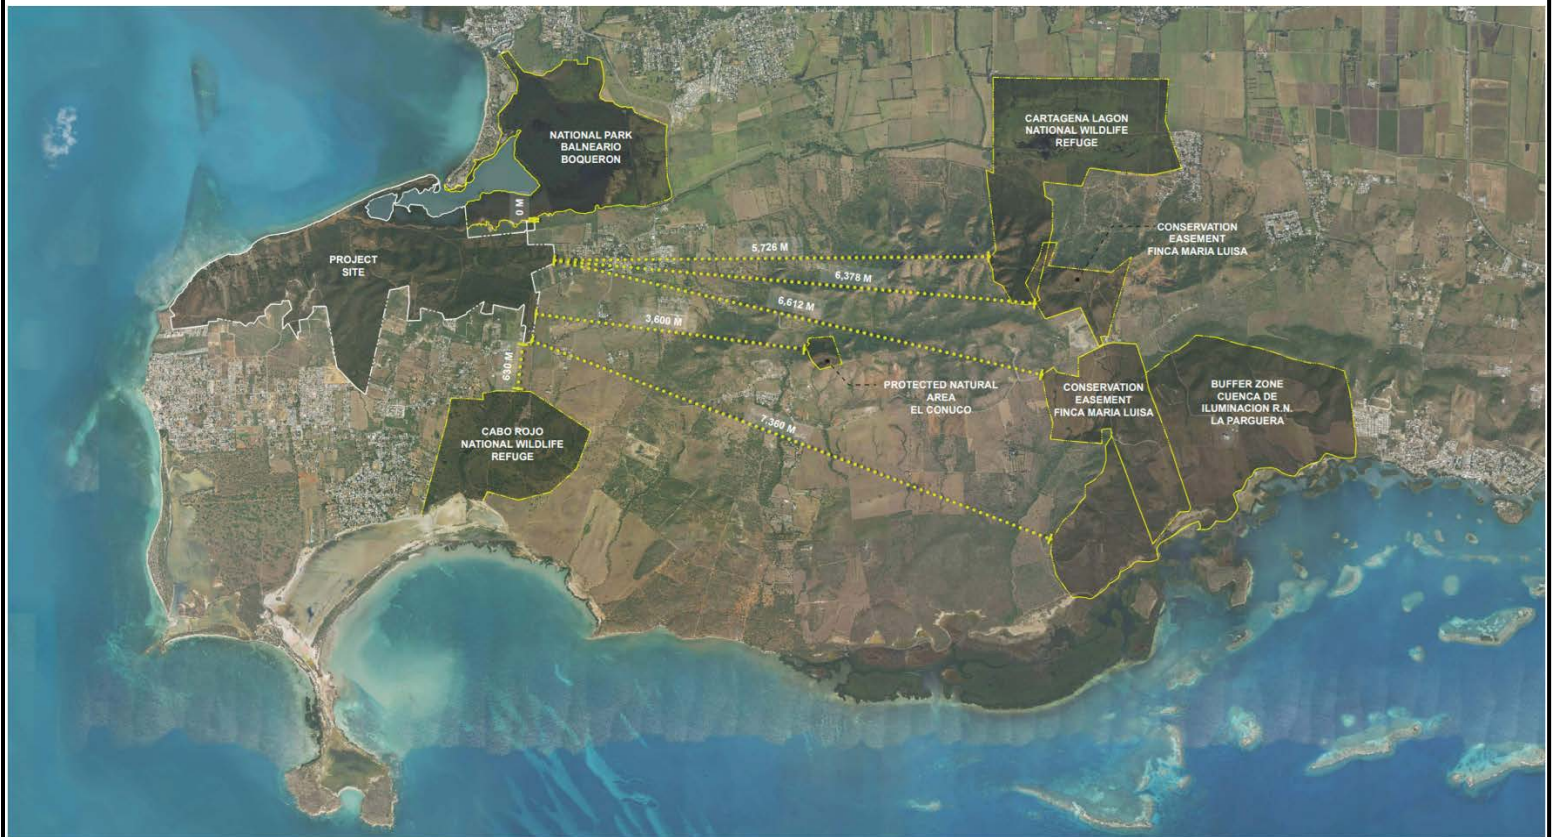
# Figura 47: Áreas Naturales y/o Protegidas en Contexto Inmediato

## NATURAL AREAS PROXIMITY

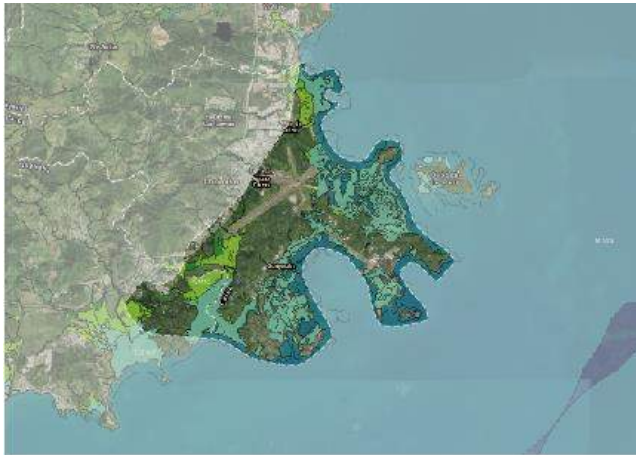
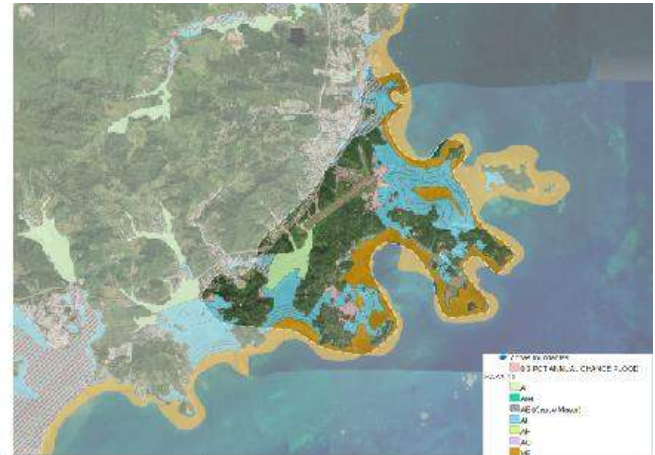
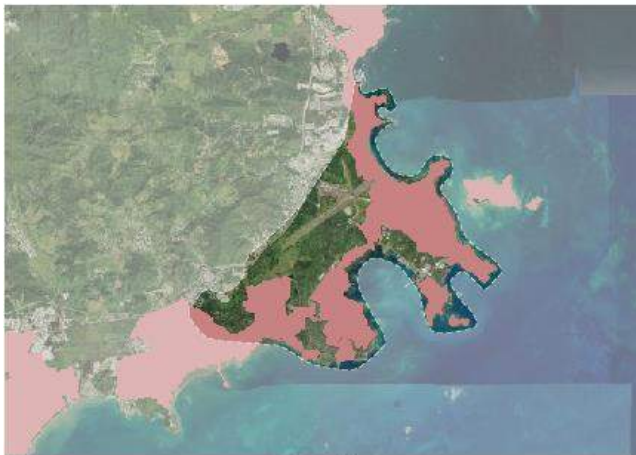
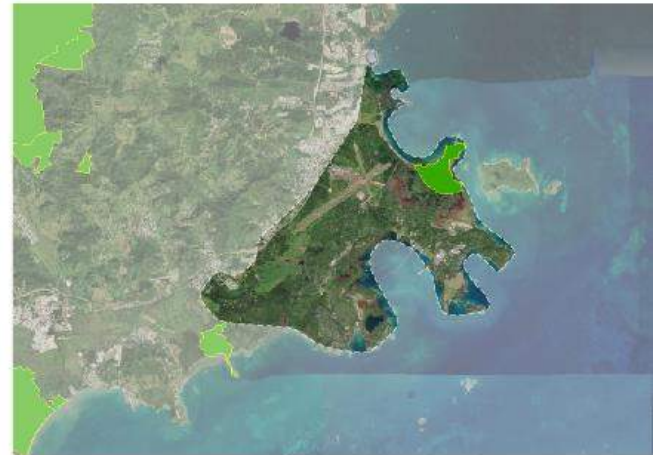
## Figura 55: Localización #1 – Información Ambiental

HUMEDALES | 4,605 acres | 47%

MAPA DE INUNDACIÓN FEMA | VE, AE, A, X

ÁREA PRIORITARIA DE CONSERVACIÓN | 4,528 acres | 46%

BOSQUES NATURALES | 368 acres | 3%

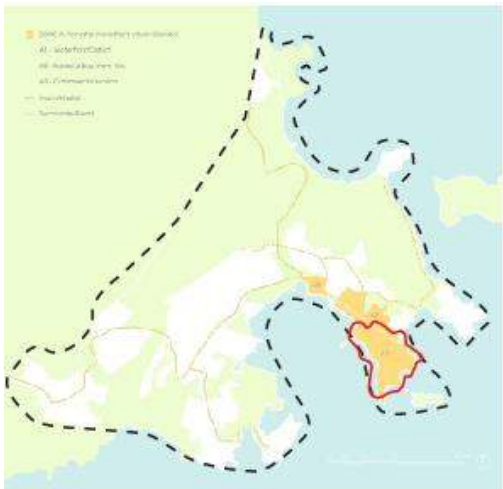
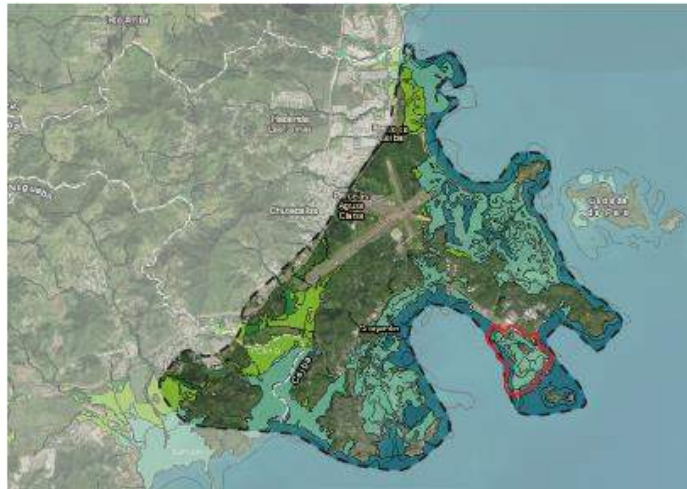
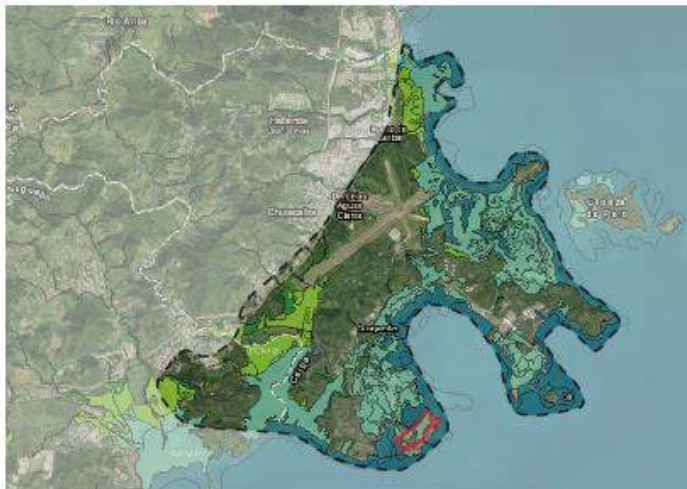
## Figura 56: Localización #1 – Impacto Potencial a Humedales

IMPACTO POTENCIAL A HUMEDALES - SUBZONA A1  
 202 ACRES / 72% DE SUBZONA A1

IMPACTO POTENCIAL A HUMEDALES - SUBZONA G2  
 47 ACRES / 49% DE SUBZONA G2

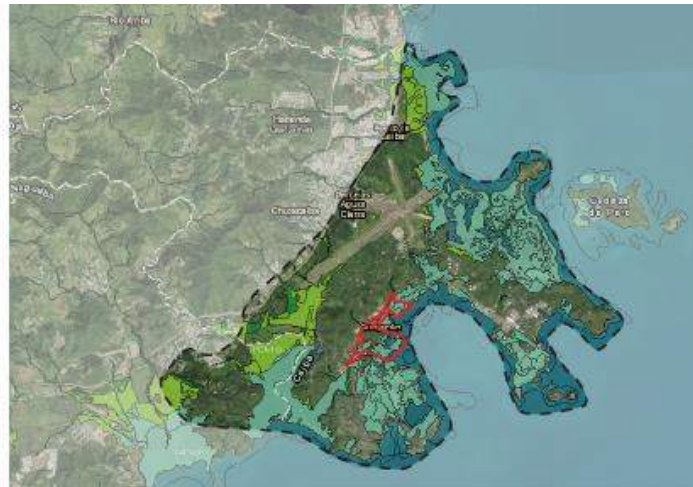
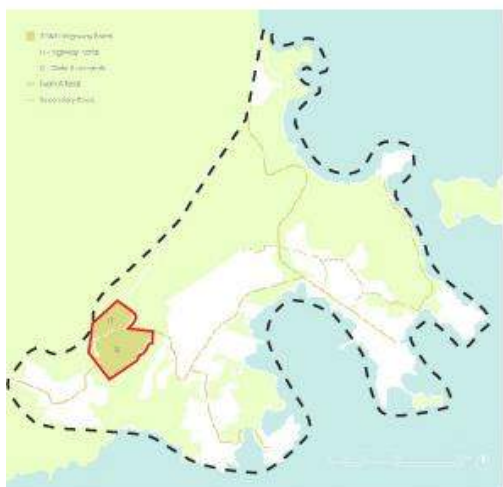
## Figura 56: Localización #1 – Impacto Potencial a Humedales

IMPACTO POTENCIAL A HUMEDALES - SUBZONA C5  
137 ACRES / 79% DE SUBZONA C5

IMPACTO POTENCIAL A HUMEDALES - ZONA I  
173 ACRES / 57% DE ACRES ZONA I
