**BORRADOR DE DECLARACIÓN DE IMPACTO AMBIENTAL**  
**ESENCIA, BOQUERÓN, CABO ROJO**

**ENERO 2025**

**TOMO 1 DE 2**  
**Borrador DIA + Anejos 1-5**

**TÍTULO DE LA ACCIÓN PROPUESTA:** Esencia, Boquerón, Cabo Rojo

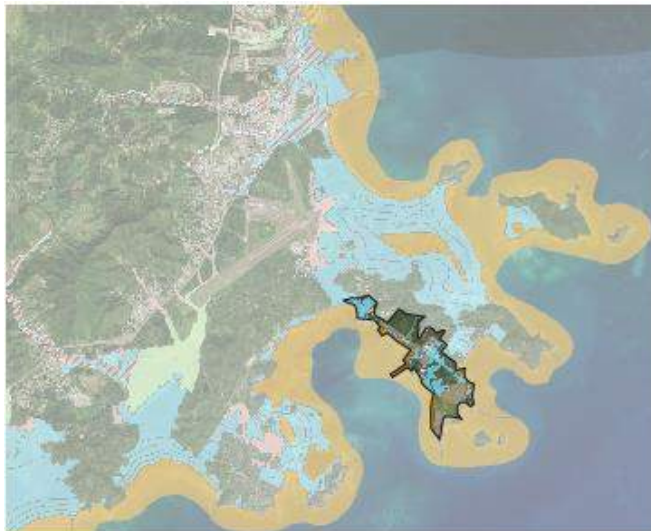
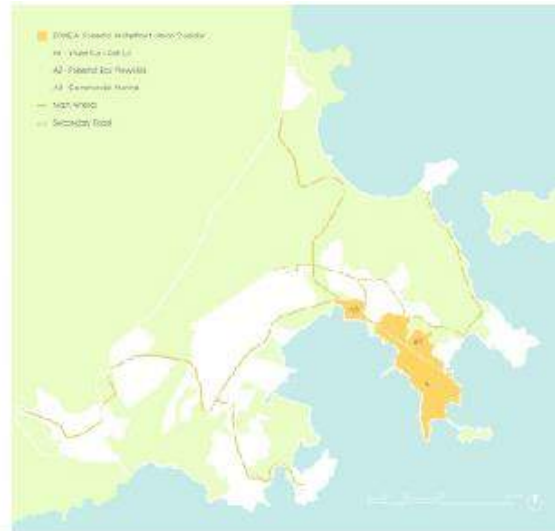
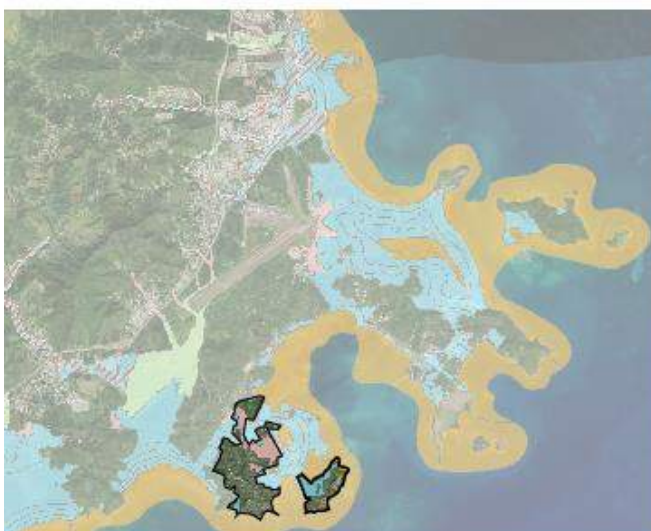
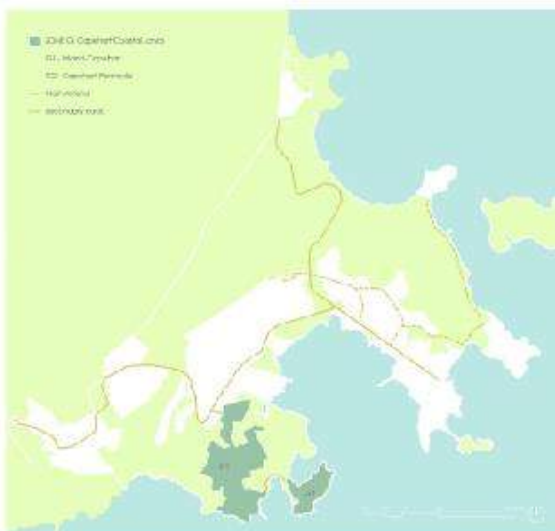
## Figura 57: Localización #1 – Áreas Inundables

ZONA A | ZONA INUNDABLE AE + VE  
ZONA DE ALTO RIESGO

ZONA G | ZONA INUNDABLE AE + X  
ZONA DE RIESGO MODERATO Y ALTO RIESGO

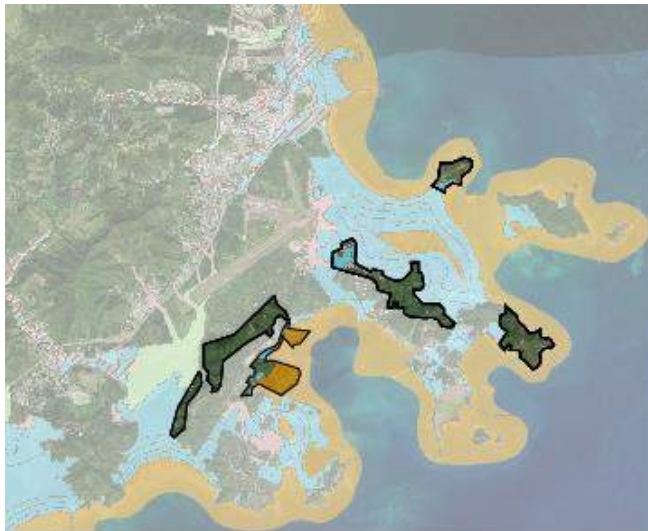
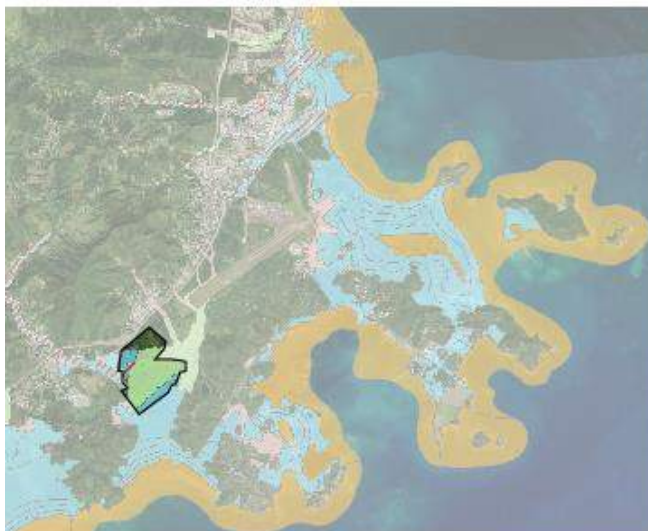
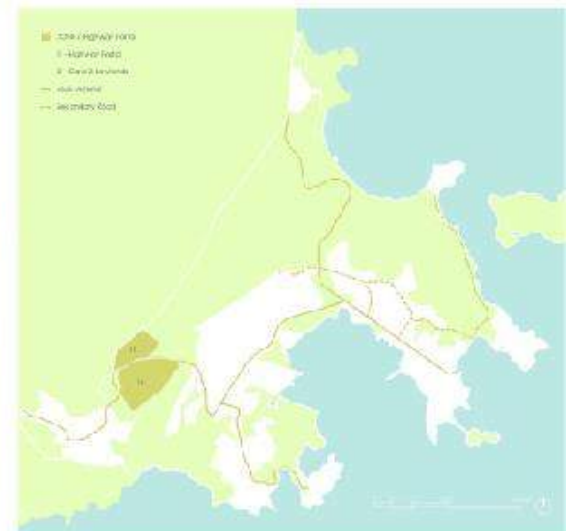
## Figura 57: Localización #1 – Áreas Inundables

ZONA C | ZONA INUNDABLE VE + AE  
ZONA DE ALTO RIESGO

ZONA I | ZONA INUNDABLE A + AE  
ZONA DE ALTO RIESGO

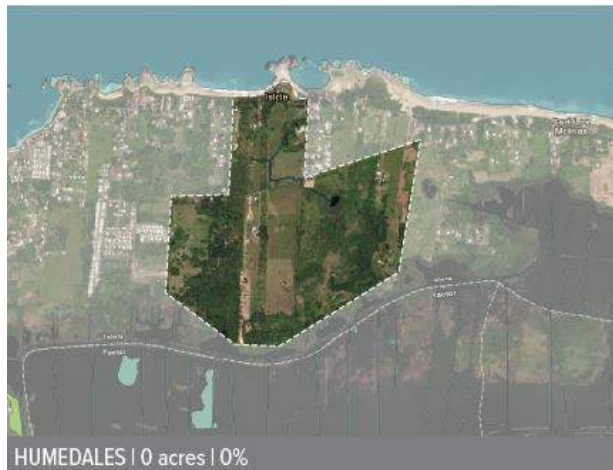
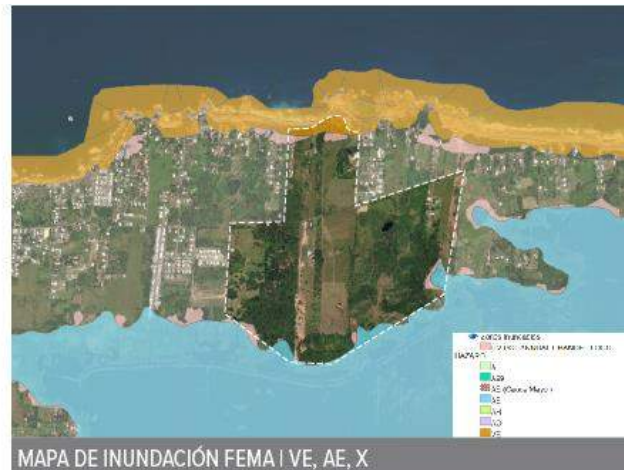
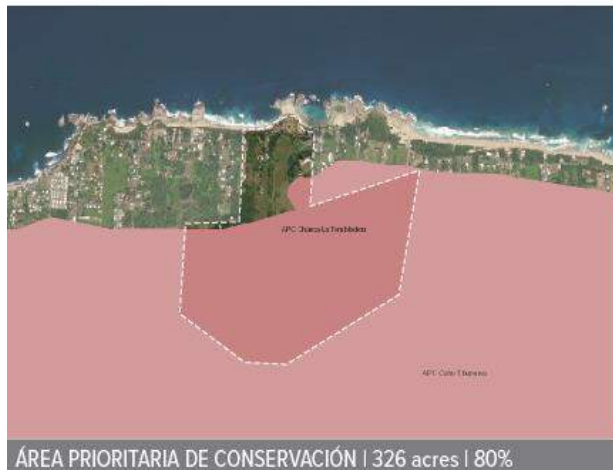
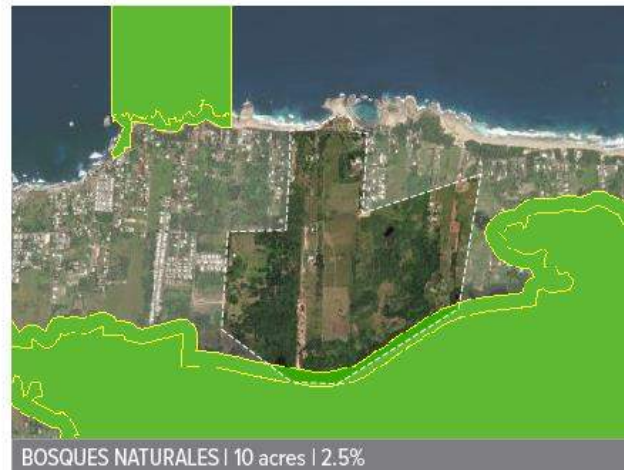
### Figura 59: Localización #3 – Información Ambiental

Fuente: National Wetlands Inventory; <https://gis.jp.pr.gov/mipr/>  
Compañía: Álvarez-Díaz & Villalón (AD&V)

- Figura 58: Evaluación de Alternativas - Localización #3 – Foto Aérea
- Figura 59: Evaluación de Alternativas - Localización #3 – Información Ambiental

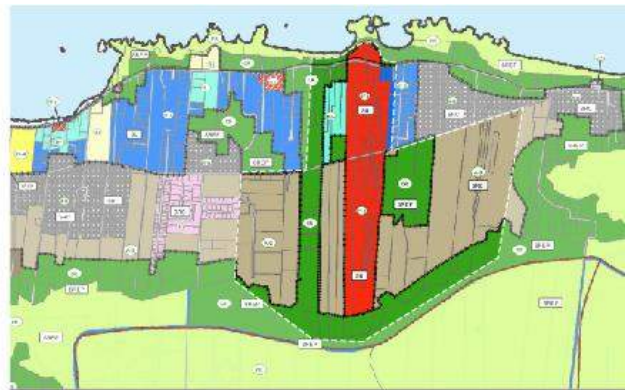
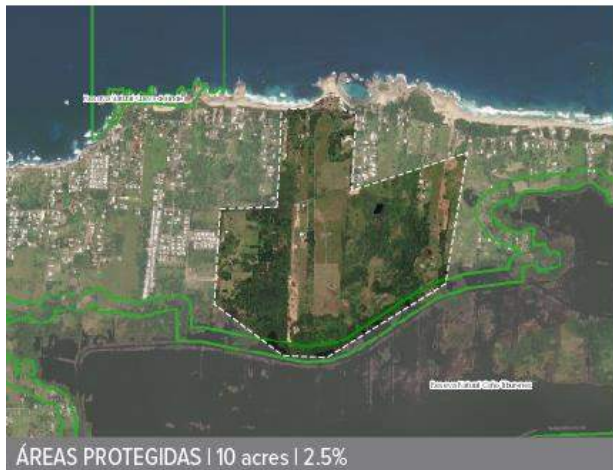
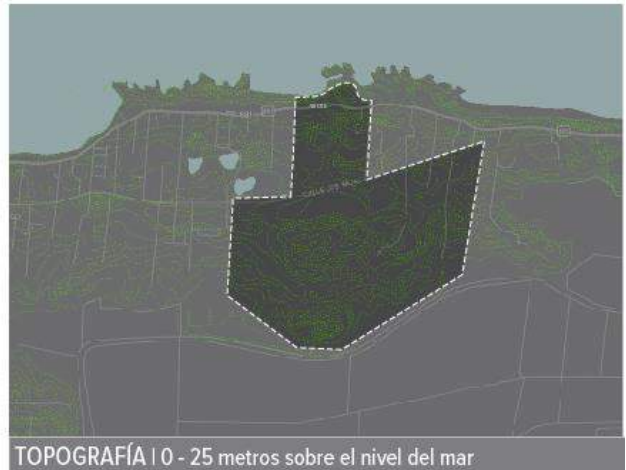
### Figura 59: Localización #3 – Información Ambiental

HÁBITAT CRÍTICO | 0 acres | 0%

ZONIFICACIÓN | CR, A-G, RT-B, RT-I, CT-1

ÁREAS PROTEGIDAS | 10 acres | 2.5%

TOPOGRAFÍA | 0 - 25 metros sobre el nivel del mar

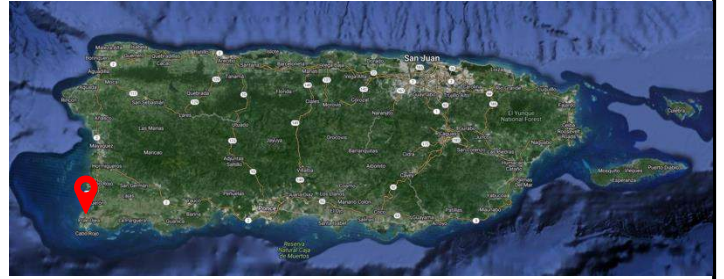
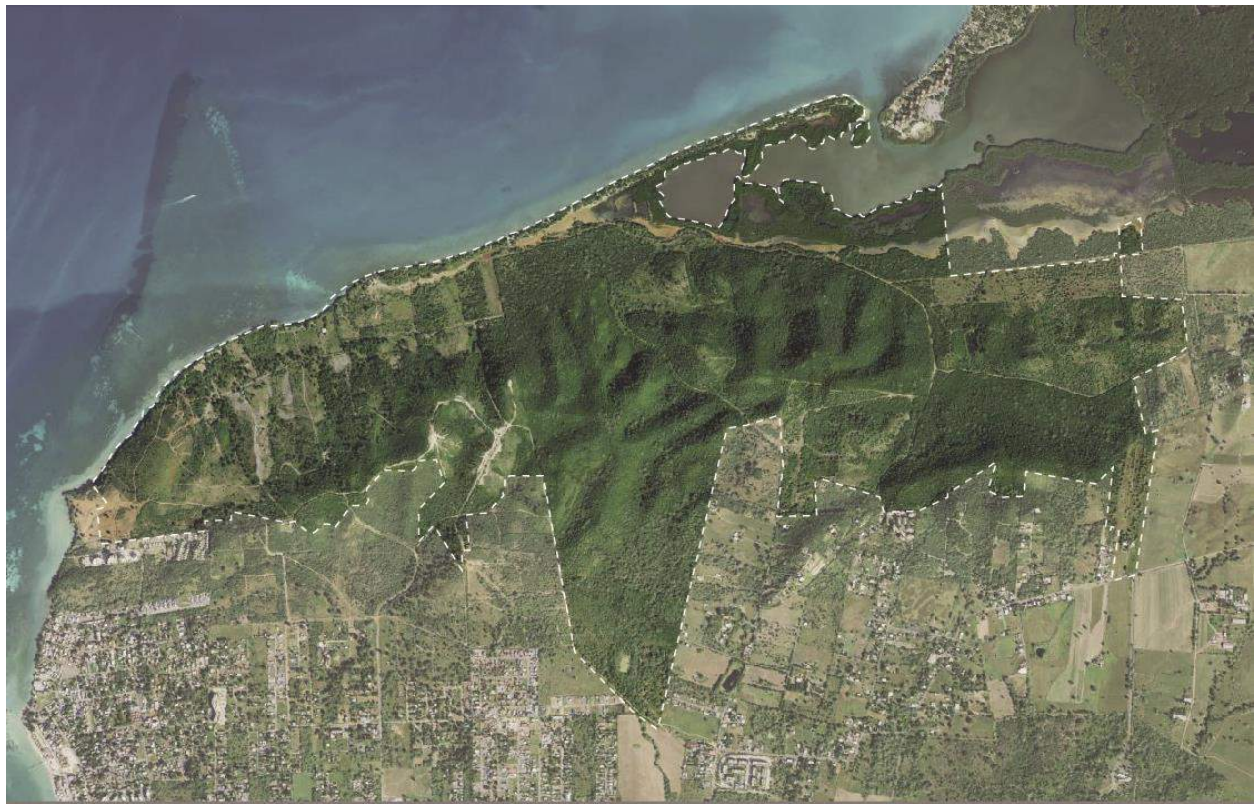
SITE 2 - CABO ROJO | 1,548 acres

- Figura 62: Evaluación de Alternativas - Localización #2 – Foto Aérea
- Figura 63: Evaluación de Alternativas - Localización #2 – Información Ambiental

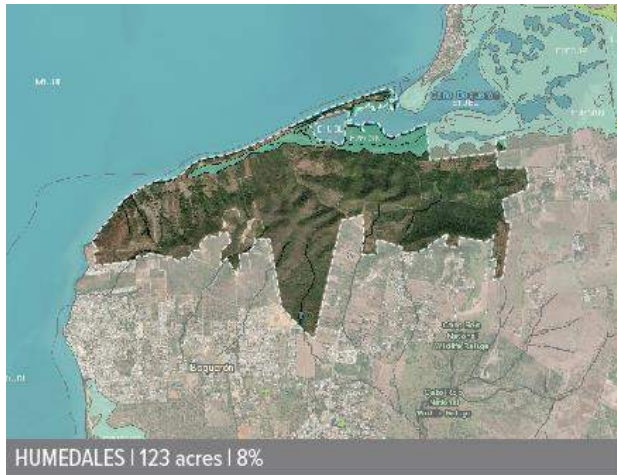
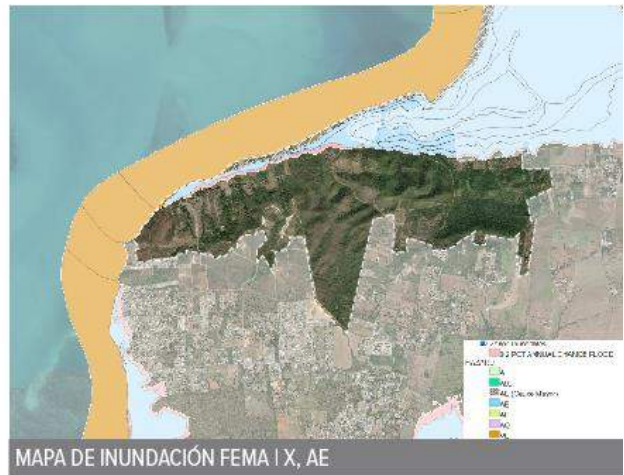
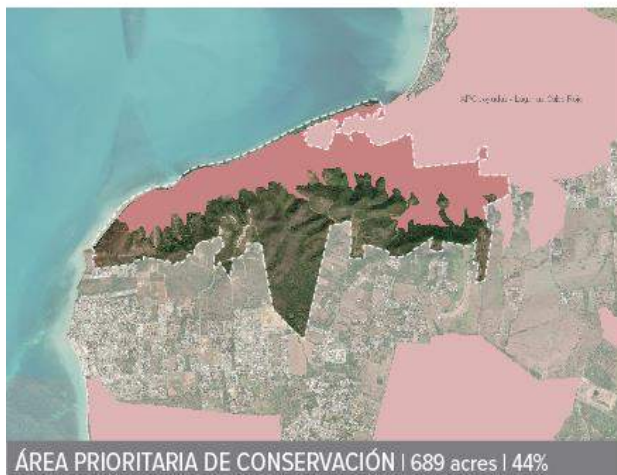
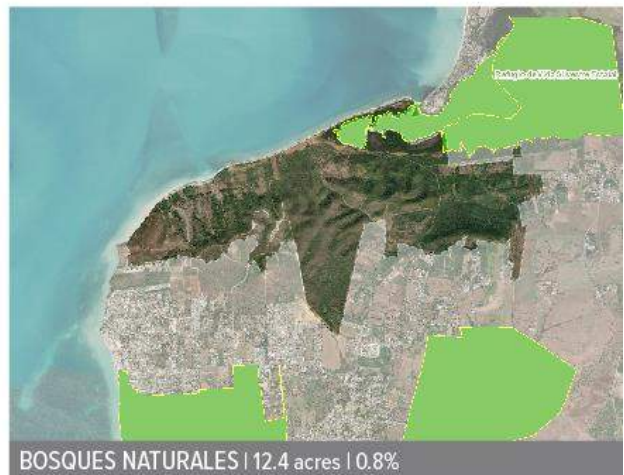
## Figura 63: Localización #2 – Información Ambiental

Fuente: National Wetlands Inventory; <https://gis.jp.pr.gov/mipr/>  
Compañía: Álvarez-Díaz & Villalón (AD&V)

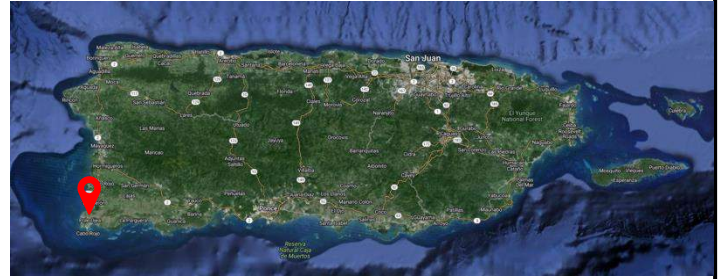
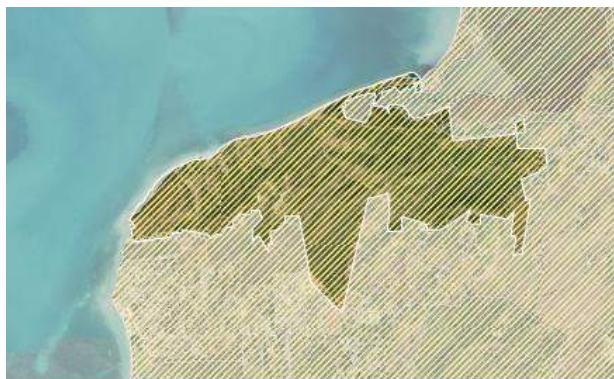
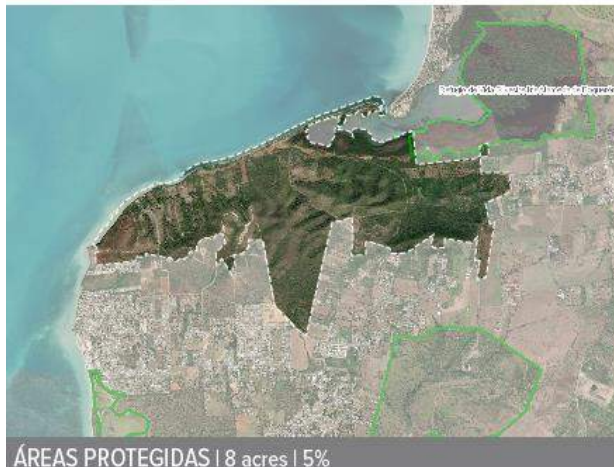
## Figura 63: Localización #2 – Información Ambiental

HÁBITAT CRÍTICO | 1,548 acres | 100%

ZONIFICACIÓN | UR, DS, R-G, DTS, CR, P-R

ÁREAS PROTEGIDAS | 8 acres | 5%

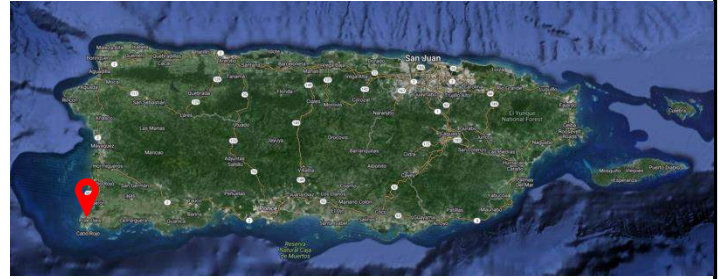
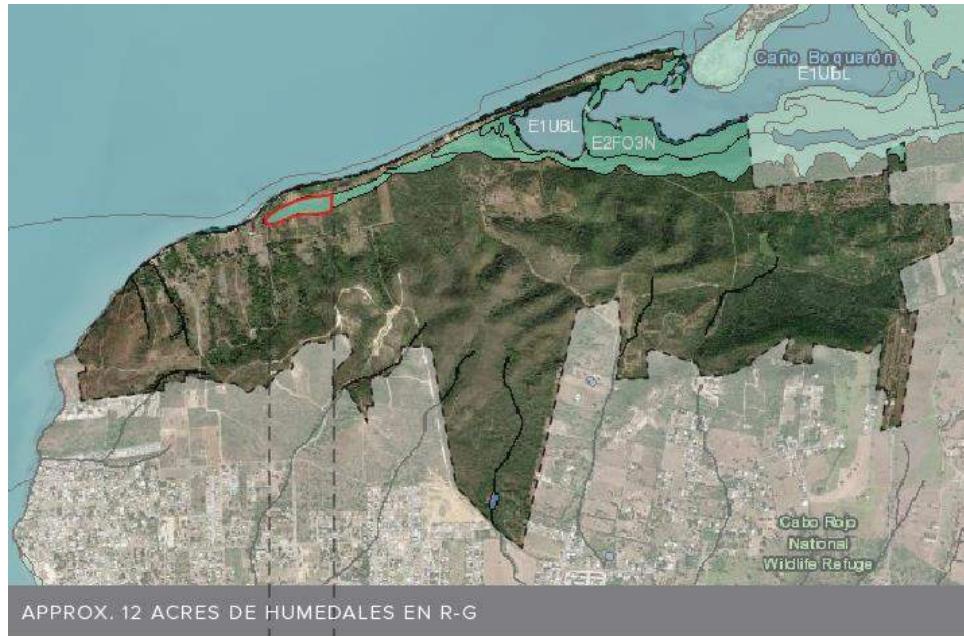
## Figura 64: Localización #2 – Impacto Potencial a Humedales

Fuente: National Wetlands Inventory; Plan de Ordenación Territorial, Junta de Planificación de Puerto Rico  
Compañía: Álvarez-Díaz & Villalón (AD&V)

- Figura 64: Evaluación de Alternativas - Localización #2 – Impacto Potencial Humedales

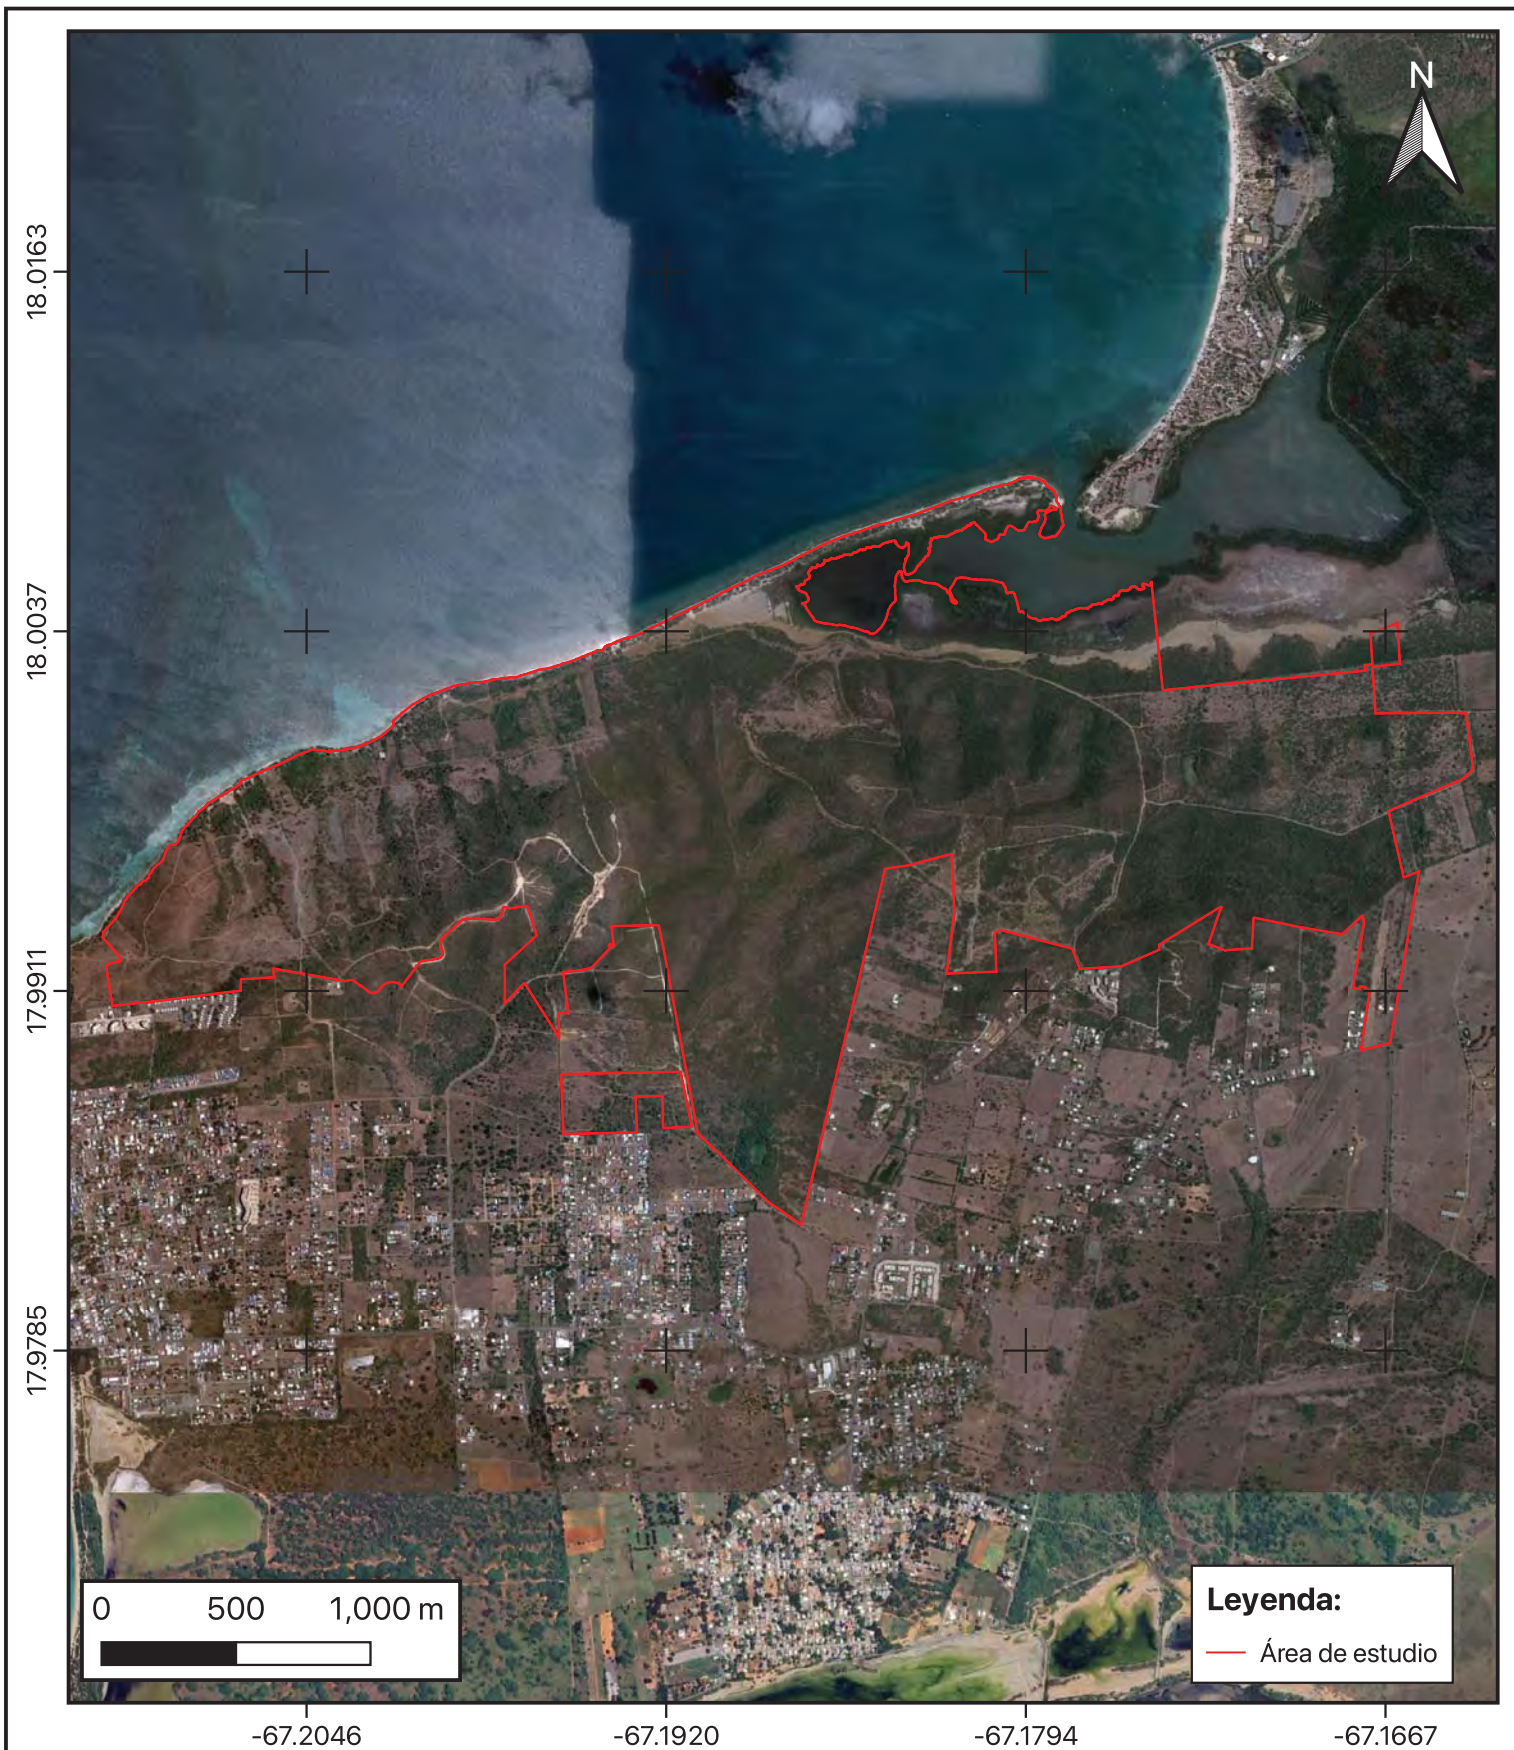
**Figura 3: Fotografía Aérea  
Esencia, Cabo Rojo, Puerto Rico**

No obstante, basado en las fotografías aéreas históricas del área, la vegetación del predio ha sido extensamente alterada en el pasado. Se encontraron áreas ecológicamente sensitivas durante los trabajos de campo tales zonas boscosas con una composición y estructura en un estado de madurez avanzado, zonas anegadas dominadas por humedales compuestos por salitrales, lodazales, manglares y lagunas costeras, y zonas de duna de arena, estas últimas mostrando erosión y dominancia de especies exóticas. La **Figura 3** muestra la fotografía aérea del Área de Estudio.

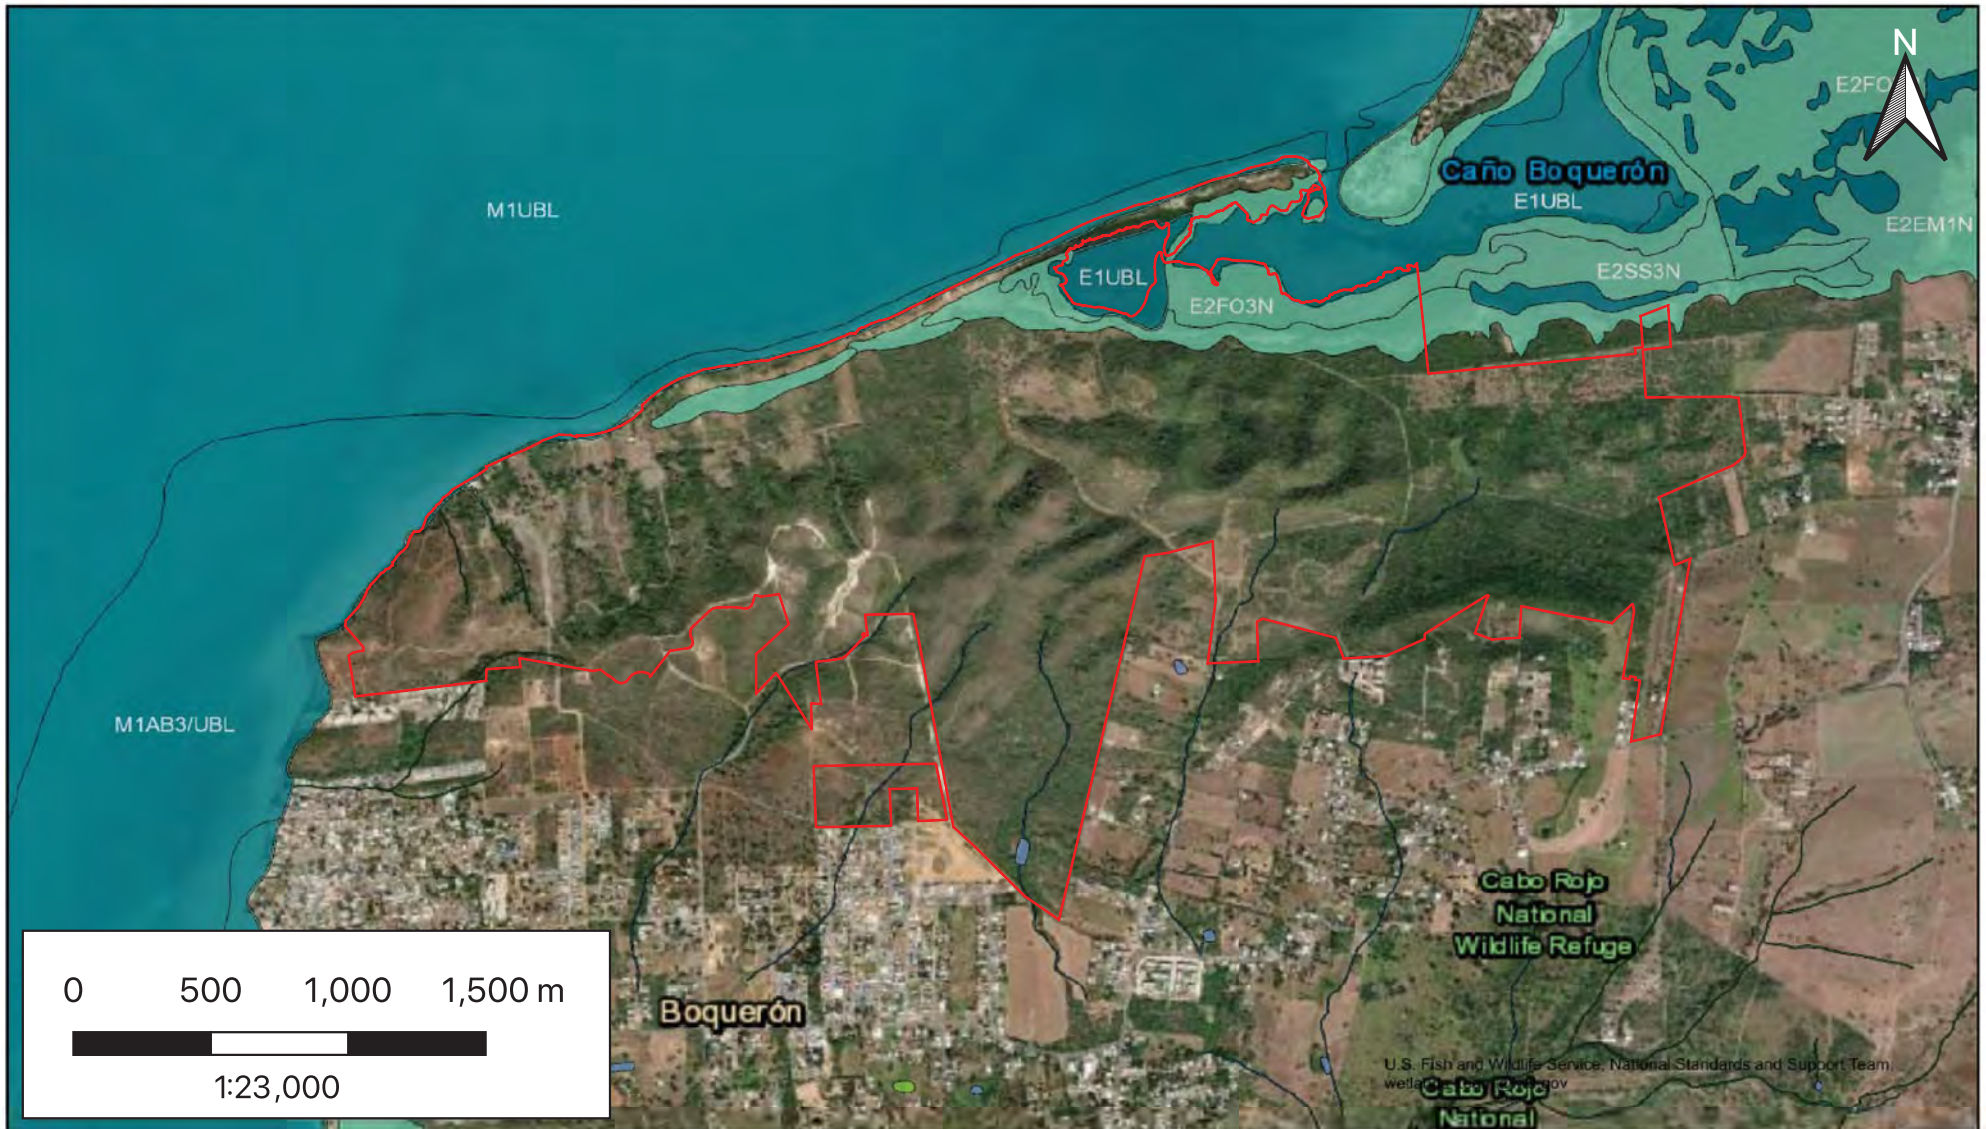
Figura 4: Mapa del Inventario Nacional de Humedales  
Esencia, Cabo Rojo, Puerto Rico

**Wetlands**

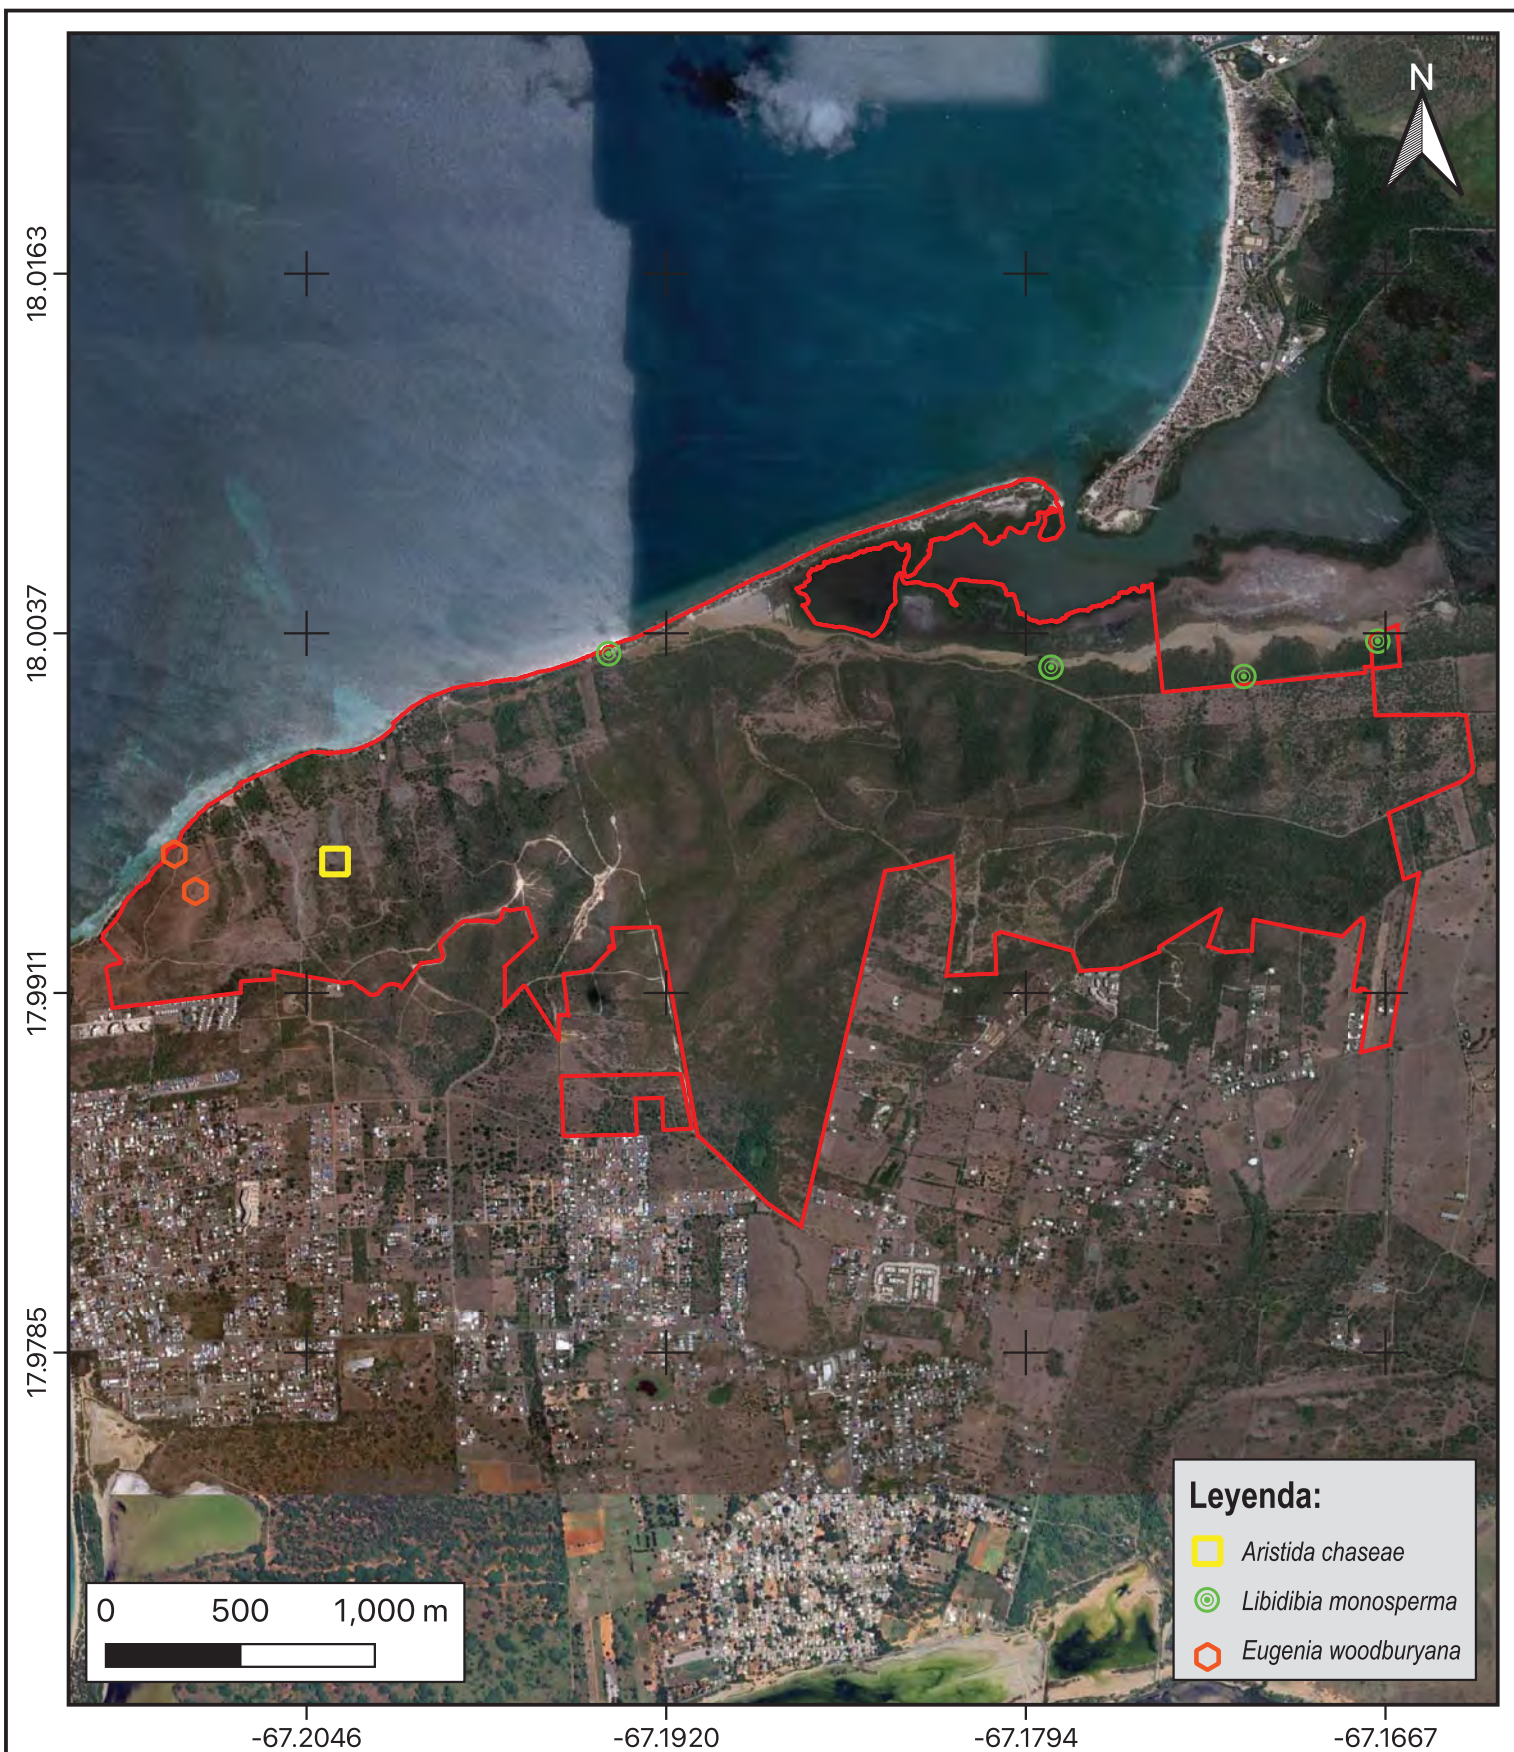
**Figura 5: Presencia confirmada de las Especies de Flora Listadas por el DRNA y USFWS Esencia, Cabo Rojo, Puerto Rico**

Se realizaron múltiples búsquedas exhaustivas de la especie *Catesbaea melanocarpa* designada como en peligro de extinción a nivel estatal y federal, la cual había sido documentada en el Área de Estudio por el DRNA y FWS, sin embargo, esta especie no fue encontrada.

Además, la evaluación de los componentes forestales sugiere que hay un promedio de 110 árboles por cuerda en las zonas forestadas y siete (7) árboles por cuerdas en las zonas de pastizales, estas cantidades promedio están basadas en la presencia de árboles con un diámetro a la altura de pecho igual o mayor a cuatro pulgadas ( $DAP \geq 4''$ ), según se estipula en el Reglamento Conjunta de la Junta de Planificación, del 16 de junio de 2023.

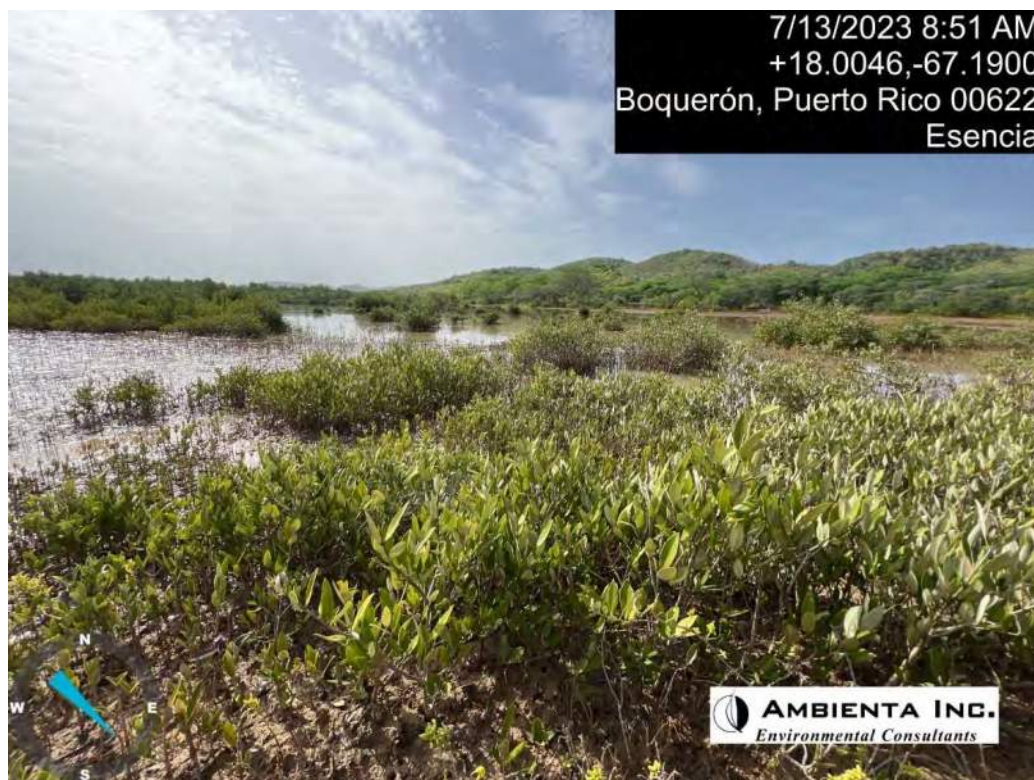
Foto 13: Instalación de grabadora de Monitoreo Acústico Pasivo (PAM).

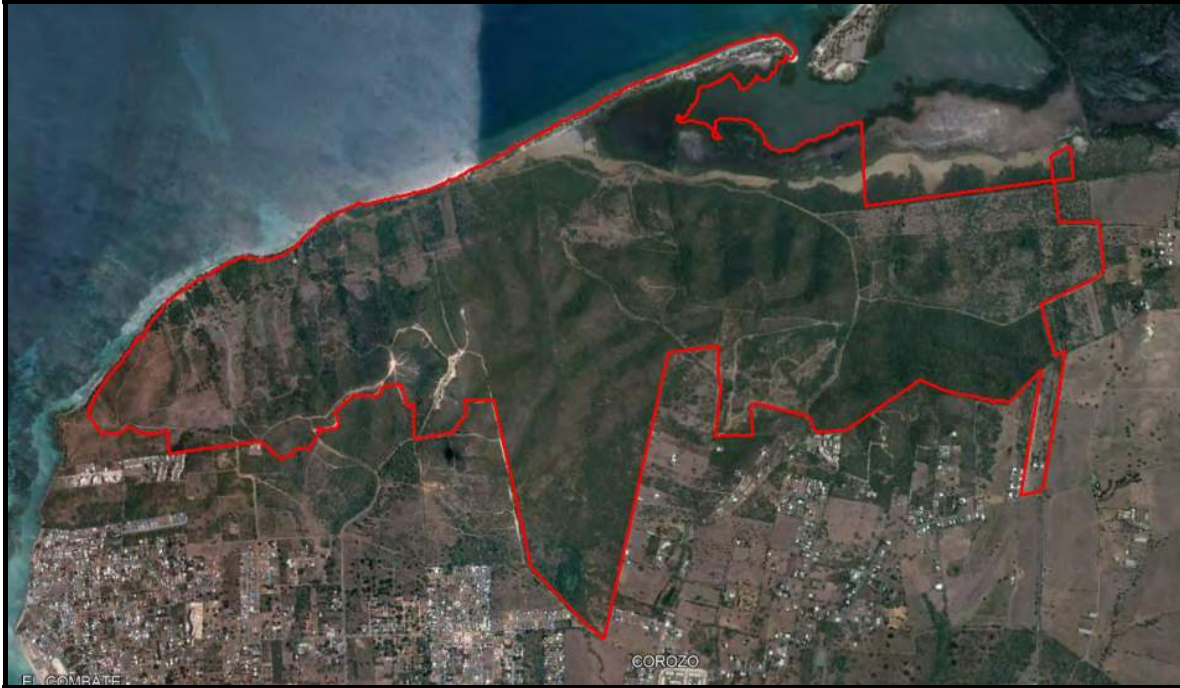
**Figure 1. Aerial extension of site**

The topography of the site varies significantly; from sea level to 200 meters in elevation. The topography is comprised of moderately to steep slopes with a relatively leveled fringe of land that runs from east to west along the northernmost portion of the site. In this report, areas of moderately to steep slopes are referred to “highland” while the relatively fringe of land is called “lowland”.

At the time of this preliminary report, proposed grading plans are not available. But considering the steep topography in some areas, it is preliminary conceived that earthworks involving cut and fill would be required. Likely, retaining walls would also be needed to contain fill embankments and to retain vertical cuts. All these presumptions shall be clarified during the final phase of the geotechnical study.

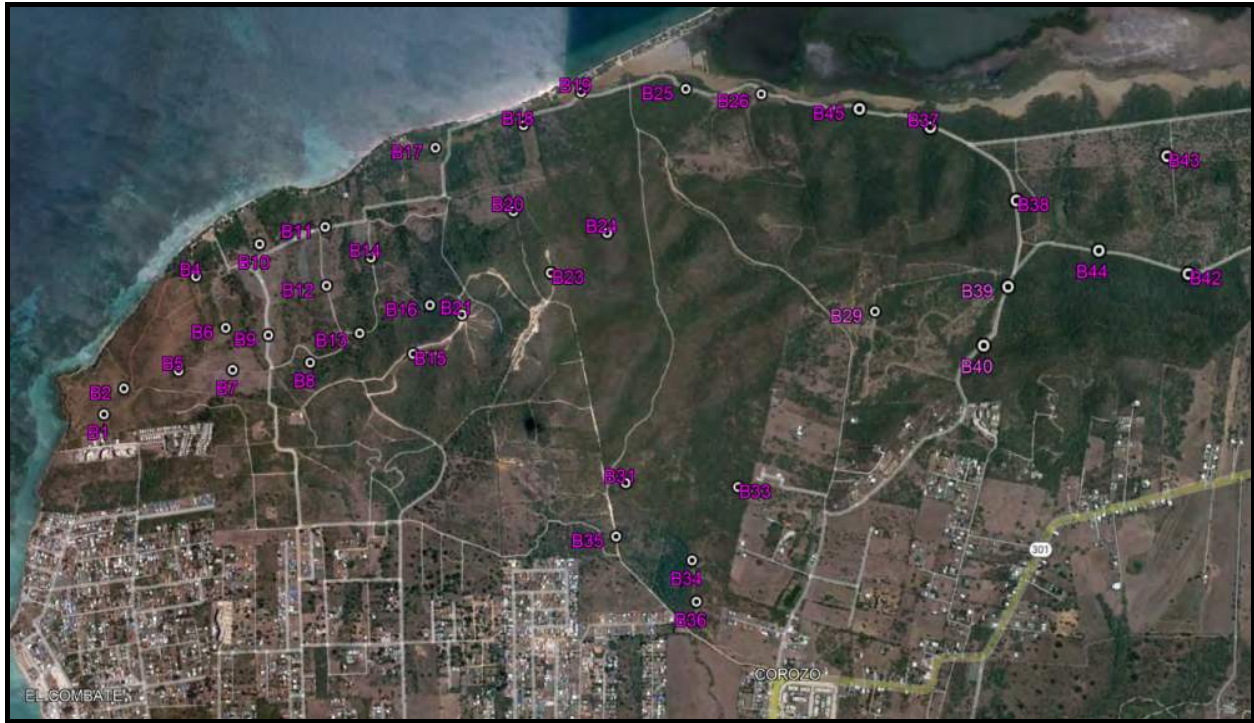
**Figure 2. Approximate boring locations.**

The test holes were advanced by means of the Power Auger Method employing a CME-45 Model drilling rig. The borings were bottomed at 30 feet deep for a total footage of 1140 ft drilled into different geomaterials. Visual/manual procedures were used to characterize the underlying soils. As part of the work, natural moisture contents, Atterberg limits, natural moisture contents and grain size distributions were performed on selected samples to determine soil behavior type, estimate strength parameters and obtained soil classification as per AASHTO Standards. The results of the testing program are discussed further in this report.

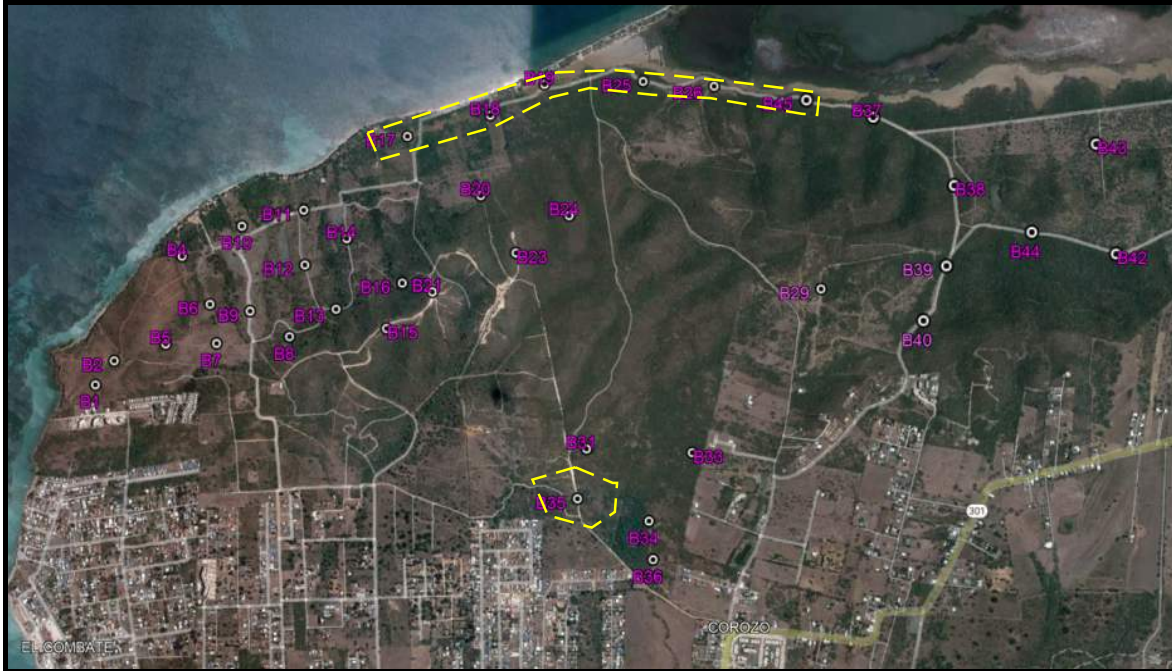
**Figure 6. Dashed areas indicate the presence of alluvial soils of medium/marginal bearing capacity.**

Of particular interest is boring B-7, which found very soft organic silt and peat (decomposed vegetative matter) between 3 and 8 feet deep. This finding requires detailed explorations around B-7, to better define the aerial extension and depth of these problematic soils.
