**BORRADOR DE DECLARACIÓN DE IMPACTO AMBIENTAL**  
**ESENCIA, BOQUERÓN, CABO ROJO**

**ENERO 2025**

**TOMO 1 DE 2**  
**Borrador DIA + Anejos 1-5**

**TÍTULO DE LA ACCIÓN PROPUESTA:** Esencia, Boquerón, Cabo Rojo

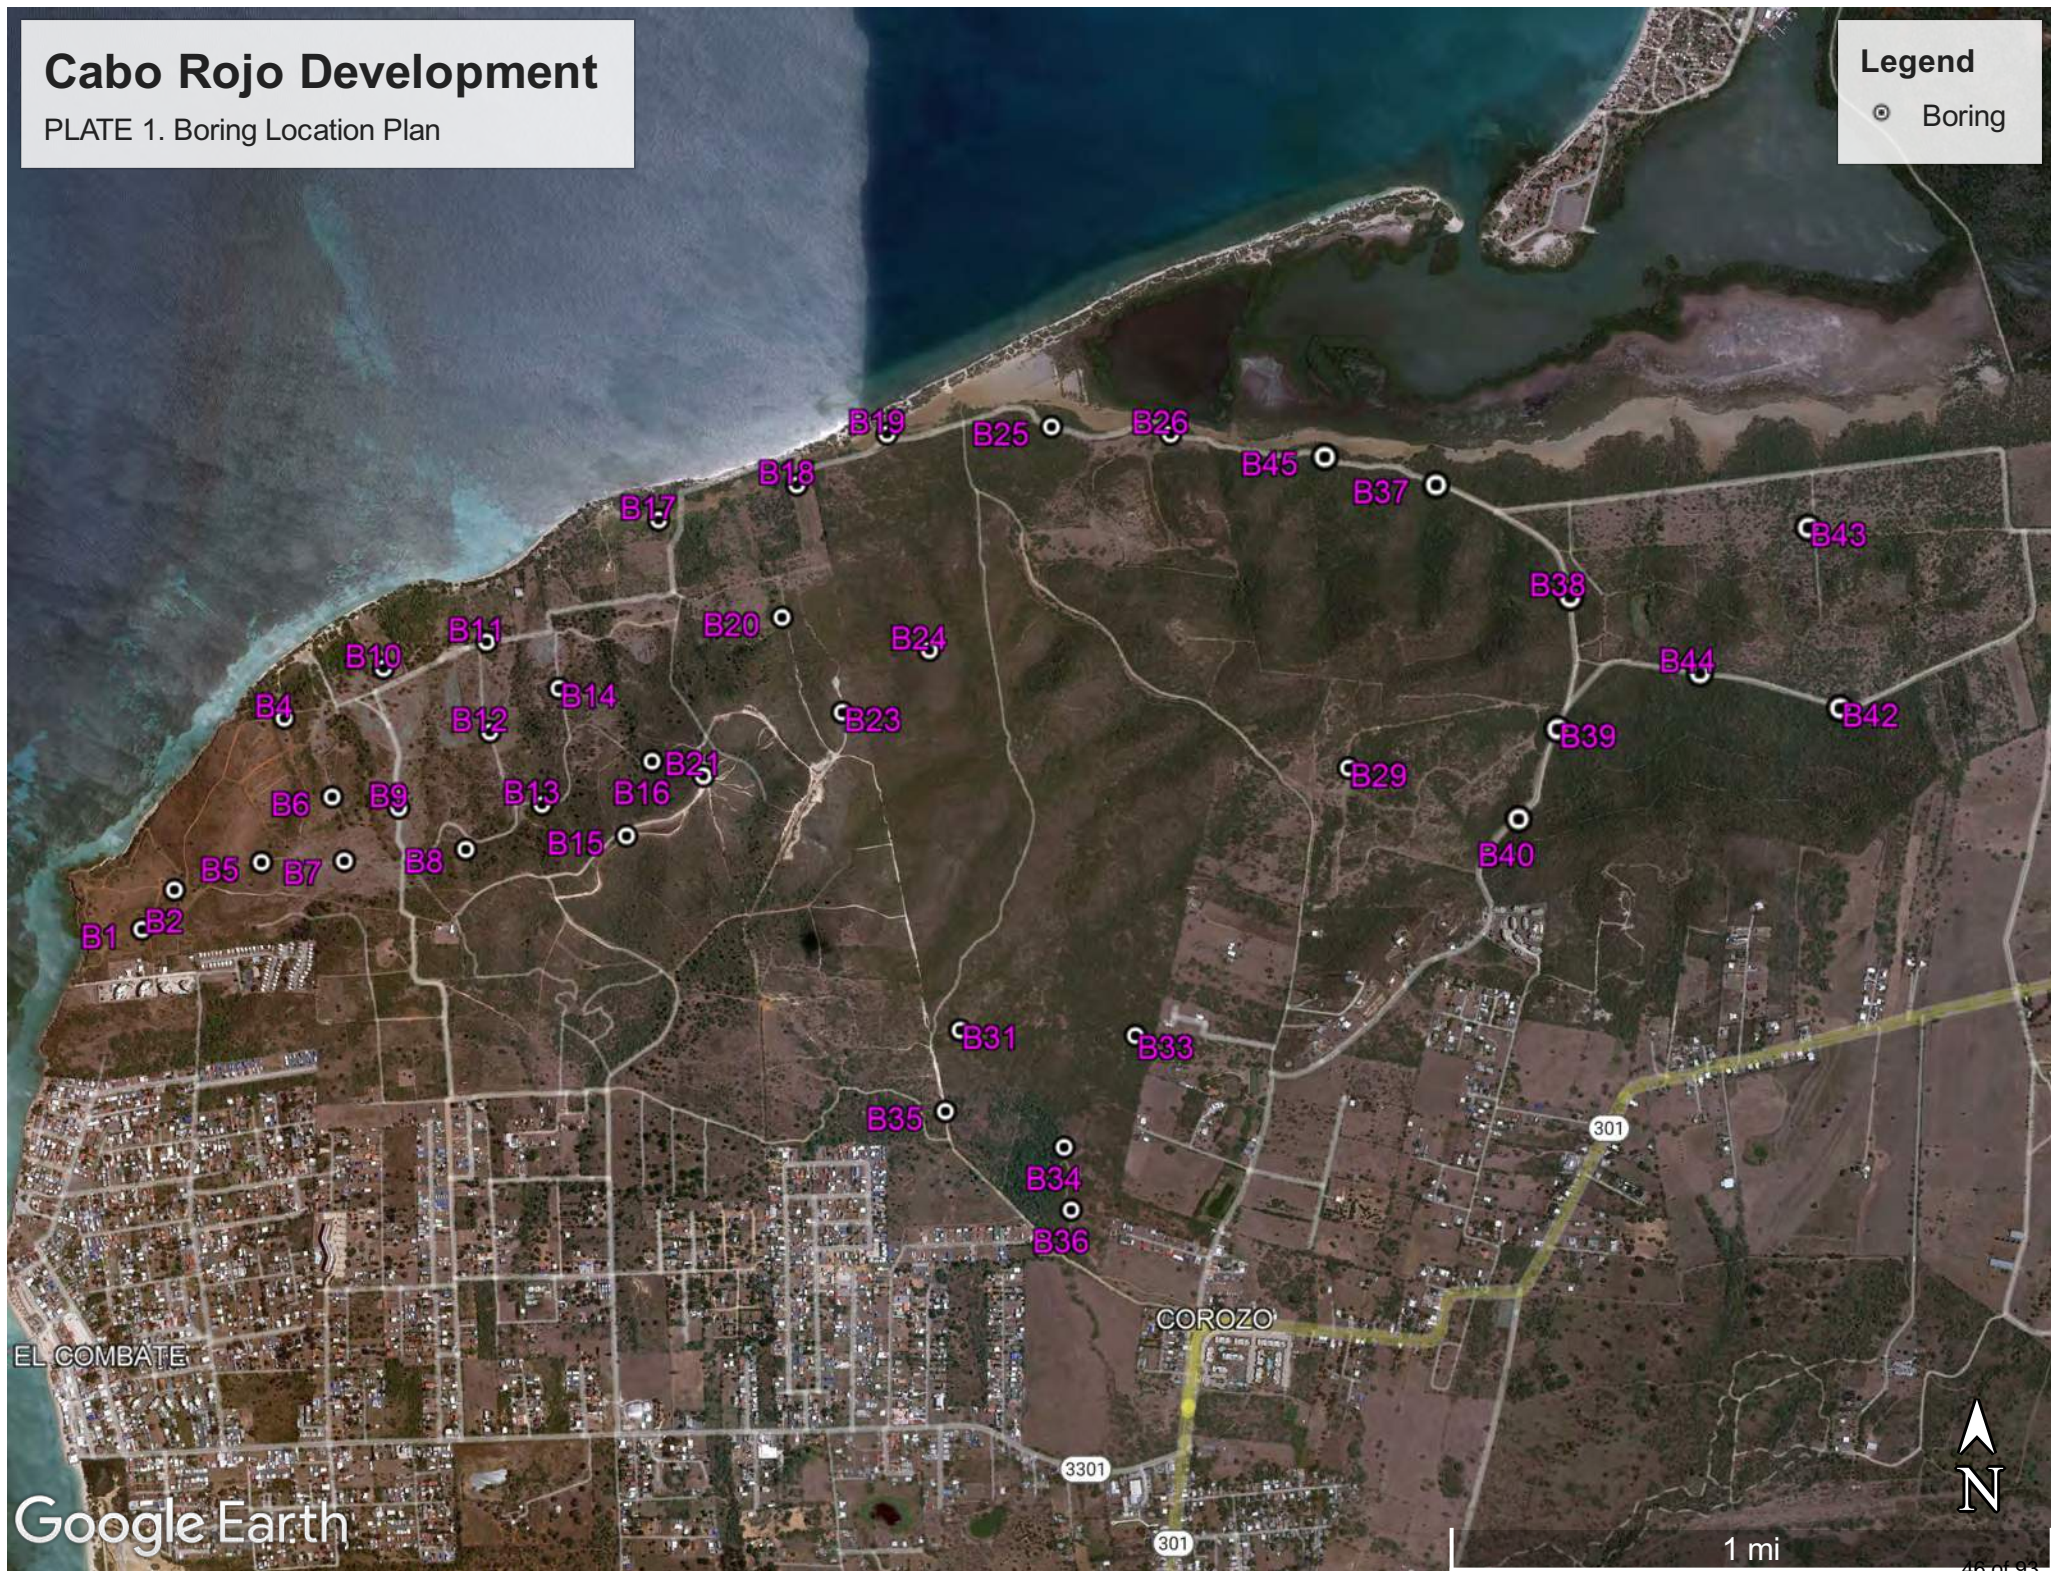
○ Boring

# Borings Coordinates

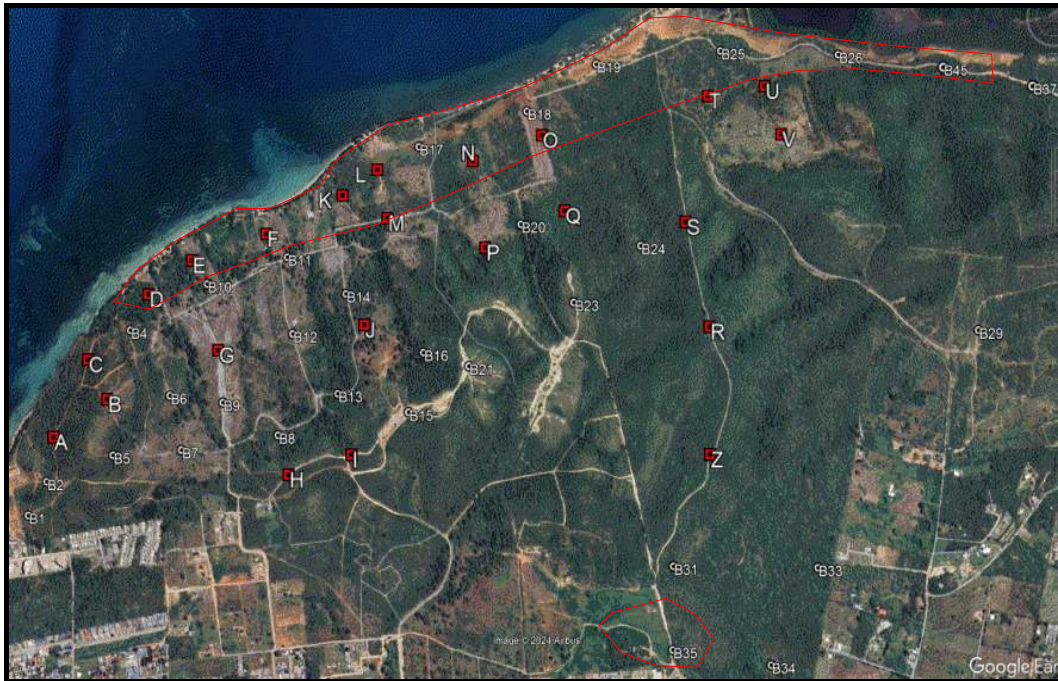
**Figure 5. Hashed area indicates the presence of alluvial soils of medium to marginal bearing capacity.**

Of particular interest are borings B-7, K, L and N, which found very soft organic silt and peat (decomposed vegetative matter) down to 10 or 12 feet deep. Final geotechnical explorations for particular structures in these areas shall take into account these findings. A test pit program is recommended in these areas to better define the extension and depth of weak soil/organic material removal.

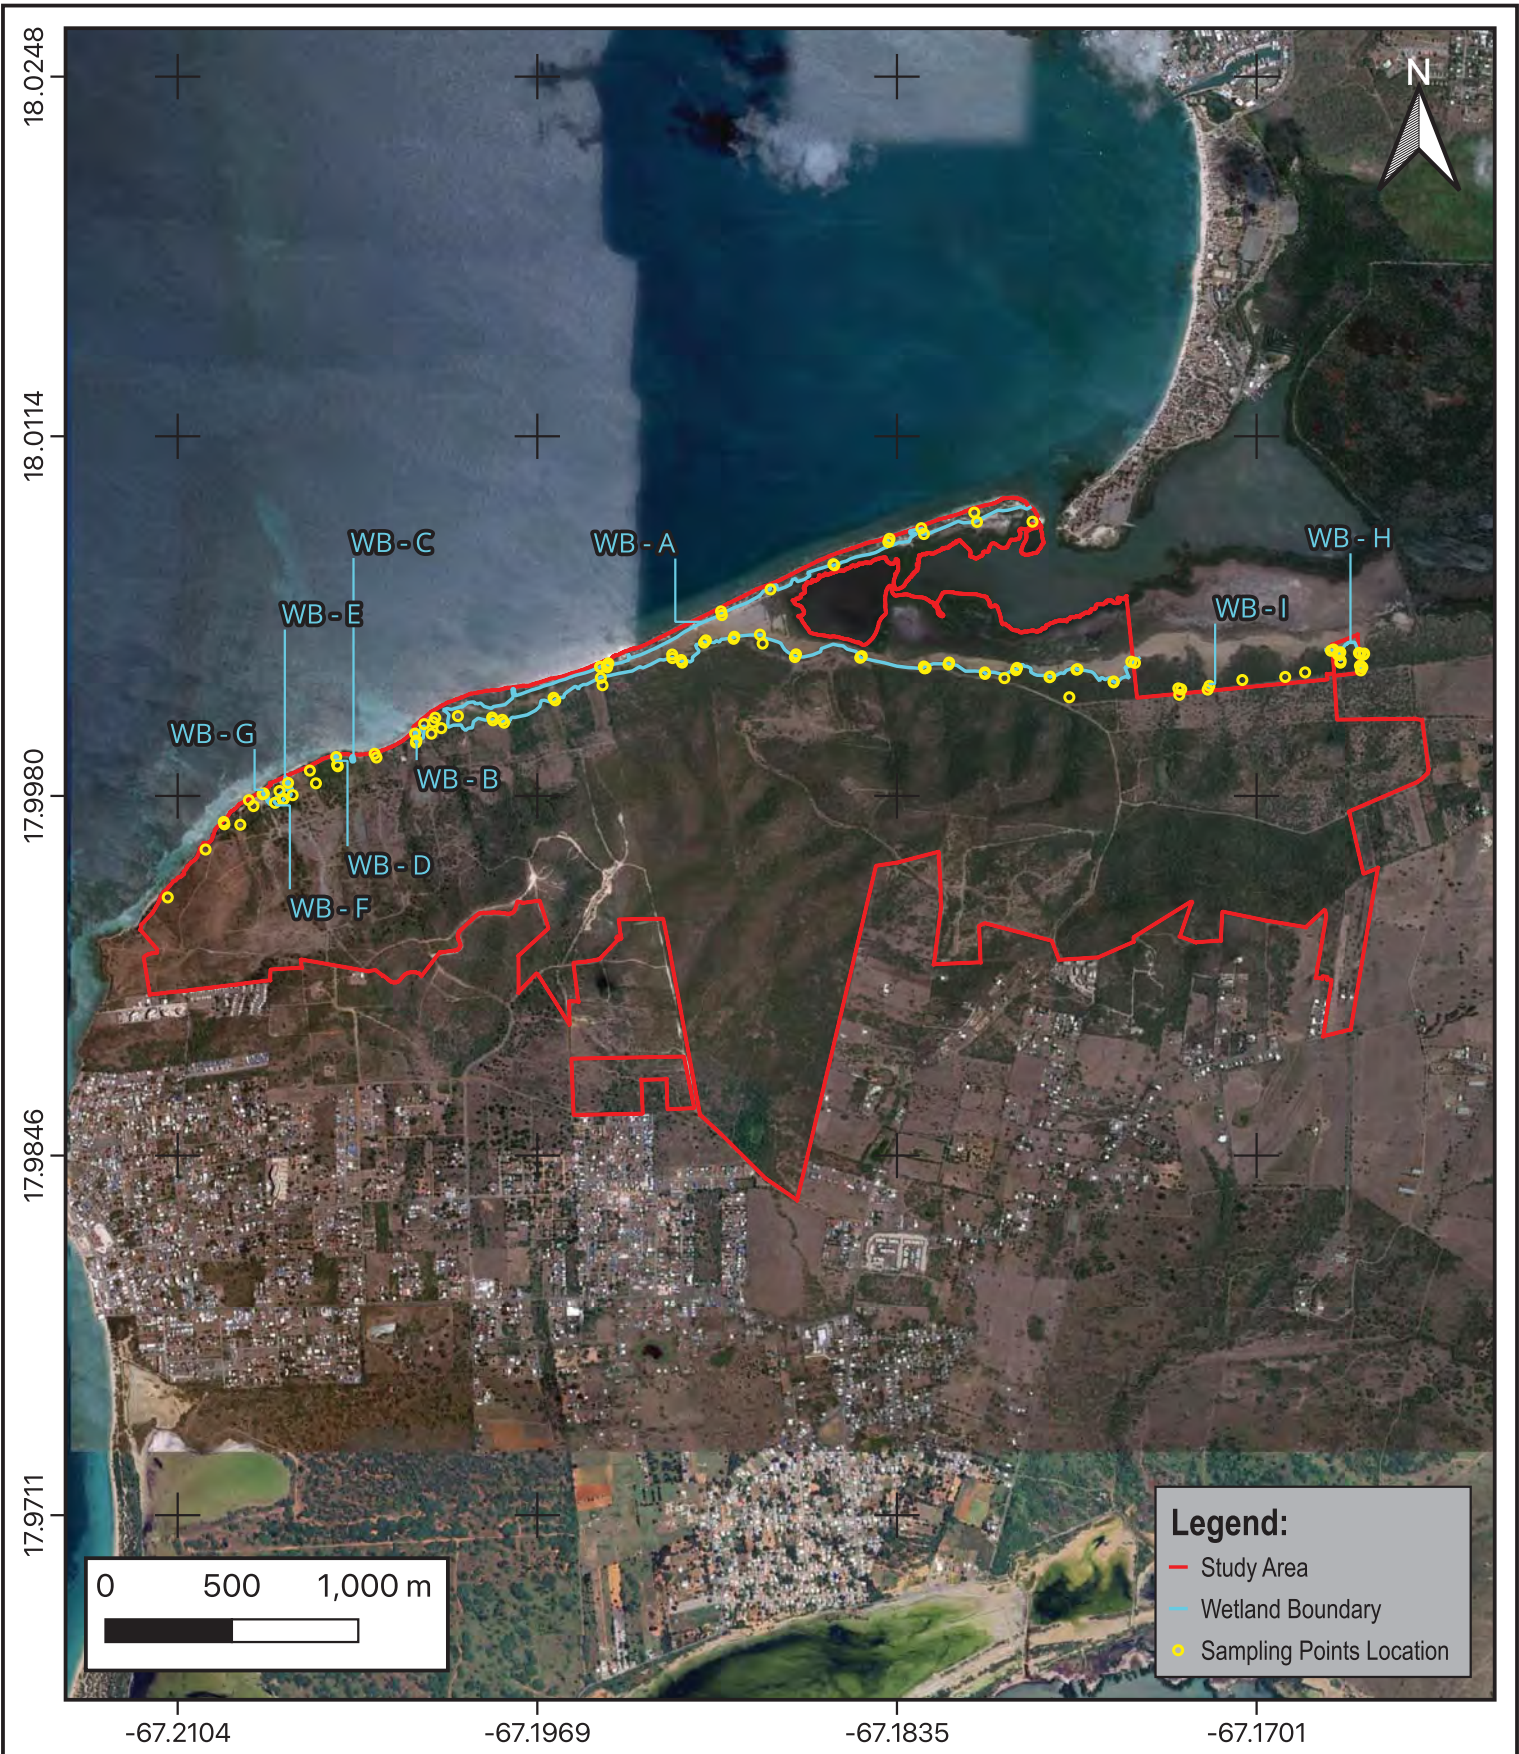
**Figure 4: Wetland Delineation and Sampling Points Locations**  
**Esencia Project**  
**Cabo Rojo, Puerto Rico**

**Figure 4** shows the sampling point locations and wetland delineation.

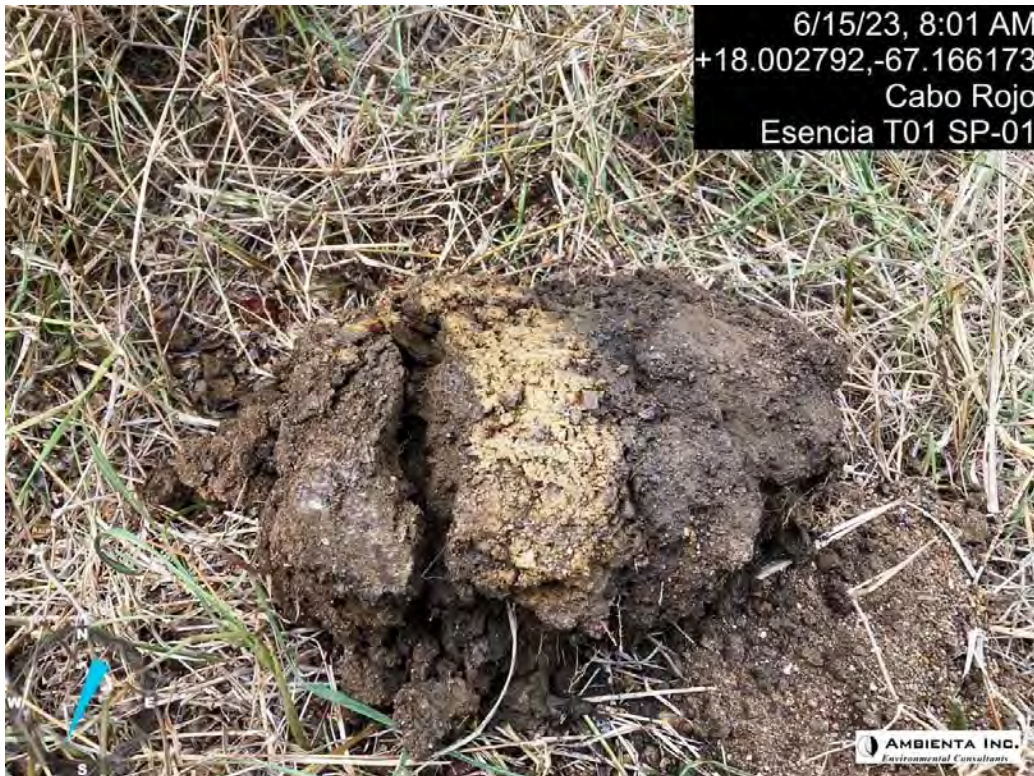
Soil Sample at SP-1.

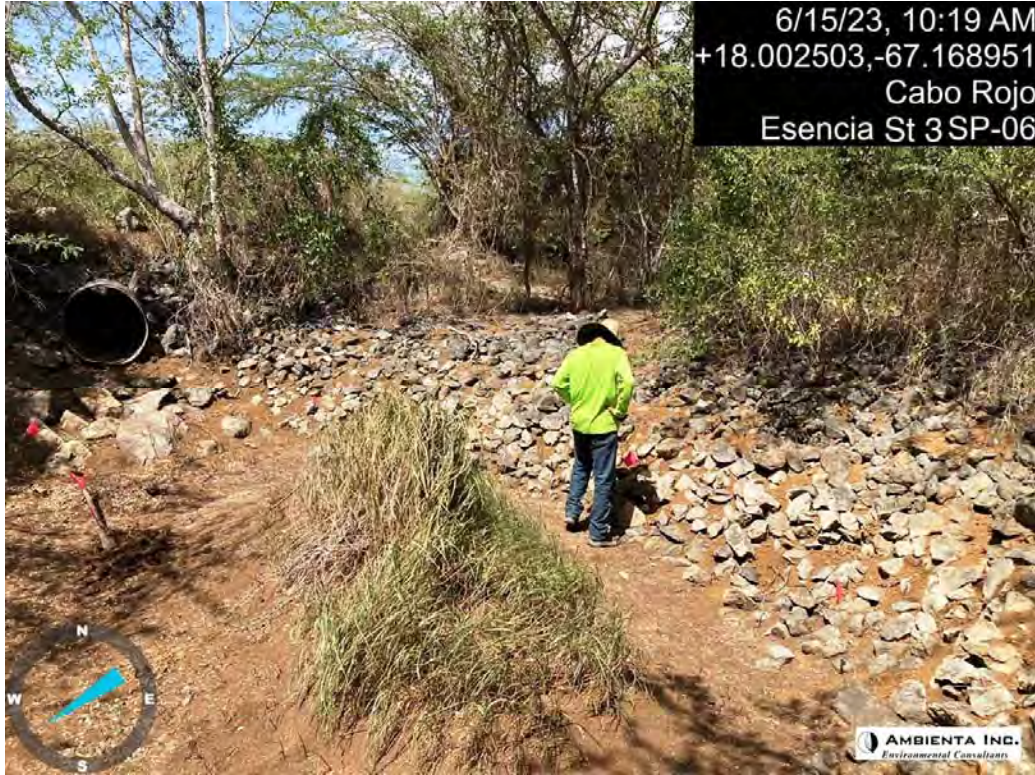
**Wetland delineation at Sampling Point SP-6.**

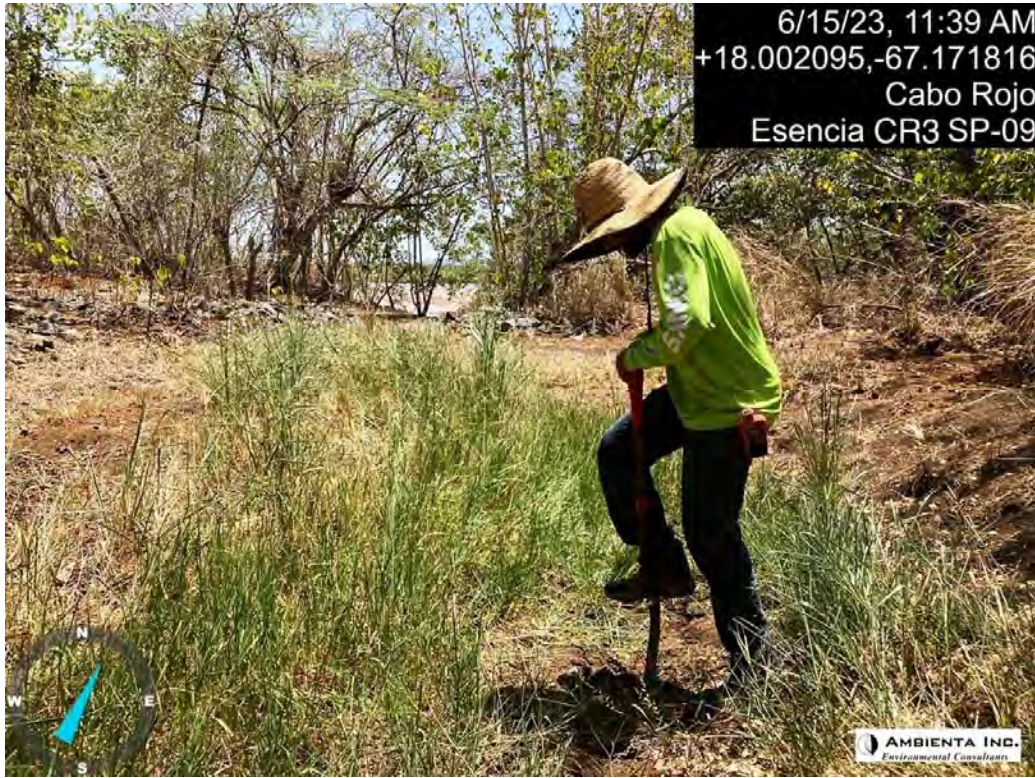
**Making the sampling pit at Sampling Point SP-09.**

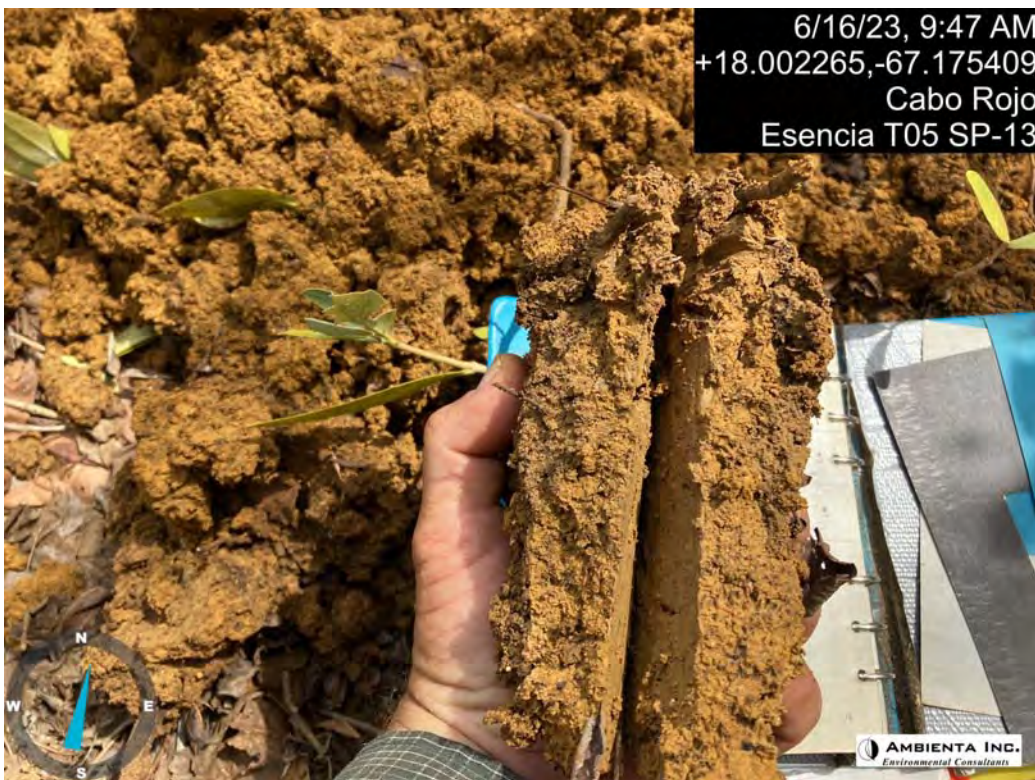
**Soil evaluation at Sampling Point SP-13.**

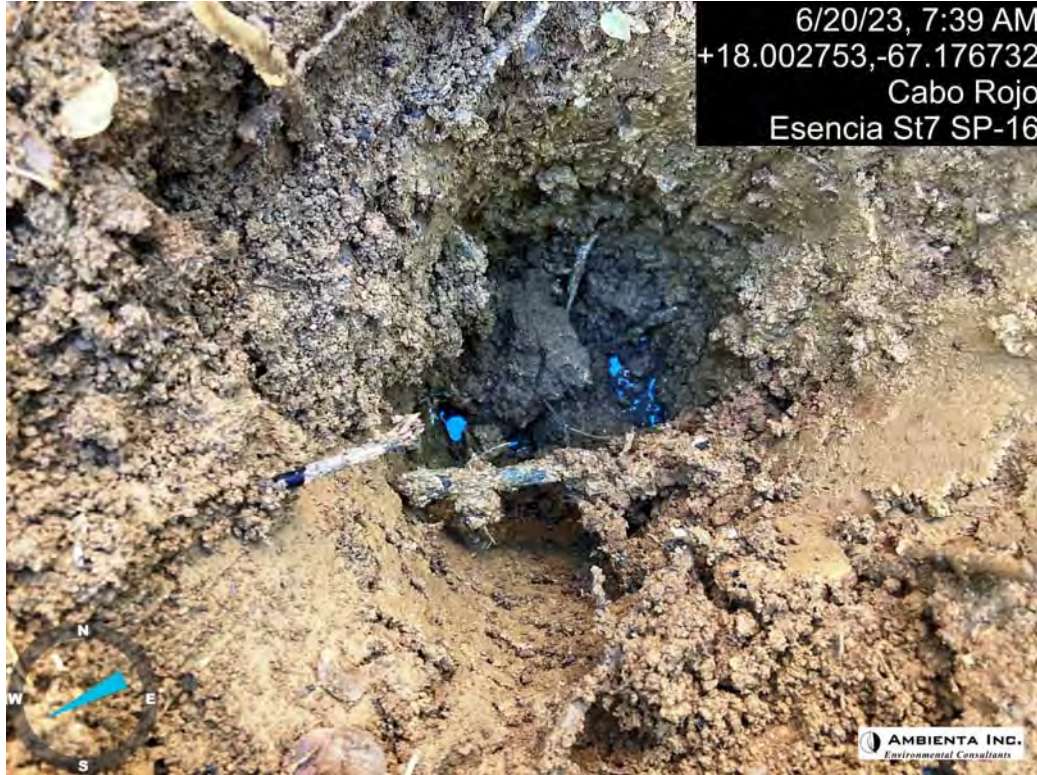
Water in sampling pit at Sampling Point SP-16.

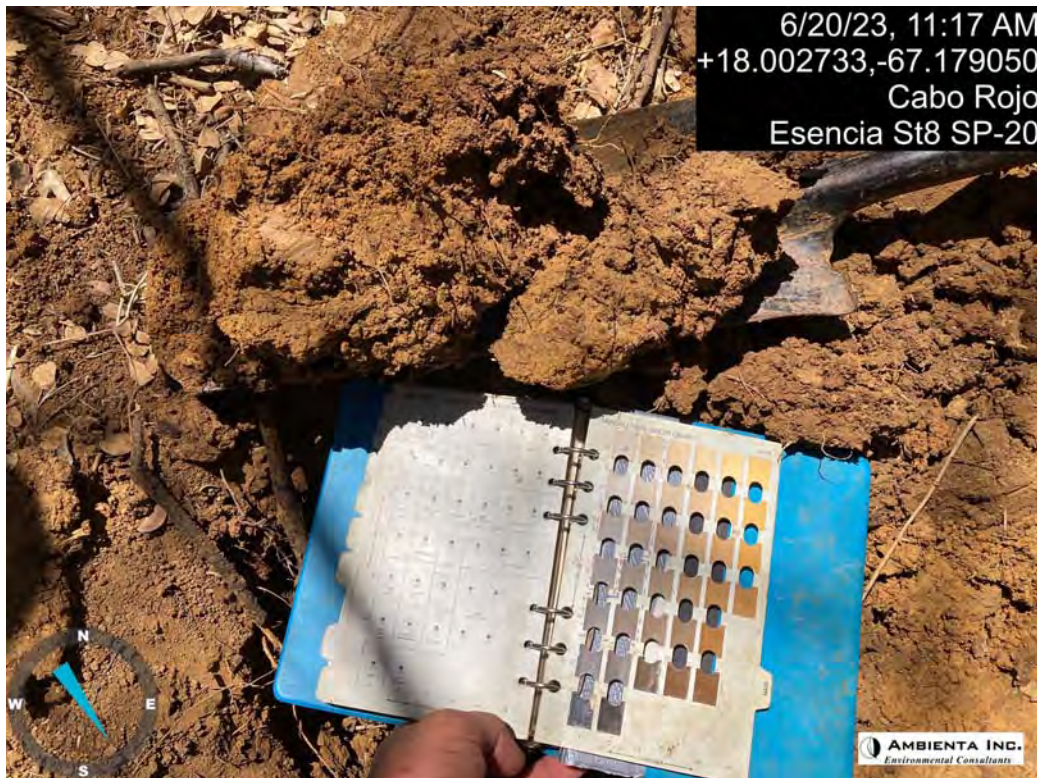
Soil evaluation at Sampling Point SP-20.

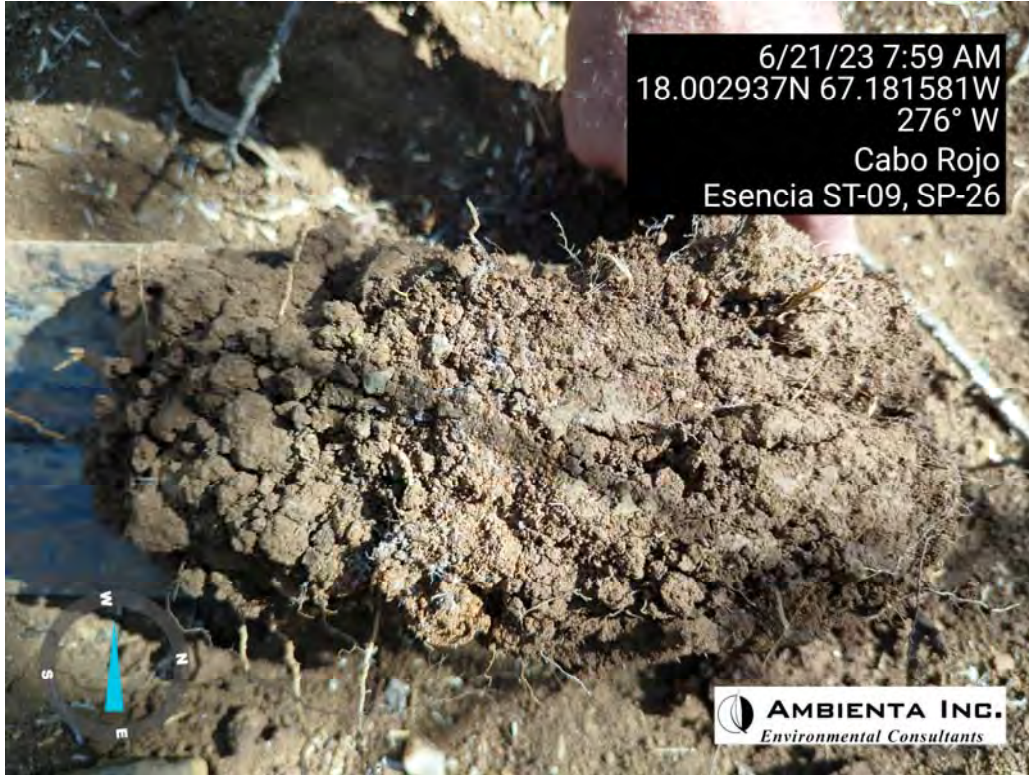
Soil sample at Sampling Point SP-26.

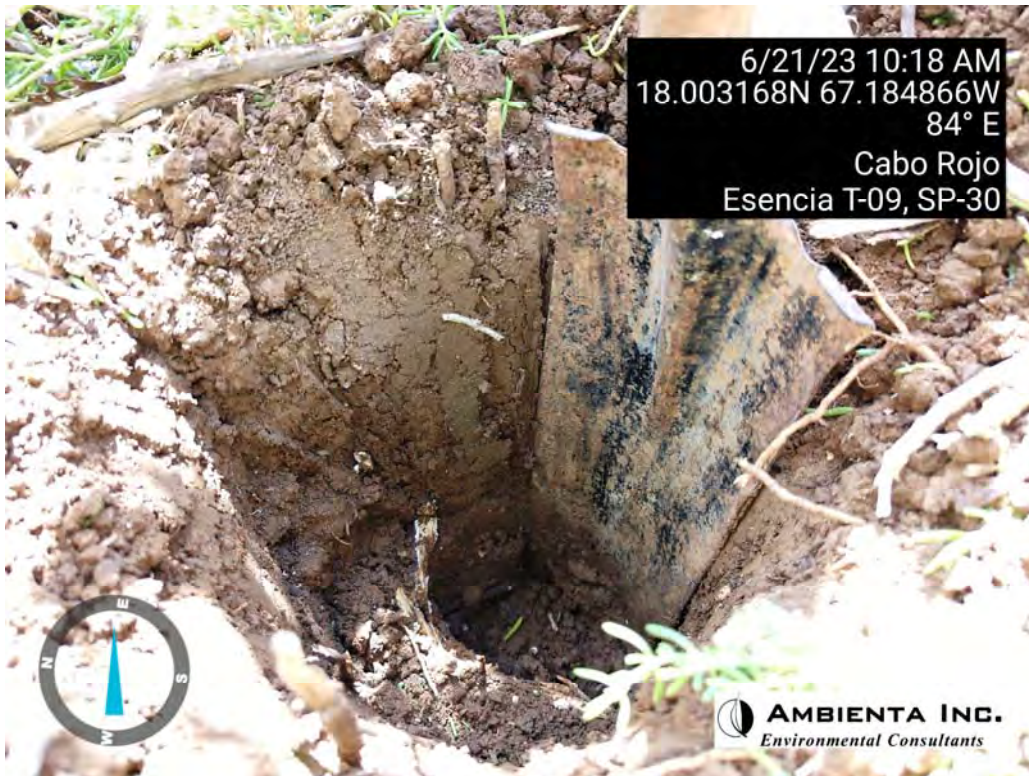
Sampling Pit at Sampling Point SP-30.

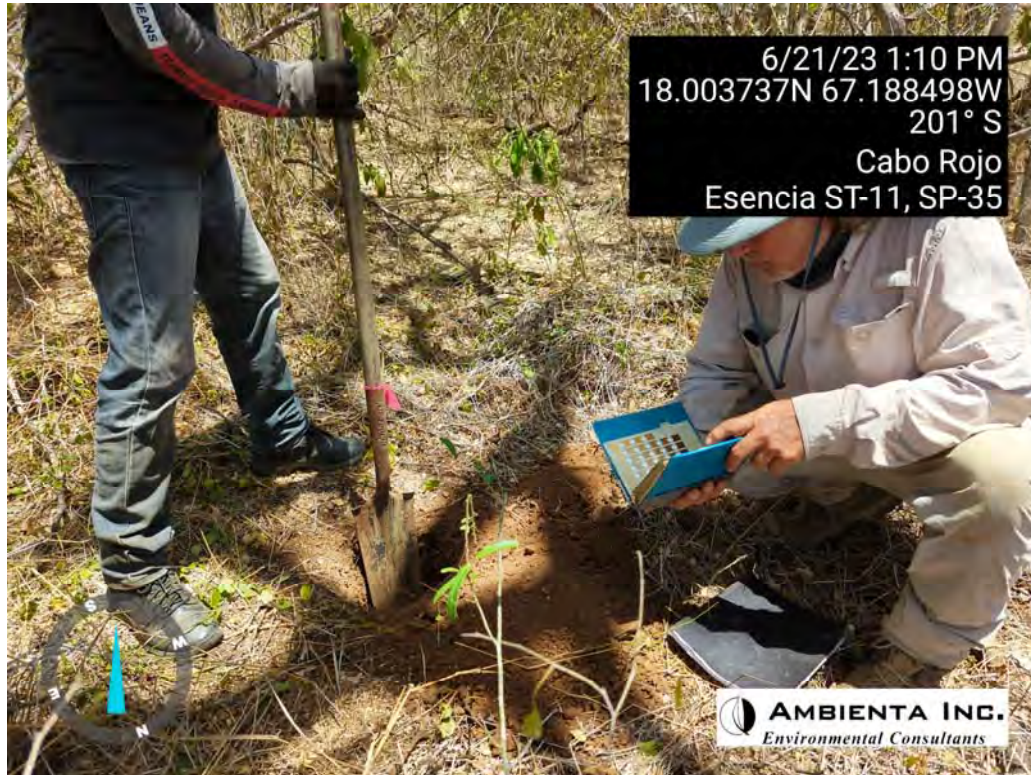
Soil evaluation at Sampling Point SP-35.

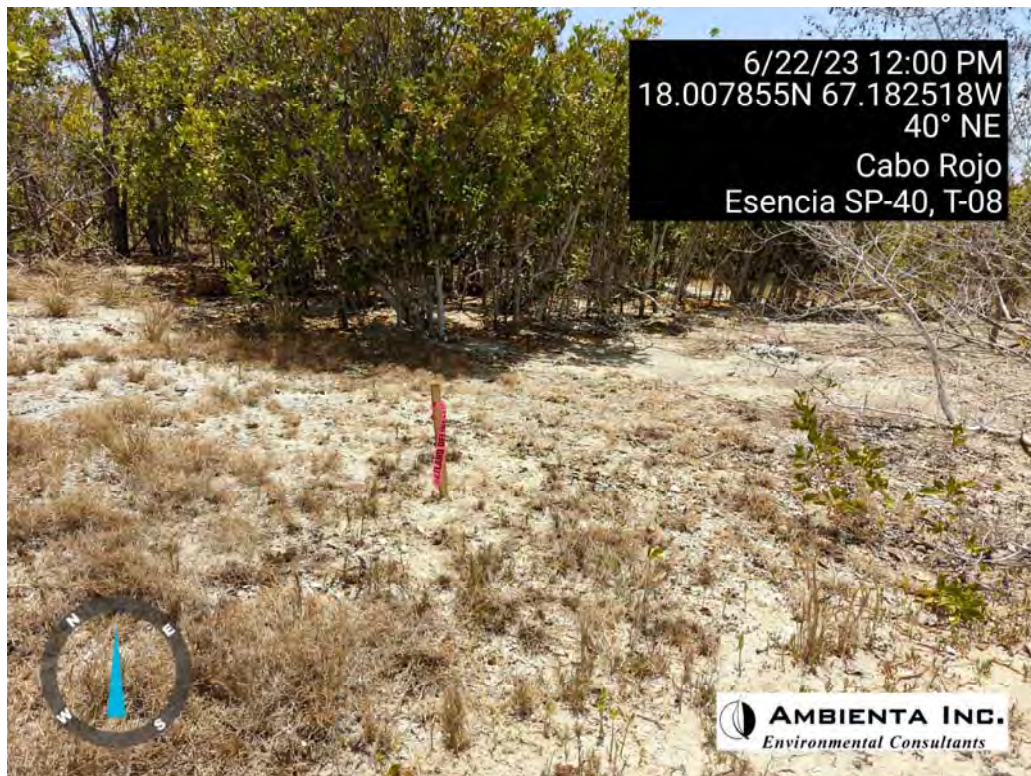
Wetland delineation at Sampling Point SP-40.

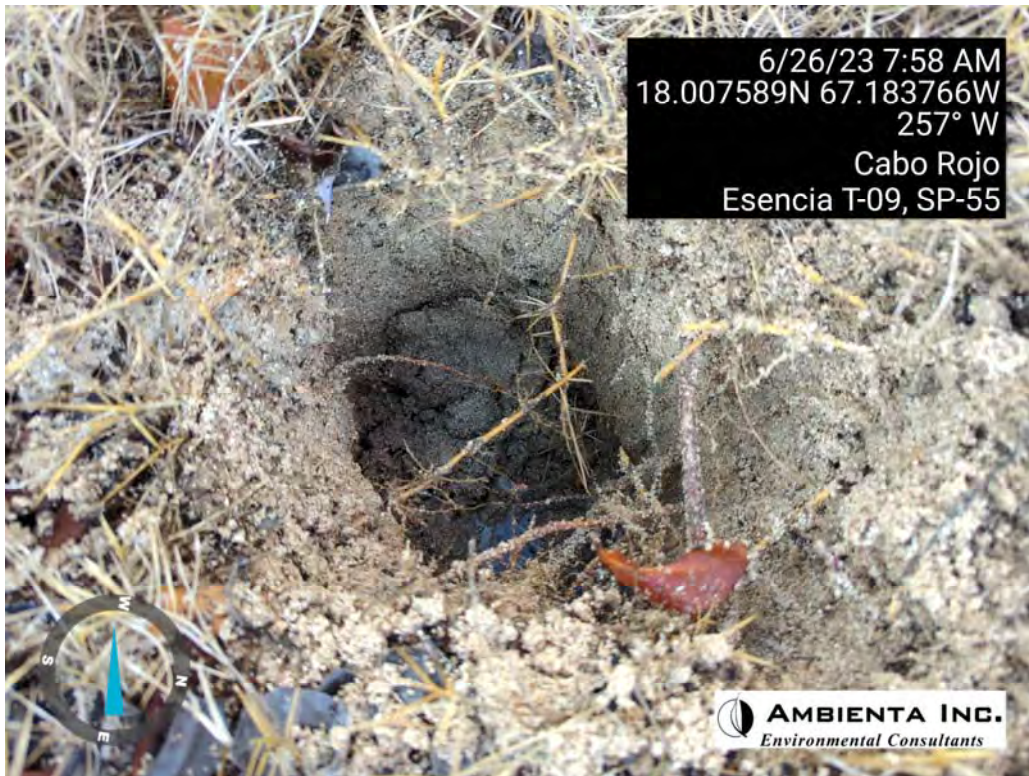
Water in sampling pit at Sampling Point SP-55.

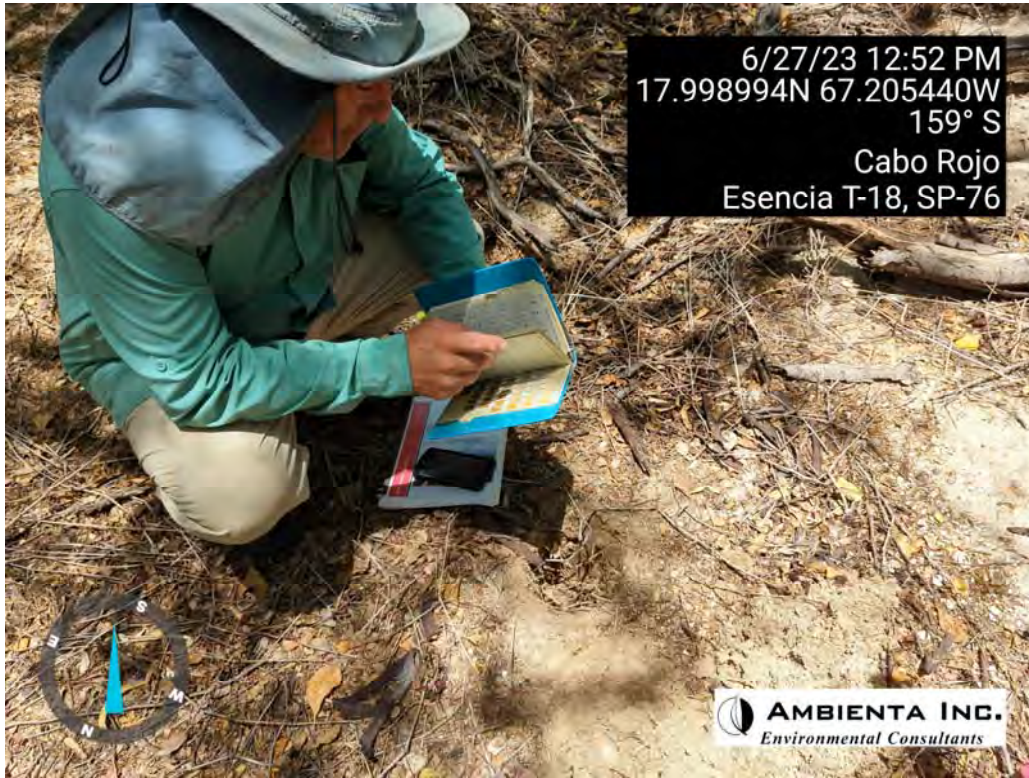
Soil evaluation at Sampling Point SP-76.

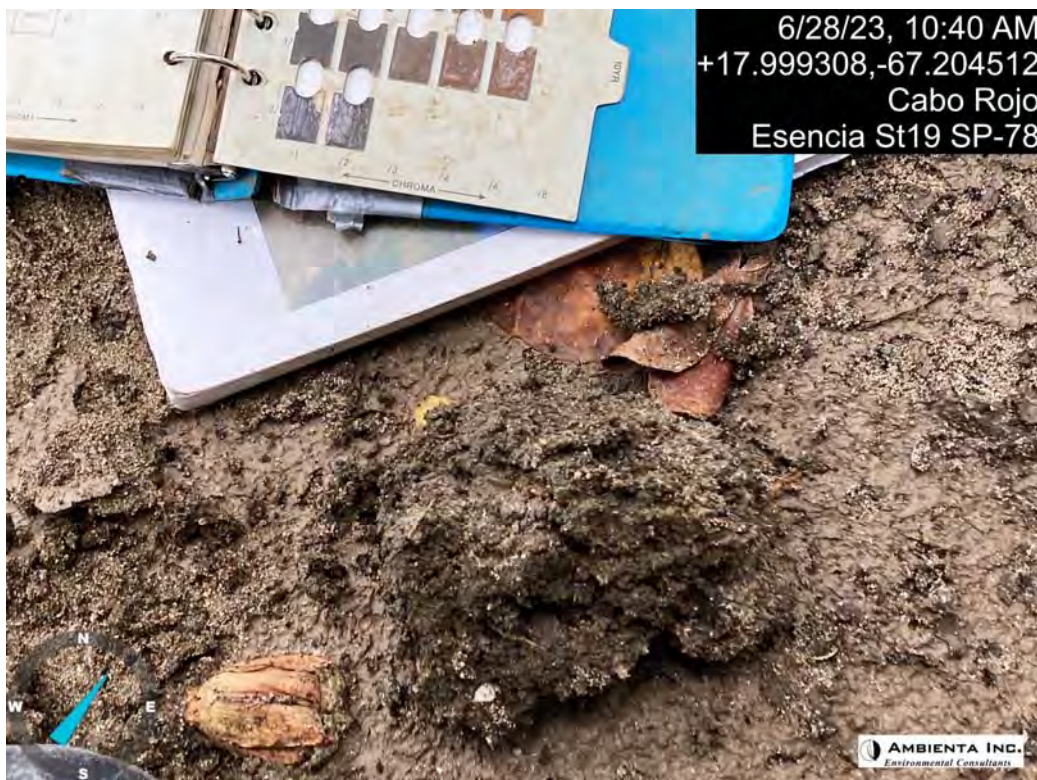
Soil evaluation at Sampling Point SP-78.

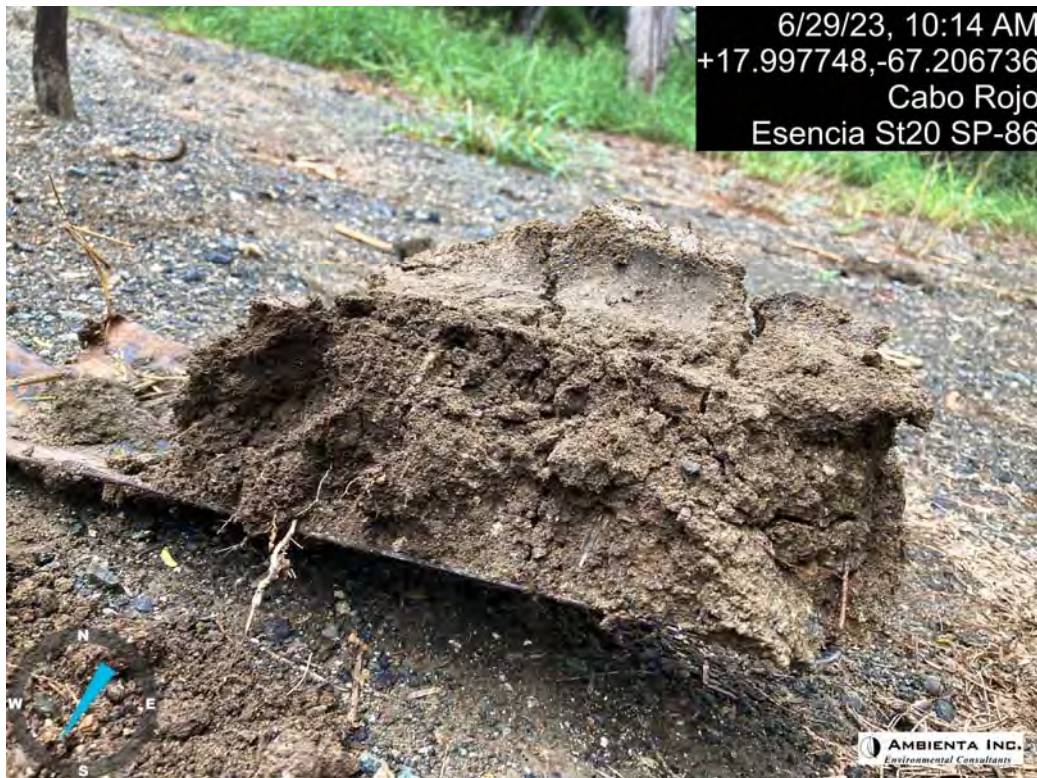
Soil sample at Sampling Point SP-86.

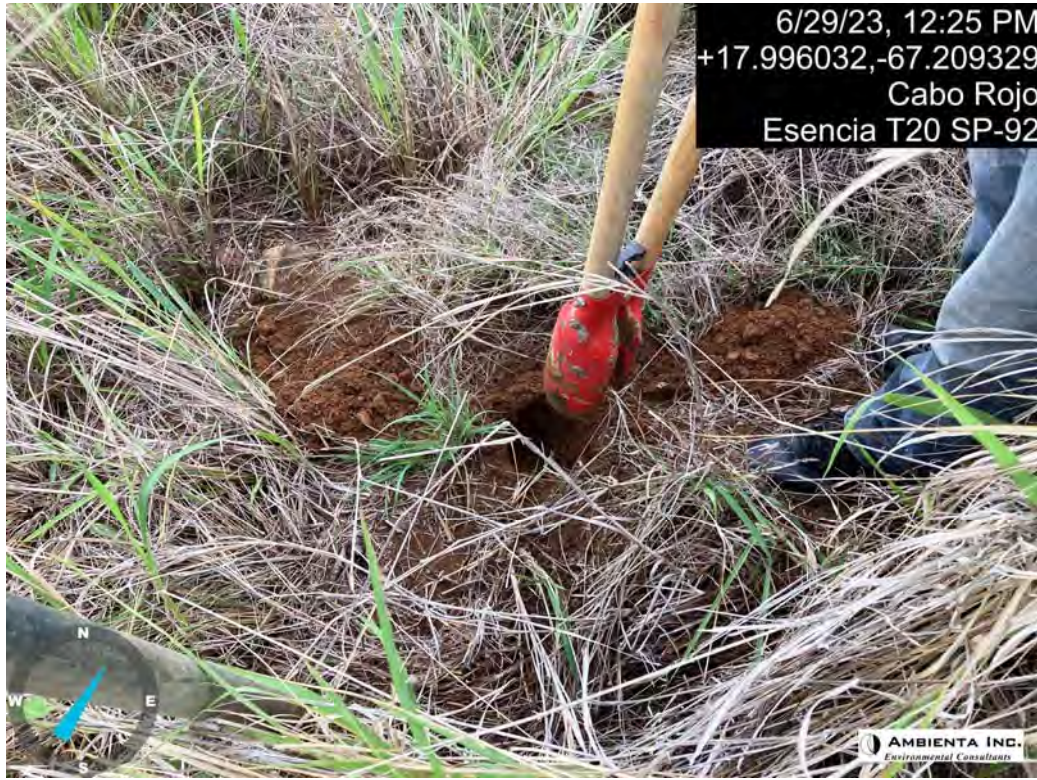
**Making the sampling pit at Sampling Point SP-92.**

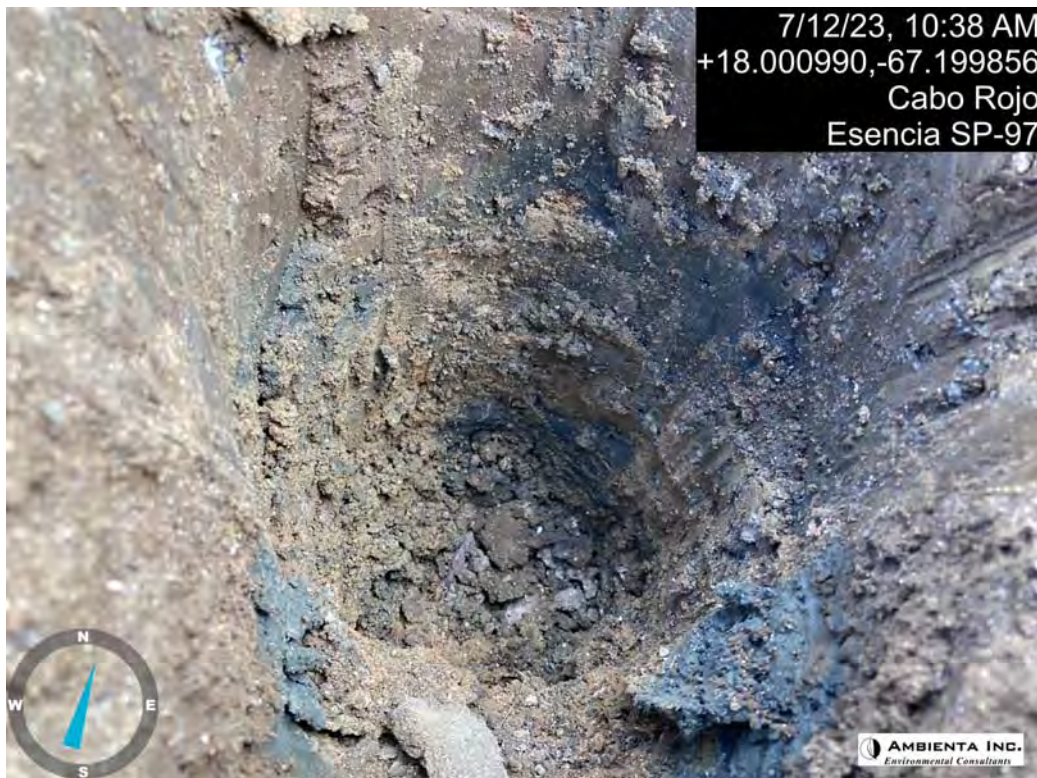
**Sampling pit at Sampling Point SP-97.**

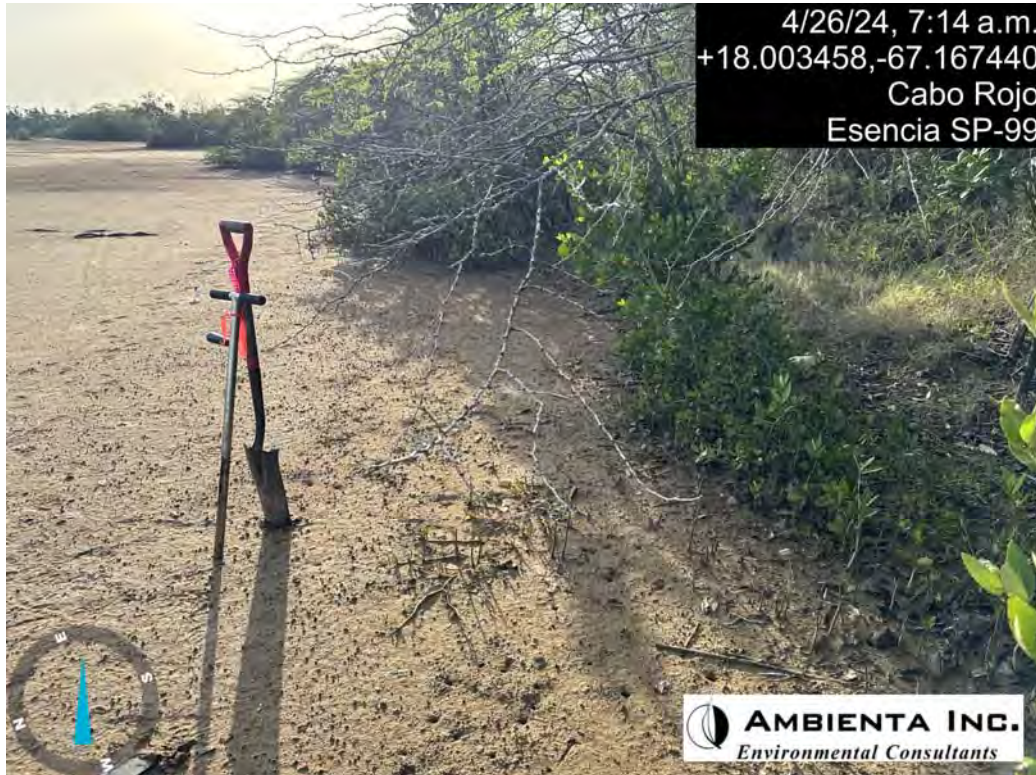
Assessment area and wetland boundary at Sampling Point SP-99.

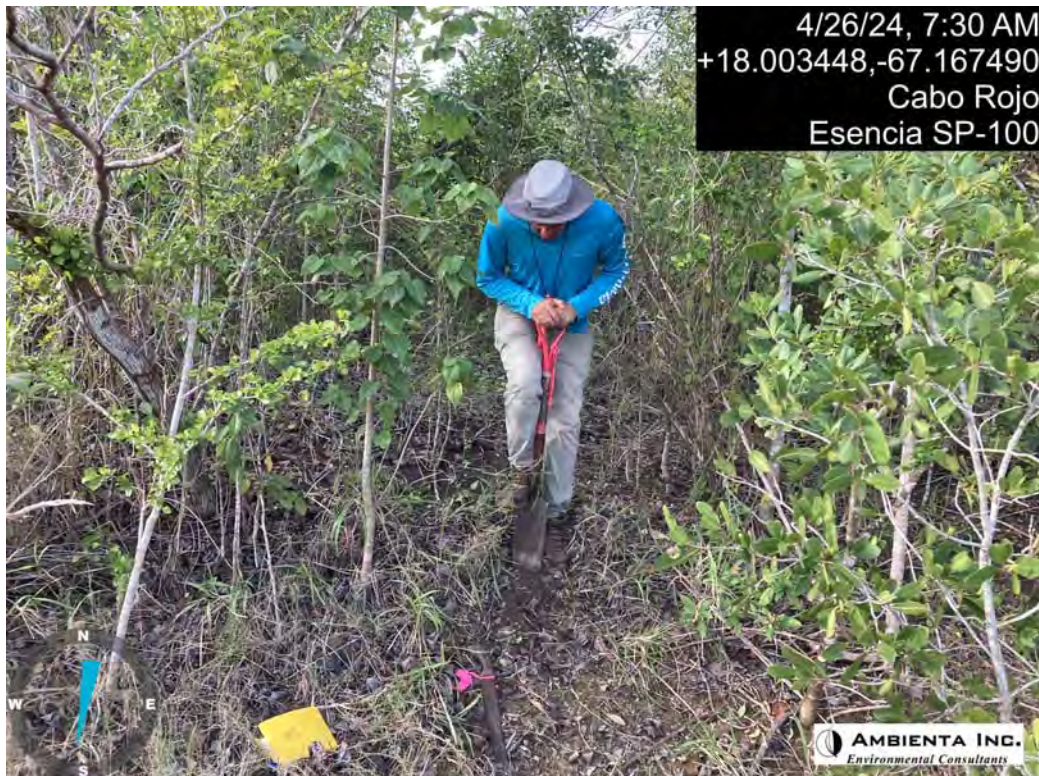
Assessment area near wetland boundary at Sampling Point SP-100.

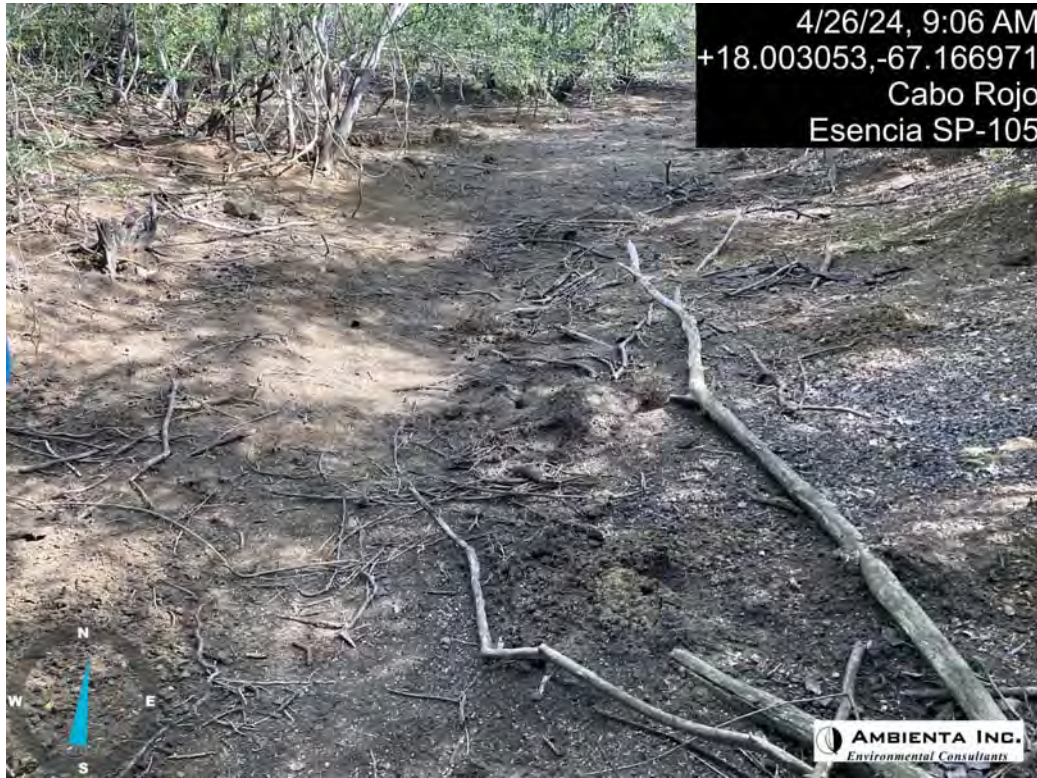
Assessment area of wetland swale at Sampling Point SP-105.

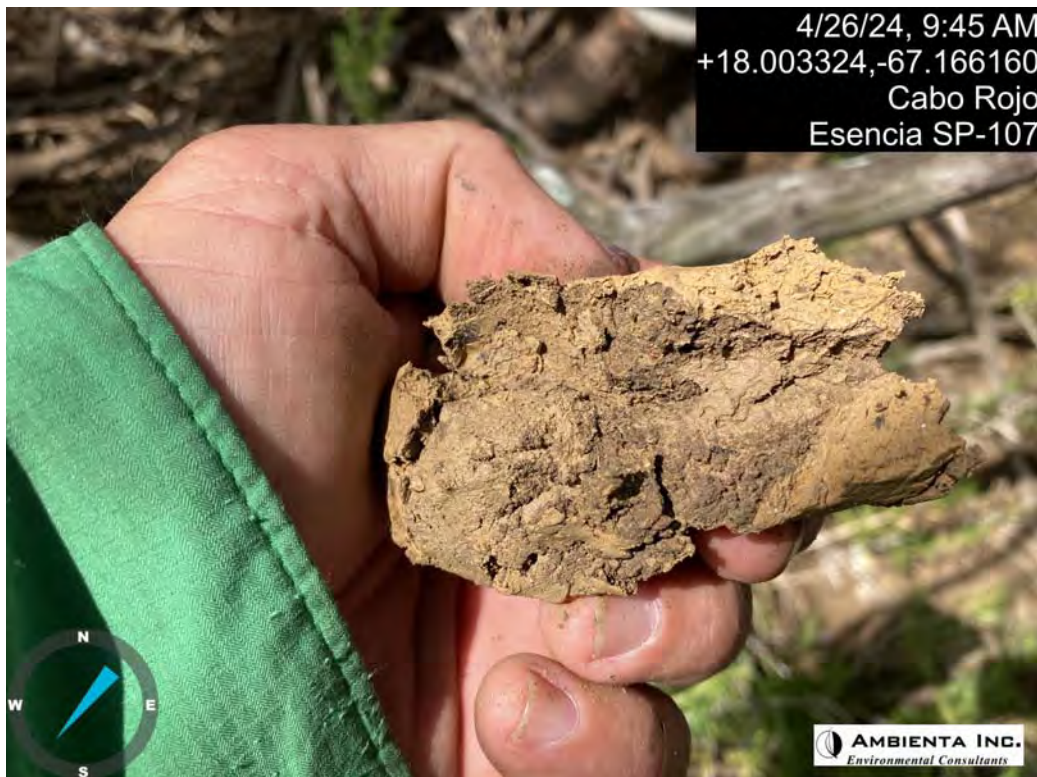
Soil evaluation at Sampling Point SP-107.
