**BORRADOR DE DECLARACIÓN DE IMPACTO AMBIENTAL**  
**ESENCIA, BOQUERÓN, CABO ROJO**

**ENERO 2025**

**TOMO 1 DE 2**  
**Borrador DIA + Anejos 1-5**

**TÍTULO DE LA ACCIÓN PROPUESTA:** Esencia, Boquerón, Cabo Rojo

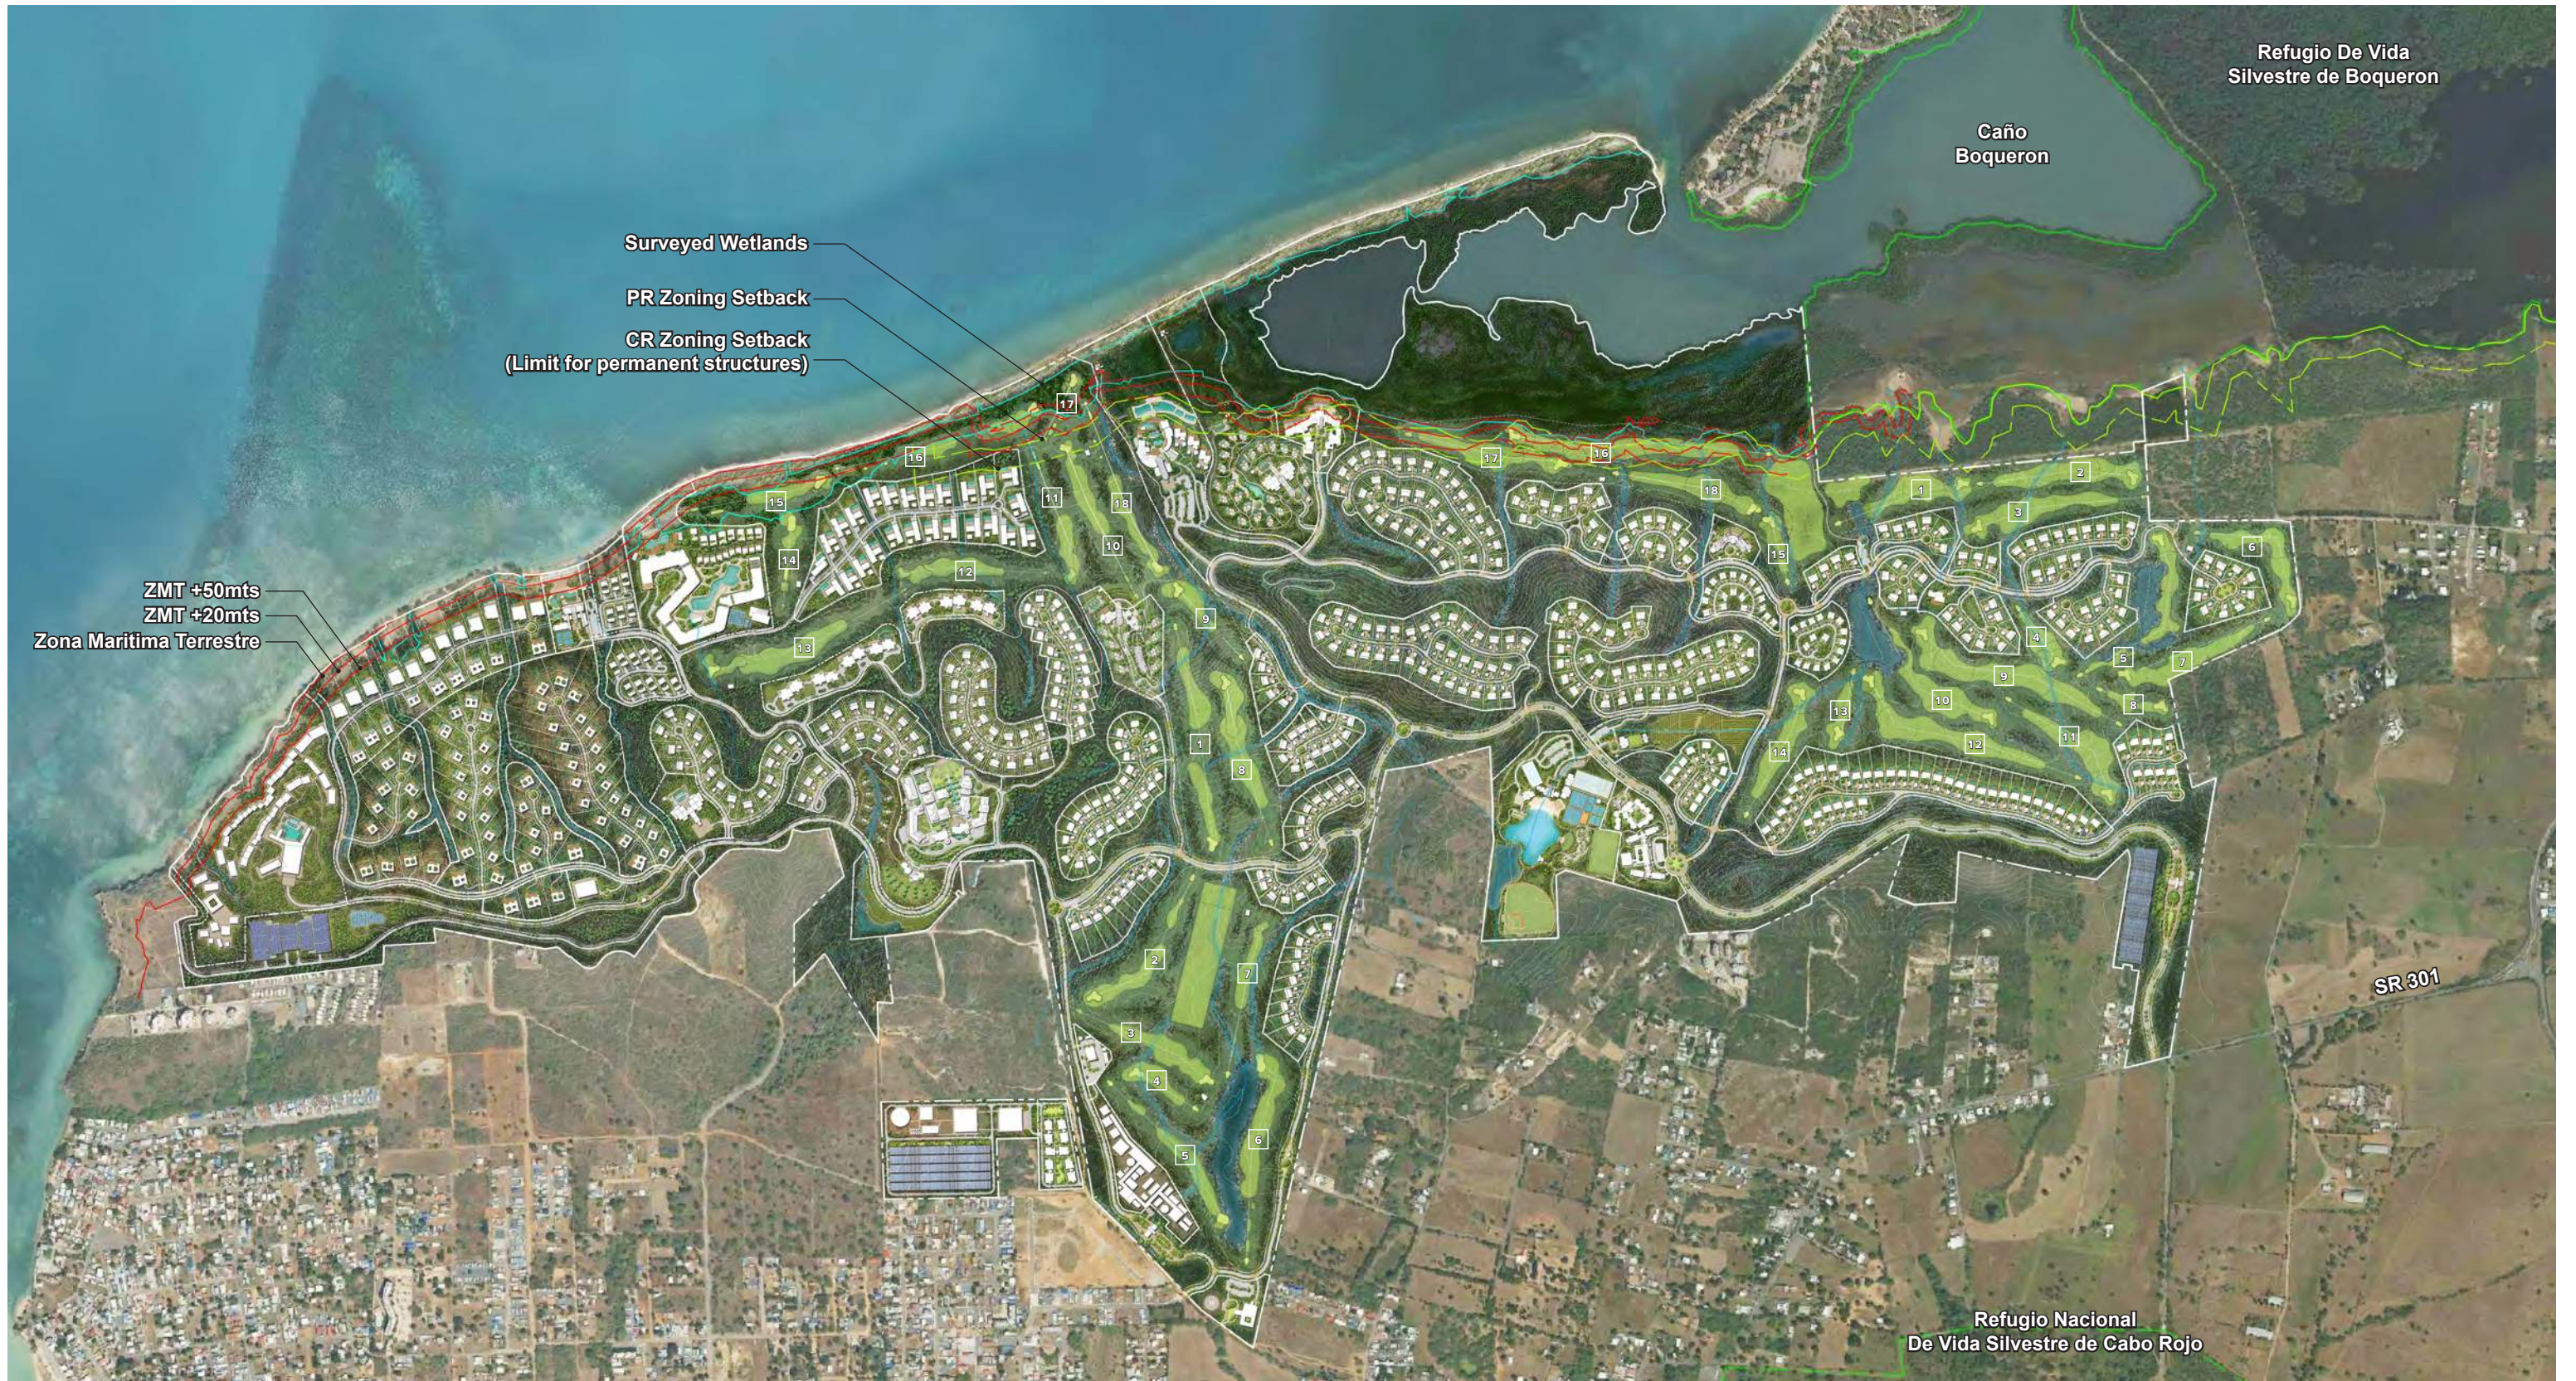
ESENCIA  
CONCEPTUAL PLANNING  
MAY 2024

## DETAILED ILLUSTRATIVE OVERALL PLAN

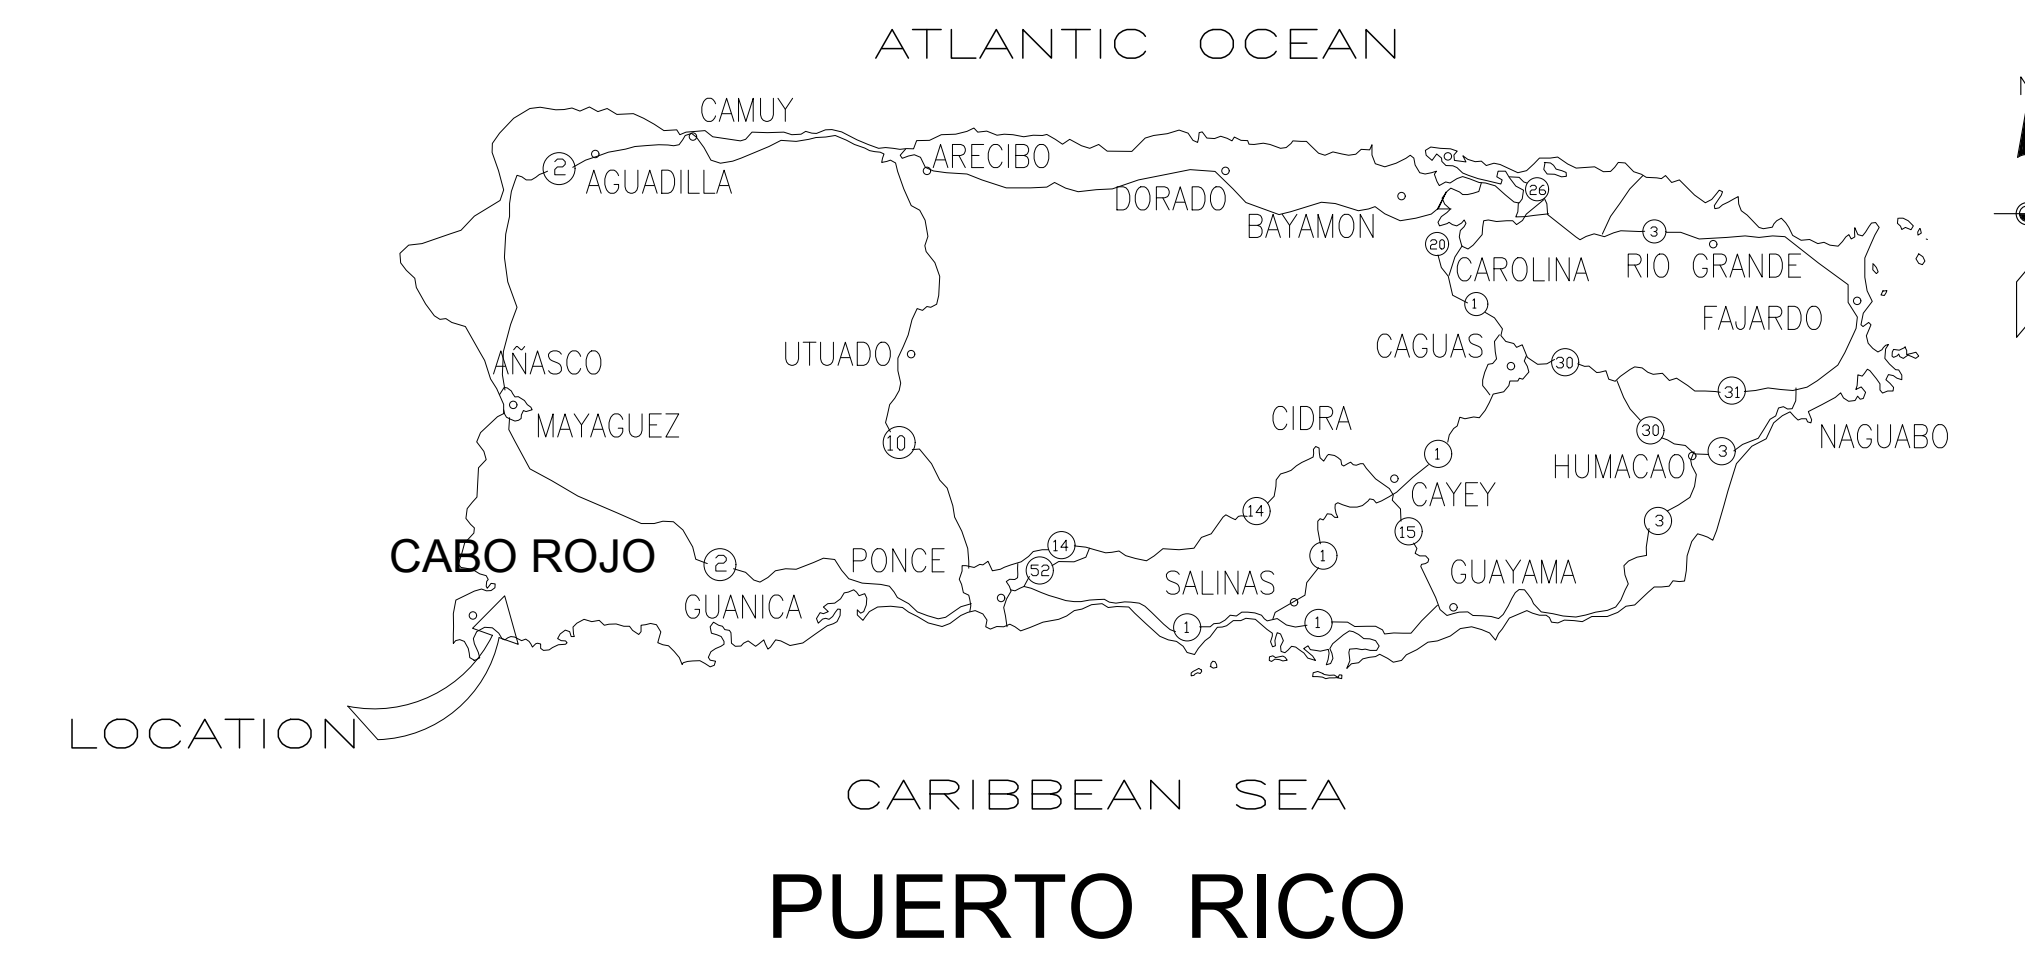
JAVIER E. BIDOT CRUZ  
LAND SURVEYOR 12972  
PROJECT: JEB-3840  
CHECKED BY: C. LEBRON  
DRAWING BY: J. CAJNS  
DATE: MAY 14, 2024  
VF-1  
23  
FILE NAME: 3840-EC

**CERTIFY CORRECT**  
I, JAVIER E. BIDOT CRUZ, HEREBY CERTIFY THAT THIS PLAN IS AN EXACT AND TRUE GRAPHIC REPRESENTATION OF THE EXISTING CONDITIONS.

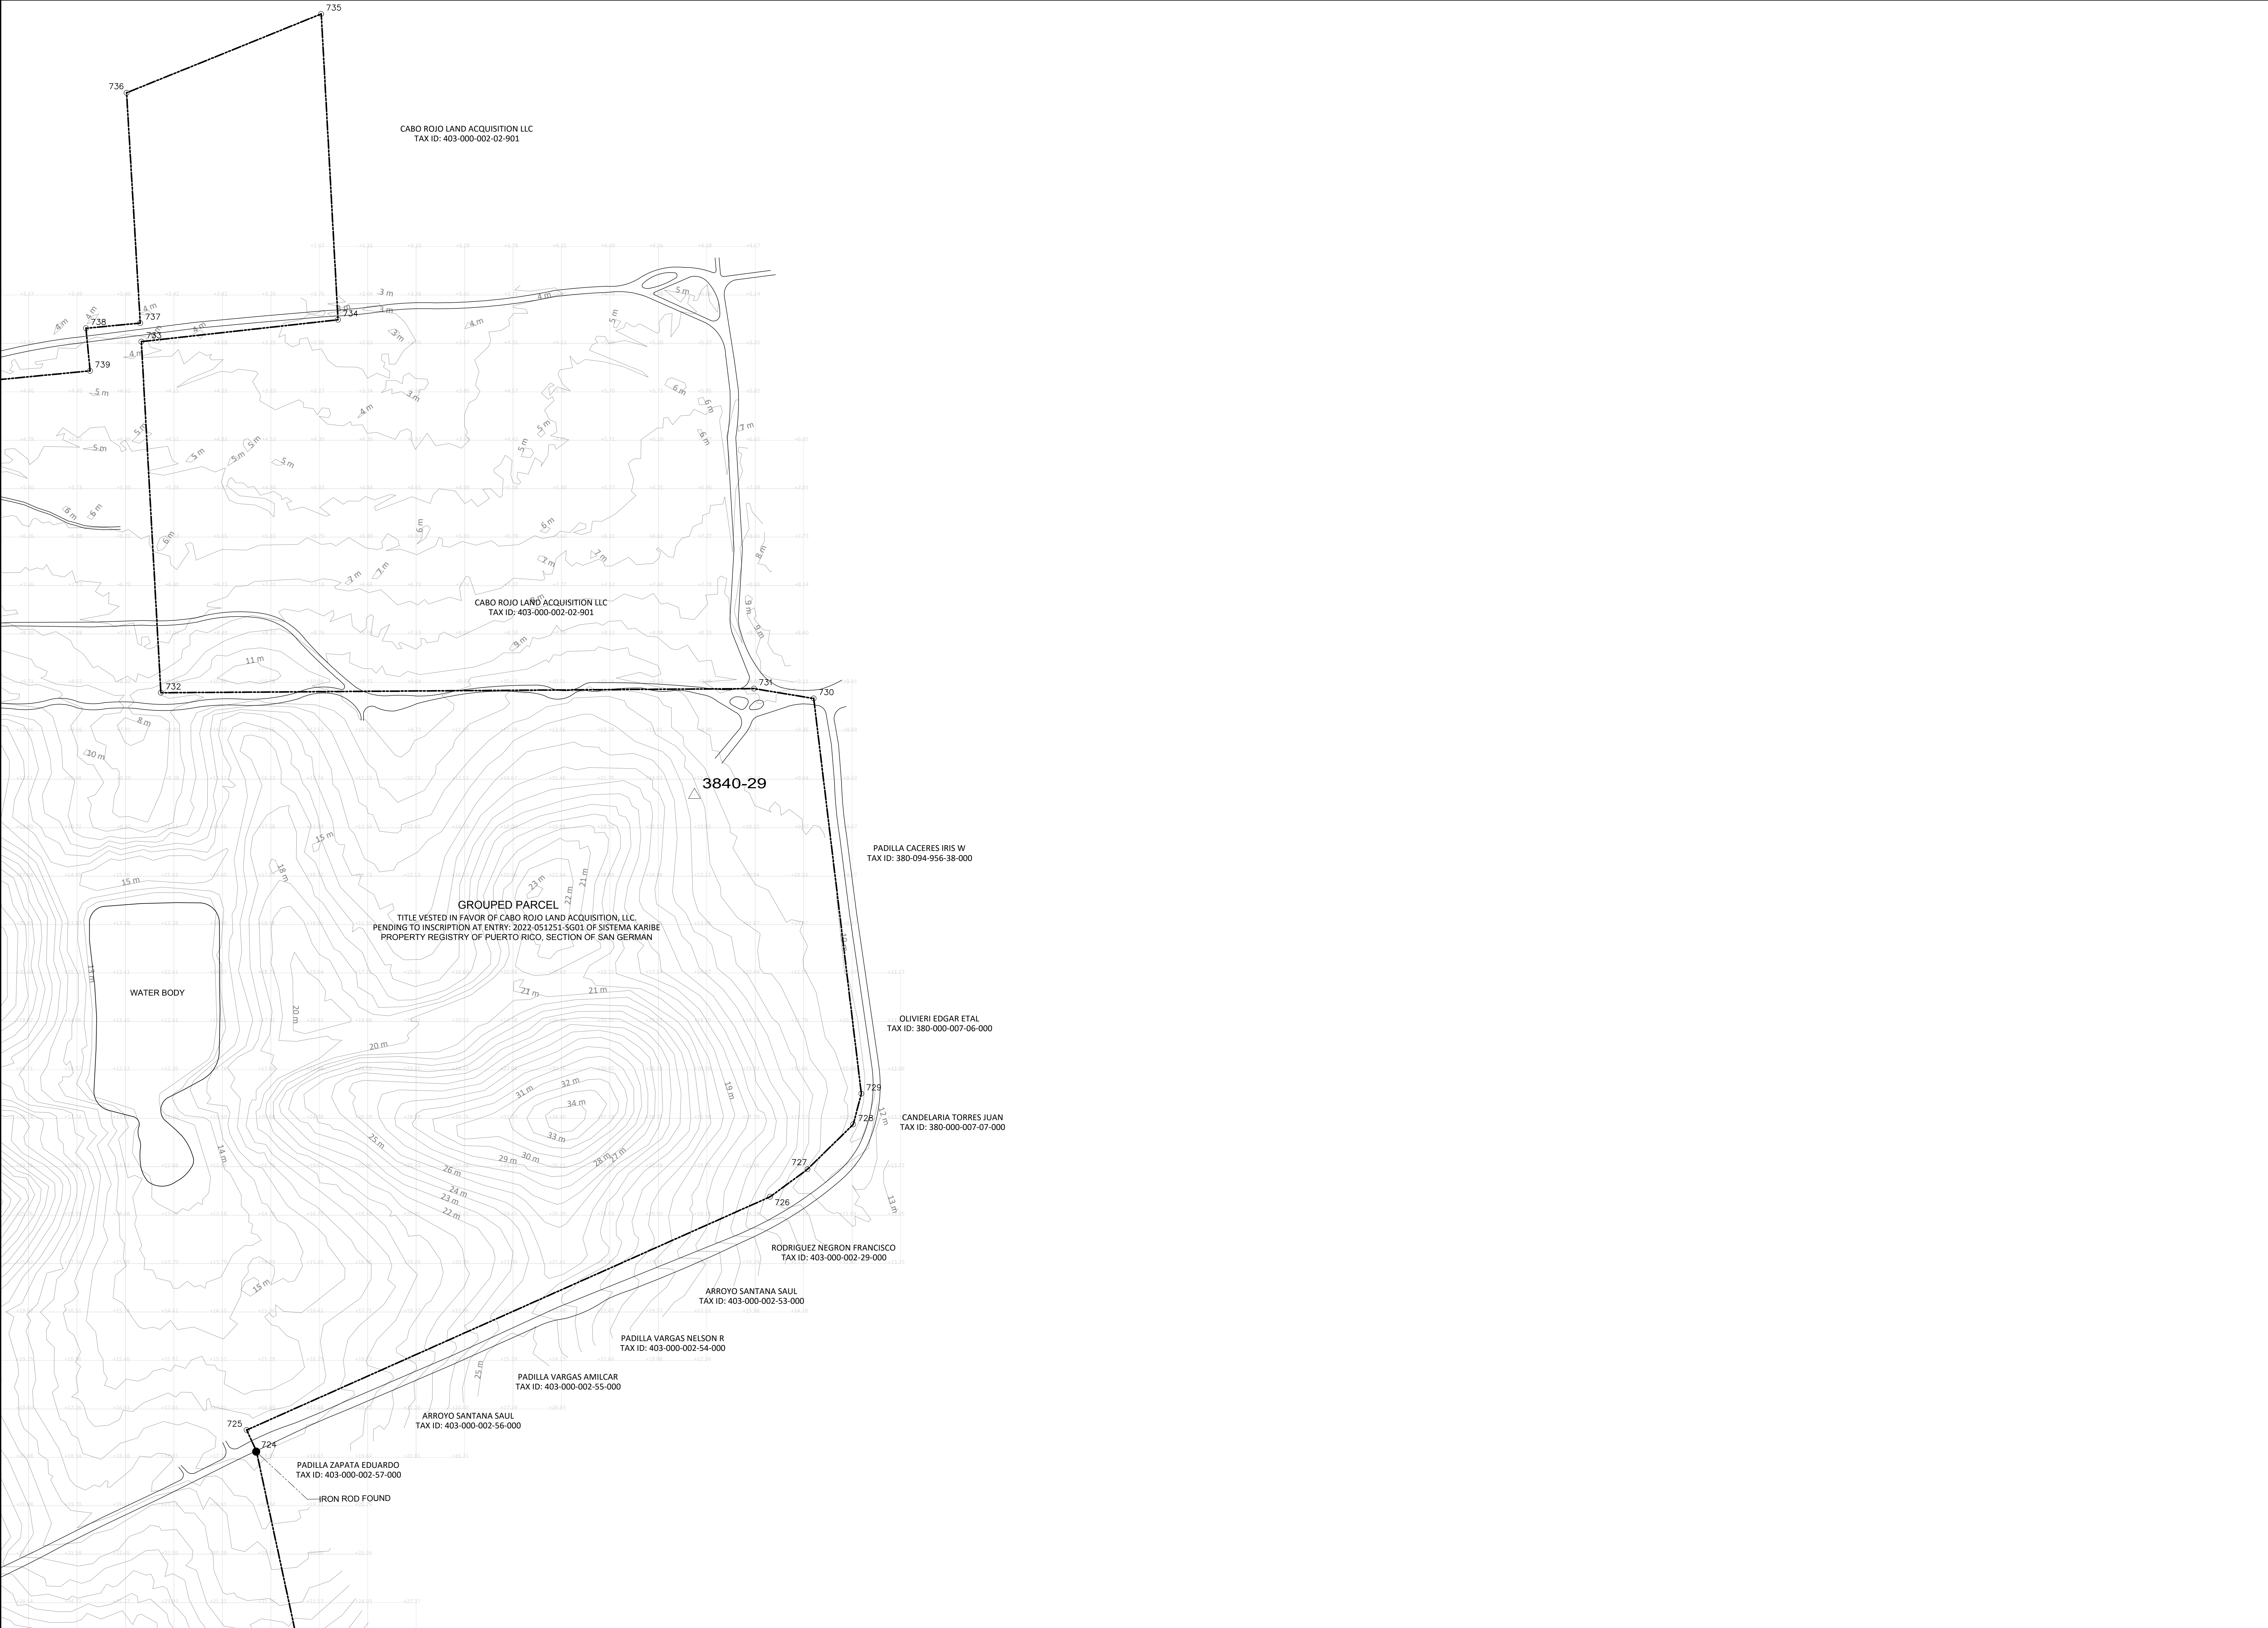
DATE: MAY 14, 2024 DWG. NO: 16 SHEET NO: 23  
 PROJECT: JEB-3840 VF-16  
 PAPER SIZE: 30x42

**EXISTING CONDITIONS AND TOPOGRAPHIC SURVEY**  
 SCALE 1 : 1200
