Re: Request for Alternate Project (Revision #2)

Project #95208 MLRA006 - Buildings 56, 374, 375, 2205 (PW 02554) FEMA PA Program DR-4339-PR

ALL HANDS BEACH

Category E – Building and Equipment
Project Tittle – MLRA006 - Buildings 56,374,375,2205

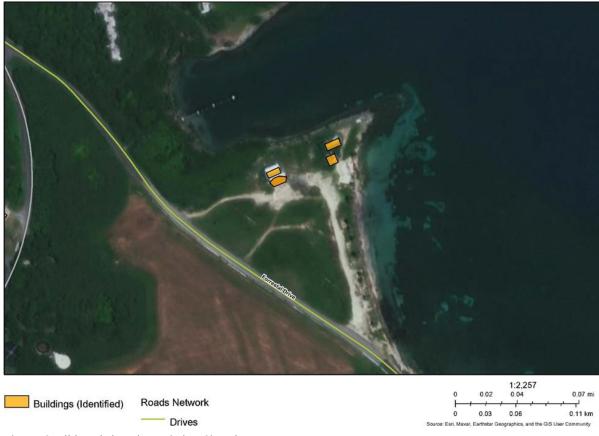
Figure 6: All hands beach – Existing Site Plan

The proposed project is located at Forrestal Drive at the Formal Naval Base of Roosevelt Road, Municipality of Ceiba Puerto Rico. The same has four (4) DI's and one (1) additional area proposed for cleanup.

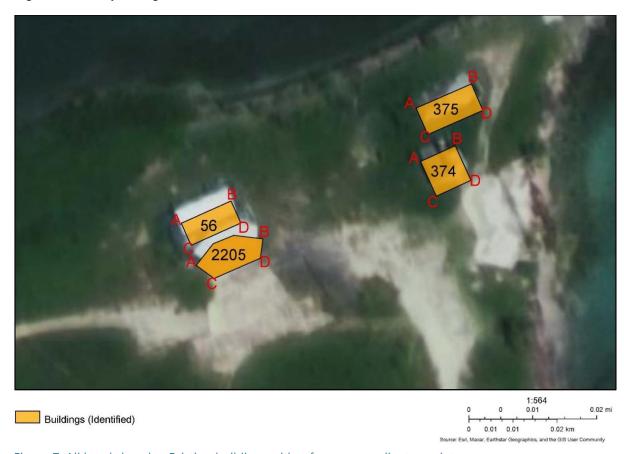
Figure 7: All hands beach – Existing buildings with reference coordinates points

The following figures and tables show the requested coordinates demarking the project boundary for each segment of facility damage:

DI#	Building #	Point	Latitude	Longitude
152473	56	Α	18.223170	-65.606873
		В	18.223217	-65.606755
		С	18.223134	-65.606846
		D	18.223180	-65.606730
152301	2205	Α	18.223088	-65.606824
		В	18.223143	-65.606689
		С	18.223061	-65.606796
		D	18.223102	-65.606693
152107	375	Α	18.223415	-65.606359
		В	18.223465	-65.606238
		C	18.223368	-65.606329
		D	18.223422	-65.606222
