Negative Lead & Asbesto Certification

Asbestos Containing Materials Inspection

**SAMPLING CONDUCTED AT:
BUILDING T085506700
(PW-7801) & (DI-219340)
NORTH REGION**

Located at Road PR-2 Km. 100.8 San Jose Ward in Quebradillas, PR

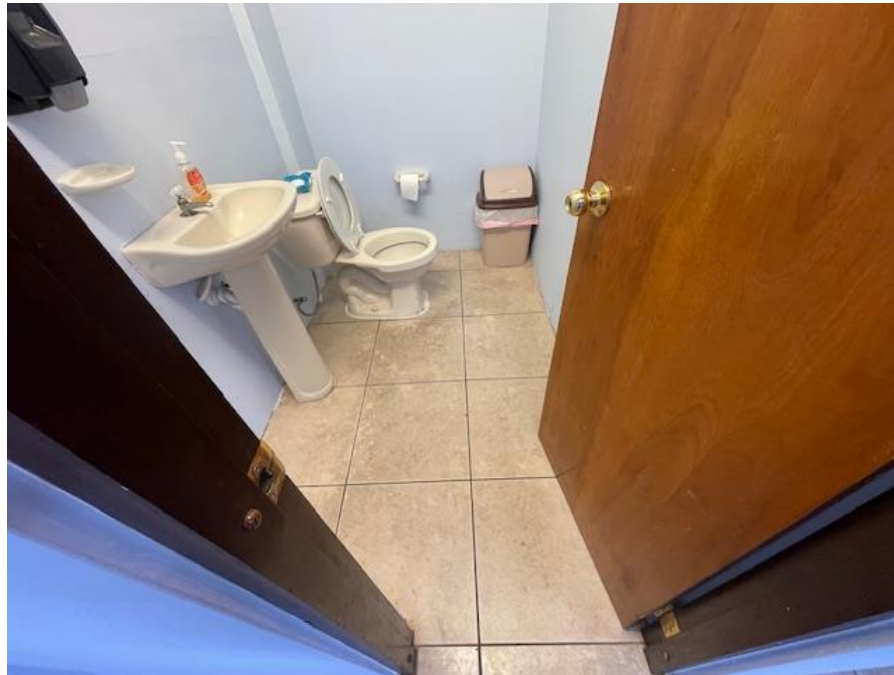
Bathroom 2- Ceramic Floor Tiles with Lead Based Paint

Global Environmental Services LLC recommends the owner or representative of owner to hire a Company Certified in the Department of Natural and Environmental Resources (DNER) of Puerto Rico to mitigate and dispose positive areas with Lead Based Paint if is going to touch or demolish the Building areas.

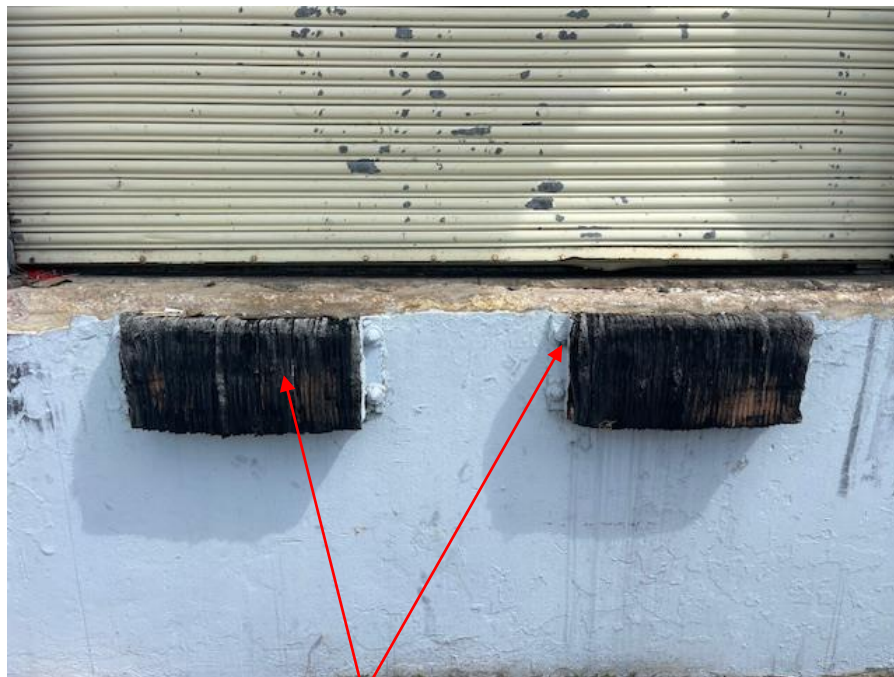
Exterior-Side D- Metal Barrier Plates with Lead Based Paint

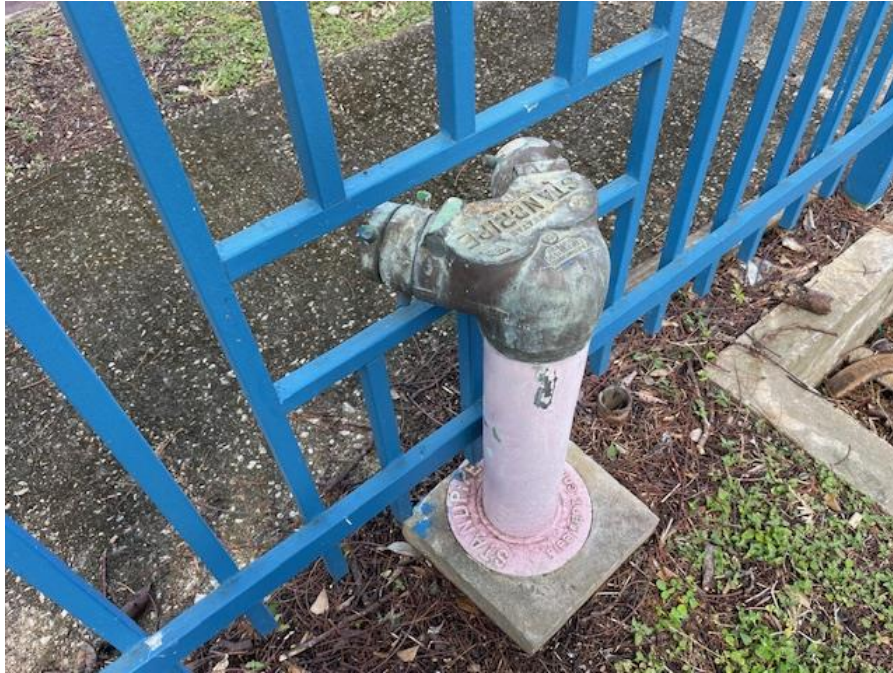
Exterior- Side D- Metal Fire Hose Connection with Lead Based Paint

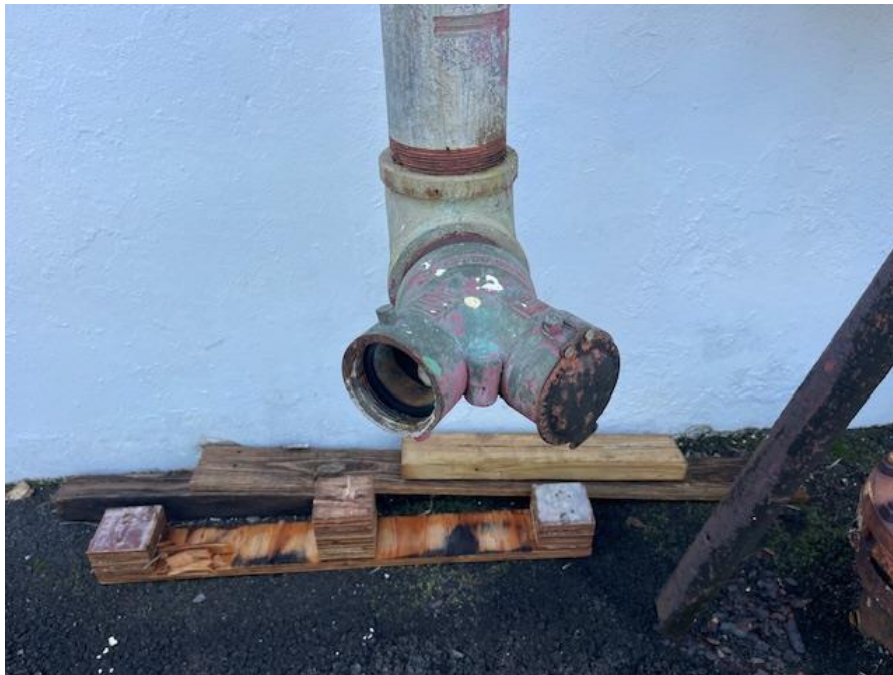
Exterior- Side B- Metal Fire Hose Connection with Lead Based Paint

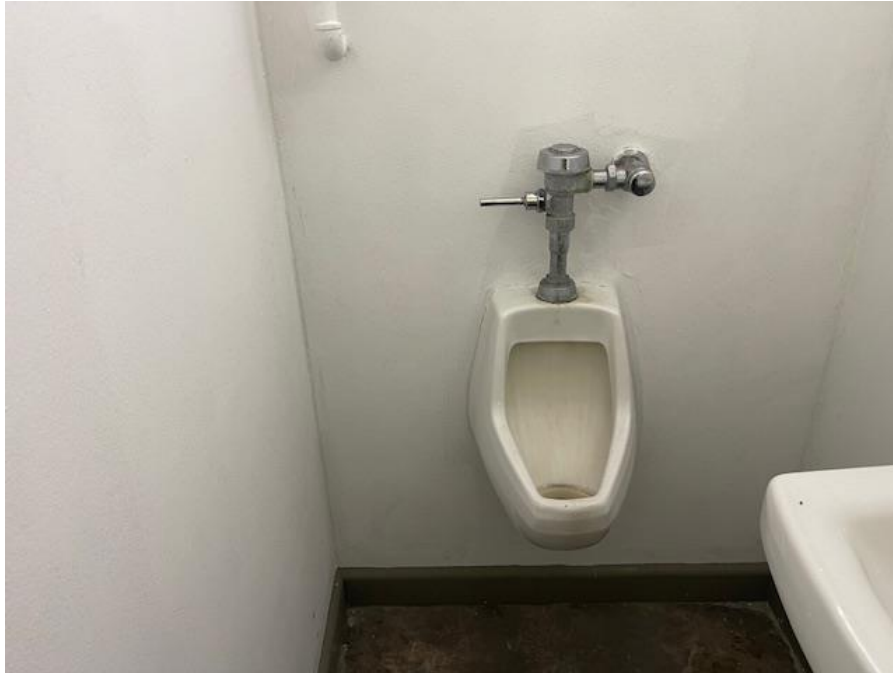
Bathroom 1- Ceramic Urinal with Lead Based Paint

Global Environmental Services LLC recommends the owner or representative of owner to hire a Company Certified in the Department of Natural and Environmental Resources (DNER) of Puerto Rico to mitigate and dispose positive areas with Lead Based Paint if is going to touch or demolish the Building areas.

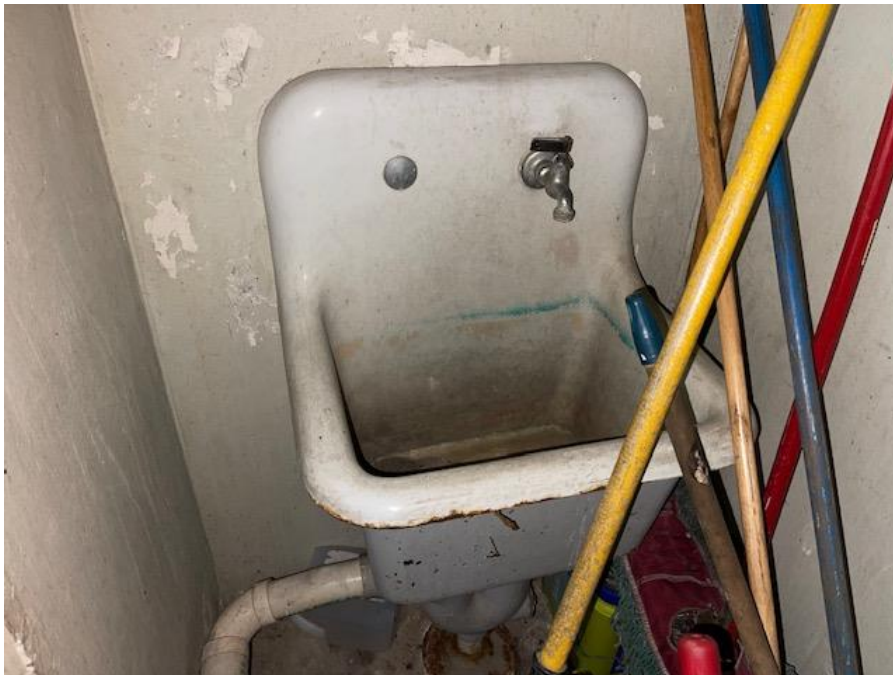
Janitor- Ceramic Sink with Lead Based Paint

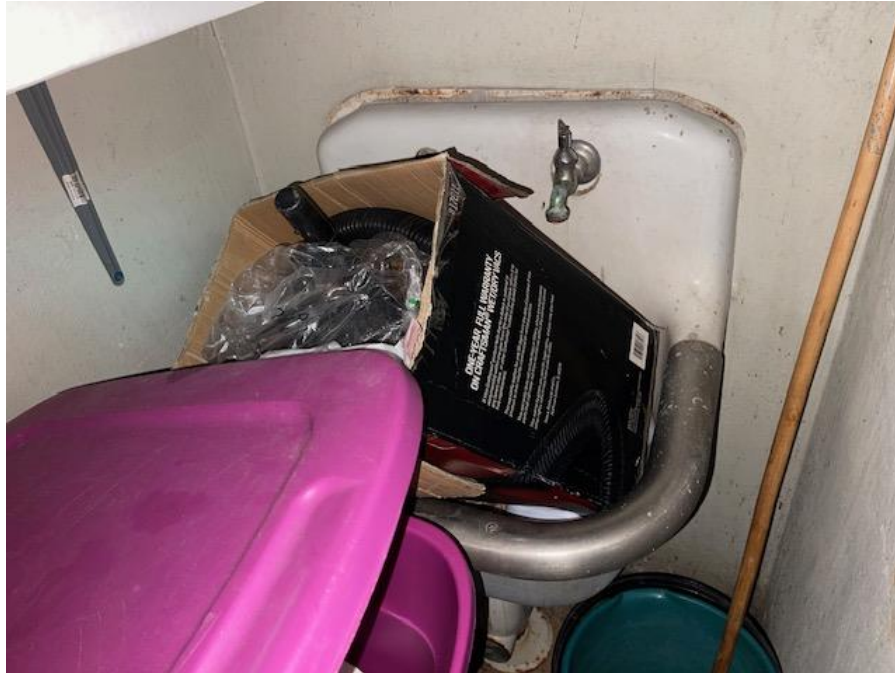
Janitor 2- Ceramic Sink with Lead Based Paint

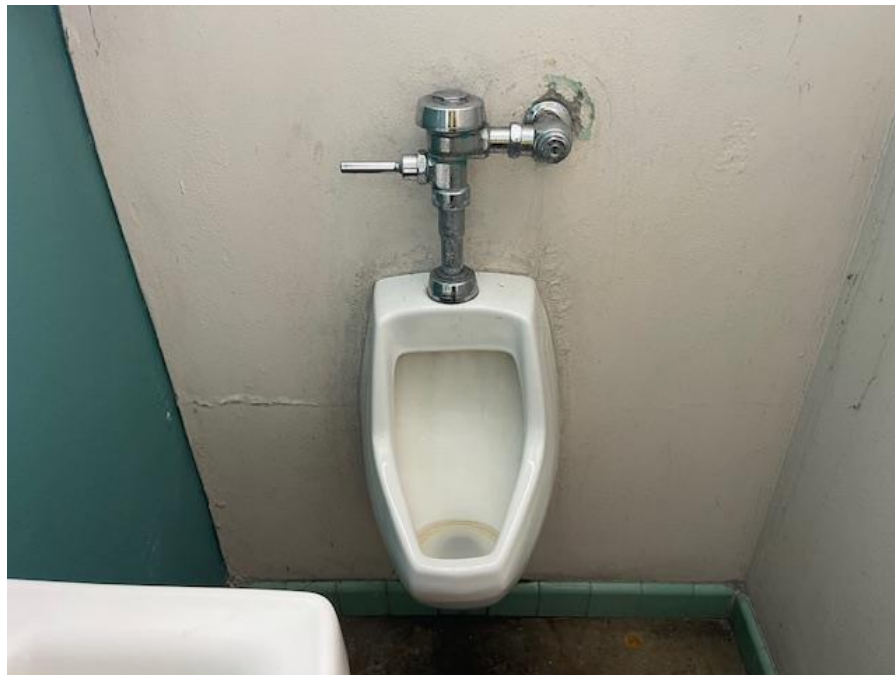
Bathroom 4- Ceramic Urinal with Lead Based Paint

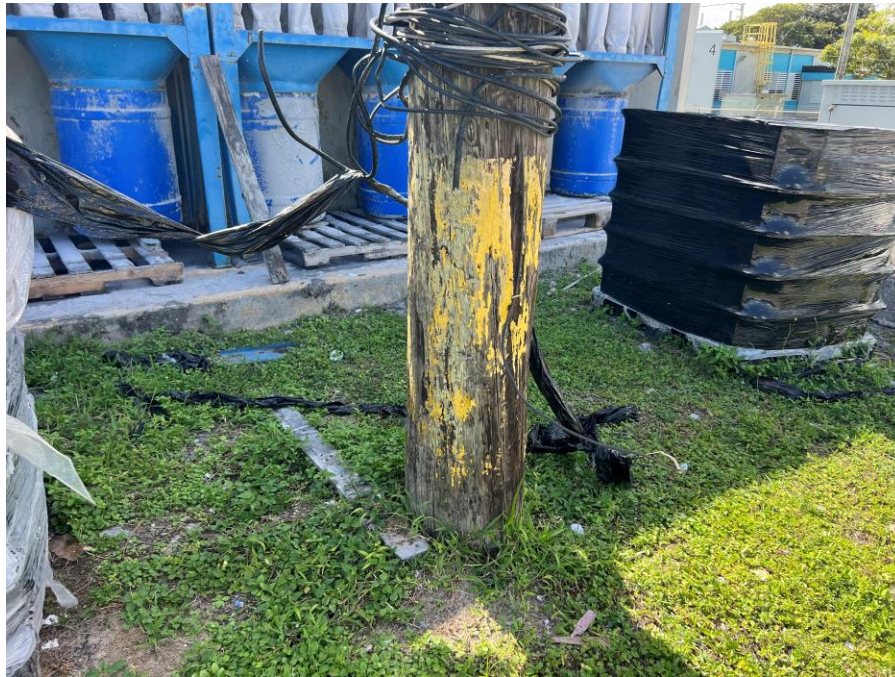
Exterior – Side B- Wood Electric Pole with Lead Based Paint

Global Environmental Services LLC recommends the owner or representative of owner to hire a Company Certified in the Department of Natural and Environmental Resources (DNER) of Puerto Rico to mitigate and dispose positive areas with Lead Based Paint if is going to touch or demolish the Building areas.
