LEAD & ASBESTOS CERTIFICATION

ASBESTOS CONTAINING MATERIALS

T13940861
PW: 8583 / DI: 407866
PR-860 Bo. Las Cuevas
Trujillo Alto, P.R.

PRIDCO

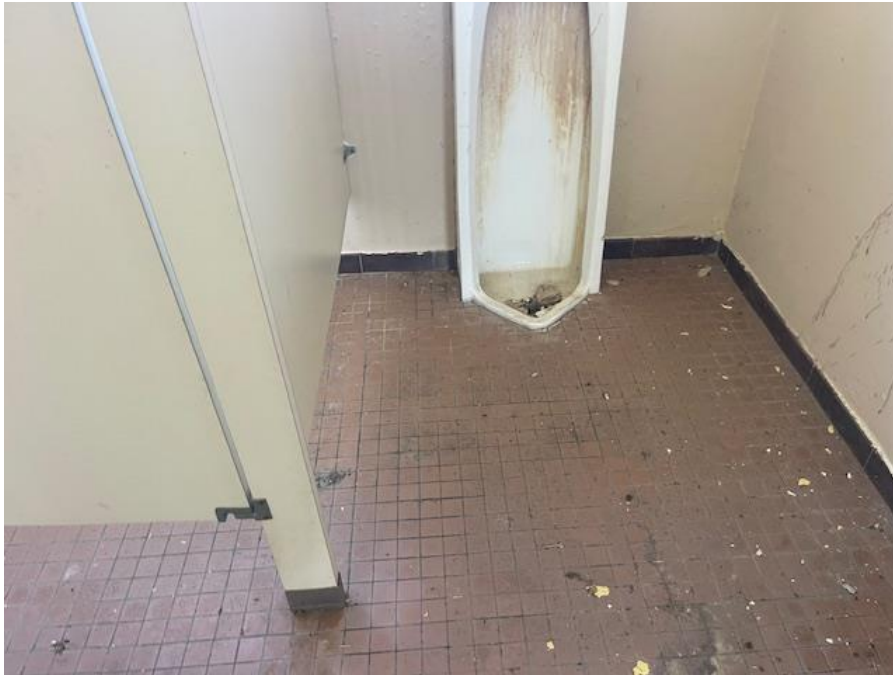
Bathroom 3- Ceramic Baseboards Tiles with Lead Based Paint

Global Environmental Services LLC recommends the owner or representative of owner to hire a Company Certified in the Department of Natural and Environmental Resources (DNER) of Puerto Rico to mitigate and dispose positive areas with Lead Based Paint if is going to touch or demolish the aforementioned areas.

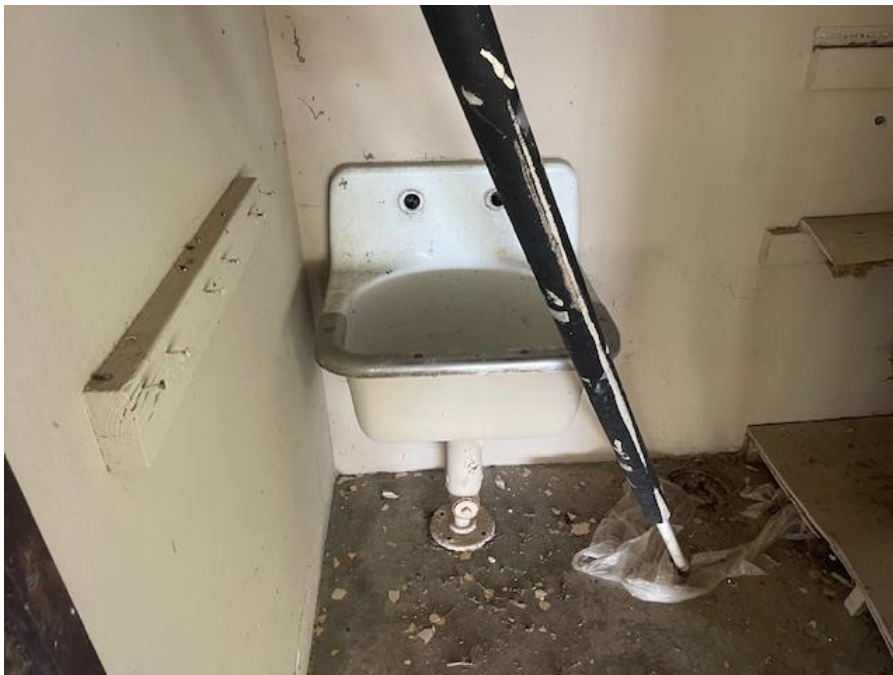
Janitor Room 2- Ceramic Sink with Lead Based Paint

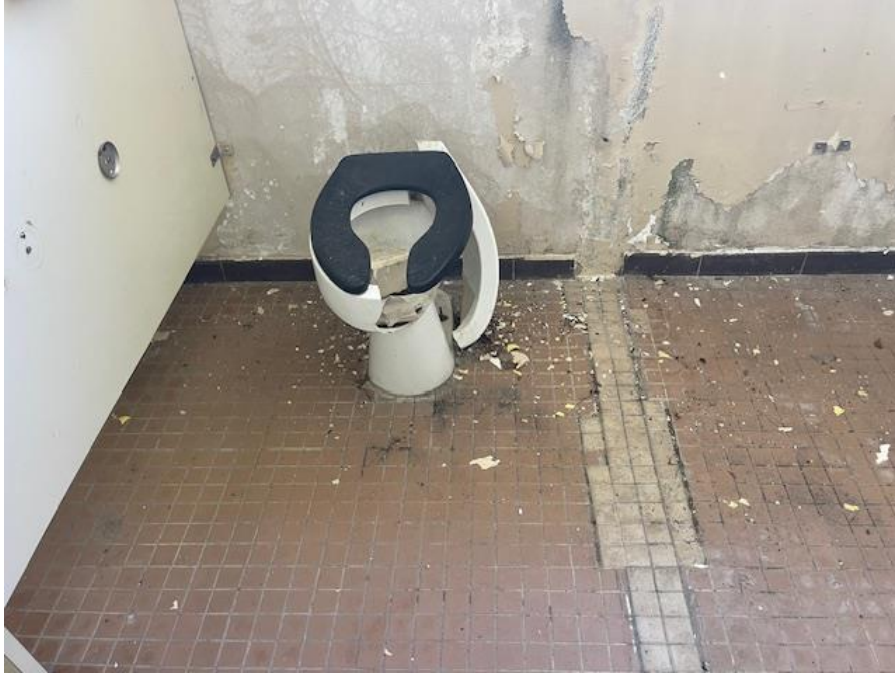
Bathroom 4- Ceramic Baseboards Tiles with Lead Based Paint

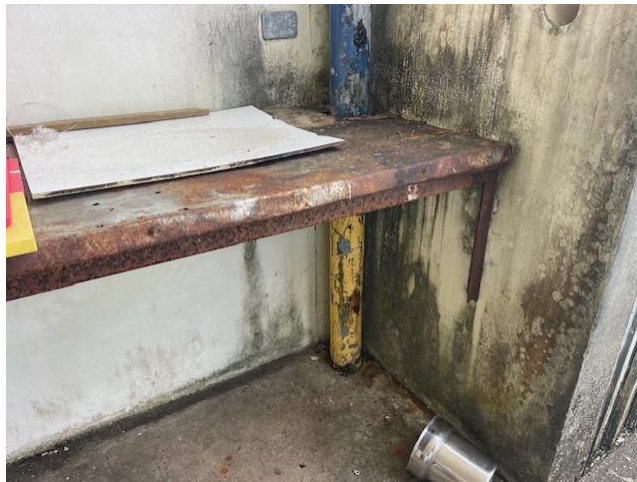
Loading Dock- Yellow Area (5) Five Metal Columns with Lead Based Paint

Global Environmental Services LLC recommends the owner or representative of owner to hire a Company Certified in the Department of Natural and Environmental Resources (DNER) of Puerto Rico to mitigate and dispose positive areas with Lead Based Paint if is going to touch or demolish the Building areas.

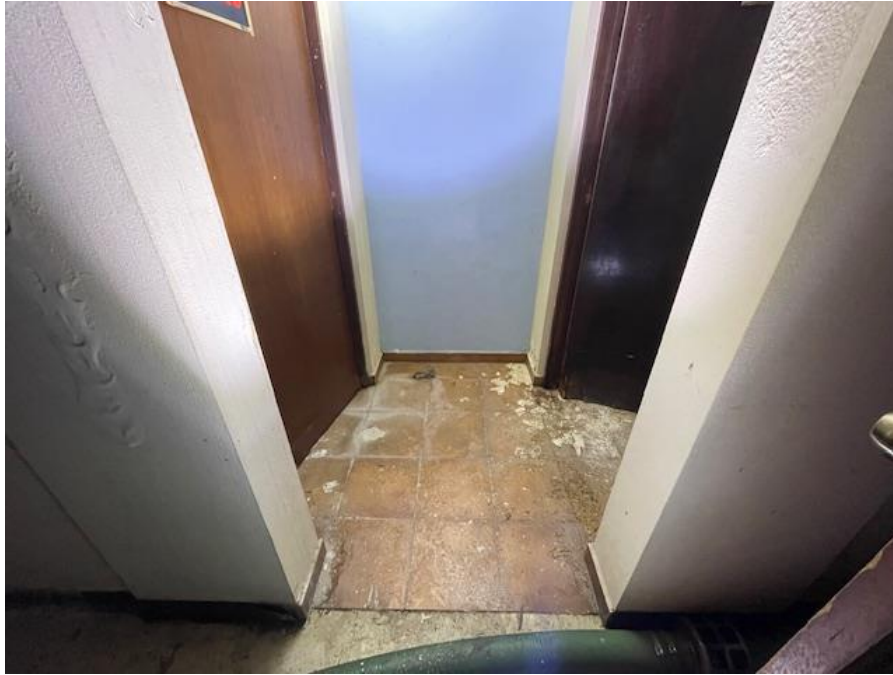
Hallway 5- Ceramic Floor Tiles & Baseboards Tiles with Lead Based Paint

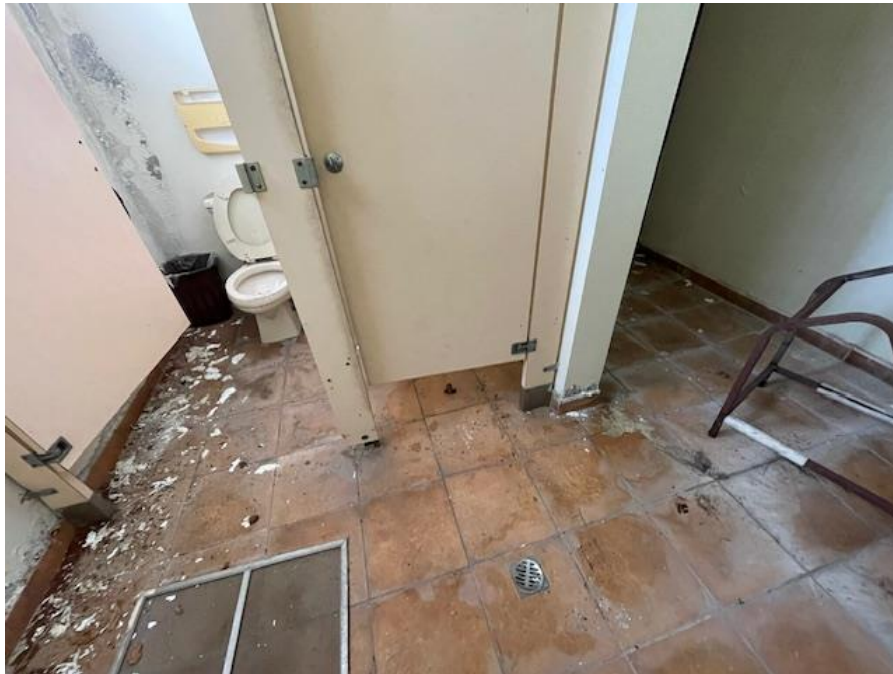
Bathroom 2- Ceramic Floor Tiles & Baseboards Tiles with Lead Based Paint

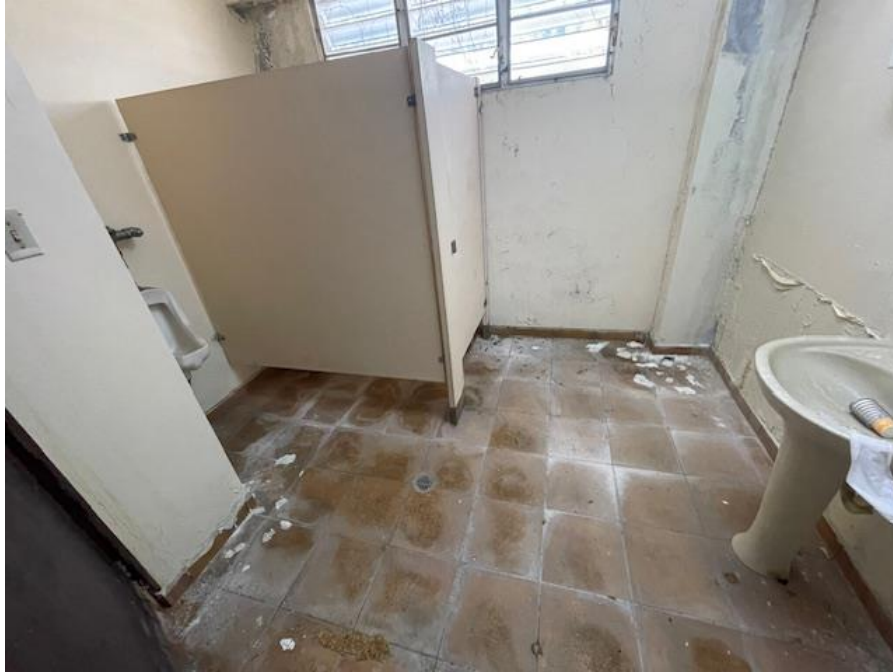
Bathroom 3- Ceramic Floor Tiles & Baseboards Tiles with Lead Based Paint

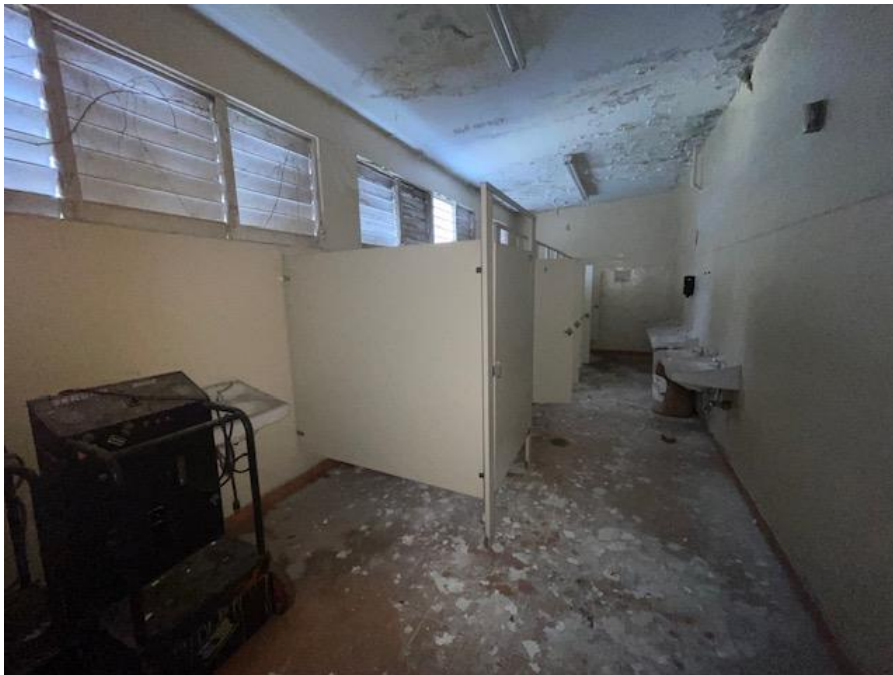
Bathroom 4- Ceramic Floor Tiles & Baseboards Tiles with Lead Based Paint

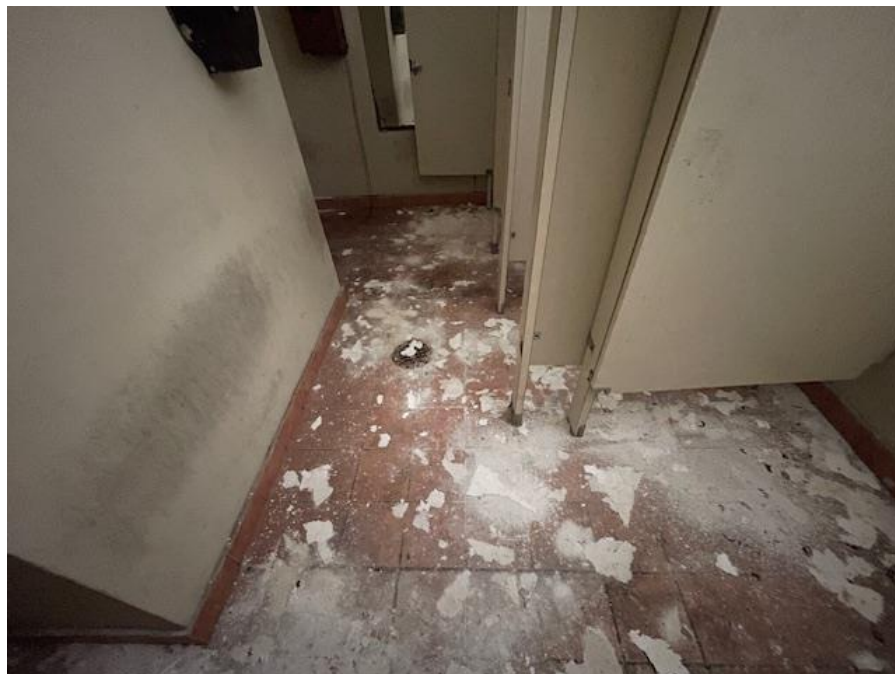
Bathroom 5- Ceramic Floor Tiles & Baseboards Tiles with Lead Based Paint

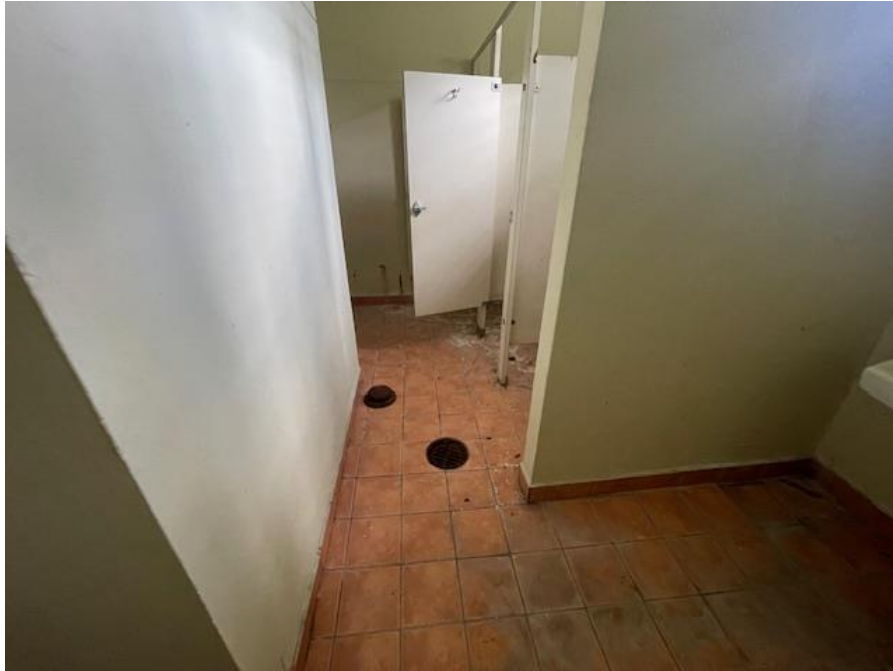
Bathroom 7- Ceramic Floor Tiles & Baseboards Tiles with Lead Based Paint

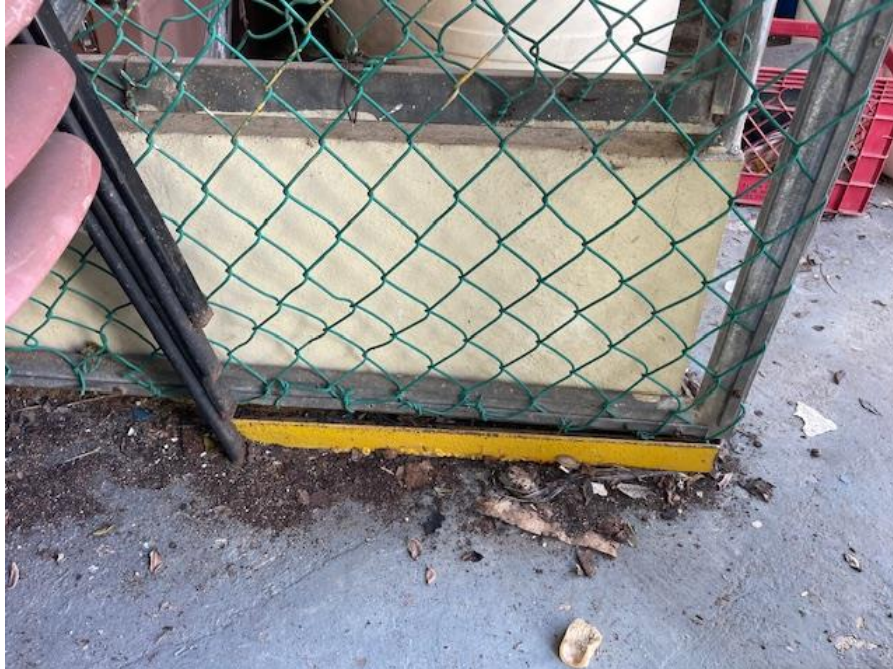
Exterior Room 40- Yellow Metal Base with Lead Based Paint

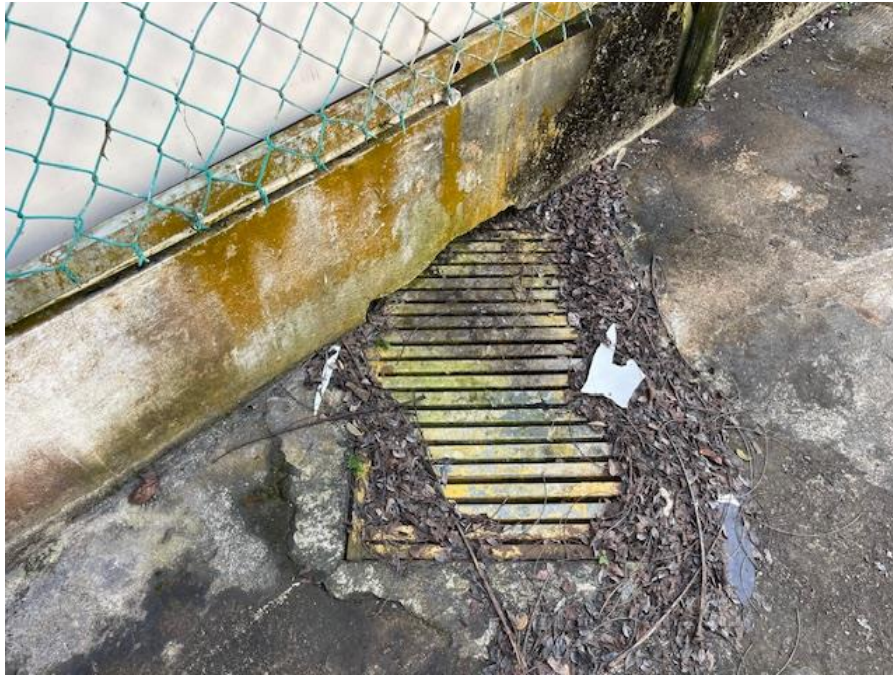
Room 40- Metal Grill with Lead Based Paint

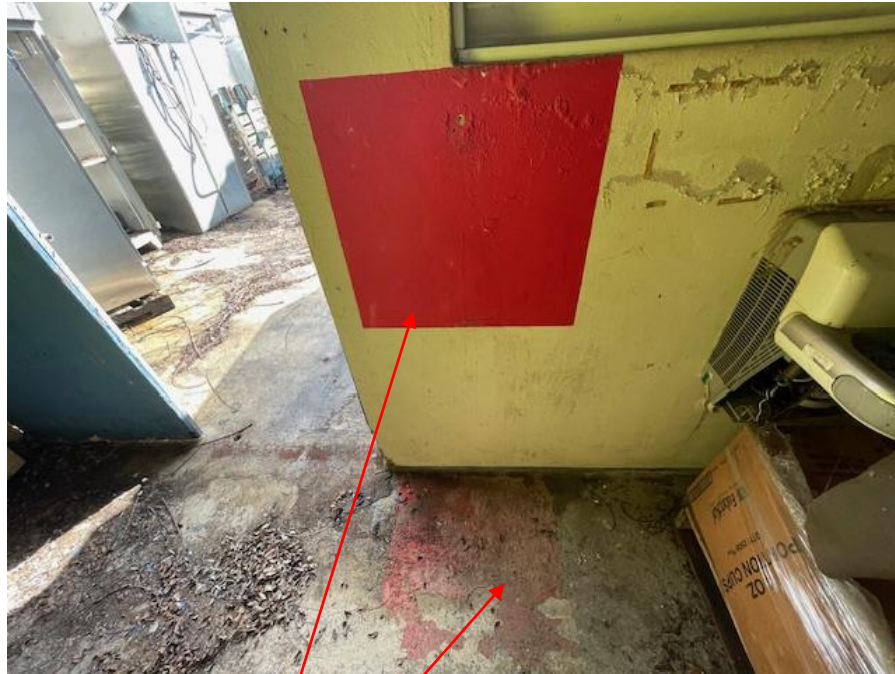
Room 41- Red Concrete Wall & Floor Extincter Area with Lead Based Paint
