POLES CONDITION ASSESSMENT REPORT

PROJECT: HURRICANE MARIA DAMAGES REPAIRS
TO ROOSEVELT ROADS ELECTRICAL
SYSTEM (19-1741)

LOCATION: Roosevelt Roads,
Ceiba, PR

DATE: May 17, 2018

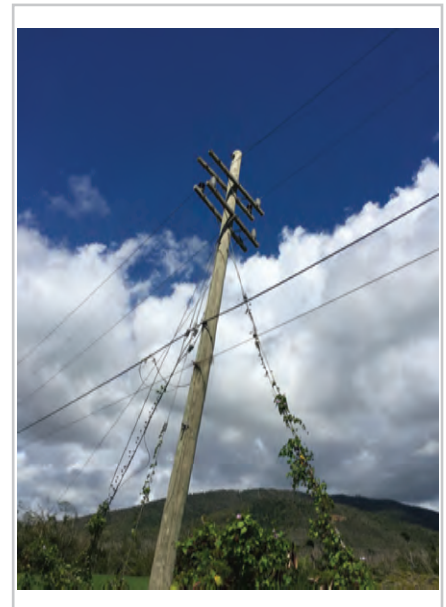
Photo 2: Pole Constr. Standards

Comments: ^{PHASE CONDUCTORS AT GROUND, STANDARD BROKEN} _____
