ADDENDUM NO. 3

LOCAL REDEVELOPMENT AUTHORITY FOR ROOSEVELT ROADS REQUEST FOR PROPOSAL RFP 2025-002 NEW APRODEC & EQUINOTERAPIA FACILITIES

Addendum No. 3, dated January 26, 2026, is hereby issued to distribute FEMA DDD, scopes, cost estimates and photos for NEW APRODEC & EQUINOTERAPIA FACILITIES.

Damage # 152174; Building 1211	Equinoterapia Administration Building
Damage # 152336; Building 2296	APRODEC
Damage # 152365; Building 2371	Equinoterapia Multipurpose Building

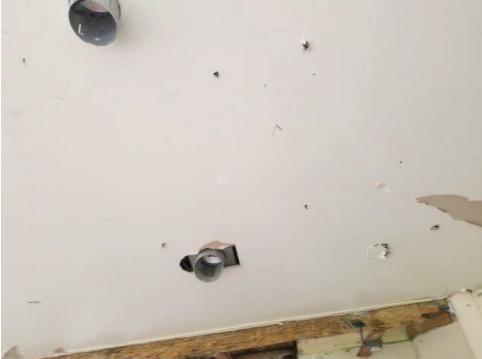
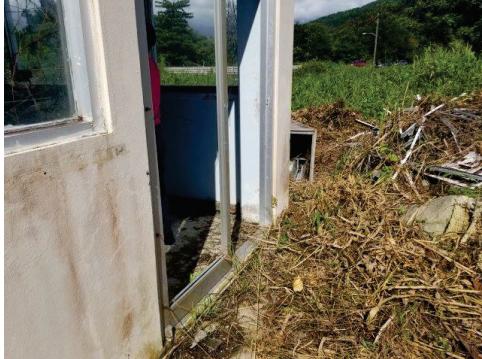
Applicant: PR INDUSTRIAL DEVELOPMENT COMPANY	Site Inspector(s):
FIPS #: 000-U5AJ6-00	Category:
Work Order #: 51136	Damage Inventory #: 152174
Damage Description	Photo# 101118
Building Interior Ceiling. 4,259 SF of 2 FT x 4 FT panel with noise reduction, water repellent membrane, acoustic ceiling tiles, Water intrusion though roof soaked acoustic ceiling tiles and induced black mold growth.	Building Exterior Door. 4 each of 40 IN x 86 IN and aluminum frame entrance to comply with astm C1036, all tempered glass shall comply with ASTM C1048 glass w/alum frame door. High winds and wind driven rain impacted, ripped off and damaged the door.

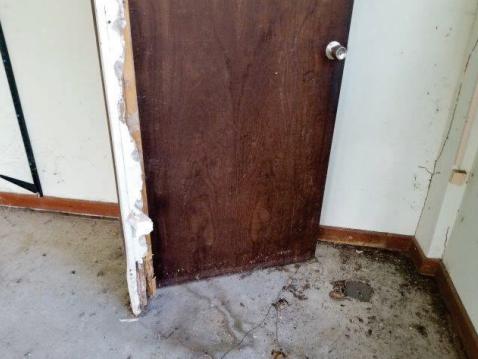
- Building Interior, 2 each of 40 IN x 86 IN solid core, mahogany, flush wood door, smooth (1-3/4" thick') flush wood door, Water intrusion through roof soaked most of door causing damages due to moisture and induced a black mold growing. Photos:(20191101_095557, 20191101_095559, 20191101_095646), 0% work completed.

Damage Description	Photo# 095557
Building Interior Door. 2 each of 40 IN x 86 IN solid core, mahogany, flush wood door, smooth (1-3/4" thick") flush wood door. Water intrusion through roof soaked most of door causing damages due to moisture and induced a black mold growing.

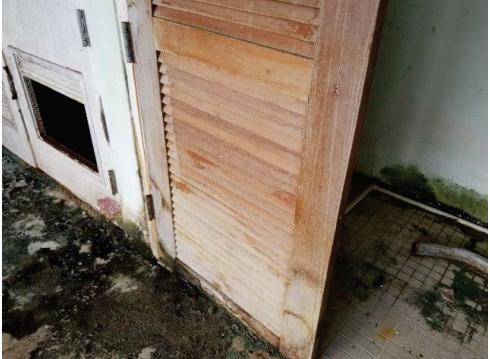
- Building Interior, 1 each of 10 FT x 7 FT solid core, mahogany, flush wood door, smooth (1-3/4" thick') wood door with accordion louver, High winds and wind driven rain impacted, ripped off and damaged the door. Photos:(20191101_095755), 0% work completed.

Applicant: PR INDUSTRIAL DEVELOPMENT COMPANY	Site Inspector(s):
FIPS #: 000-U5AJ6-00	Category:
Work Order #: 51136	Damage Inventory #: 152174
Damage Description	Photo# 095755
Building Interior Door. 1 each of 10 FT x 7 FT solid core, mahogany, flush wood door, smooth (1-3/4"thick") wood door with accordion louver. High and wind driven rain impacted, ripped off and damaged the door.	Damage Description

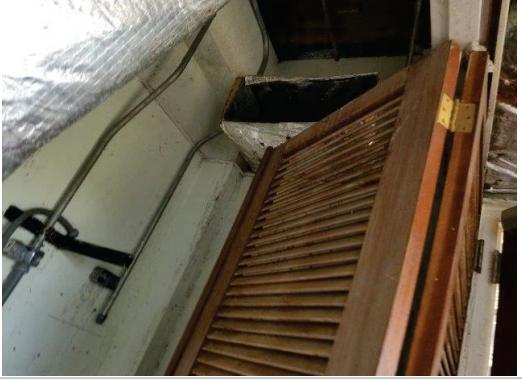
Photo# 100140
Building Interior Door. 1 each of 13 FT x 7 FT solid core, mahogany, flush wood door, smooth (1-3/4"thick") wood accordion door with louver. High winds and wind driven rain impacted, ripped off and damaged the door.	Damage Description

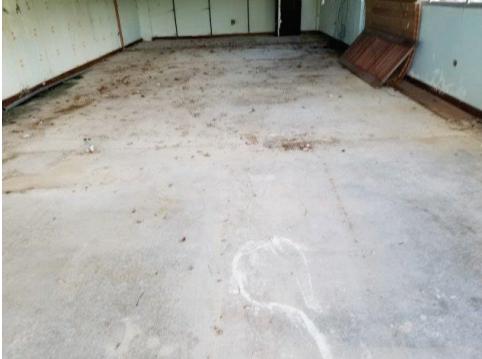
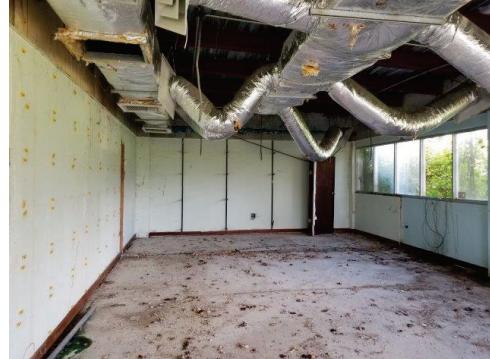
- Building Interior, 4,947 SF of 12 IN x 12 IN impervious tile and comply with abrasion resistance – ASTM C1027 ceramic tile to be cleaned, Water intrusion through roof soaked most of ceramic tiles then the floor was stained due to moisture and induced a black mold growing. Photos:(20191101_095518, 20191101_095529, 20191101_095624), 0% work completed.

Applicant: PR INDUSTRIAL DEVELOPMENT COMPANY	Site Inspector(s):
FIPS #: 000-U5AJ6-00	Category:
Work Order #: 51136	Damage Inventory #: 152174
Damage Description	Photo# 095518
Building Interior Floor. 4,947 SF of 12 IN x 12 IN impervious tile and comply with abrasion resistance- ASTM C1027 ceramic tile to be cleaned. Water intrusion through roof soaked most of ceramic tiles.	Damage Description

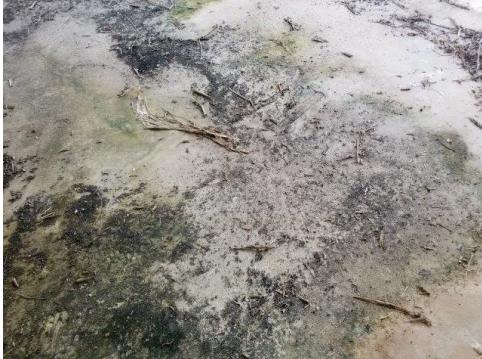
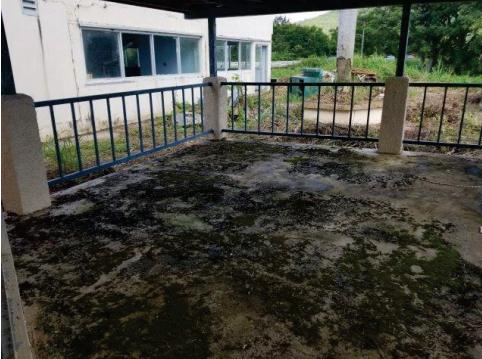
Applicant: PR INDUSTRIAL DEVELOPMENT COMPANY	Site Inspector(s):
FIPS #: 000-U5AJ6-00	Category:
Work Order #: 51136	Damage Inventory #: 152174
Damage Description	Photo# 101138
Building Interior Floor. 6,001 SF of mold remediation floor treatment. Strong winds and wind driven rain detached roof, water intruded through roof the Fungus growth.	Building Interior Floor. 6,001 SF of mold remediation floor treatment. Strong winds and wind driven rain detached roof, water intruded through roof the Fungus growth.

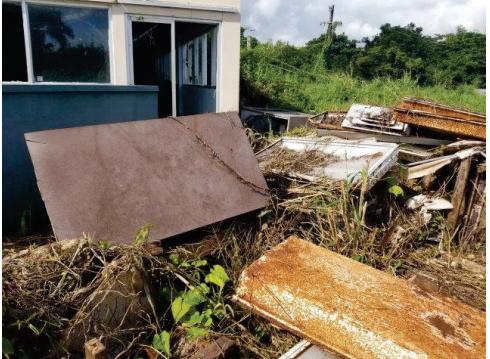
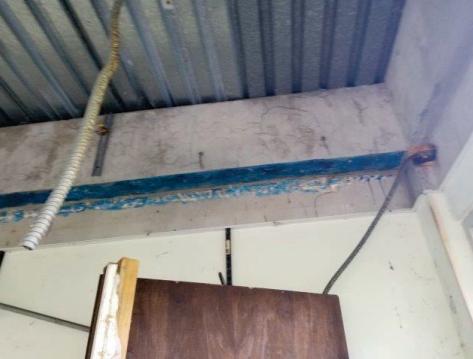
- Building Interior, 60 each of 2 FT X 4 FT T12, medium bi-pi (G13), 1450 lumens, 6500k bulb color temp fluorescent, c.w. lamps, four 40 watts, Water intrusion through roof soaked an acoustic ceiling Tiles and induced black mold growing damaged frame and lamps. Photos:(20191101_094819, 20191101_094822), 0% work completed.

Applicant: PR INDUSTRIAL DEVELOPMENT COMPANY	Site Inspector(s):
FIPS #: 000-U5AJ6-00	Category:
Work Order #: 51136	Damage Inventory #: 152174
	Photo# 094822
Building Interior Light Fixture. 60 each of 2 FT x 4 FT T12, medium bi-pin (G13), 1450 lumen's, 6500k bulb color temp fluorescent, cw lamps, flour 40 watts, Water intrusion through roof soaked and acoustic ceiling tiles and induced black mold growing damaged frame and lamps.	Damage Description

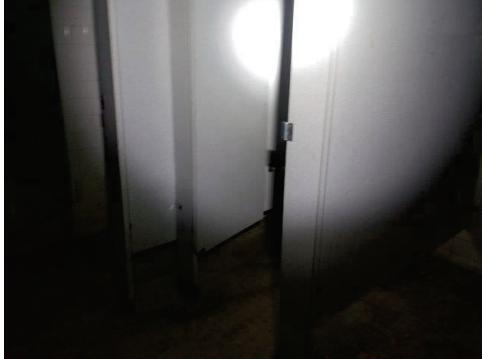
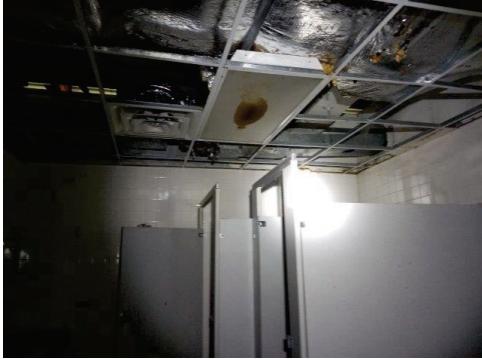
- Building Interior, 100 SF of solid plastic bathroom partition, water intrusion through roof soaked most of bathroom partitions then the partitions was damaged due to moisture and induced a black mold growing. Photos:(20191101_100515, 20191101_100505, 20191101_100454), 0% work completed.

Applicant: PR INDUSTRIAL DEVELOPMENT COMPANY	Site Inspector(s):
FIPS #: 000-U5AJ6-00	Category:
Work Order #: 51136	Damage Inventory #: 152174
Damage Description	Photo# 100515
Building Interior Restroom. 100 SF of solid plastic bathroom partition, water intrusion through roof soaked most of bathroom partitions then the partitions was damaged due to moisture and induced a black mold growing.	Damage Description

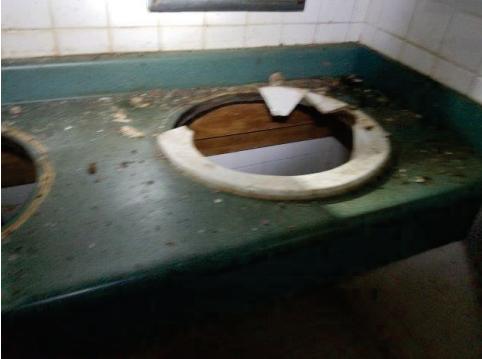
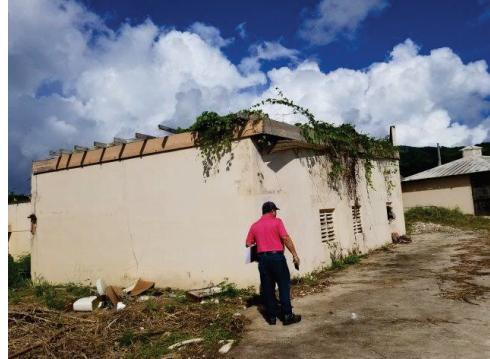
Applicant: PR INDUSTRIAL DEVELOPMENT COMPANY	Site Inspector(s):
FIPS #: 000-U5AJ6-00	Category:
Work Order #: 51136	Damage Inventory #: 152174
Damage Description	Photo# 100531
Building Interior Restroom. 6 each of bowl sizes 15" (381mm) wide, 10" (254mm) front-to-back, 6-3/4" (171mm) deep ADA compliant, self-draining deck area with contoured back and side splash shields, front overflow bathroom lavatory.	Building Exterior Roof. 4,922 SF of thickness: 0.88 to 2mm, cr steel as per is: 513 d-quality, bare, primer coat, galvanized, pre- painted metal shed. Wind, airborne debris and wind driven rain caused panels to collapse and damaged beyond repair.

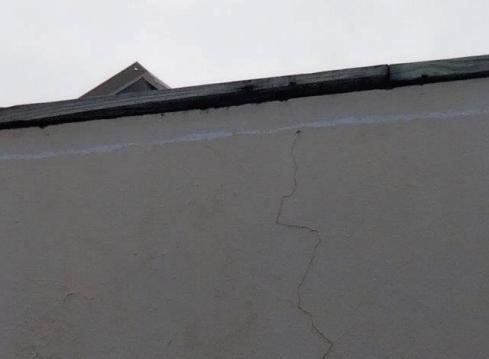
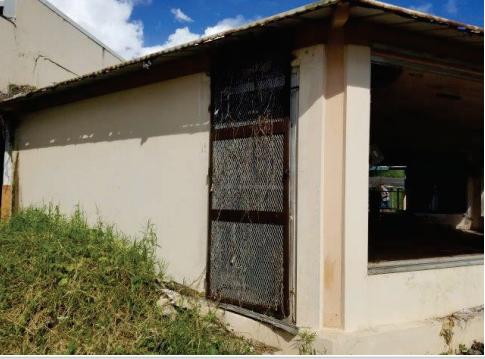
Applicant: PR INDUSTRIAL DEVELOPMENT COMPANY	Site Inspector(s):
FIPS #: 000-U5AJ6-00	Category:
Work Order #: 51136	Damage Inventory #: 152174
Damage Description	Photo# 101329
Building Exterior Roof. Aluminum, Ga. 0.032 metal flashing, 179 FT long, High wind and wind driven rain detached metal flashing from edges of roof.	Building Exterior Roof. 484 SF of section 07510 ceramic roof tile. Strong wind and debris in the air lifted and detached the part of roof, this caused the water to enter through the roof, the soaked the ventilation.

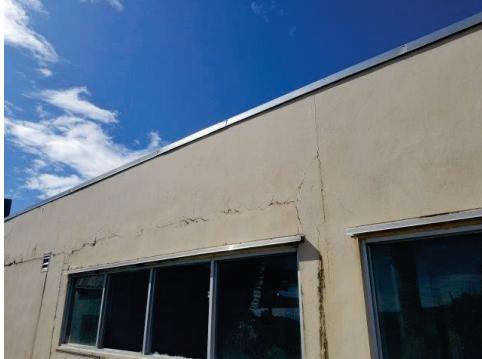
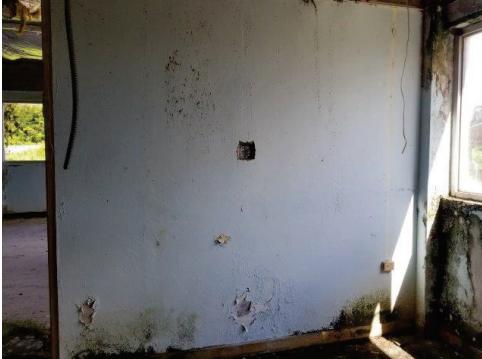
Applicant: PR INDUSTRIAL DEVELOPMENT COMPANY	Site Inspector(s):
FIPS #: 000-U5AJ6-00	Category:
Work Order #: 51136	Damage Inventory #: 152174
Damage Description	Photo# 095450
uilding Exterior Wall. 11,780 SF of water based exterior paint first coat exterior paintwork, high wind and wind driven rain damaged and removed interior paint layers.	Building Exterior Wall. 24,830 SF of clean wall cleaning. High wind and wind driven rain caused a water intrusion through roof damaged soiled the exterior wall.

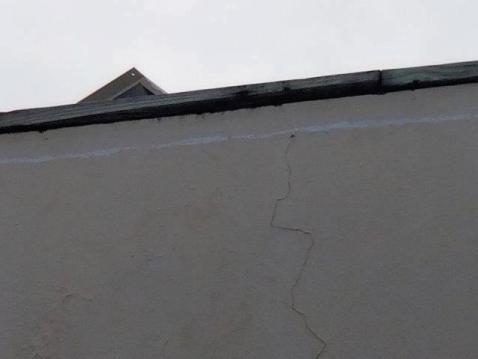
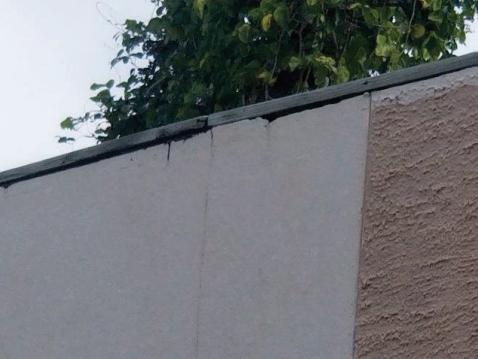
Applicant: PR INDUSTRIAL DEVELOPMENT COMPANY	Site Inspector(s):
FIPS #: 000-U5AJ6-00	Category:
Work Order #: 51136	Damage Inventory #: 152174
	Photo# 101329
Building Exterior Wall. 138 SF of 0.25 IN thickness cement plastering, high wind and wind driven rain detached cement plaster layer from wall.	Building Exterior Wall. 138 SF of 0.25 IN thickness cement plastering, high wind and wind driven rain detached cement plaster layer from wall.

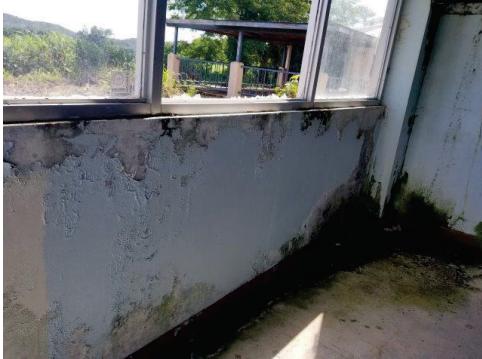
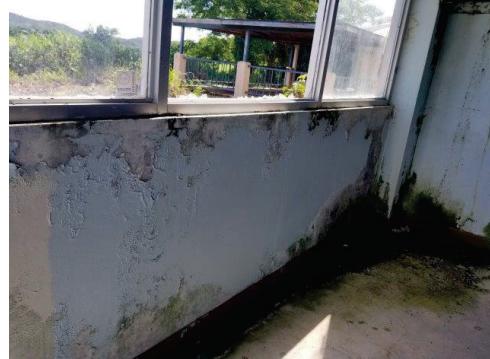
Applicant: PR INDUSTRIAL DEVELOPMENT COMPANY	Site Inspector(s):
FIPS #: 000-U5AJ6-00	Category:
Work Order #: 51136	Damage Inventory #: 152174
Damage Description	Photo# 095639
Building Interior Wall. 5,320 SF of wall black mold remediation, Water intrusion through roof soaked and acoustic ceiling tiles and induced black mold growing damaged most of wall.	Building Interior Wall. 8,040 SF of water based interior paint first coat interior paintwork, high wind and wind driven rain damaged and removed interior paint layers.

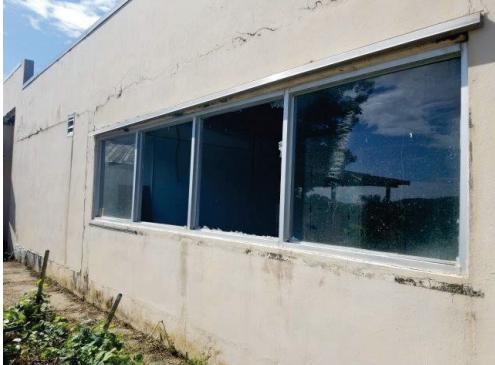
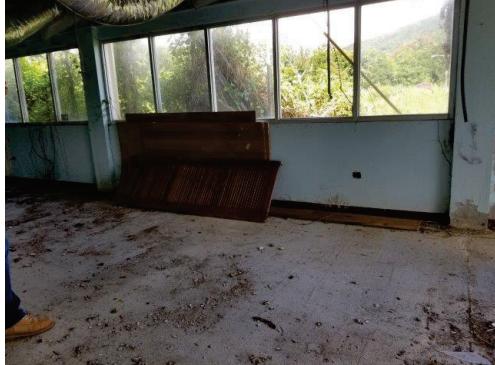
Applicant: PR INDUSTRIAL DEVELOPMENT COMPANY	Site Inspector(s):
FIPS #: 000-U5AJ6-00	Category:
Work Order #: 51136	Damage Inventory #: 152174
Damage Description	Photo# 095455
Building Exterior Window. 6 each of 4 FT x 4 FT insulated glass to have edge tech warm edge spacer as secondary seal with butyl primary seal, all glass to be glazed with double sided adhesive glazing tape on exterior, retained on interior with snap in glazed bead. Glass thickness to be 1/8 double strength feet fixed glass up to 8 square feet fixed glass aluminum window, High winds and wind driven rain impacted and damaged window glasses lattices.	Damage Description

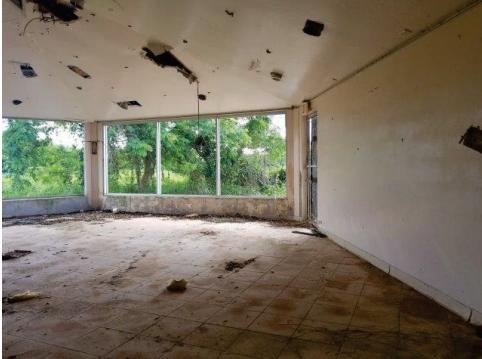
Applicant: PR INDUSTRIAL DEVELOPMENT COMPANY	Site Inspector(s):		
FIPS #: 000-U5AJ6-00	Category:	Inspection Date: GPS: 18.22256 -65.67021	
Work Order #: 51136	Damage Inventory #: 152174	Facility name: Bld. 1211 Golf Club House	
Damage Description Building Exterior Window. 3 each of 16 FT x 16 FT insulated glass to have edge tech warm edge spacer as secondary seal with butyl primary seal, all glass to be glazed with double sided adhesive glazing tape on exterior, retained on interior with snap in glazing bead. High winds and wind driven rain impacted and damaged window glasses lattices.	Photo# 101054	Damage Description	Photo#

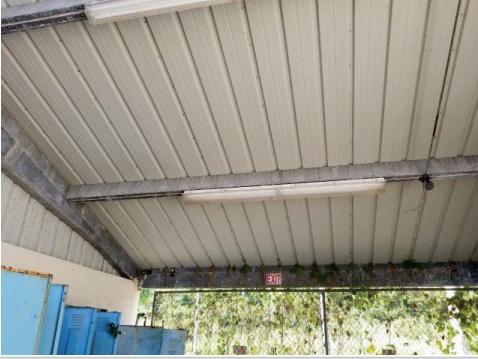
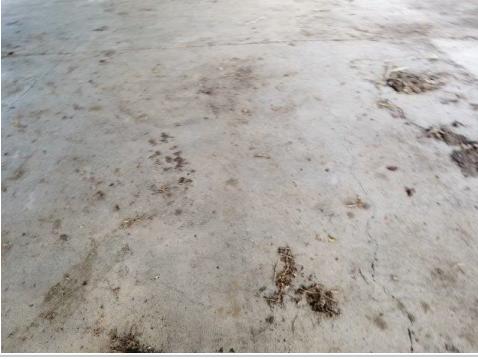
Applicant: PR INDUSTRIAL DEVELOPMENT COMPANY	Site Inspector(s):
FIPS #: 000-U5AJ6-00	Category: E
Work Order #: 51136	Damage Inventory #: 152365
Damage Description	Photo# 093637
Building Exterior Ceiling , 12 each of 1 FT x 8 FT An ANSI ballast for standard 40-watt F40T12 lamps requires a ballast factor of 0.95. the same ballast has a ballast factor of 0.87 for 34-watt energy saving F40T12 lamps.	Building Interior Floor. 4,500 SF of Apply bleach to the stain (using a spray bottle is the most efficient way to apply bleach) Let sit 20 minutes. floated cement to be clean Water intrusion through roof soaked most of floated cement floor was stained due to moisture and induced a black mold growing.

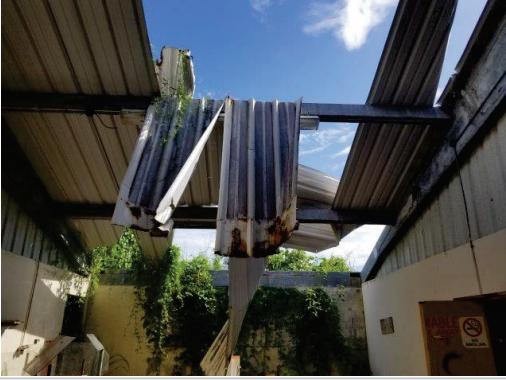
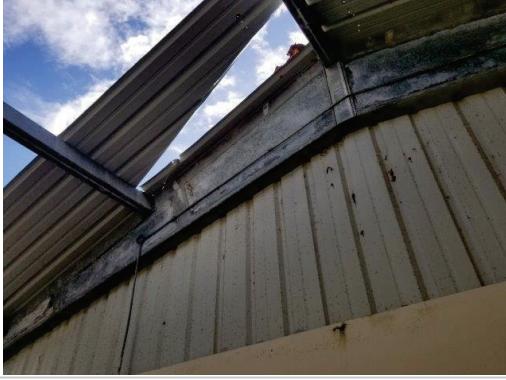
Damage Description	Photo# 093645
Building Exterior Roof. 00 SF of Thickness, 0.80 to 2mm, CR Steel as per IS: 513 D-Quality, Bare, Primer coated, Galvanized, Pre- painted metal deck (45 FT x 20 FT). The strong wind and debris in the air lifted and separated the roof which caused the water to enter through the roof, so that the structure collapsed.	Building Exterior Roof. 00 SF of Thickness, 0.80 to 2mm, CR Steel as per IS: 513 D-Quality, Bare, Primer coated, Galvanized, Pre- painted metal deck (45 FT x 20 FT). The strong wind and debris in the air lifted and separated the roof which caused the water to enter through the roof, so that the structure collapsed.

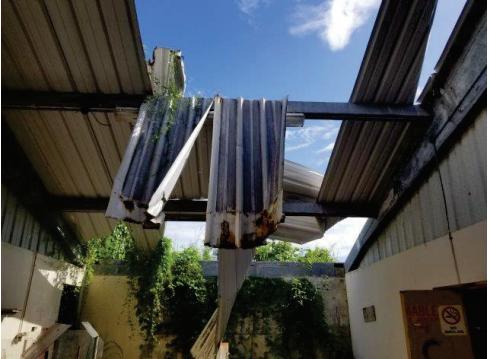
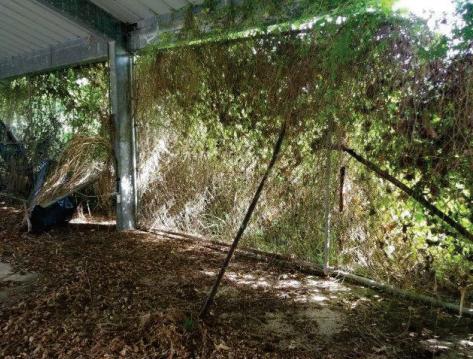
Applicant: PR INDUSTRIAL DEVELOPMENT COMPANY	Site Inspector(s):
FIPS #: 000-U5AJ6-00	Category: E
Work Order #: 51136	Damage Inventory #: 152365
Damage Description	Photo# 093645
Building Exterior Roof. 00 SF of Thickness, 0.80 to 2mm, CR Steel as per IS: 513 D-Quality, Bare, Primer coated, Galvanized, Pre- painted metal deck (45 FT x 20 FT). The strong wind and debris in the air lifted and separated the roof which caused the water to enter through the roof, so that the structure collapsed.	Building Exterior Site. Chain link fence, Glav. Ga. No. 9, Post - 2.5 inch diam x 6 feet height galv, 3-strands Barbed Wire (4-point) Perimeter building. 520 LF long. High wind and airborne debris dislodged and detached fence.

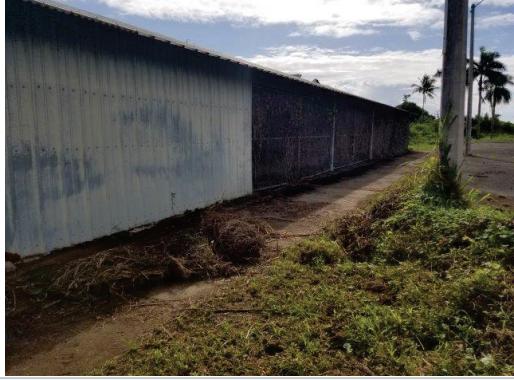
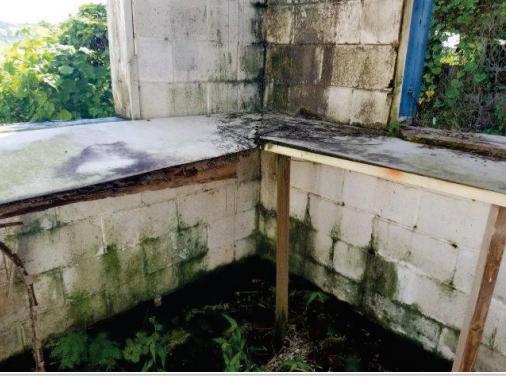
Damage Description	Photo# 093331
Building Exterior Wall. 960 SF of Water based exterior Paint First Coat exterior paintwork, High wind and wind driven rain caused intrusion through roof damaged exterior paint and created a black mold in walls.	Building Interior Window. 3 each of Jalousie Utility Louver Aluminum Screen Window White, 100% weather tripped , finished aluminum frames. 3 FT x 5 FT jalousie aluminum windows, Strong winds and wind driven rain impacted adventitiously most of windows, then broke various class lattices.

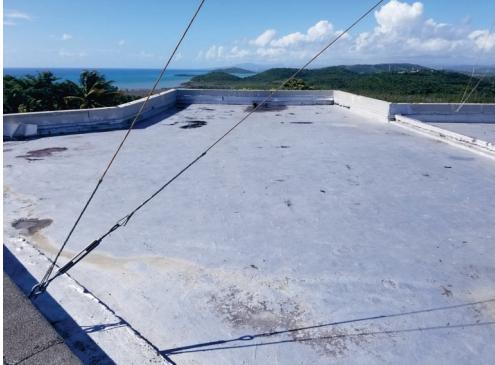
Applicant: Local Redevelopment Authority for Roosevelt Roads	Site Inspector(s): Francisco Martir
FIPS #: 000-U5AJ6-00	Category: E
Work Order #: 51135	Damage Inventory #: 152336
Damage Description	Photo# 100334
Building Exterior Roof. 3,857 SF of Section 07510 - Built- Up Bituminous Roofing, Section 07540 - Thermoplastic Membrane Roofing roof and Deck Insulation.	Building Exterior Roof. 3,857 SF of Section 07510 - Built- Up Bituminous Roofing, Section 07540 - Thermoplastic Membrane Roofing roof and Deck Insulation.

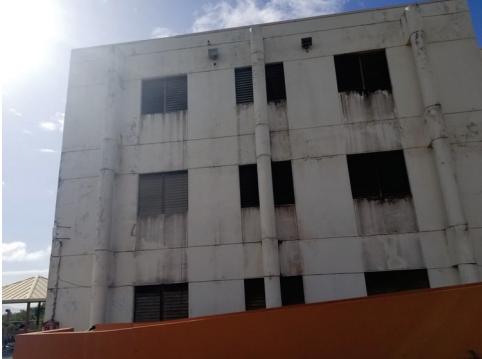
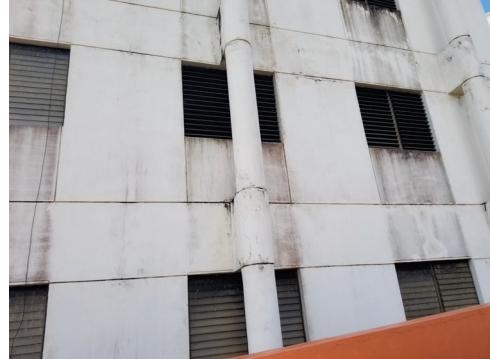
Applicant: Local Redevelopment Authority for Roosevelt Roads	Site Inspector(s): Francisco Martir
FIPS #: 000-U5AJ6-00	Category: E
Work Order #: 51135	Damage Inventory #: 152336
Damage Description	Photo# 092529
Building Exterior Wall. 21,680 SF of water based exterior paint first coat exterior paintwork, High wind and wind driven rain damaged and removed interior paint layers.	Building Exterior Wall. 21,680 SF of water based exterior paint first coat exterior paintwork, High wind and wind driven rain damaged and removed interior paint layers.

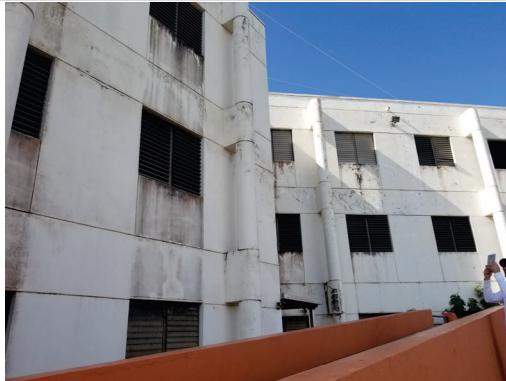
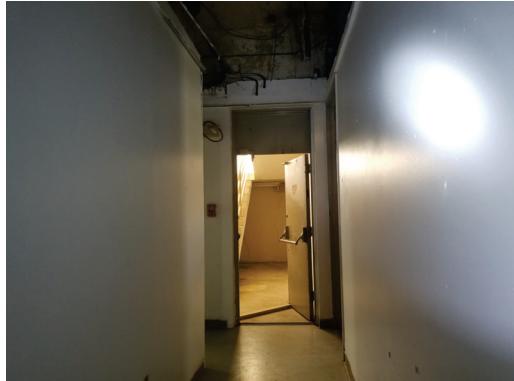
Damage Description:	Photo# 092550
Building Exterior Wall. 21,680 SF of water based exterior paint first coat exterior paintwork, High wind and wind driven rain damaged and removed interior paint layers.	Building Interior Wall. 3,240 SF of Impervious tile and comply with abrasion resistance - ASTM C1027 ceramic tile.

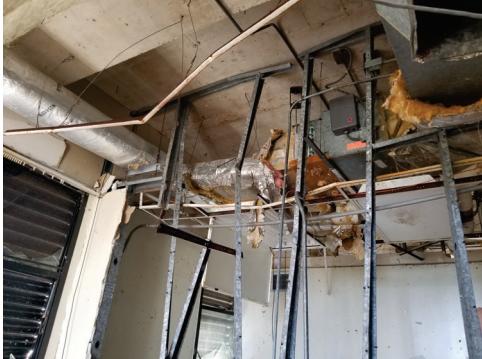
Applicant: Local Redevelopment Authority for Roosevelt Roads	Site Inspector(s): Francisco Martir
FIPS #: 000-U5AJ6-00	Category: E
Work Order #: 51135	Damage Inventory #: 152336
Damage Description	Photo# 102048
Building Interior Wall 1,450 SF of 1/2 IN thick as a standard product, Vinyl covered Durasan panels comply with ASTM Specification C1396 and Federal Specification SS-L-30D. Approved sag resistance equivalent to 5/8 IN Type x wallboard. Surface burning ASTM E 84, Fiberglass Insulation with Galvanized Stud @ 16 IN gypsum Board (Colapsed),

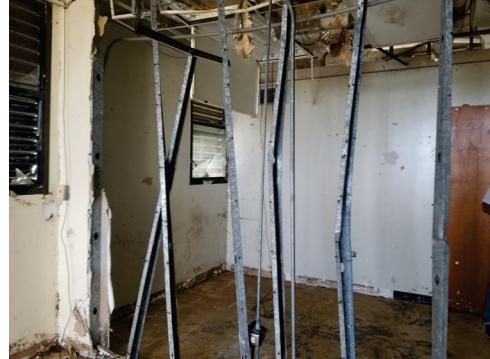
Damage Description	Photo# 102051
Building Interior Wall 1,450 SF of 1/2 IN thick as a standard product, Vinyl covered Durasan panels comply with ASTM Specification C1396 and Federal Specification SS-L-30D. Approved sag resistance equivalent to 5/8 IN Type x wallboard. Surface burning ASTM E 84, Fiberglass Insulation with Galvanized Stud @ 16 IN gypsum Board (Colapsed),

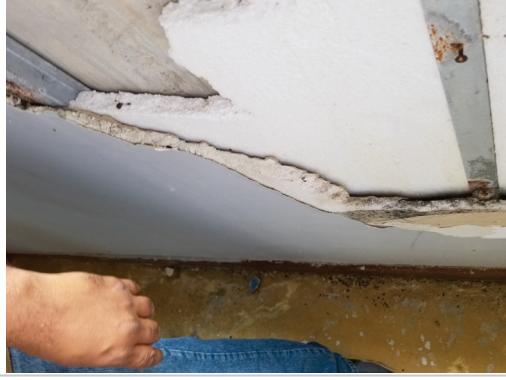
Damage Description:	Photo# 104628
Building Interior Wall 1,450 SF of 1/2 IN thick as a standard product, Vinyl covered Durasan panels comply with ASTM Specification C1396 and Federal Specification SS-L-30D. Approved sag resistance equivalent to 5/8 IN Type x wallboard. Surface burning ASTM E 84, Fiberglass Insulation with Galvanized Stud @ 16 IN gypsum Board (Colapsed),

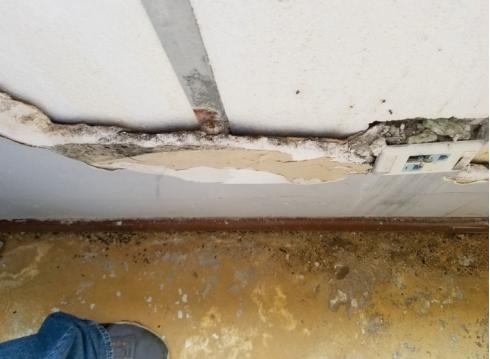
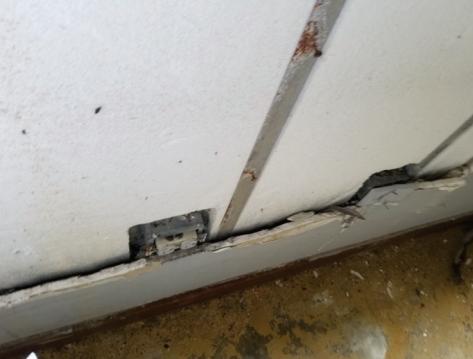
Applicant: Local Redevelopment Authority for Roosevelt Roads	Site Inspector(s): Francisco Martir
FIPS #: 000-U5AJ6-00	Category: E
Work Order #: 51135	Damage Inventory #: 152336
Damage Description	Photo# 104627
Building Interior Wall. 45,750 SF of black mold remediation gypsum board.	Building Interior Wall. 45,750 SF of black mold remediation gypsum board.

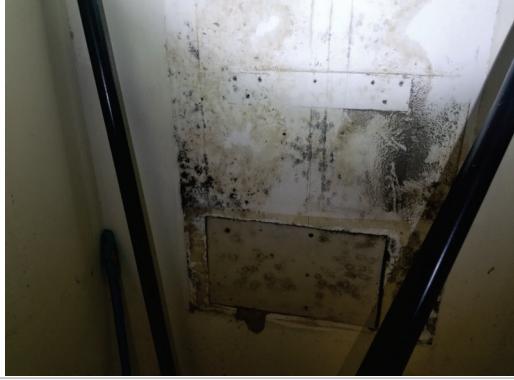
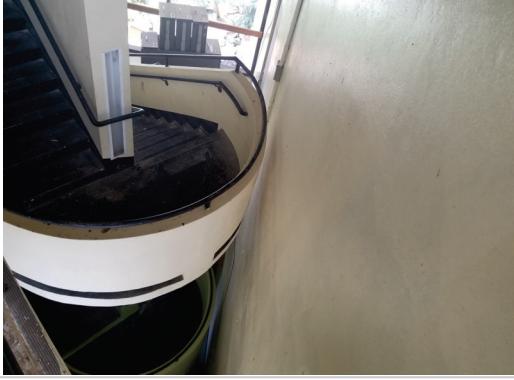
Damage Description:	Photo# 114114
Building Interior Wall. 45,750 SF of black mold remediation gypsum board.	Building Interior Wall. 58, 512 SF of Water based interior paint first coat interior paintwork.

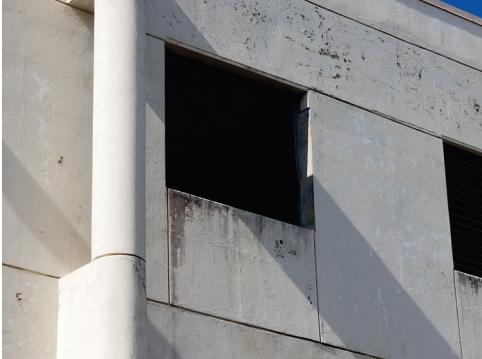
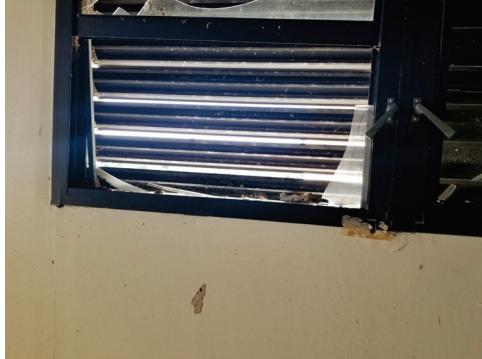
Applicant: Local Redevelopment Authority for Roosevelt Roads	Site Inspector(s): Francisco Martir
FIPS #: 000-U5AJ6-00	Category: E
Work Order #: 51135	Damage Inventory #: 152336
Damage Description	Photo# 093549
Building Exterior Window. 33 each of 3 FT x 5 FT AAMA 2604 Dual seal single hung window, High winds and wind driven rain impacted the windows and ripped the lattice off, therefore damaged the door.	Building Exterior Window. 33 each of 3 FT x 5 FT AAMA 2604 Dual seal single hung window, High winds and wind driven rain impacted the windows and ripped the lattice off, therefore damaged the door.

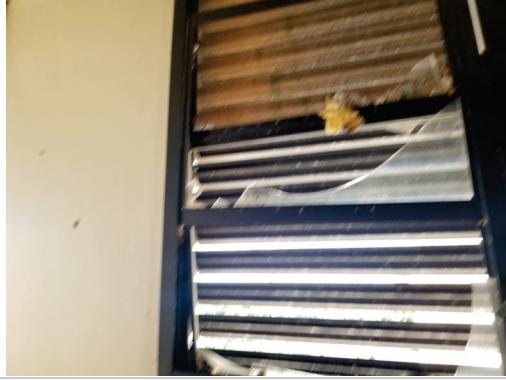
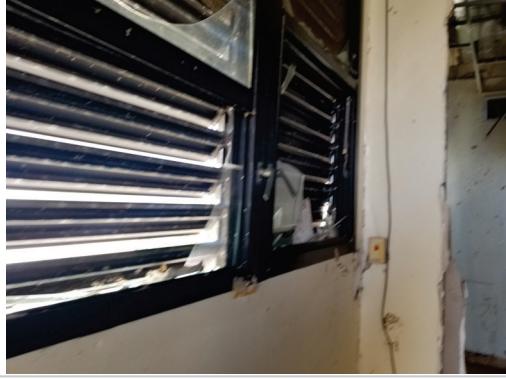
Damage Description:	Photo 102109
Building Exterior Window. 33 each of 3 FT x 5 FT AAMA 2604 Dual seal single hung window, High winds and wind driven rain impacted the windows and ripped the lattice off, therefore damaged the door.	Building Exterior Window. 33 each of 3 FT x 5 FT AAMA 2604 Dual seal single hung window, High winds and wind driven rain impacted the windows and ripped the lattice off, therefore damaged the door.

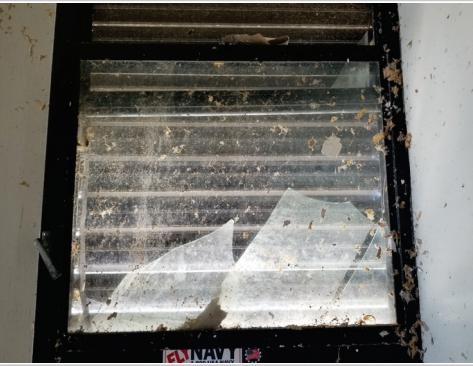
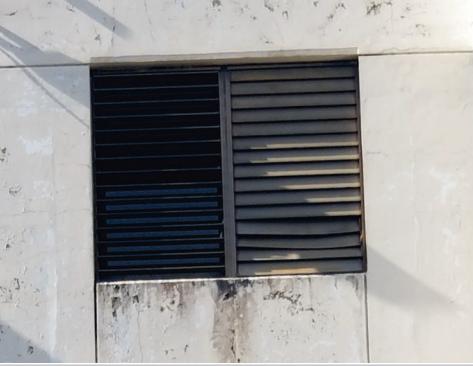
Applicant: Local Redevelopment Authority for Roosevelt Roads	Site Inspector(s): Francisco Martin	
FIPS #: 000-U5AJ6-00	Category: E	Inspection Date: 11/08/19 GPS: 18.21717 -65.65569
Work Order #: 51135	Damage Inventory #: 152336	Facility name: Bld. 2296 Adm. Bld. Afwtf
Damage Description	Photo# 102230	Damage Description
Building Exterior Window. 33 each of 3 FT x 5 FT AAMA 2604 Dual seal single hung window, High winds and wind driven rain impacted the windows and ripped the lattice off, therefore damaged the door.	Building Exterior Windows. 81 each of 6 FT W X 5 FT Jalousie Utility Louver Aluminum Window - White, 100% weather-stripped, finished aluminum frames jalousie aluminum windows to replaced, Strong winds and wind driven rain impacted adversatively most of windows, damaging lattices beyond repair.	Photo# 092322

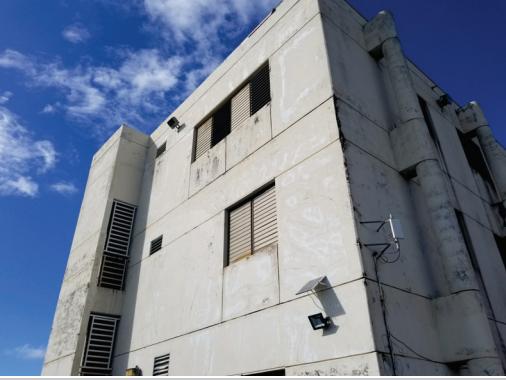
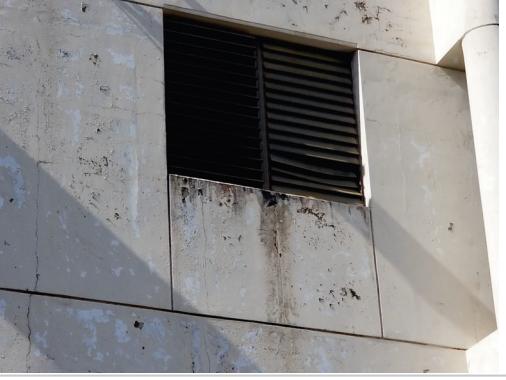
Damage Description:	Photo# 092637	Damage Description
Building Exterior Windows. 81 each of 6 FT W X 5 FT Jalousie Utility Louver Aluminum Window - White, 100% weather-stripped, finished aluminum frames jalousie aluminum windows to replaced, Strong winds and wind driven rain impacted adversatively most of windows, damaging lattices beyond repair.	Building Exterior Windows. 81 each of 6 FT W X 5 FT Jalousie Utility Louver Aluminum Window - White, 100% weather-stripped, finished aluminum frames jalousie aluminum windows to replaced, Strong winds and wind driven rain impacted adversatively most of windows, damaging lattices beyond repair.	Photo# 093551

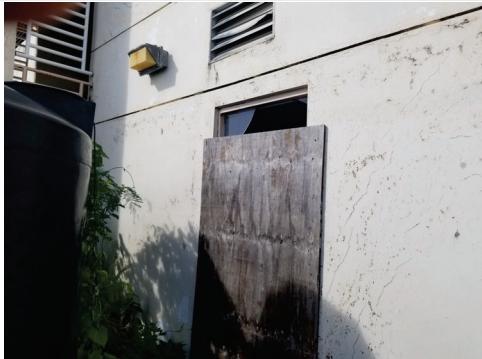
Applicant: Local Redevelopment Authority for Roosevelt Roads	Site Inspector(s): Francisco Martir
FIPS #: 000-U5AJ6-00	Category: E
Work Order #: 51135	Damage Inventory #: 152336
Damage Description	Photo# 092740
Building Exterior Windows. 2 each of 3 FT x 8 FT Insulated glass to have Edgetech warm edge spacer as secondary seal with Butyl primary seal. All glass is glazed with double sided adhesive glazing tape on exterior, retained on interior with snap in glazing bead. Glass thickness to be 1/8 double strength up to 18 square feet fix glass aluminum Window.

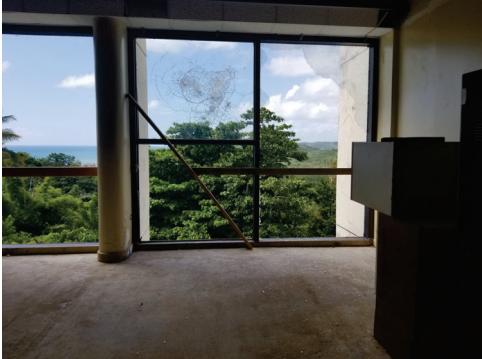
Damage Description	Photo# 103901
Building Exterior Windows. 3 each of 12 FT x 9 FT Insulated glass to have Edgetech warm edge spacer as secondary seal with Butyl primary seal. All glass to be glazed with double sided adhesive glazing tape on exterior, retained on interior with snap in glazing bead. Glass thickness to be 1/8 IN double strength up to 18 SF fix glass aluminum Window

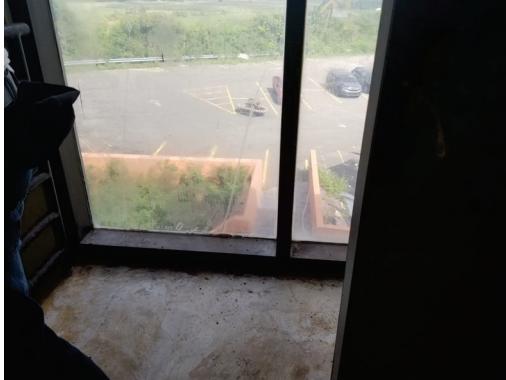
Damage Description:	Photo# 103623
Building Exterior Window. , 2 each of 8 FT x 9 FT Insulated glass to have Edgetech warm edge spacer as secondary seal with Butyl primary seal. All glass to be glazed with double sided adhesive glazing tape on exterior, retained on interior with snap in glazing bead. Glass thickness to be 1/8 double strength up to 18 square feet Fix Glass Aluminum Window.

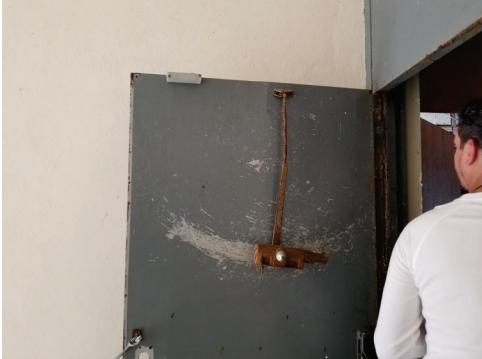
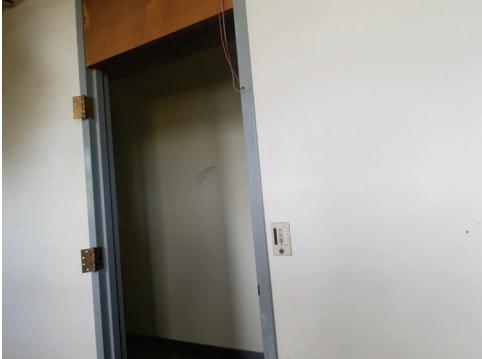
Applicant: Local Redevelopment Authority for Roosevelt Roads	Site Inspector(s): Francisco Martir
FIPS #: 000-U5AJ6-00	Category: E
Work Order #: 51135	Damage Inventory #: 152336
	Photo# 102036
Building Exterior Door. 1 each of 40 IN x 86 IN Comply with ANSI/UL 10B, ANSI/UL 10C, ANSI/UL 1784 Steel hollow to repair.	Damage Description Building Exterior Door. 1 each of 40 IN x 86 IN Comply with ANSI/UL 10B, ANSI/UL 10C, ANSI/UL 1784 Steel hollow to repair Photo# 111537

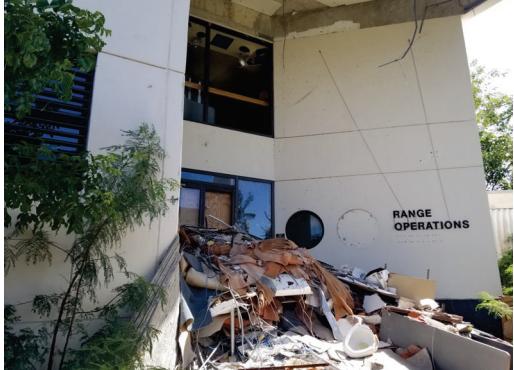
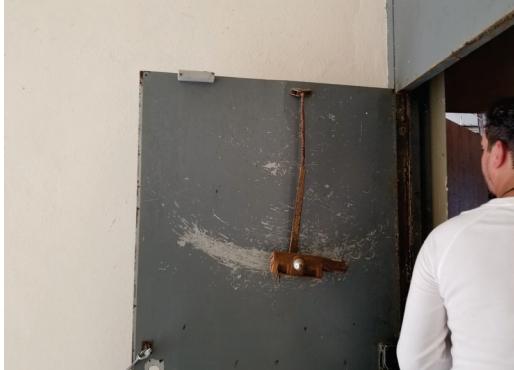
Damage Description: Building Exterior Door. 1 each of 76 IN x 86 IN All-Glass door comply with ASTM C1036, Fire Heavy duty 18-gauge aluminum. All tempered glass shall comply with ASTM C1048 glass w/alum frame door.	Photo# 095031
	Damage Description Building Interior Door. 2 each of 40 IN x 86 IN Comply with ANSI/UL 10C, ANSI/UL 1748 Steel hollow to replace. Photo# 102036

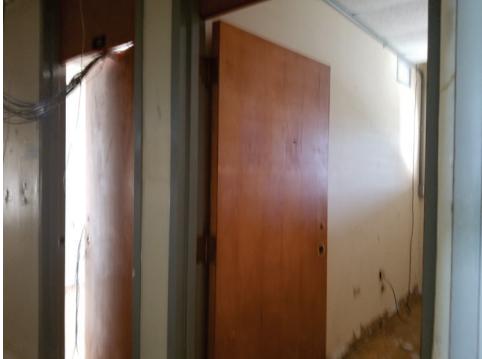
Applicant: Local Redevelopment Authority for Roosevelt Roads	Site Inspector(s): Francisco Martir
FIPS #: 000-U5AJ6-00	Category: E
Work Order #: 51135	Damage Inventory #: 152336
Damage Description	Photo# 103755
Building Interior Door. 27 each of 40 IN x 86 IN hollow Core, mahogany, Flush Wood Door, Smooth (1-3/4 IN Thick) wood door to repair.	Damage Description

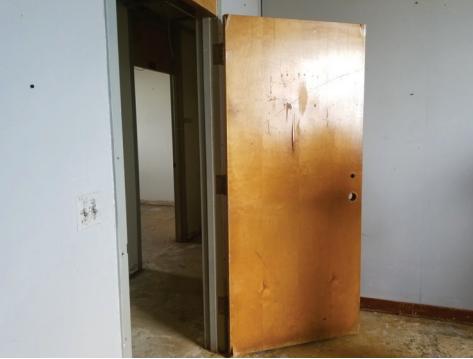
Photo# 104711
Building Interior Door. 27 each of 40 IN x 86 IN hollow Core, mahogany, Flush Wood Door, Smooth (1-3/4 IN Thick) wood door to repair.	Photo# 104711

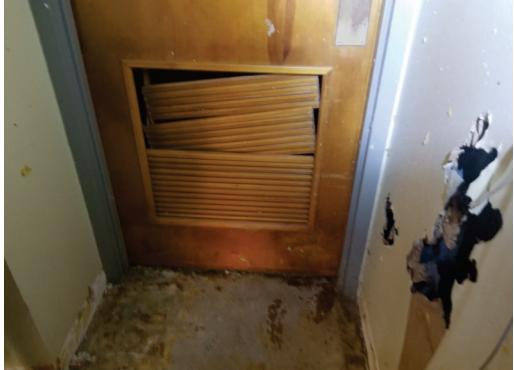
Damage Description:	Photo# 103311
Building Interior Door. 2 each of 40 IN x 86 IN hollow Core, mahogany, Flush Wood Door, Smooth (1-3/4 IN Thick) wood door w/ louve (24 IN x 18 IN) to replace.	Damage Description

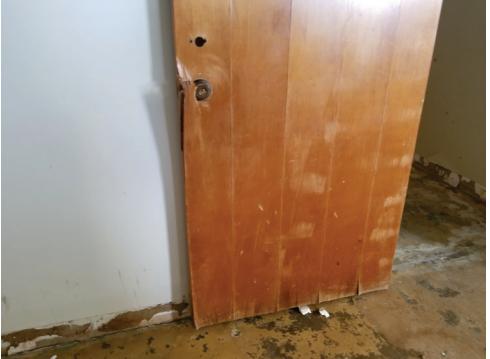
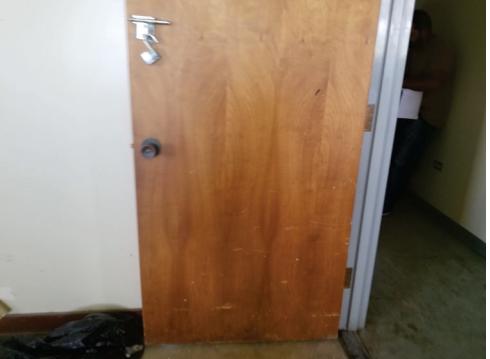
Applicant: Local Redevelopment Authority for Roosevelt Roads		Site Inspector(s): Francisco Martir	
FIPS #: 000-U5AJ6-00	Category: E	Inspection Date: 11/08/19	GPS 18.21717 -65.65569
Work Order #: 51135	Damage Inventory #: 152336	Facility name: Bld. 2296 Adm. Bld. Afwtf	
Damage Description	Photo# 102932	Damage Description	Photo# 110945
Building Interior Door. 2 each of 67 IN x 86 IN hollow Core, mahogany, Flush Wood Door, Smooth (1-3/4 IN Thick) double wood door.		Building Interior Door. 2 each of 67 IN x 86 IN hollow Core, mahogany, Flush Wood Door, Smooth (1-3/4 IN Thick) double wood door.

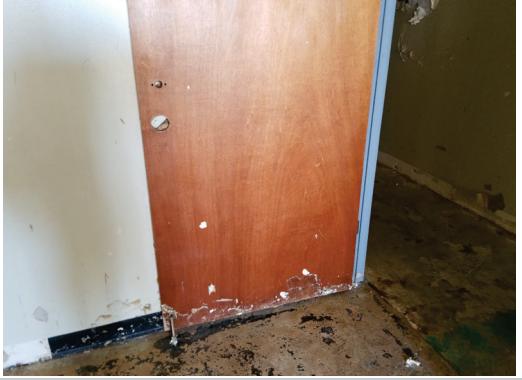
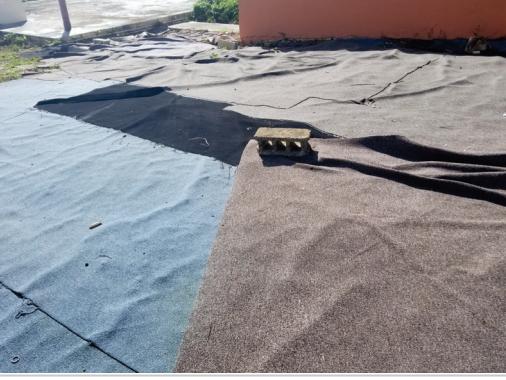
Damage Description:	Photo# 102220	Damage Description	Photo# 092524
Building Interior Door. 2 each of 67 IN x 86 IN hollow Core, mahogany, Flush Wood Door, Smooth (1-3/4 IN Thick) double wood door.		Building Interior Floor. 14,274 SF of carpet required for the installation should be stated according to the requirements of AS/NZS 2455 carpet.

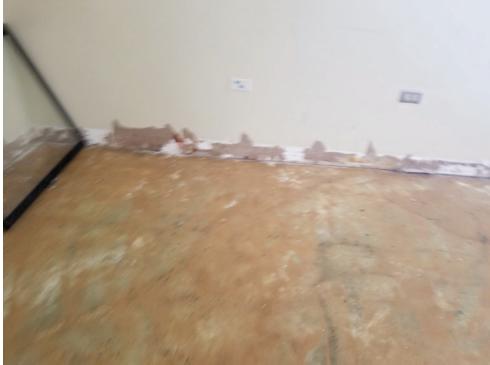
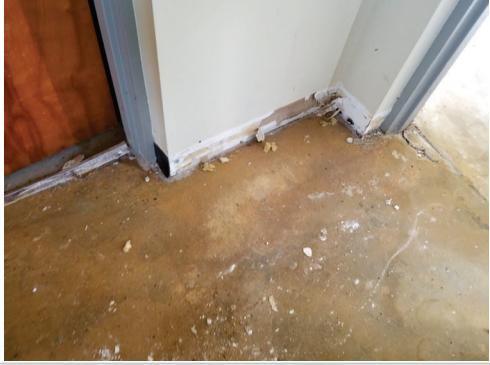
Applicant: Local Redevelopment Authority for Roosevelt Roads	Site Inspector(s): Francisco Martir
FIPS #: 000-U5AJ6-00	Category: E
Work Order #: 51135	Damage Inventory #: 152336
Damage Description	Photo# 103456
Building Interior Floor. 1,577 each of Neoprene Rubber Sheet, Rolls, Strip 1/8 IN (.25 IN) Thick x 6 IN Wide x 10 FT Solid, 0.125 IN Thick resilient base board, 1,342 LF long.	Building Interior Floor. 1,577 each of Neoprene Rubber Sheet, Rolls, Strip 1/8 IN (.25 IN) Thick x 6 IN Wide x 10 FT Solid, 0.125 IN Thick resilient base board, 1,342 LF long.

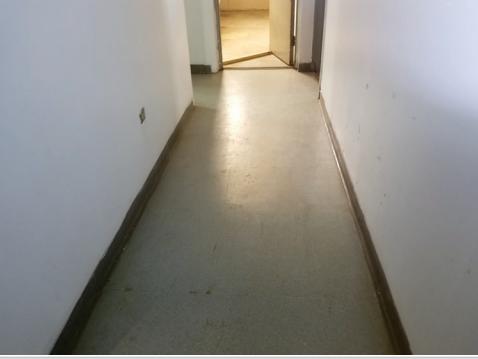
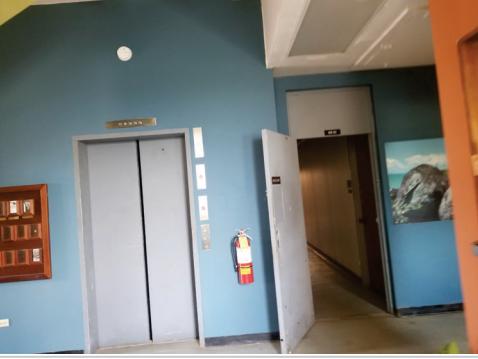
Applicant: Local Redevelopment Authority for Roosevelt Roads	Site Inspector(s): Francisco Martir
FIPS #: 000-U5AJ6-00	Category: E
Work Order #: 51135	Damage Inventory #: 152336
Damage Description	Photo# 114136
Building Interior Floor. 2,782 SF of Apply bleach t the stain (using a spray bottle is the most efficient way to apply bleach) vinyl tiles to clean.	Building Interior Floor. 1, 506 SF of polyvinyl chloride resin binder, fillers and pigments vinyl tiles to replaces.

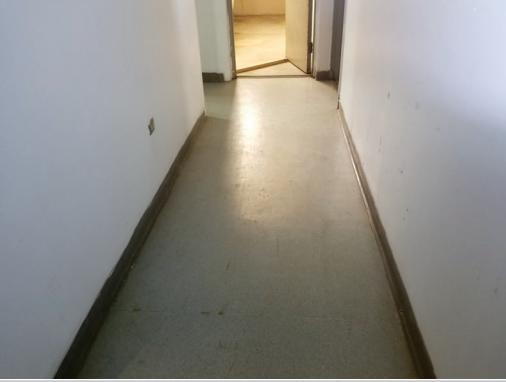
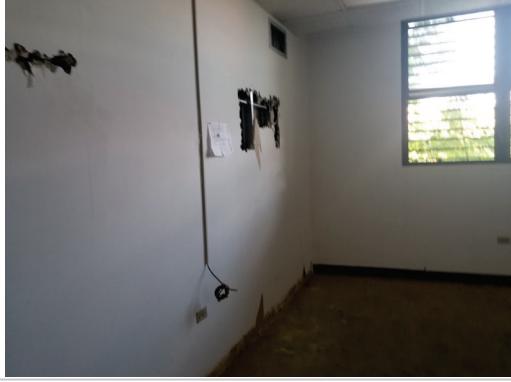
Damage Description:	Photo# 114136
Building Interior Floor. 1, 506 SF of polyvinyl chloride resin binder, fillers and pigments vinyl tiles to replaces.	Damage Description

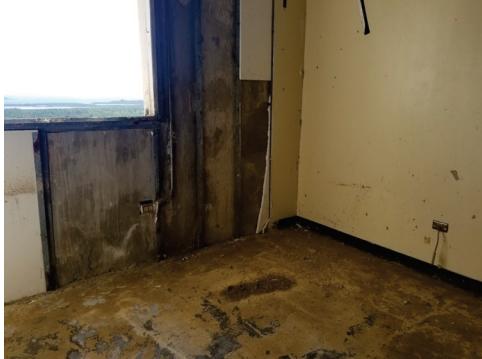
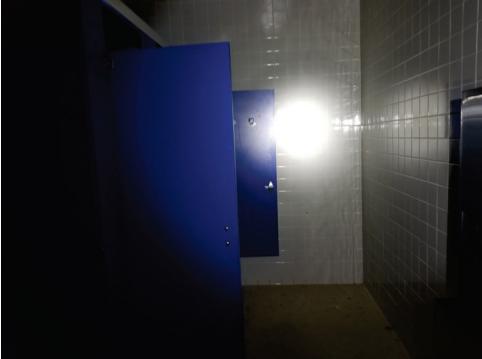
Applicant: Local Redevelopment Authority for Roosevelt Roads	Site Inspector(s): Francisco Martir	
FIPS #: 000-U5AJ6-00	Category: E	
Work Order #: 51135	Damage Inventory #: 152336	
	Photo# 102125	
Building Interior Floor. 2,659 each of clear, stained or painted wood baseboard molding. 2,659 LF long, Distributed thru various floors (Wing A first floor 313 LF, second floor 248 LF, third floor 523 LF, Wind B first floor 549 LF, second floor 483 LF, third floor 543 LF).	Damage Description Building Interior Restroom. 684 SF of solid plastic bathroom partition. Water intrusion through roof soaked most of bathroom partitions (Wing A first floor = 228 SF, second floor 228 SF, third floor 228 SF).	Photo# 103206

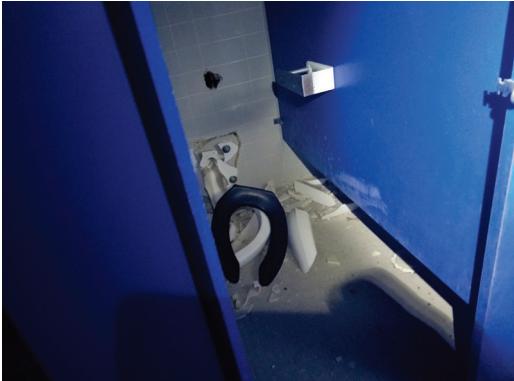
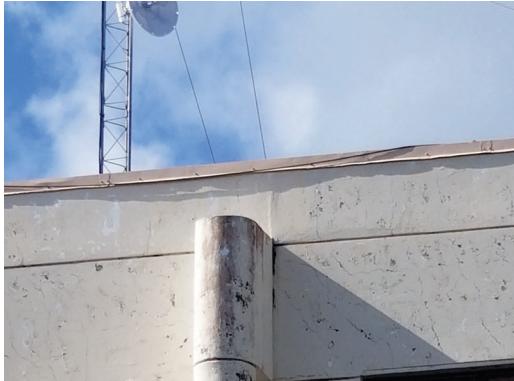
Damage Description:	Photo# 103215	
Building Interior Restroom. 684 SF of solid plastic bathroom partition. Water intrusion through roof soaked most of bathroom partitions (Wing A first floor = 228 SF, second floor 228 SF, third floor 228 SF).	Damage Description Building Exterior Roof. Aluminum, Ga. 0.032 flashing, 450 LF long, intense and constant wind driven rain impacted and ripped off part of metal flashing.	Photo# 092251

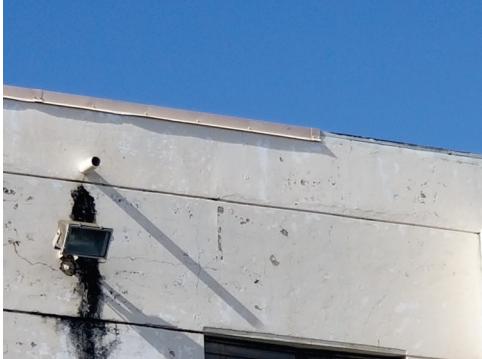
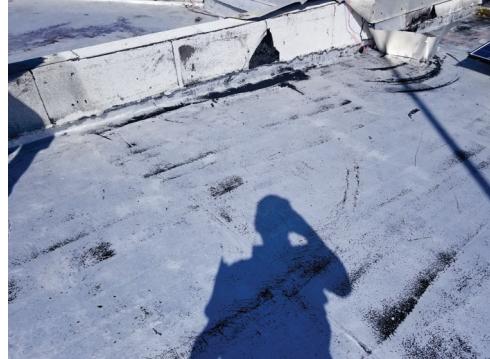
Applicant: Local Redevelopment Authority for Roosevelt Roads	Site Inspector(s): Francisco Martir
FIPS #: 000-U5AJ6-00	Category: E
Work Order #: 51135	Damage Inventory #: 152336
Damage Description	Photo# 092315
Building Exterior Roof. Aluminum, Ga. 0.032 flashing, 450 LF long, intense and constant wind driven rain impacted and ripped off part of metal flashing.	Building Exterior Roof. Aluminum, Ga. 0.032 flashing, 450 LF long, intense and constant wind driven rain impacted and ripped off part of metal flashing.

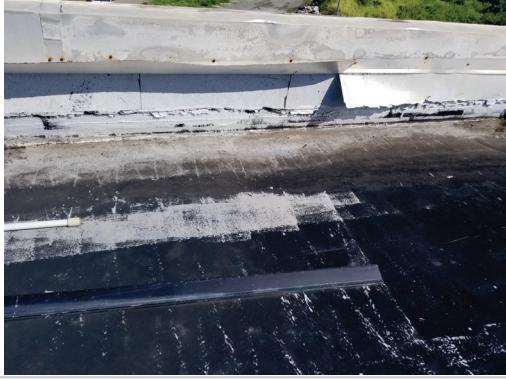
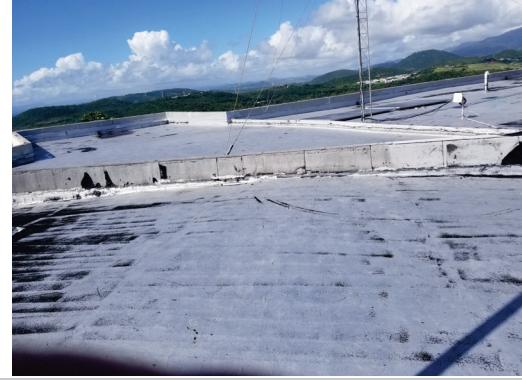
Damage Description:	Photo# 100411
Building Exterior Roof. Aluminum, Ga. 0.032 flashing, 450 LF long, intense and constant wind driven rain impacted and ripped off part	Building Exterior Roof. 3,857 SF of Section 07510 - Built-Up Bituminous Roofing, Section 07540 - Thermoplastic Membrane Roofing roof and Deck Insulation.
