# National Register of Historic Places Continuation Sheet

Property Name: Sistema de riego de las tres haciendas  
(Waterworks in Puerto Rico, 1840-1898 MPS)

County: Santa Isabel Municipality

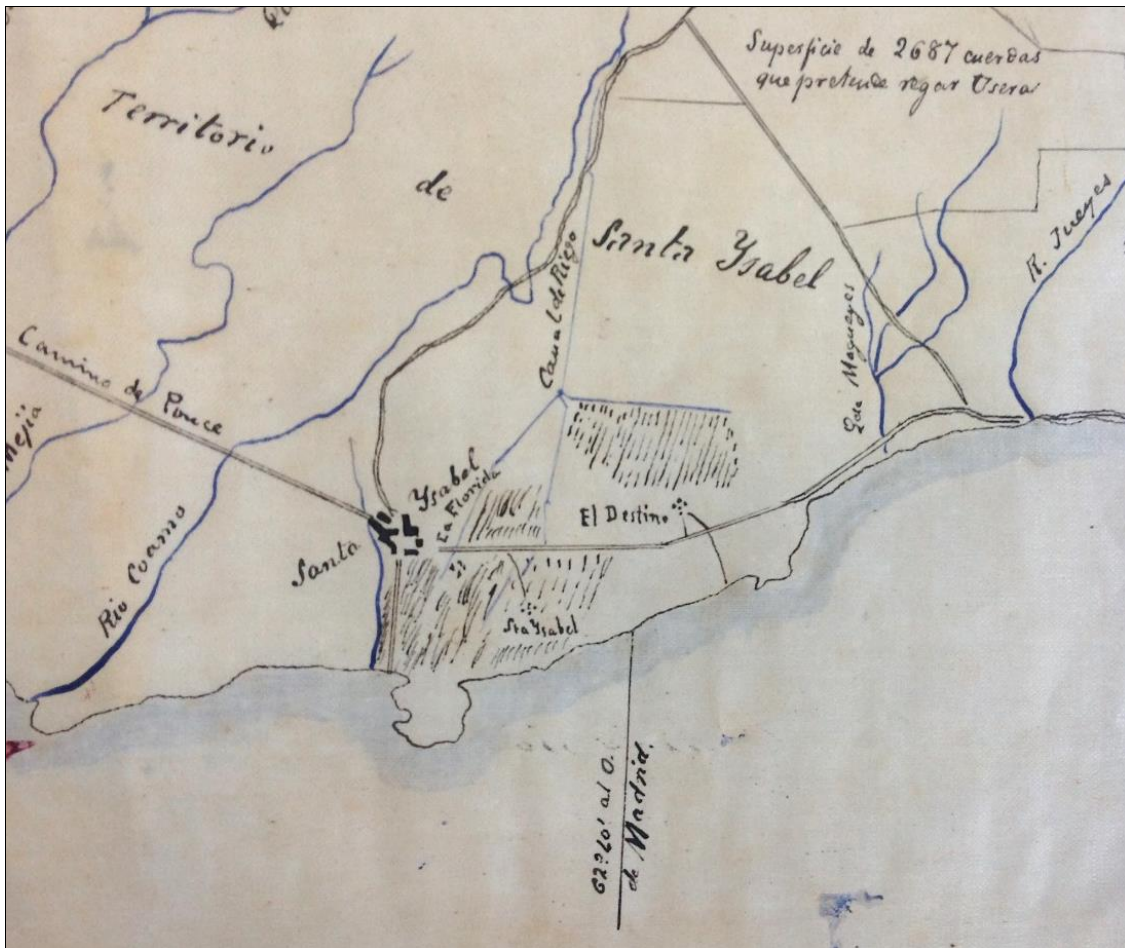
Detail of the sketch of the basin of the Coamo river, 1866 (AGPR Serie Aguas, Subserie Sistema de Riego, Caja 410, Legajo 21, Exp. 927).

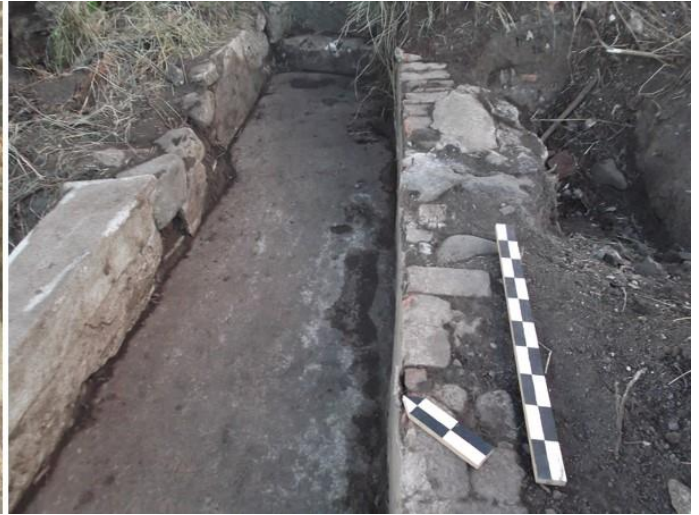
On the left, view of barrel vaulted section of the supply channel, facing south. Right; view of the partially buried open channel of the Hacienda Destino, facing north.

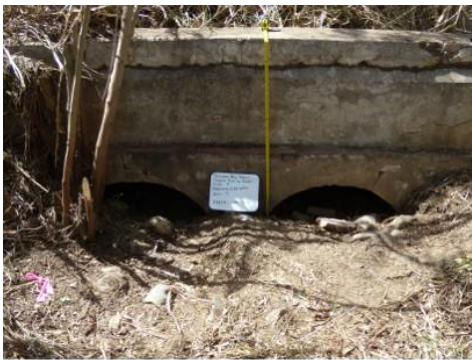
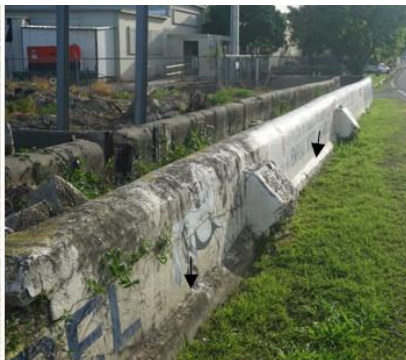
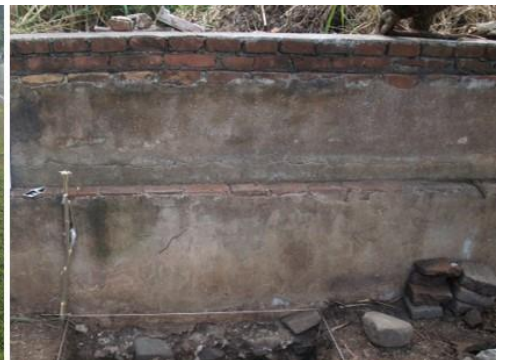
Left; Channel of the Hacienda Florida, raised on arches. Center; Channel of the Hacienda Florida, elevated on a base (note black arrows). Right; Channel of the Hacienda Florida, raised using a staggered base.

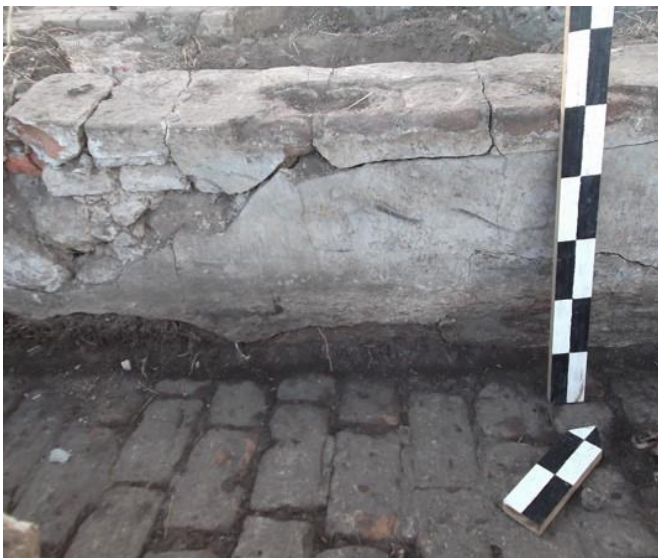
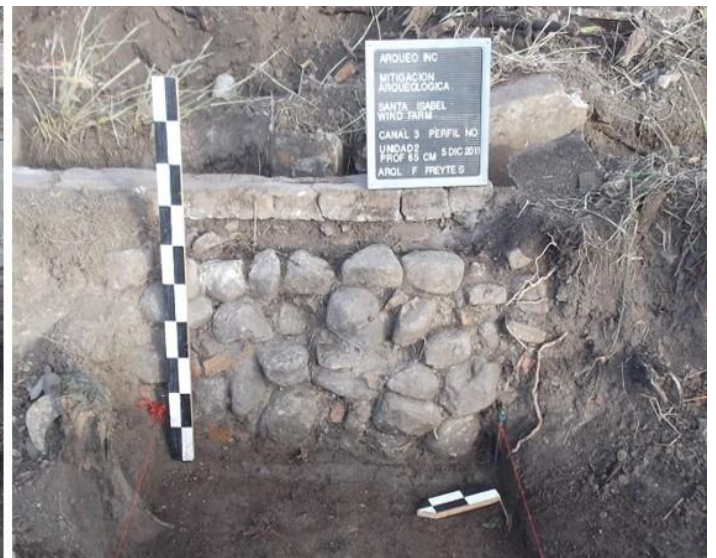
Detail of the makeup and construction method for the Hacienda El Destino Channel. Left, the inside of the west wall of the channel, covered with concrete, with some exposed bricks. Note that the floor has lost its concrete plastering. On the right, exterior view of the same wall segment.

The type of masonry used in the irrigation channels varies depending on the elevation of the tops of the walls in relation to the ground surface. The walls or wall segments that are underground are built with stone, fragmented brick and mortar. The above-the-surface wall portions, or the tops of the walls, are completed with several rows of brick, laid in a stretcher bond, with some scattered stones, consolidated with mortar, and coated with concrete. In the sections where the channel runs completely above the surface the walls are constructed almost entirely in brick and mortar masonry, with very few scattered stones, and concrete coating both outside and inside. The channel floors are built with brick, placed horizontally, with concrete plastering.

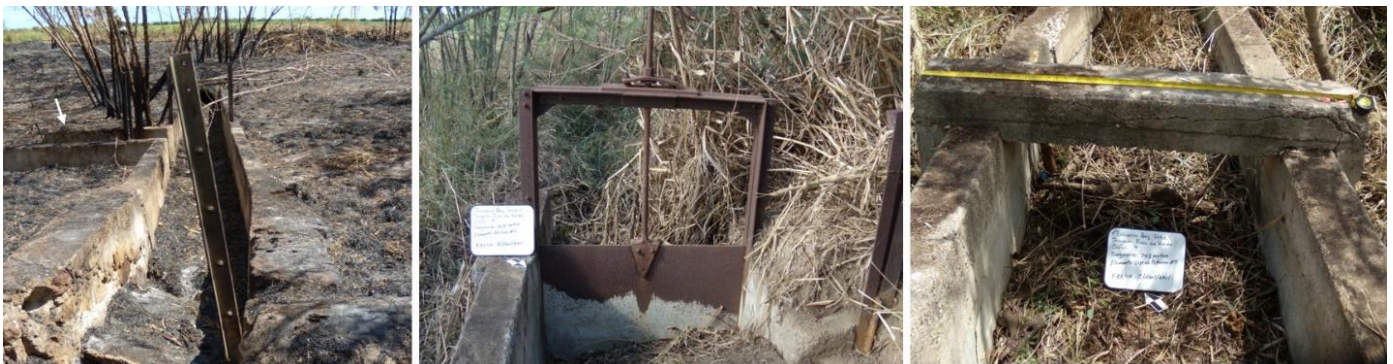
On the left, view of the *Hacienda Destino* channel, facing west. White arrow shows a channel that was added when it became part of the Irrigation District. In the center, detail of added sluice gate. Right; reinforcement beam added to the *Hacienda Florida* Channel.

The modifications made to the system of the *Tres Haciendas* in the early 20th century mainly consist of the addition of secondary channels built of reinforced concrete, connected by sluice gates that were added to the walls of the nineteenth-century system channels. Other sluice gates were installed to fill ponds or to water the sugarcane fields by direct irrigation. Some sections of the *Tres Haciendas* irrigation system were fortified, either by using buttresses and constructing reinforced concrete beams, or they were reinforced or rebuilt with the same technique. The dam and the low and torrential water modules were also modified, as will be discussed in detail below.

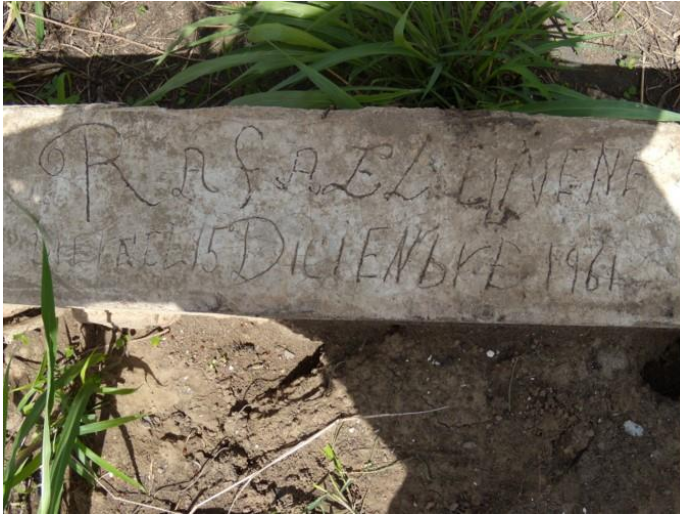
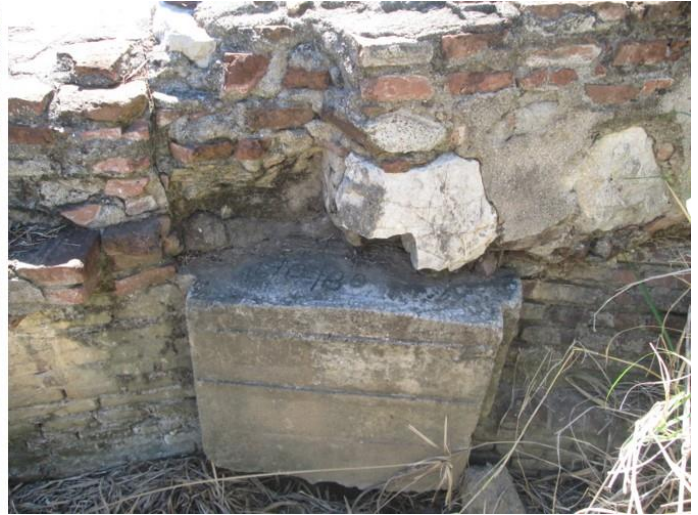
Repairs with date inscriptions. On the left, repair on the supply channel dated 1961 and to the right, repair to the low and torrential waters modules, dated 1980.

The *Tres Haciendas* Irrigation System was partially in use until the 1990s, when it was abandoned. For its full length, repairs that were performed throughout its period of usefulness can be found. Some repairs include inscriptions with the dates in which they were made, such as December 15, 1961 or December 16, 1980.

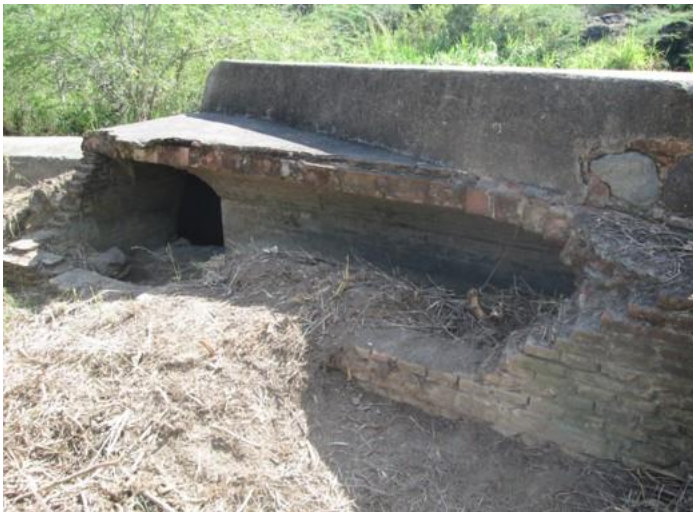
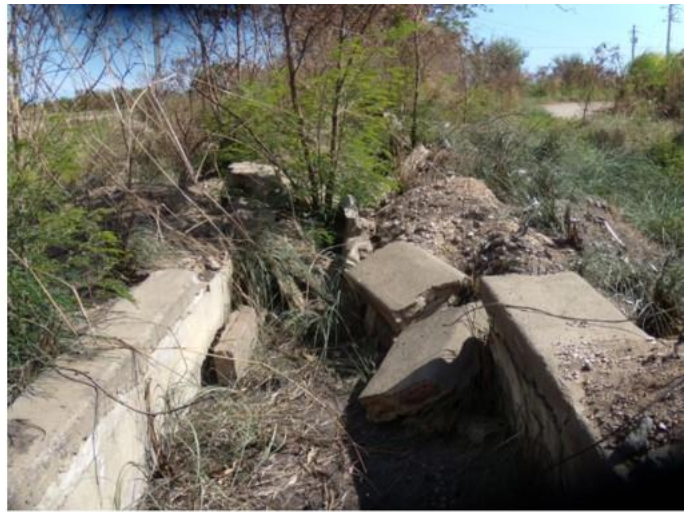
On the left, collapsed section of the torrential waters inlet channel, looking southwest. On the right segment of the supply channel with side impact caused by agricultural machinery.

After its abandonment, the irrigation system has deteriorated. Some segments of the vaulted channel have collapsed, as have walls of the open channels affected by agricultural activities. In urbanized areas, open channels have been filled with earth or covered, using sheet metal on which a layer of concrete was poured (Photo 8). In rural areas, open channels are hidden by the vegetation, filled with soil, or buried under mounds of dirt and even rubble.

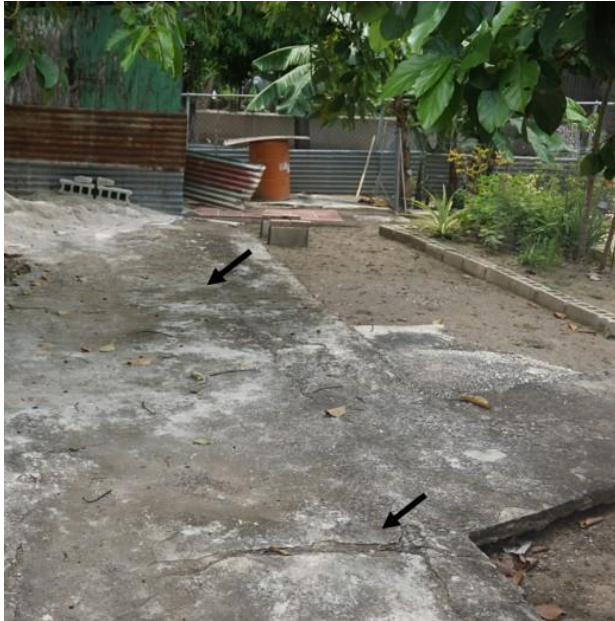
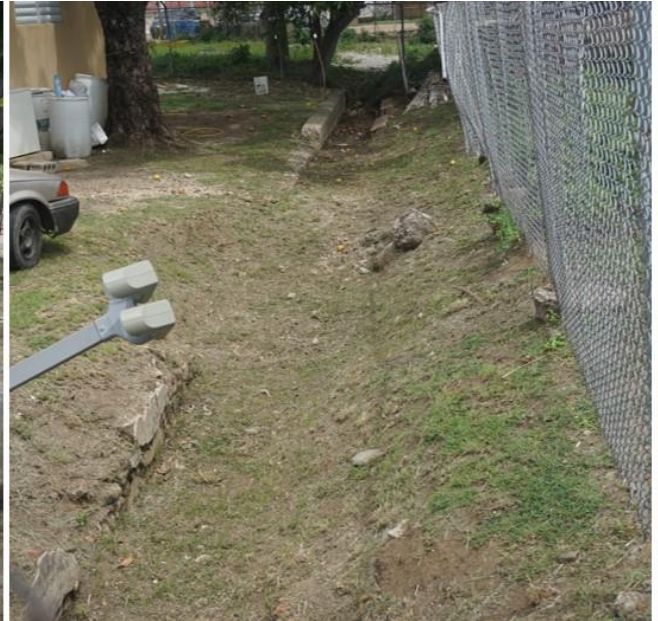
On the left, section of the supply channel covered with corrugated metal sheets and a slab of concrete. Arrows indicate the channel's route. To the right, supply channel in a backyard, filled with earth.

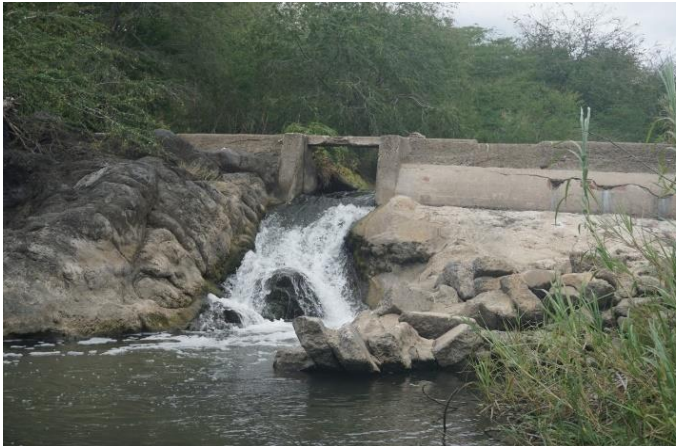
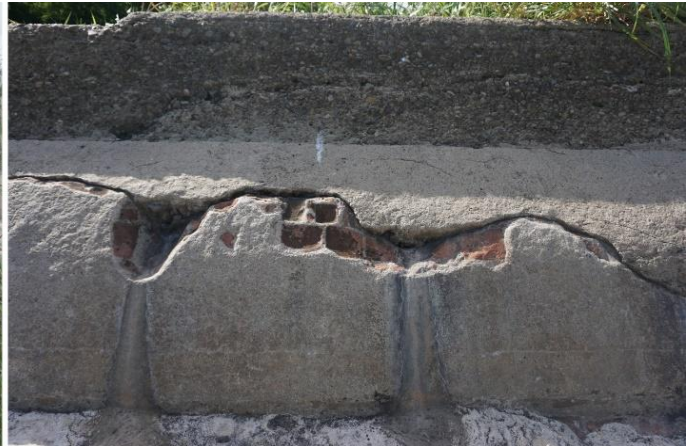
On the left, view the central area of the dam with the added opening for the sluice, seen upstream from the east bank. On the right; detail of the two construction phases of the structure: lower part built from brick masonry in the 19th century, and 20th century upper part of reinforced concrete.

The dam has two evident construction stages. The original dam, a weir built in 1846, was built of masonry, as described. It is rounded on top, measuring between 1.8 and 2 m in width, with a height of 90 cm. The structure does not extend presently from bank to bank of the river, but begins in the low-waters module to the east and ends on a rock formation to the west, with a total length of 19 m. Subsequently, during the 20th century, the height of the dam was raised to 1.2 m, by building a concrete wall reinforced with spiral steel rod. The addition has a trapezoidal shape, with straight walls and a flat top, measuring 60 cm wide at the base and 30 cm on top,

with a height of 30 cm. Also during the 20th century, a sluice gate was added to the dam, it measures 1.5 m wide by 90 cm high. The frame for sluice gate was constructed of reinforced concrete, leaving a molding in which, according to local residents, wooden planks would be slid in to control the flow from the reservoir. This part of the dam does extend to the west bank of the river, with a total length of 27 m.

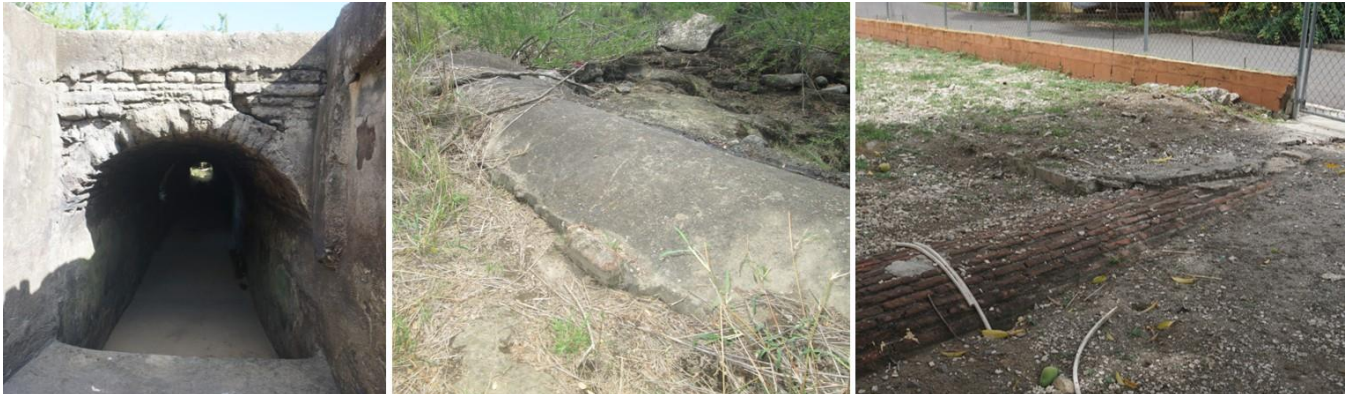
On the left, entrance to the Supply channel at the low-waters module, looking south from within the inlet. In the center, vaulted segment of the supply channel that runs along the surface in the area of the dam. Notice the concrete plastering over the vault. On the right, view of the channel as it emerges to the surface, in the backyard of a property of the *El Ojo* Community. Note that the vault does not have plastering.

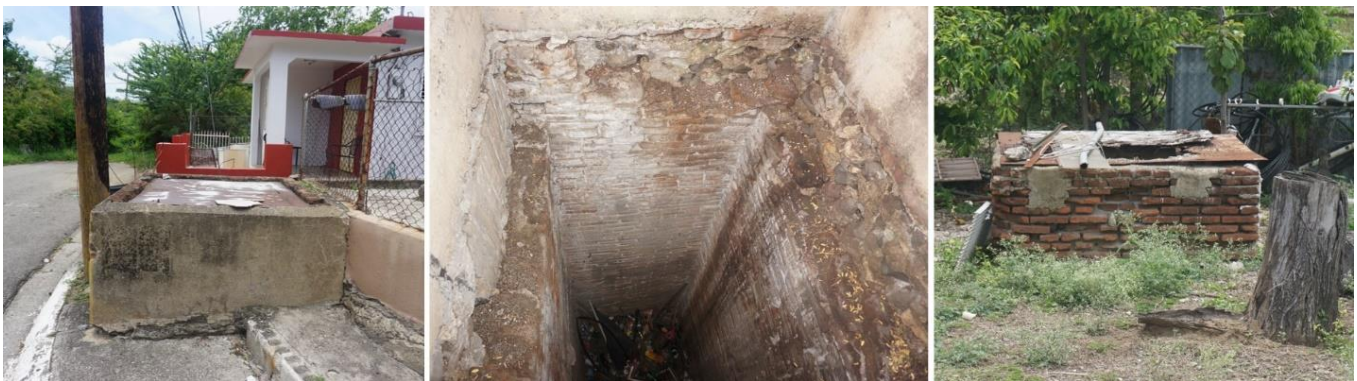
On the left, service manhole to the supply channel, located on a sidewalk of the *El Ojo* Community. In the center, detail of the service shaft inside a manhole. Right, manhole which features an advanced degree of damage by erosion, located in the backyard of a house.

the manholes varies, with an average of 1.8 m long by 1.7 m wide. Six of this structures were located, found in a vacant lot and on the sidewalks and backyards of the *El Ojo* Community. Most of them are in good condition, although partially filled with dirt, debris, and garbage. Only one such structure, located in the backyard of a house, presents a severe erosion of the bricks, both inside and outside. Some had their walls raised by using reinforced concrete. Their exterior height ranges from 63 cm to 1 m above the surface. It is estimated that many more of this manholes are yet to be identified.

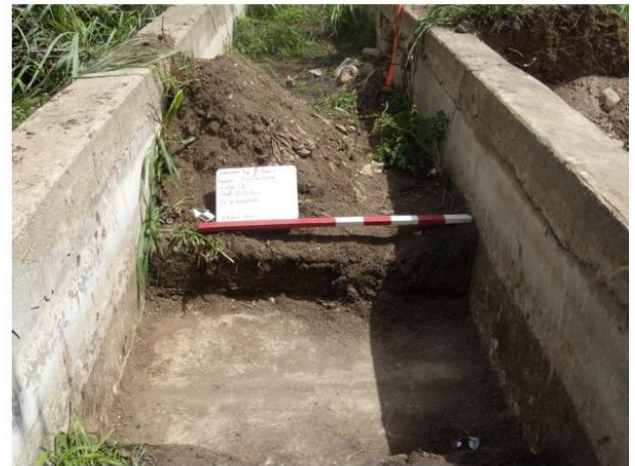
Outline of the open supply channel (from Meléndez Maíz 2011, drawing no. 7) and interior view.

The open section of the supply channel begins partially buried, with the top of the walls at ground level, and gradually rises over the surrounding terrain until set completely above the surface. It has straight sides and a flat bottom. Its average inner width is 1.2 m and its interior height measures up to 77 cm. The foundation was documented in several excavation units, where it reached 30 to 90 cm deep below the bottom of the walls, and projected from 4 to 9 cm from their exterior sides.

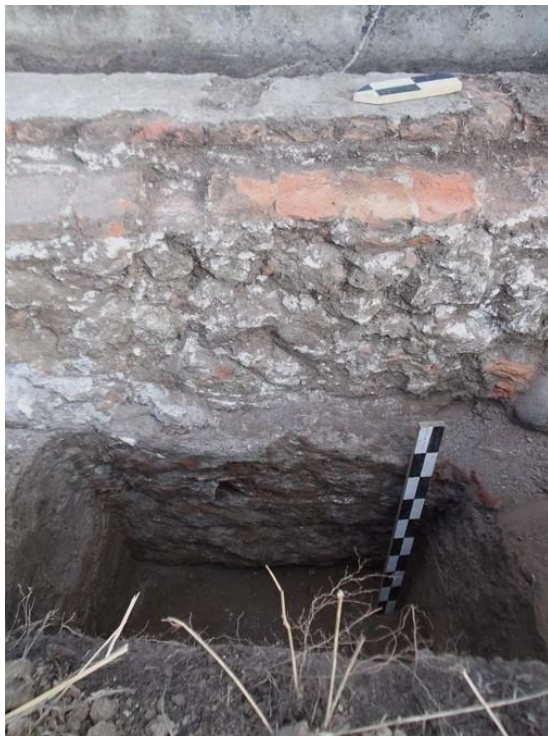
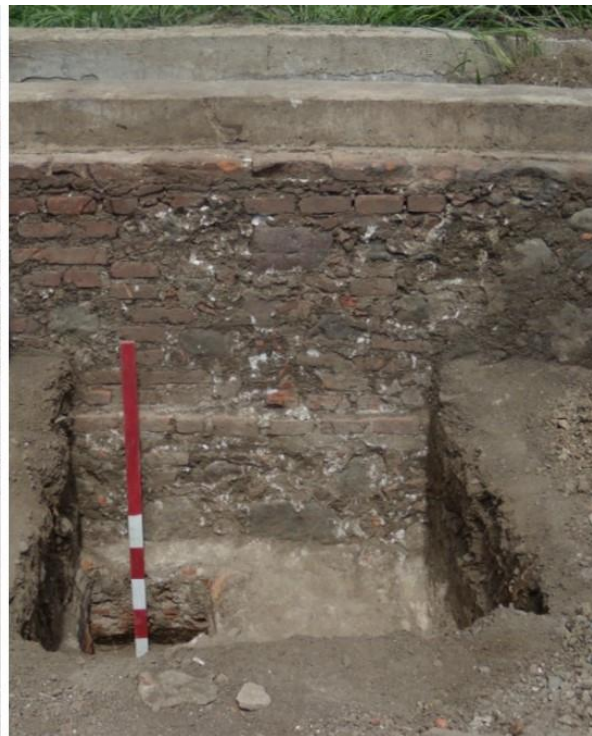
Left, detail of outer side of the west wall and foundation of the supply channel, in an area where the open channel is buried. On the right, detail of outer side of the west wall and foundation, in an open section where the channel is above the surface.

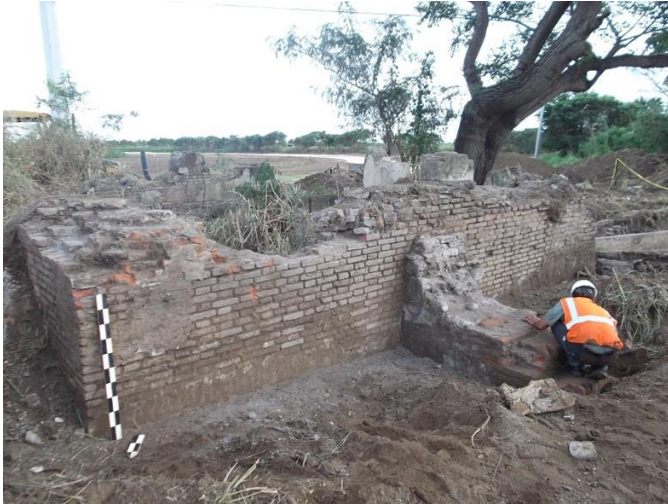
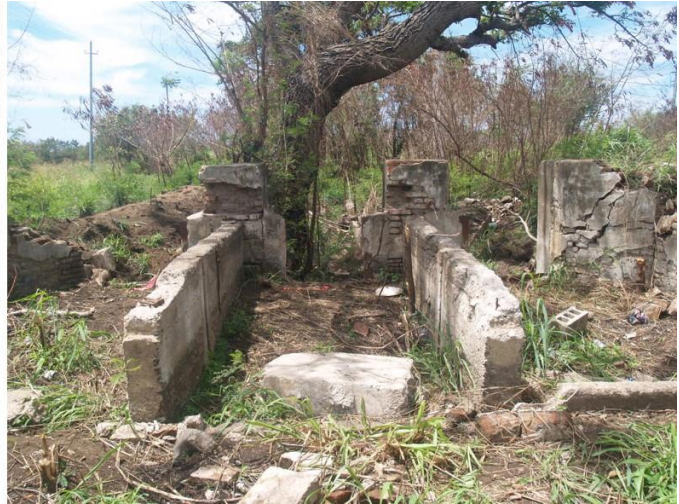
On the left, general view of the distribution module, during archaeological documentation works performed in 2012, looking south. On the right, view of the structure in 2011, looking northeast.

The supply channel ends south at the distribution module, from where the water was divided and distributed through three branching channels, which were responsible for delivering the water to the fields of the *Santa Isabel*, *El Destino* and *Florida haciendas*. The structure was designed to withstand weight and lateral forces, since it was built on a foundation of stones, fragmented brick and lime mortar that was 60 cm deep and protruded 35 cm from the exterior of the walls. It had walls 60 cm wide and a buttress 94 cm wide by 1.80 m long.

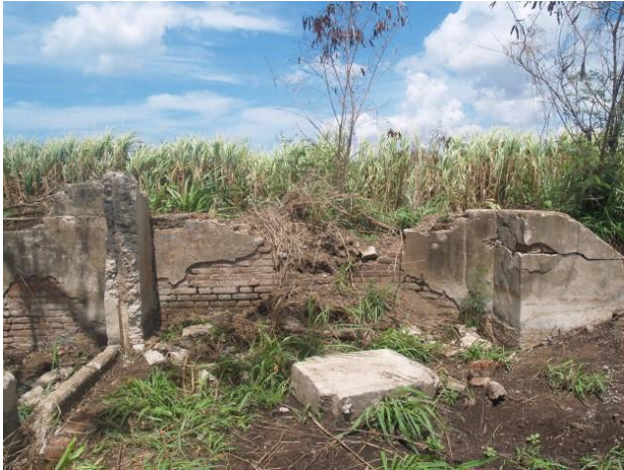
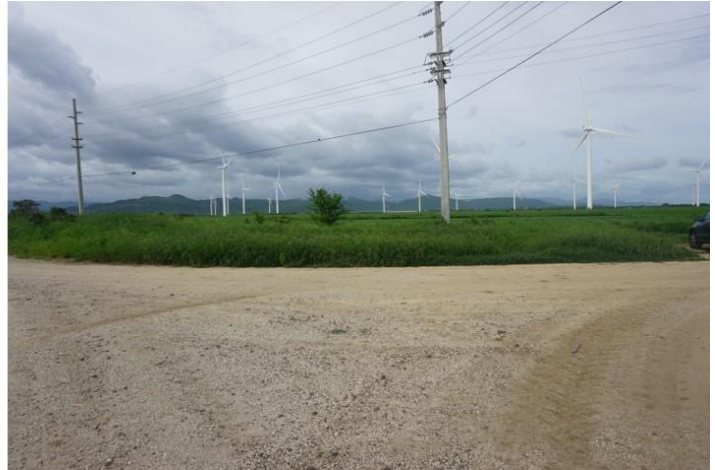
On the left, view of the distribution module in 2011, facing southeast. On the right, current view (2016) of the area where the module was located.

The imposing structure was demolished during the year 2012, as part of the construction work of the *Finca de Viento* project. It was documented in two archaeological studies (Meléndez Maíz 2011 and Meléndez Ortiz 2012). It is understood that beneath the surface there are still remnants of its foundations and the foundations of the channels associated with it. It is for this reason, and for the importance of this property as a geographical reference to the other components of the irrigation system, that it is included in this nomination as a contributing site.

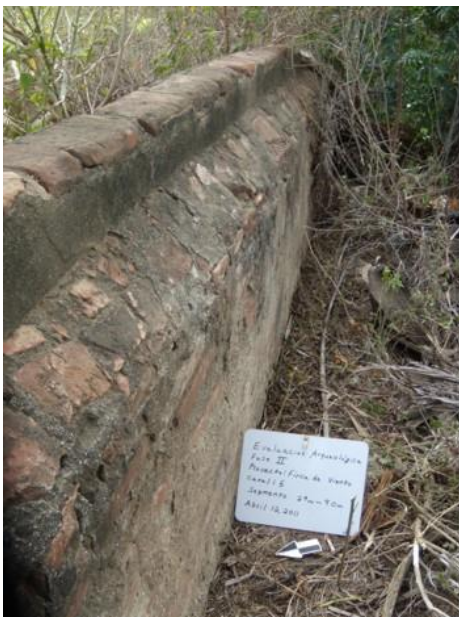
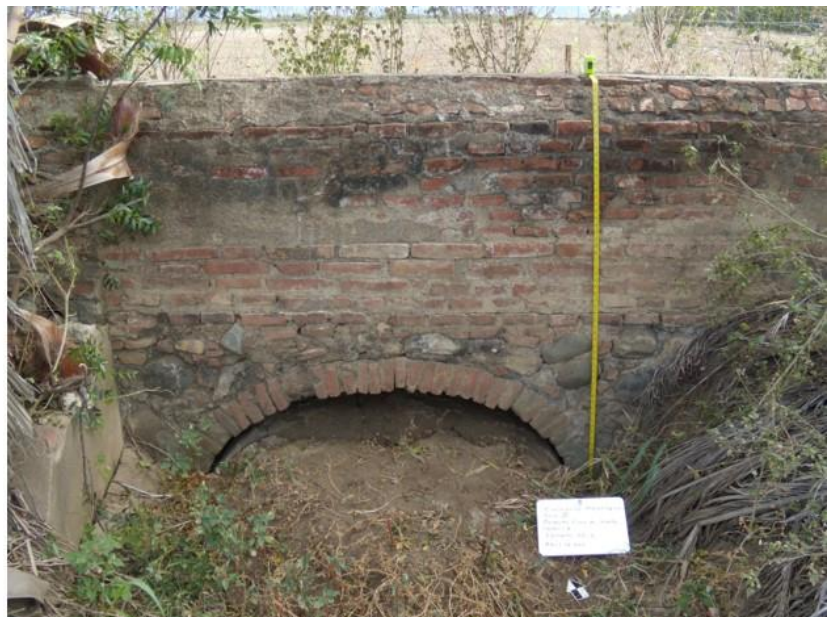
On the left, a segment of the *Santa Isabel Hacienda* channel, with setback feature. Right; arched bridge.

The *Santa Isabel hacienda* channel, or Channel 2, transported the water from the distribution module a distance of 2.3 km to the fields of the *Hacienda Santa Isabel*. For 1.7 km, the channel runs southwards. In most of this stretch of its route, the top of the walls is level with the surface, with an inside depth of 50 cm. The only alteration observed in this segment is the addition of four reinforced concrete buttresses to the east wall.

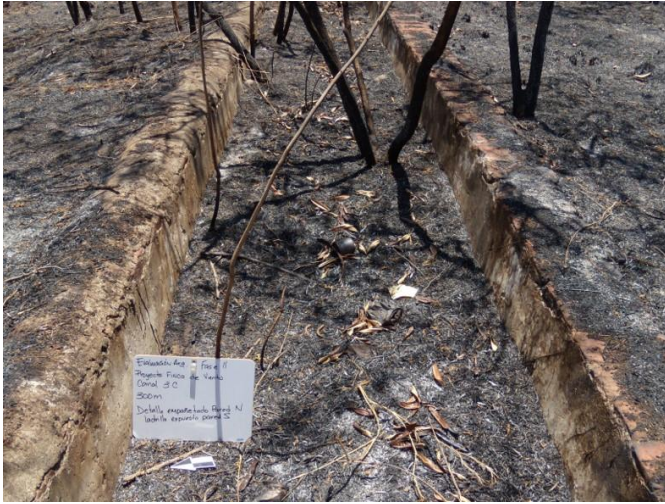
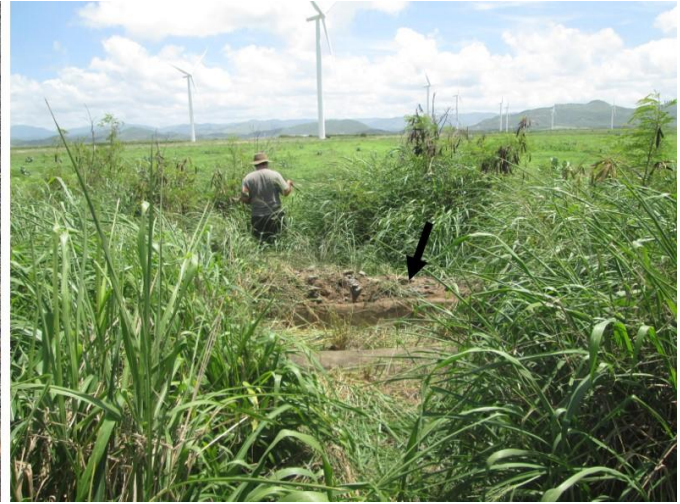
Left; photo of a segment of the channel of the *El Destino hacienda*, taken in 2012 after a wildfire cleared the vegetation. Right; area where a section of the canal was exposed in 2016 (marked with the black arrow), completely hidden by the vegetation.

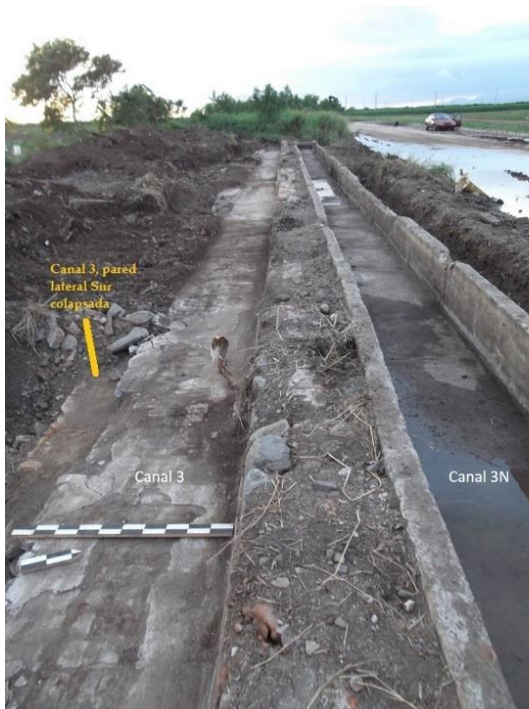
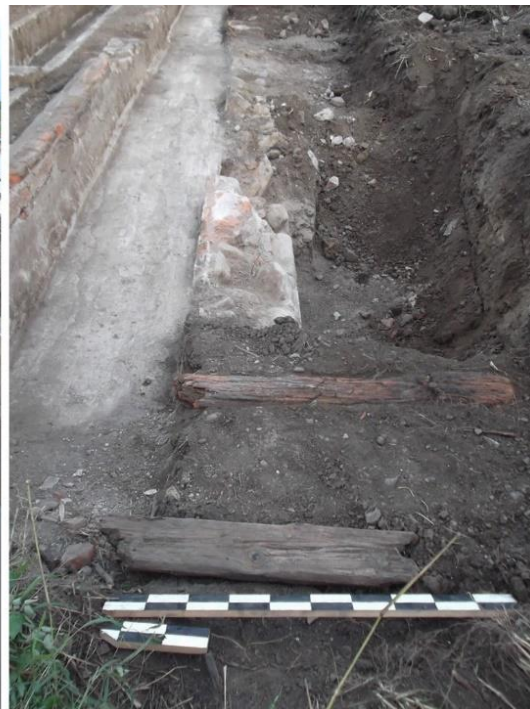
Left; view of channels 3 and 3N, looking west. The remains of the *El Destino hacienda* channel is seen to the left, with its south wall flattened to ground level and channel 3N alongside, constructed soon after. In the right photo, detail of sleepers of the railway line, in situ, resting on the footing of the south wall of channel 3.

At 450 m from its origin, Channel 3 is interrupted by a reinforced concrete wall that diverted the waters through a sluice gate into a parallel channel of the same build, designated Channel 3N. This construction was made when the system was integrated into the Irrigation District of the South Coast. The side by side channel was necessary because, around 1904, a stretch of 310 meters from the south wall of the channel was demolished to the ground level, to lay the railway line of the Aguirre Sugar Company. To the east of this detour, two additional sluice gates were built to supply water through other channels also built in the 20th century.

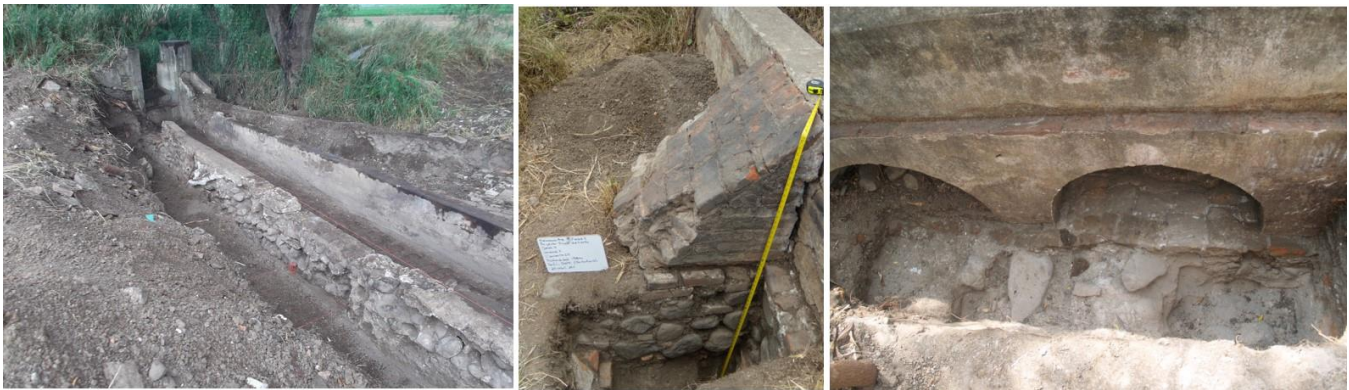
Left; view of the *Hacienda Florida* channel at its origin as it left the distribution module, facing northeast. Center; Detail of an abutment. Right; segment of the channel on arches. Note the stone pavement under the channel.

From the north, the channel begins partially buried, with the top of the walls level with the surface. It is 48 cm deep inside. From 163 m to 213 m from the starting point, Channel 4 is entirely above the surface, and even elevated on a masonry base. At a section located between 435 m and 595 m from the start, the channel is raised above the surface and supported by abutments located on both sides of the structure at 30 points. They are located at an interval of 4 to 7 m, with variable dimensions, and consist of triangular structures built with the same materials and construction technique as the channel. Here the channel is 68 cm deep. Between 635 m and 700 meters from the start, the channel rises again on a massive foundation. In this section, the channel walls feature a setback step formed by two rows of bricks coursed at a stretcher bond. Meanwhile, the cement has two levels: an upper level to 25 cm tall, made of stone and bricks bound with lime mortar, and a lower level measuring 30 cm, built of stones and fragmented bricks with no consolidating material. Between 666 m and 686 m from the start, the channel is elevated on four arches - one simple and three double arches. The area surrounding the arches is paved with stone to prevent soil erosion. The base continues to be massive and with staggered sides.

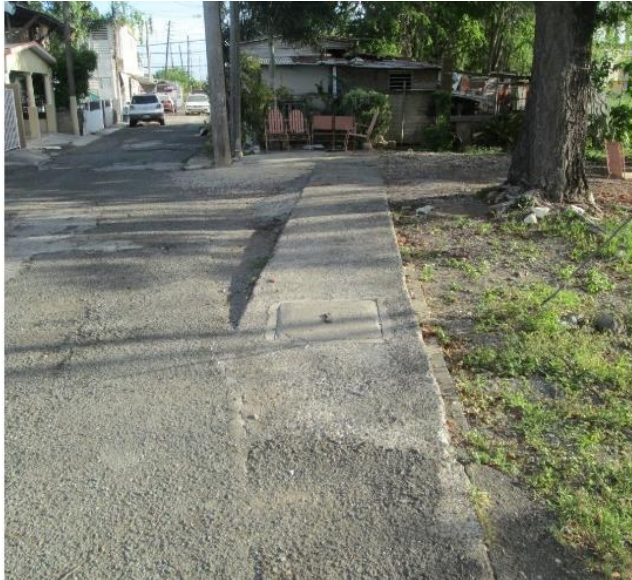
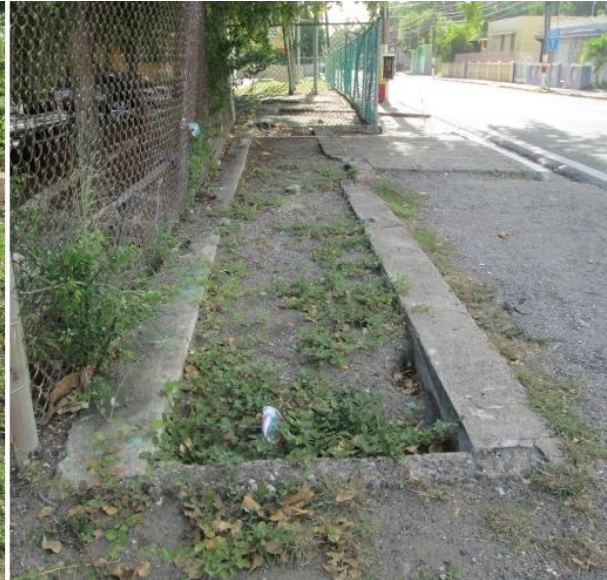
General views of the *Hacienda Florida* channel in the urban area of Santa Isabel. Left; covered channel through vacant lot and under a dwelling. Right; the channel as it appears along the south sidewalk of road PR-1, facing west.

Some segments of Channel 4 were modified during the 20th century. The modifications consist of the construction of six reinforced concrete beams to prevent the collapse of the walls, the reconstruction of a section of 10 m where two steel sluice gates were installed, with the knife gates operated by a lifting screw, and the installation of three gates which opened to a pool which is now dry.

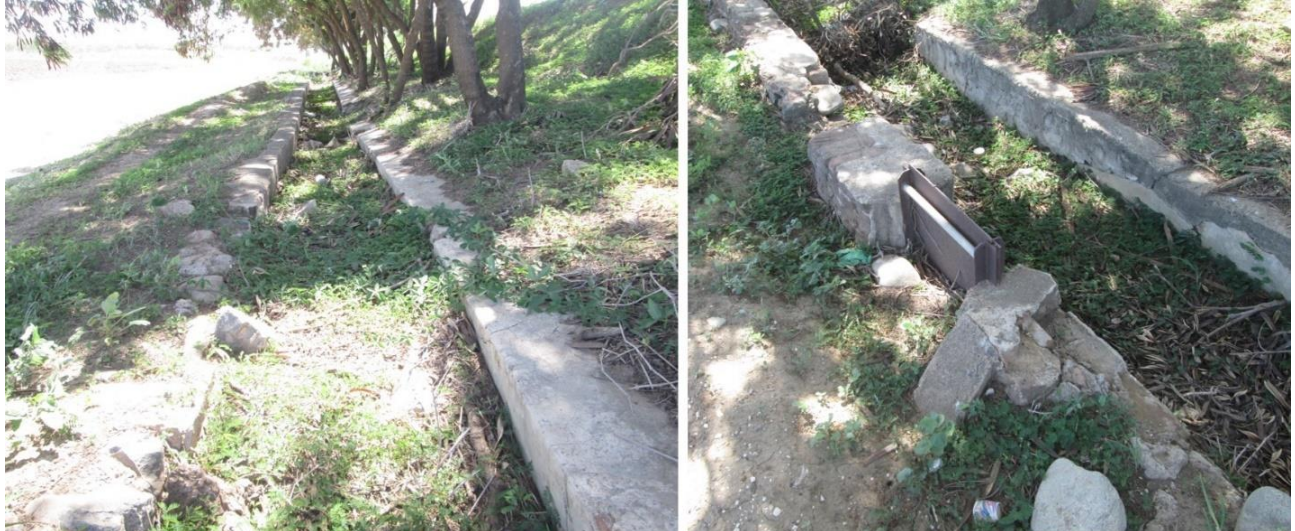
Left; view of the sub-branch, or Channel 5, facing west. Right; detail of the sluice gate.

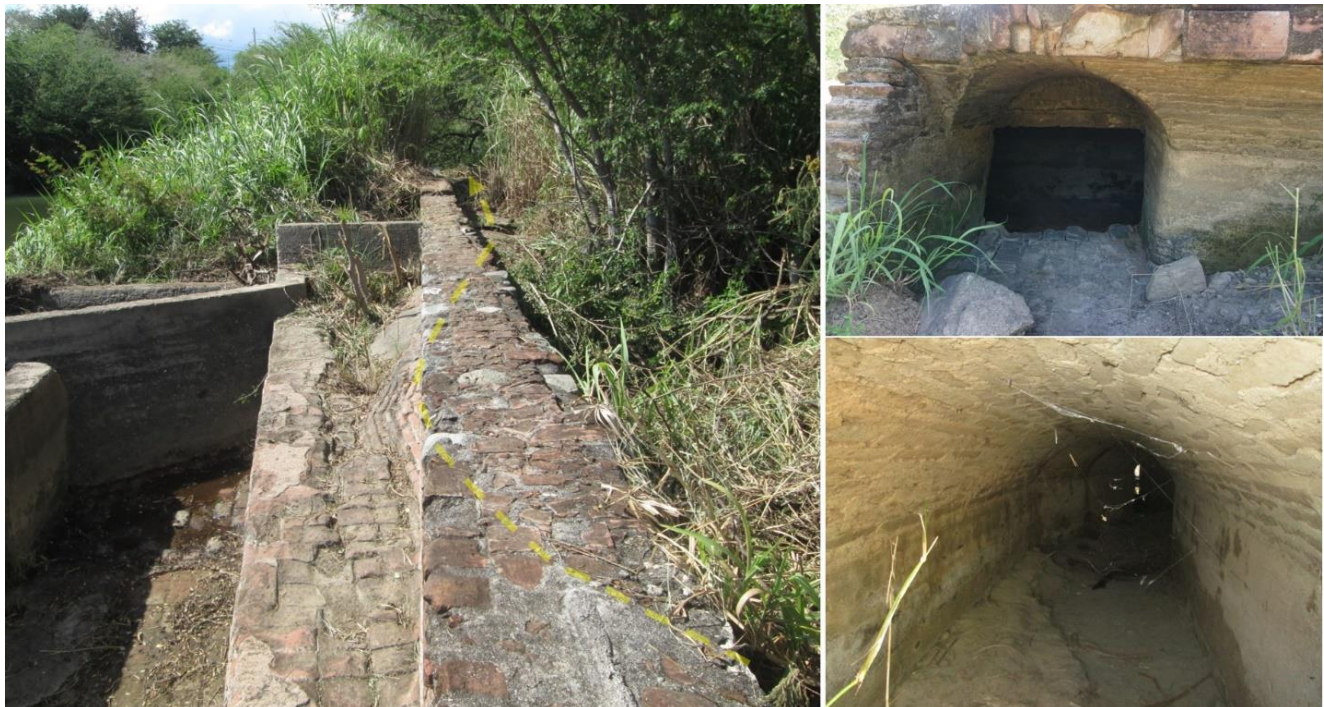
Views of the torrential waters channel. Left; General view of the channels route, marked by the yellow dotted line. Right top; entrance into the supply channel facing west, and inside view of the torrential waters channel looking south.

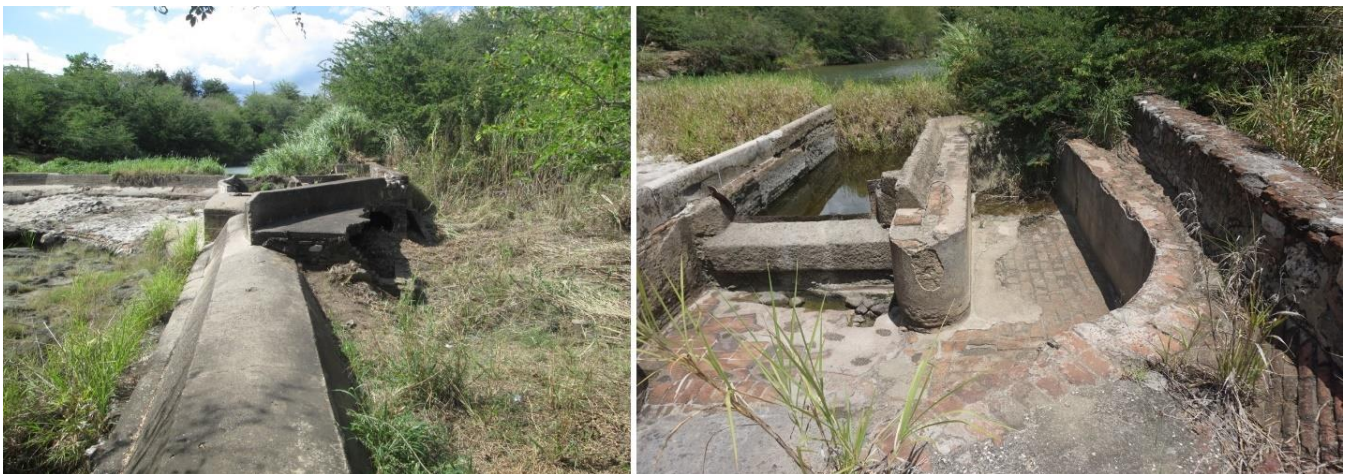
Left, general view of the area of the low waters and seasonal waters modules. In the foreground we see the supply channel, with the module and the dam in the background. Right, view of the modules, showing the low waters module full of water on the left and the seasonal waters module on the right of the photo, facing north.

Four construction stages are noticed. Firstly, the *estiales* waters intake module was constructed, which consisted of a structure that collected water from the reservoir even in times of drought through a sluice gate and into a module where the amount of water was measured, to then continue through a second wooden gate through the Supply channel. The west wall of the module had different heights, allowing for the return to the river of waters in excess of those accorded.

A year later, the *estacionales* water module is added. It allowed for the harnessing of the additional water during the rainy season. This module also featured a gated intake to collect water from the reservoir, but with a higher threshold than that of the *estiales* module. This water would flow freely into the supply channel, for which part of the wall dividing the two modules was demolished. The footprint of the demolished wall segment is visible on the floor, and remnants of a wooden sluice gate at the entrance to the channel are visible in the floor and west wall. The first sluice gate was removed, replaced by another one which was built at the exit of the *estiales* water module.

The structure was modified in the 20th century. The height of the walls was elevated by adding reinforced concrete walls. The *estacionales* (seasonal) water module was bypassed by demolishing a section of the central wall and the construction of a diagonal wall that closed the intake above the module. The waters from the two sluice gates at the reservoir now entered a single module. Several parallel rods were installed facing the inner sluice gate of the *aguas estiales* module to make a garbage trap. Finally, the two sluice gates facing the reservoir were walled up. The current condition of the area where the dam, module, storm water intake and supply channel begins is depicted on Figure 8.

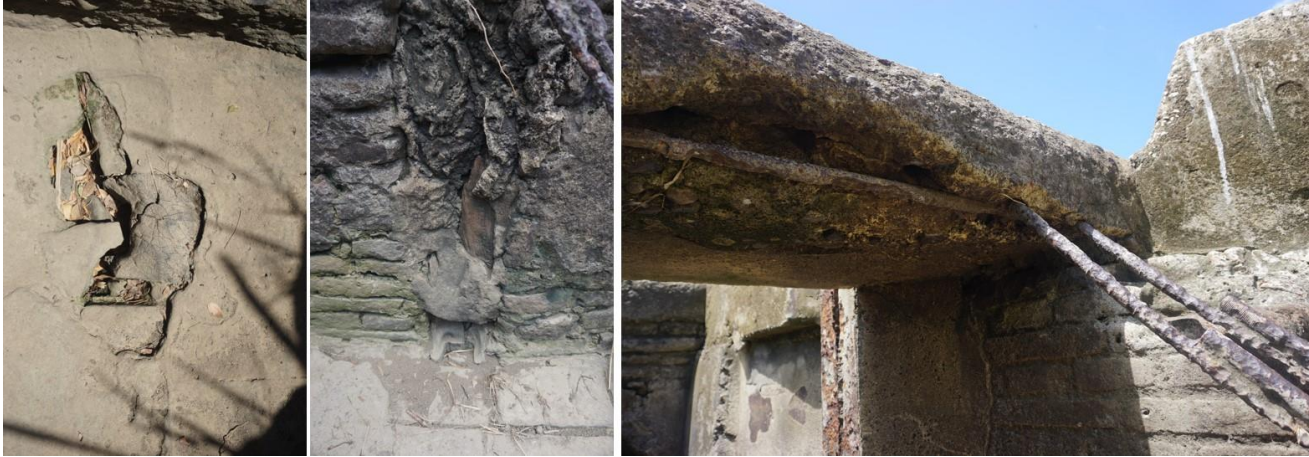
Left and center; remnants of the wood frame of the inner sluice gate of the low waters module. Left; detail of the inner gate of the module, with part of the metal sluice and metal bars that created a garbage trap.

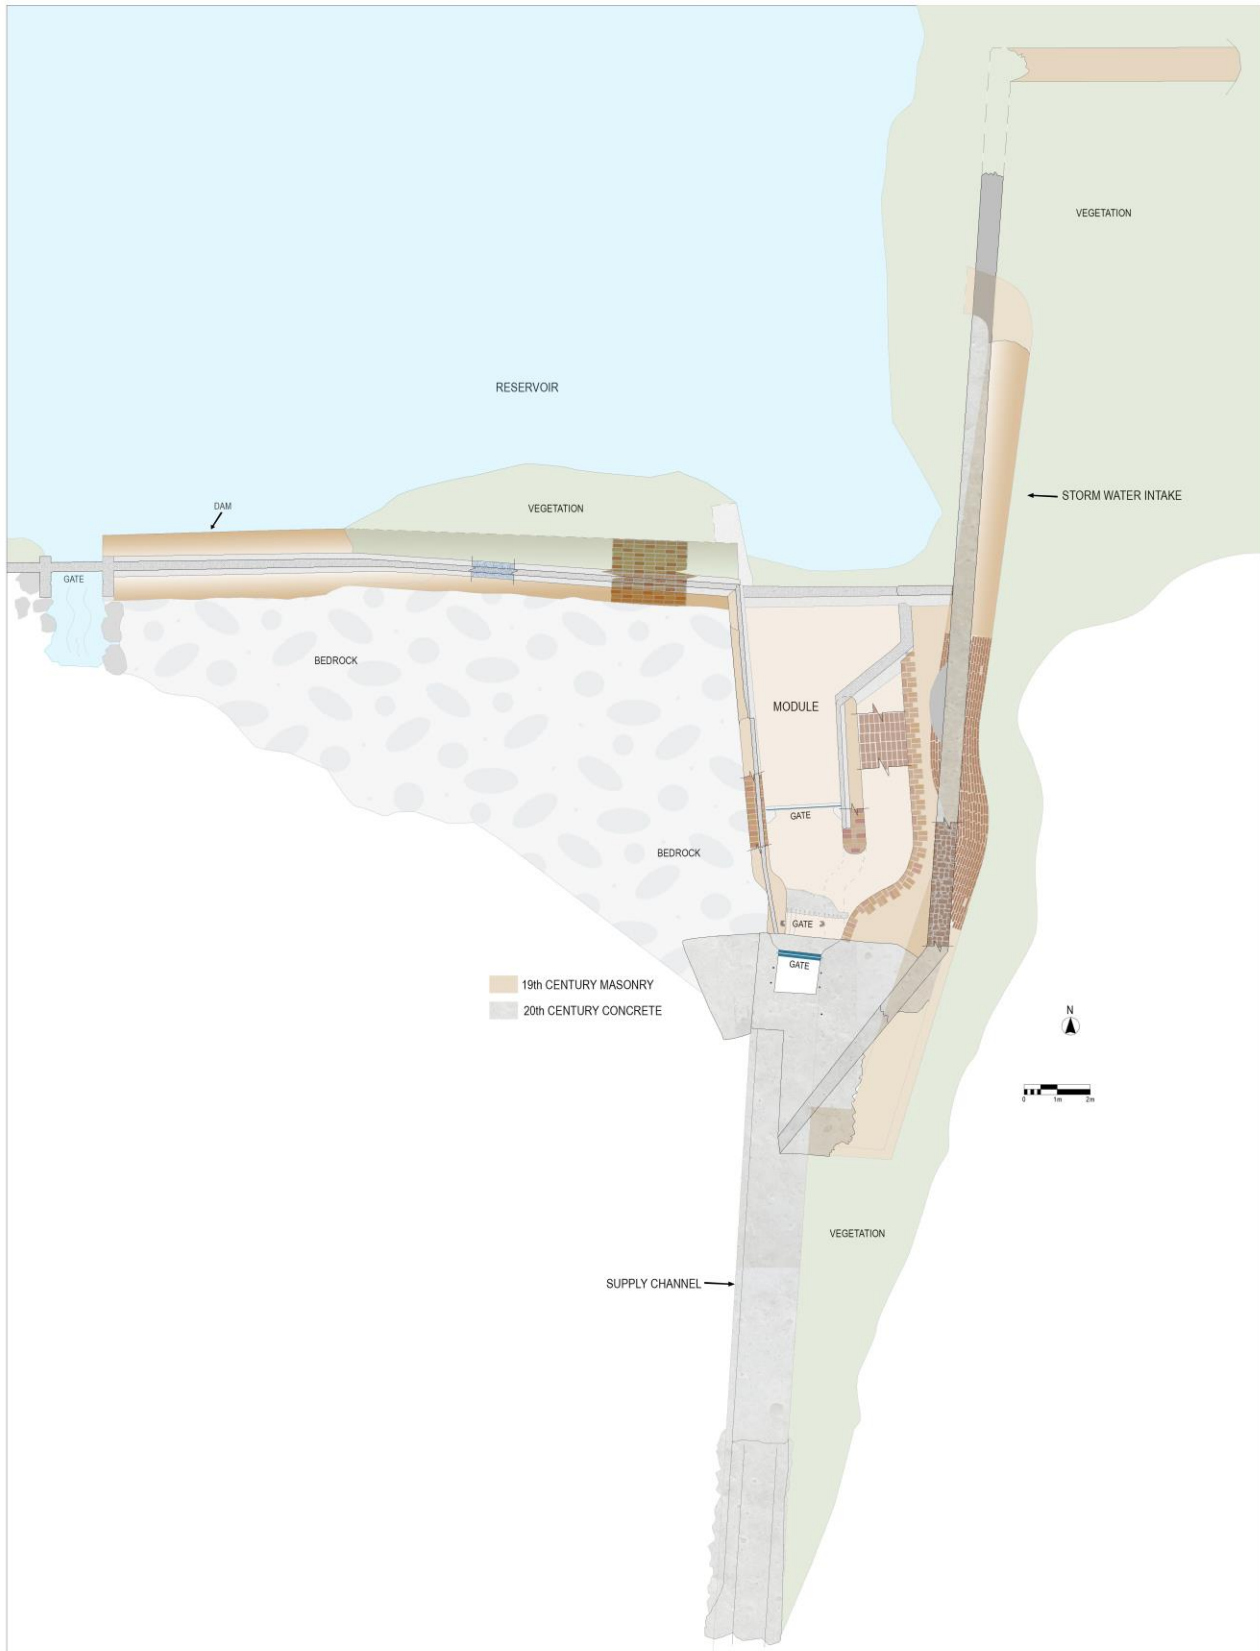
Drawing of the dam and modules of the *Tres Haciendas* Irrigation System
