# National Register of Historic Places Continuation Sheet

Property Name: Sistema de riego de las tres haciendas  
(Waterworks in Puerto Rico, 1840-1898 MPS)

County: Santa Isabel Municipality

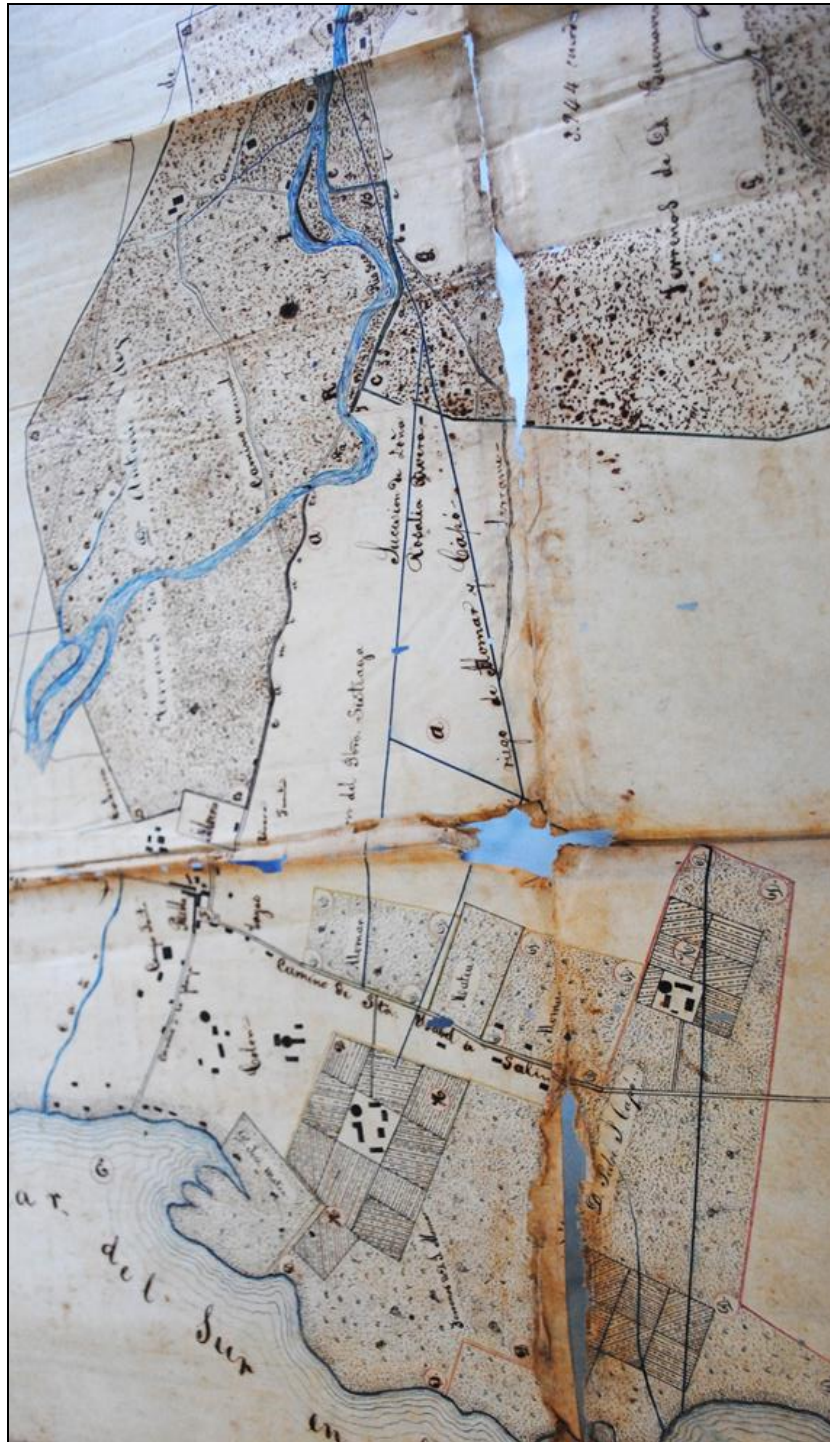
Segment of the topographic map of the lands that request and question irrigation in the jurisdiction of Sta. Ysabel to Coamo, placed according to local jurisdiction of each and belonging to Messrs. Dn. José Alomar, Dn. Pedro Juan Capó, Dn. Buenaventura Toses, neighbors from Ponce and to Dn. Antonio Vélez, neighbour of Sta. Ysabel, 1853 (AGPR, Obras Públicas, Agua, Leg. 21, Caja 410, Plano 56.2).

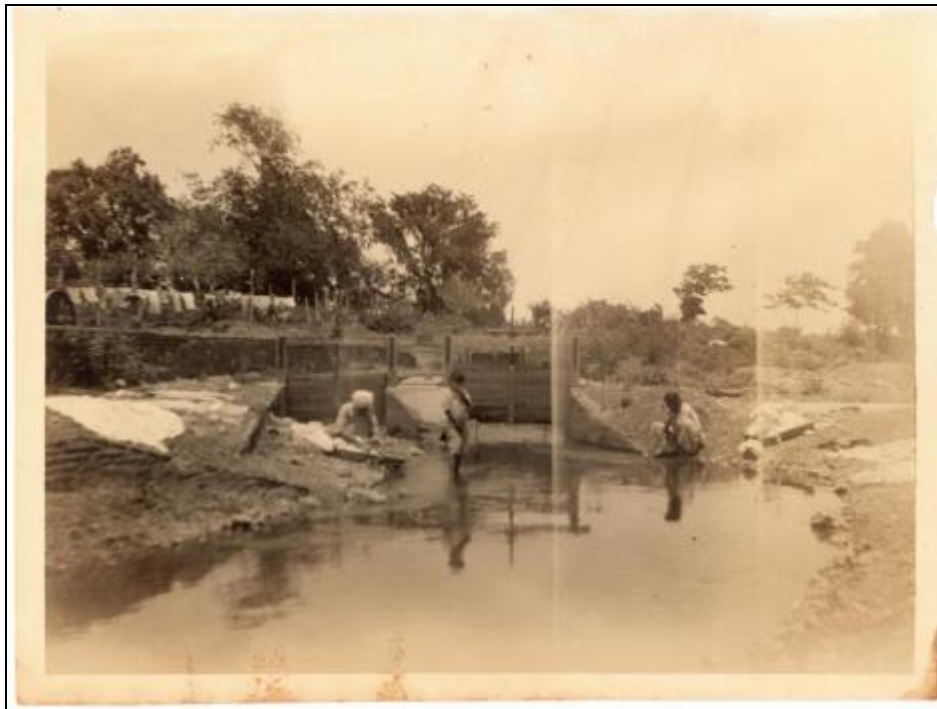
Photo of the main intake for the Florida, Santa Isabel and Destino *Haciendas* or *Tres Haciendas* at the junction of the main canal and the Coamo river, 1913, AAA (from Meléndez Maíz 2011).

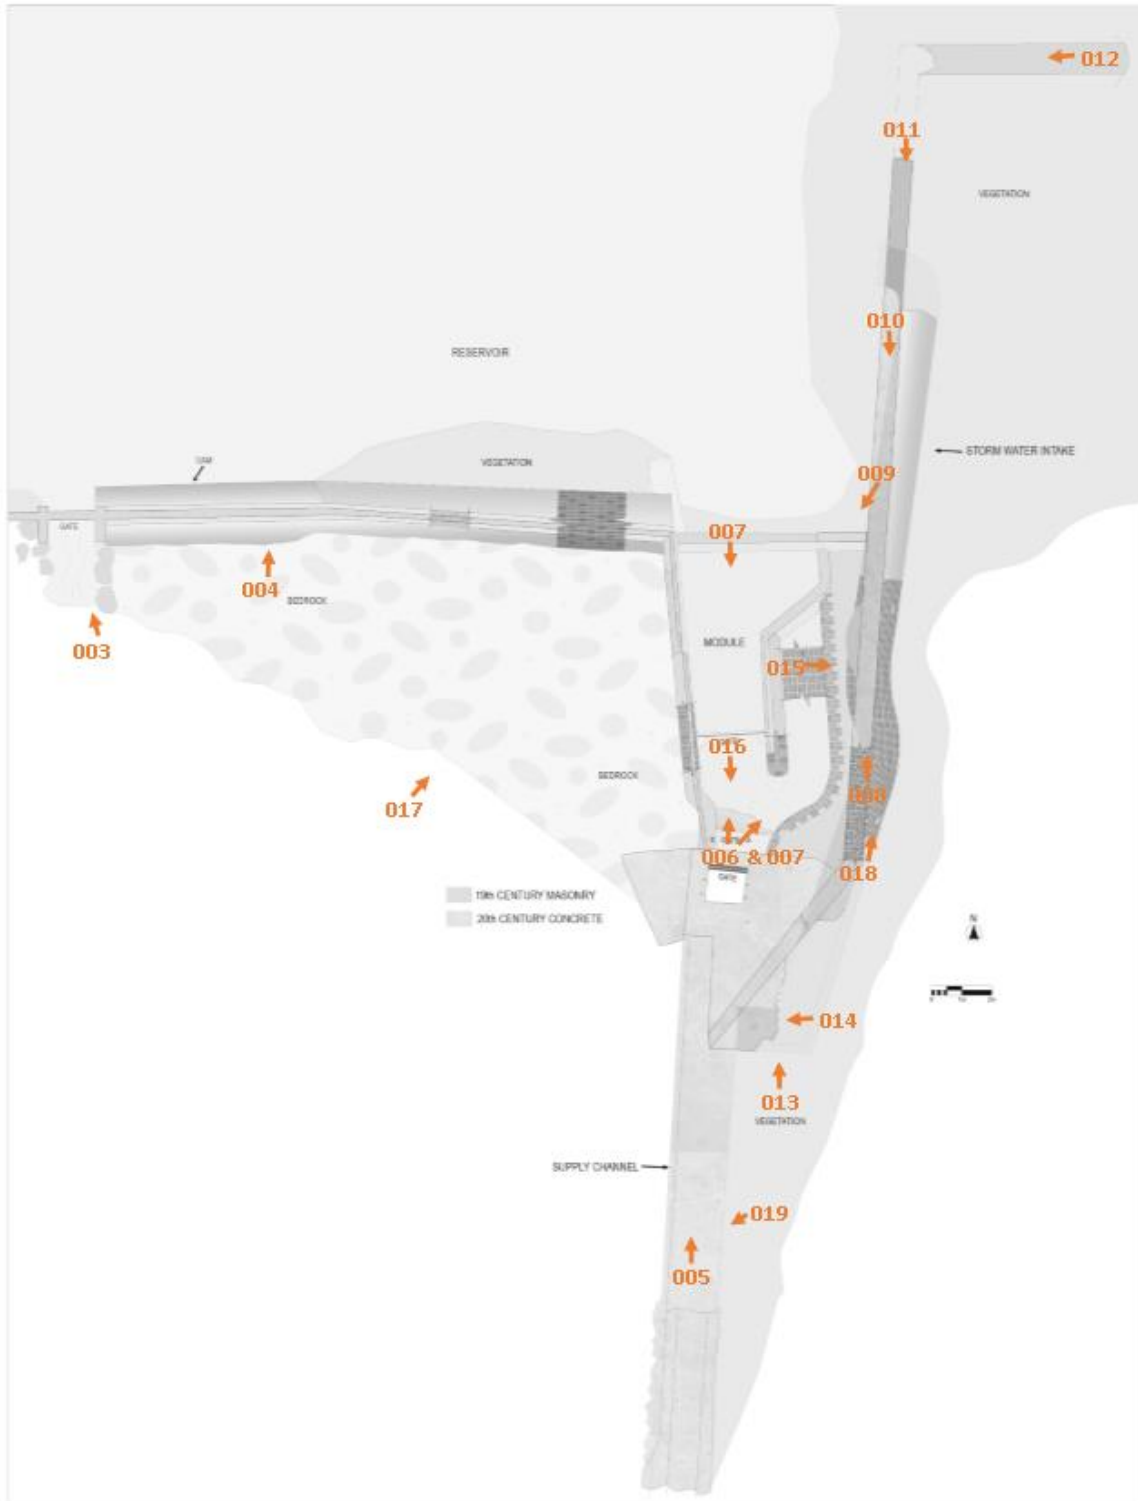
Figure 23: Drawing of dam and module areas with photo locations
