ENVIRONMENTAL SURVEY FOR LEAD BASE PAINT

WAVE RANCH MANUFACTURERS

PW: 8004 / DI: 219020

March 2024

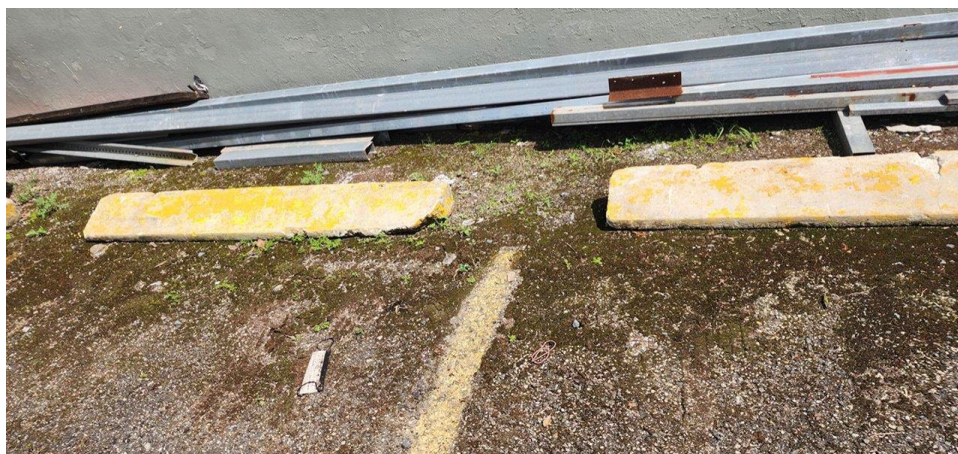
GENERAL VIEW OF POSITIVE EXTERIOR YELLOW, PARKING STOPS (20 units total)

According to the PREQB lead regulations, prior to demolishing a structure containing lead base paint, the contaminated surfaces or substrates must be abated or removed. The waste generated has to be characterized to determine if the waste generated is hazardous or non-hazardous waste according to the regulation. The firm contracted to provide the abatement services must be certified and certified as abatement workers and supervisors by a training provider accredited by PREQB.

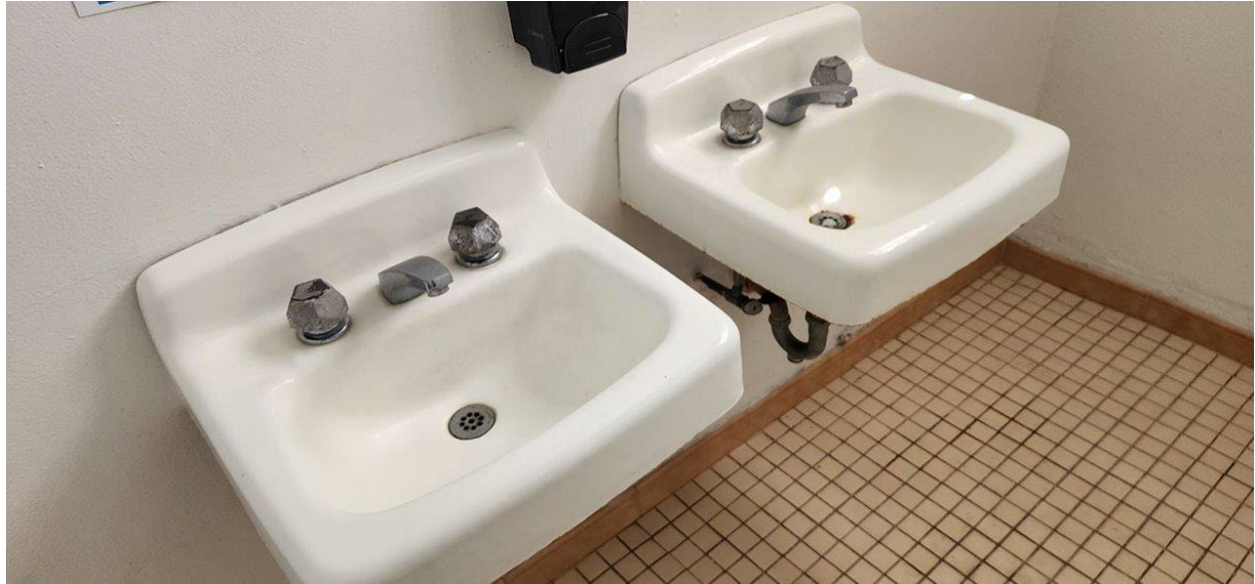
GENERAL VIEW OF POSITIVE MEN BATHROOM CERAMIC, WHITE, SINKS (2 units total)

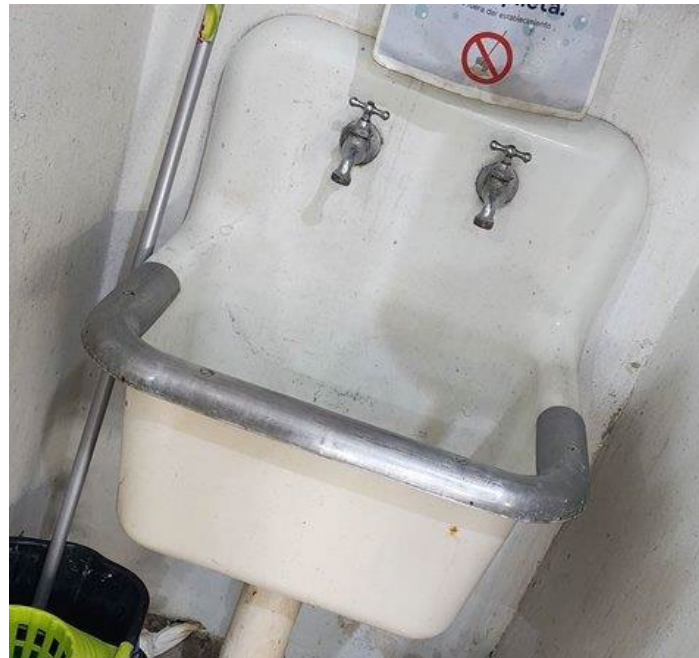
GENERAL VIEW OF POSITIVE MAINTENANCE ROOM CERAMIC, WHITE, SINK (1 unit)

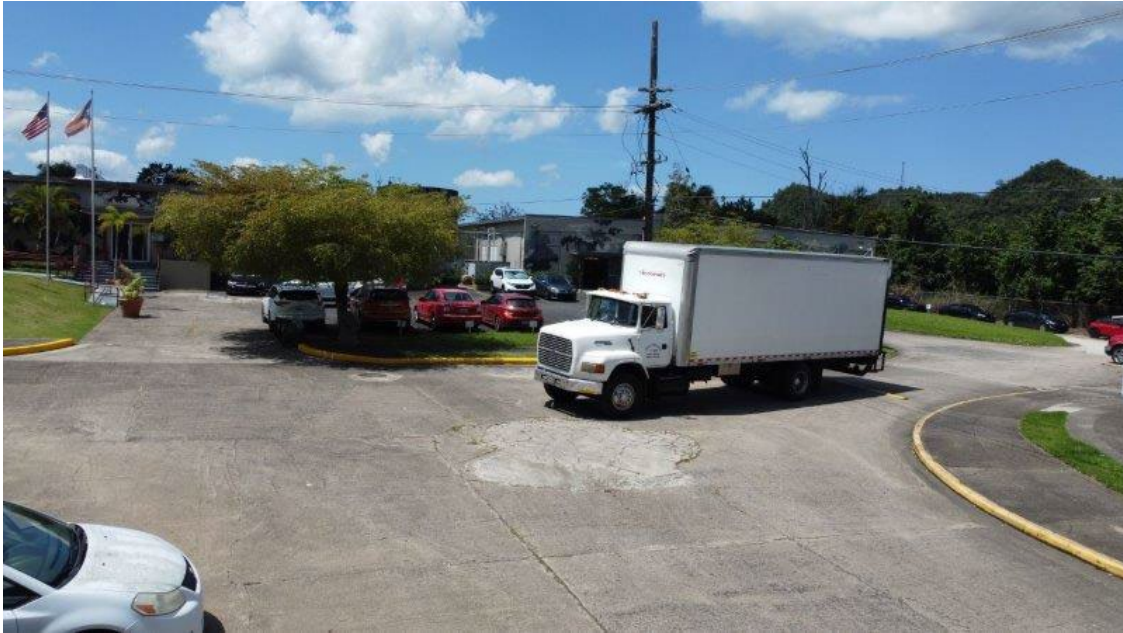
GENERAL VIEW OF POSITIVE PARKING AREA, YELLOW, STREET CURB (200 lf)

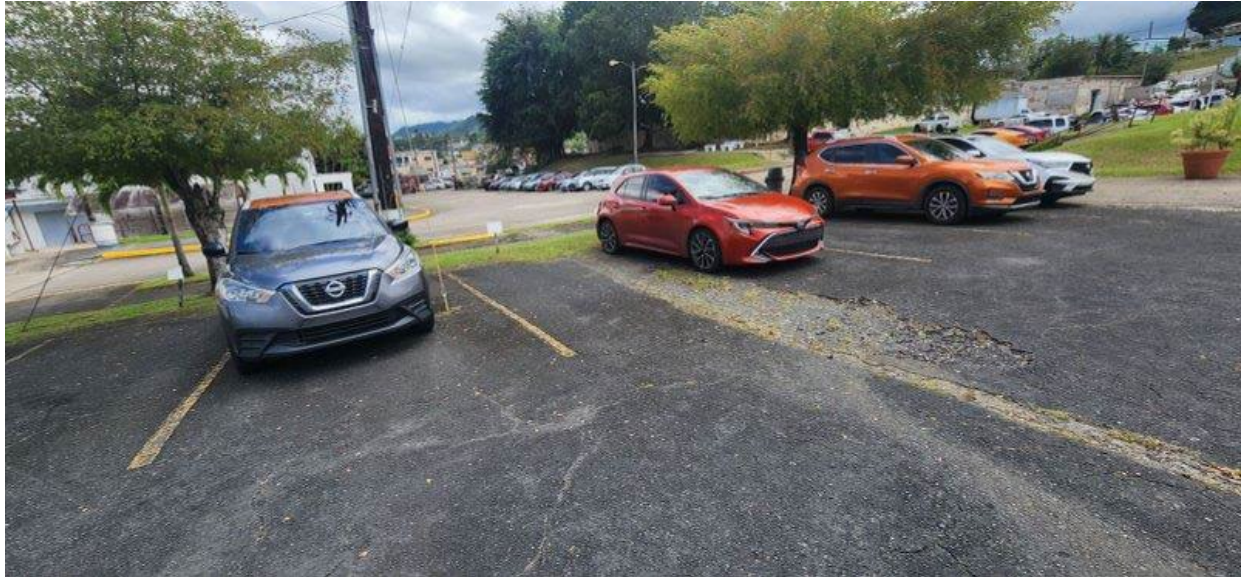
**GENERAL VIEW OF POSITIVE PARKING AREA,
BLUE, DISABLED LINES (400 lf)**
