Negative Lead & Asbesto Certification

Asbestos Containing Materials Inspection

**SAMPLING CONDUCTED AT:
BUILDING T085506700
(PW-7801) & (DI-219340)
NORTH REGION**

Located at Road PR-2 Km. 100.8 San Jose Ward in Quebradillas, PR

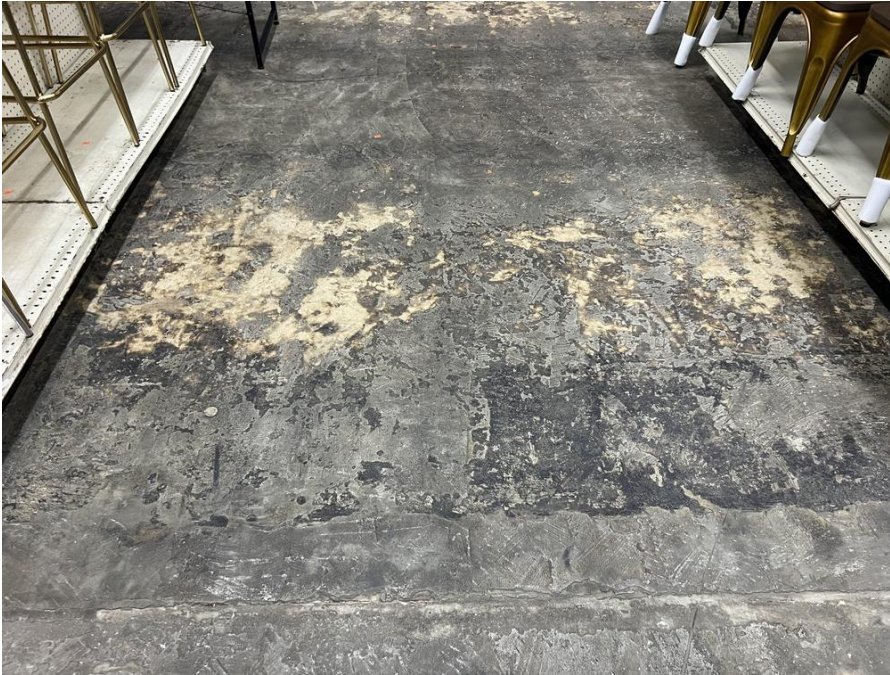
MATERIAL	FUNCTIONAL SPACES	% WITH ASBESTOS	QUANTITY
Black Mastic in Floor	Room 1	2% Chrysotile	1,480 sq. ft. approx. (View Appendix VIII)

Black Mastic in Floor with Asbestos

Global Environmental Services LLC recommends the owner or representative of the owner to hire a Certified Company by Department of Natural and Environmental Resources of Puerto Rico to removal and dispose positive area with Asbestos Containing Material if is going to touch, remodeling or demolish the reference project.

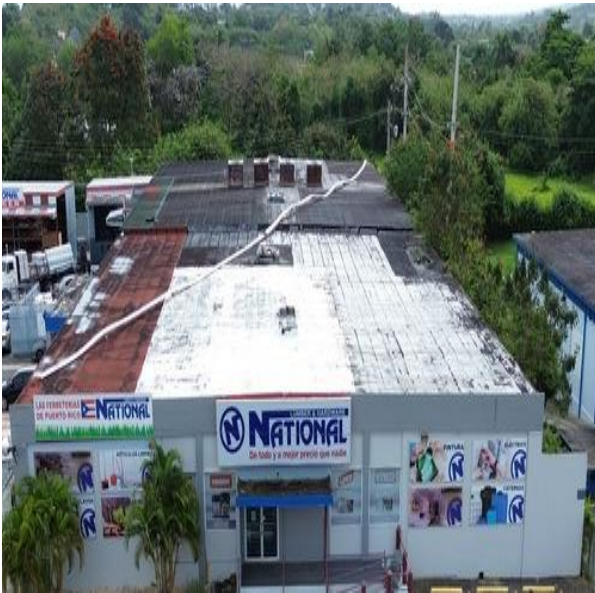
Rooftop area

MATERIAL	FUNCTIONAL SPACES	% WITH ASBESTOS	QUANTITY
Built Top & Flashing (Roofing Materials)	Rooftop Area	5% Chrysotile	25,498 sq. ft. approx. (View Appendix VIII)

Built Top & Flashing with Asbestos

Global Environmental Services LLC recommends the owner or representative of the owner to hire a Certified Company by Department of Natural and Environmental Resources of Puerto Rico to removal and dispose positive area with Asbestos Containing Material if is going to touch, remodeling or demolish the reference project.

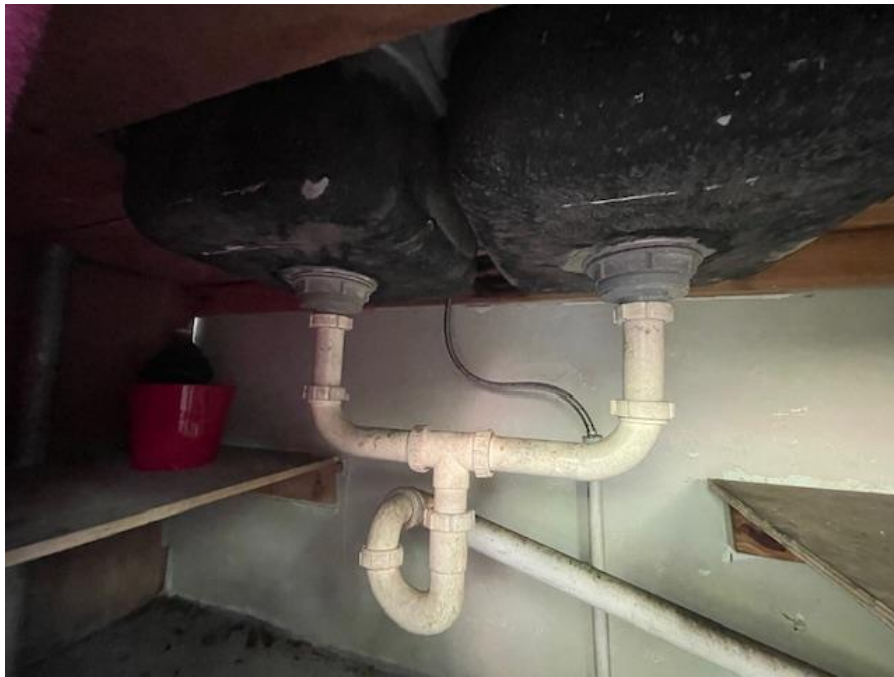
SAMPLE-DI-219458-AR-01

TABLE 1.0 – SUMMARY OF MATERIALS WITH ASBESTOS			
FUNCTIONAL SPACE	MATERIAL	% WITH ASBESTOS	SQ. FT. APPROX.
Lunch Area	Beige Mastic under sink	1% Chrysotile	4 sq. ft. approx. (1 Unit) (View Appendix VIII)

If remodeling or demolishing activities will be conducted in the nearest future it is recommended to remove all Asbestos Containing Materials present within the structure as to comply with NESHAP/DNER requirement.

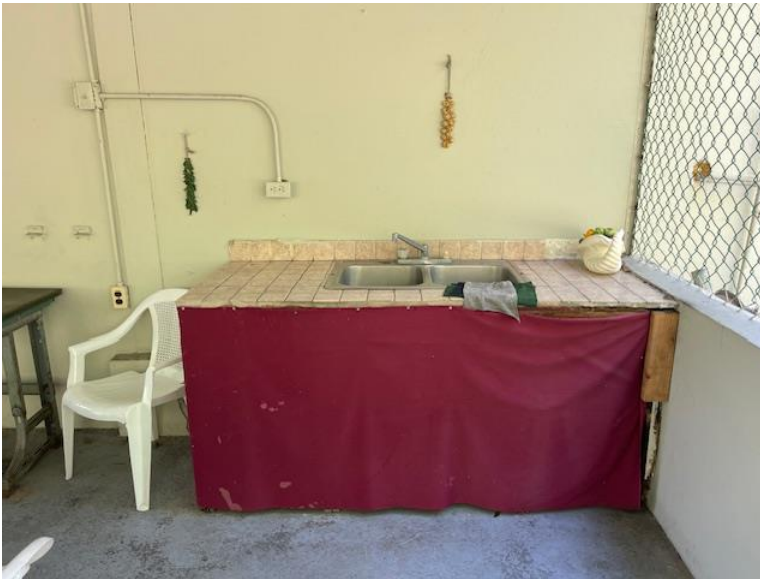
MATERIAL	FUNCTIONAL SPACES	% WITH ASBESTOS	QUANTITY
Black Mastic under sink	Lunch Area	4% Chrysotile	4 sq. ft. approx. (1 Unit) (View Appendix VIII)

Black Mastic under sink with Asbestos

Global Environmental Services LLC recommends the owner or representative of the owner to hire a Certified Company by Department of Natural and Environmental Resources of Puerto Rico to removal and dispose positive area with Asbestos Containing Material if is going to touch, remodeling or demolish the reference project.

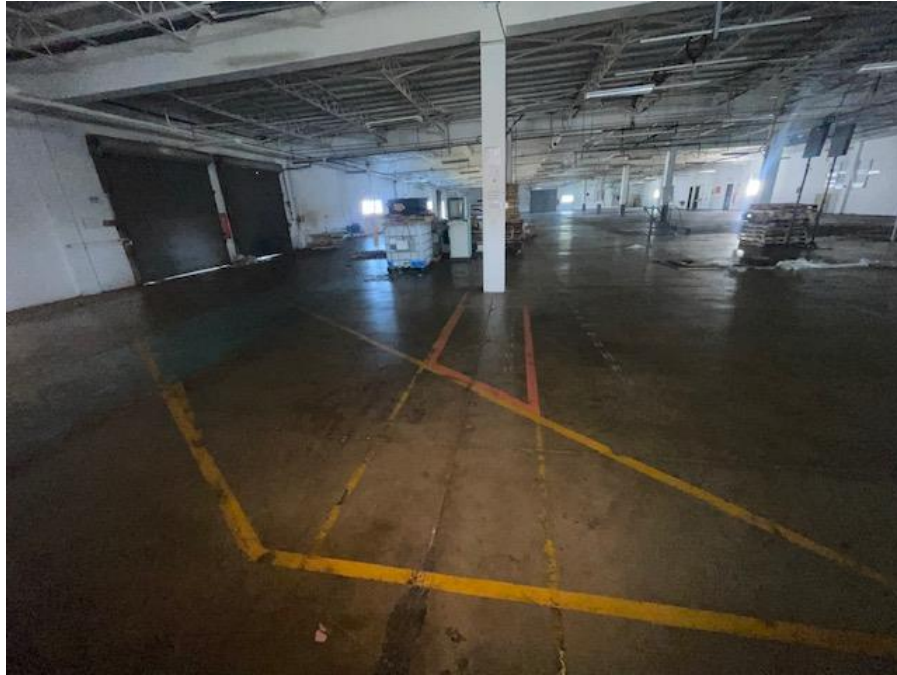
Room 1- Concrete All Yellow Floor Lines with Lead Based Paint

Global Environmental Services LLC recommends the owner or representative of owner to hire a Company Certified in the Department of Natural and Environmental Resources (DNER) of Puerto Rico to mitigate and dispose positive areas with Lead Based Paint if is going to touch or demolish the Building areas.

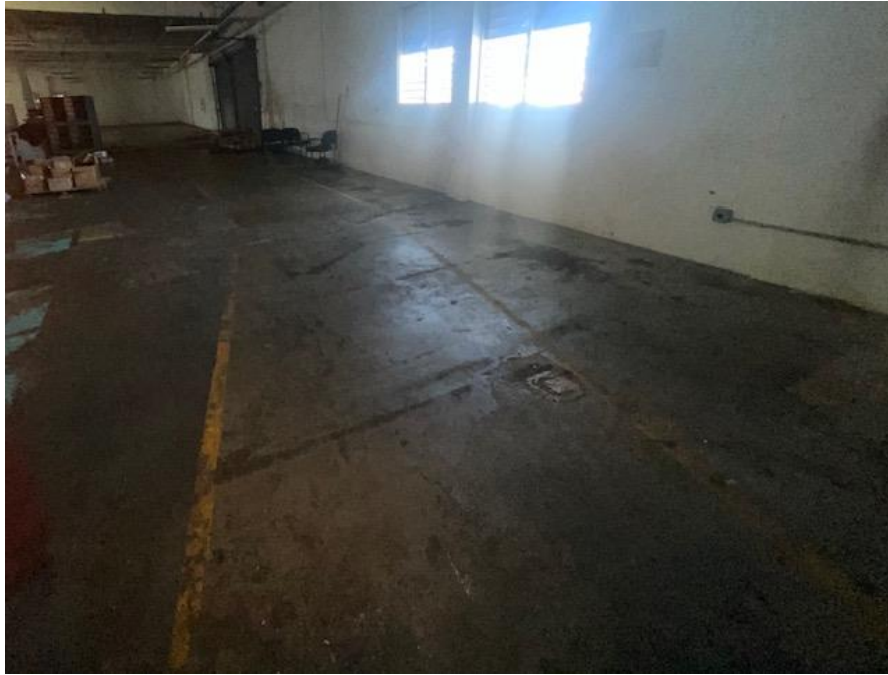
Room 1- Concrete All Yellow Floor Lines with Lead Based Paint

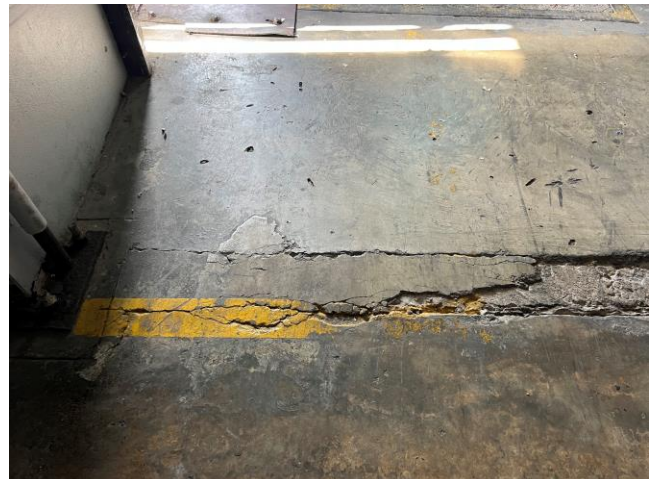
Room 1- Concrete Yellow Floor Lines with Lead Based Paint

Global Environmental Services LLC recommends the owner or representative of owner to hire a Company Certified in the Department of Natural and Environmental Resources (DNER) of Puerto Rico to mitigate and dispose positive areas with Lead Based Paint if is going to touch or demolish the Building areas.
