LEAD & ASBESTOS CERTIFICATION

ASBESTOS CONTAINING MATERIALS

T13940861
PW: 8583 / DI: 407866
PR-860 Bo. Las Cuevas
Trujillo Alto, P.R.

PRIDCO

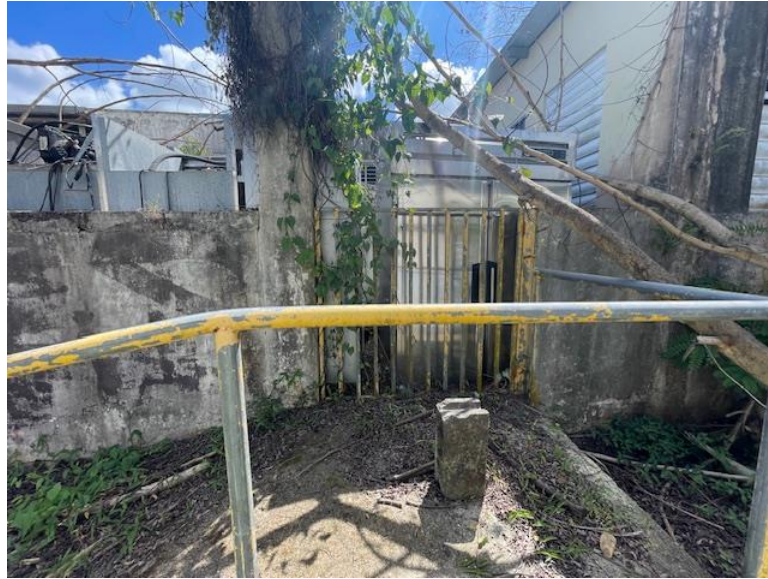
Exterior- Side D- Metal Gate with Lead Based Paint

Global Environmental Services LLC recommends the owner or representative of owner to hire a Company Certified in the Department of Natural and Environmental Resources (DNER) of Puerto Rico to mitigate and dispose positive areas with Lead Based Paint if is going to touch or demolish the Building areas.

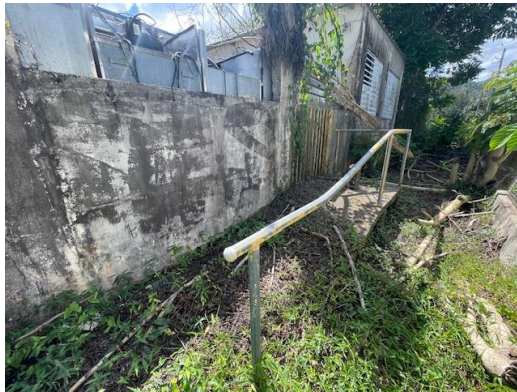
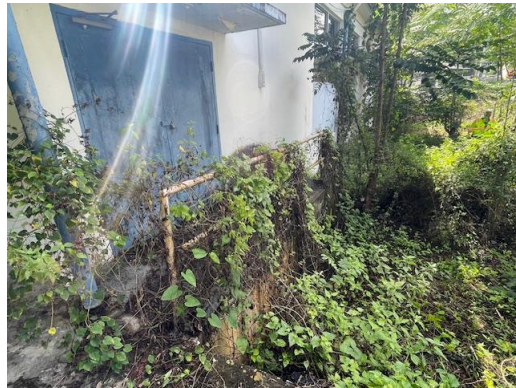
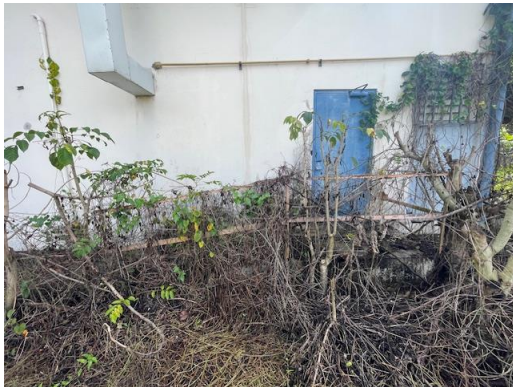
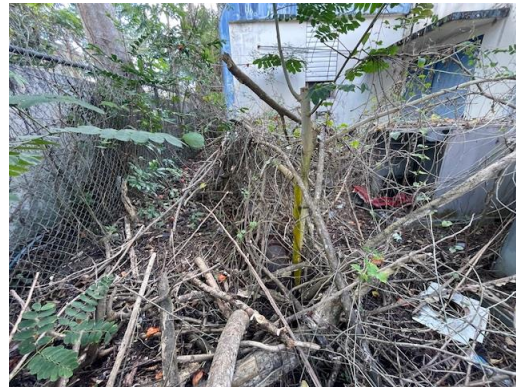
Exterior- Sides - Metal Handrails with Lead Based Paint

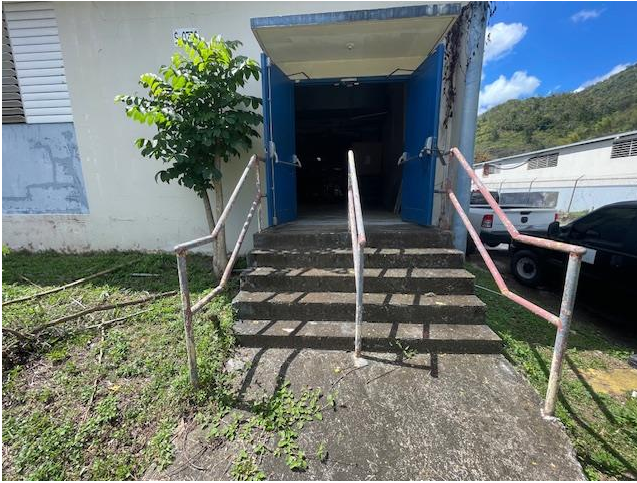
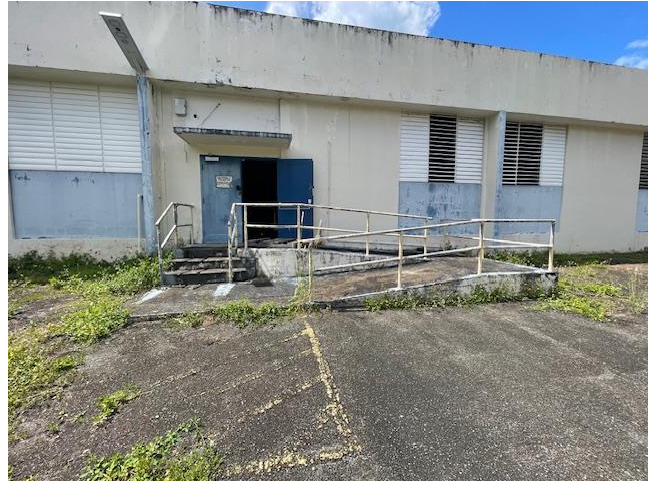
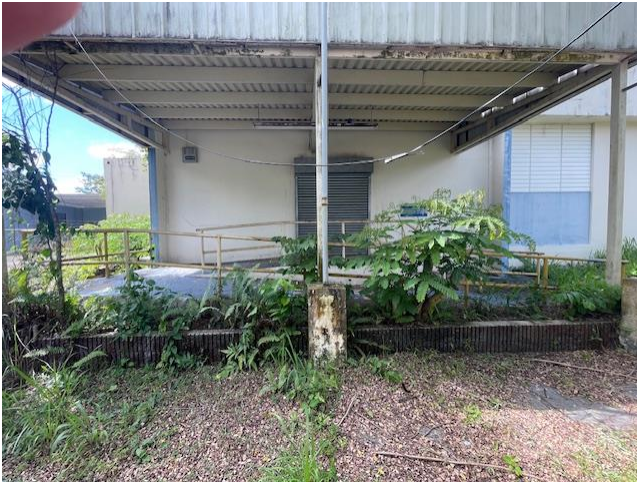
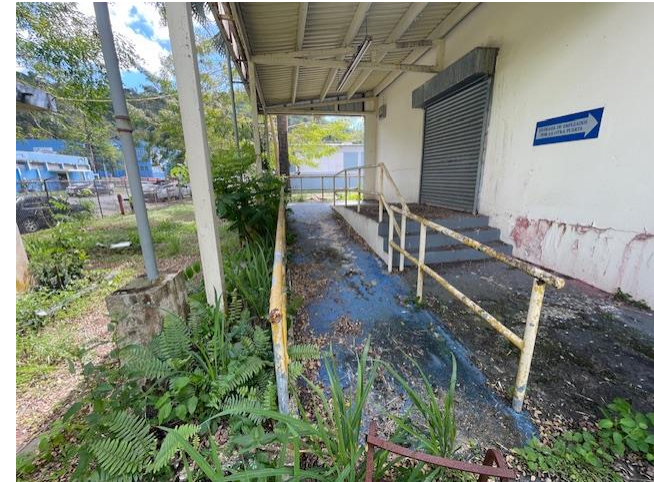
Exterior- Sides - Metal Handrails with Lead Based Paint

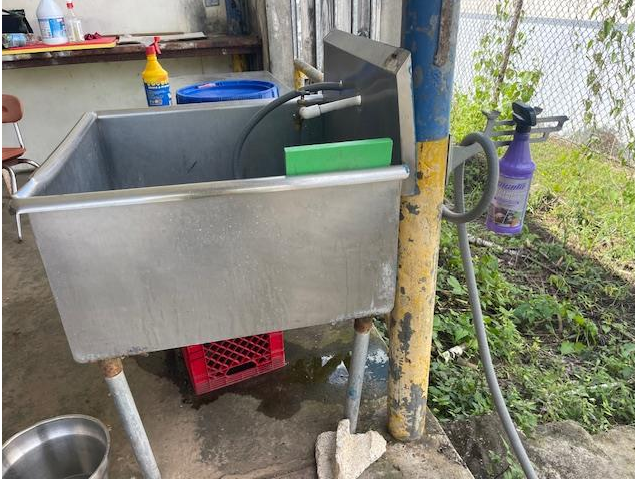
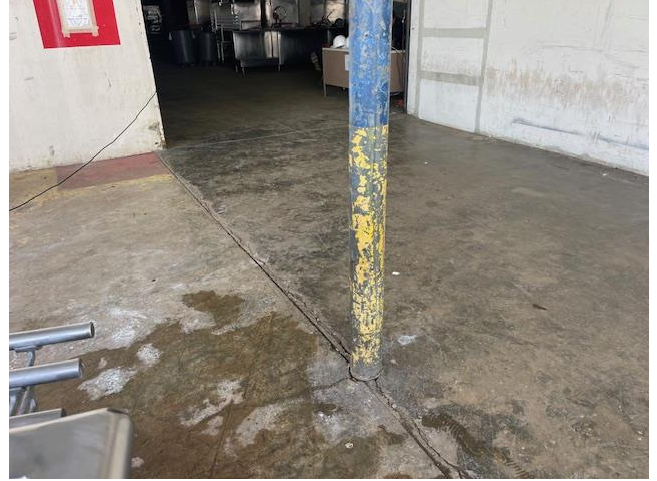
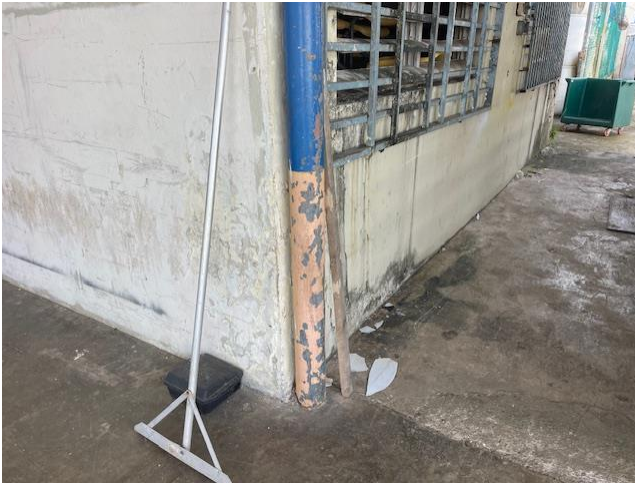
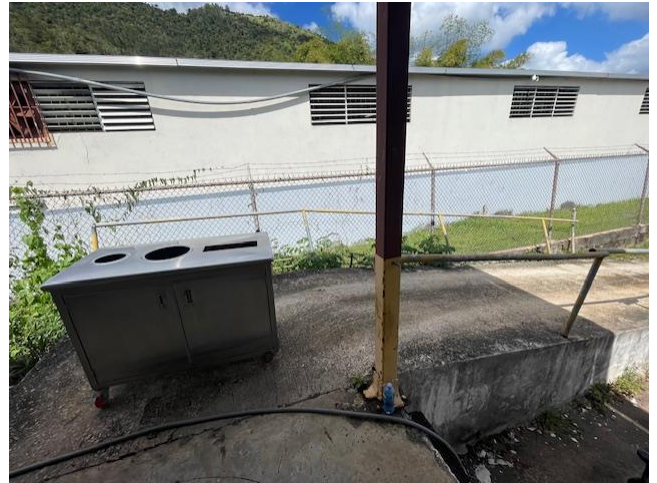
Loading Dock- Yellow Area (5) Five Metal Columns with Lead Based Paint

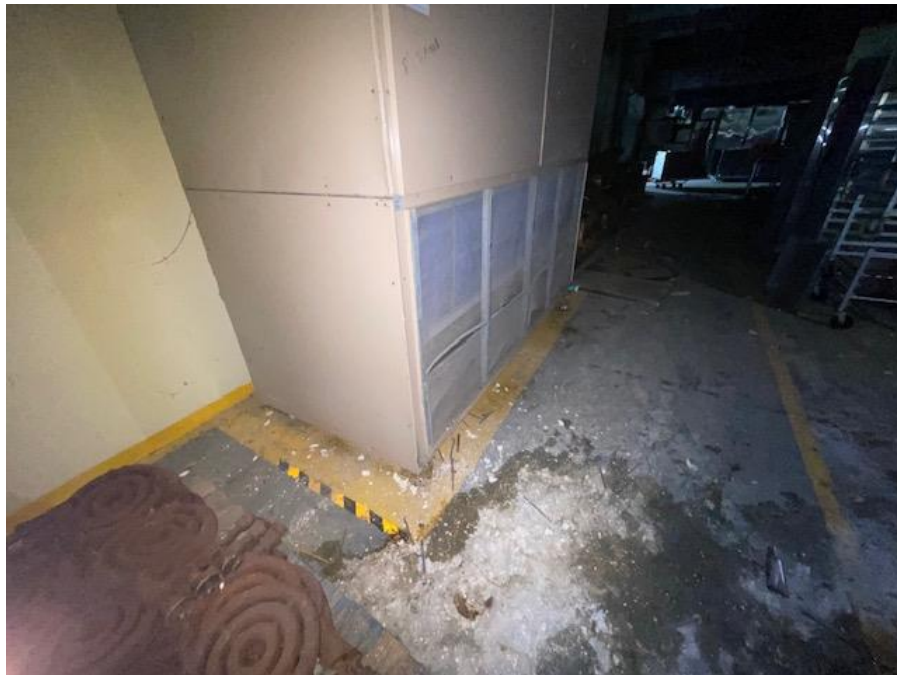
Room 1- Yellow All Floor Lines with Lead Based Paint

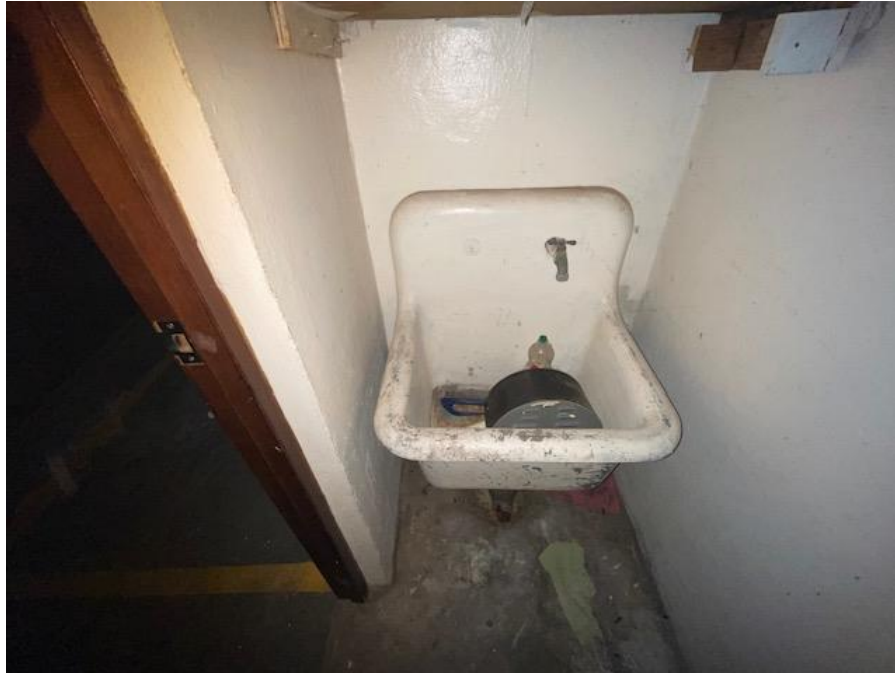
Janitor 1- Ceramic Sink with Lead Based Paint

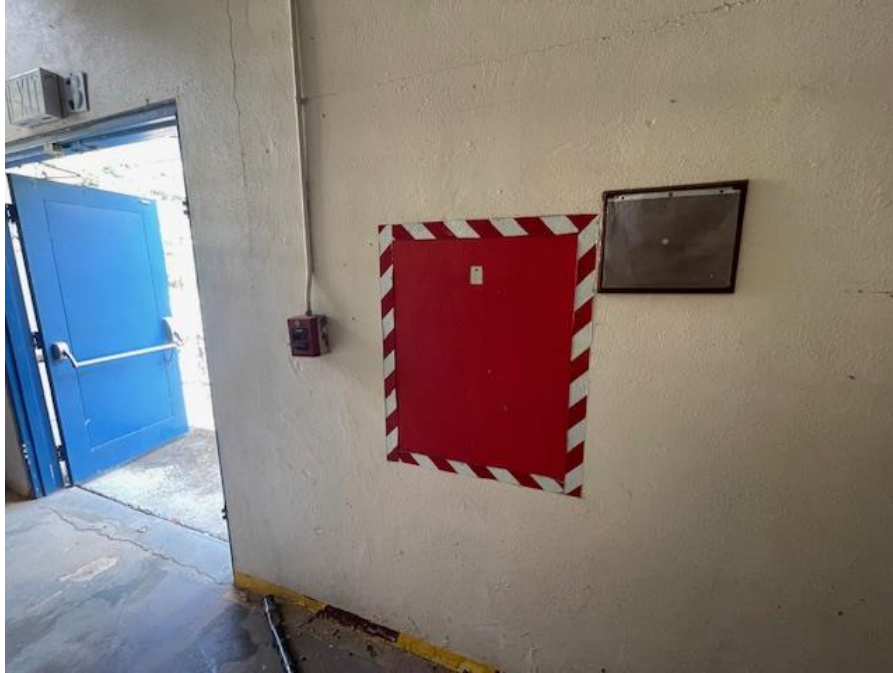
Room 1- Red Concrete Wall & Floor Extincter Area with Lead Based Paint
