POLES CONDITION ASSESSMENT REPORT

PROJECT: HURRICANE MARIA DAMAGES REPAIRS
TO ROOSEVELT ROADS ELECTRICAL
SYSTEM (19-1741)

LOCATION: Roosevelt Roads,
Ceiba, PR

DATE: May 17, 2018

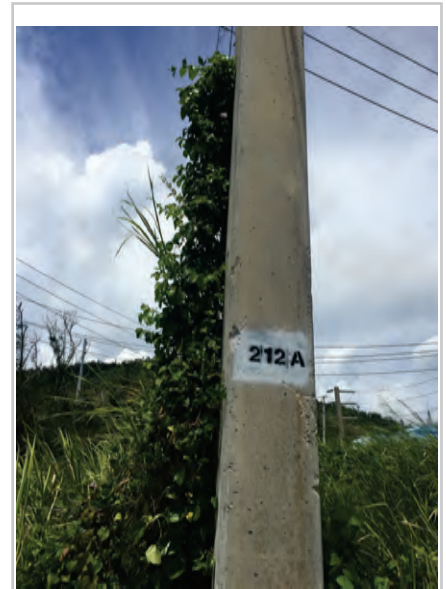
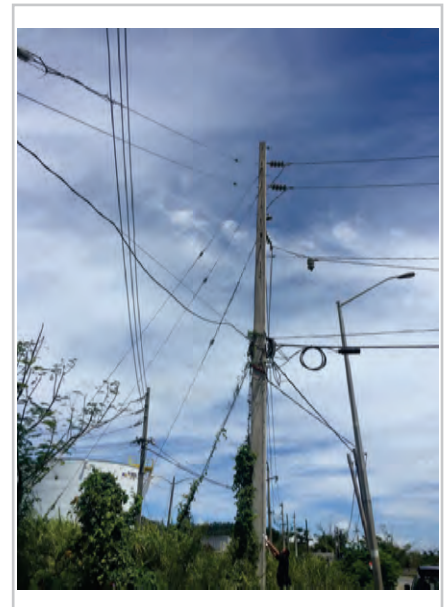
Condition: GOOD

Comments: ONE 38 KV INSULATOR HANGING FROM LINE

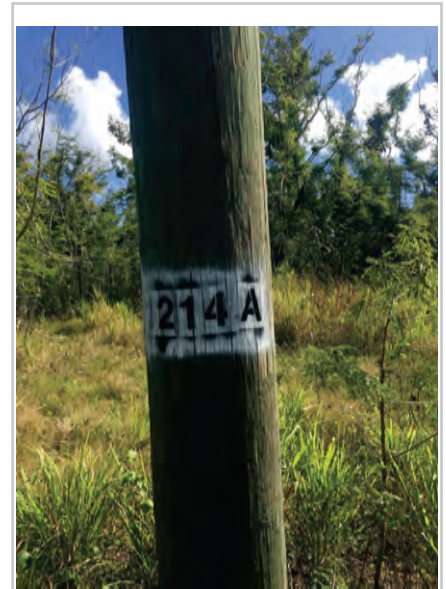
Condition: ^{OUT OF SERVICE} _____

Comments: ^{ONLY ONE PHASE AND GROUND REMAIN CONNECTED} _____
N/A

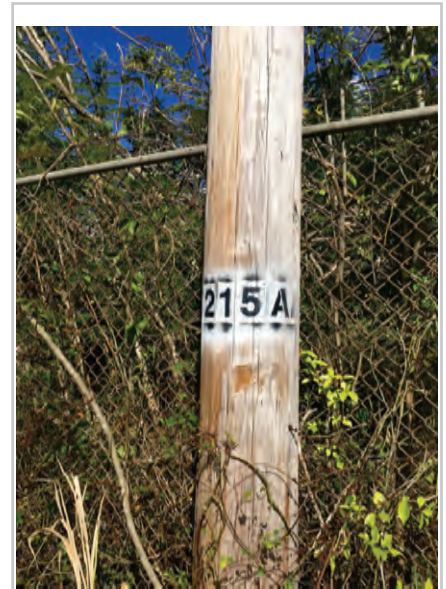
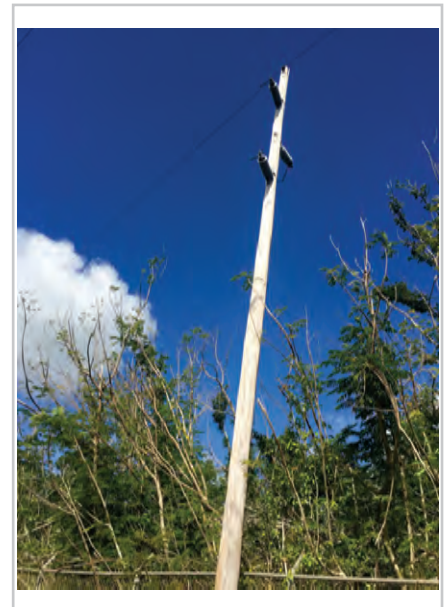
Condition: OUT OF SERVICE

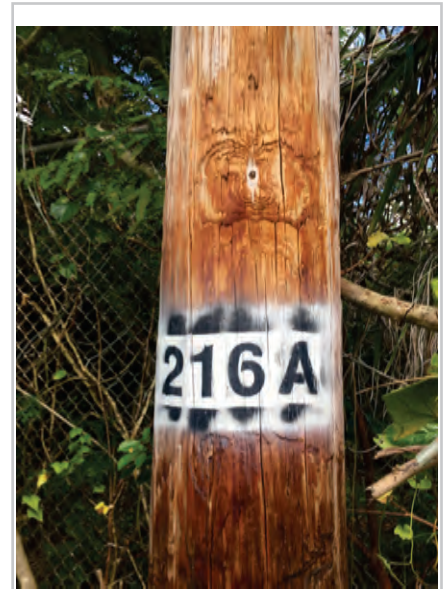
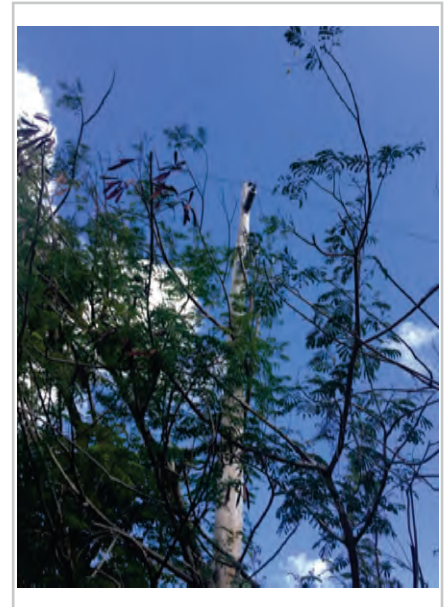
Condition: ^{OUT OF SERVICE} _____

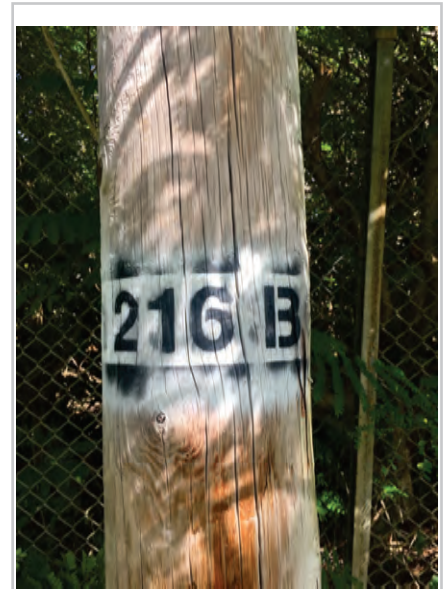
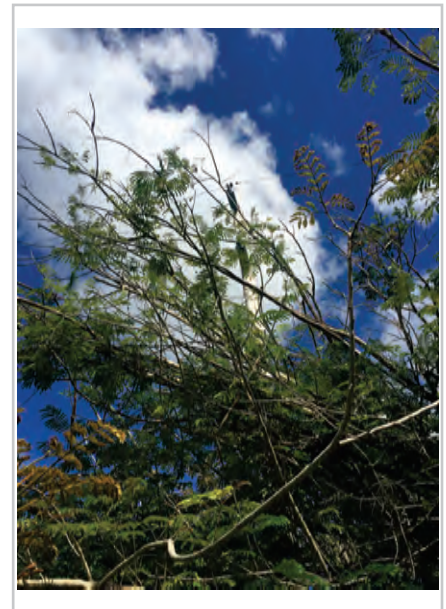
Condition: ^{OUT OF SERVICE} _____

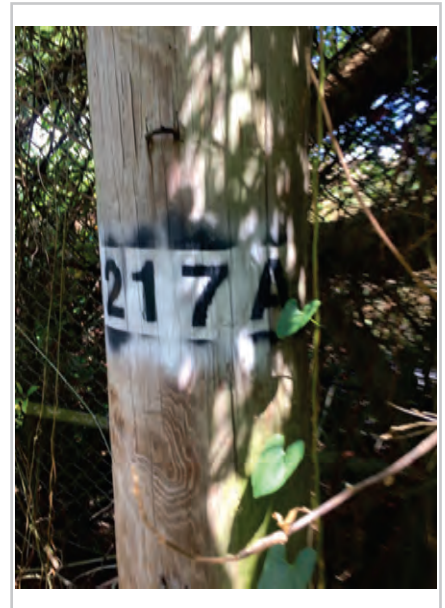
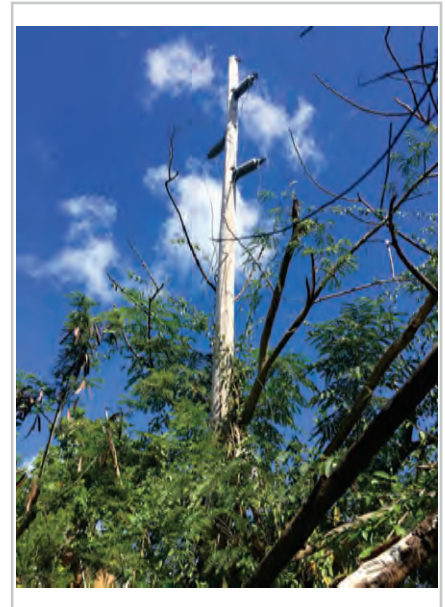
Condition: ^{OUT OF SERVICE} _____

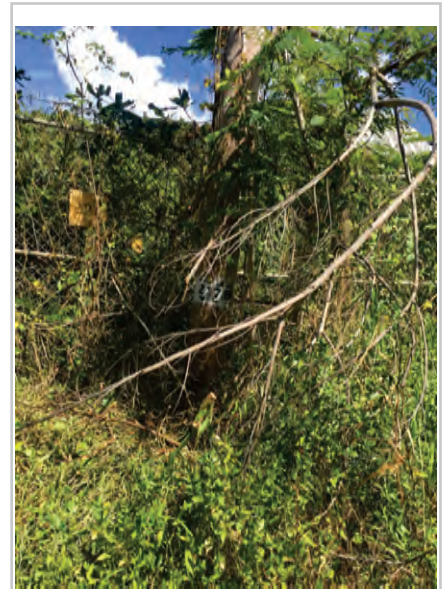
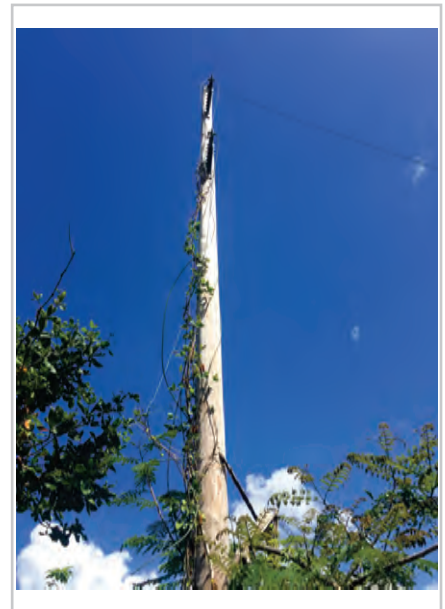
Condition: ^{OUT OF SERVICE} _____

Comments: ^{ONLY GROUND REMAIN CONNECTED} _____
N/A

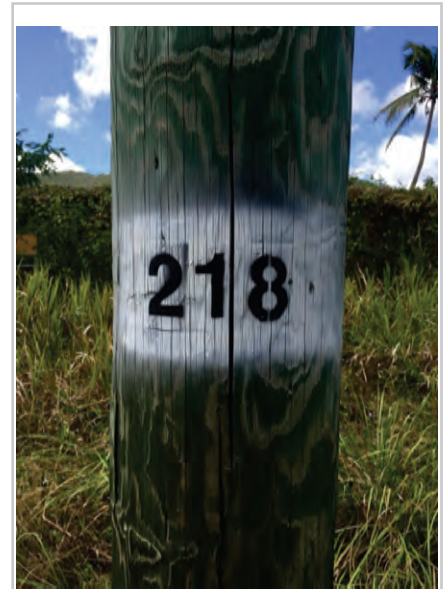
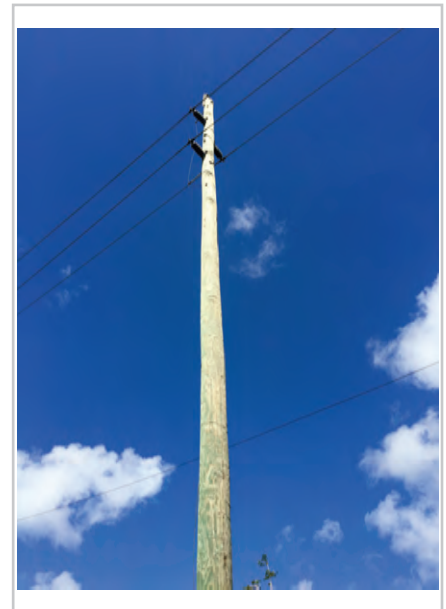
Comments: GROUND CONDUCTOR IS DISCONNECTED FROM INSULATOR

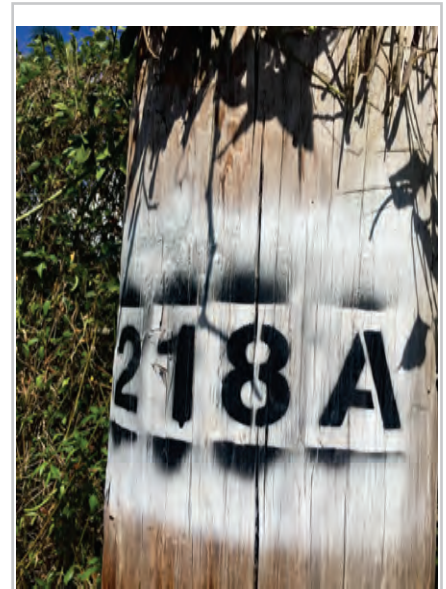
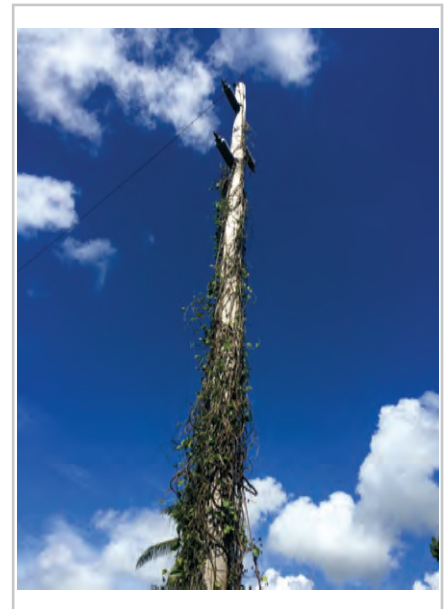
Condition: OUT OF SERVICE

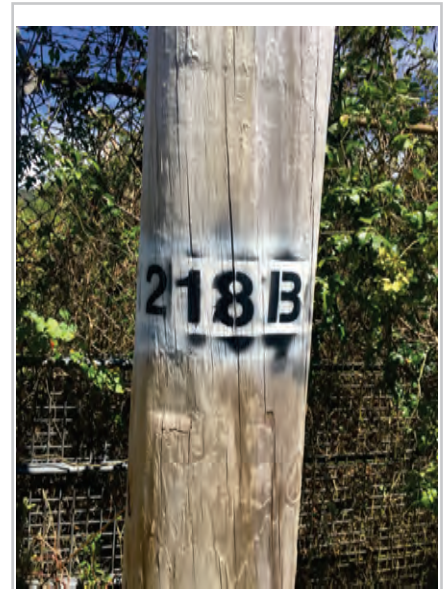
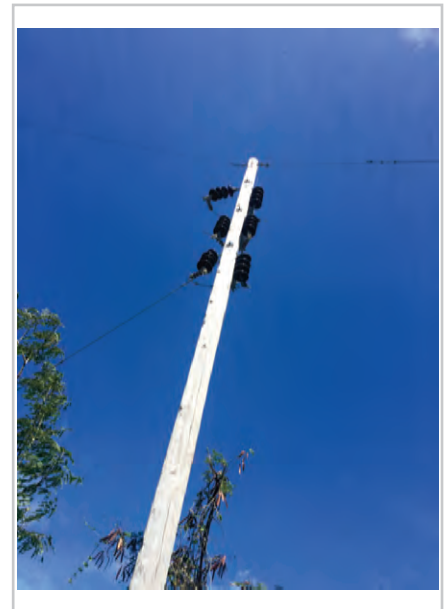
Condition: ^{OUT OF SERVICE} _____

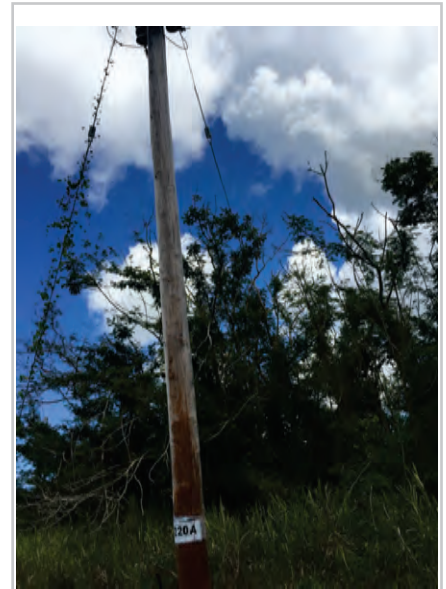
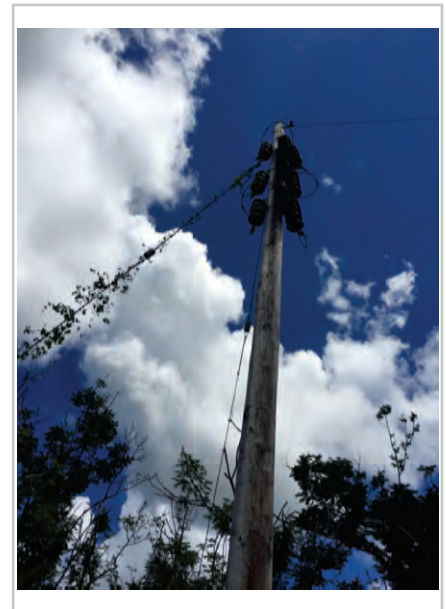
Condition: ^{OUT OF SERVICE} _____

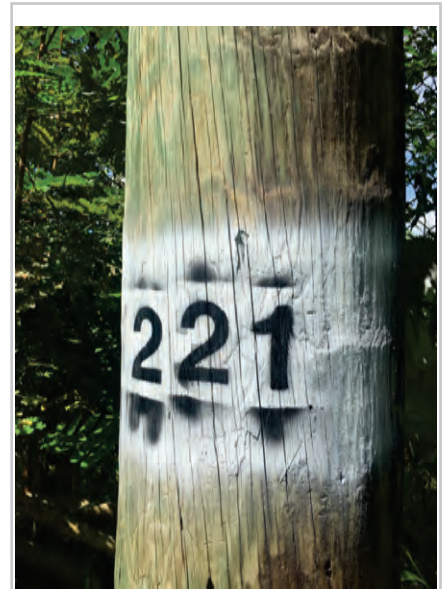
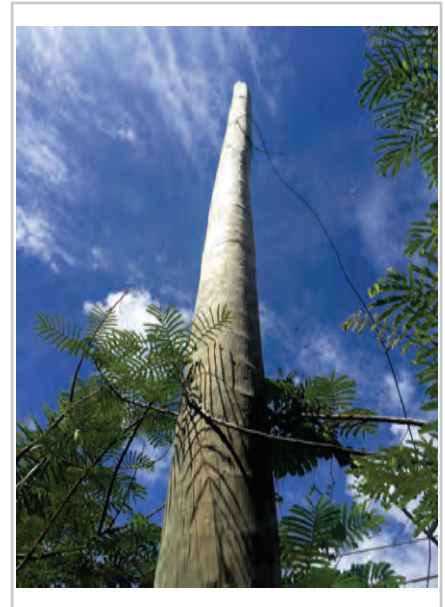
Photo 1: Pole Identification

Condition: BROKEN

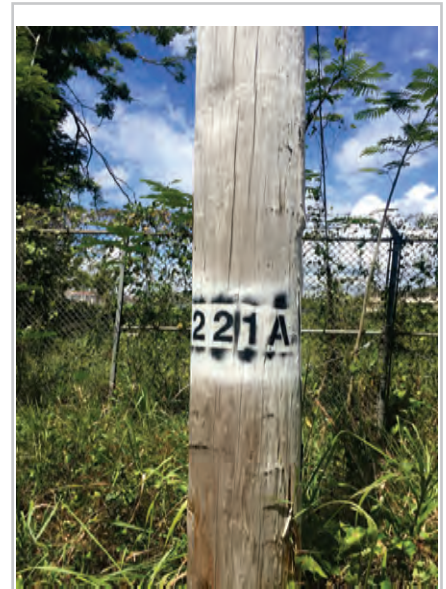
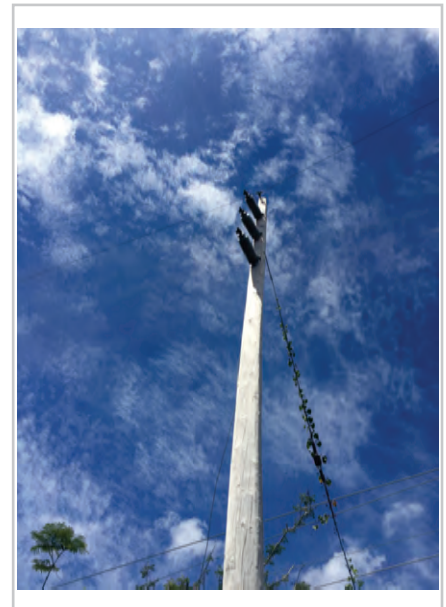
Photo 1: Pole Identification

Condition: ^{OUT OF SERVICE} _____

Comments: ^{ONLY GROUND CONNECTED} _____
N/A

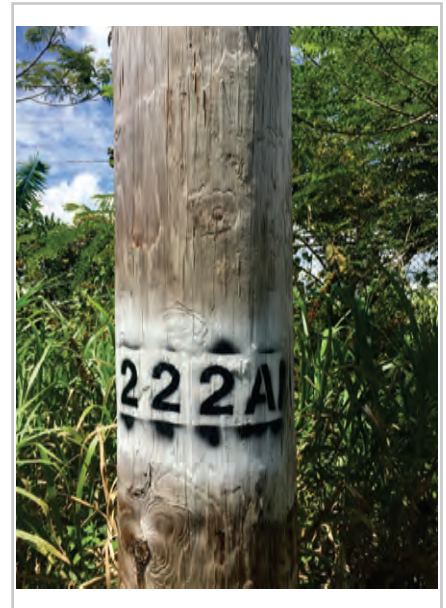
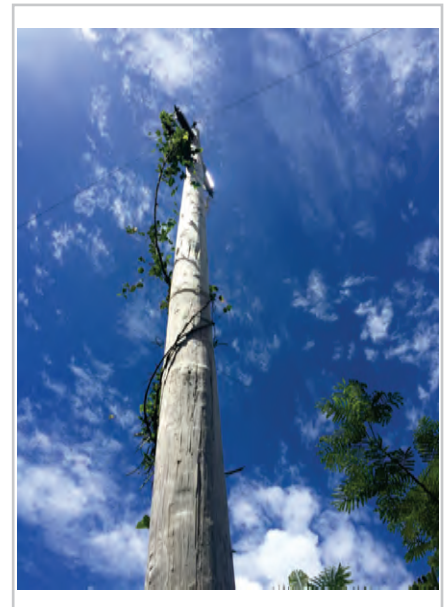
Photo 1: Pole Identification

Condition: OUT OF SERVICE

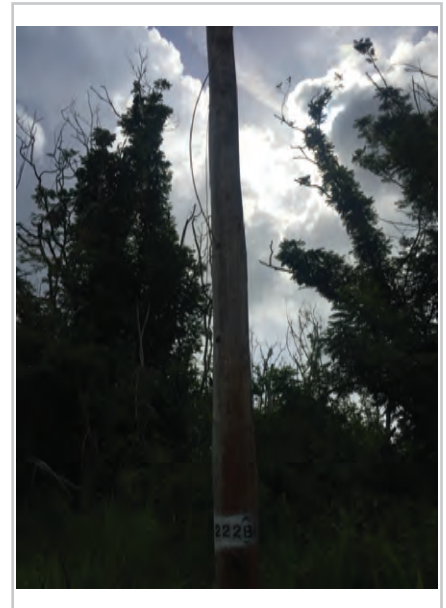
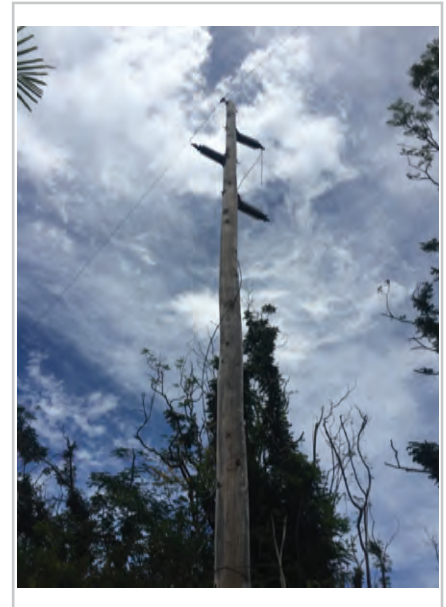
Photo 1: Pole Identification

Condition: OUT OF SERVICE

Comments: ONLY GROUND CONNECTED

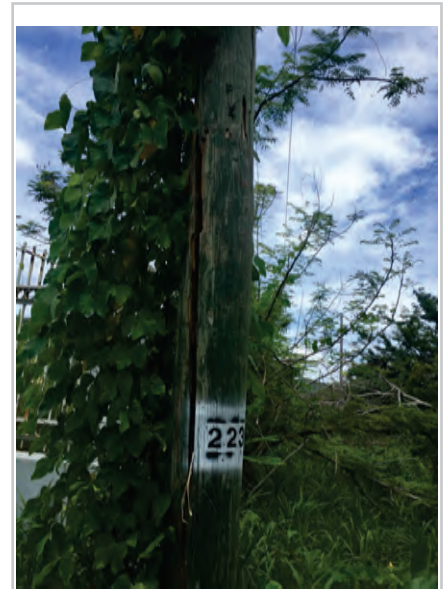
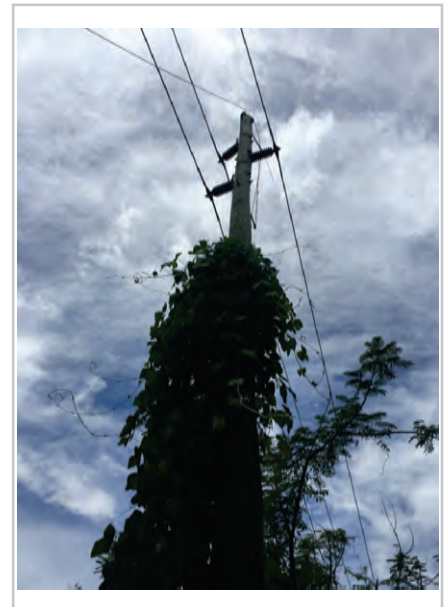
Photo 1: Pole Identification

Condition: ^{BROKEN AT BASE} _____

Comments: ^{GROUND CONDUCTOR AT FLOOR} _____

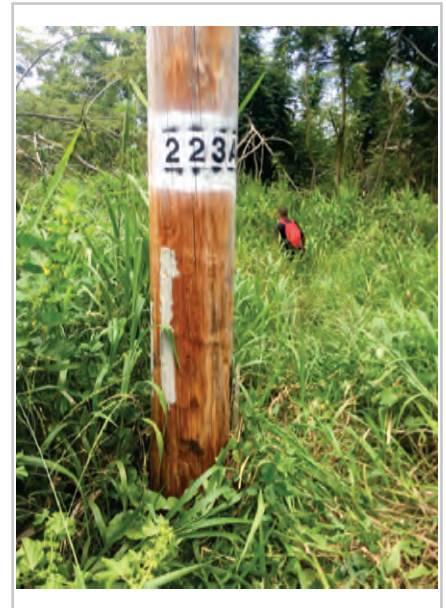
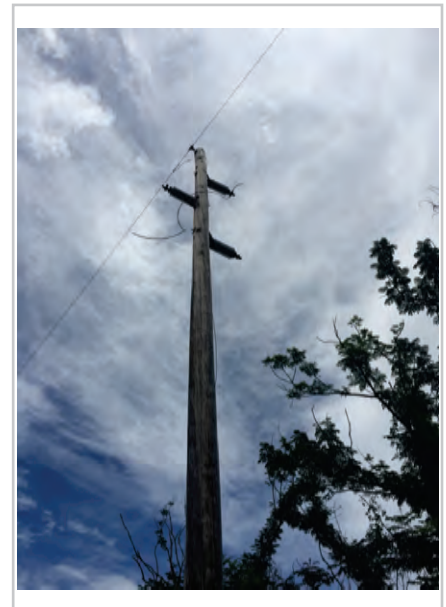
Photo 1: Pole Identification

Condition: ^{OUT OF SERVICE} _____

Comments: ^{ONLY GROUND CONNECTED} _____
N/A

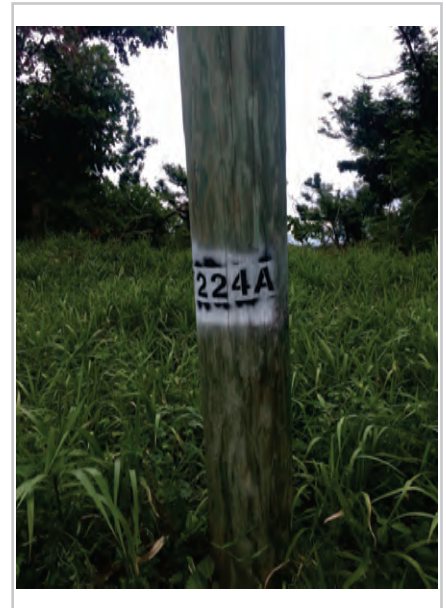
Photo 1: Pole Identification

Condition: OUT OF SERVICE

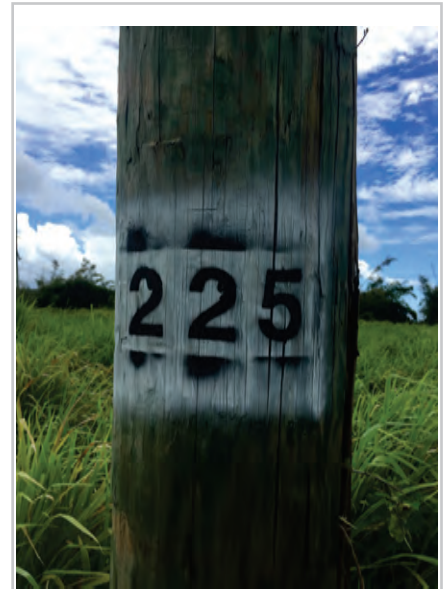
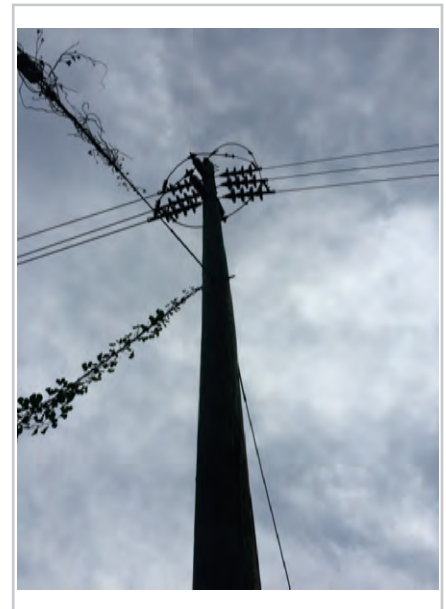
Photo 1: Pole Identification

Condition: BROKEN AT BASE

Comments: GROUND CONDUCTOR AT FLOOR

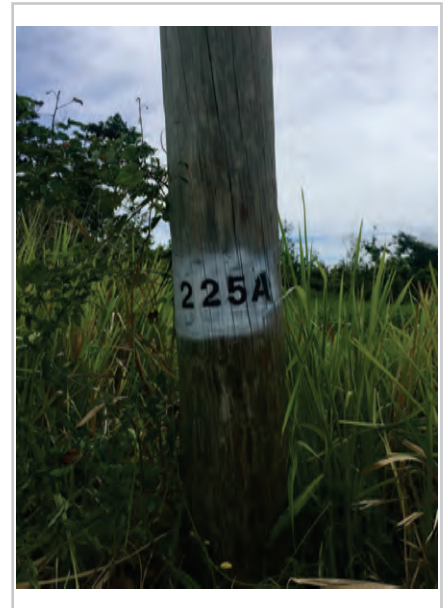
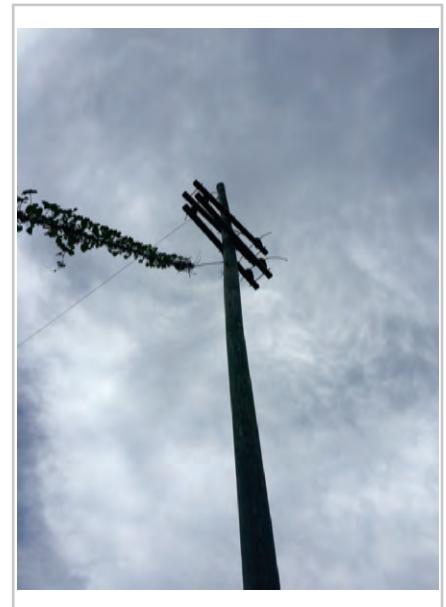
Photo 1: Pole Identification

Condition: ABANDONED

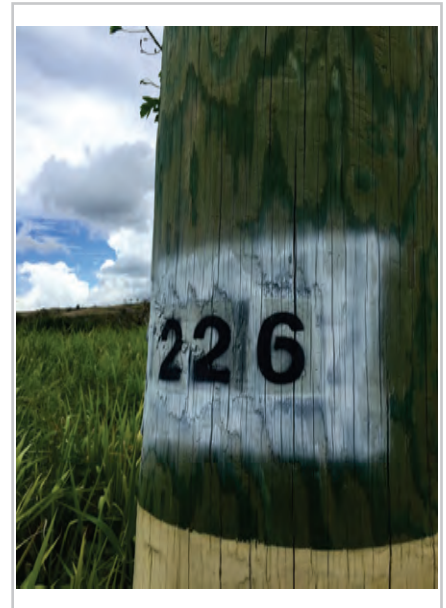
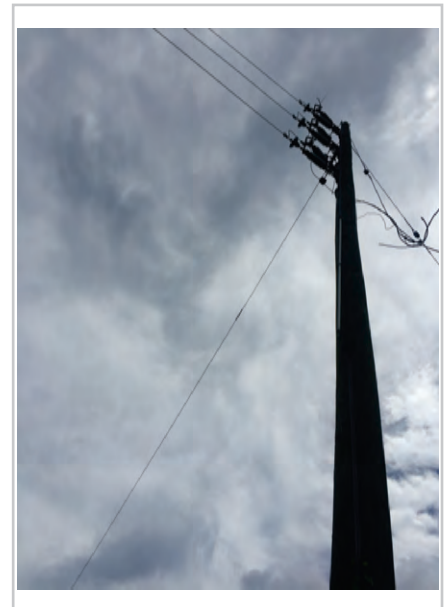
Photo 1: Pole Identification

Condition: ^{GOOD, LITTLE INCLINED} _____

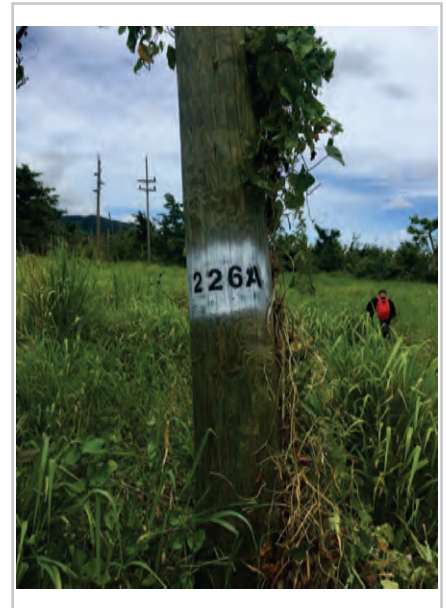
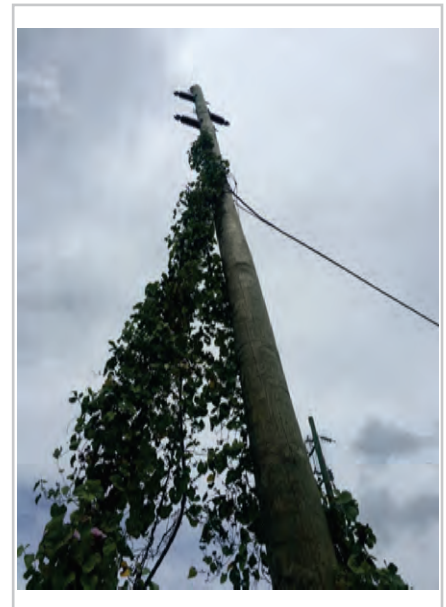
Photo 1: Pole Identification

Condition: OUT OF SERVICE

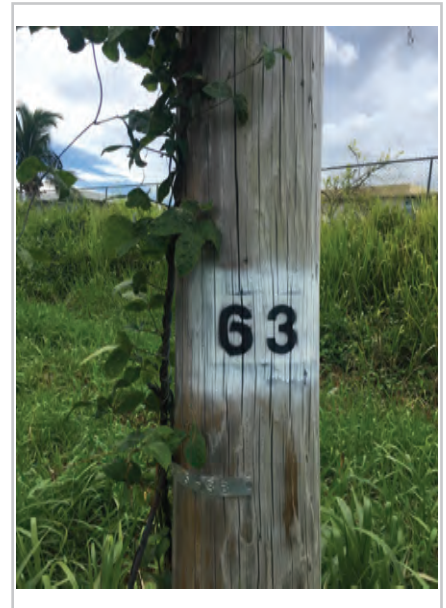
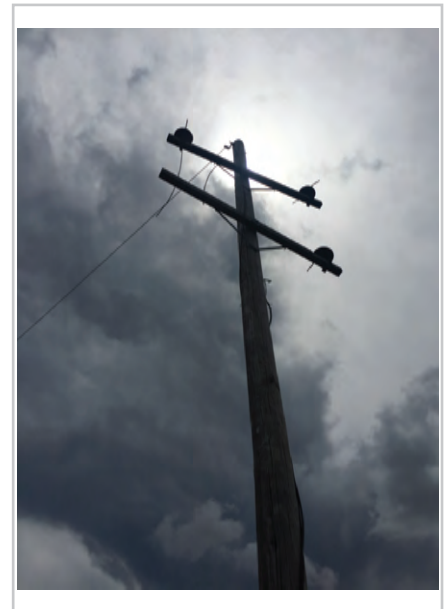
Photo 1: Pole Identification

Condition: OUT OF SERVICE

Comments: ONLY GROUND CONNECTED AT ONE SIDE

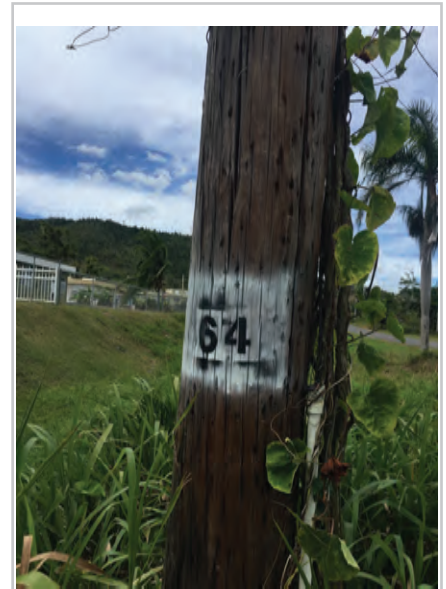
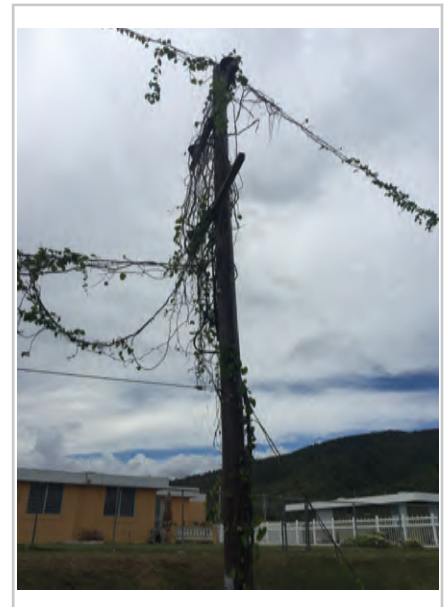
Photo 1: Pole Identification

Condition: OUT OF SERVICE

Comments: ONLY GROUND CONNECTED
N/A

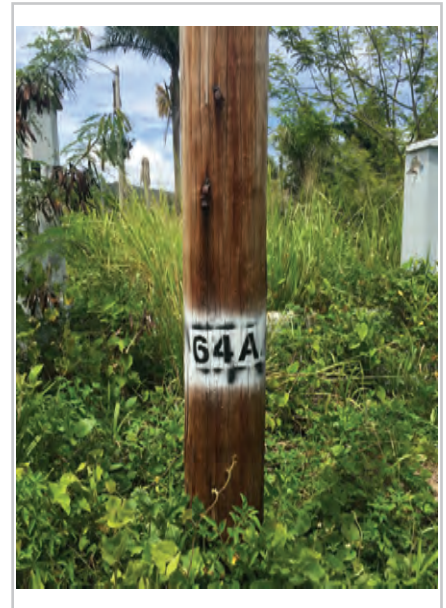
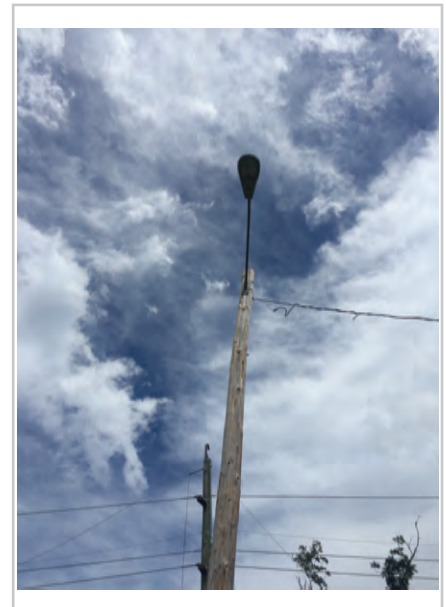
Photo 1: Pole Identification

Condition: ^{OUT OF SERVICE} _____

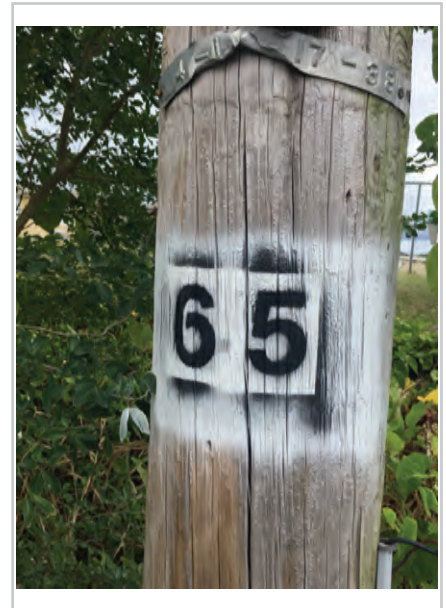
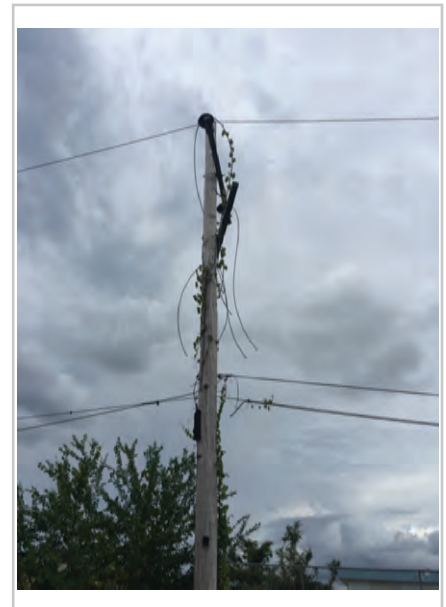
Photo 1: Pole Identification

Condition: OUT OF SERVICE

Comments: ONLY GROUND CONNECTED
N/A

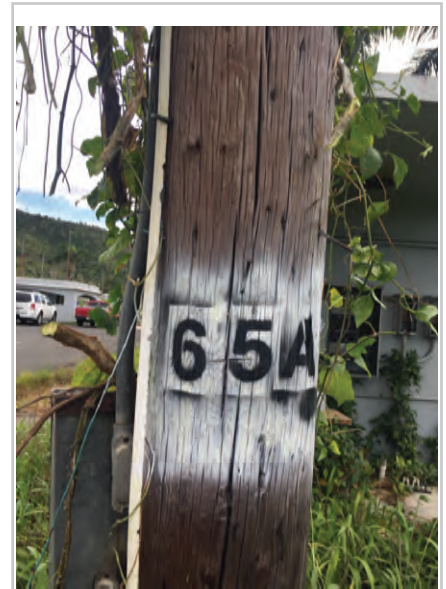
Photo 1: Pole Identification

Condition: ^{OUT OF SERVICE} _____

Comments: ^{JUNCTION BOX AT BASE} _____

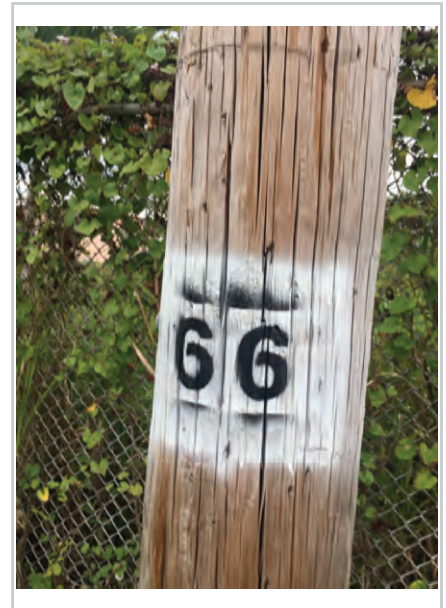
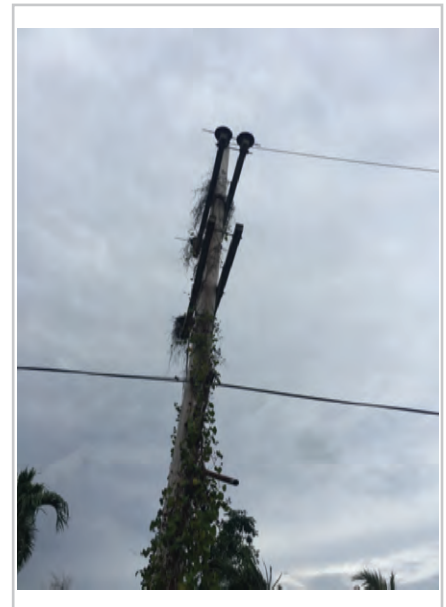
Photo 1: Pole Identification

Condition: OUT OF SERVICE

Comments: ONLY GROUND CONNECTED AT ONE SIDE
N/A

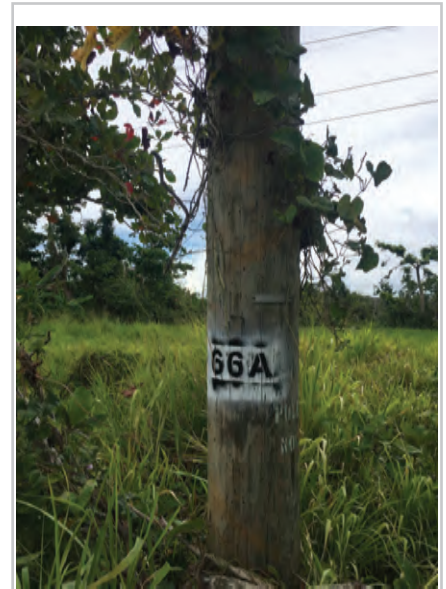
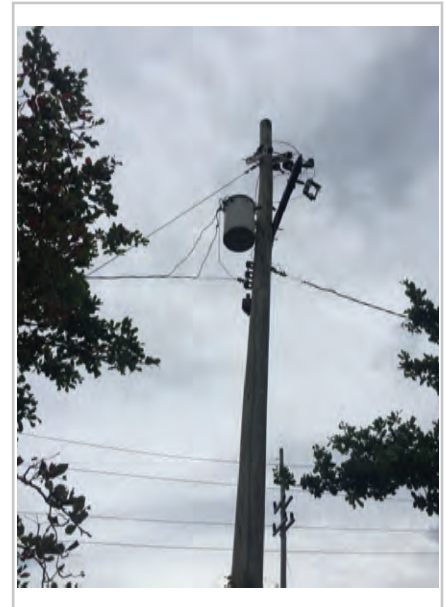
Photo 1: Pole Identification

Condition: OUT OF SERVICE

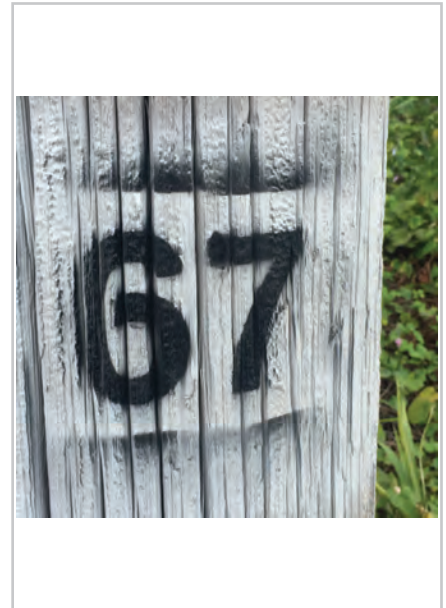
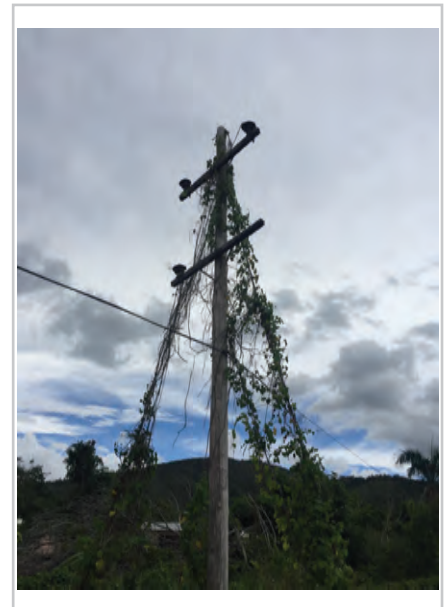
Photo 1: Pole Identification

Condition: OUT OF SERVICE

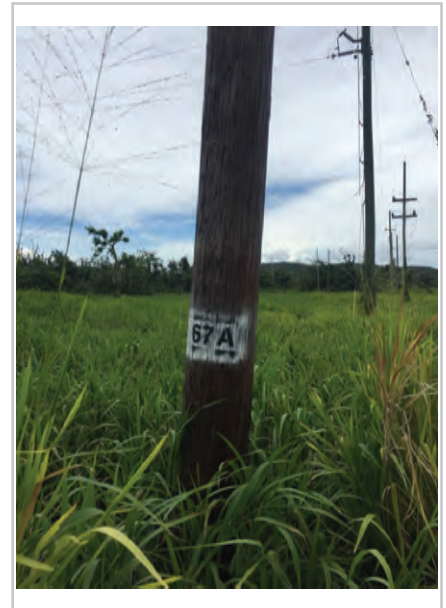
Photo 1: Pole Identification

Condition: OUT OF SERVICE

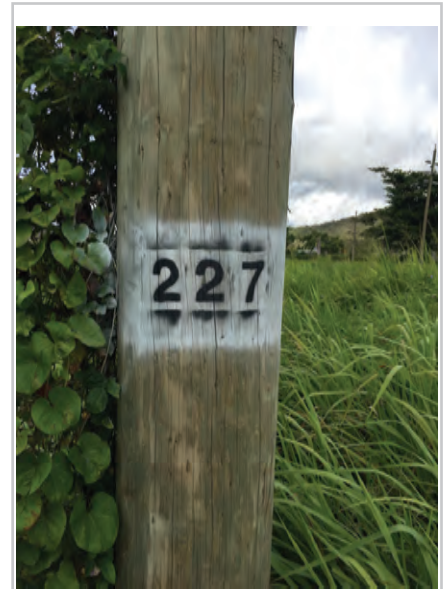
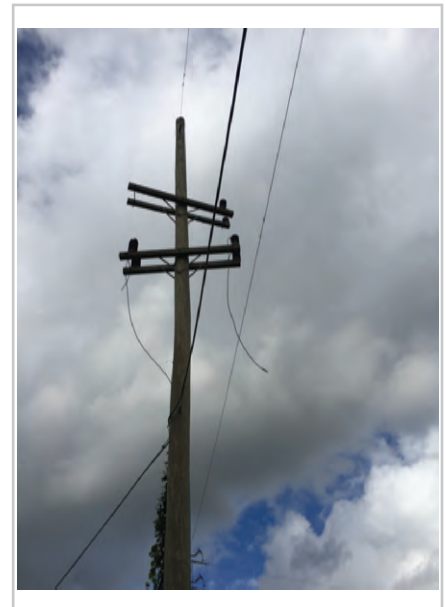
Condition: GOOD

Comments: ONLY GROUND CONNECTED AT ONE SIDE

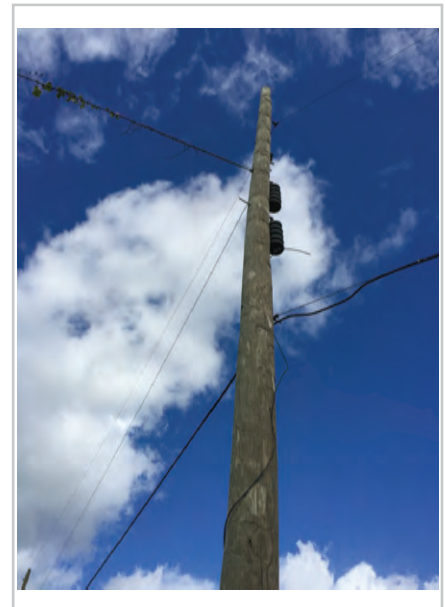
Condition: ^{GOOD} _____

Comments: ^{ONLY GROUND CONNECTED, MISSING INSULATORS} _____

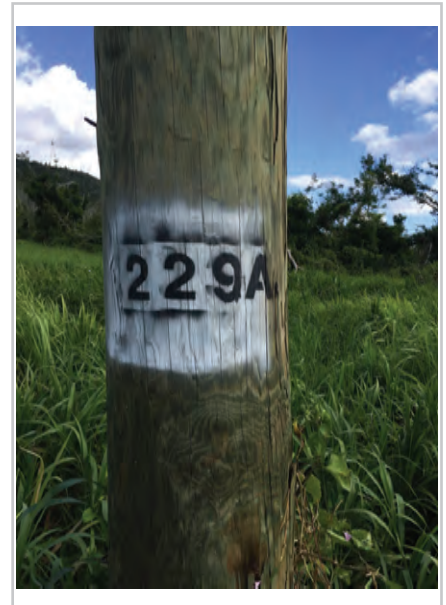
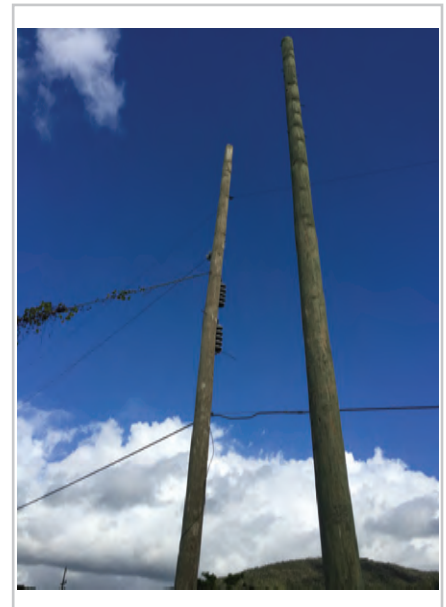
Condition: OUT OF SERVICE

Comments: NOTHING CONNECTED
N/A

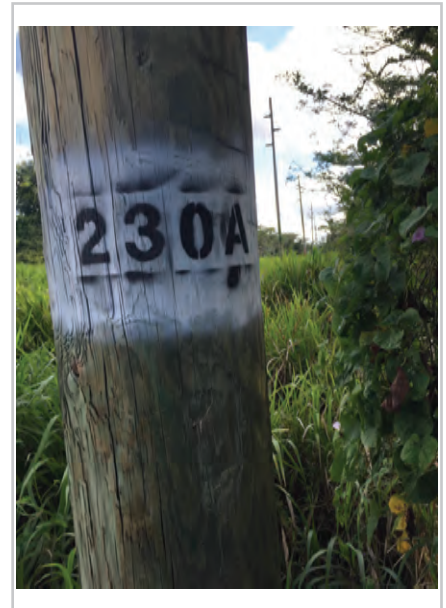
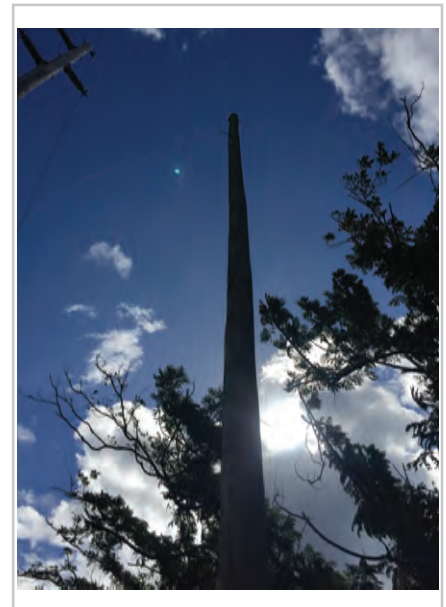
Condition: ^{OUT OF SERVICE} _____

Comments: ^{NOTHING CONNECTED} _____

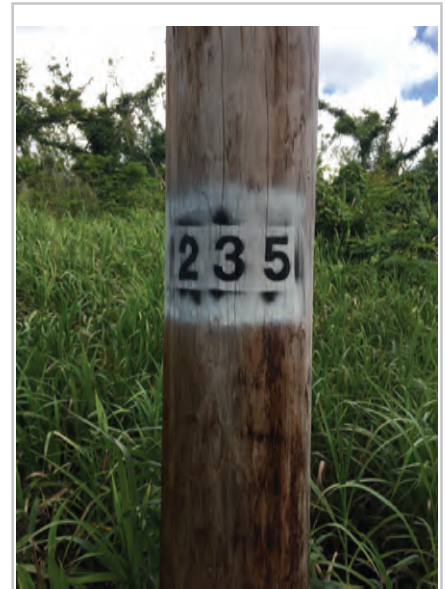
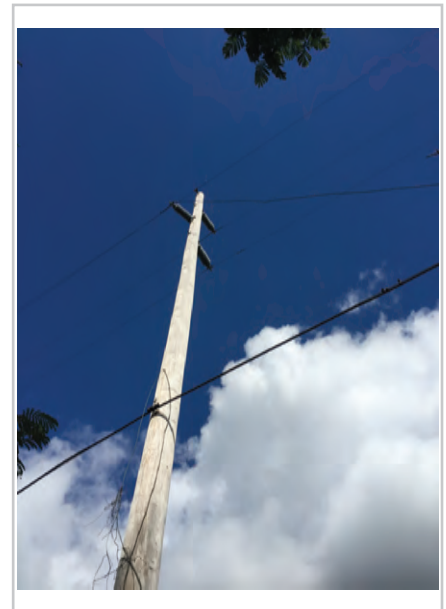
Condition: ^{GOOD}_____

Comments: ^{ONE SIDE OF ONE PHASE AT GROUND}_____

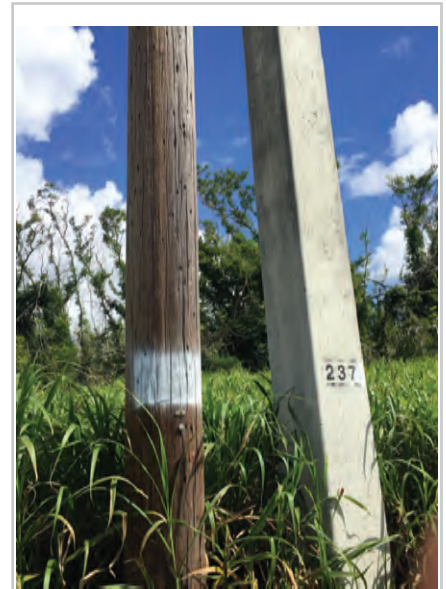
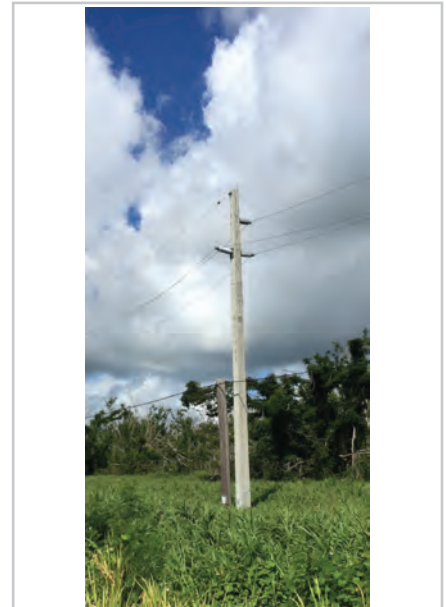
Condition: GOOD

Comments: GROUND AT ONE SIDE DROPPED

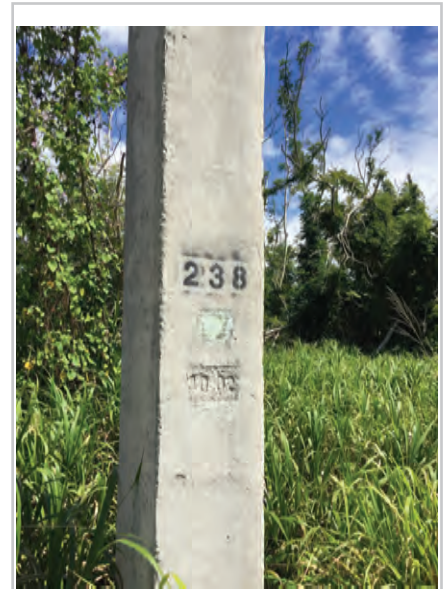
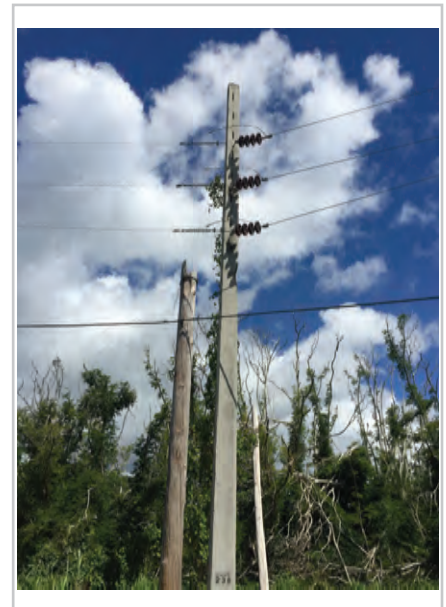
Condition: GOOD

Comments: GROUND NOT CONNECTED

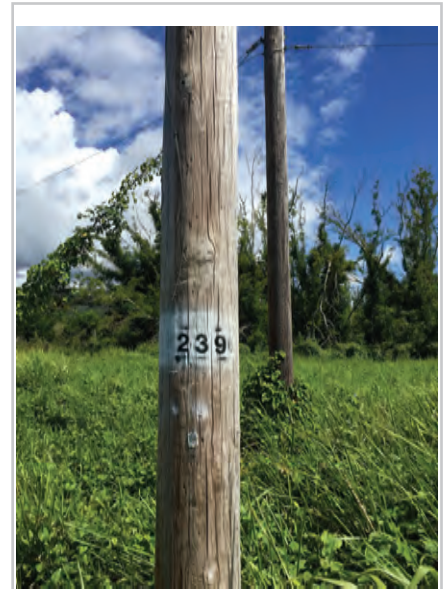
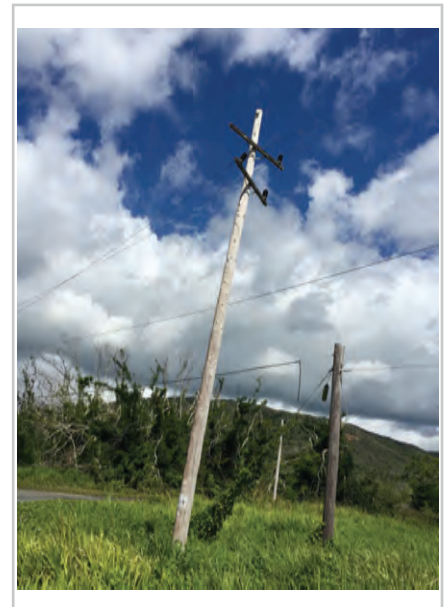
Condition: GOOD, INCLINED

Comments: GROUND AND ONE PHASE CONDUCTORS AT GROUND

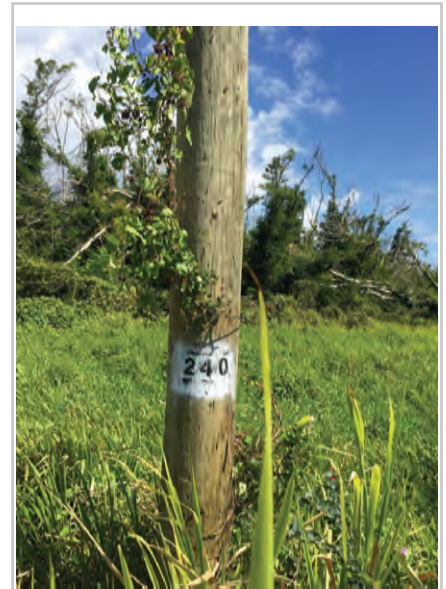
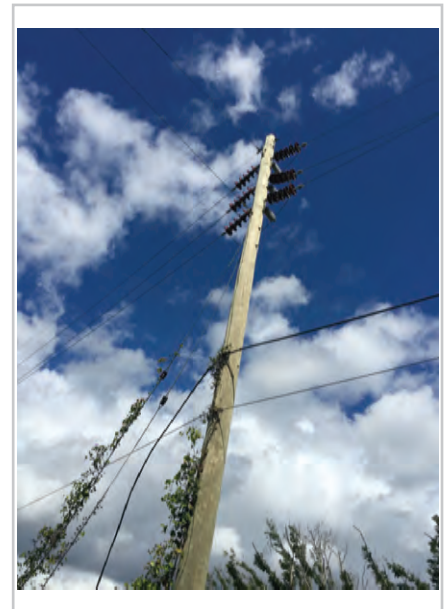
Condition: ^{GOOD} _____

Comments: ^{TELEPHONE CONDUCTOR AT GROUND} _____

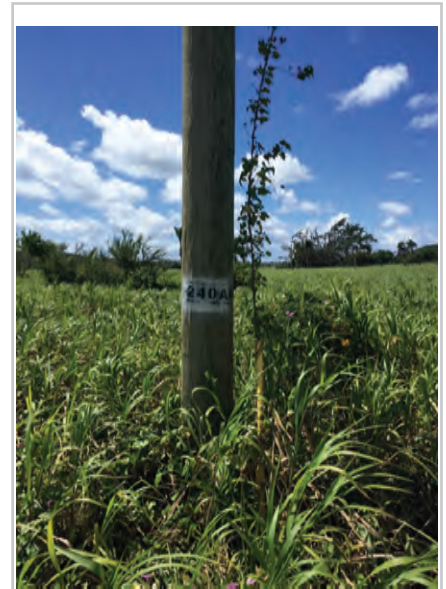
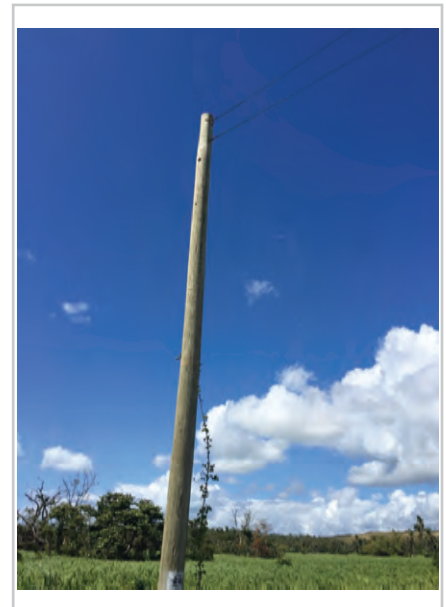
Condition: GOOD

Comments: STUB, POLE, DOWN GUY DETACHED FROM GROUND

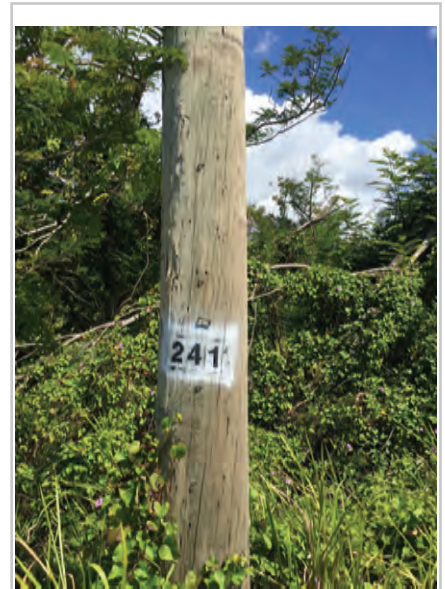
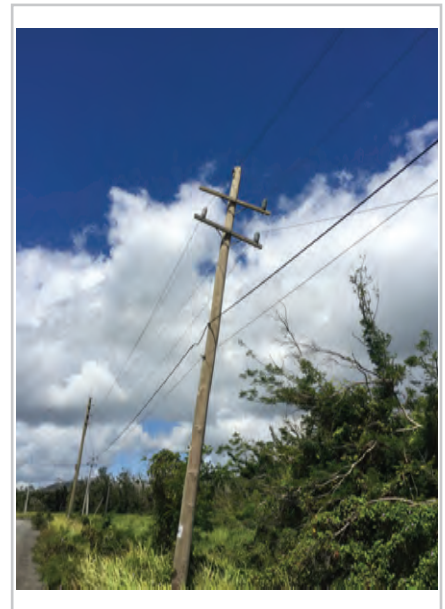
Condition: GOOD, INCLINED

Comments: ONE PHASE CONDUCTOR AT ONE SIDE AT GROUND

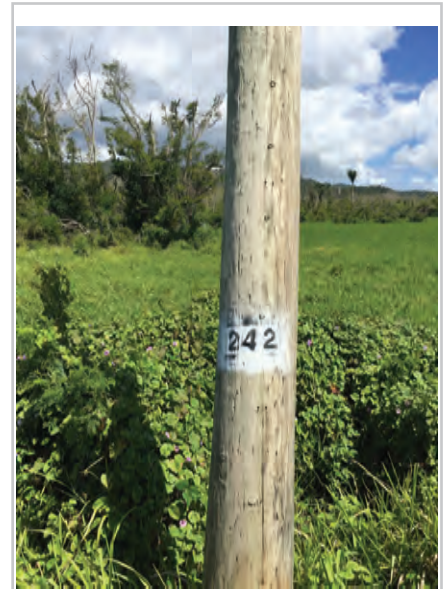
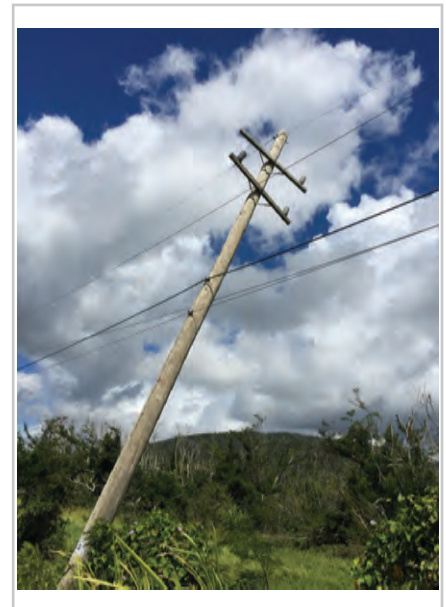
Condition: ^{GOOD, INCLINED} _____

Comments: ^{PHASE CONDUCTORS AT GROUND} _____

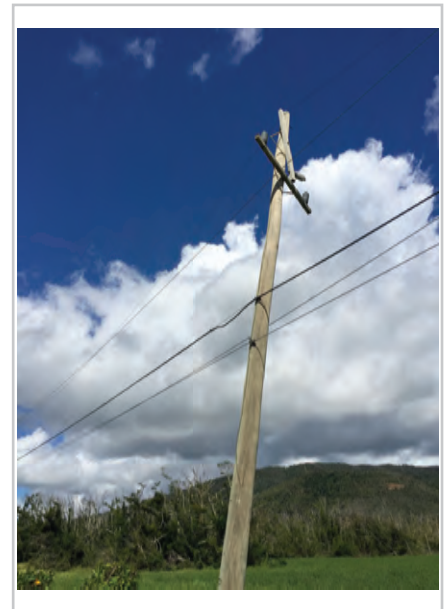
Condition: ^{GOOD, INCLINED} _____

Comments: ^{PHASE CONDUCTORS AT GROUND, STANDARD BROKEN} _____

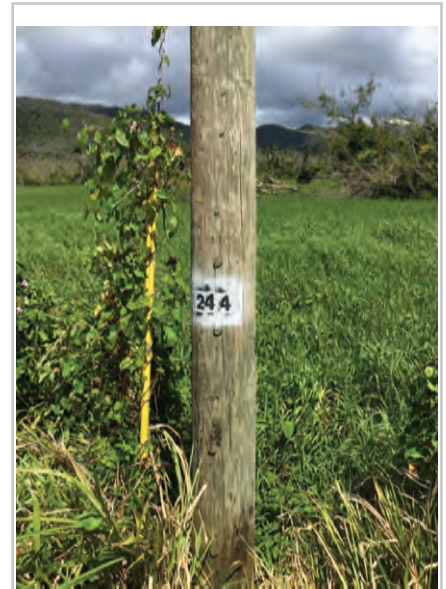
Condition: ^{GOOD, INCLINED} _____

Comments: ^{ONE PHASE CONDUCTOR AT GROUND} _____
