POLES CONDITION ASSESSMENT REPORT

PROJECT: HURRICANE MARIA DAMAGES REPAIRS
TO ROOSEVELT ROADS ELECTRICAL
SYSTEM (19-1741)

LOCATION: Roosevelt Roads,
Ceiba, PR

DATE: May 17, 2018

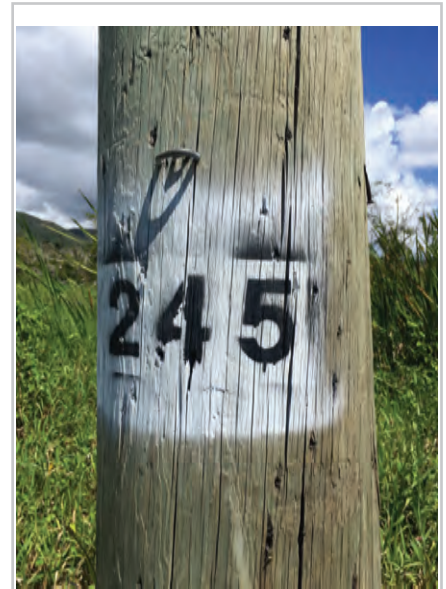
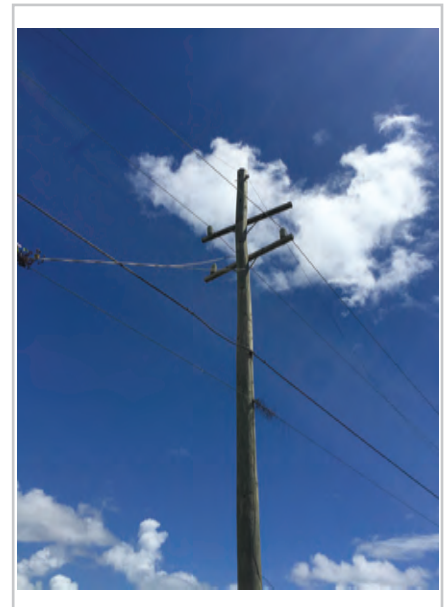
Condition: ^{GOOD} _____

Comments: ^{ONE PHASE CONDUCTOR AT GROUND} _____

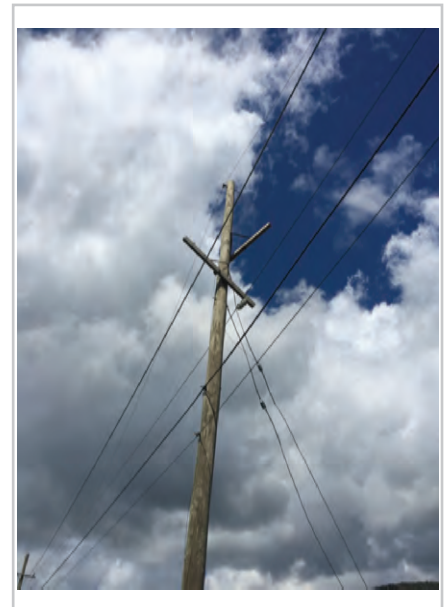
Photo 2: Pole Constr. Standards

Comments: PHASES CONDUCTORS AT GROUND, STANDARD BROKEN

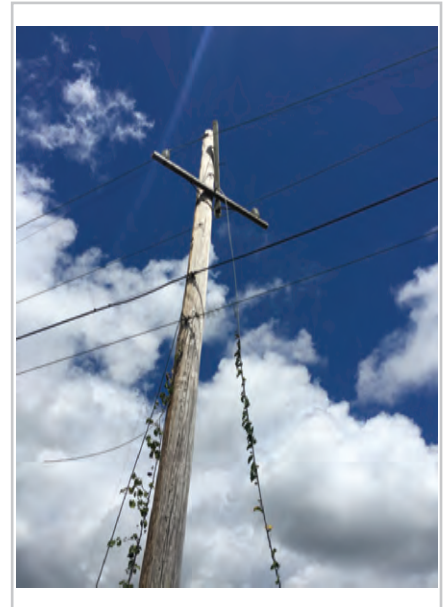
Photo 2: Pole Constr. Standards

Comments: ^{PHASES CONDUCTORS AT GROUND, STANDARD BROKEN} _____

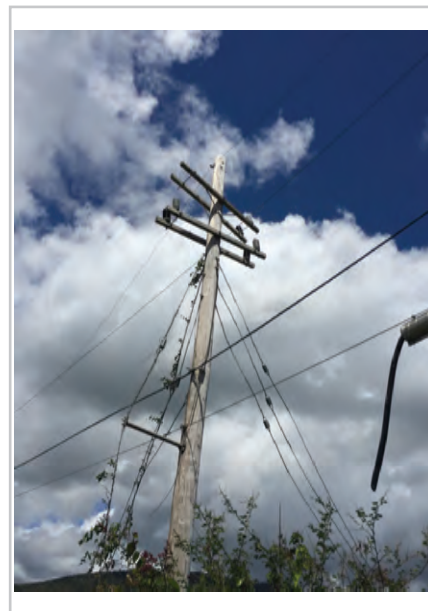
Photo 2: Pole Constr. Standards

Comments: ^{PHASES CONDUCTORS AT GROUND, STANDARD BROKEN} _____

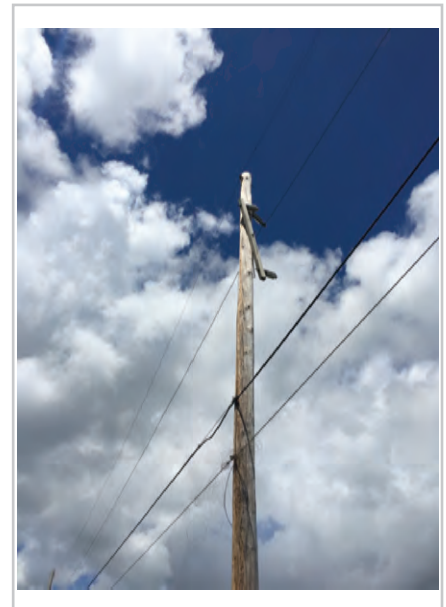
Photo 2: Pole Constr. Standards

Condition: ^{GOOD, LITTLE INCLINED} _____

Comments: ^{PHASES CONDUCTORS AT GROUND, STANDARD BROKEN} _____

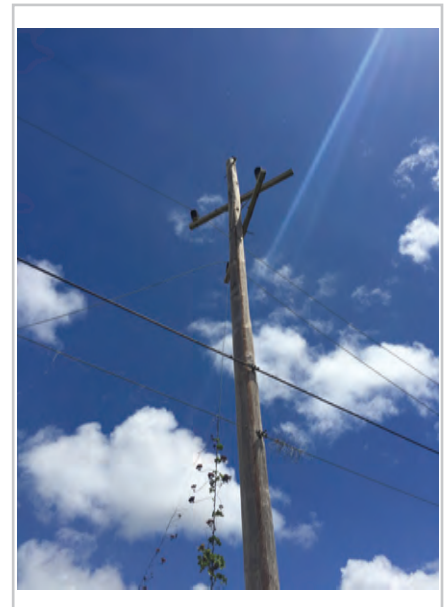
Photo 2: Pole Constr. Standards

Condition: GOOD, LITTLE INCLINED

Comments: PHASES CONDUCTORS AT GROUND, STANDARD BROKEN

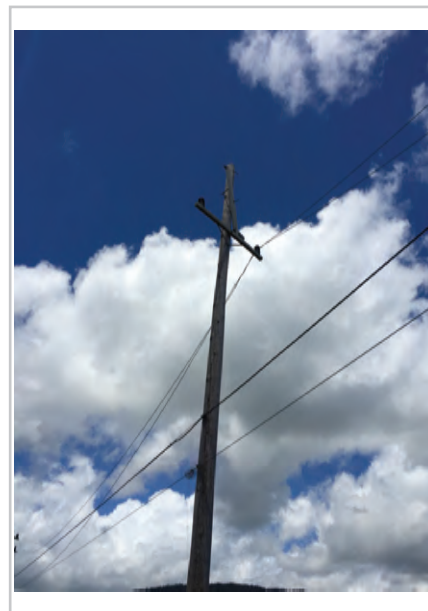
Photo 2: Pole Constr. Standards

Comments: ^{PHASES CONDUCTORS AT GROUND, STANDARD BROKEN} _____

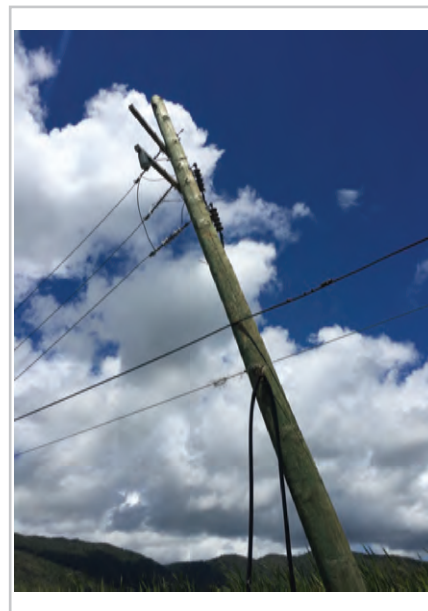
Photo 2: Pole Constr. Standards

Condition: ^{GOOD, VERY INCLINED} _____

Comments: ^{PHASES CONDUCTORS AT GROUND, STANDARD BROKEN} _____

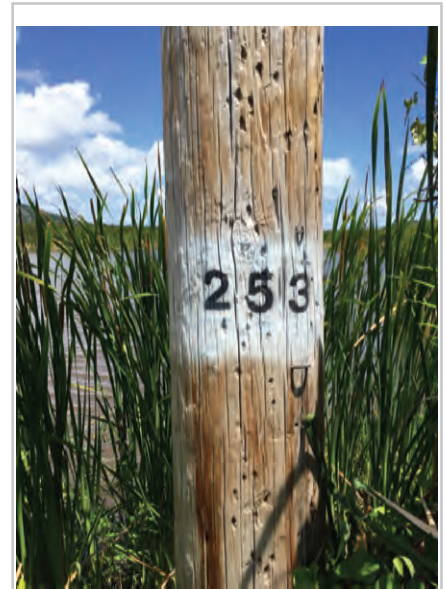
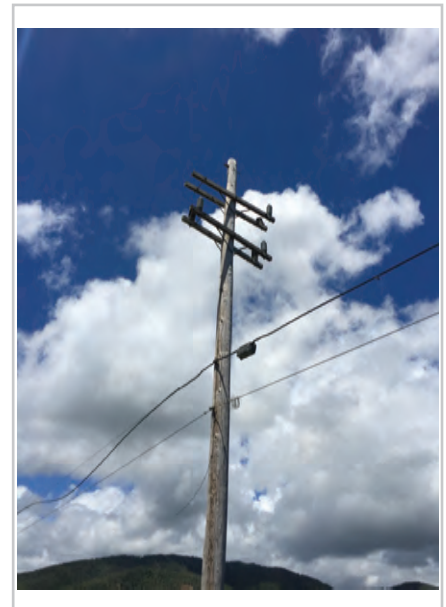
Comments: PHASES CONDUCTORS AT GROUND, STANDARD AFFECTED

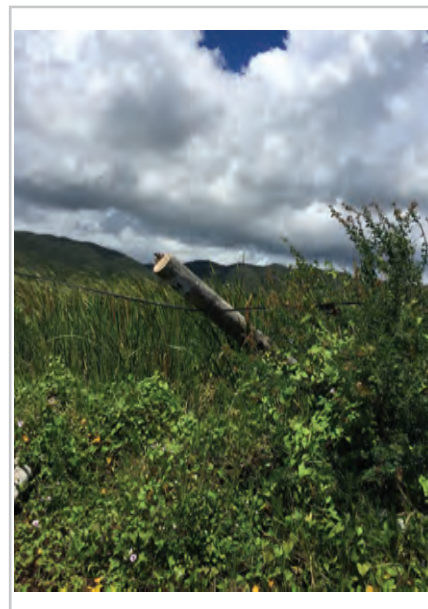
Photo 2: Pole Constr. Standards

Condition: ^{BROKEN AT FLOOR} _____

Comments: ^{PHASES CONDUCTORS AND POLE BROKEN AT FLOOR} _____

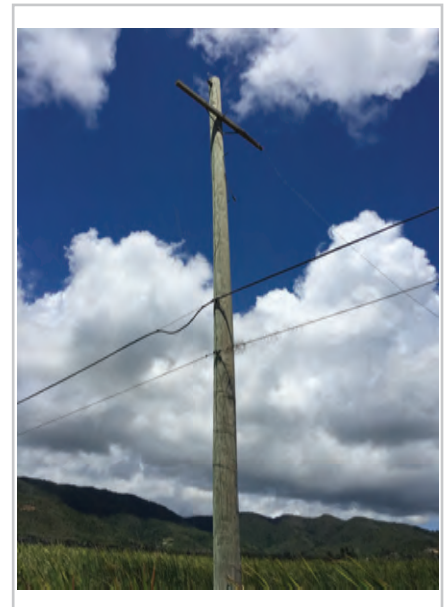
Photo 2: Pole Constr. Standards

Condition: ^{GOOD, LITTLE INCLINED} _____

Comments: ^{PHASES CONDUCTORS AT GROUND, STANDARD BROKEN} _____

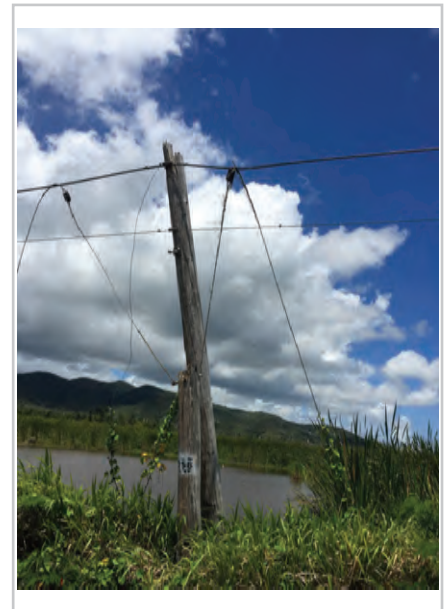
Photo 2: Pole Constr. Standards

Condition: ^{BROKEN AT FLOOR} _____

Comments: ^{PHASES CONDUCTORS AND POLE BROKEN AT FLOOR} _____

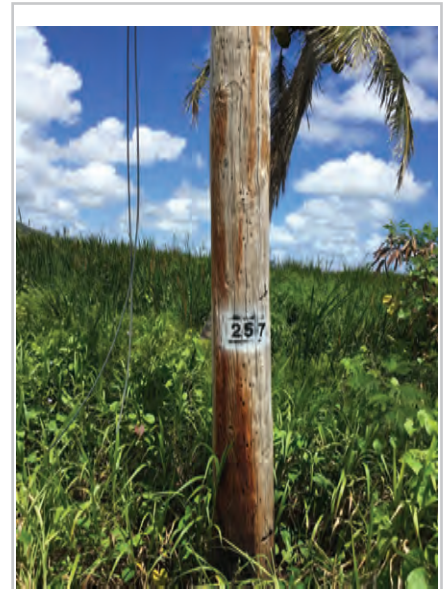
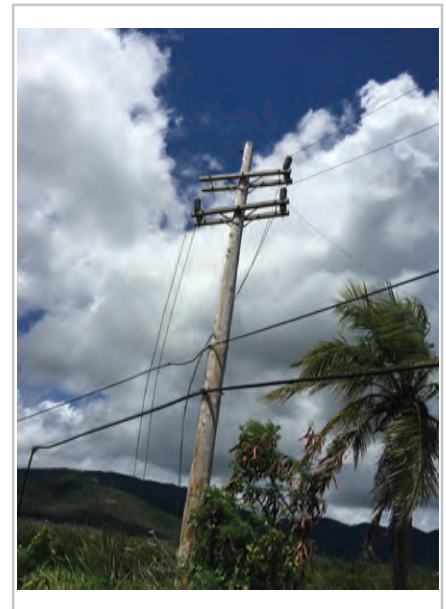
Condition: GOOD, LITTLE INCLINED

Comments: PHASES CONDUCTORS AT GROUND, STANDARD AFFECTED

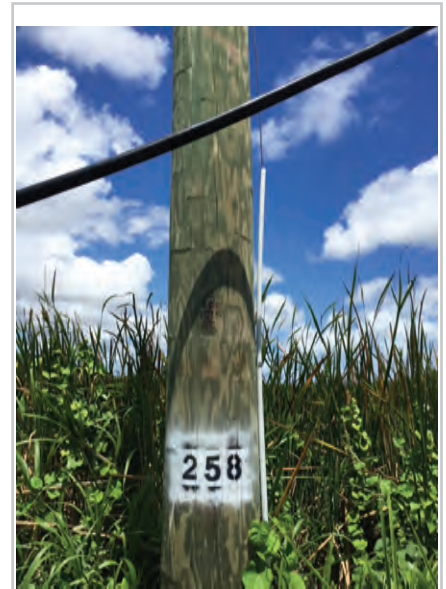
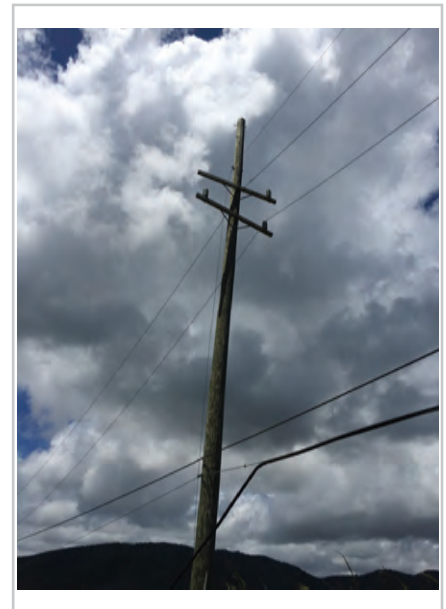
Comments: PHASES CONDUCTORS AT GROUND, STANDARD AFFECTED

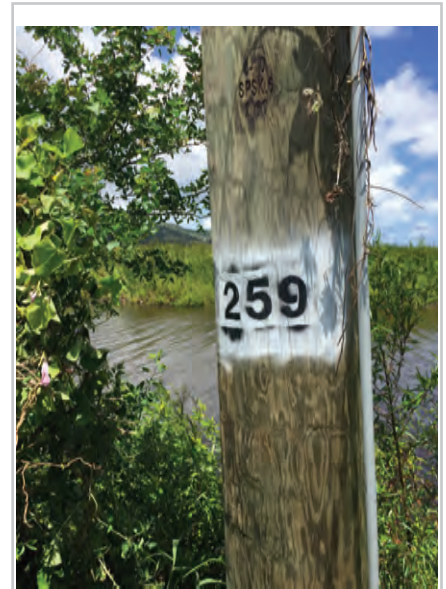
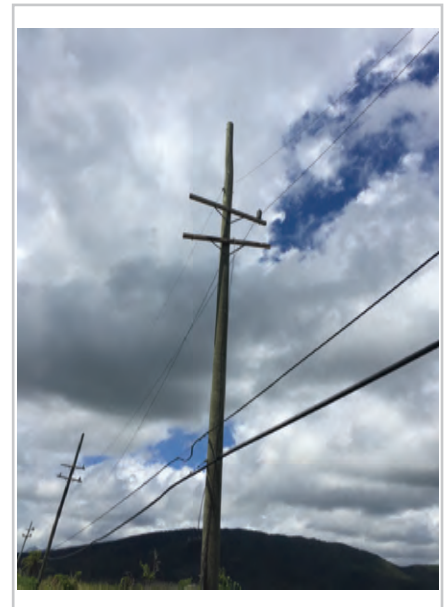
Comments: PHASES CONDUCTORS AT GROUND, STANDARD AFFECTED

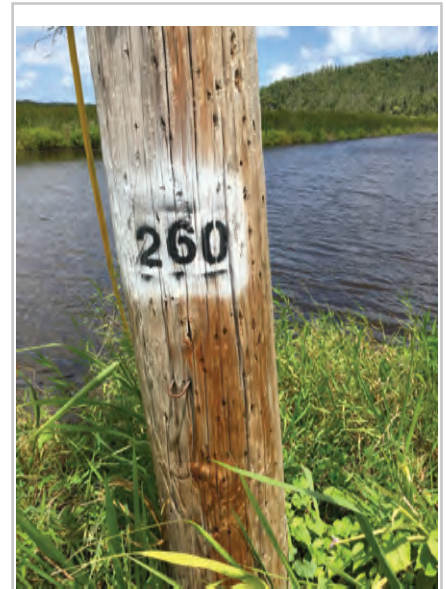
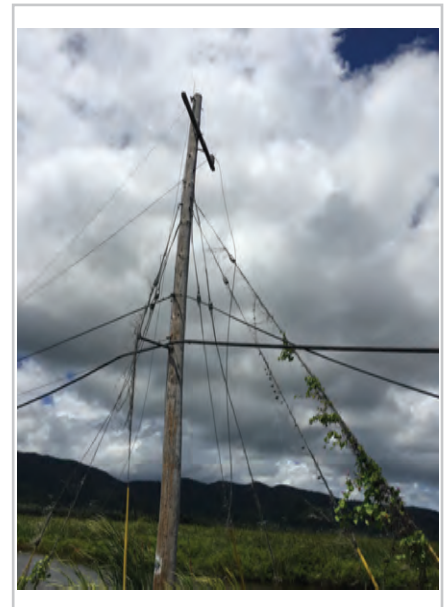
Comments: ^{PHASES CONDUCTORS AT GROUND, STANDARD AFFECTED} _____

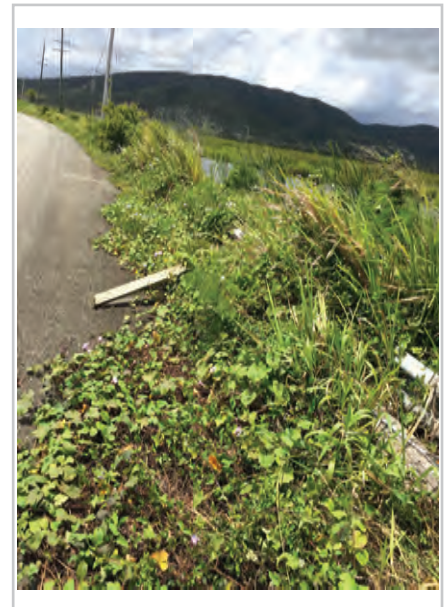
Photo 2: Pole Constr. Standards

Condition: ^{BROKEN AT FLOOR} _____

Comments: ^{PHASES CONDUCTORS AND POLE BROKEN AT FLOOR} _____

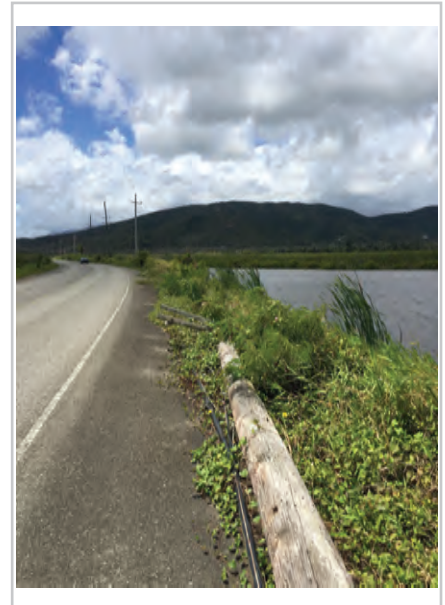
Photo 2: Pole Constr. Standards

Condition: ^{BROKEN AT FLOOR} _____

Comments: ^{PHASES CONDUCTORS AND POLE BROKEN AT FLOOR} _____

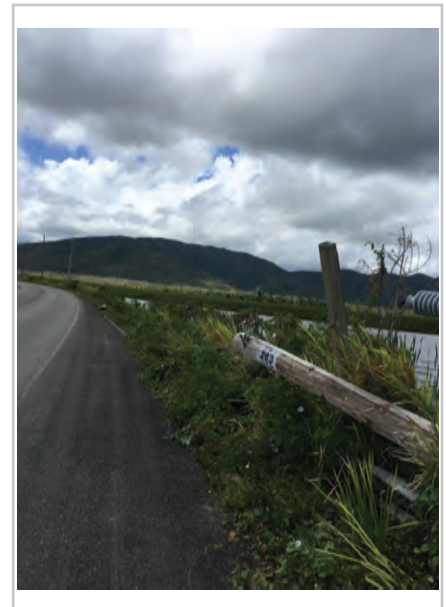
Photo 2: Pole Constr. Standards

Condition: ^{BROKEN AT FLOOR} _____

Comments: ^{PHASES CONDUCTORS AND POLE BROKEN AT FLOOR} _____

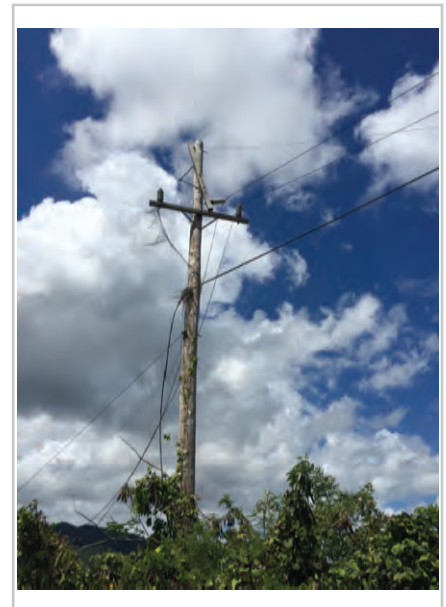
Photo 2: Pole Constr. Standards

Comments: ^{PHASES CONDUCTORS AT GROUND, STANDARD BROKEN} _____

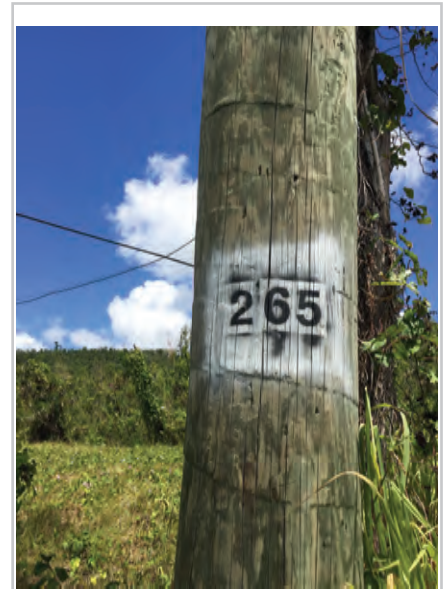
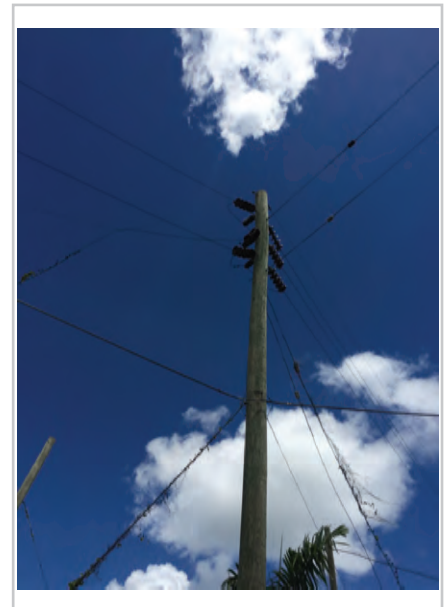
Comments: ^{CONDUCTORS AT GROUND AT ONE SIDE} _____

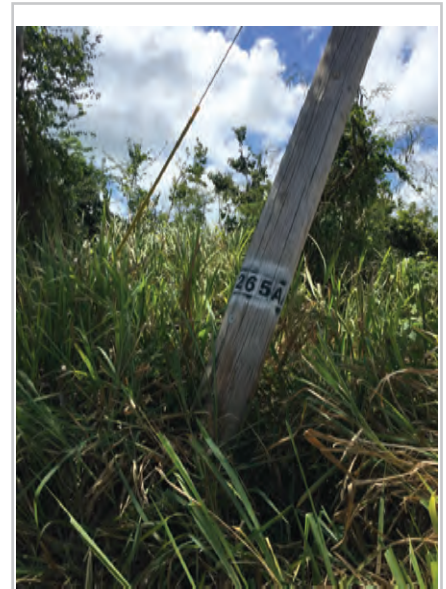
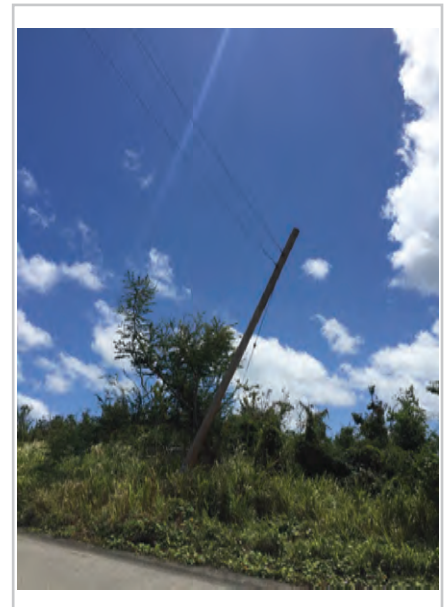
Condition: GOOD, VERY INCLINED

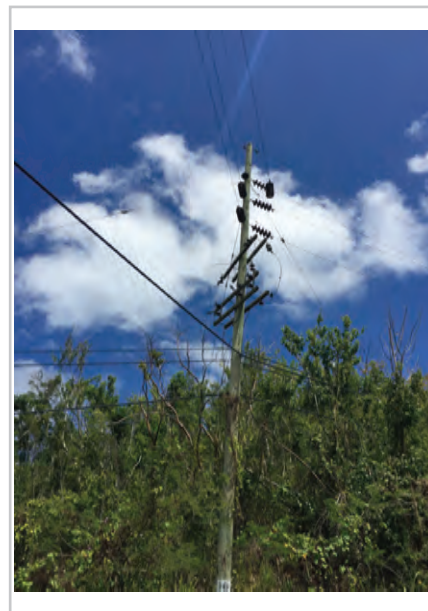
Photo 2: Pole Constr. Standards

Comments: INSULATOR BROKEN

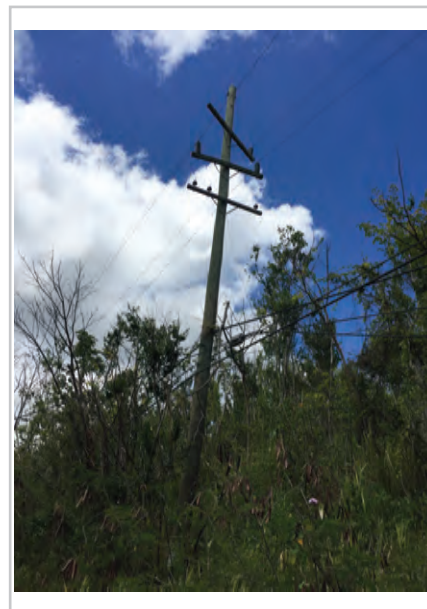
Photo 2: Pole Constr. Standards

Comments: ^{STANDARD BROKEN} _____

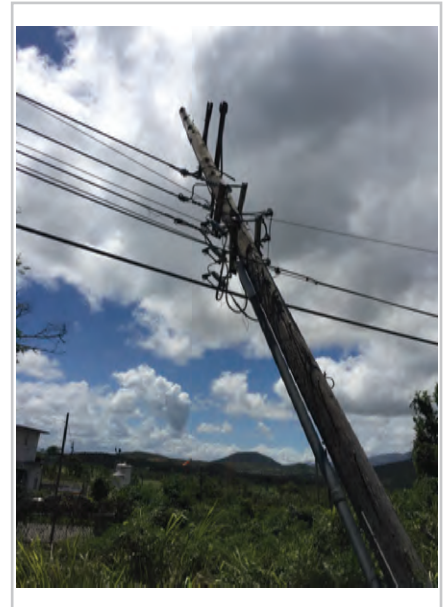
Photo 2: Pole Constr. Standards

Condition: BROKEN AT TOP AND BASE, VERY INCLINED

Comments: 38 KV STANDARD BROKEN AND CONDUCTORS AT GROUND

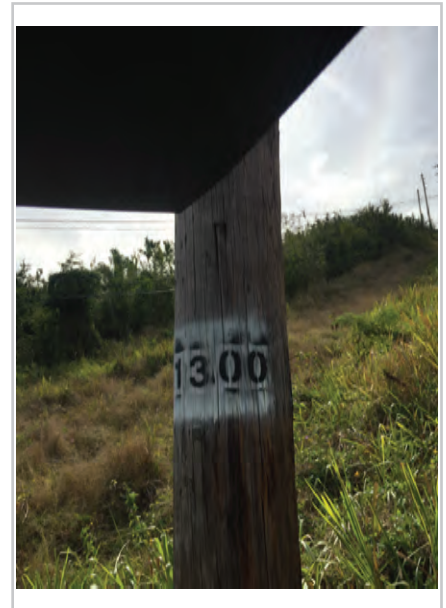
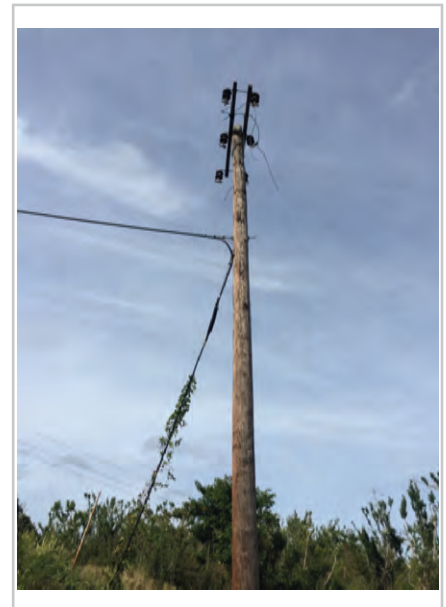
Condition: INCLINED

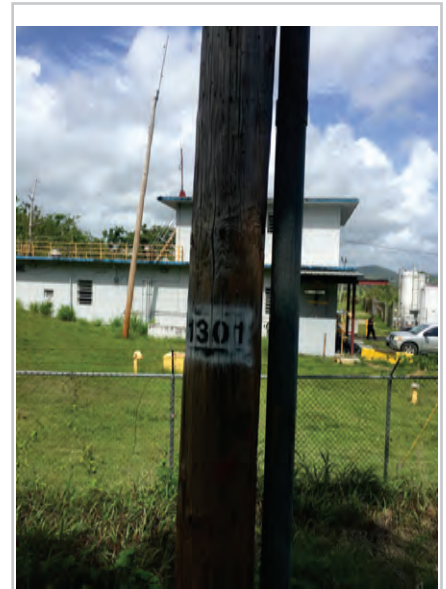
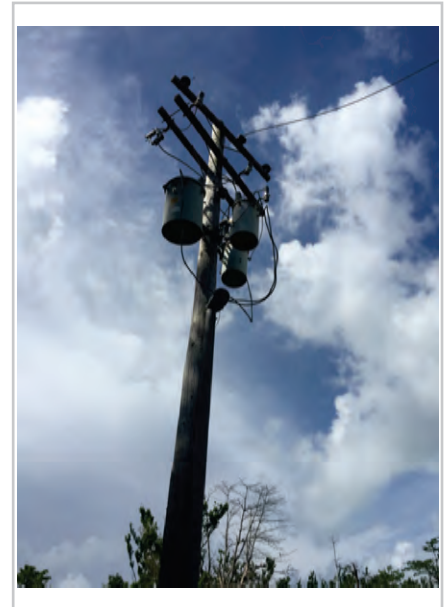
Comments: OUT OF SERVICE POLE MOUNTED SUBSTATION WITH WITH ALL

COMPONENTS INSTALLED ON WOOD CROSS ARMS

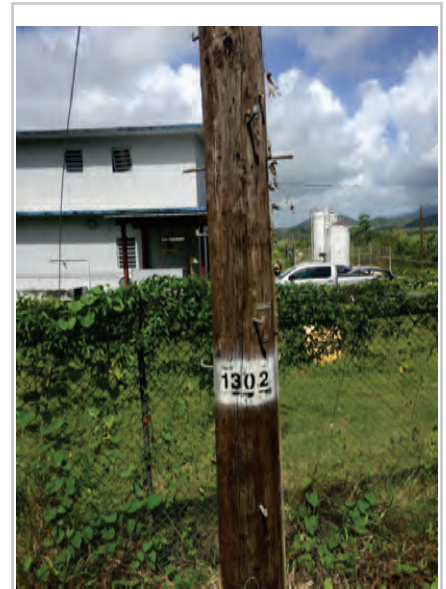
Comments: OUT OF SERVICE POLE, FUSED CUT OUT AND LIGHTNING ARRESTER

INSTALLED ON WOOD CROSS ARMS

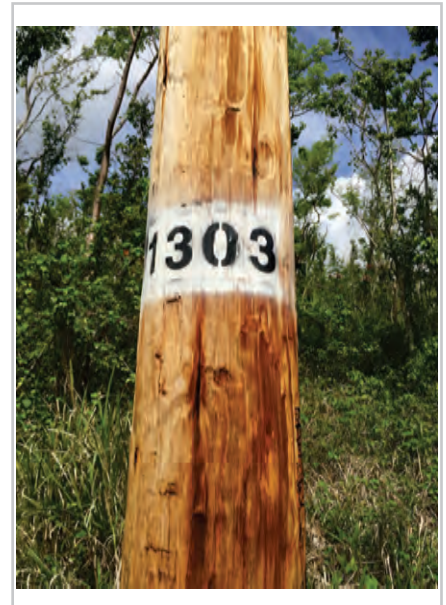
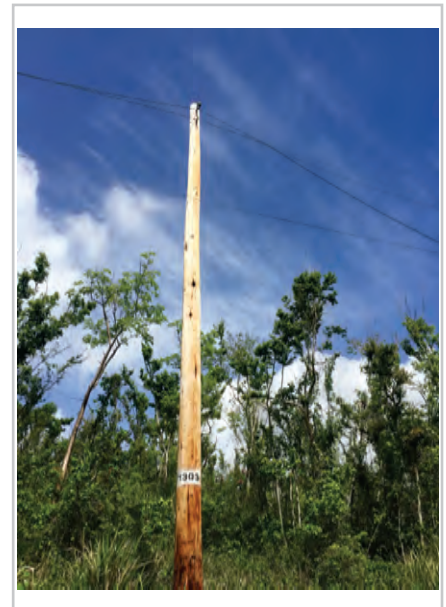
Condition: ^{GOOD} _____

Comments: ^{OUT OF SERVICE TELECOMMUNICATION POLE} _____
N/A

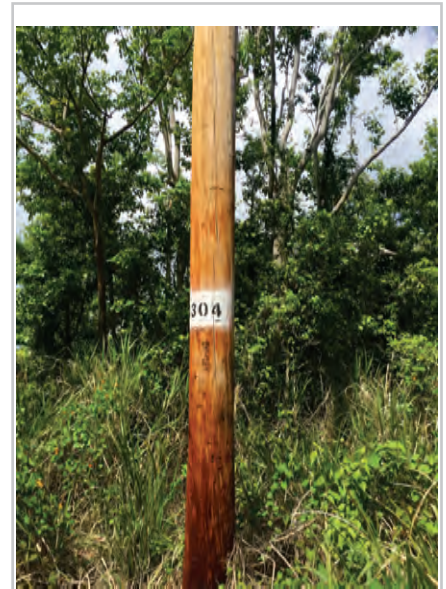
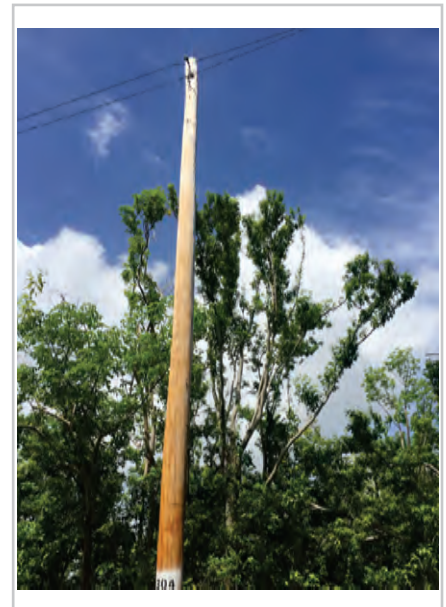
Condition: GOOD

Comments: OUT OF SERVICE TELECOMMUNICATION POLE

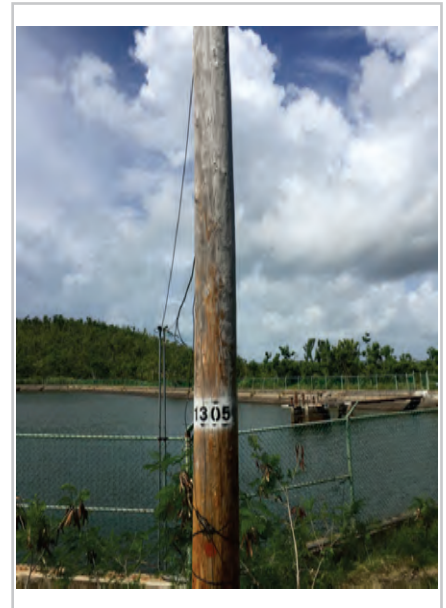
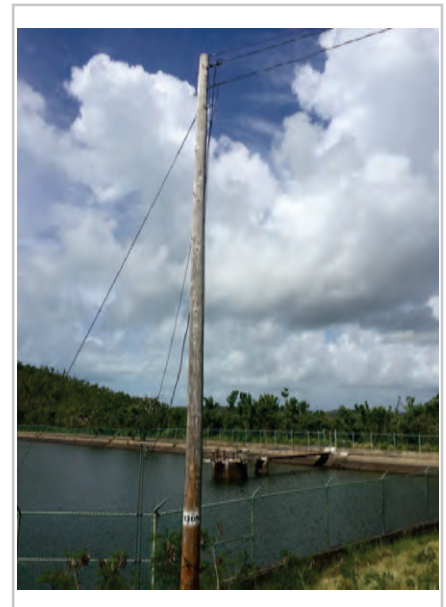
Condition: GOOD

Comments: OUT OF SERVICE TELECOMMUNICATION POLE

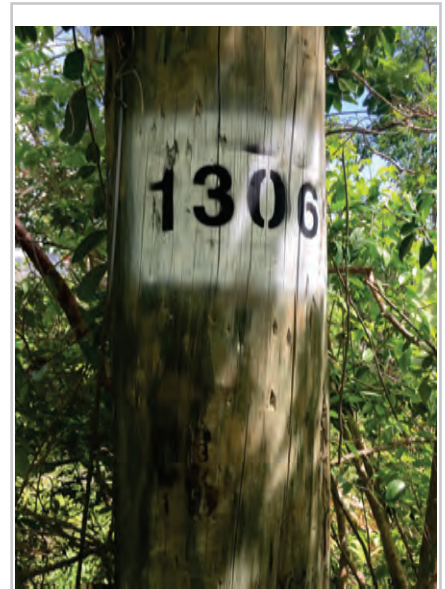
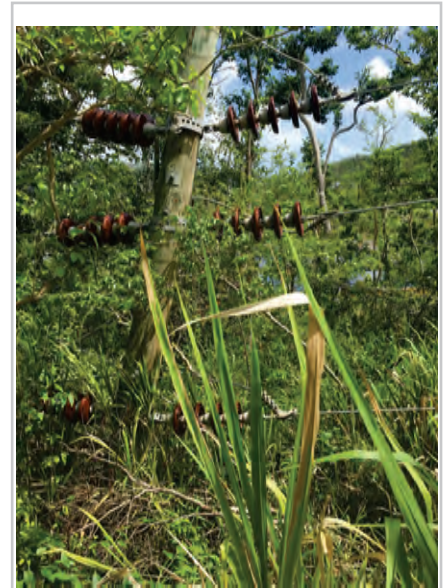
Condition: ^{BROKEN} _____

Comments: ^{ALL CONDUCTORS ON GROUND} _____

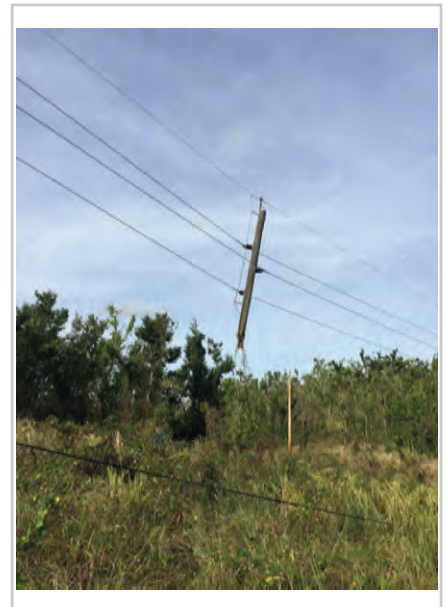
Photo 2: Pole Constr. Standards

Condition: ^{BROKEN} _____

Comments: ^{POLE BROKEN, PART OF POLE HANGING FROM LINES} _____

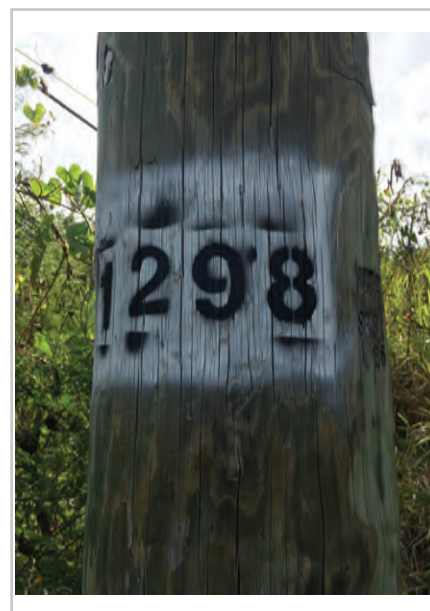
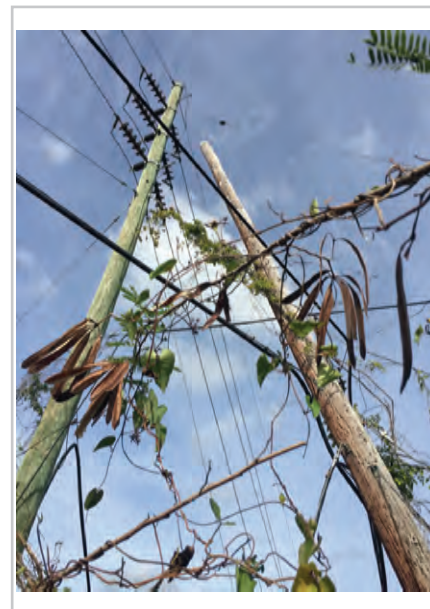
Condition: ^{OUT OF SERVICE} _____

Comments: ^{ONLY SUPPORT TELECOMMUNICATIONS LINES} _____
N/A

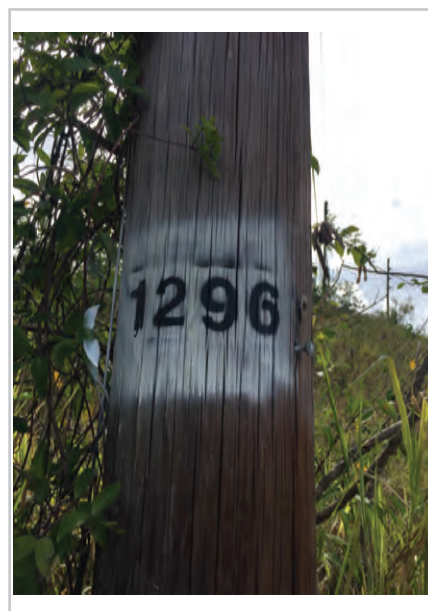
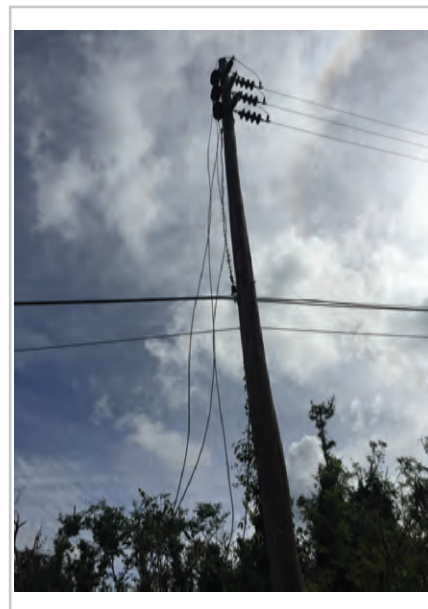
Condition: ^{GOOD} _____

Comments: ^{ONE SIDE OF 38 KV LINE DROPPED} _____

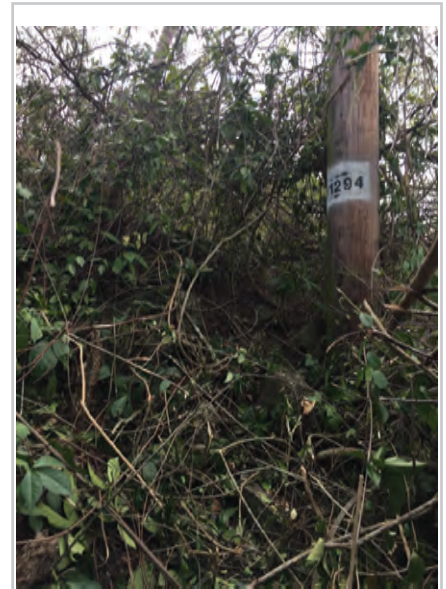
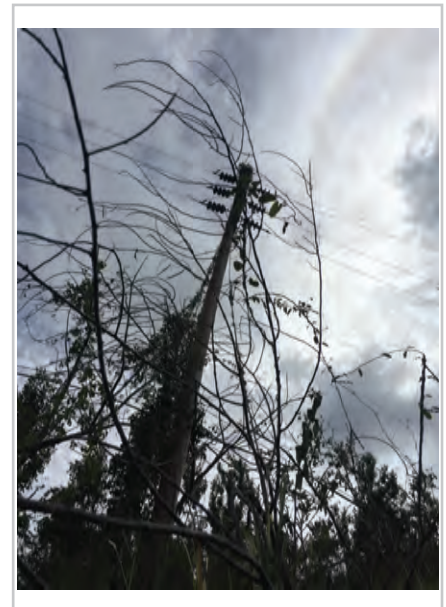
Condition: ^{GOOD} _____

Comments: ^{GROUND CONDUCTOR DROPPED AT ONE SIDE} _____

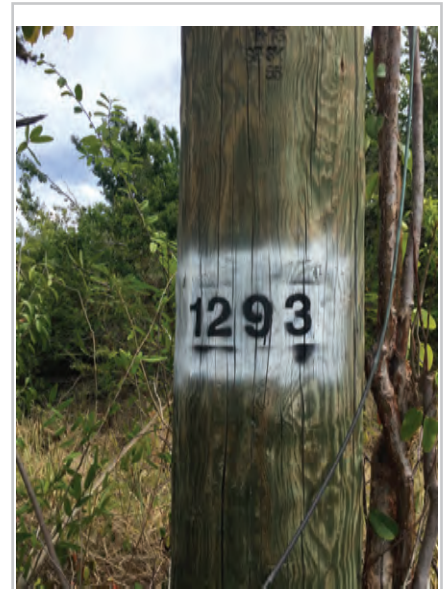
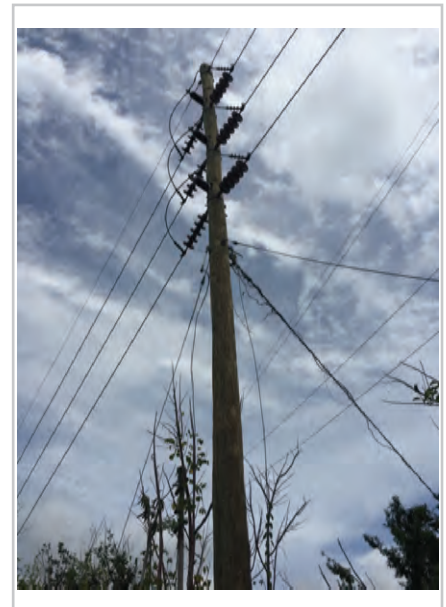
Condition: GOOD

Comments: ONE DOWN GUY DROPPED

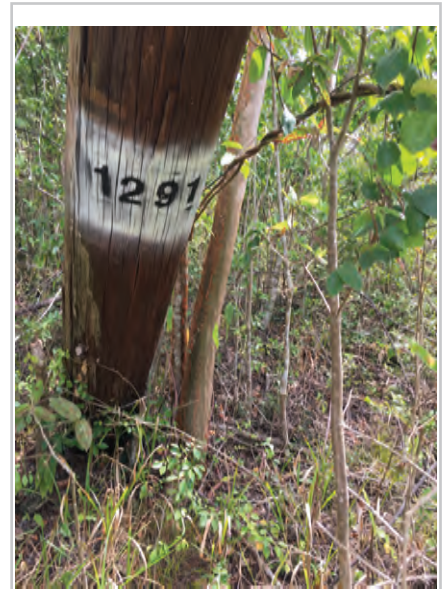
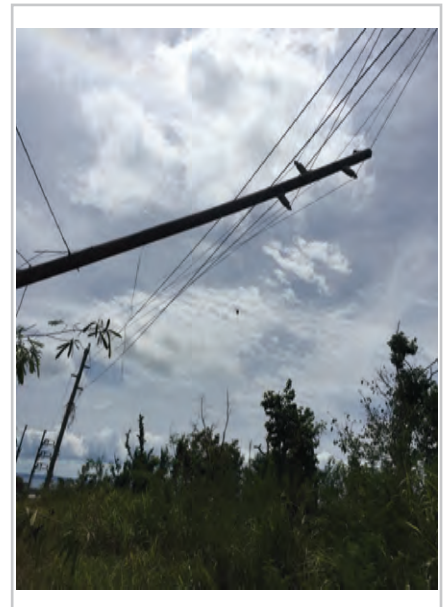
Condition: ^{BROKEN AT BASE, INCLINED} _____

Comments: ^{SUPPORTED FROM SIDE 38 KV LINE} _____

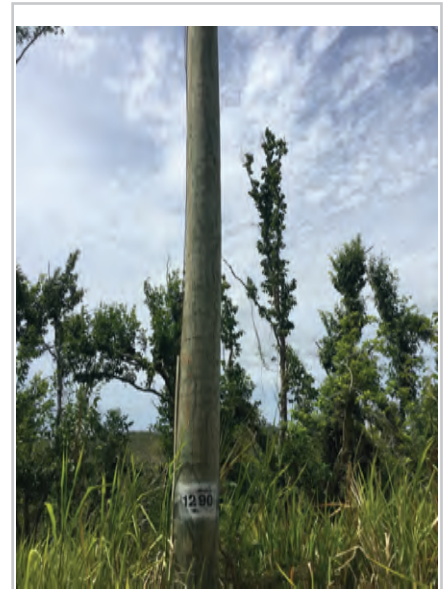
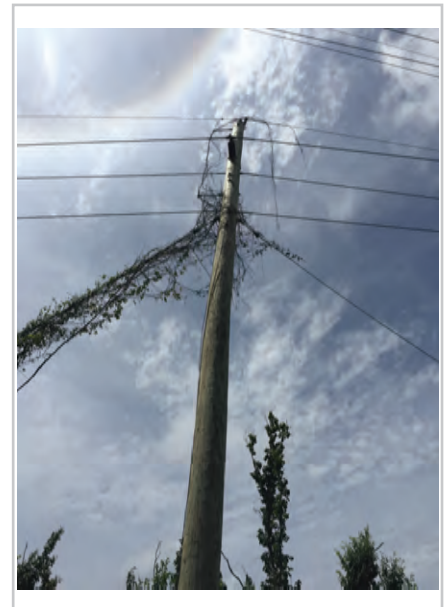
Condition: GOOD

Comments: ONE DOWN GUY REMOVED FROM GROUND

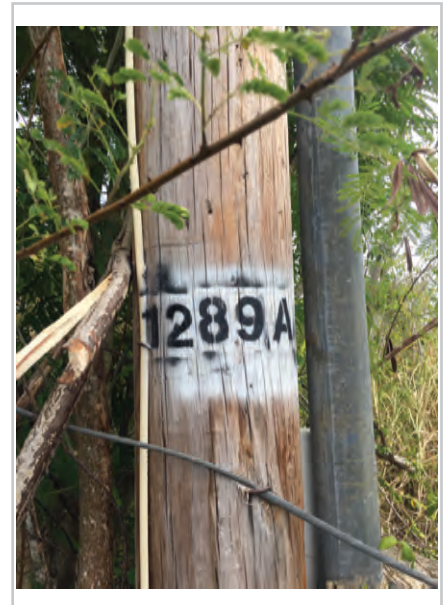
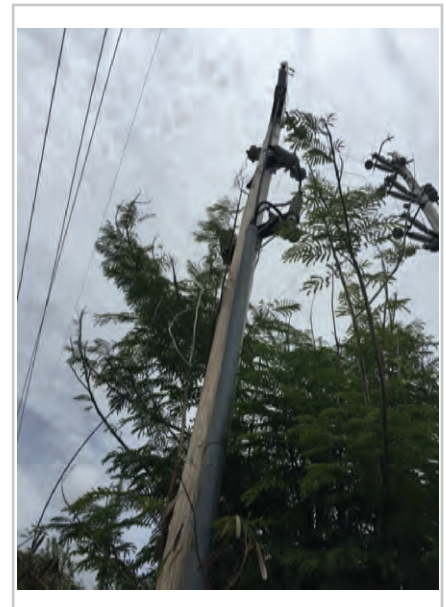
Condition: GOOD

Comments: LIGHTNING ARRESTER AT GROUND

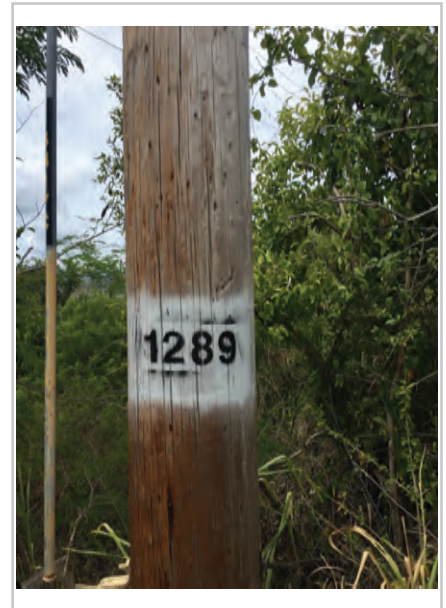
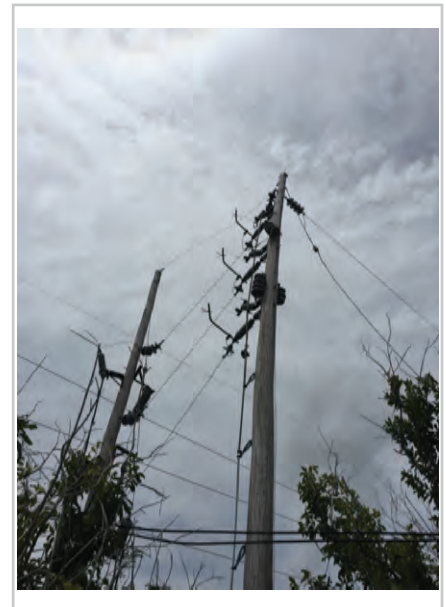
Condition: ^{GOOD} _____

Comments: ^{CONDUCTORS AT ONE SIDE DROPPED} _____

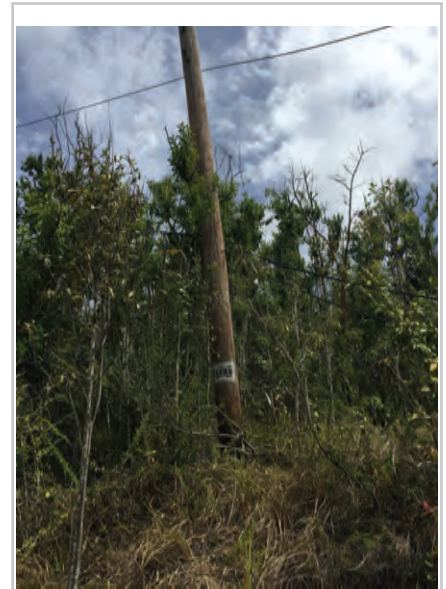
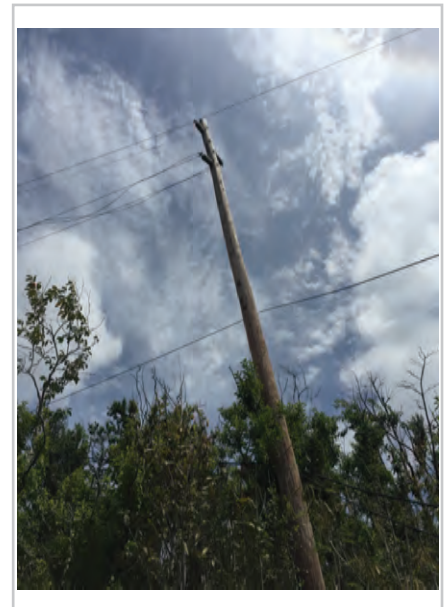
Condition: ^{GOOD} _____

Comments: ^{PHASE CONDUCTORS AT ONE SIDE DROPPED} _____

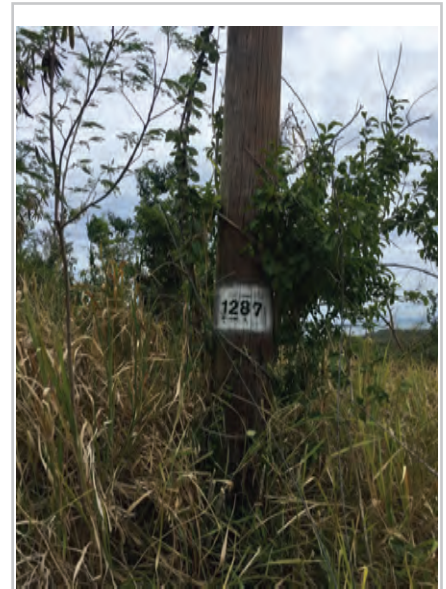
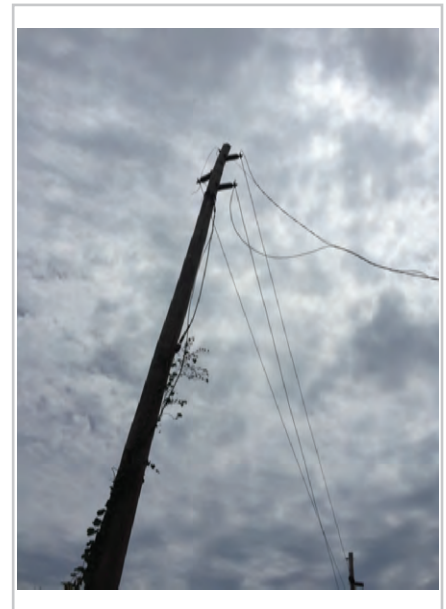
Condition: ^{GOOD} _____

Comments: ^{CONDUCTORS AT ONE SIDE DROPPED, DOWN GUYS REMOVED} _____

FROM GROUND

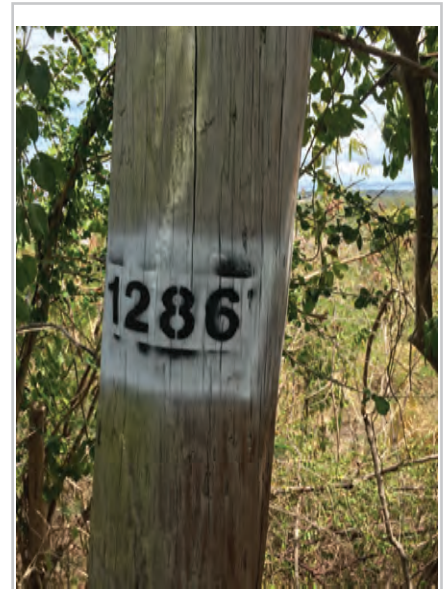
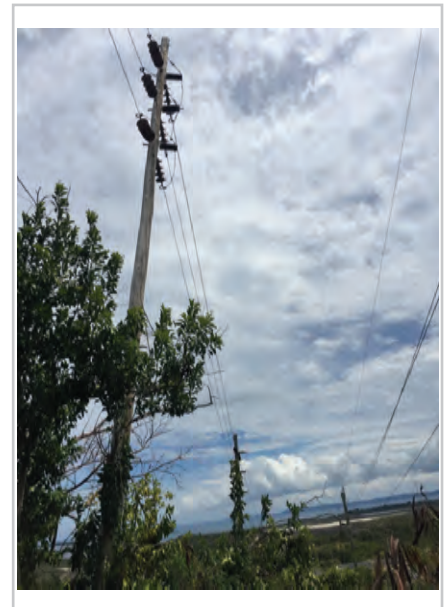
Condition: ^{GOOD} _____

Comments: ^{GROUND CONDUCTOR AT GROUND} _____

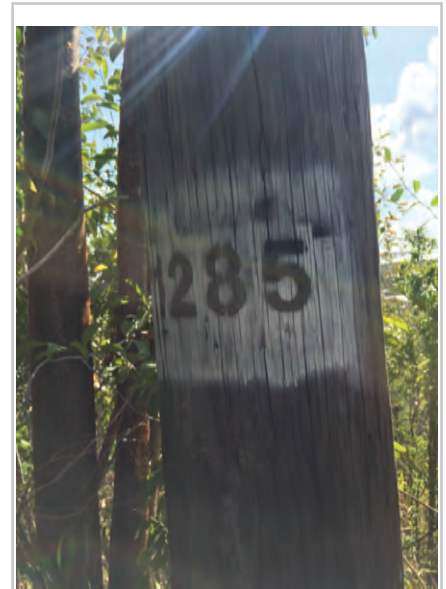
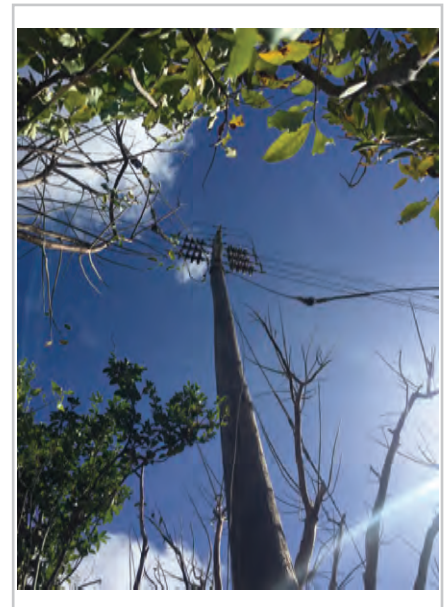
Condition: GOOD

Comments: DOWN GUYS REMOVED FROM GROUND

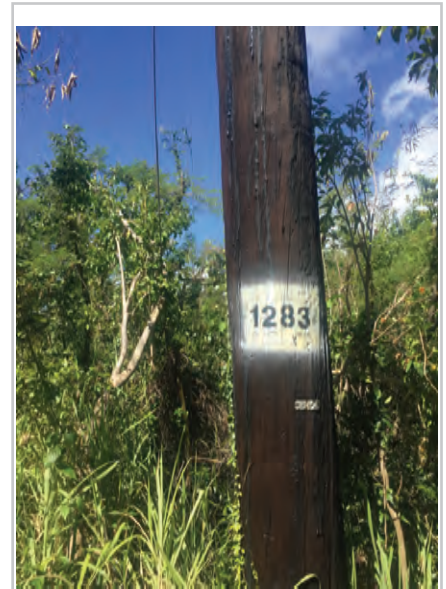
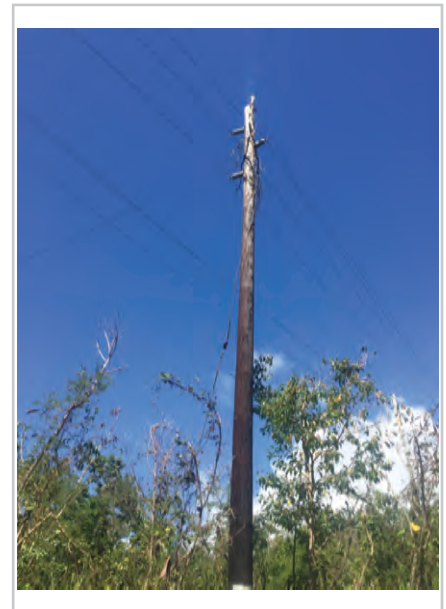
Condition: ^{GOOD} _____

Comments: ^{ONE SIDE OF GROUND CONDUCTOR AT GROUND} _____

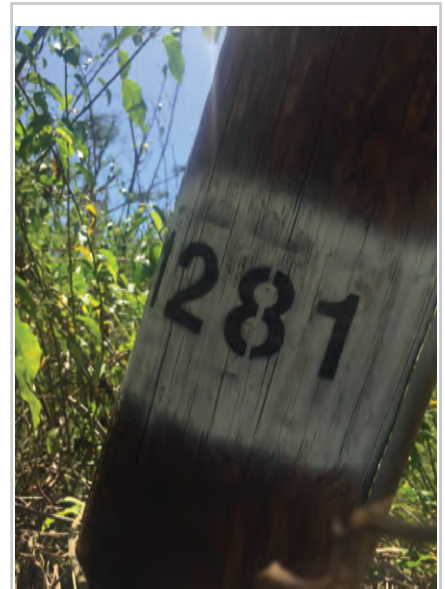
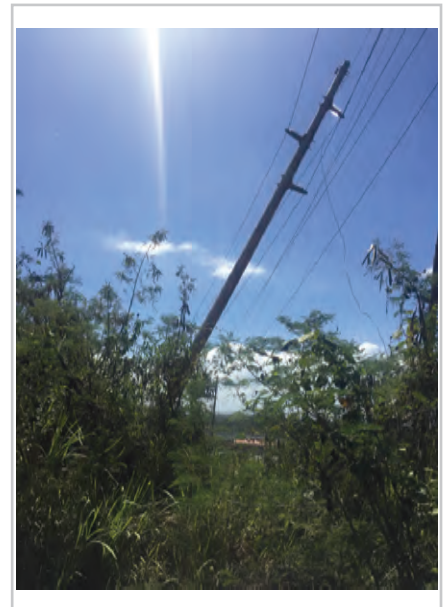
Condition: ^{INCLINED} _____

Comments: ^{SOME CONDUCTORS AT GROUND} _____

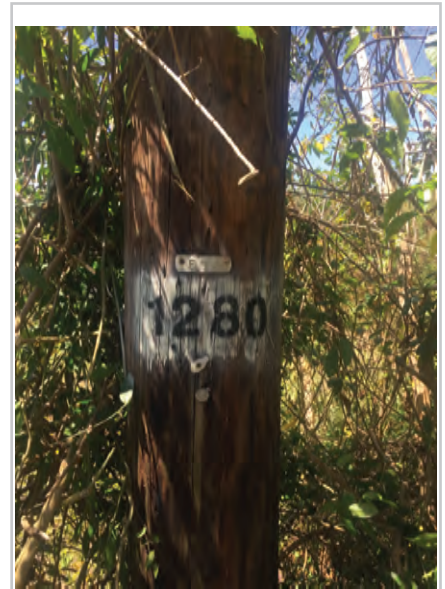
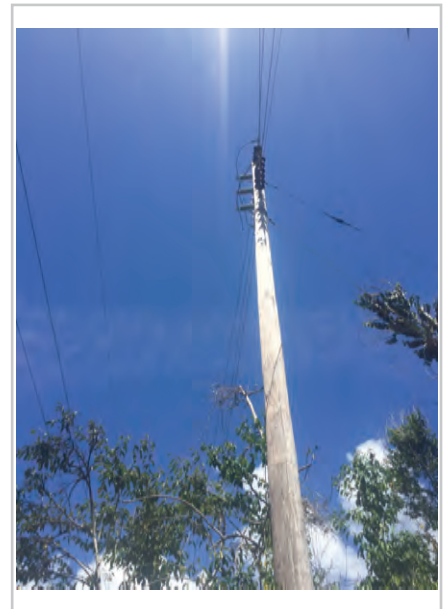
Comments: ^{GROUND CONDUCTOR DROPPED., DOWN GUY REMOVED FROM} _____

FROM GROUND

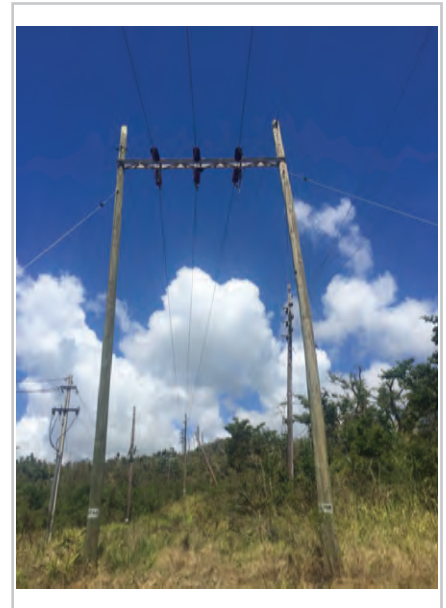
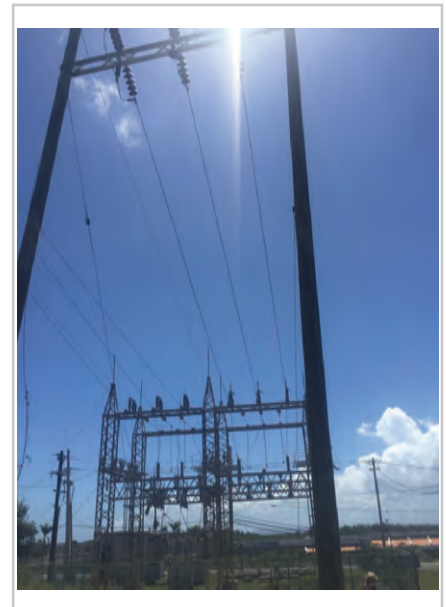
Comments: CUSTOM MADE "H" TYPE STRUCTURE WITH STEEL CROSS ARM

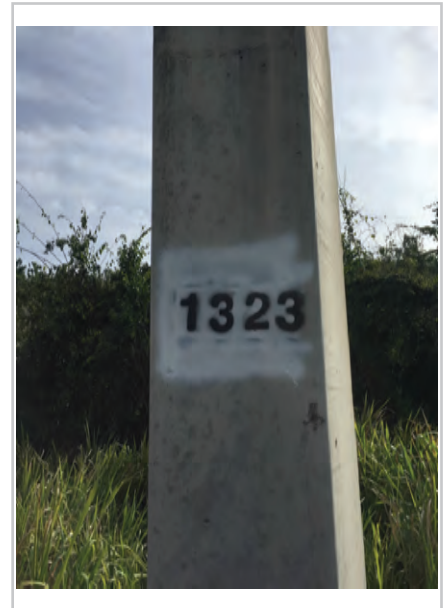
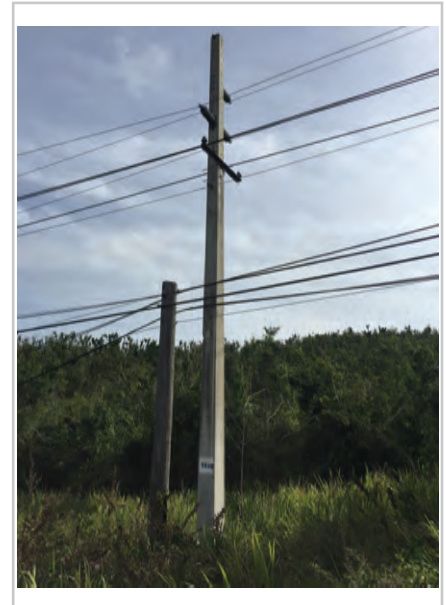
Comments: 38 KV GROUND CONDUCTOR AT GROUND, 13.2 KV CONDUCTORS

DISCONNECTED FROM CROSS ARM INSULATORS
