POLES CONDITION ASSESSMENT REPORT

PROJECT: HURRICANE MARIA DAMAGES REPAIRS
TO ROOSEVELT ROADS ELECTRICAL
SYSTEM (19-1741)

LOCATION: Roosevelt Roads,
Ceiba, PR

DATE: May 17, 2018

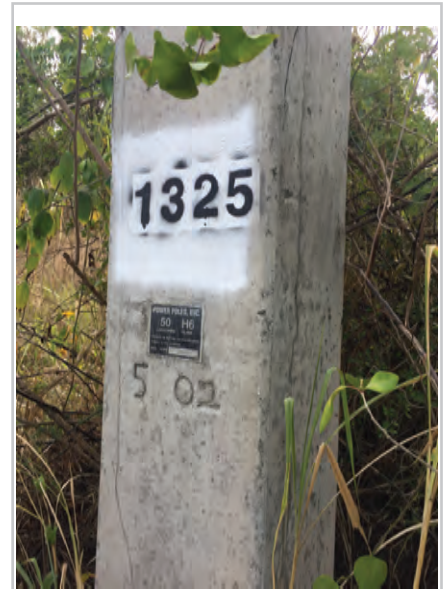
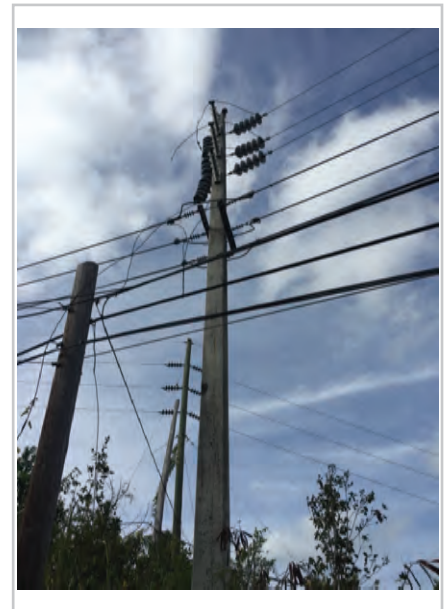
Comments: ONE SIDE OF 38 KV LINE AND STANDARD DROPPED

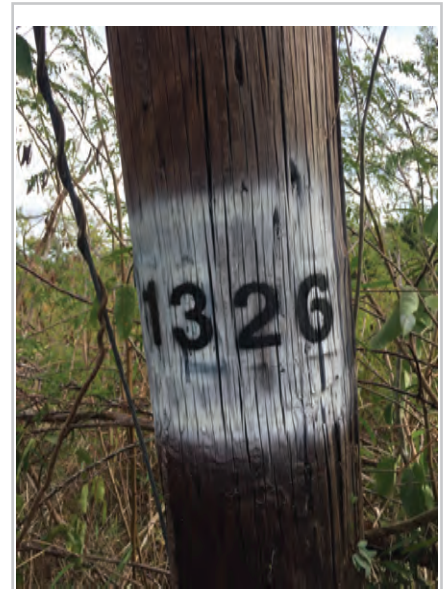
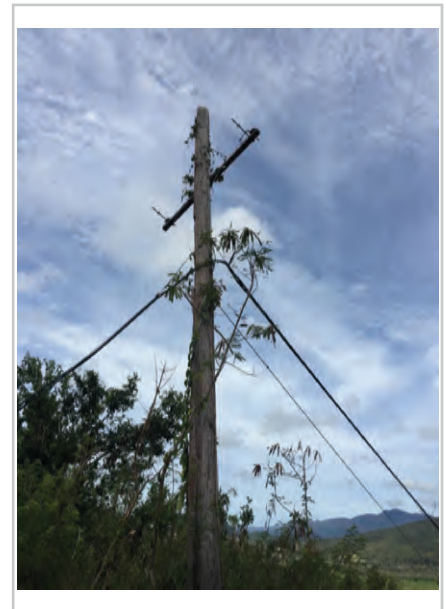
Condition: ^{OUT OF SERVICE} _____

Comments: ^{OUT OF SERVICE, ONLY SUPPPORT TELECOMMUNICATIONS LINES} _____
N/A

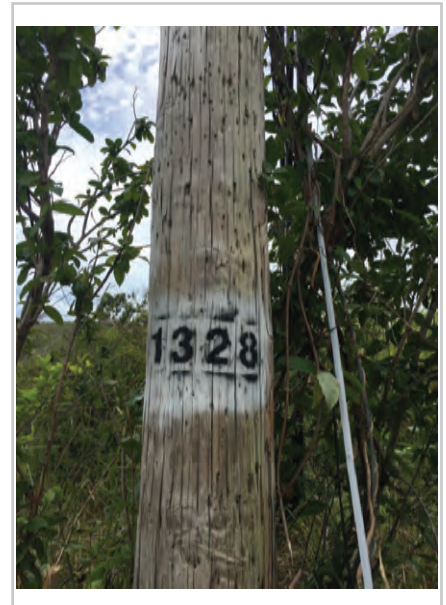
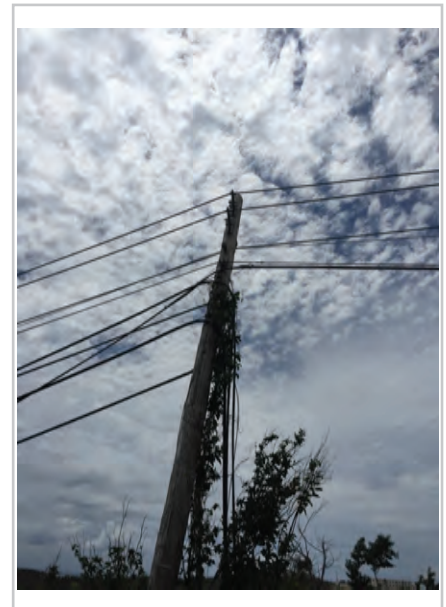
Condition: ^{INCLINED} _____

Comments: ^{POLE INCLINED} _____

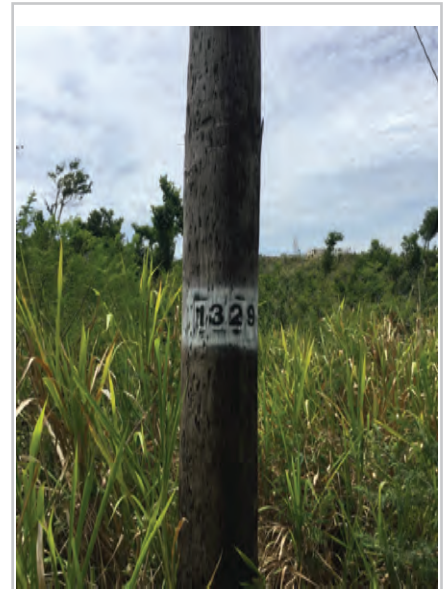
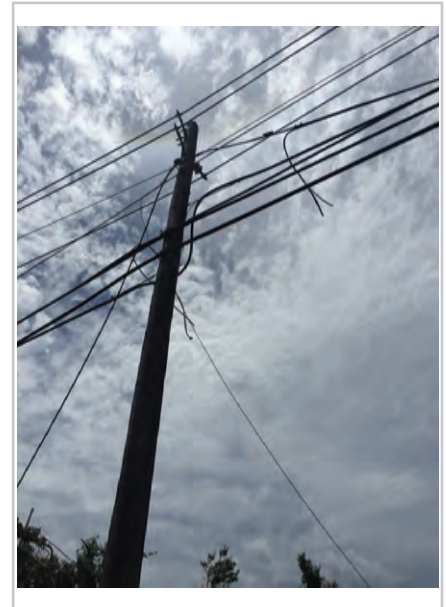
Condition: INCLINED

Comments: POLE INCLINED

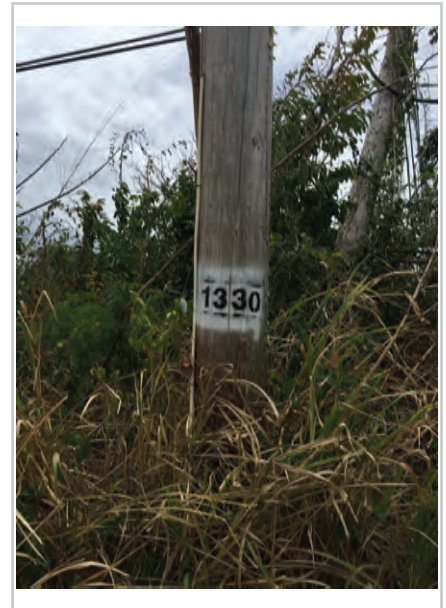
Condition: INCLINED

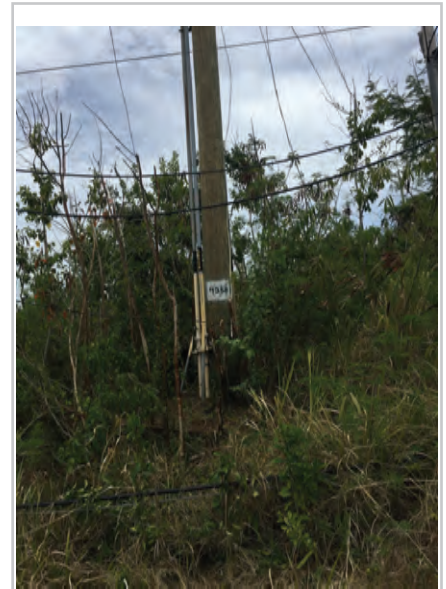
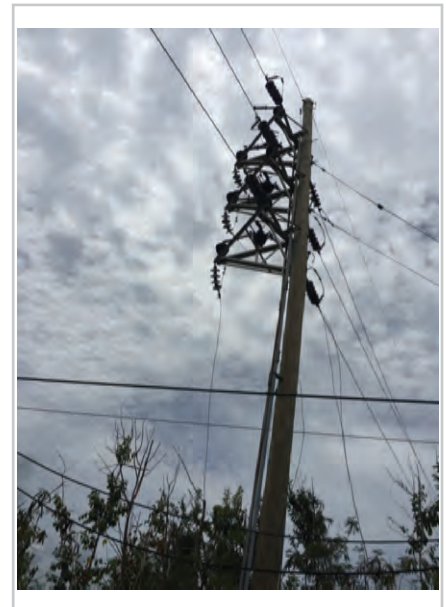
Comments: ONE WAY CONDUCTORS DROPPED AT GROUND

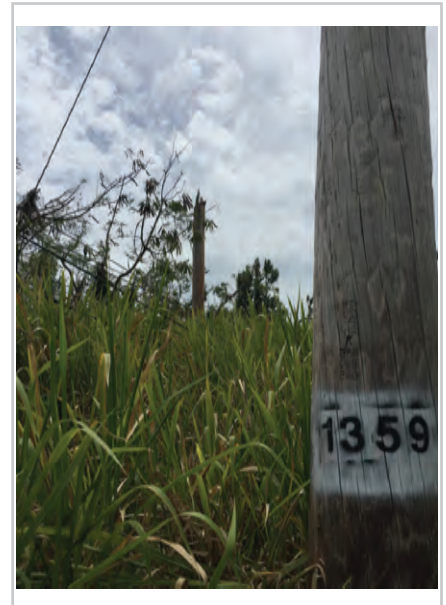
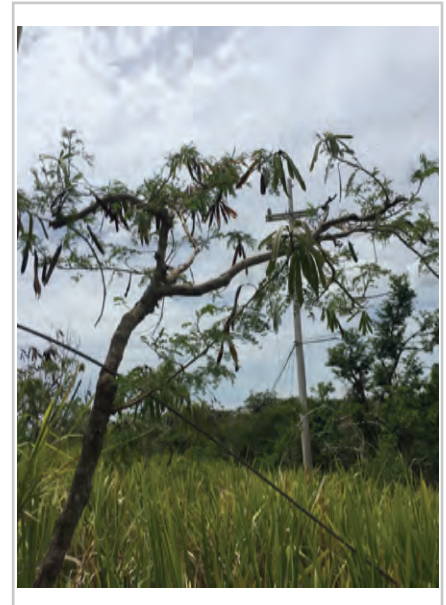
Condition: INCLINED

Comments: CONDUCTORS AT GROUND

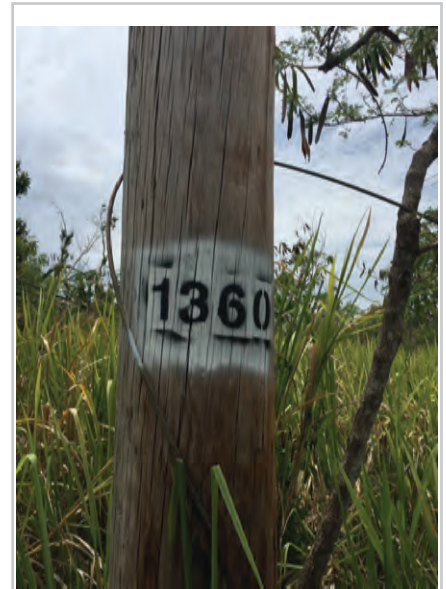
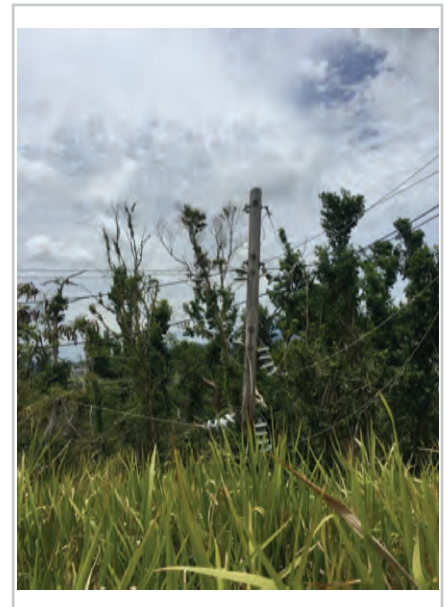
Condition: BROKEN

Comments: ALL CONDUCTORS AT GROUND

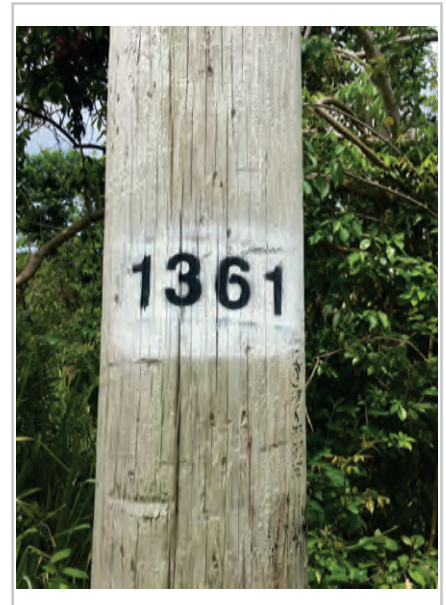
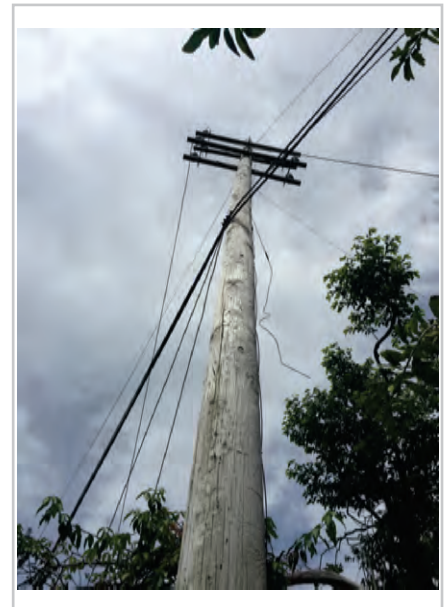
Comments: ALL CONDUCTORS ON GROUND

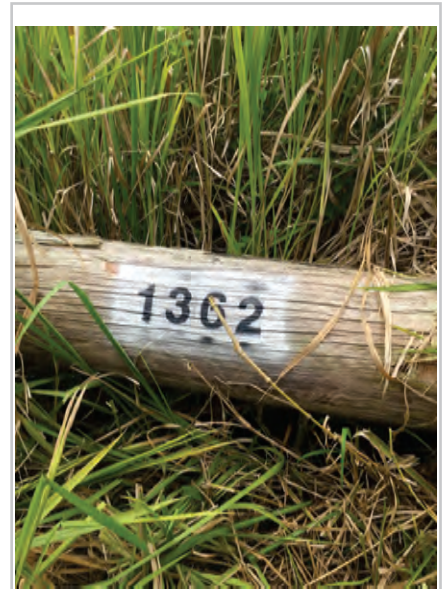
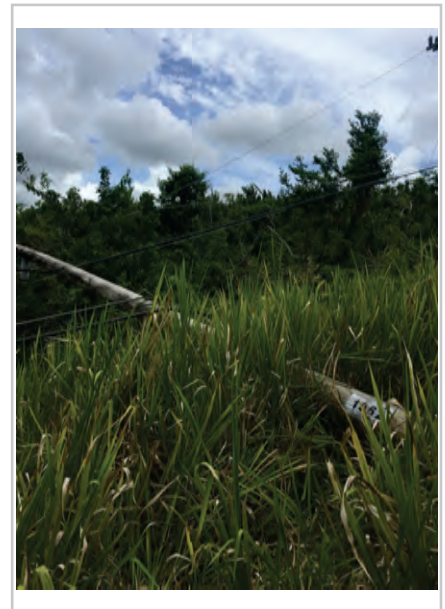
Condition: ^{BROKEN} _____

Comments: ^{ALL CONDUCTORS ON GROUND} _____

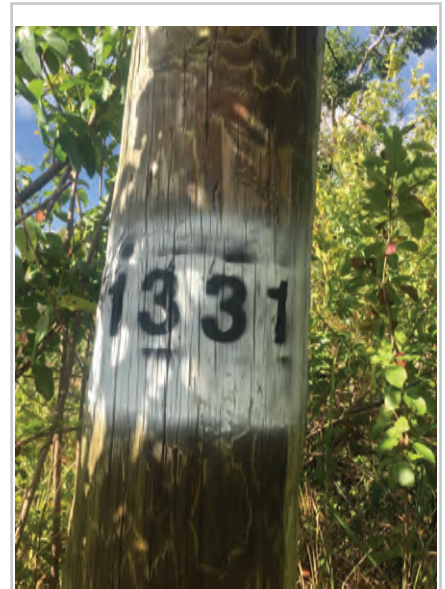
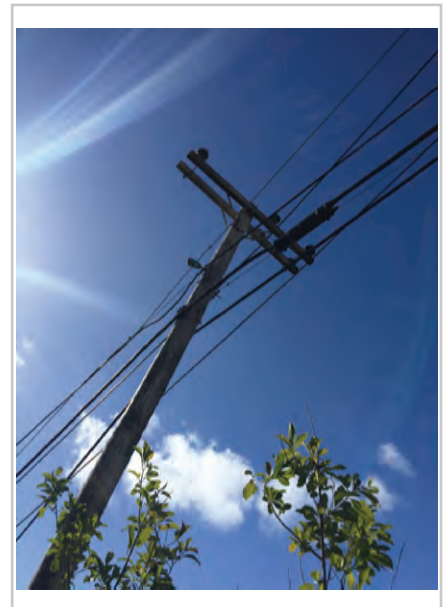
Condition: INCLINED

Comments: SOME CONDUCTORS AT GROUND

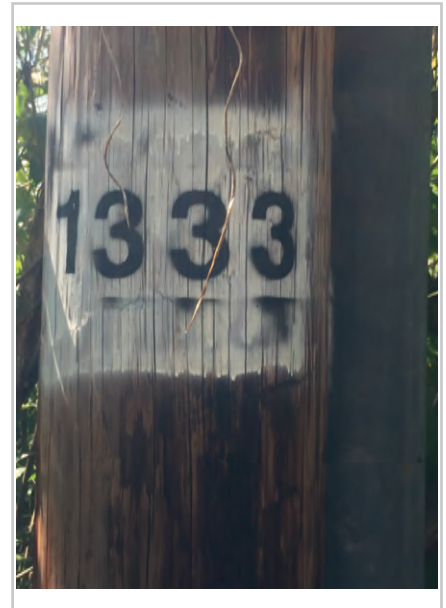
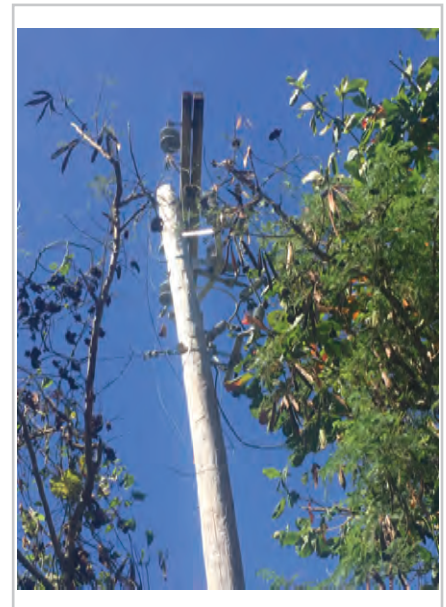
Comments: OUT OF SERVICE POLE FOR RISER CONNECTION

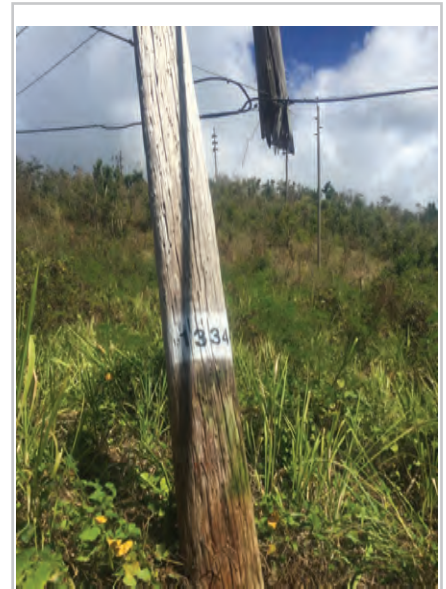
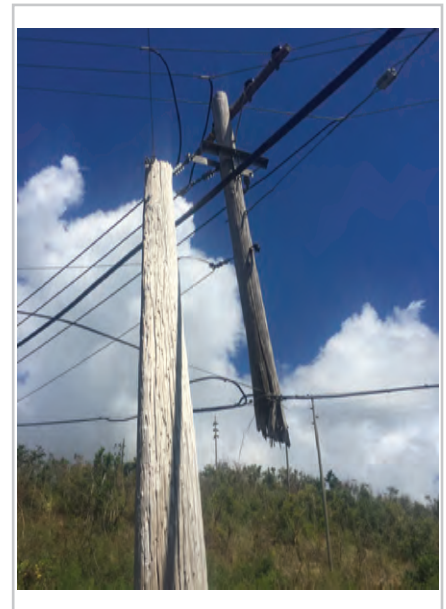
Condition: BROKEN AND INCLINED

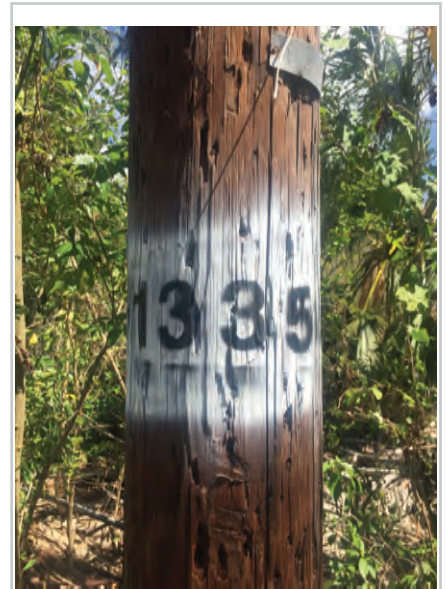
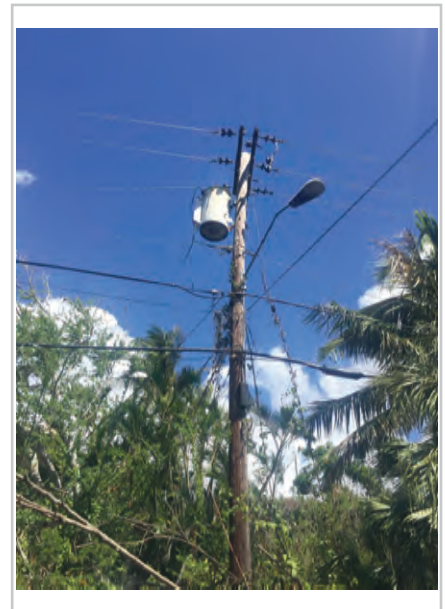
Comments: ^{INSULATORS AND CONDUCTORS CONNECTION AFFECTED} _____

TRANSFORMER AND SECONDARY LINES ARE OUT OF SERVICE

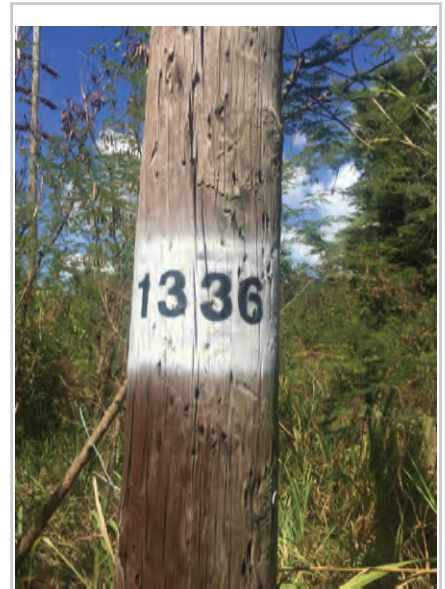
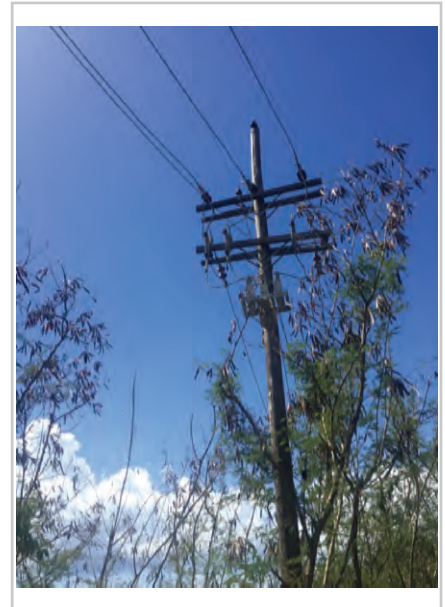
Comments: ^{SOME CONDUCTORS ON GROUND, CAPACITOR BANK ON POLE} _____
N/A

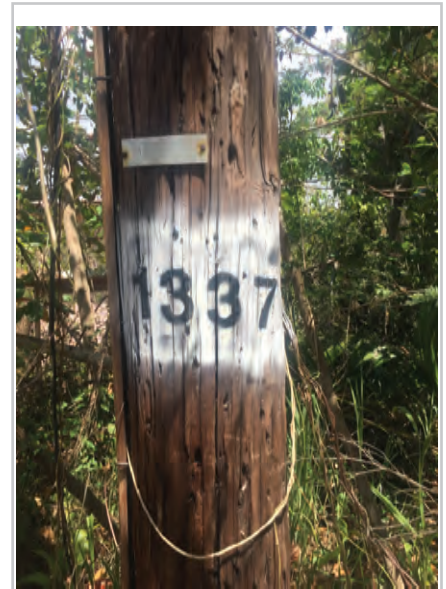
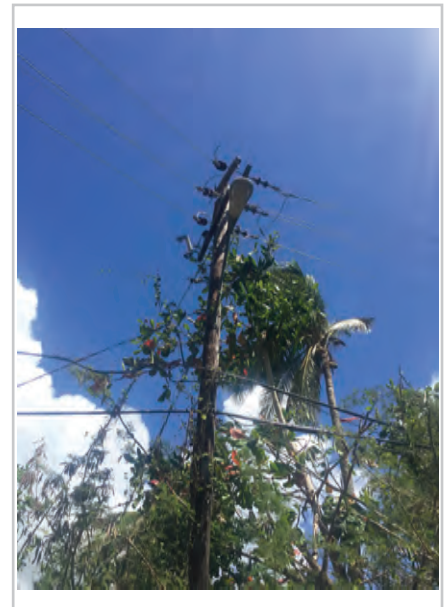
Condition: ^{INCLINED} _____

Comments: ^{SOME CONDUCTORS ON GROUND, TRANSFORMER OUT OF SERVICE} _____

ON FLOOR

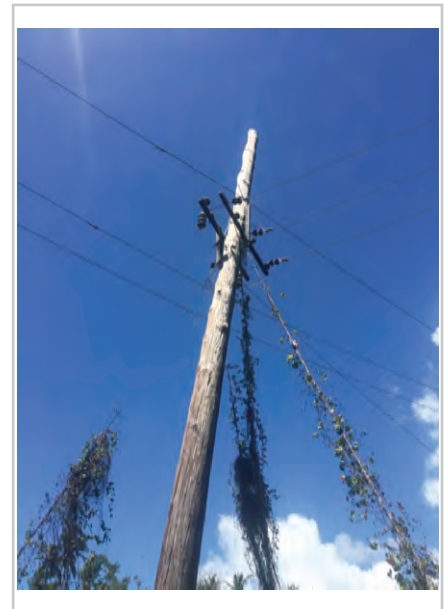
Condition: ^{BROKEN AT BASE} _____

CROOS ARM DAMAGED

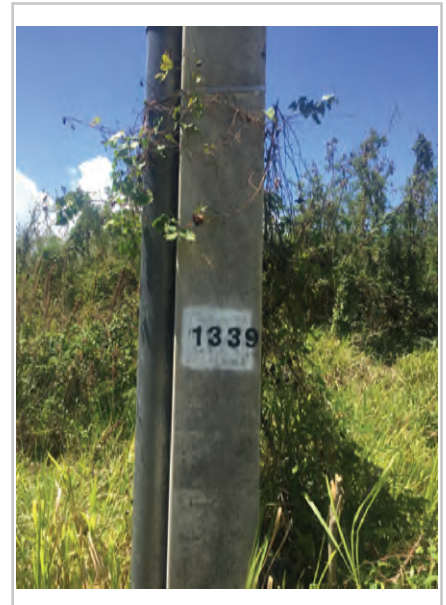
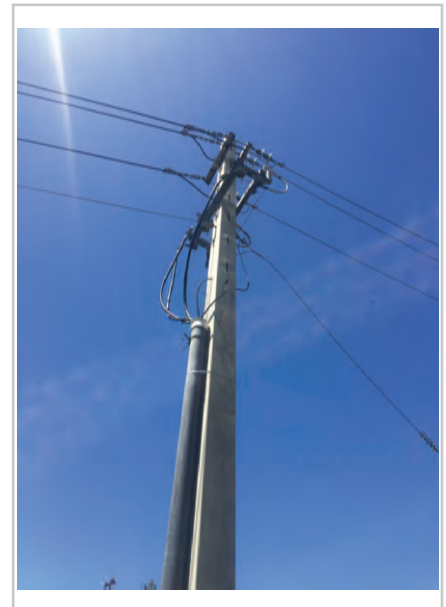
Riser Connection: ^{RISER IS IN GOOD CONDITIONS BUT OUT OF SERVICE} _____

Comments: ^{ONE CONDUCTOR DROPPED} _____
N/A

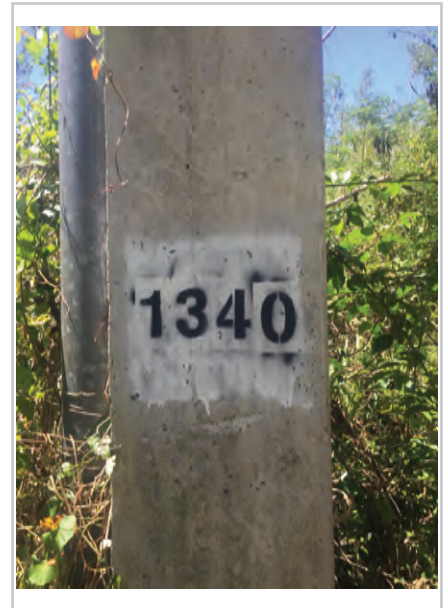
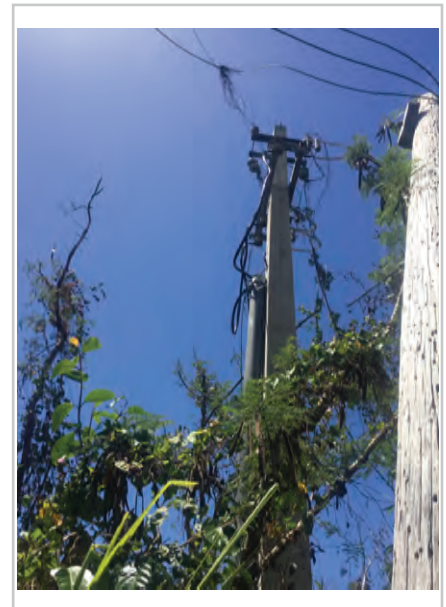
Condition: INCLINED

Riser Connection: RISER IS IN GOOD CONDITIONS BUT OUT OF SERVICE

Comments: CONDUCTORS DROPPED
N/A

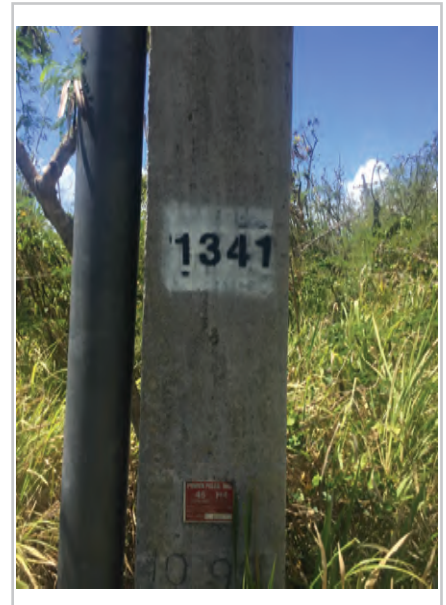
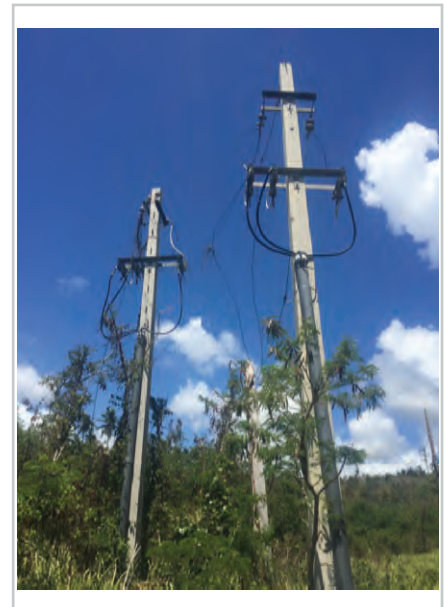
Condition: ^{INCLINED} _____

Riser Connection: ^{RISER IS IN GOOD CONDITIONS BUT OUT OF SERVICE} _____

Comments: ^{CONDUCTORS DROPPED} _____
N/A

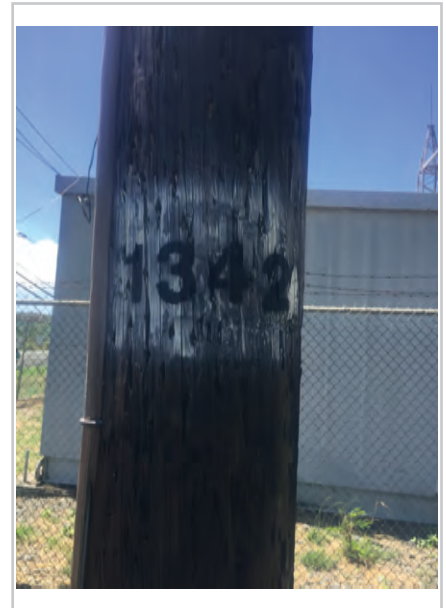
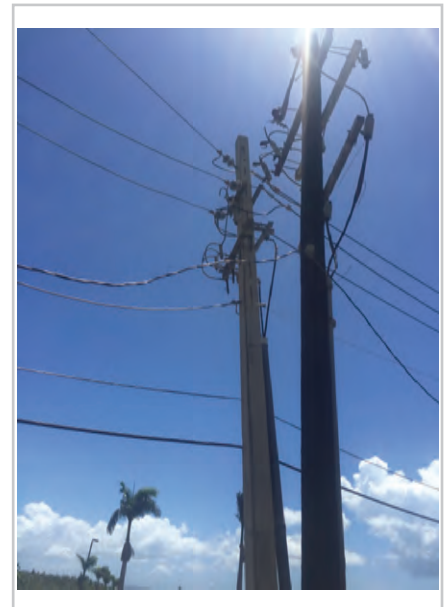
Condition: ^{OUT OF SERVICE} _____

Comments: ^{OUT OF SERVICE, NO CONDUCTORS} _____
N/A

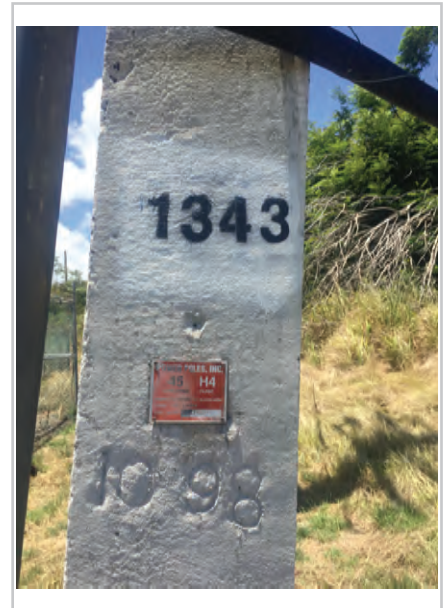
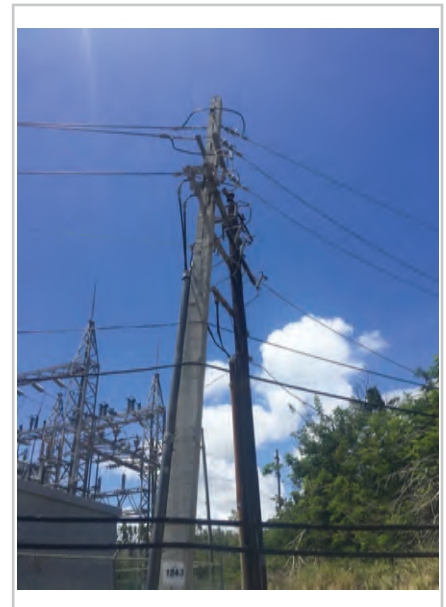
Condition: ^{INCLINED} _____

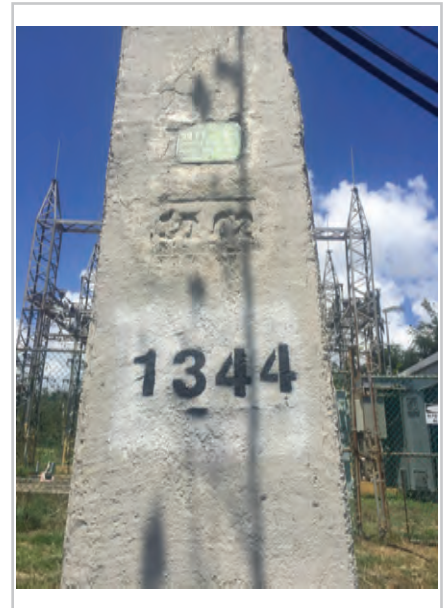
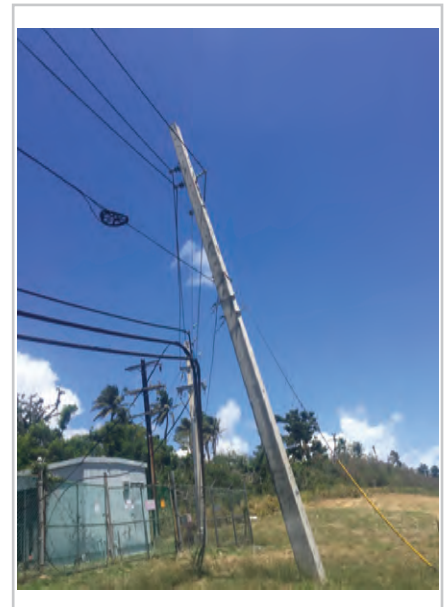
Condition: ^{INCLINED} _____

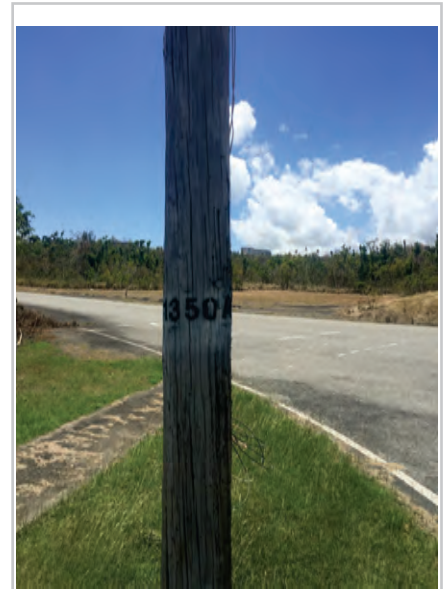
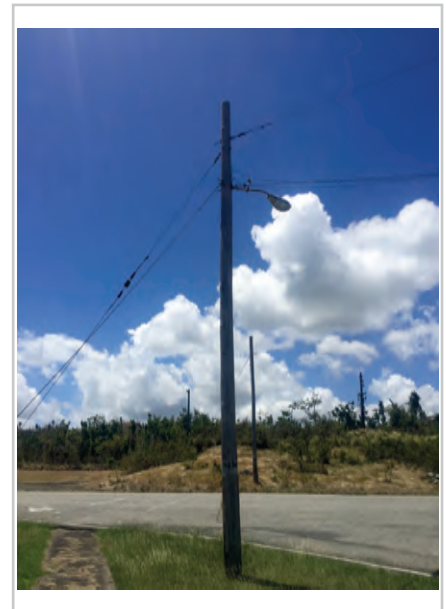
Comments: STUB POLE, SECONDARY LINE INSULATOR DROPPED
N/A

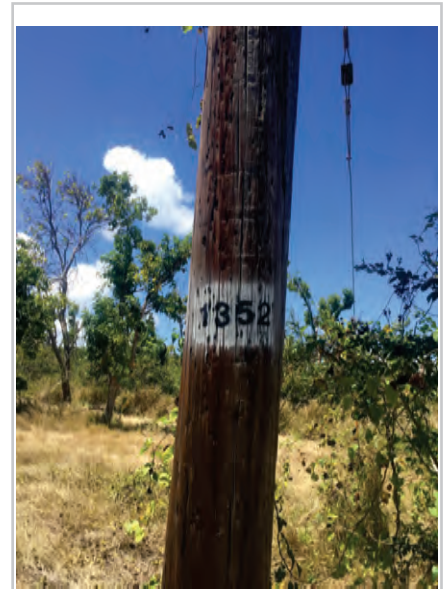
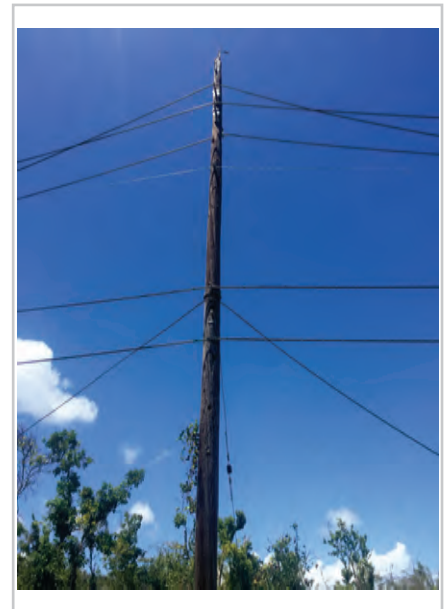
Condition: ^{GOOD} _____

Comments: ^{CONDUCTORS NEED TENSION} _____
N/A

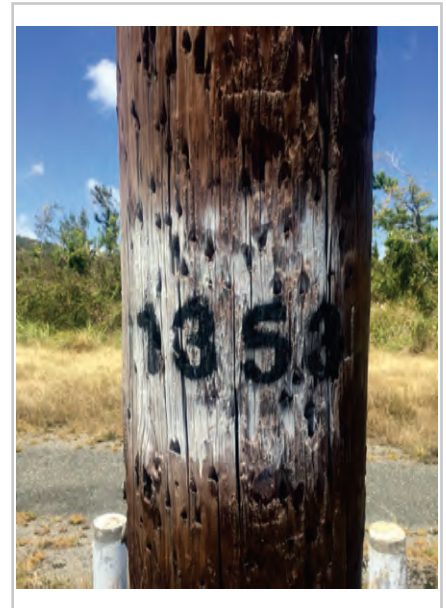
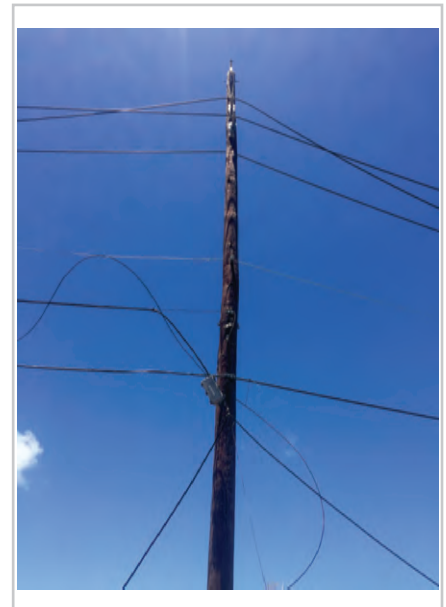
Condition: GOOD

Comments: CONDUCTORS NEED TENSION
N/A

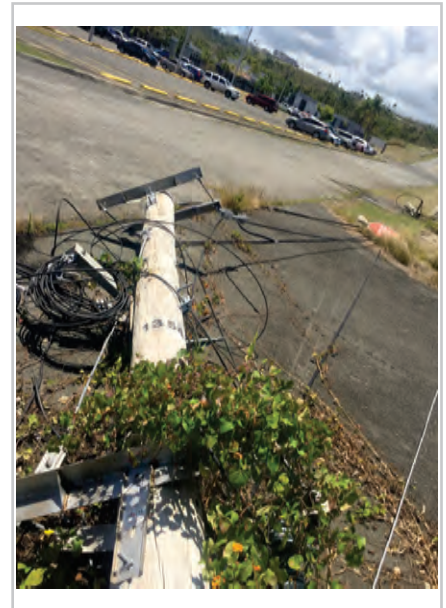
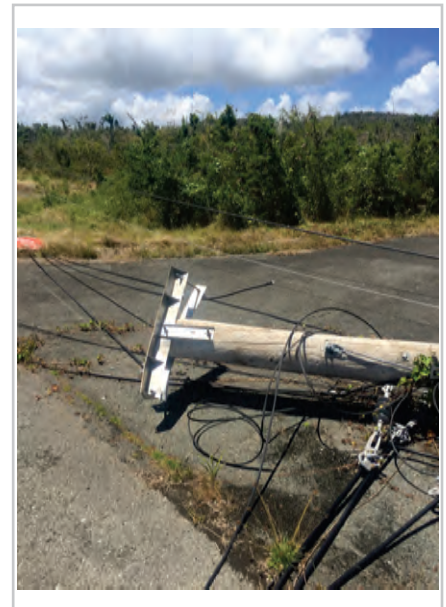
Condition: BROKEN

Comments: CONDUCTORS AT GROUND

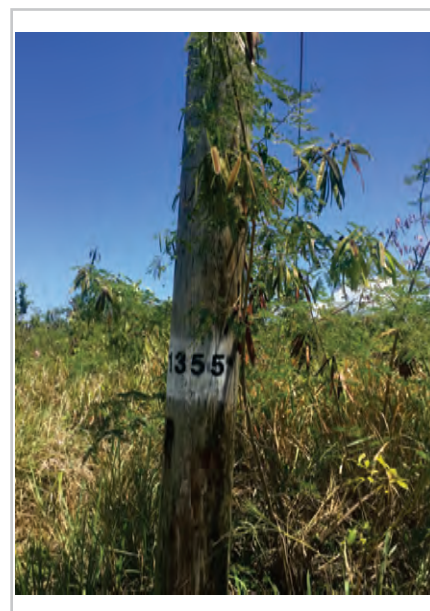
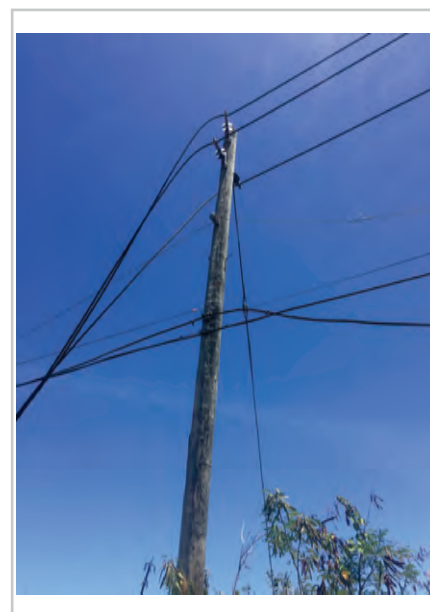
Condition: GOOD

Comments: CONDUCTORS AT ONE SIDE DROPPED
N/A

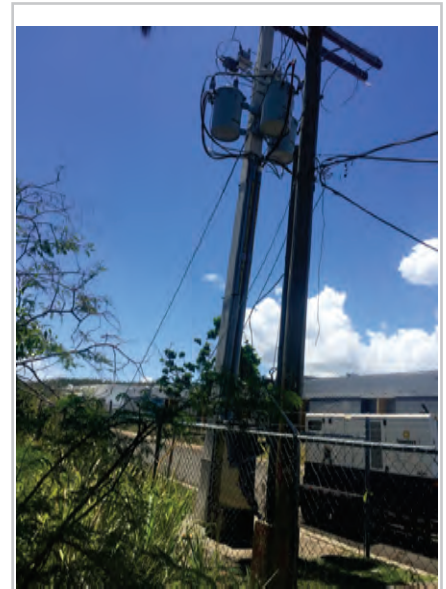
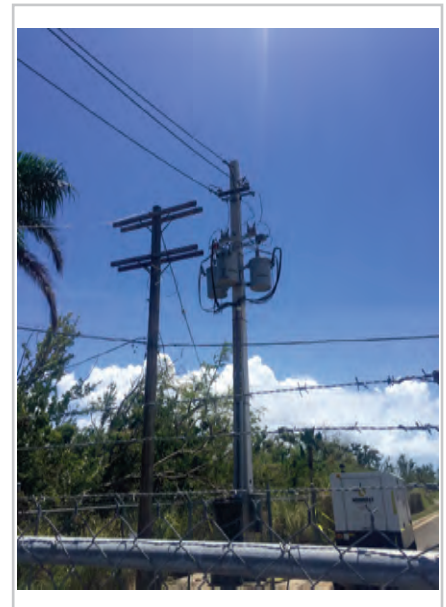
Condition: ^{GOOD} _____

Comments: ^{POLE MOUNTED SUSBTATION FOR CROEC} _____
N/A

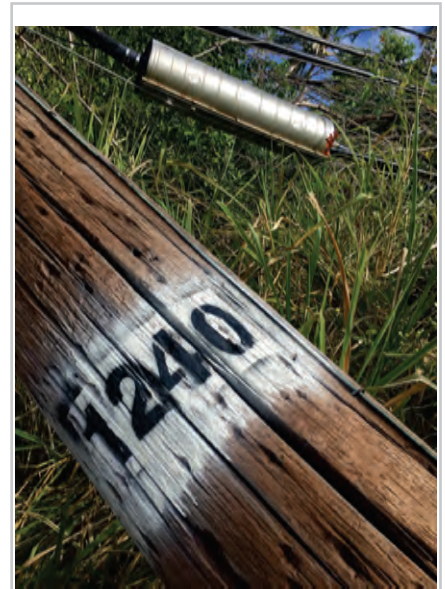
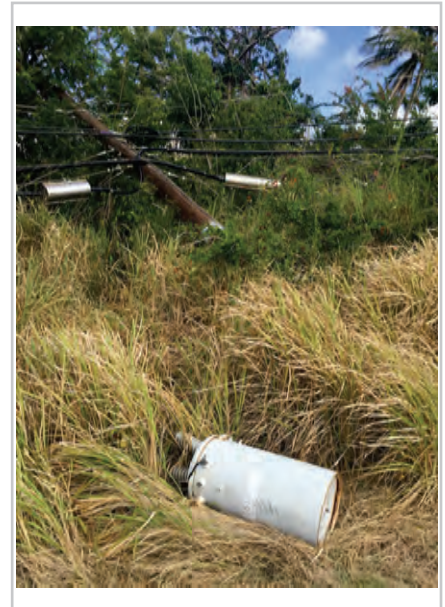
Condition: ^{BROKEN} _____

Comments: ^{ALL CONDUCTORS AT GROUND, TRANSFORMER AT GROUND} _____

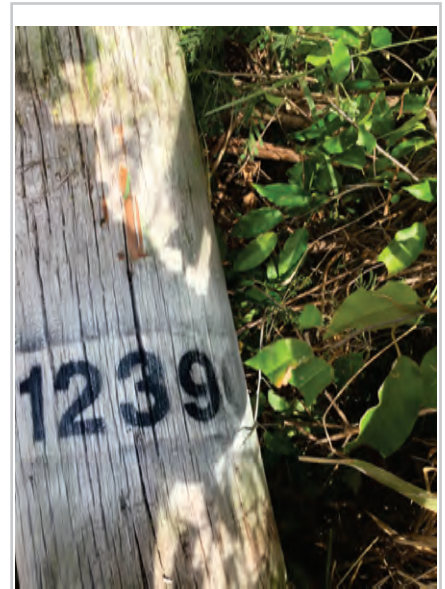
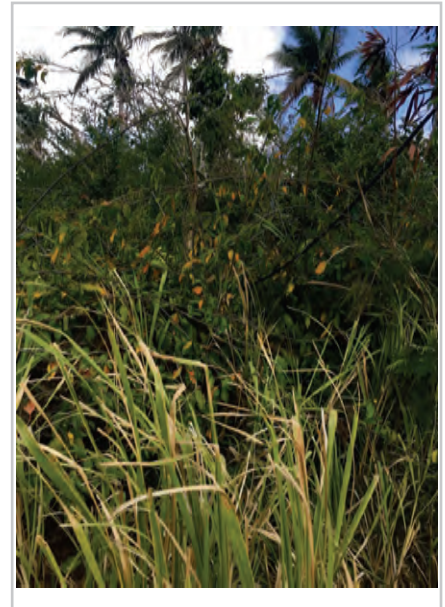
Condition: ^{BROKEN} _____

Comments: ^{ALL CONDUCTORS AT GROUND} _____

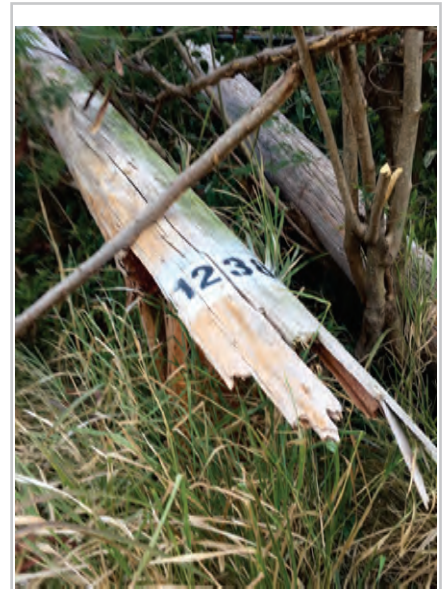
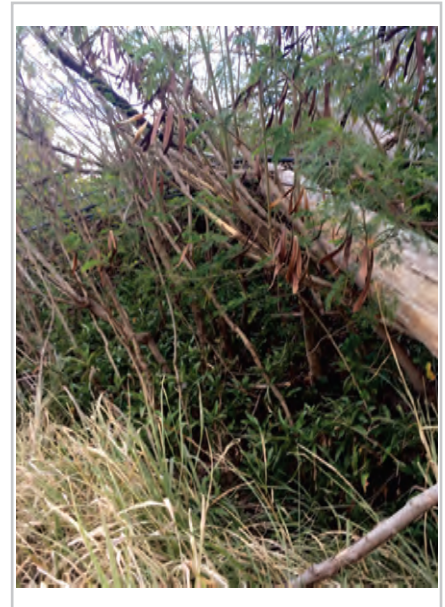
Condition: BROKEN

Comments: ALL CONDUCTORS AT GROUND

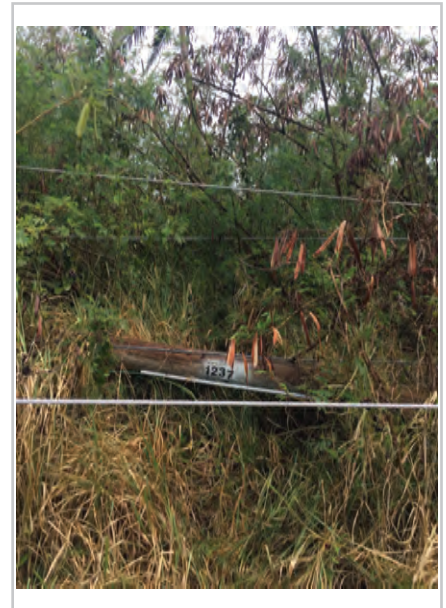
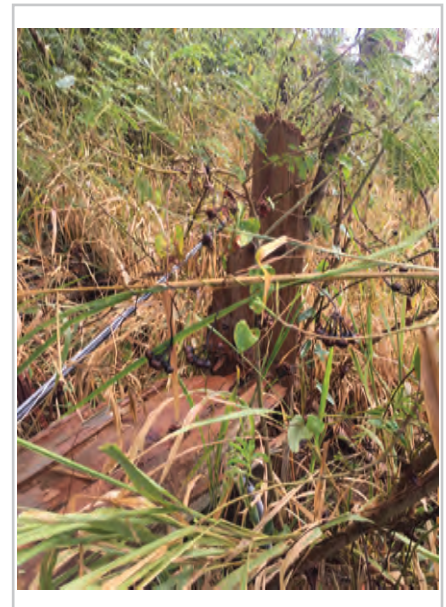
Condition: ^{BROKEN} _____

Comments: ^{ALL CONDUCTORS AT GROUND} _____

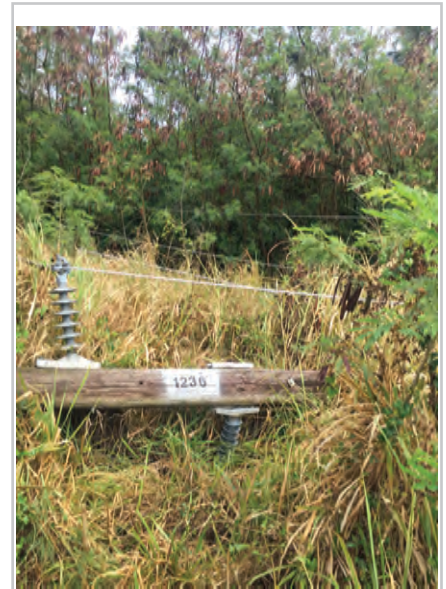
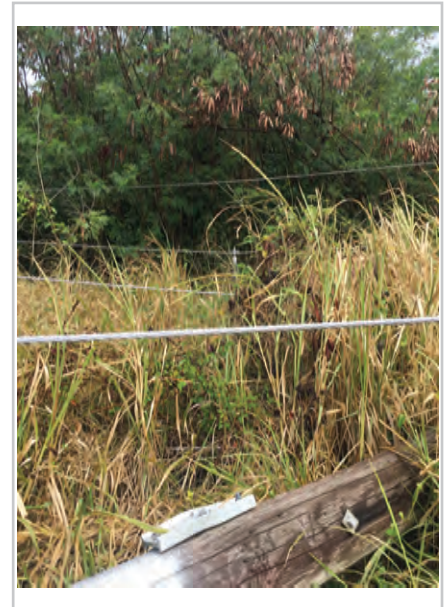
Condition: BROKEN

Comments: ALL CONDUCTORS AT GROUND

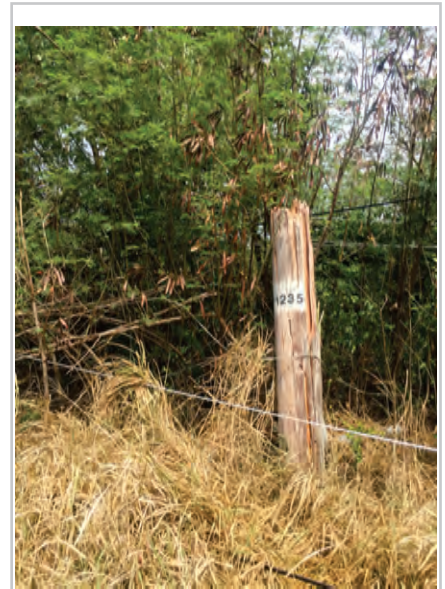
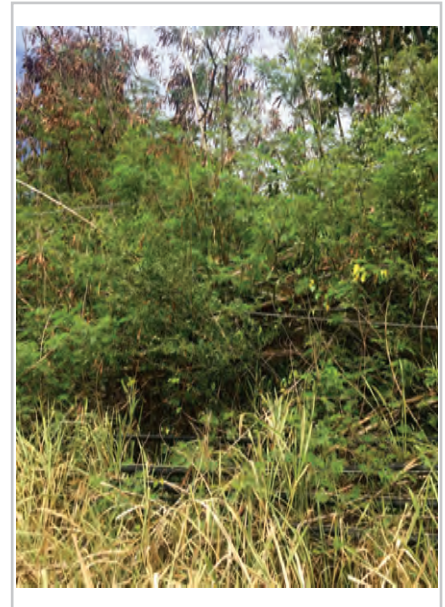
Condition: BROKEN

Comments: POLE, CROSS ARMS AND CONDUCTORS AT GROUND

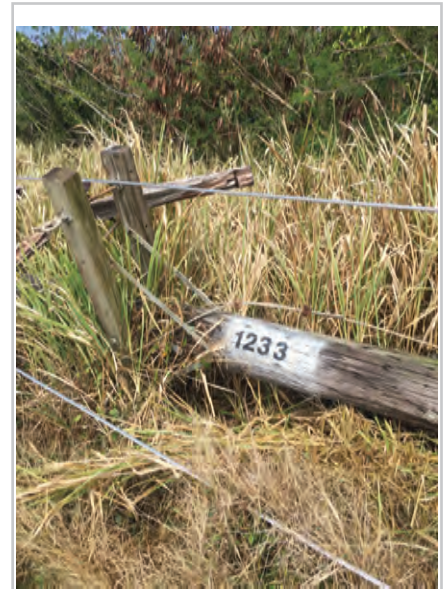
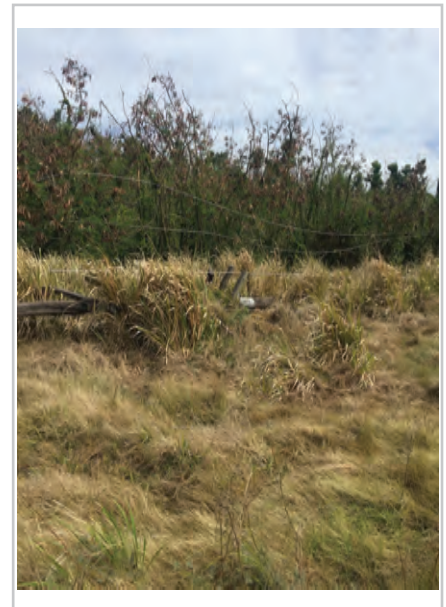
Condition: BROKEN

Comments: ALL CONDUCTORS AT GROUND

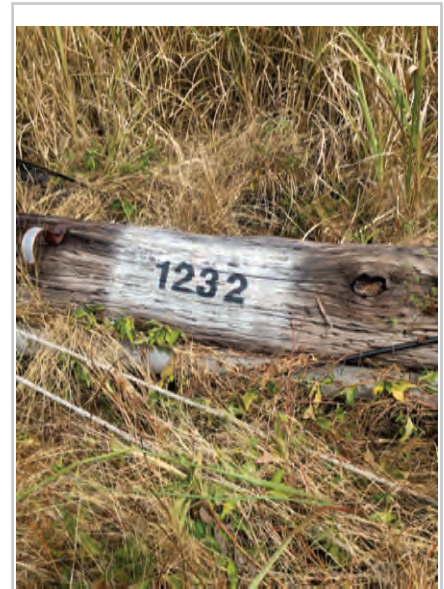
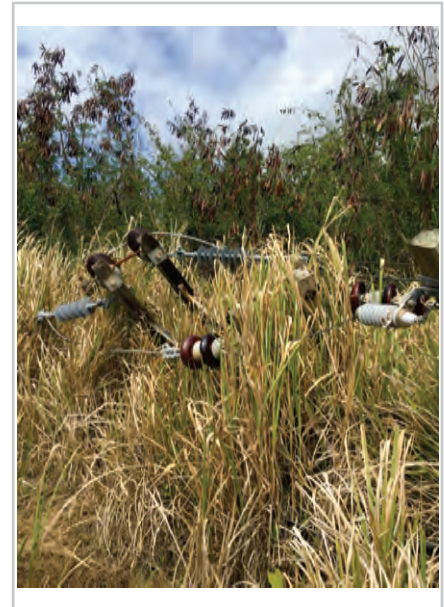
Condition: ^{BROKEN} _____

Comments: ^{ALL CONDUCTORS AT GROUND} _____

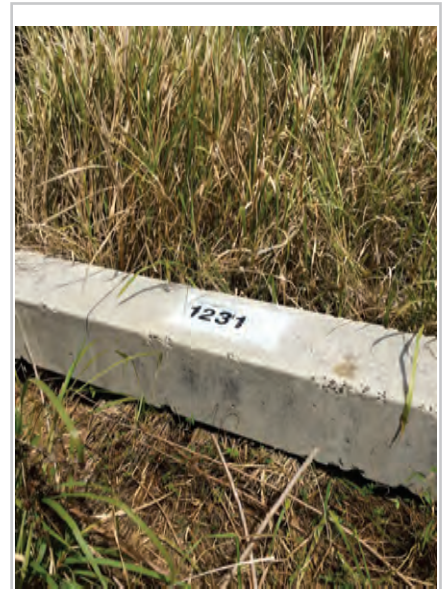
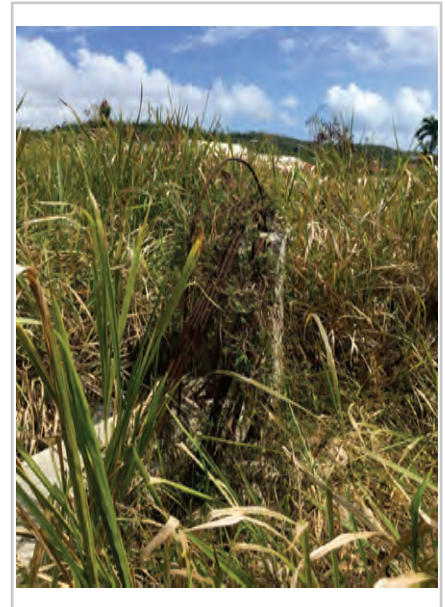
Condition: BROKEN

Comments: ALL CONDUCTORS AT GROUND

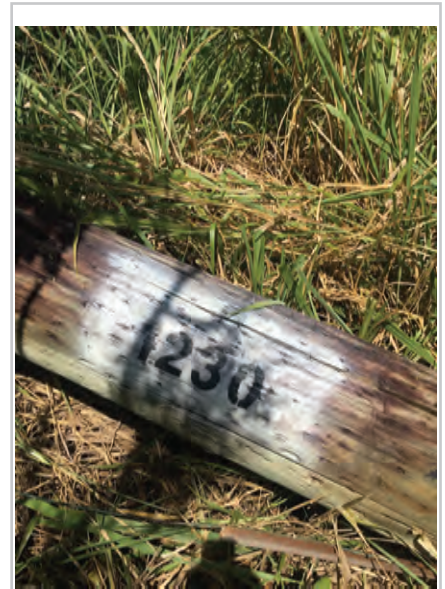
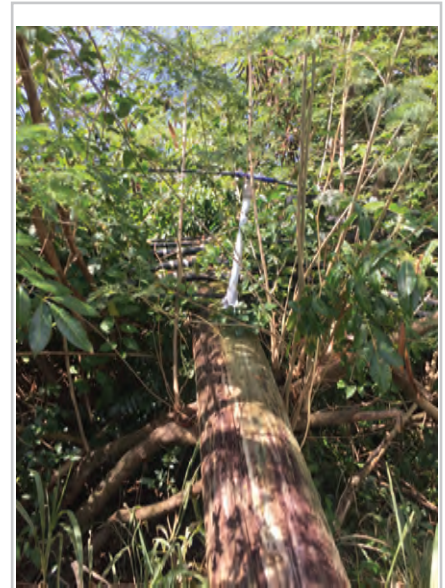
Condition: BROKEN

Comments: ALL CONDUCTORS AT GROUND

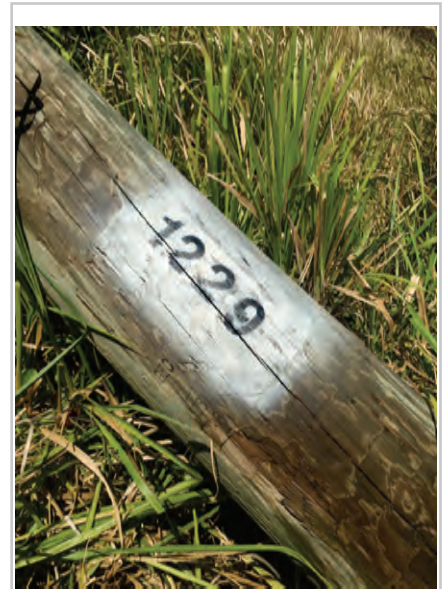
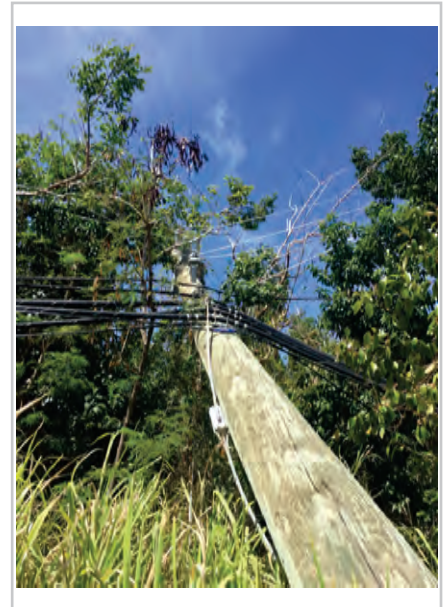
Condition: BROKEN

Comments: ALL CONDUCTORS AT GROUND

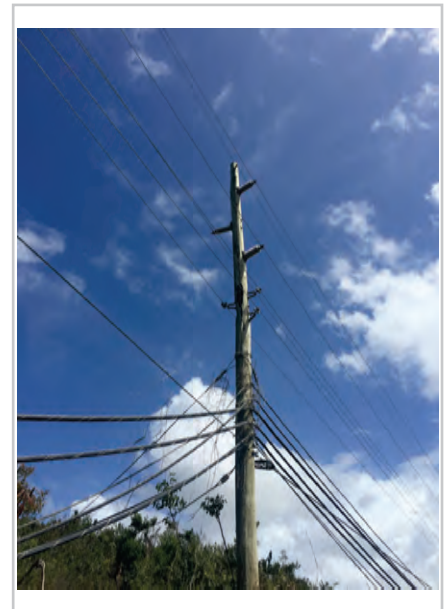
Condition: BROKEN

Comments: DAMAGE BY LIGHTNING OR FIRE

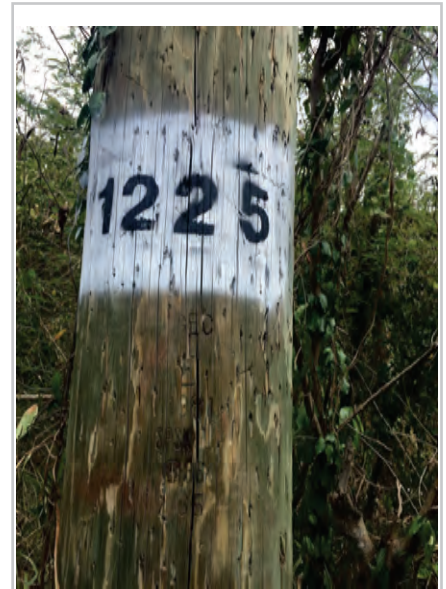
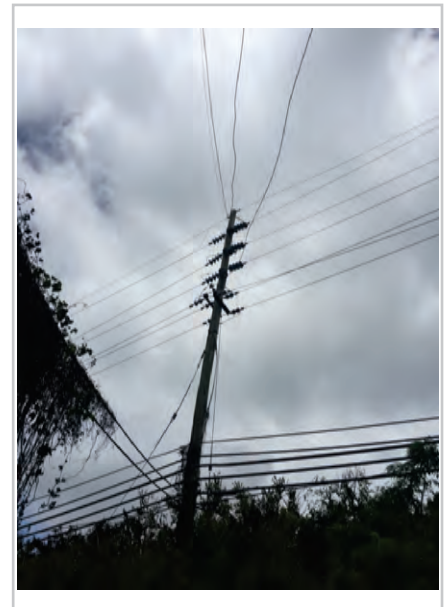
Condition: GOOD

Comments: 38 KV TAP TO SUBSTATION WITH NO GANG OPERATED SWITCH

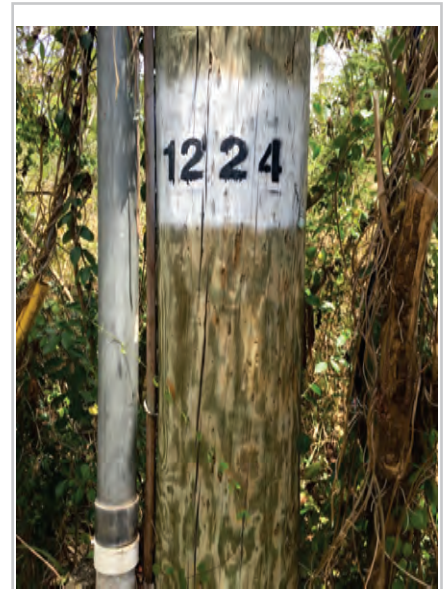
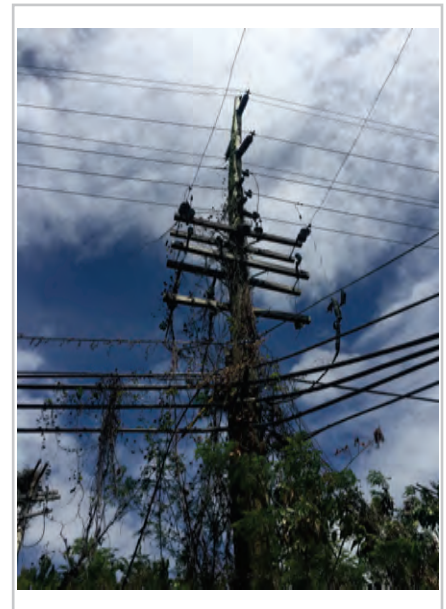
Condition: GOOD
