POLES CONDITION ASSESSMENT REPORT

PROJECT: HURRICANE MARIA DAMAGES REPAIRS
TO ROOSEVELT ROADS ELECTRICAL
SYSTEM (19-1741)

LOCATION: Roosevelt Roads,
Ceiba, PR

DATE: May 17, 2018

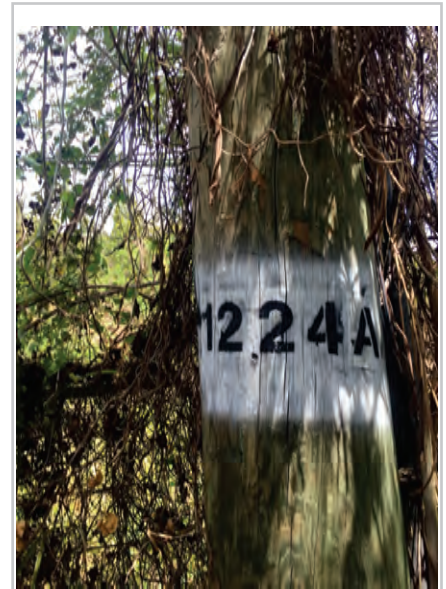
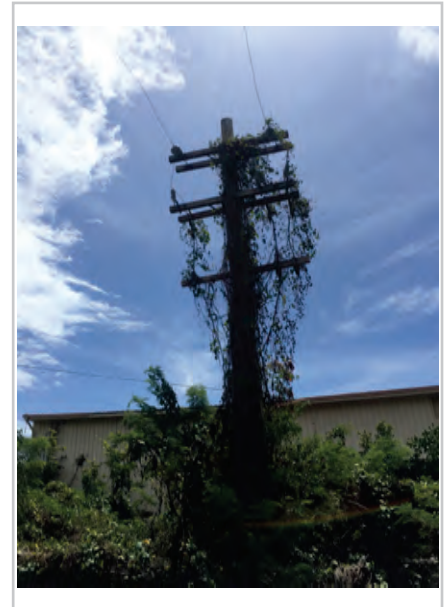
Condition: GOOD

Comments: OUT OF SERVICE

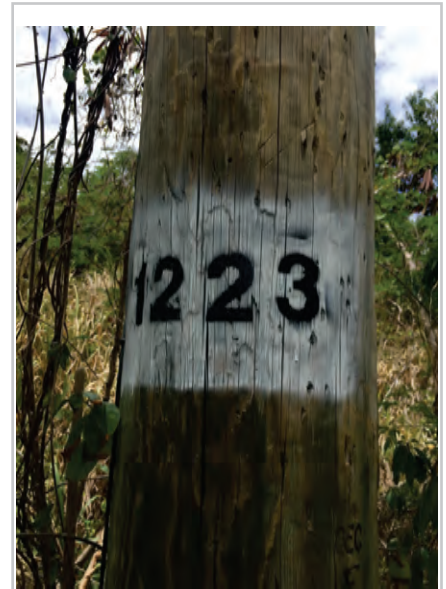
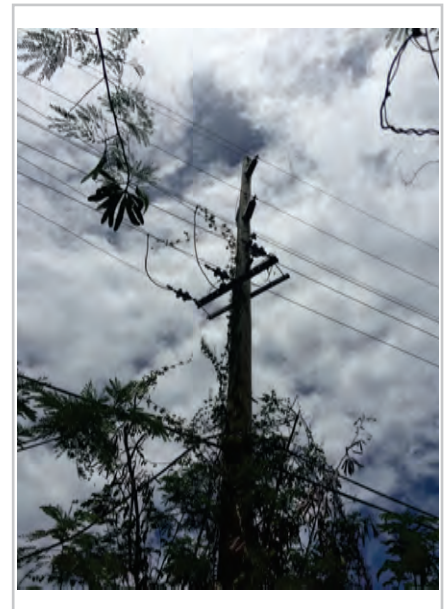
Condition: ^{GOOD} _____

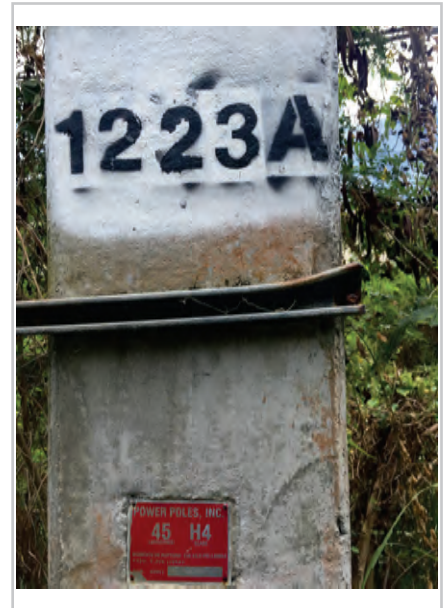
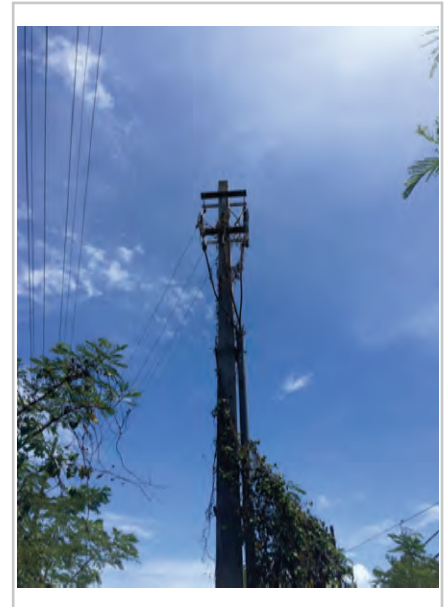
Condition: GOOD

Comments: OUT OF SERVICE
N/A

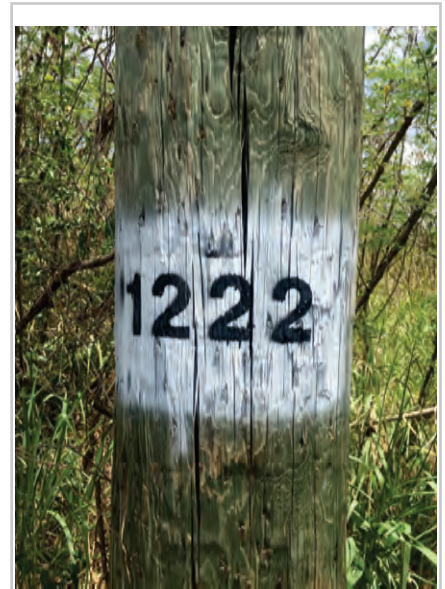
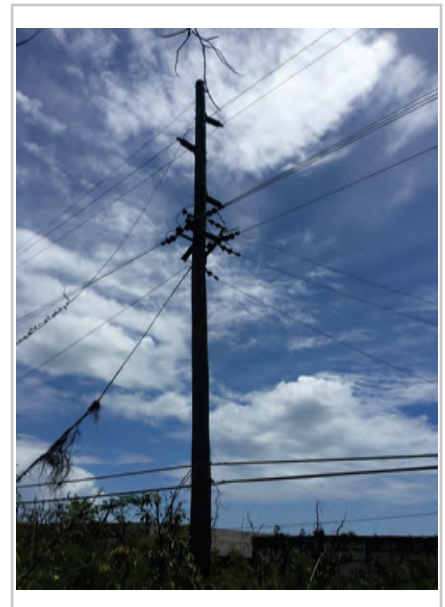
Condition: ^{GOOD} _____

Comments: ^{GROUND CONDUCTOR AT GROUND AT ONE SIDE} _____

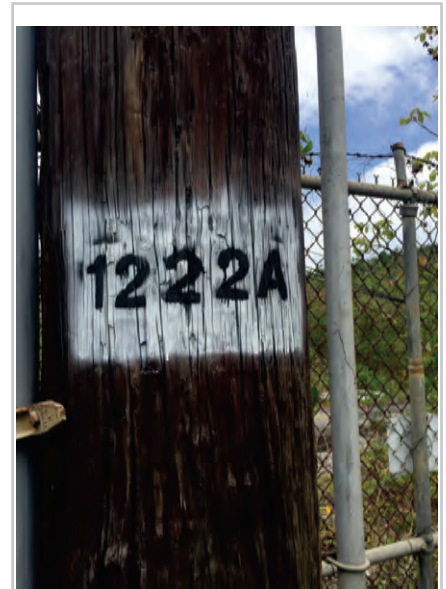
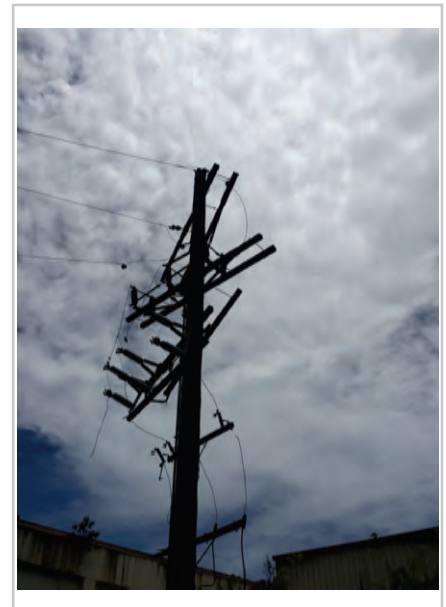
Condition: GOOD

Comments: OUT OF SERVICE

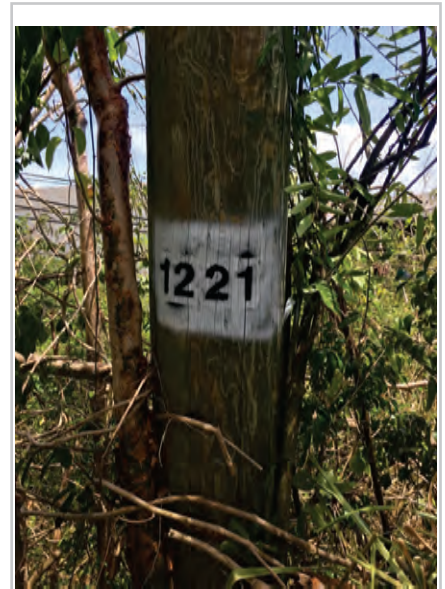
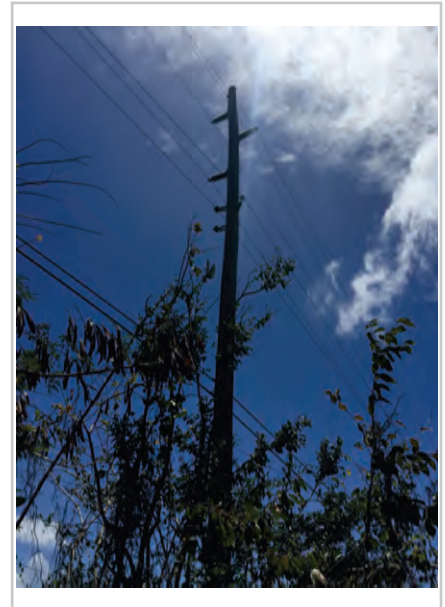
Condition: GOOD

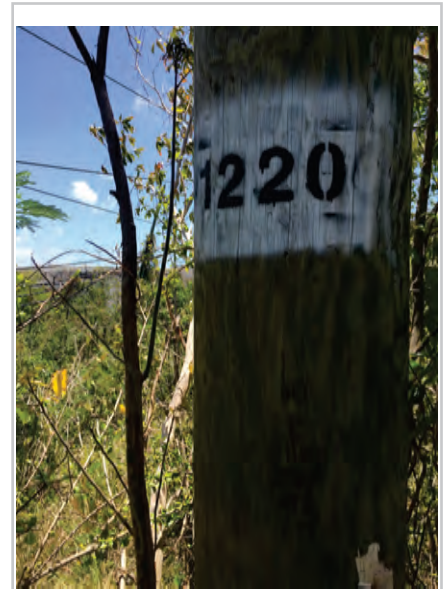
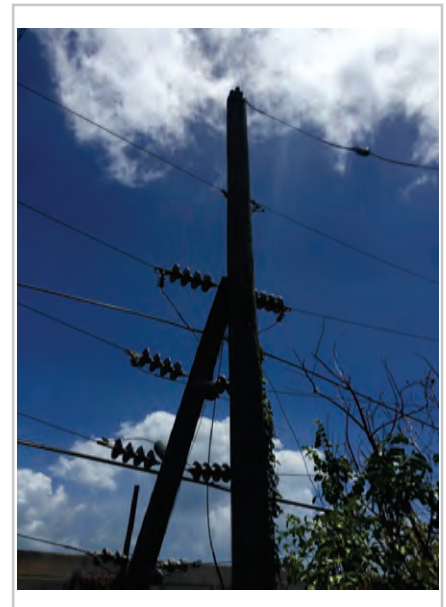
Condition: BROKEN

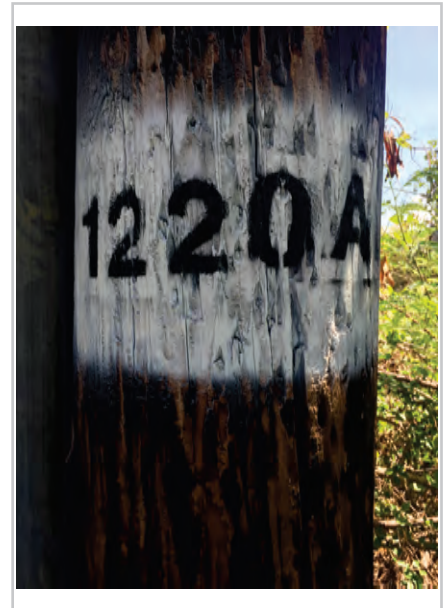
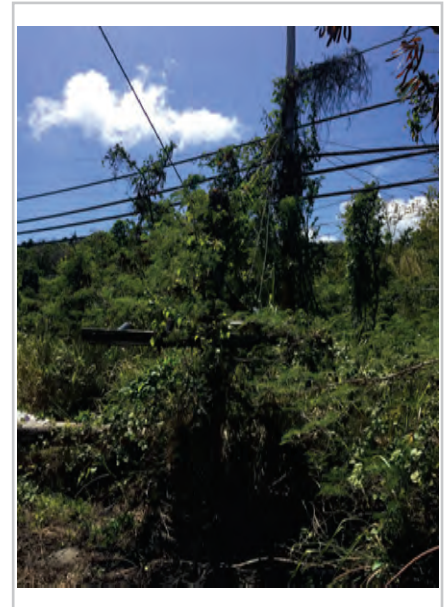
Condition: BROKEN

Comments: OUT OF SERVICE
N/A

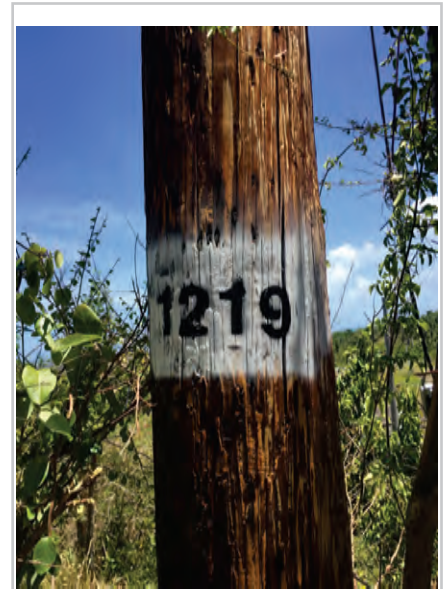
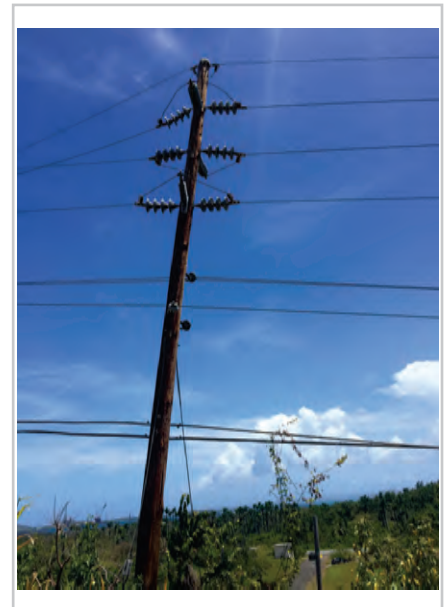
Condition: INCLINED

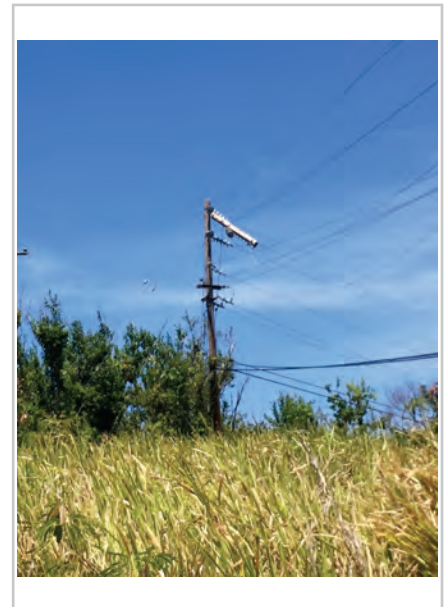
Condition: ^{BROKEN} _____

Comments: ^{BROKEN AT TOP} _____

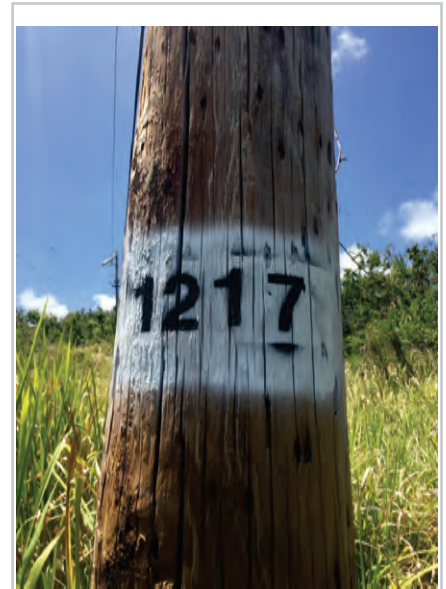
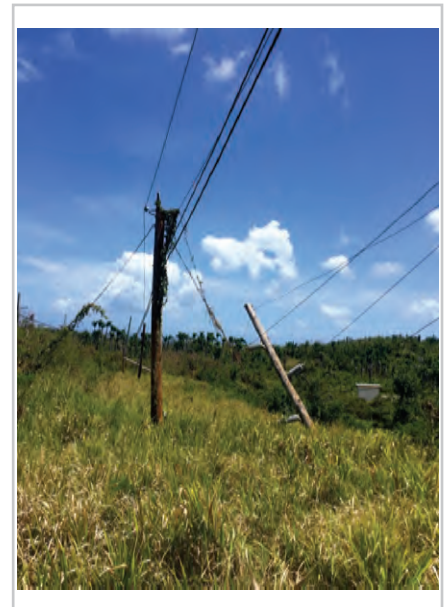
Condition: BROKEN

Comments: CONDUCTORS AT GROUND

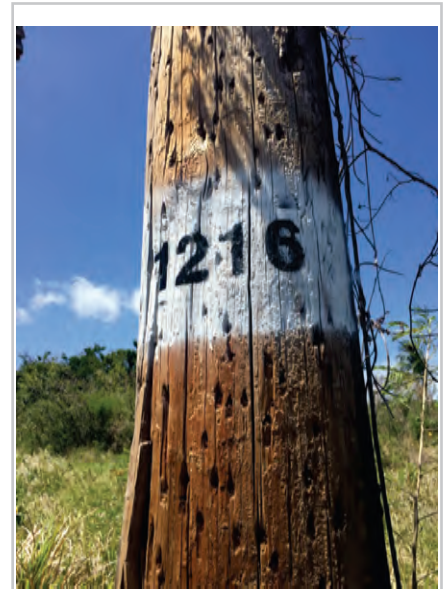
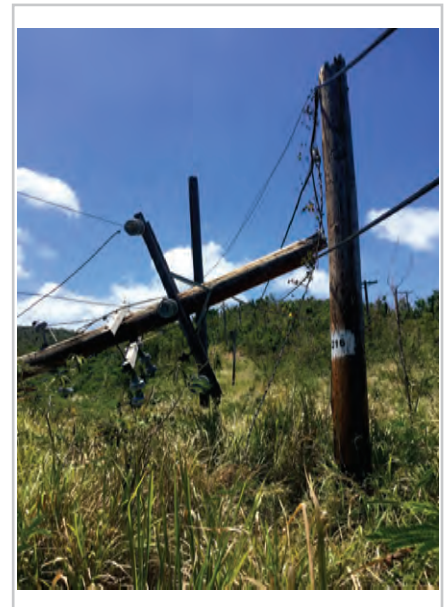
Condition: ^{BROKEN} _____

Comments: ^{CONDUCTORS AT GROUND} _____

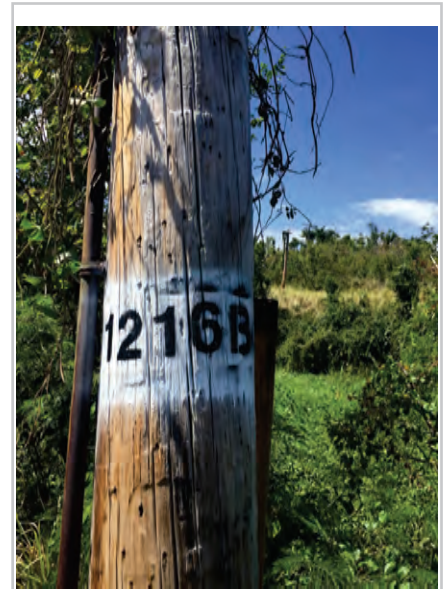
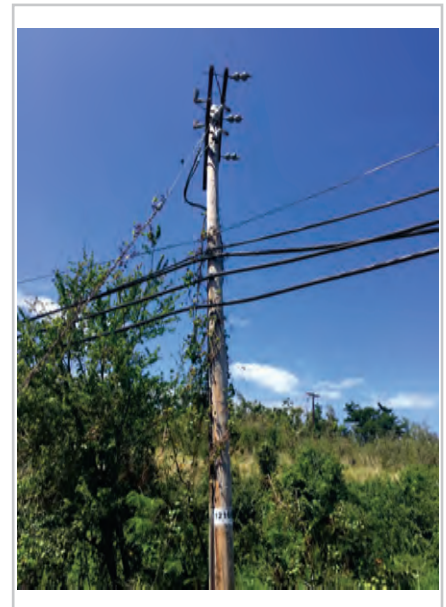
Condition: ^{GOOD} _____

Comments: ^{OUT OF SERVICE} _____
N/A

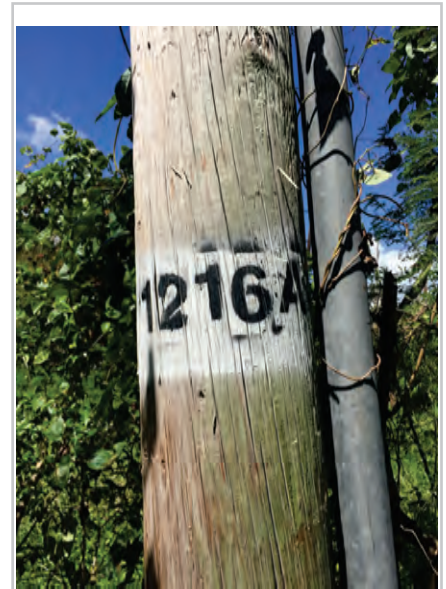
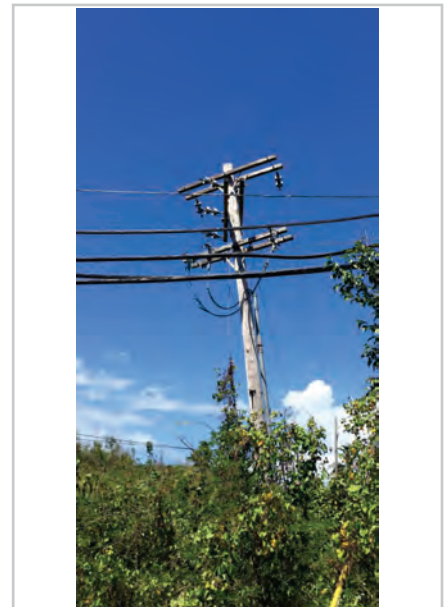
Condition: ^{INCLINED} _____

Comments: ^{OUT OF SERVICE} _____
N/A

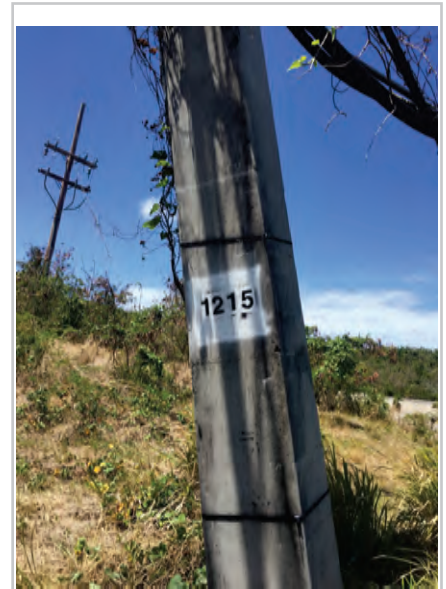
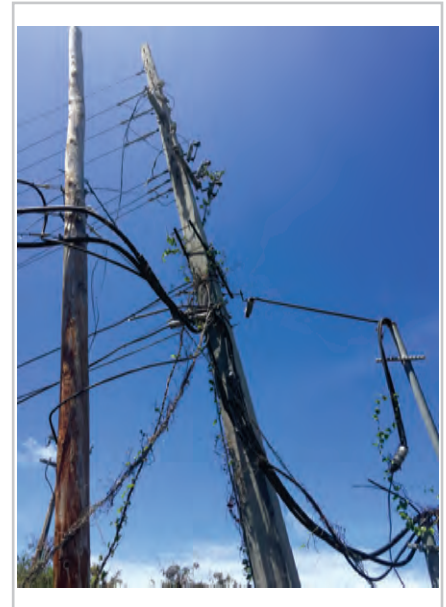
Condition: INCLINED

Comments: RISER CONNECTION NOT SUPPORTED FROM POLE AND AT THIS

POLE THE 13.2 KV FEEDER TRANSFER TO UNDERGROUND FACILITIES

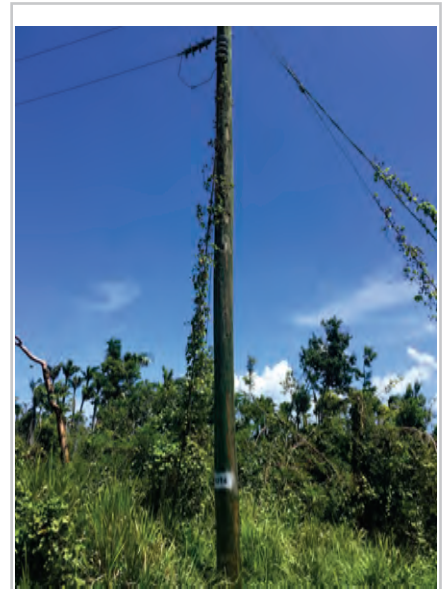
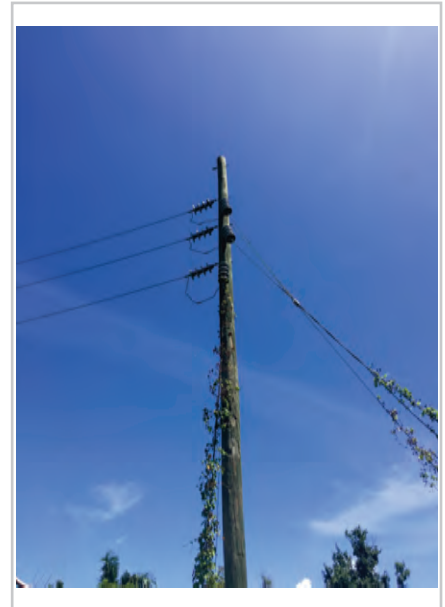
Condition: GOOD

Comments: CONDUCTORS AT GROUND AT ONE SIDE AND NO OVERHEAD

GROUND CONDUCTOR

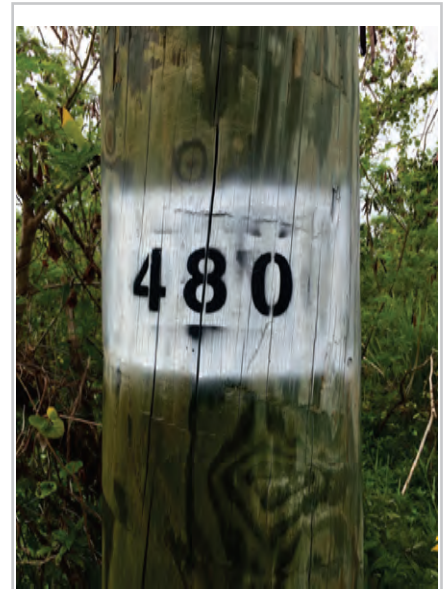
Condition: GOOD

Comments: NO OVERHEAD GROUND CONDUCTOR

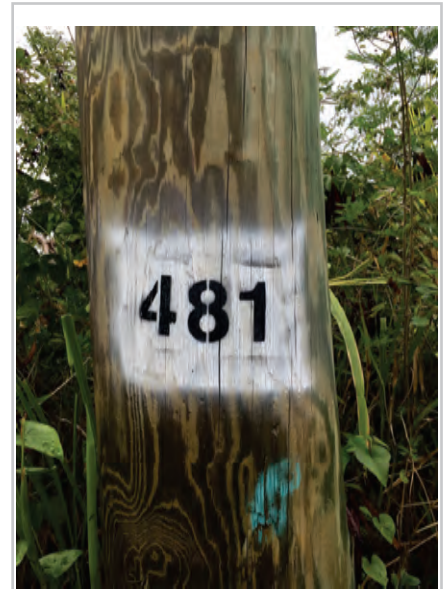
Condition: GOOD

Comments: NO OVERHEAD GROUND CONDUCTOR

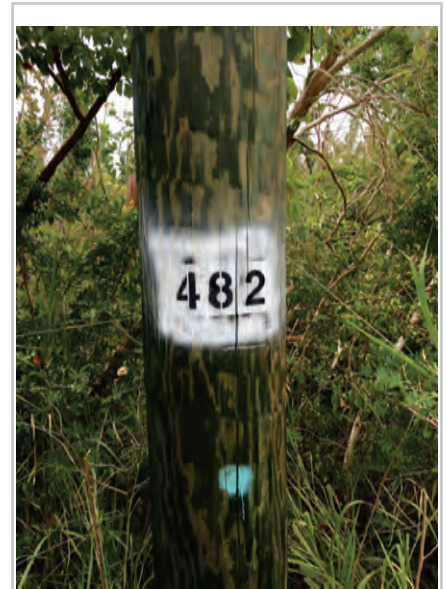
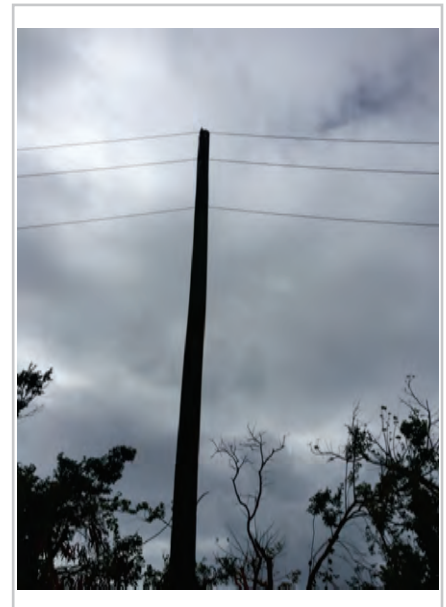
Condition: GOOD

Comments: NO OVERHEAD GROUND CONDUCTOR

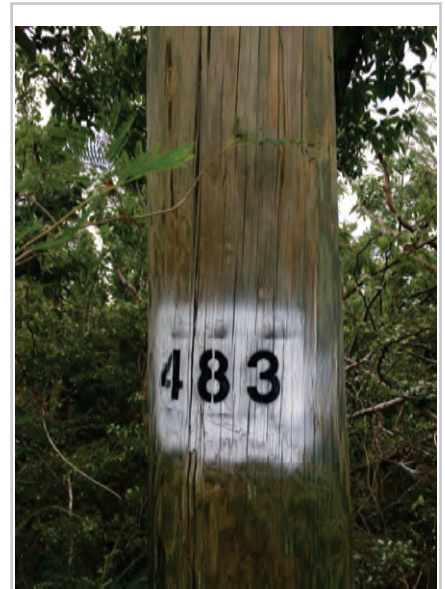
Condition: GOOD, LITTLE INCLINED

Comments: NO OVERHEAD GROUND CONDUCTOR

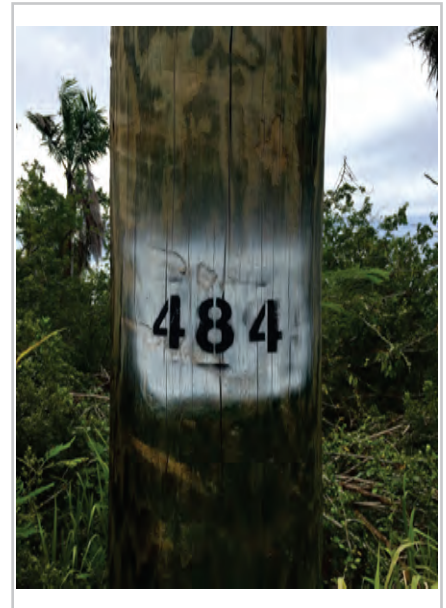
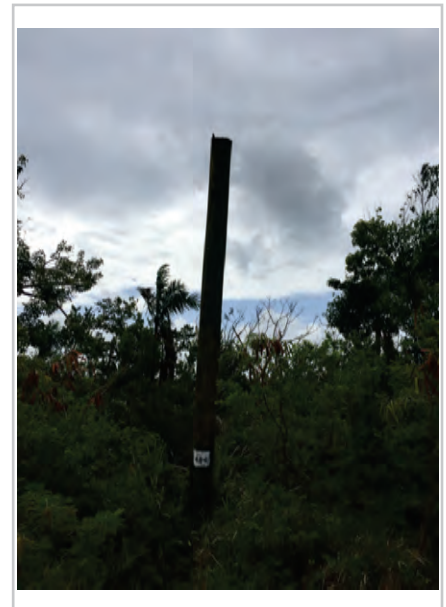
Condition: BROKEN

Comments: CONDUCTORS AT GROUND

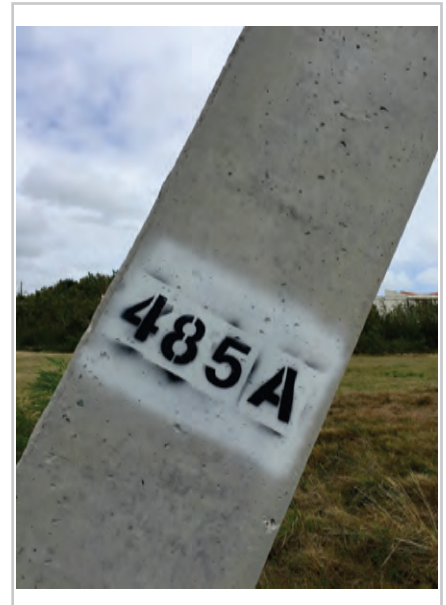
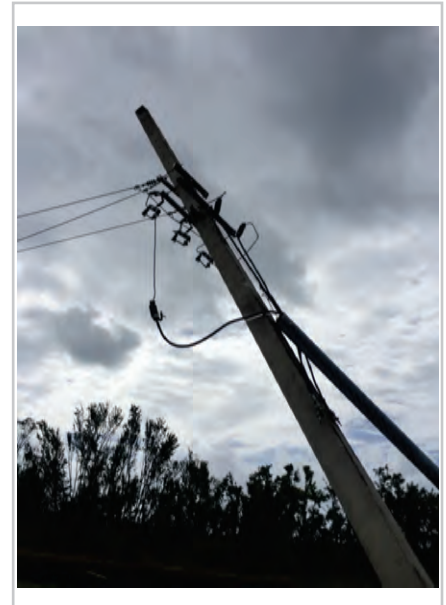
Condition: VERY INCLINED

Comments: TRANSITION OF MAIN 13.2 KV FROM UNDERGROUND TO OVERHEAD
RISER NOT SUPPORTED FROM POLE

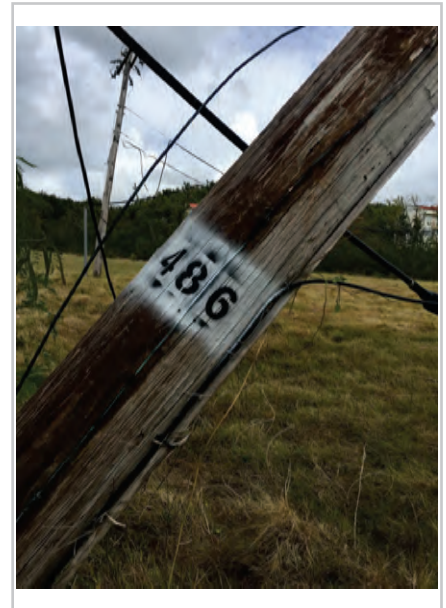
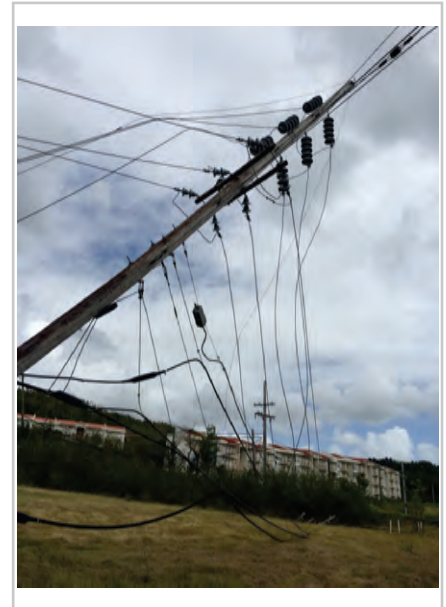
Condition: BROKEN

Comments: ALL CONDUCTORS AT GROUND

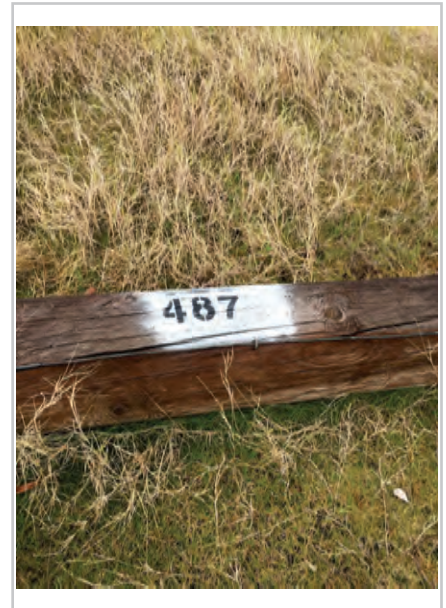
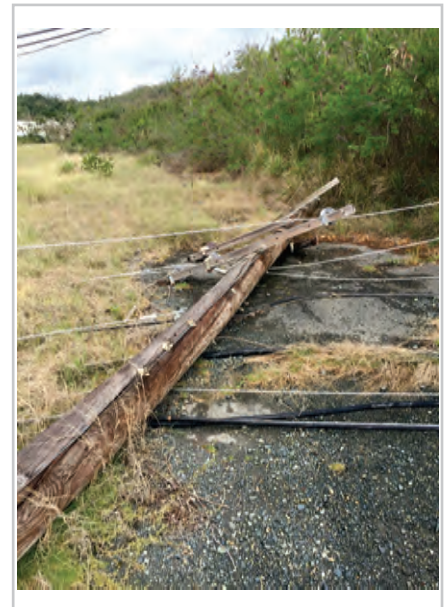
Condition: BROKEN

Comments: ALL CONDUCTORS AT GROUND

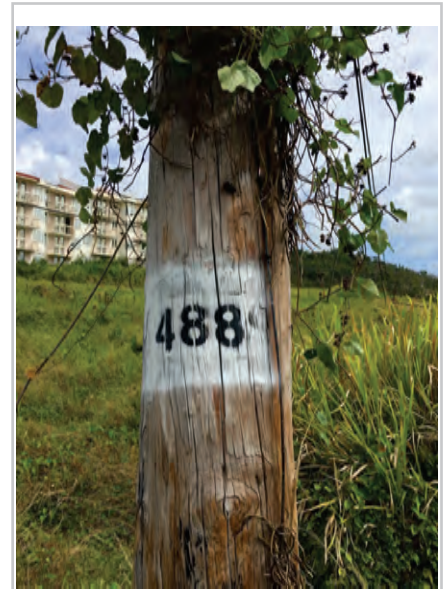
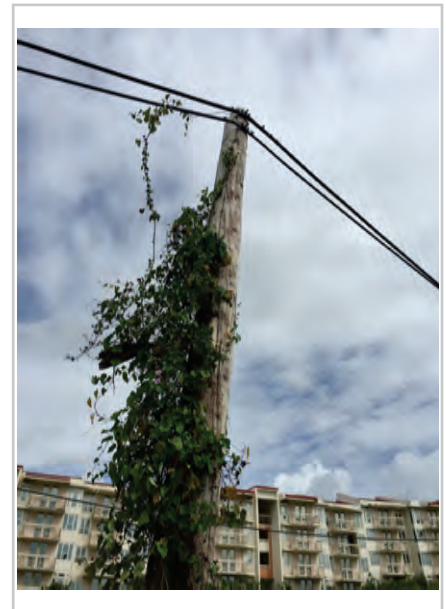
Condition: BROKEN

Comments: ALL CONDUCTORS AT GROUND

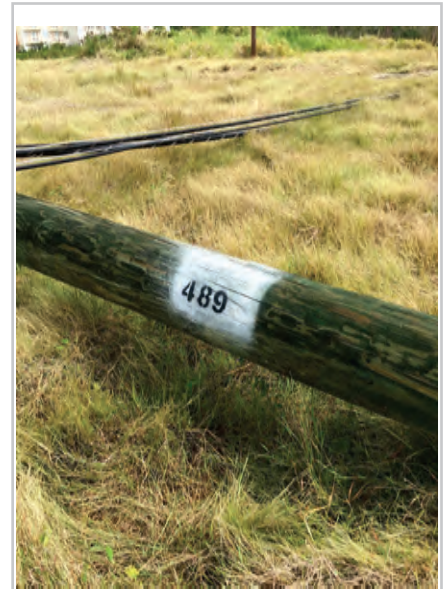
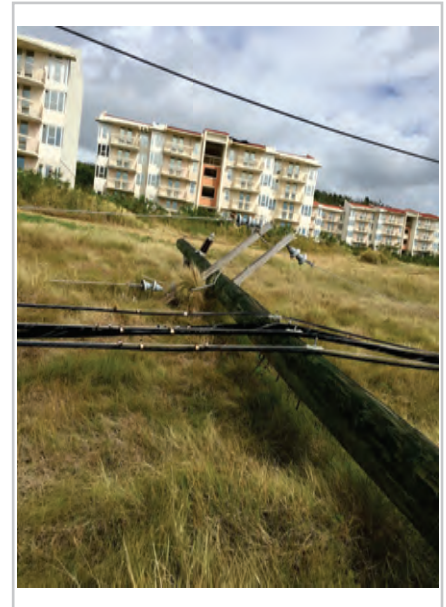
Condition: BROKEN

Comments: ALL CONDUCTORS AT GROUND

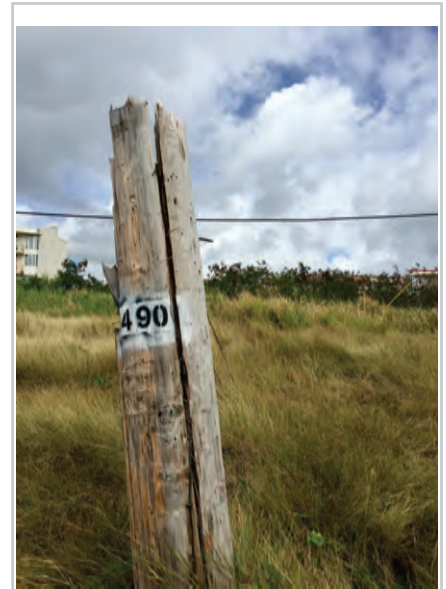
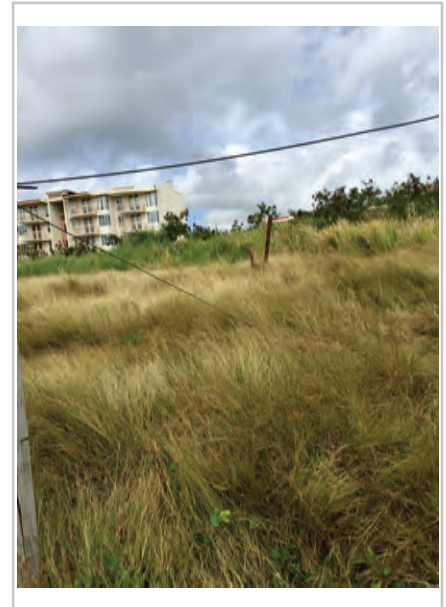
Condition: BROKEN

Comments: ALL CONDUCTORS AT GROUND

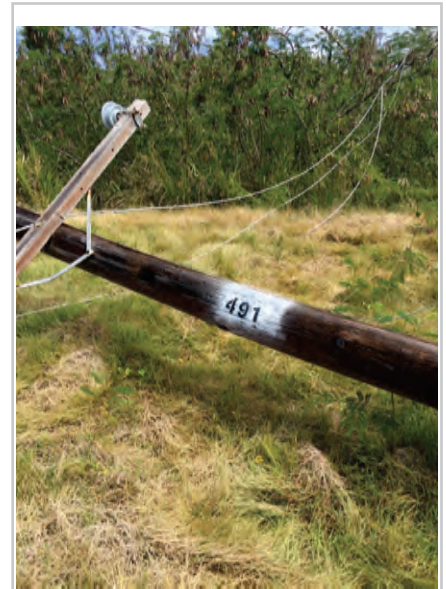
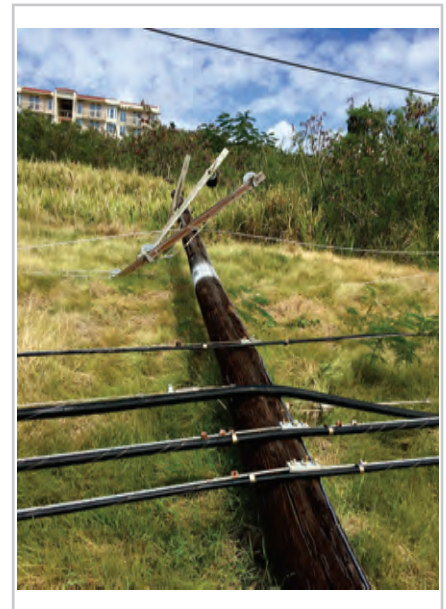
Condition: BROKEN

Comments: ALL CONDUCTORS AT GROUND

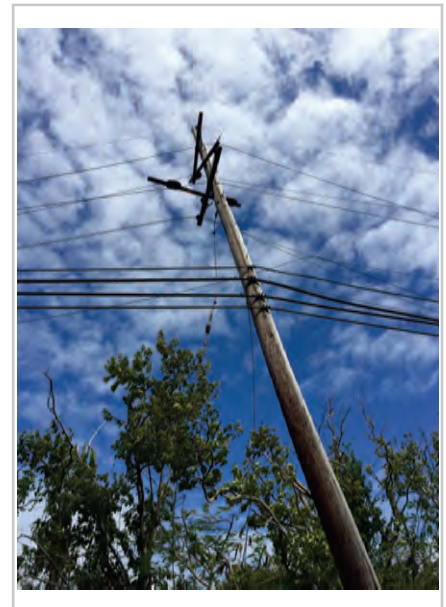
Condition: INCLINED

Comments: BROKEN WOOD CROSS ARMS AND CONDUCTORS FALLEN

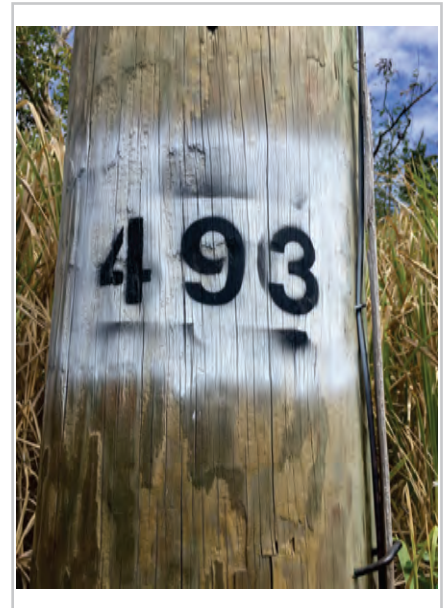
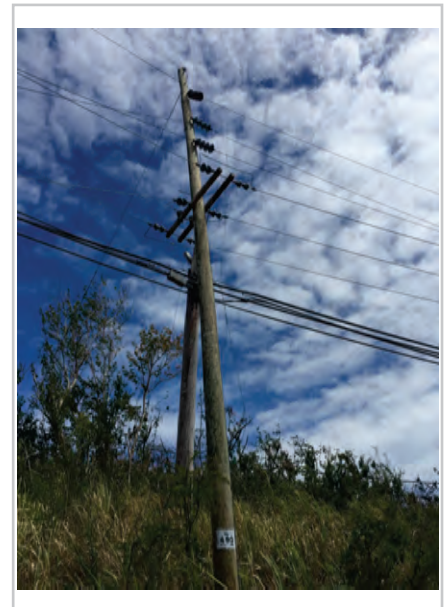
Condition: INCLINED

Comments: OVERHEAD GROUND CONDUCTOR FALLEN AT ONE SIDE

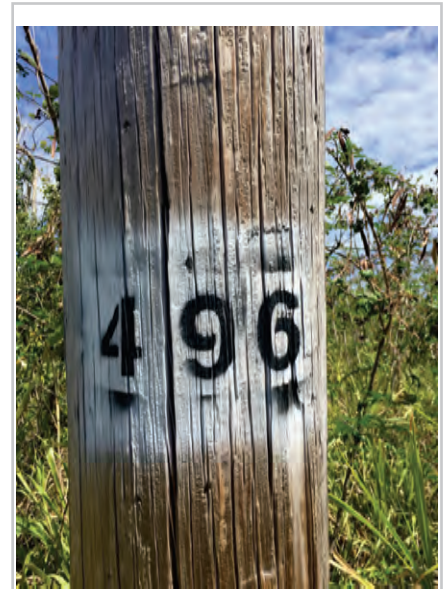
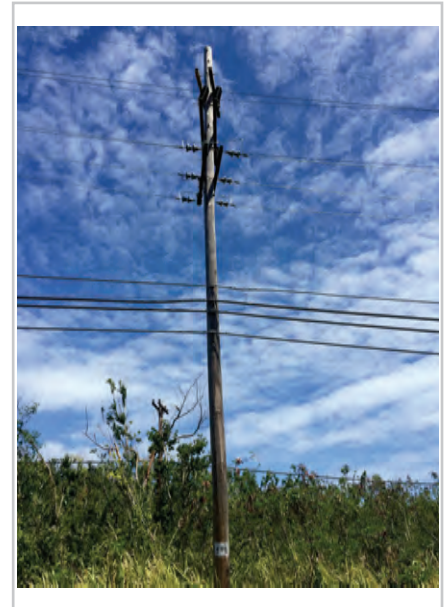
Comments: 38 KV CROSS ARMS AFFECTED

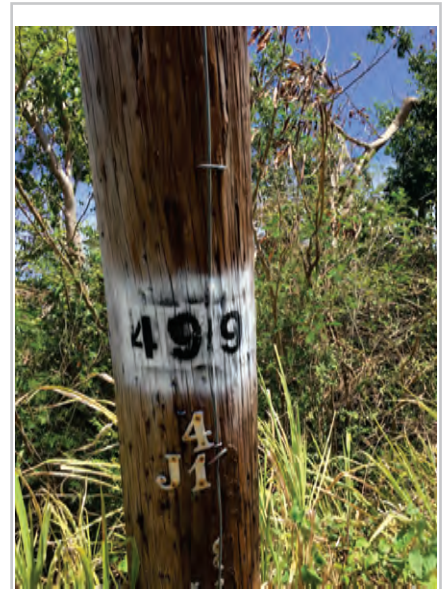
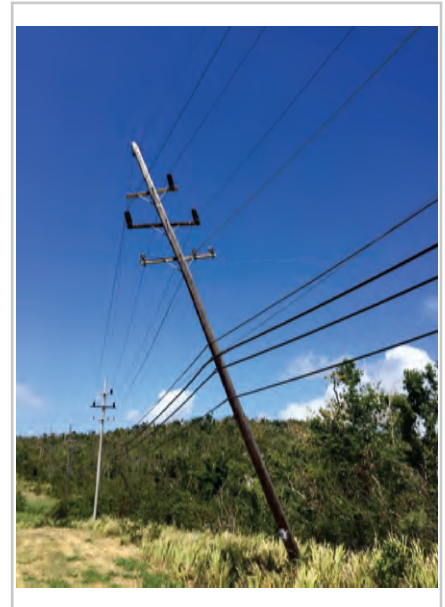
Condition: INCLINED

Comments: WOOD CROSS ARMS ARE MIS ALIGNED

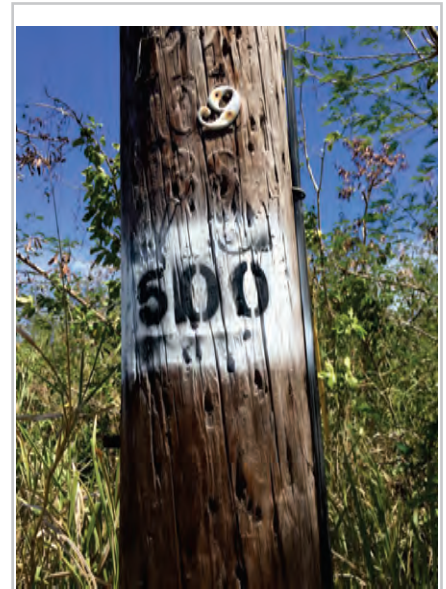
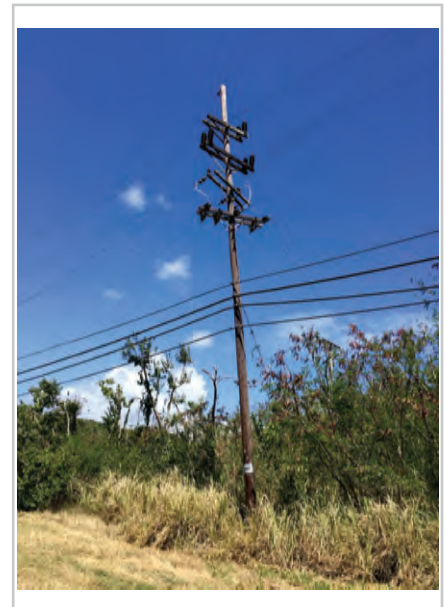
Comments: ONE SIDE OF OVERHEAD GROUND AT GROUND

POLE INCLUDE A 13.2 KV LOAD BREAK INSTALLED ON WOOD CROSS ARMS

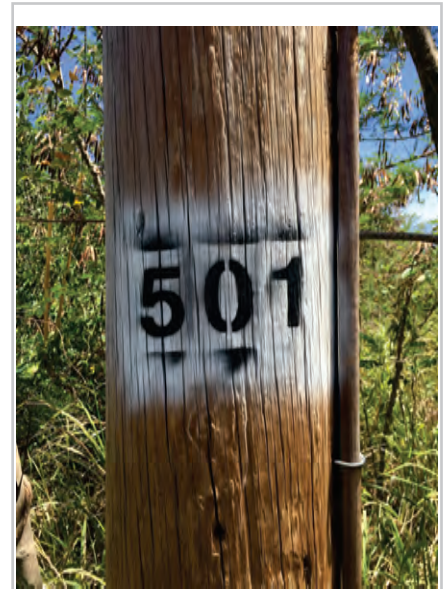
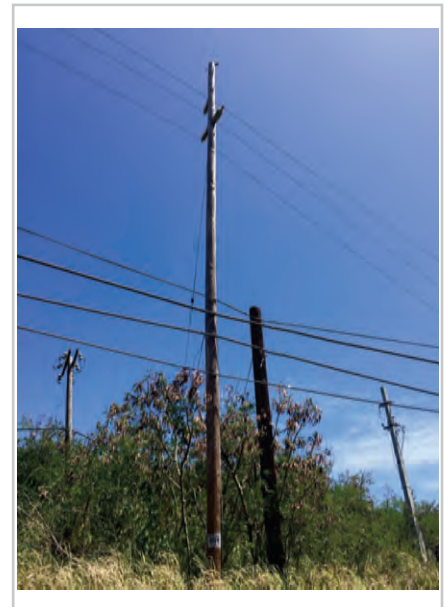
Comments: OVERHEAD GROUND WIRE AT GROUND

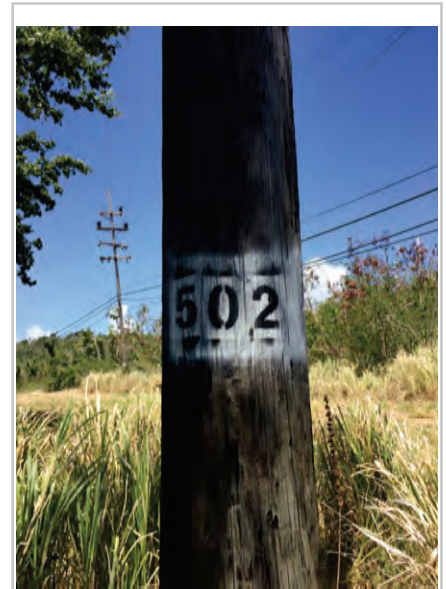
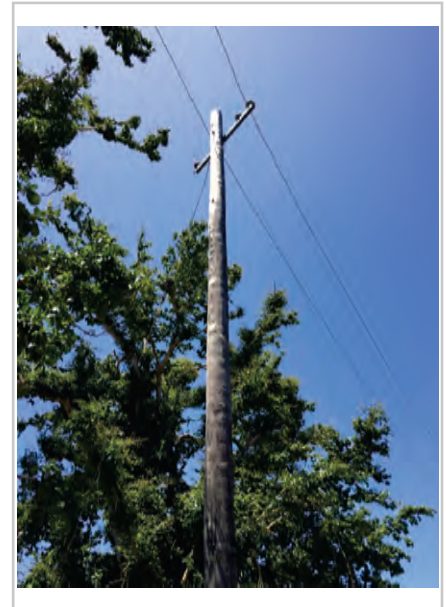
Comments: ONE PHASE CONDUCTOR AT GROUND

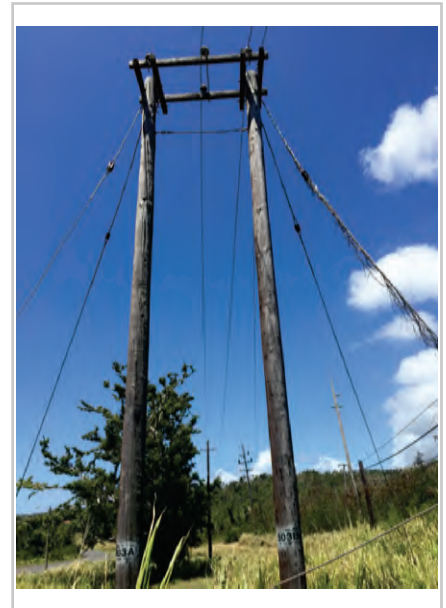
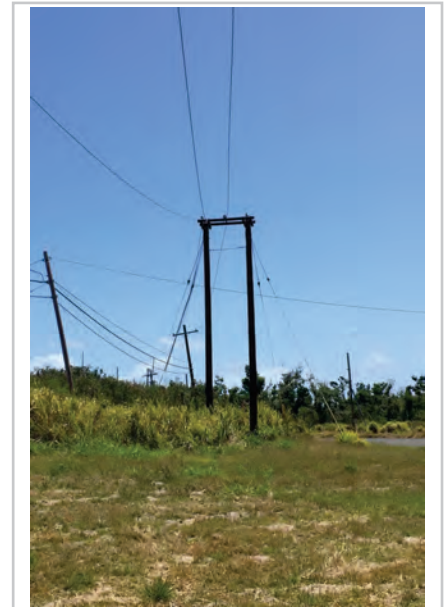
Comments: ONE PHASE CONDUCTOR DISPLACED

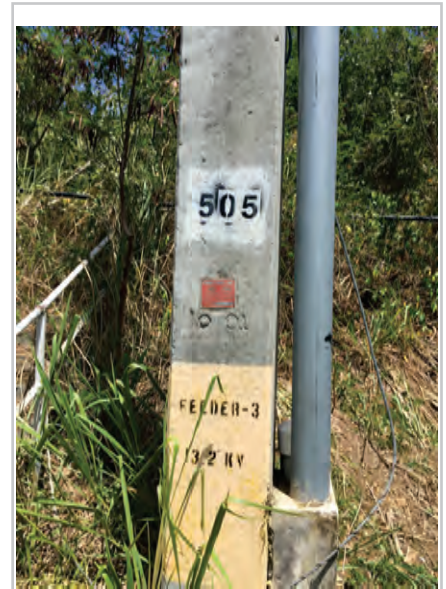
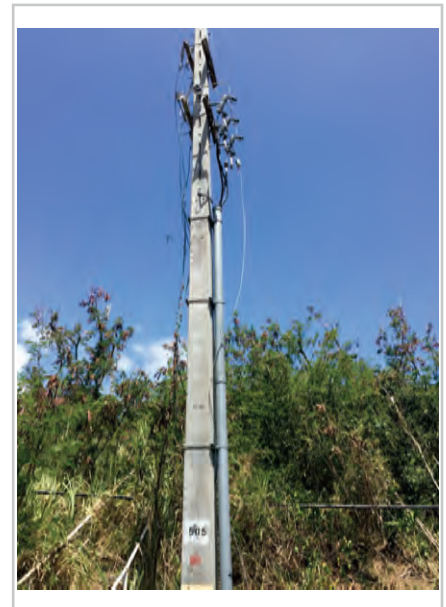
Comments: OUT OF SERVICE
N/A

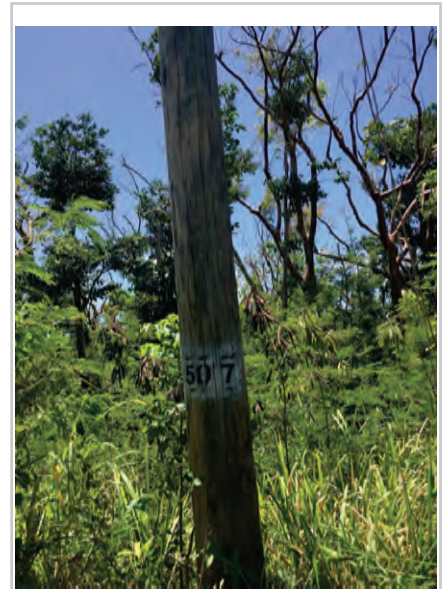
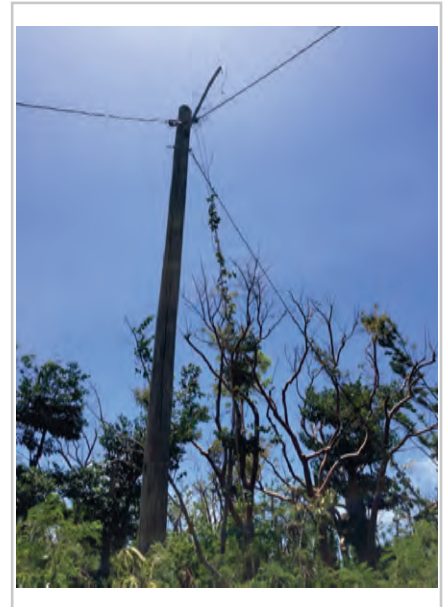
Luminaire: 1, ONLY EXIST THE ARM

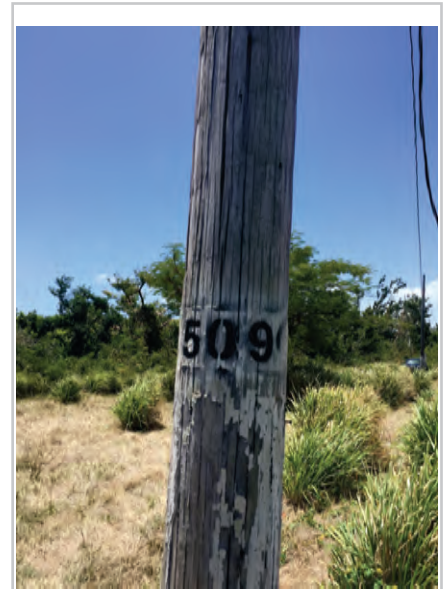
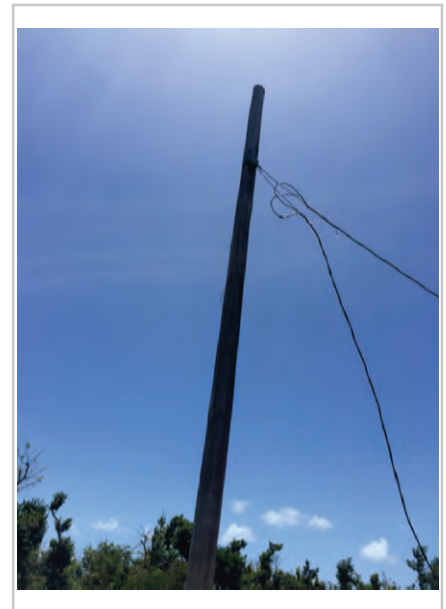
Comments: LINE AT GROUND AT ONE SIDE
N/A

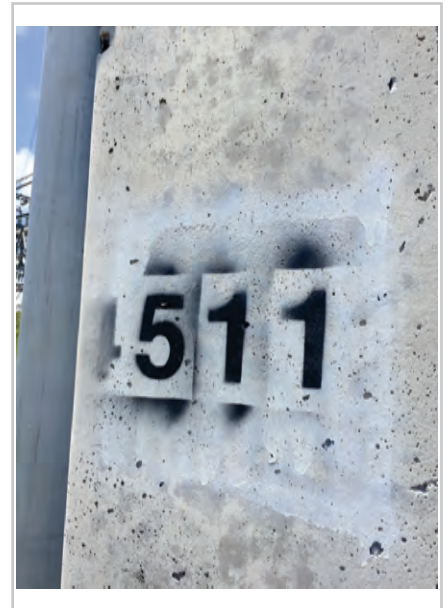
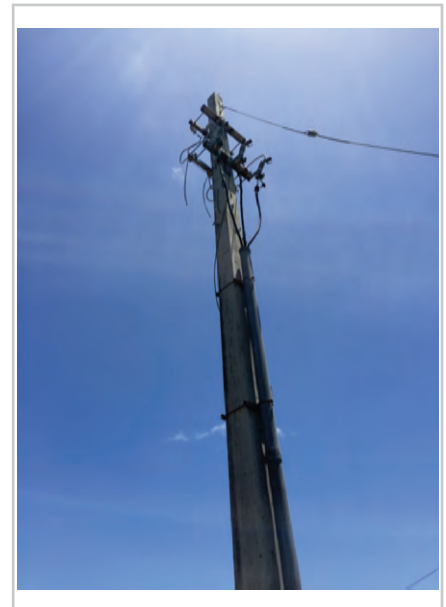
Comments: OUT OF SERVICE
N/A

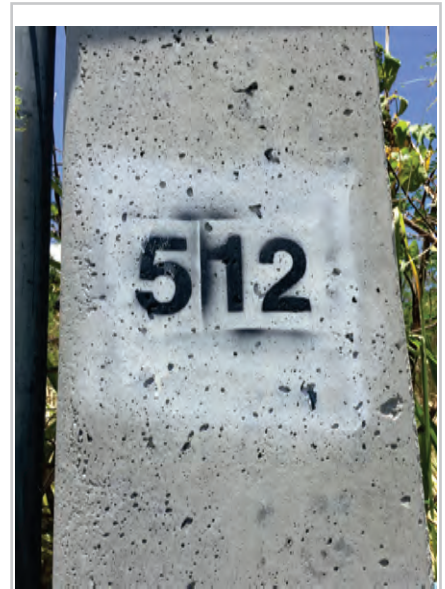
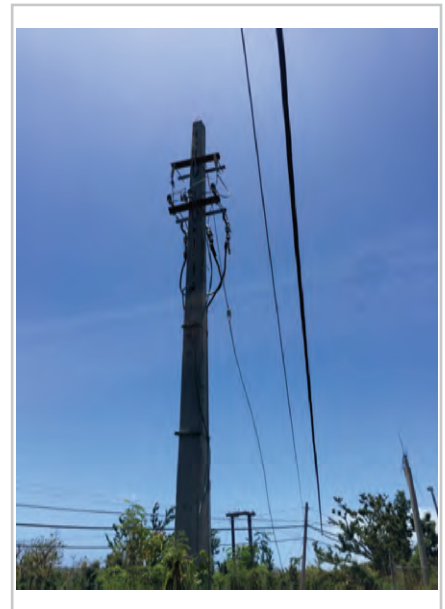
Comments: OUT OF SERVICE
N/A

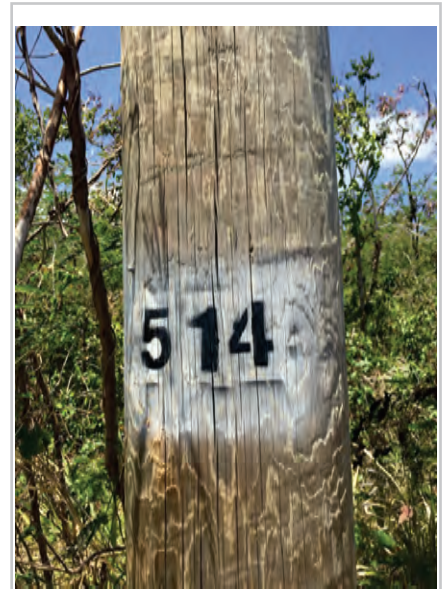
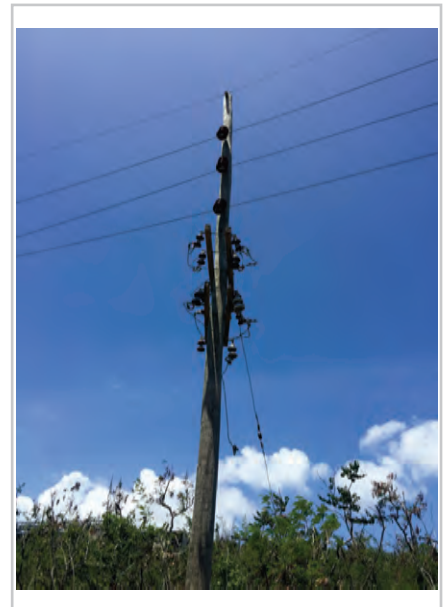
Comments: POLE CONTAINS OUT OF SERVICE CONSTRUCTION STANDARDS

WITH WOOD CROSS ARMS OF PREVIOUS 4.16 KV LINE

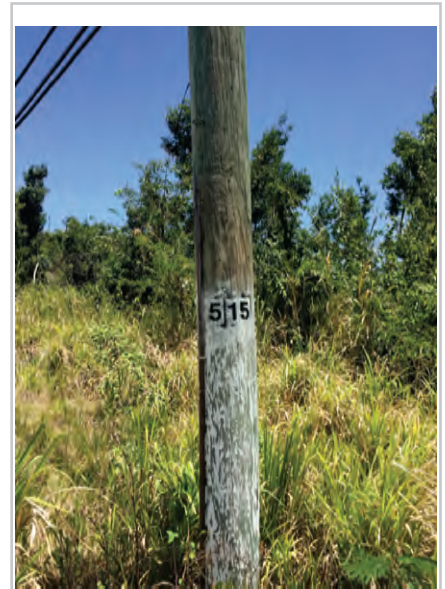
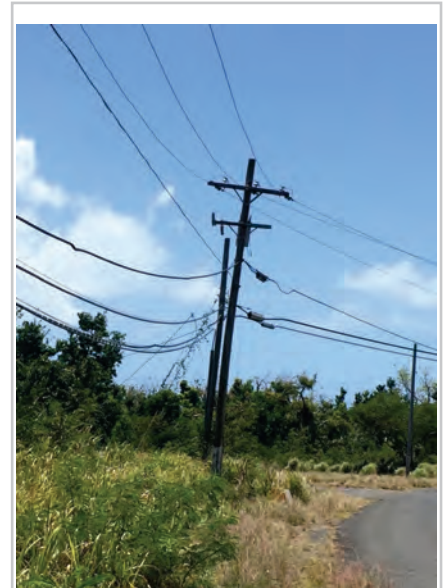
SINGLE TERMINAL, K-5, DAMAGED

Comments: ^{TRANSFORMER FUSES AND LIGHTNING ARRESTER MOUNTED WITH} _____

WOOD CROSS ARM

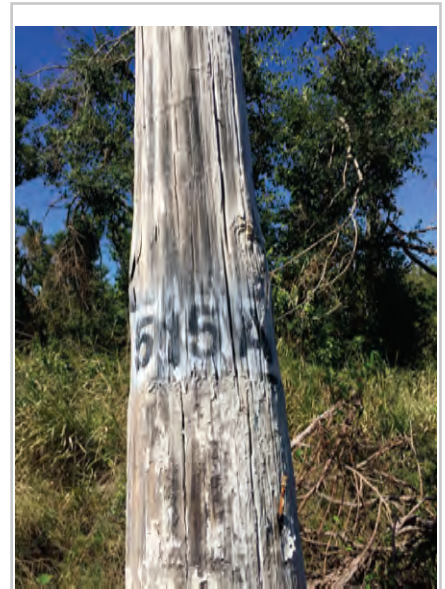
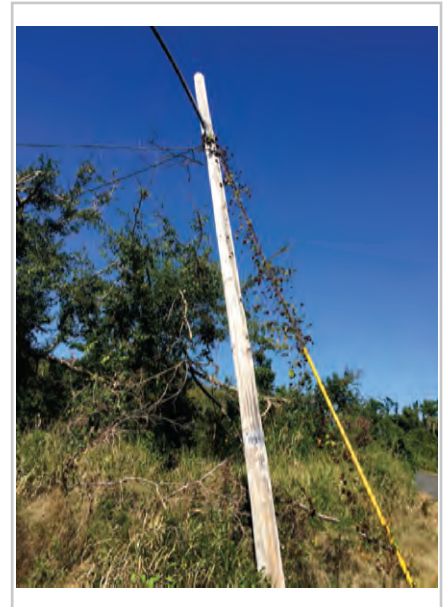
Condition: BROKEN
