POLES CONDITION ASSESSMENT REPORT

PROJECT: HURRICANE MARIA DAMAGES REPAIRS
TO ROOSEVELT ROADS ELECTRICAL
SYSTEM (19-1741)

LOCATION: Roosevelt Roads,
Ceiba, PR

DATE: May 17, 2018

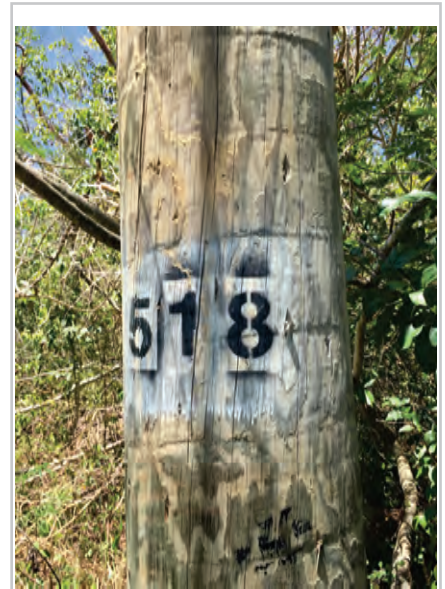
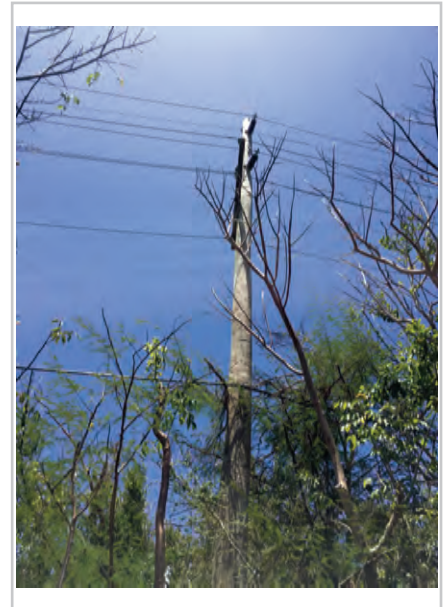
Condition: ^{GOOD} _____

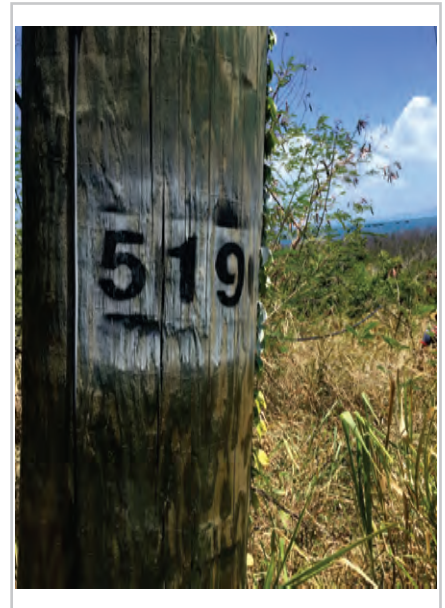
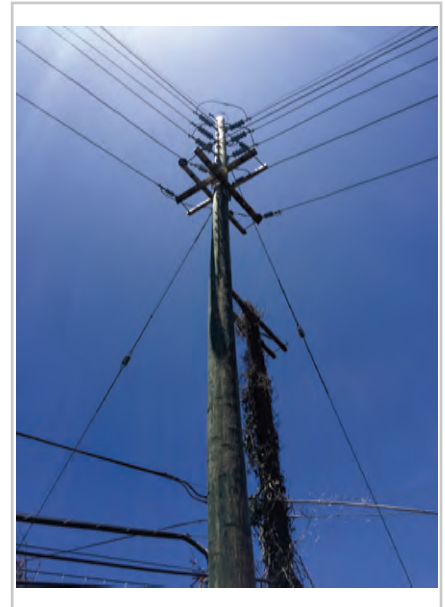
Condition: GOOD

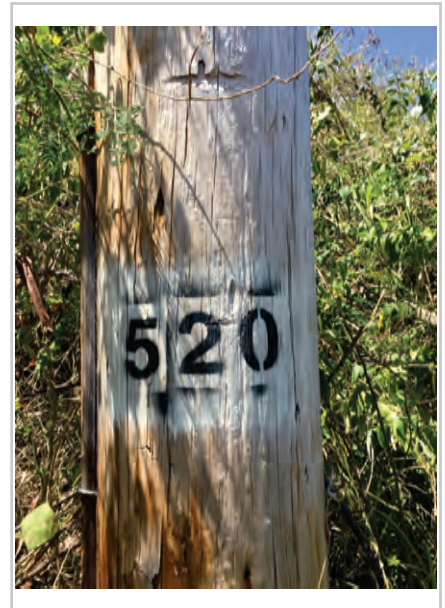
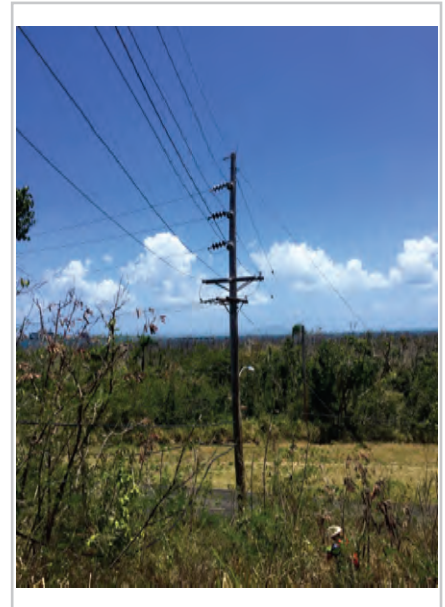
Condition: GOOD

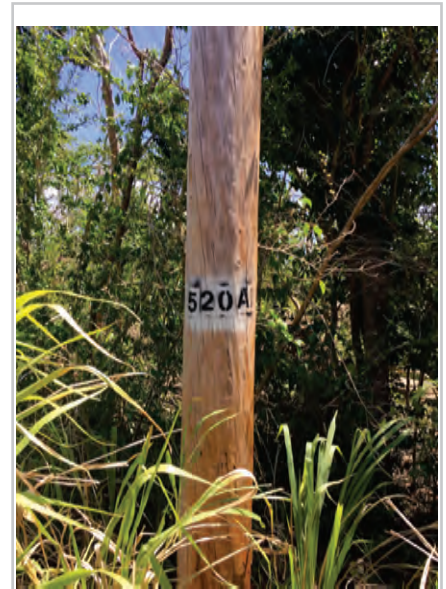
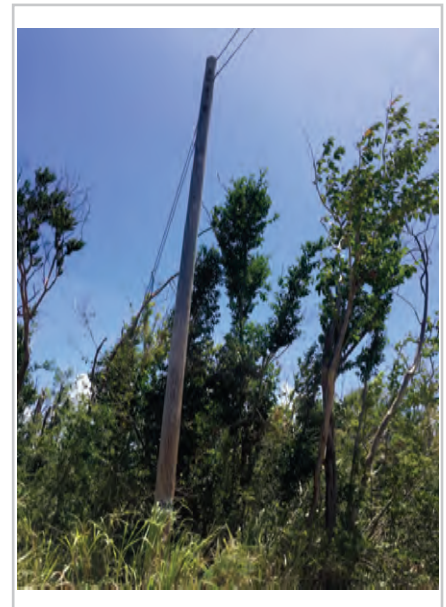
Condition: GOOD

Comments: STUB POLE FOR POLE 520
N/A

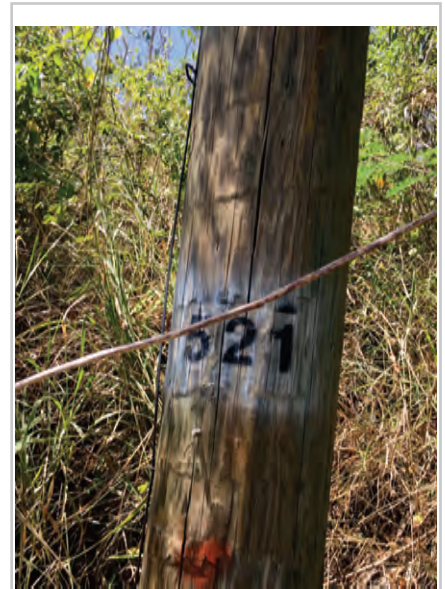
Condition: GOOD

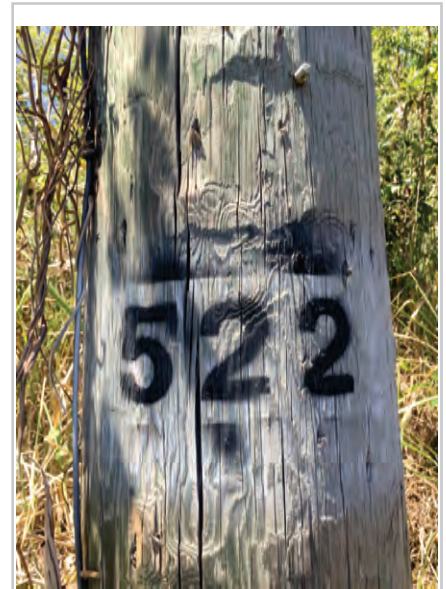
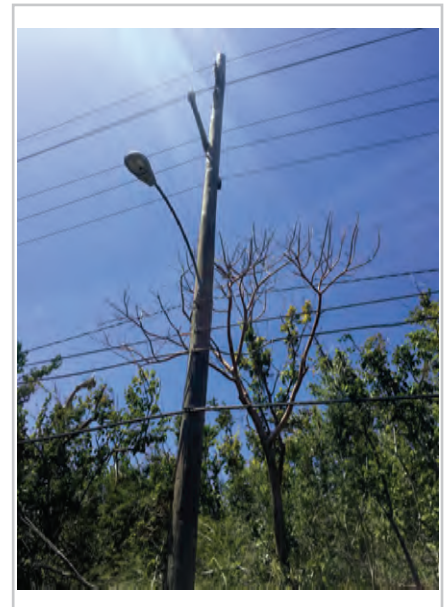
Condition: GOOD

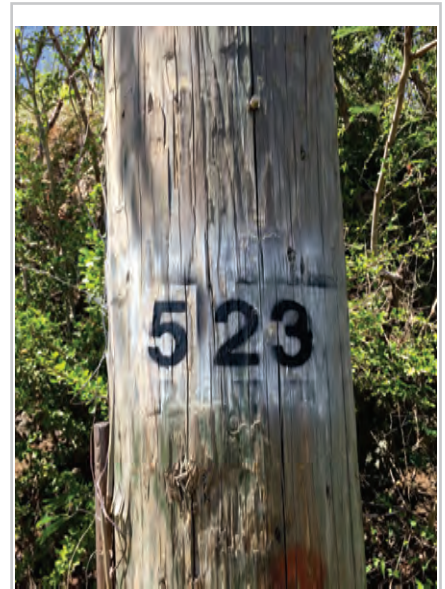
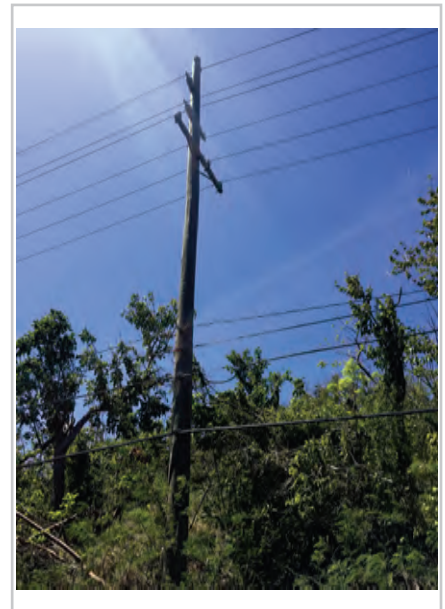
Condition: ^{GOOD} _____

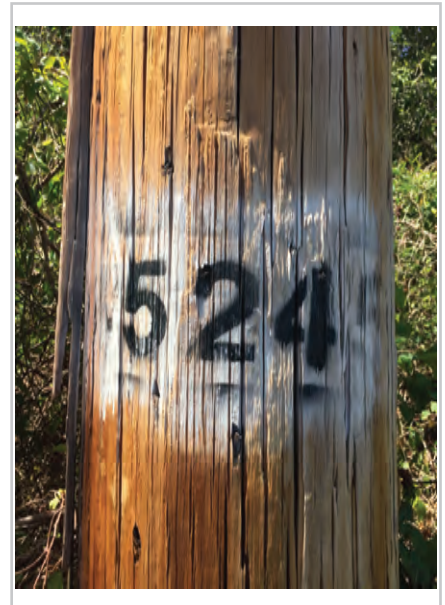
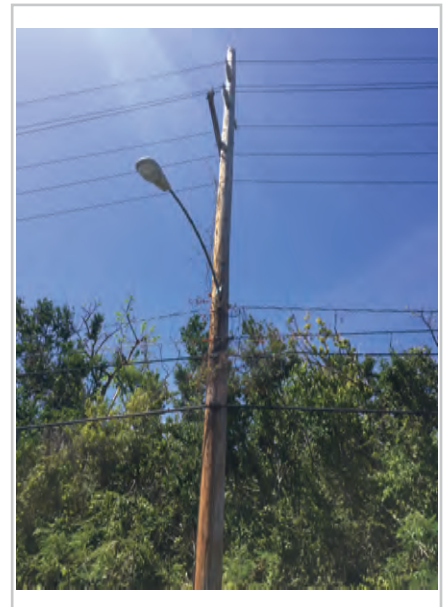
Condition: GOOD

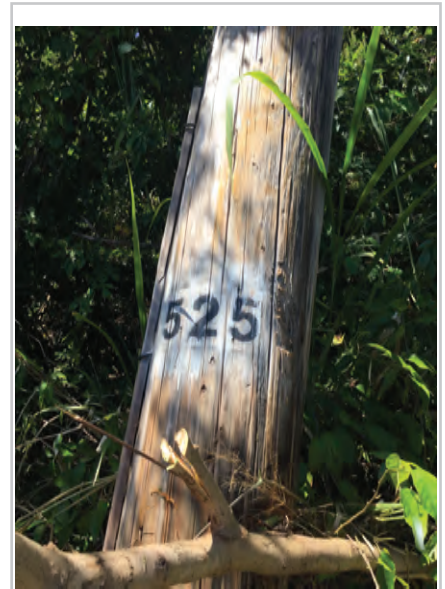
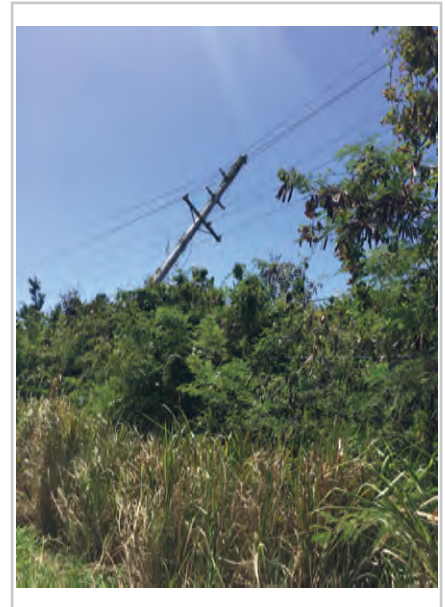
Condition: ^{VERY INCLINED}_____

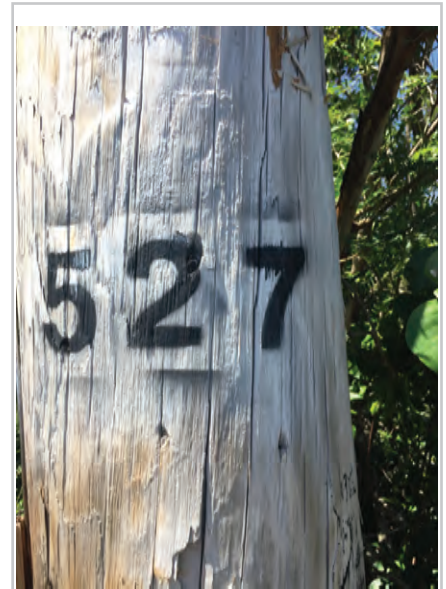
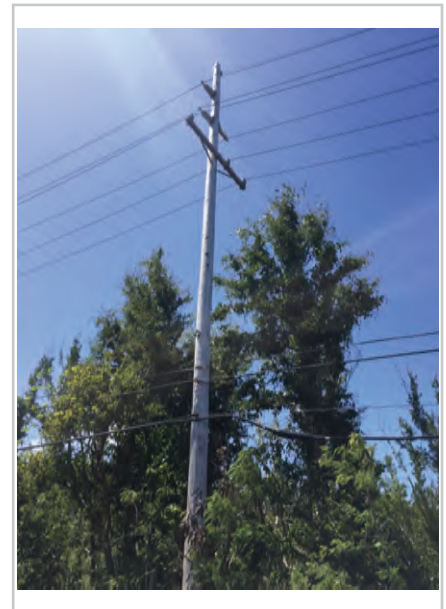
Condition: INCLINED

Comments: SECONDARY CONDUCTOR AT GROUND

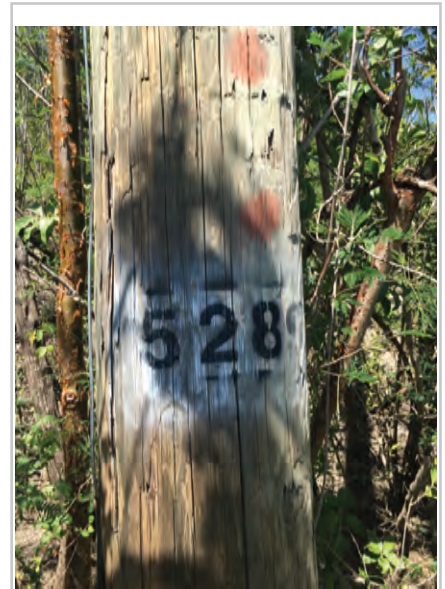
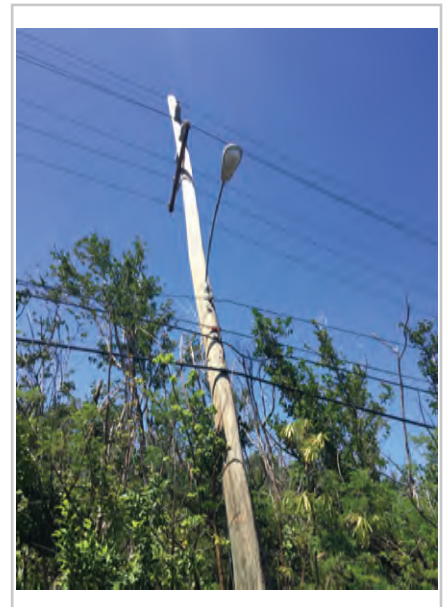
Condition: VERY INCLINED

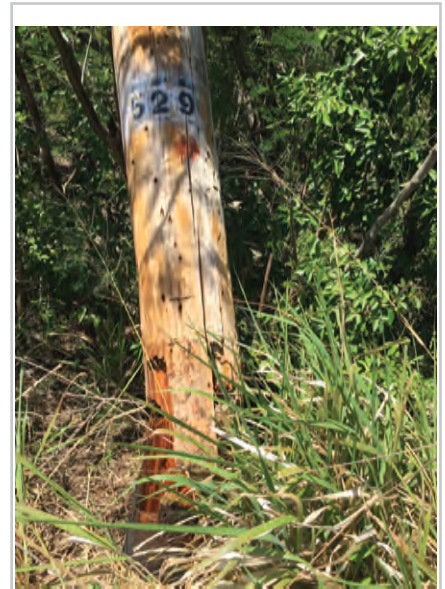
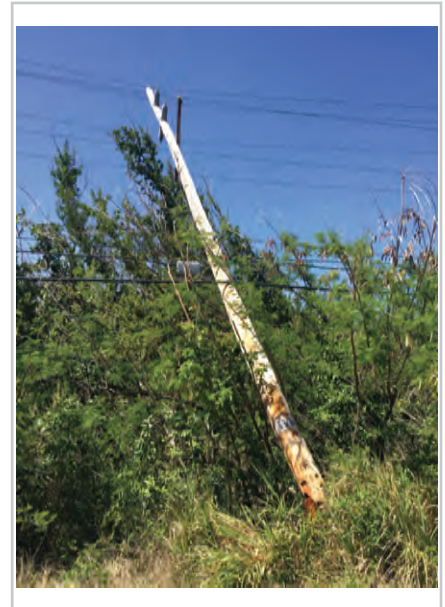
Condition: BROKEN

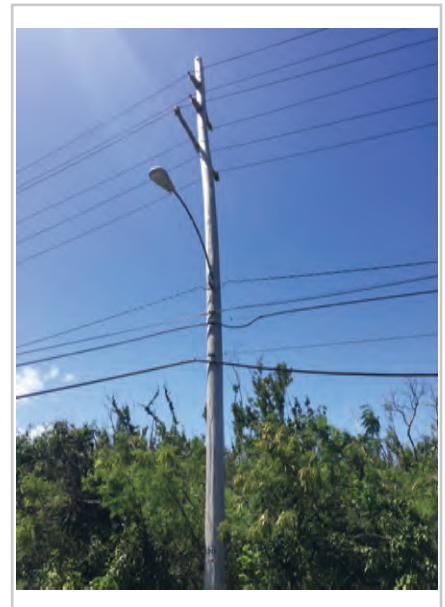
Condition: BROKEN

Comments: CRACKED AT BASE

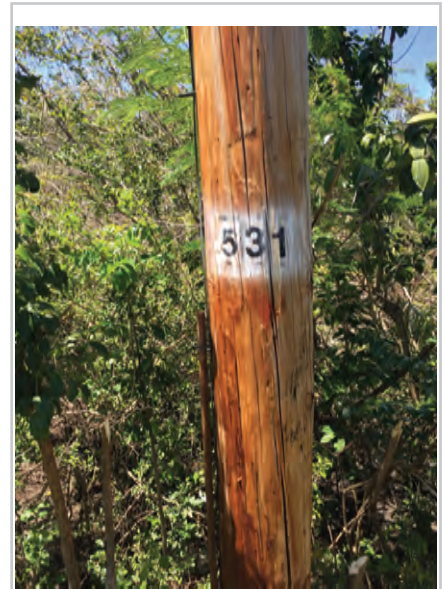
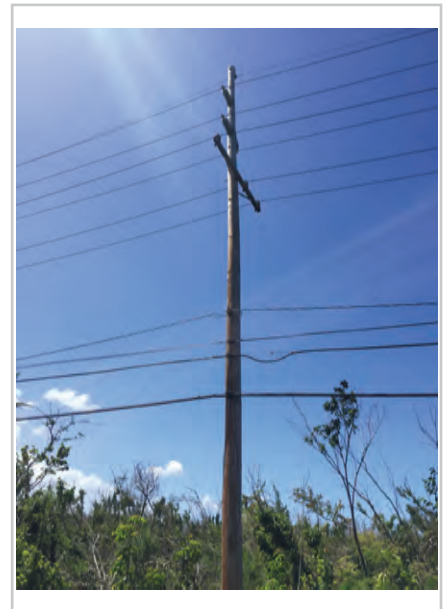
Condition: GOOD

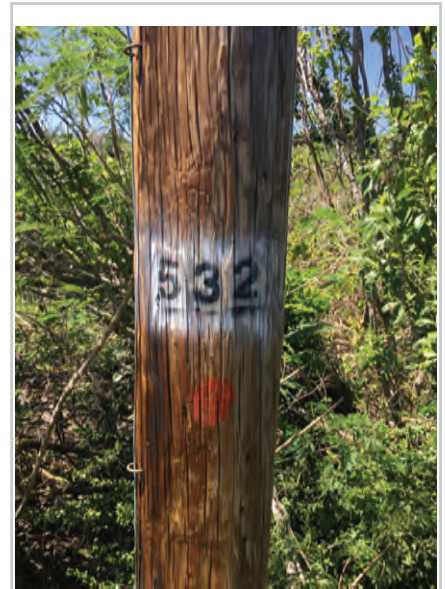
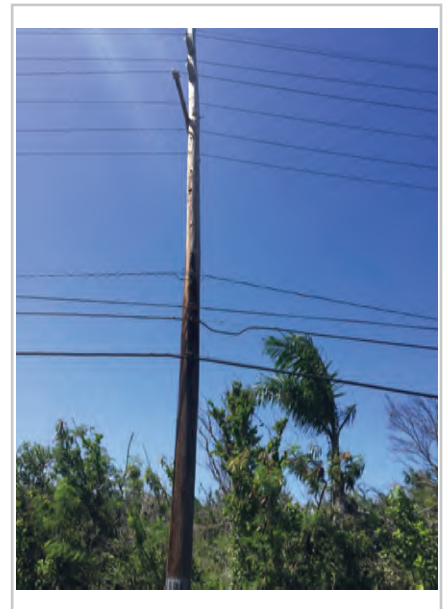
Condition: INCLINED

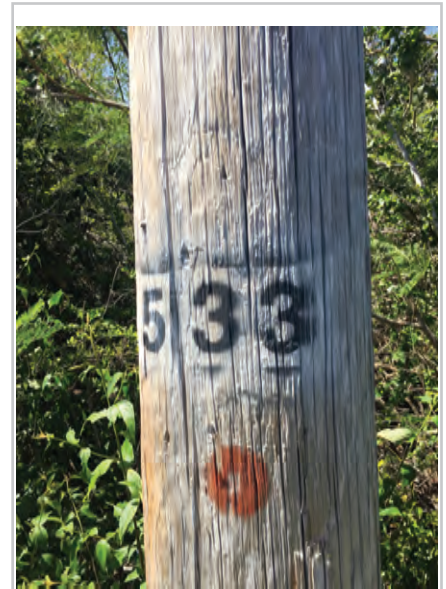
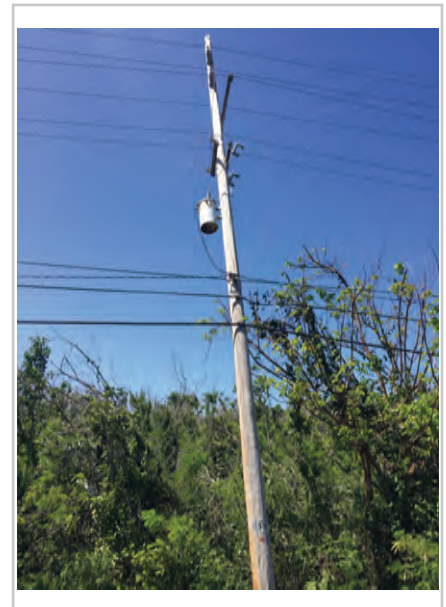
Condition: VERY INCLINED

Comments: FUSES AND LIGHTNING ARRESTER FOR TRANSFORMER INSTALLED

ON WOOD CROSS ARM

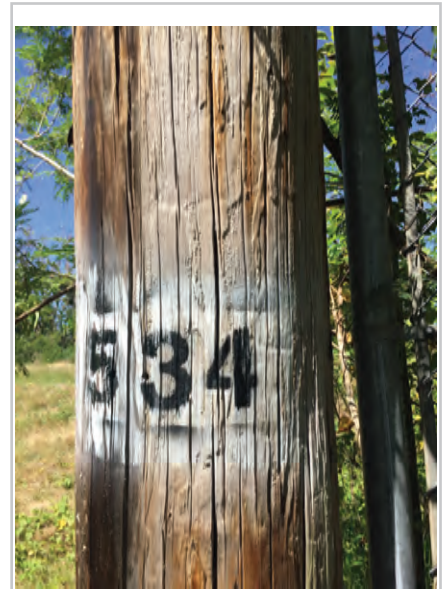
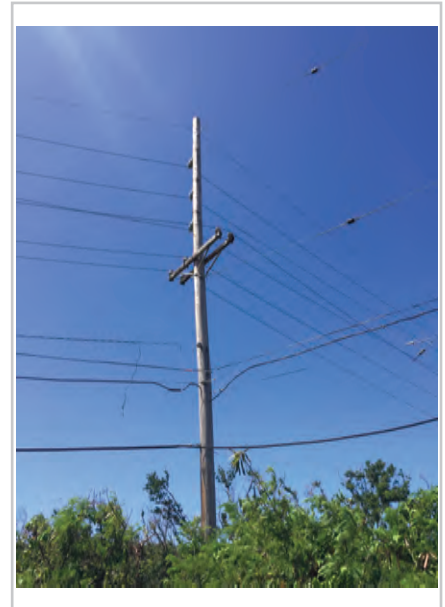
Condition: GOOD

Comments: LUMINARIE AT GROUND

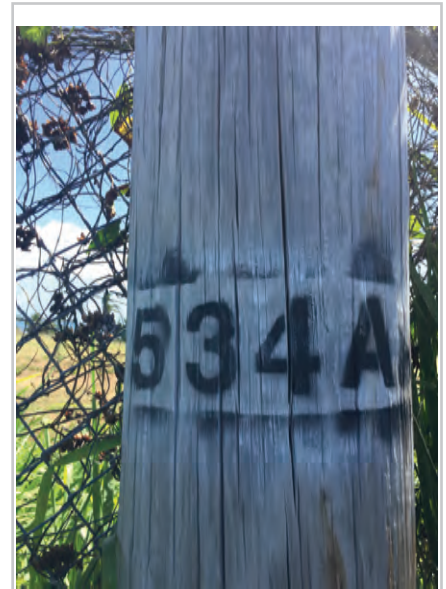
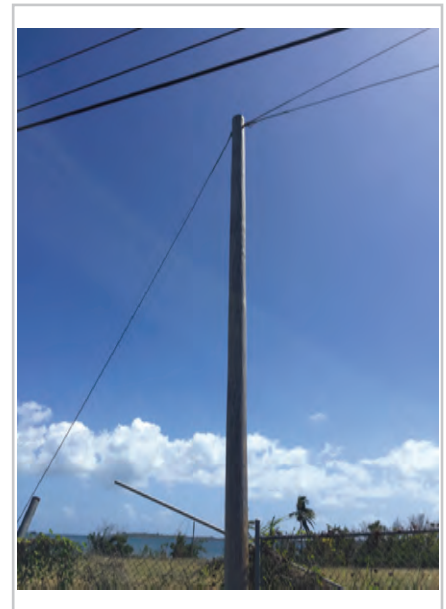
Condition: GOOD

Comments: STUB POLE FOR POLE 534

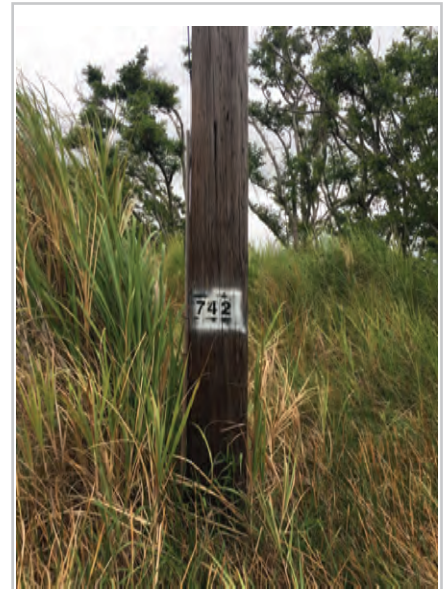
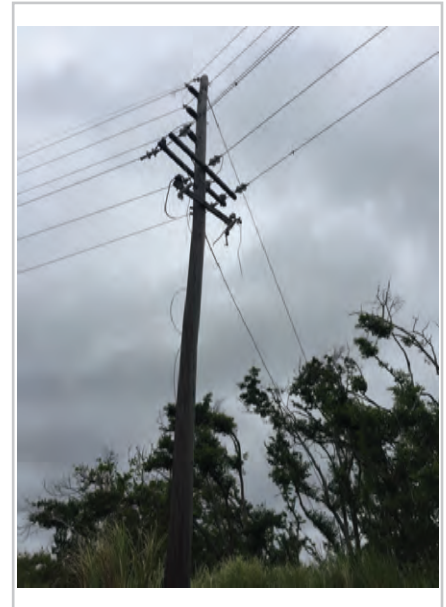
Condition: ^{GOOD} _____

Comments: ^{POLE HAS OUT OF SERVICE FUSES ON WOOD CROSS ARM} _____

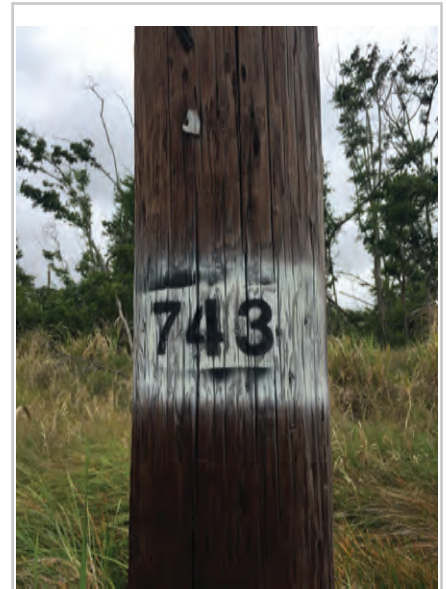
Condition: ^{GOOD}_____

Comments: ^{SOME CONDUCTORS AT GROUND}_____

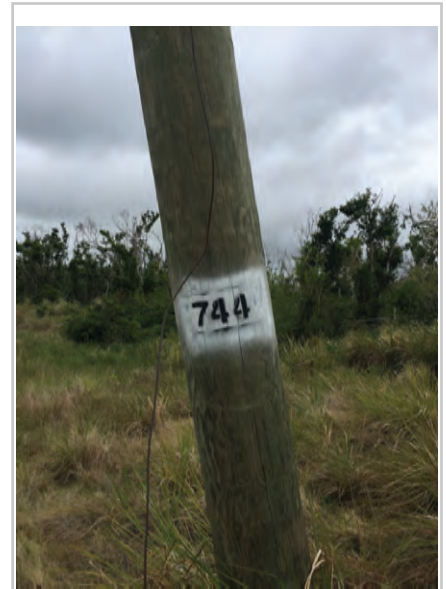
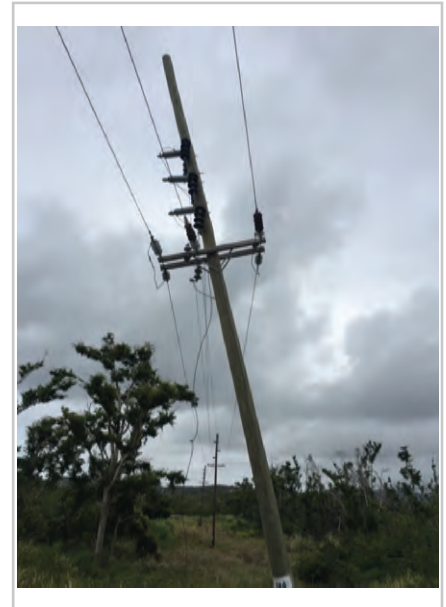
Condition: ^{VERY INCLINED} _____

Comments: ^{CONDUCTORS AT ONE SIDE AT GROUND} _____

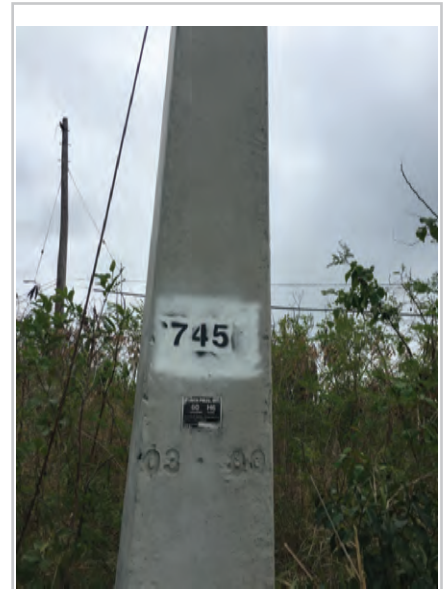
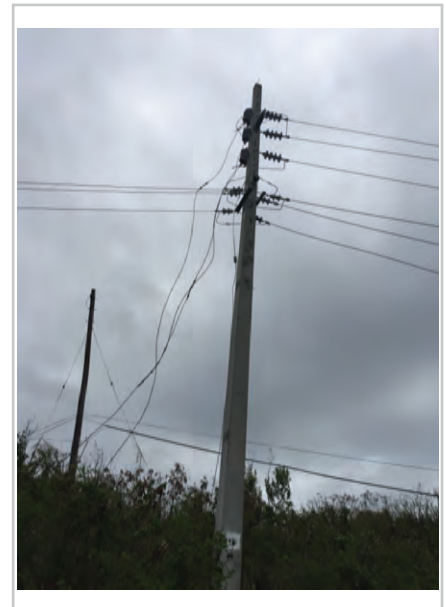
Condition: ^{INCLINED} _____

Comments: ^{CONDUCTORS AT ONE SIDE OF 38 KV LINE AT GROUND, DOWN GUY} _____

PULLED OUT

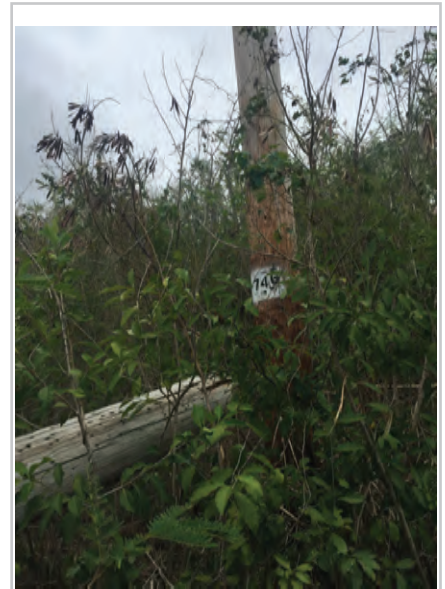
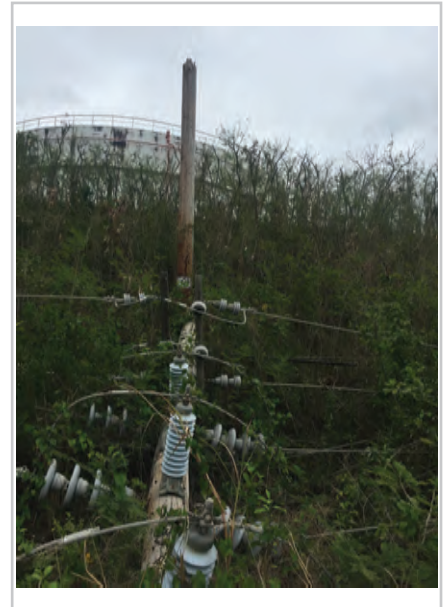
Condition: ^{BROKEN} _____

Comments: ^{ALL CONDUCTORS AT GROUND} _____

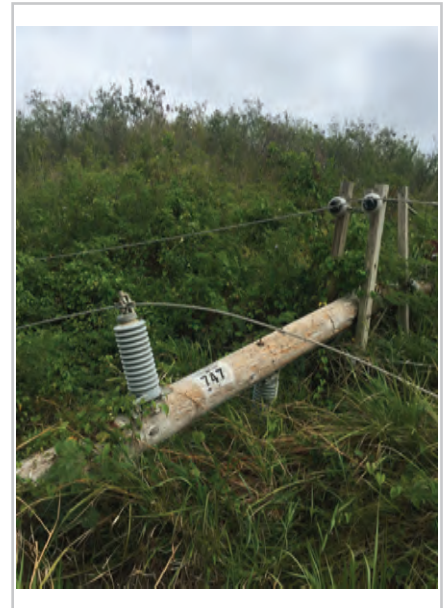
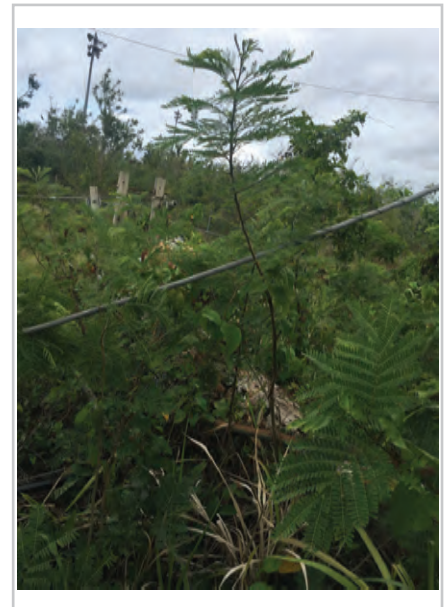
Condition: BROKEN

Comments: ALL CONDUCTORS AT GROUND

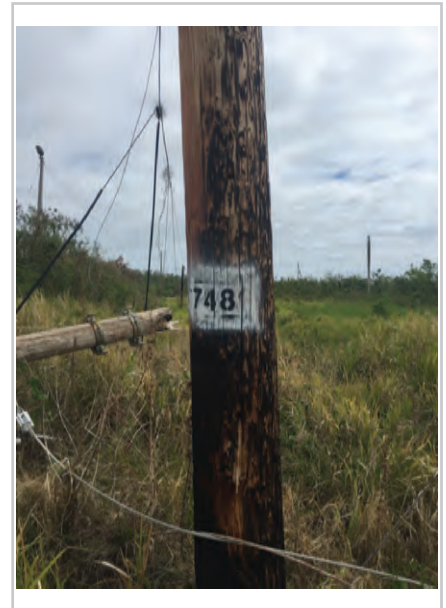
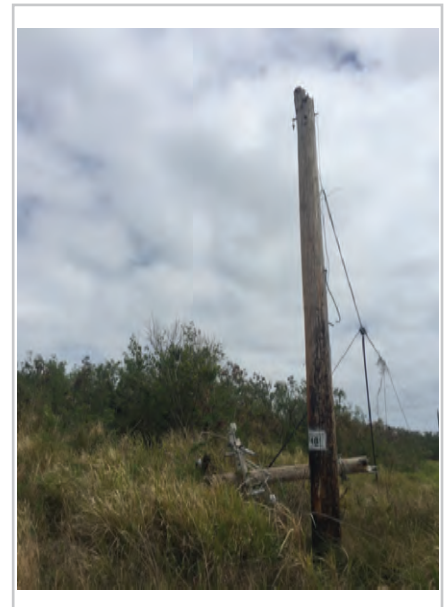
Condition: ^{BROKEN} _____

Comments: ^{POLE HAS THE CLUSTER MOUNT FOR A OUT OF SERVICE SUBSTATION} _____

SUSBTATION NOT EXIST

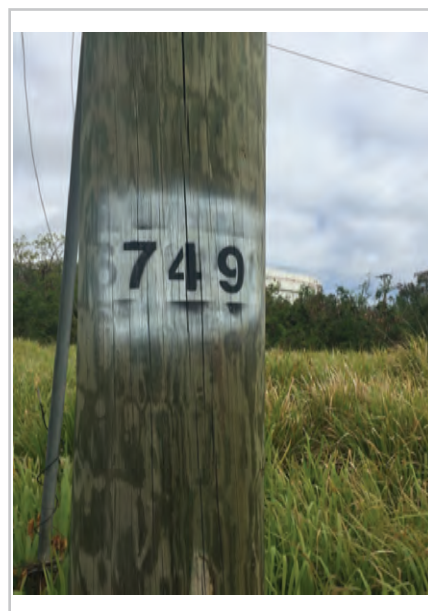
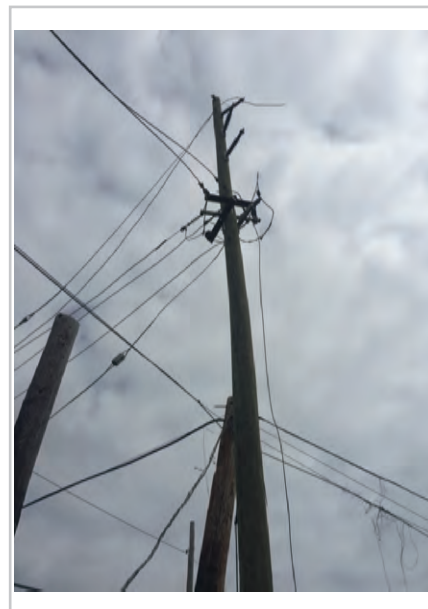
Condition: ^{GOOD} _____

Comments: ^{ALMOST ALL CONDUCTORS AT GROUND} _____

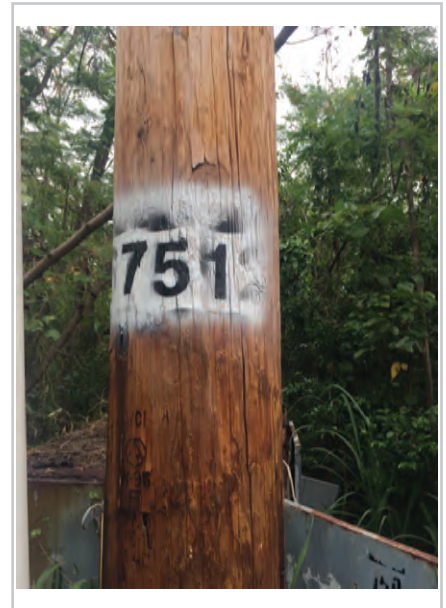
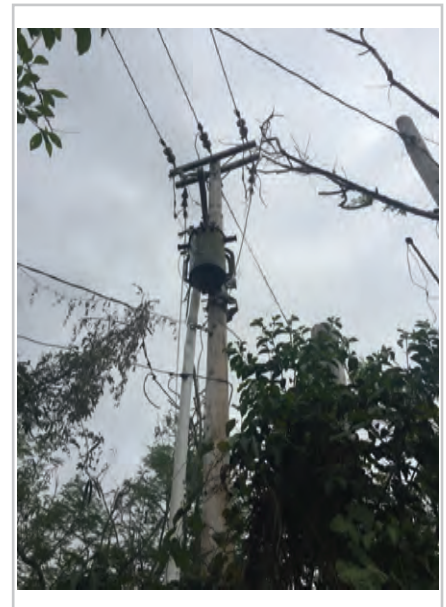
Condition: ^{GOOD} _____

Comments: ^{CONDUCTORS AT ONE SIDE AT GROUND} _____
N/A

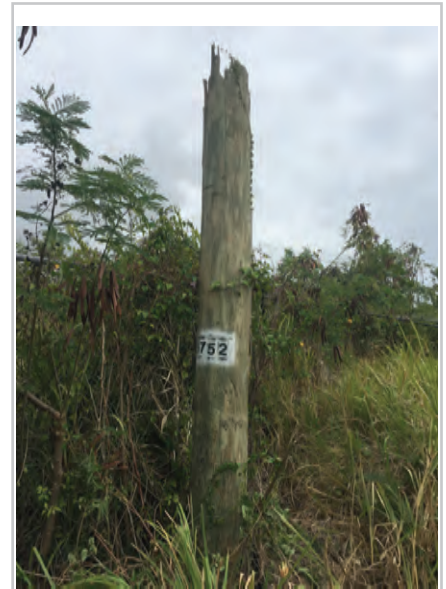
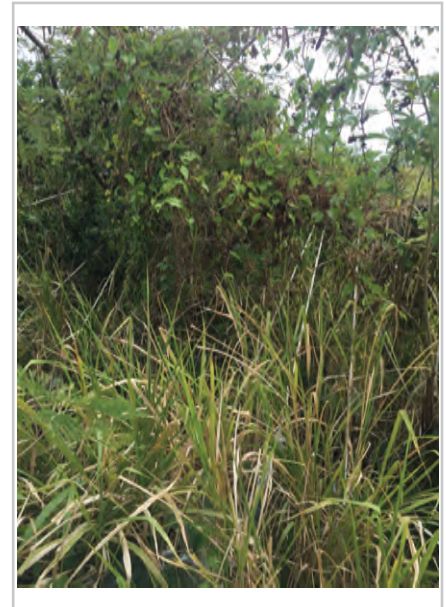
Condition: BROKEN

Comments: ALL CONDUCTORS AT GROUND

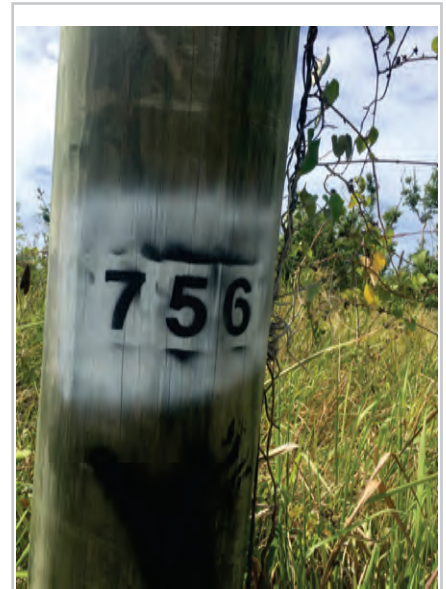
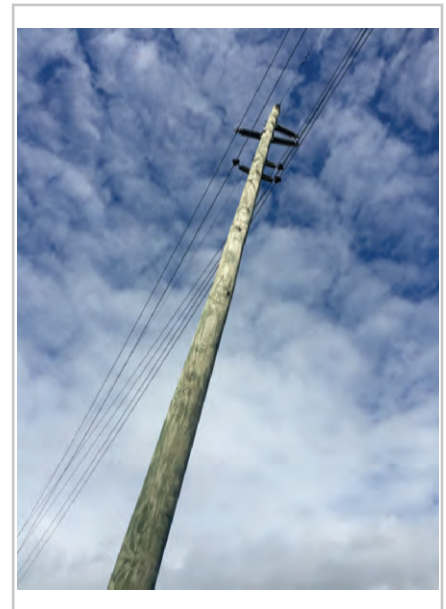
Condition: ^{INCLINED} _____

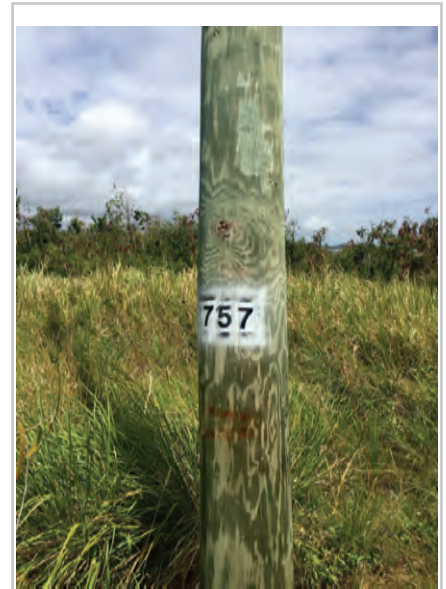
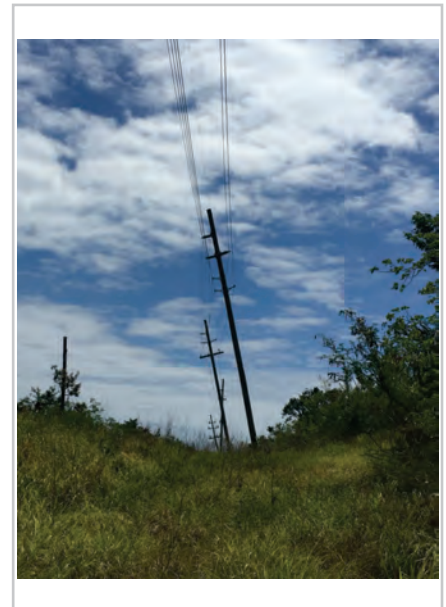
Condition: INCLINED

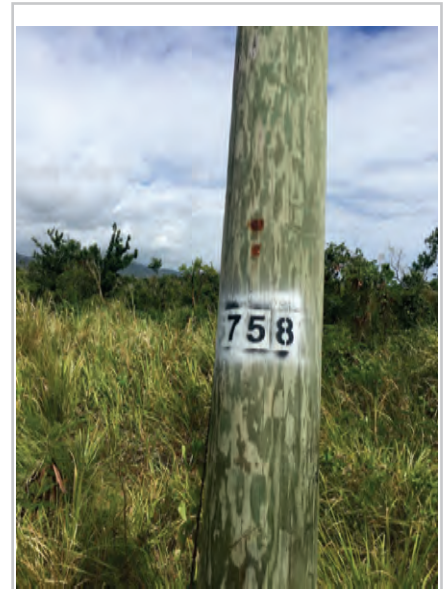
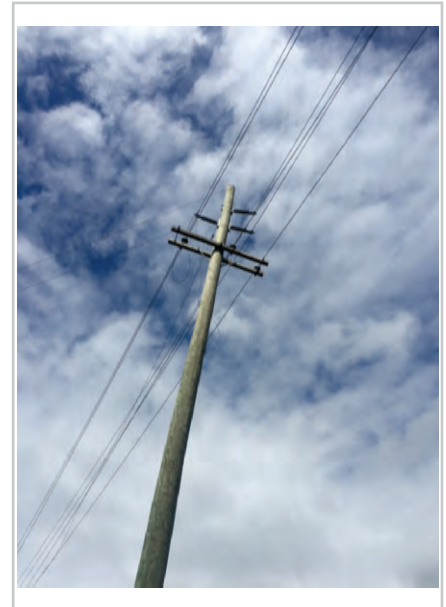
Condition: ^{INCLINED} _____

Comments: ^{38 KV GROUND CONDUCTOR FALLEN} _____

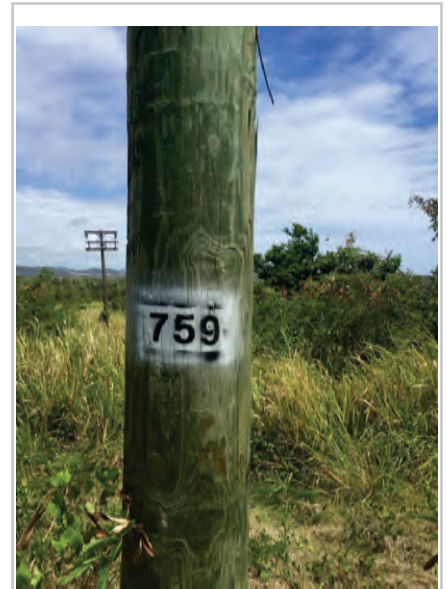
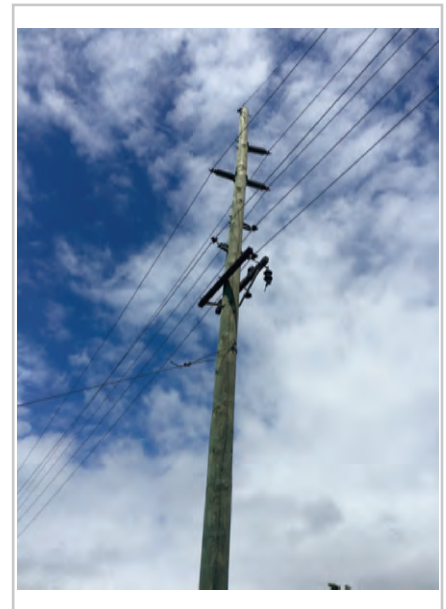
Condition: GOOD

Comments: 38 KV GROUND CONDUCTOR FALLEN AT ONE SIDE, POLE INCLUDE

WOOD CROSS ARMS STANDARD OF OUT OF SERVICE 4.16 KV FEEDER

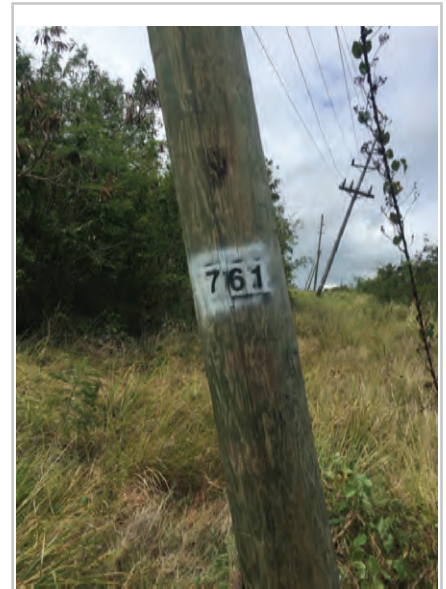
Condition: INCLINED

Comments: ONE GUY WIRE AT GROUND

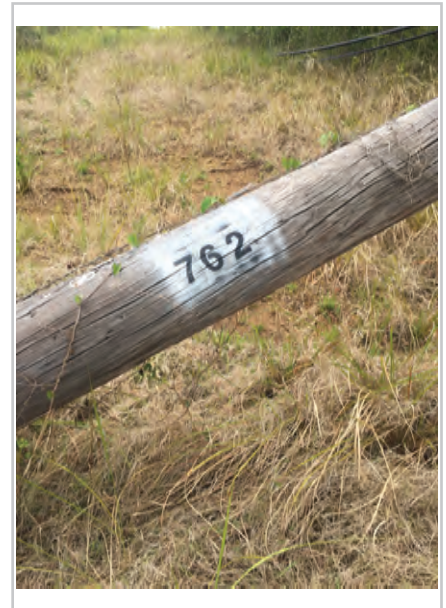
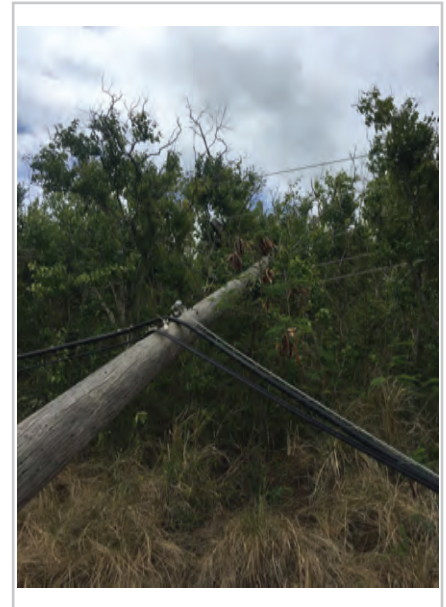
Condition: ^{BROKEN}_____

Comments: ^{ALL CONDUCTORS AT GROUND}_____

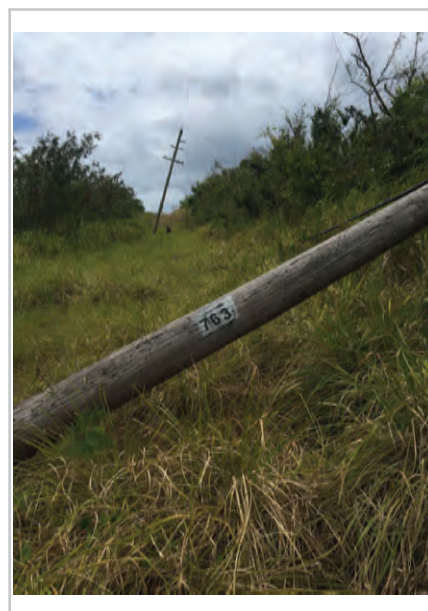
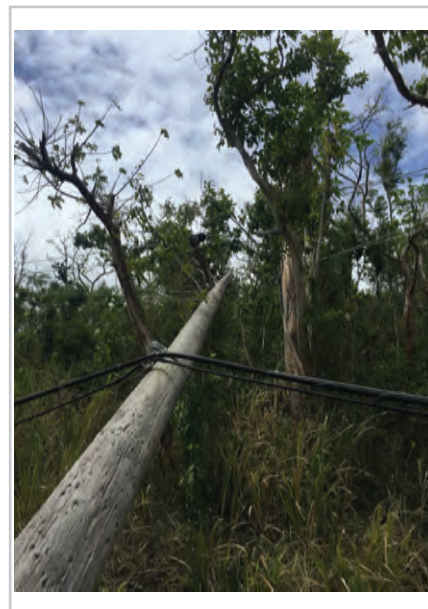
Condition: ^{BROKEN} _____

Comments: ^{ALL CONDUCTORS AT GROUND} _____

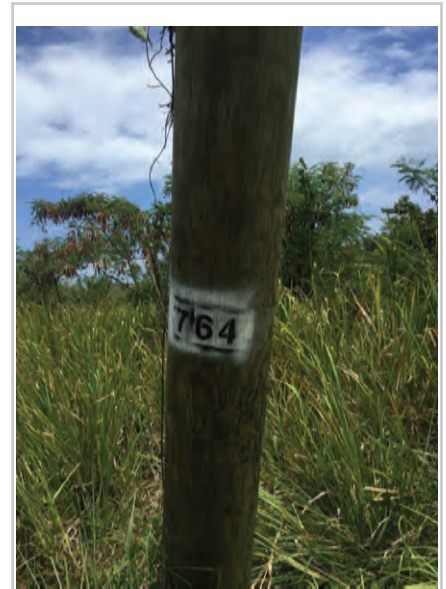
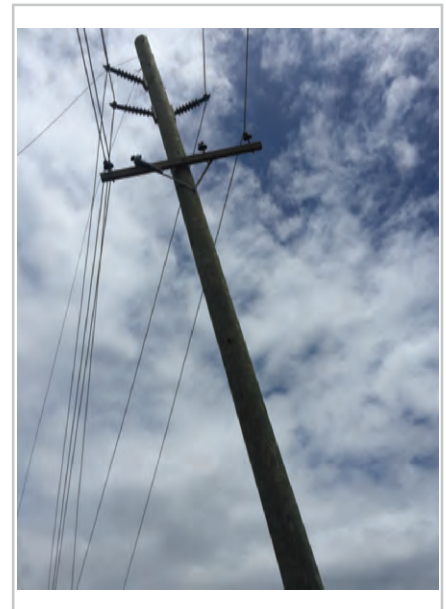
Condition: INCLINED

Comments: 38 KV GROUND CONDUCTOR FALLEN AT ONE SIDE, SOME 13.2 KV

CONDUCTORS FALLEN OR OUT OF POSITION

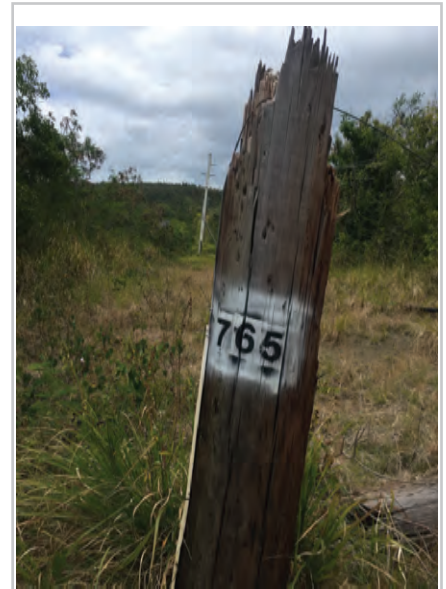
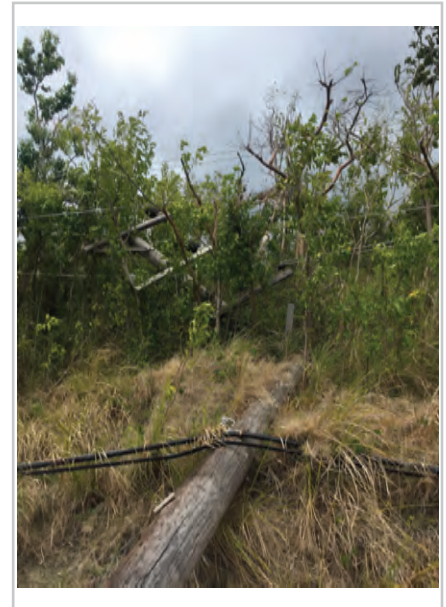
Condition: ^{BROKEN} _____

Comments: ^{ALL CONDUCTOR AT GROUND} _____

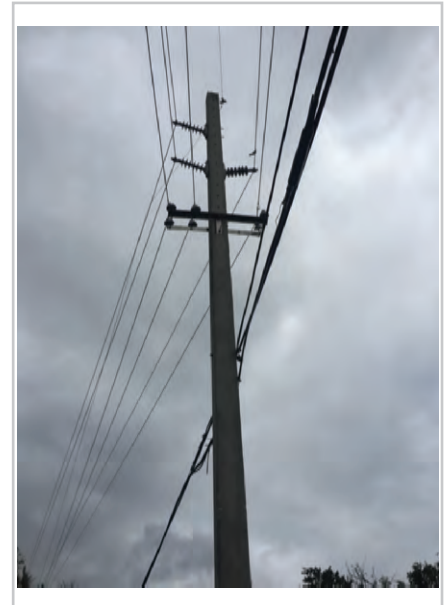
Photo 2: Pole Constr. Standards

Condition: INCLINED

Comments: ONE SIDE OF OVERHEAD GROUND CONDUCTOR IS LOOSED

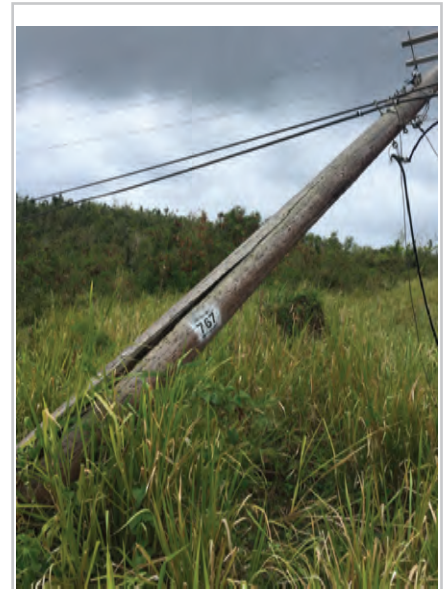
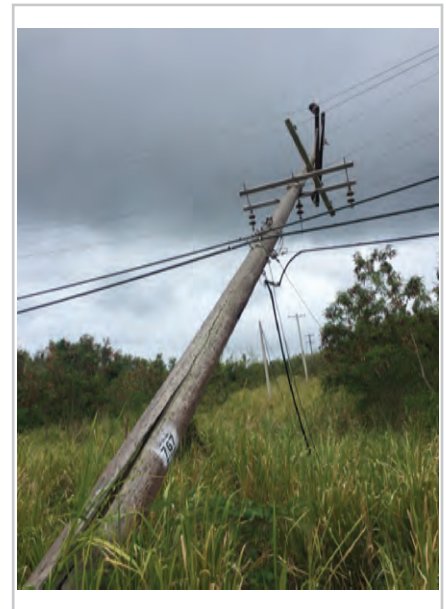
Condition: ^{BROKEN} _____

Comments: ^{POLE CONTAIN A WOOD CROSS ARMS STANDARD FOR OUT OF} _____

SERVICE 4.16 KV LINE

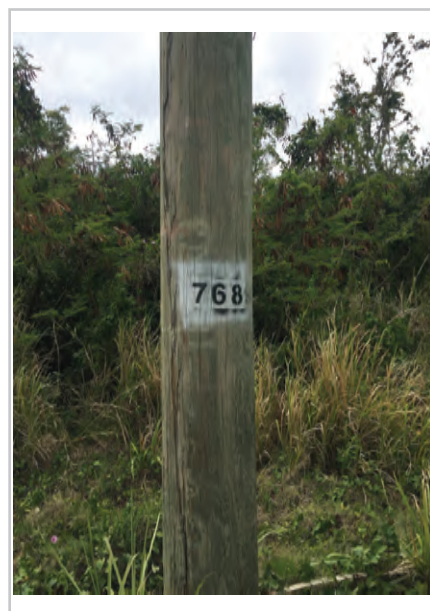
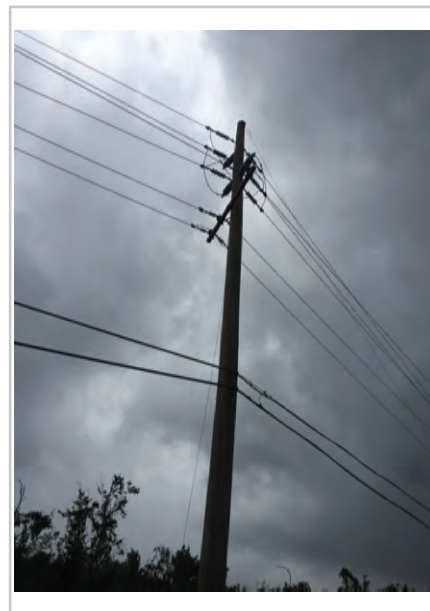
Comments: ^{ONE SIDE OF OVERHEAD GROUND CONDUCTOR FALLEN OR MISSED} _____

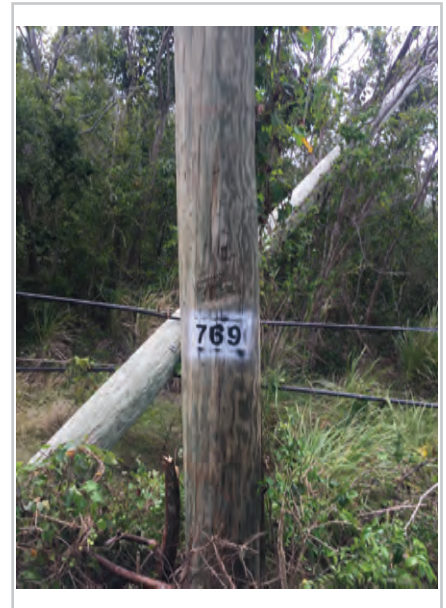
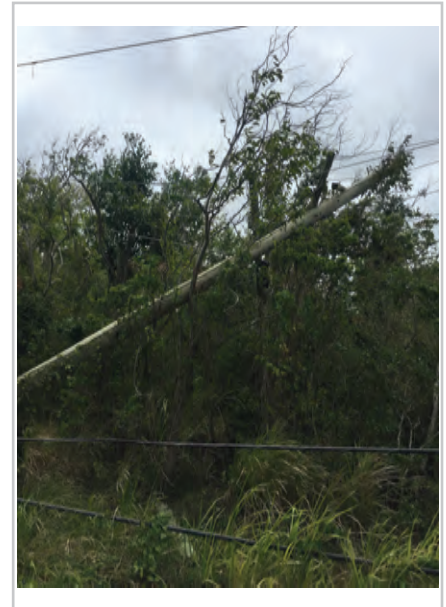
Condition: ^{BROKEN} _____

Comments: ^{ALL CONDUCTORS AT GROUND} _____

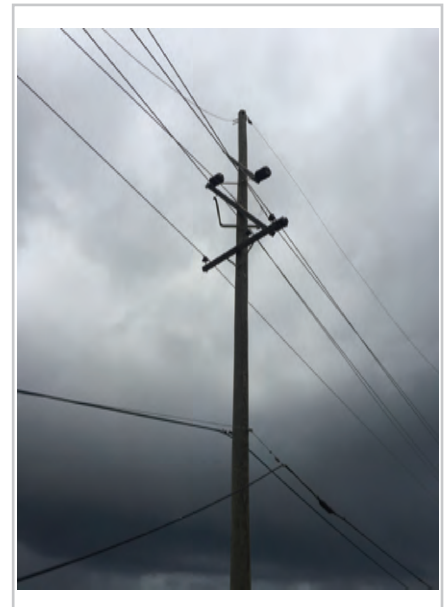
Photo 2: Pole Constr. Standards

Comments: ^{BROKEN CROSS ARMS, MIS ALIGNED AND LOOSE CONDUCTORS} _____

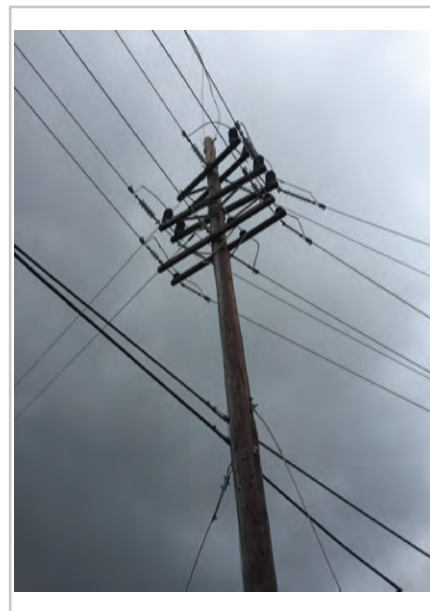
Photo 2: Pole Constr. Standards

Comments: ^{OVERHEAD GROUND CONDUCTOR LOOSE OR FALLEN} _____

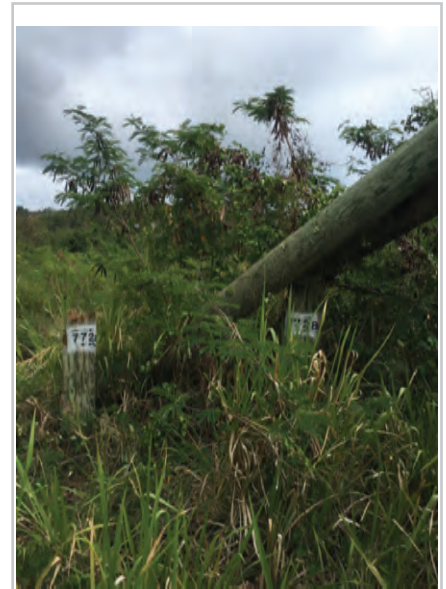
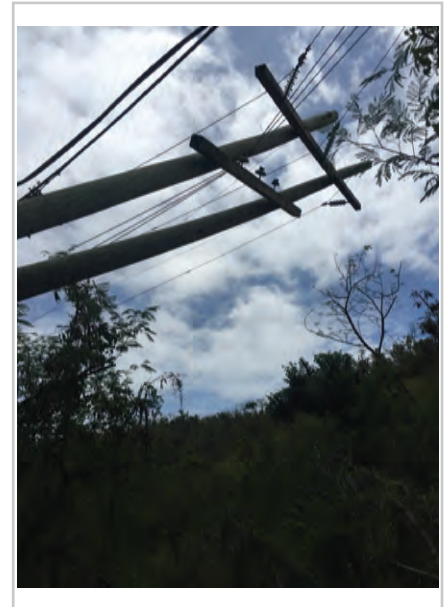
Condition: BROKEN

Comments: TYPE "H" STRUCTURE, ALL CONDUCTORS AT GROUND

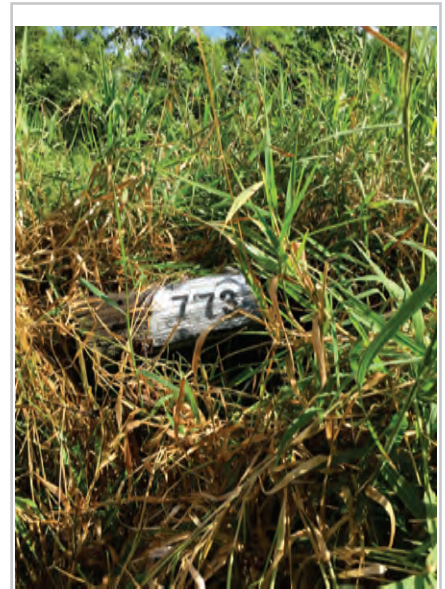
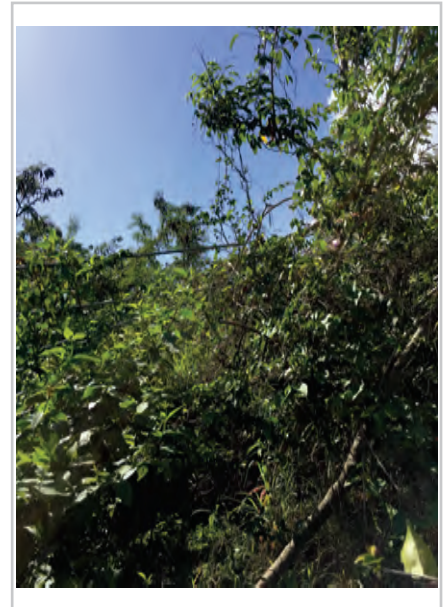
Condition: BROKEN

Comments: ALL CONDUCTORS AT GROUND
