POLES CONDITION ASSESSMENT REPORT

PROJECT: HURRICANE MARIA DAMAGES REPAIRS
TO ROOSEVELT ROADS ELECTRICAL
SYSTEM (19-1741)

LOCATION: Roosevelt Roads,
Ceiba, PR

DATE: May 17, 2018

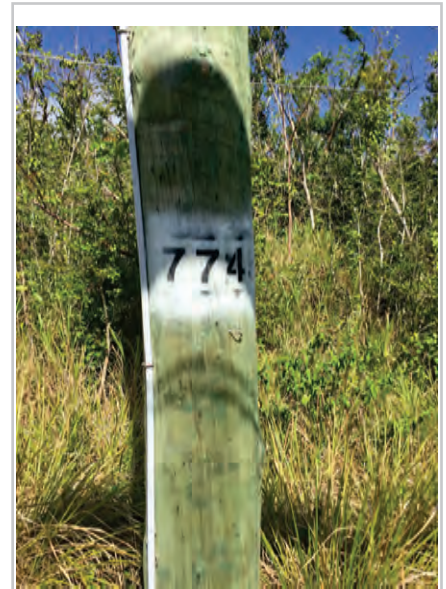
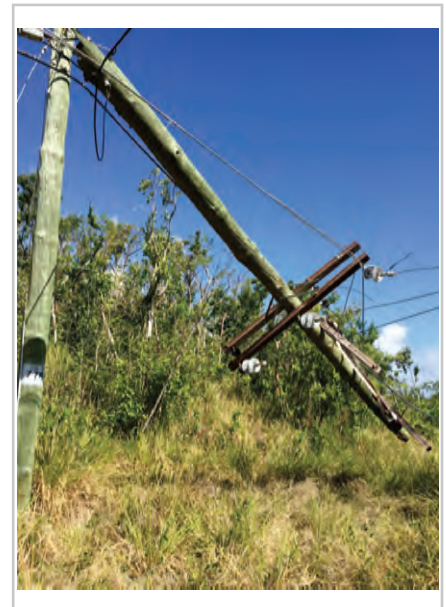
Condition: ^{BROKEN} _____

Comments: ^{ALL CONDUCTORS AT GROUND} _____

ANCHORED WITH WOOD CROSS ARMS STANDARD TO PRIMARY POLE 775

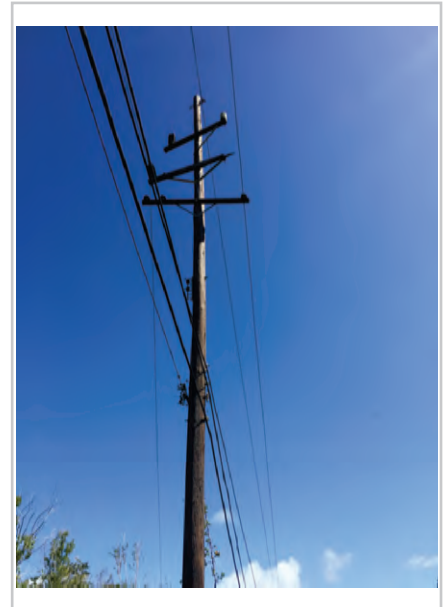
Photo 2: Pole Constr. Standards

Comments: ^{CROSS ARMS BROKEN AND MIS ALIGNED, SOME CONDUCTORS} _____

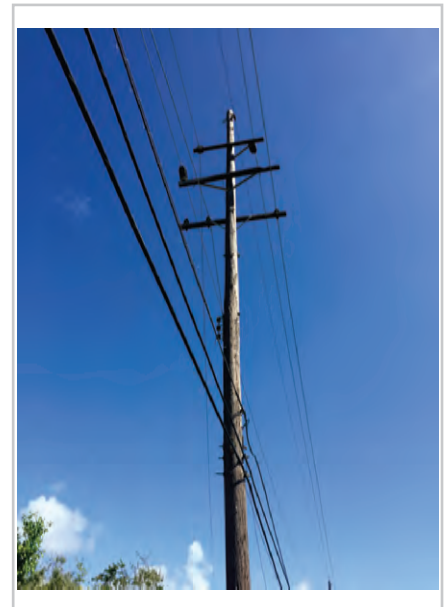
Photo 2: Pole Constr. Standards

Comments: CROSS ARMS BROKEN AND MIS ALIGNED, SOME CONDUCTORS

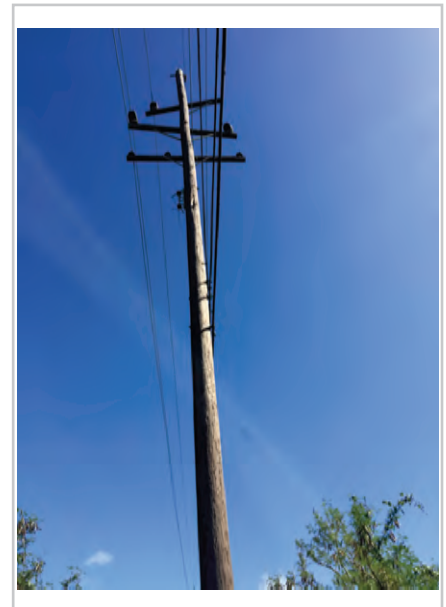
Photo 2: Pole Constr. Standards

Comments: ^{CROSS ARMS BROKEN OR MIS ALIGNED, SOME CONDUCTORS} _____

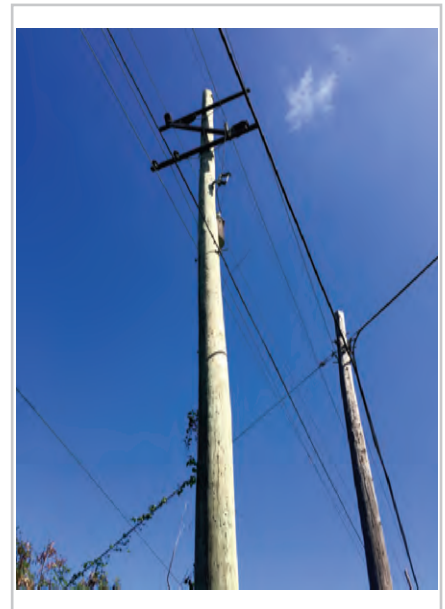
Photo 2: Pole Constr. Standards

38 KV INSULATORS DAMAGED, FUSED CUT OUT FOR TRANSFORMER

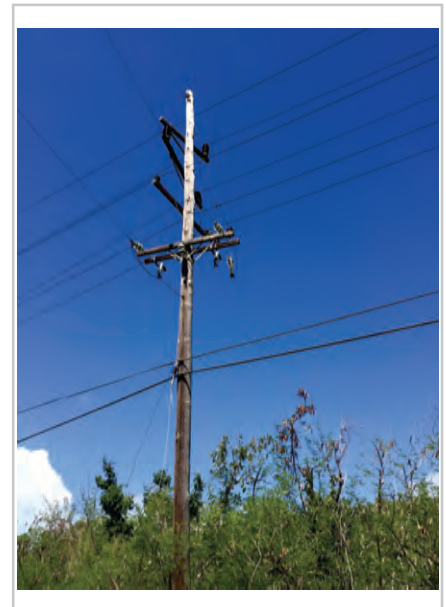
Photo 2: Pole Constr. Standards

WITH FUSED CUT OUT, CROSS ARMS BROKEN OR MIS ALIGNED

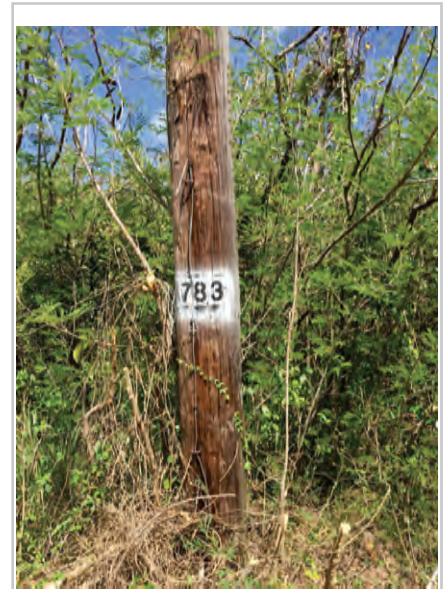
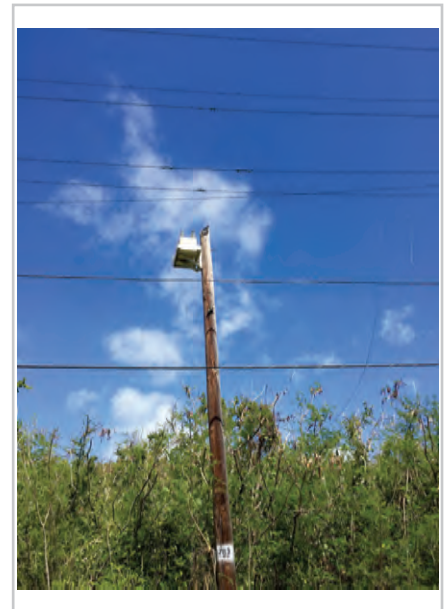
Condition: OUT OF SERVICE

Comments: OUT OF SERVICE POLE WITH CAPACITOR BANK

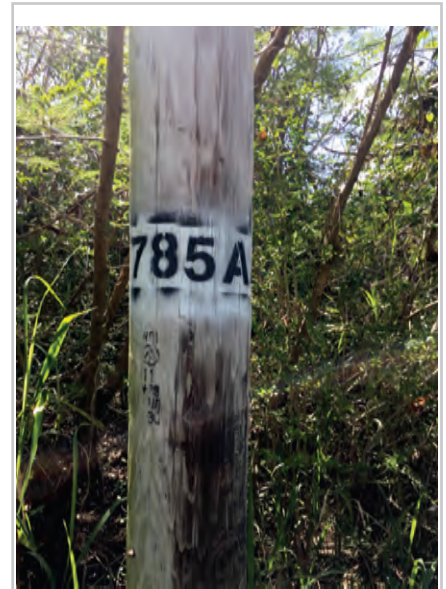
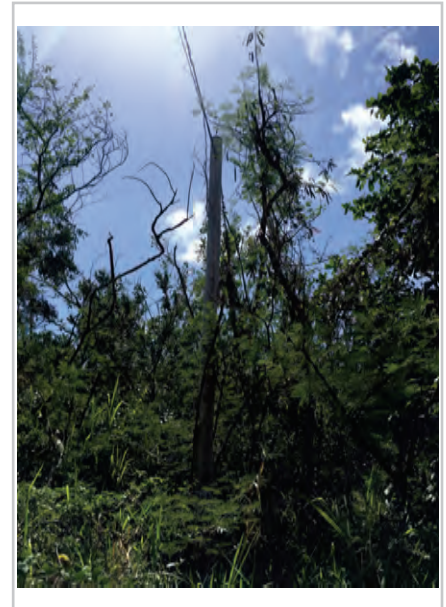
Condition: GOOD

Comments: STUB POLE FOR POLE 785

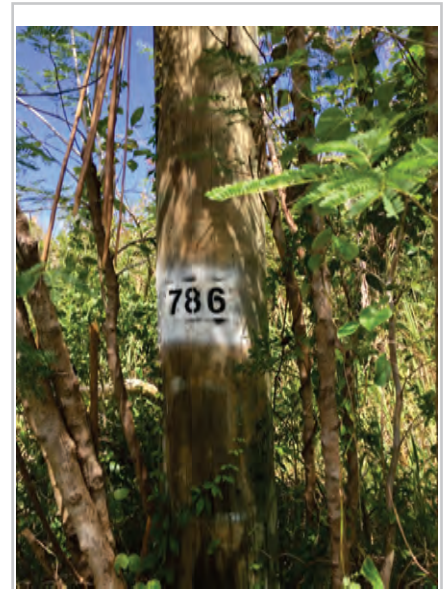
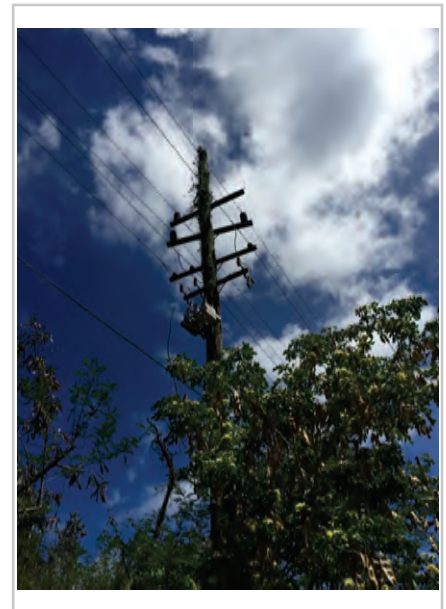
Condition: ^{GOOD} _____

Comments: ^{POLE CONTAIN A CAPACITOR BANK WITH FUSES AND ARRESTER} _____

ON WOOD CROSS ARMS STANDARD, CROSS ARMS ARE MIS ALIGNED

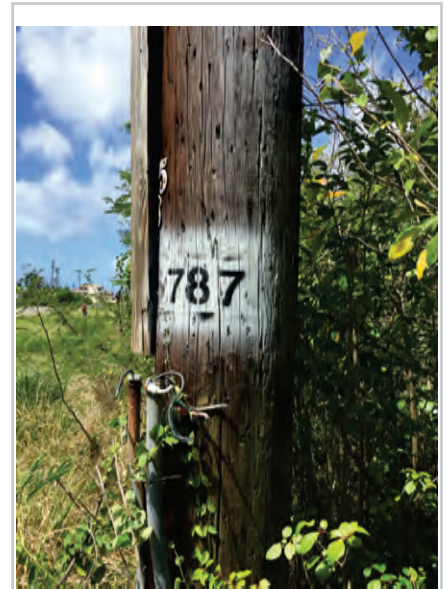
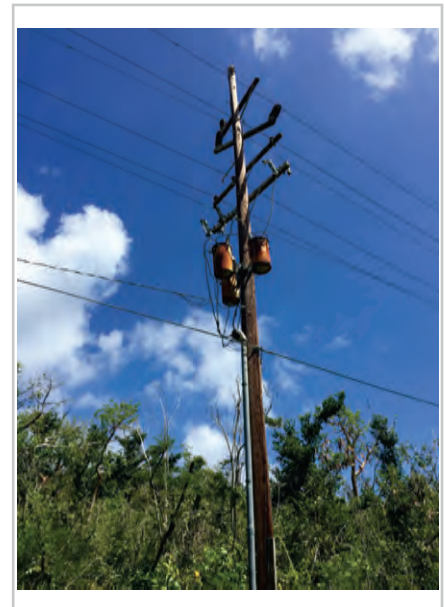
Condition: ^{GOOD} _____

Comments: ^{POLE CONTAIN A SUBSTATION WITH FUSES AND ARRESTER ON WOOD} _____

CROSS ARMS STANDARD, CROSS ARMS ARE MIS ALIGNED

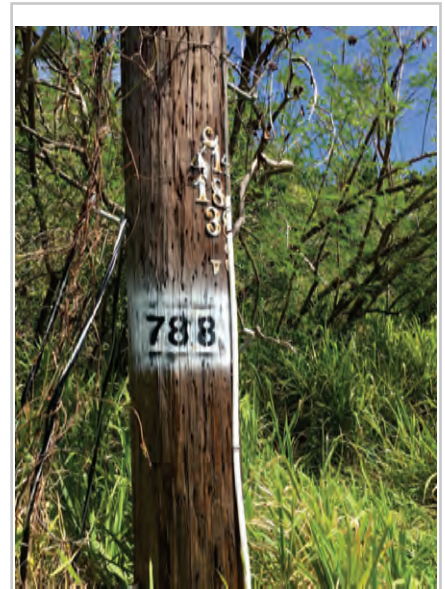
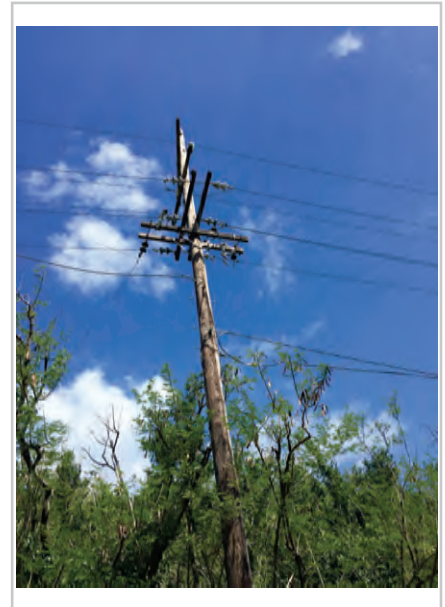
Condition: GOOD

Comments: POLE CONTAIN A OUT OF SERVICE WOOD CROSS ARMS STANDARD

FOR 4.16 KV FEEDER, ONE SIDE OF SECONDARY CONDUCTOR ON GROUND

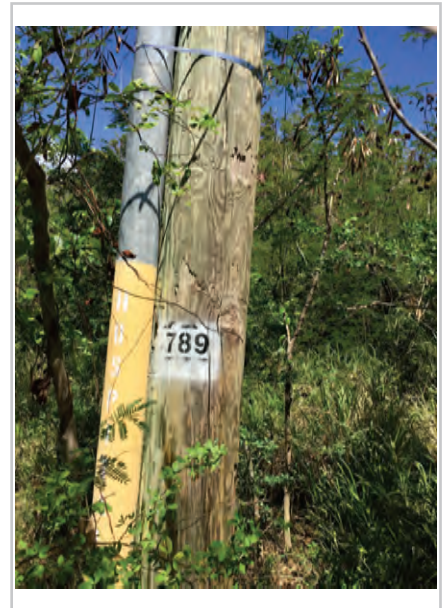
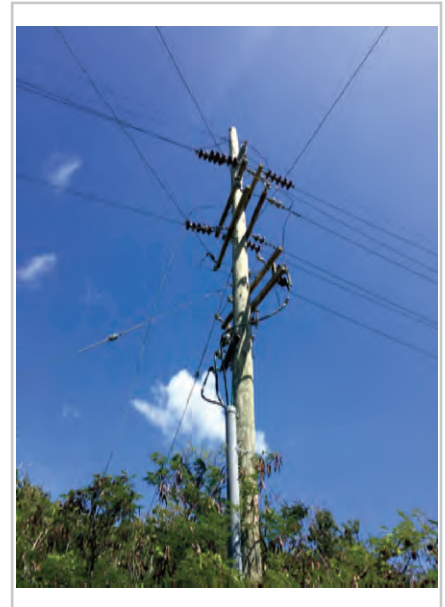
Condition: ^{GOOD} _____

Comments: ^{POLE CONTAIN A RISER WITH WOOD CROSS ARMS STANDARD WITH} _____

600 A LOAD BREAK, UNDERGROUND FEEDER FROM INDIA SUBSTATION SWITCHGEAR

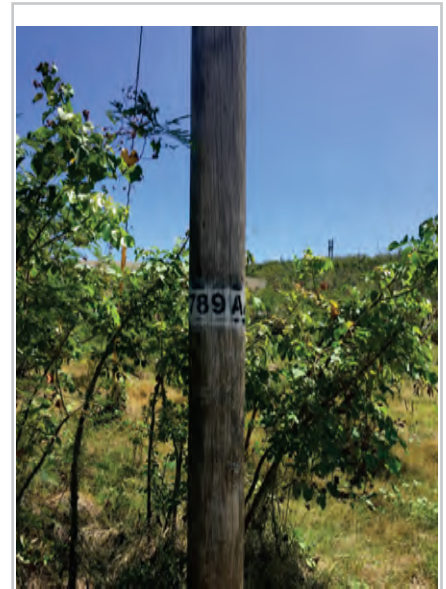
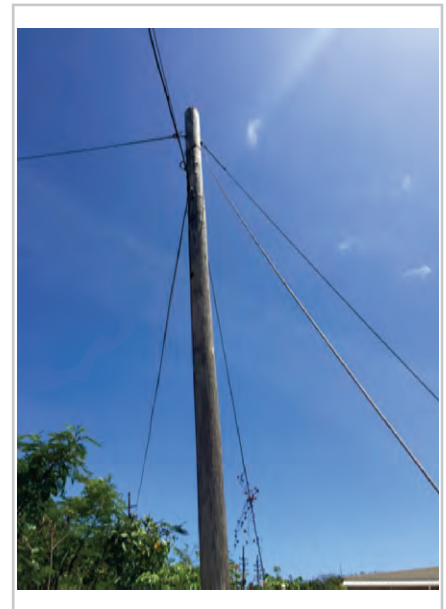
Condition: GOOD

Comments: STUB POLE FOR POLE 789

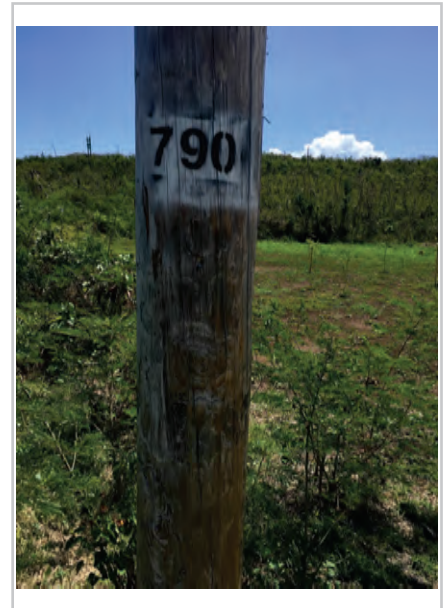
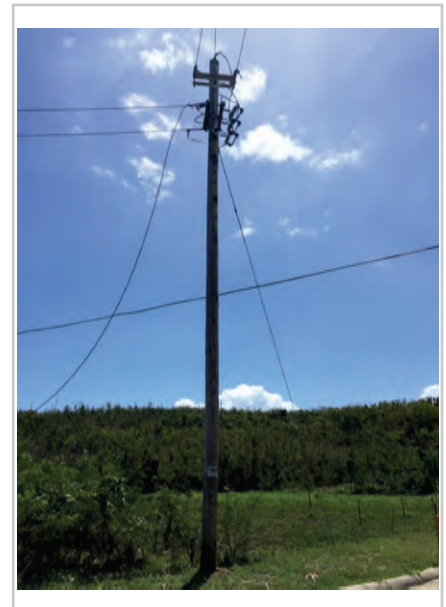
Condition: ^{GOOD} _____

Comments: ^{FUSED CUT OUT INSTALLED IN LINE WITH PRIMARY LINE ON STEEL} _____

CROSS ARM, ONE CONDUCTOR FALLEN

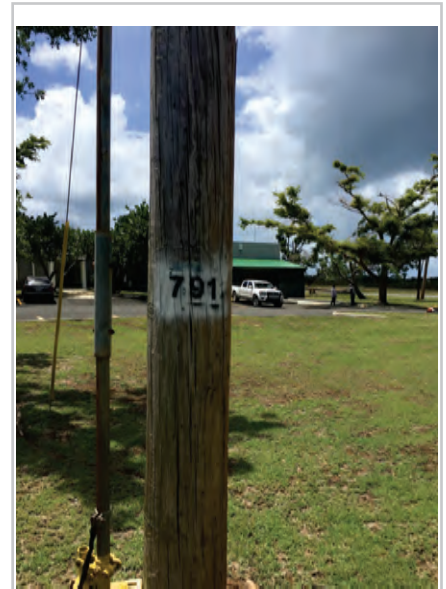
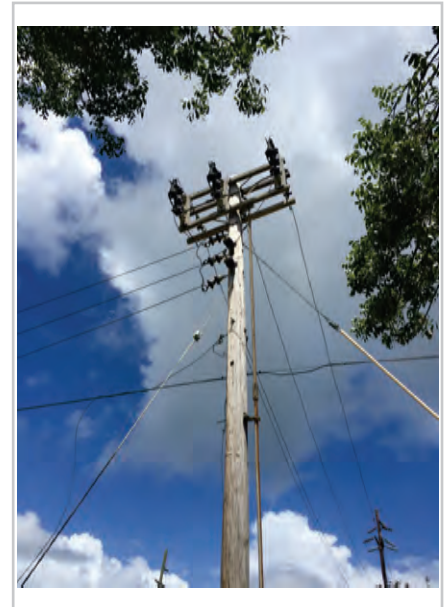
Condition: ^{GOOD}_____

Comments: ^{GANG OPERATED 600 A LOAD BREAK INSTALLED ON WOOD CROSS}_____

ARMS AND OPERATING HANDLE

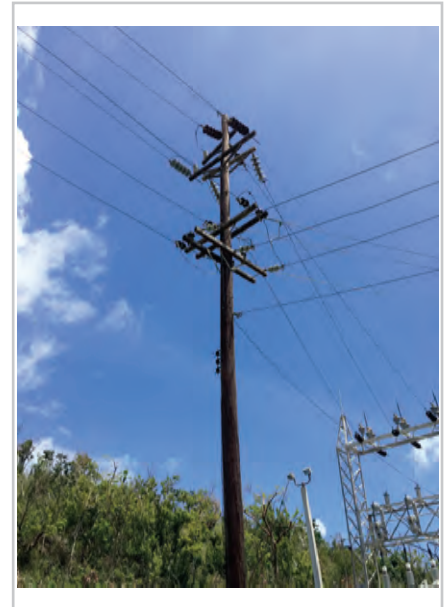
Condition: ^{GOOD}_____

Comments: ^{CROSS ARMS MIS ALIGNED AND DAMAGED}_____

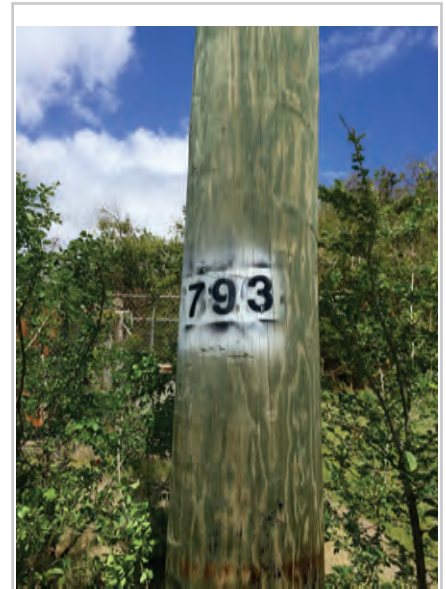
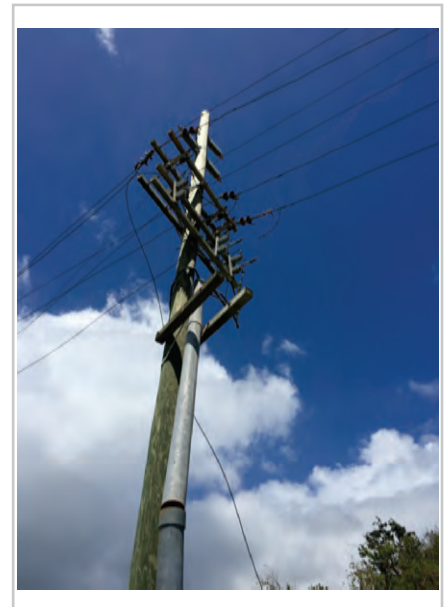
Condition: ^{INCLINED} _____

Riser Connection: ^{1, PRIMARY RISER FOR INDUSTRIAL SECTOR, DAMAGE CONDUI} _____

Comments: ^{POLE CONTAIN A RISER WITH WOOD CROSS ARMS STANDARD WITH} _____

^{600 A LOAD BREAK, UNDERGROUND FEEDER FROM INDIA SUBSTATION SWITCHGEAR}

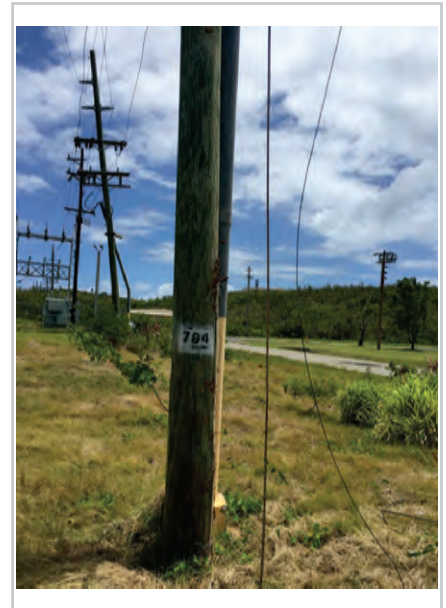
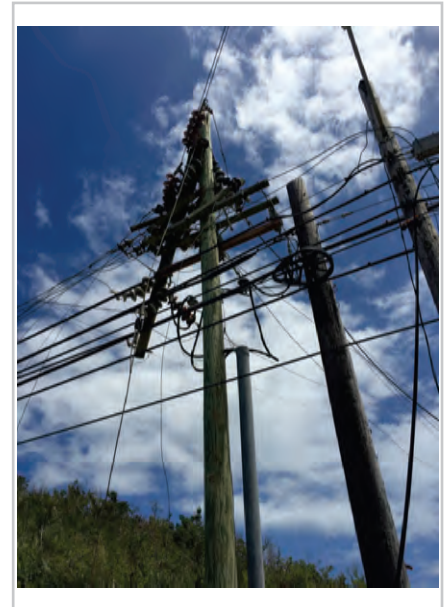
Condition: BROKEN

Riser Connection: 1, PRIMARY RISER FOR MARINA SECTOR, DAMAGE CONDUIT

Comments: POLE CONTAIN A RISER WITH WOOD CROSS ARMS STANDARD WITH

600 A LOAD BREAK, UNDERGROUND FEEDER FROM INDIA SUBSTATION SWITCHGEAR

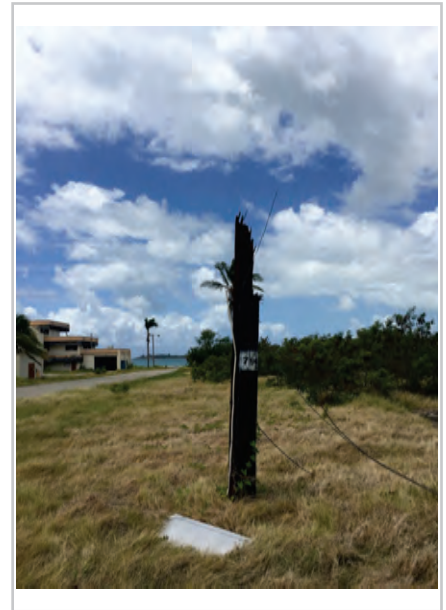
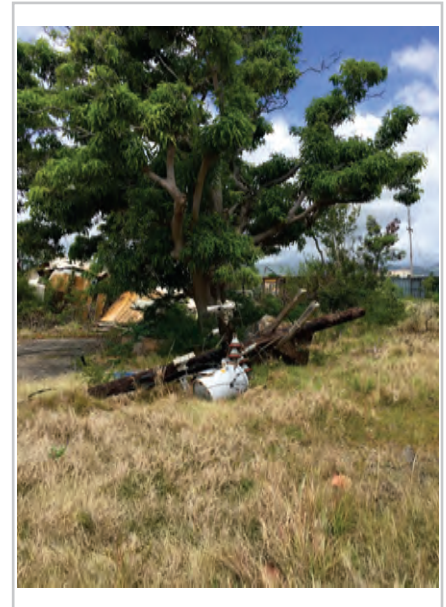
Condition: BROKEN

Comments: STUB POLE FOR POLE 794

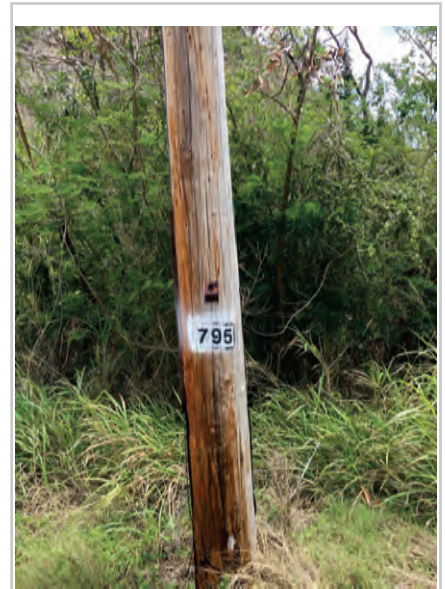
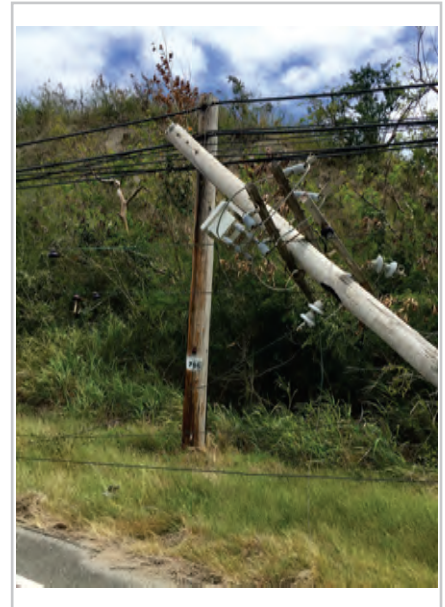
Condition: BROKEN

Comments: POLE CONTAIN A CAPACITOR BANK WITH FUSED CUT OUT ON WOOD

CROSS ARMS

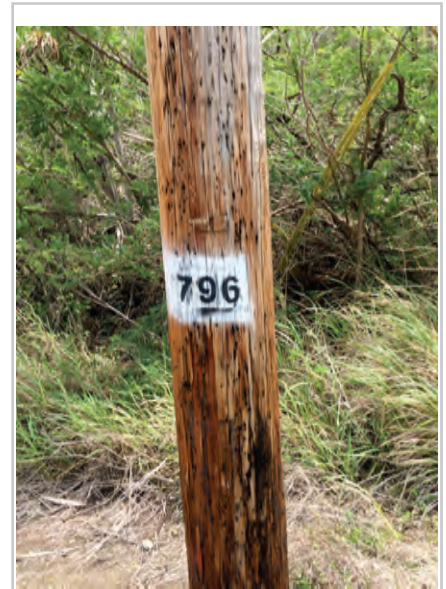
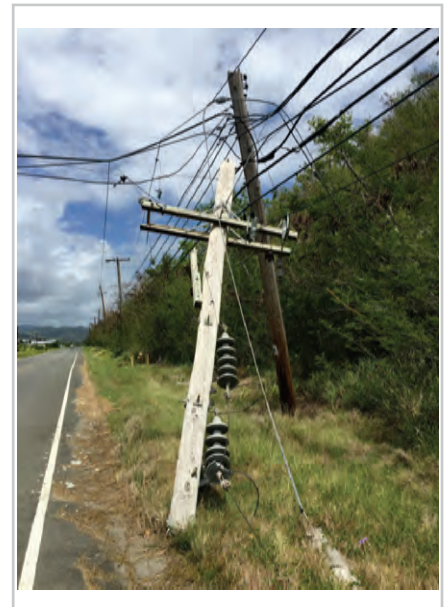
Condition: BROKEN

Comments: POLE CONTAIN FUSED CUT OUT ON WOOD CROSS ARMS FOR

PRIMARY TAP

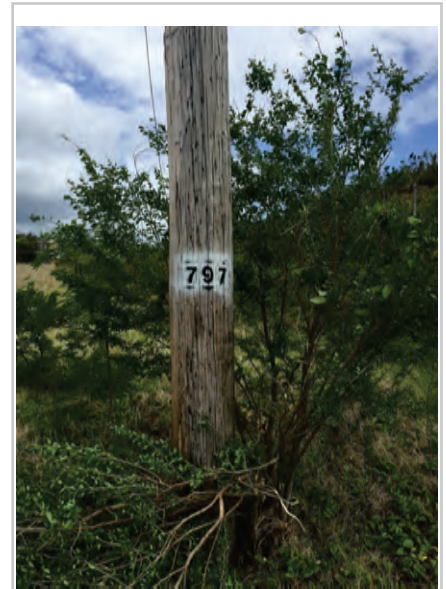
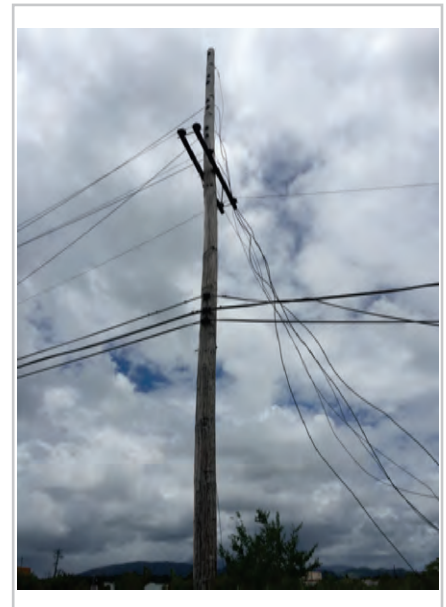
Condition: ^{INCLINED} _____

Comments: ^{AT ONE SIDE ALMOST ALL CONDUCTORS ON GROUND} _____

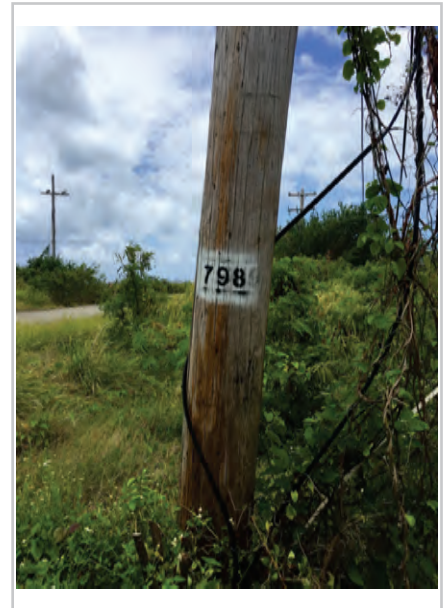
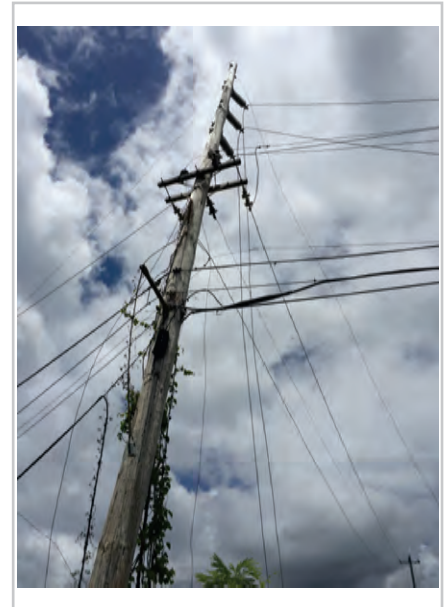
Condition: INCLINED

Comments: AT ONE SIDE ALMOST ALL CONDUCTORS ON GROUND

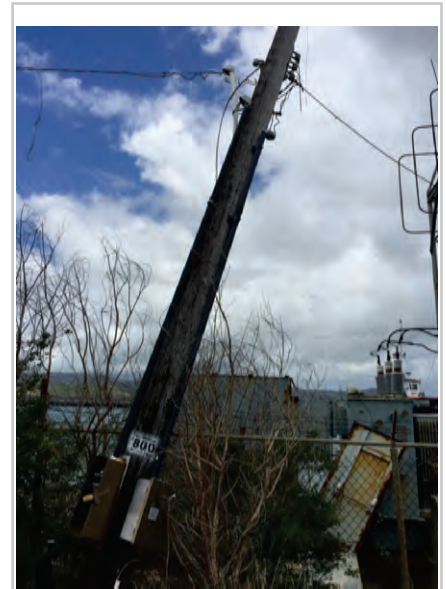
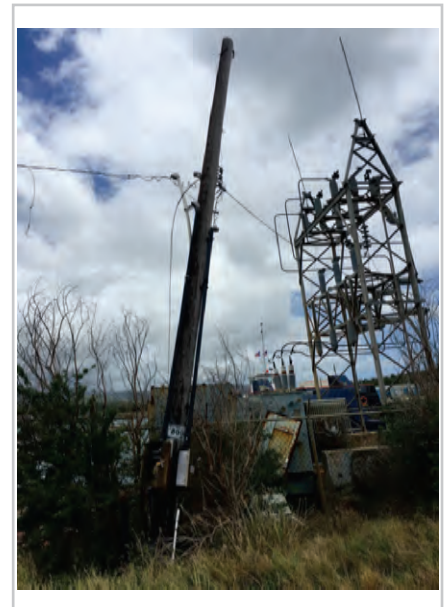
Condition: ^{BROKEN} _____

Comments: ^{OUT OF SERVICE POLE WITH DISCONNECT SWITCHES AT BASE} _____
N/A

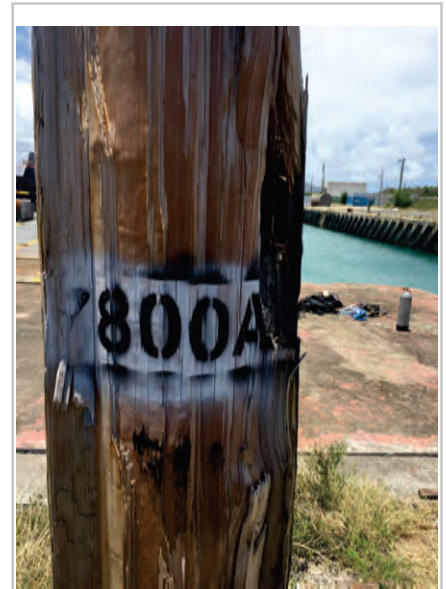
Condition: BROKEN

Comments: ONLY EXIST PIECES OF POLE WATER SHORE

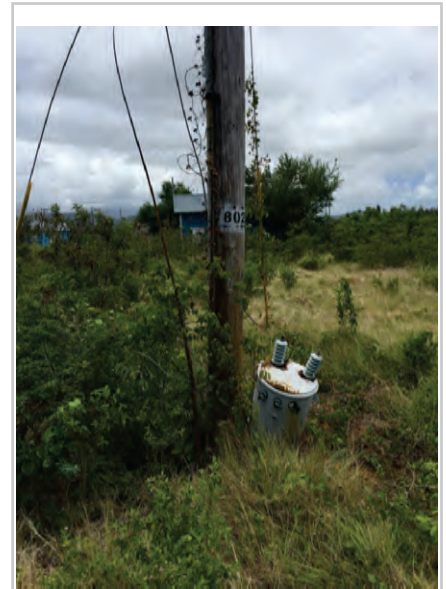
Condition: GOOD

Comments: ONLY REMAIN ONE TRANSFORMER ON POLE OF THREE
TWO TRANSFORMERS AND SECONDARY CONDUCTORS ON GROUND

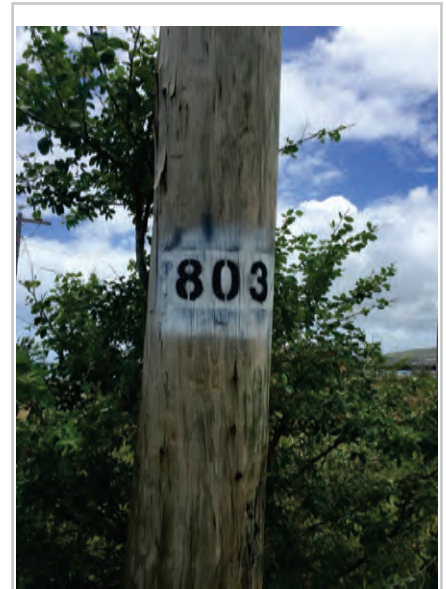
Comments: ^{ONLY EXIST TWO PHASES CONDUCTORS WITH FUSED CUT OUT} _____
^{ON WOODS CROSS ARMS}

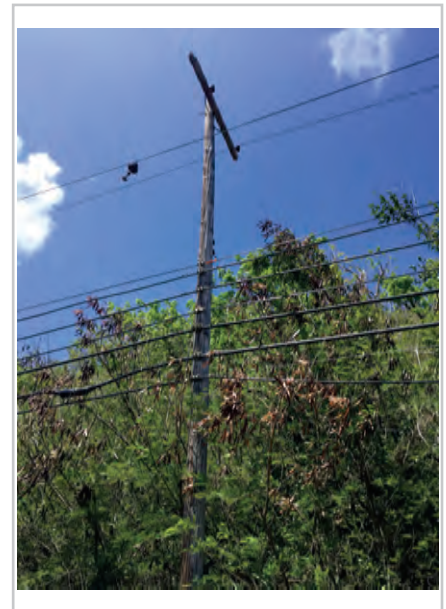
Photo 2: Pole Constr. Standards

Comments: ^{CROSS ARM DAMAGED, SOME CONDUCTORS FALLEN} _____
N/A

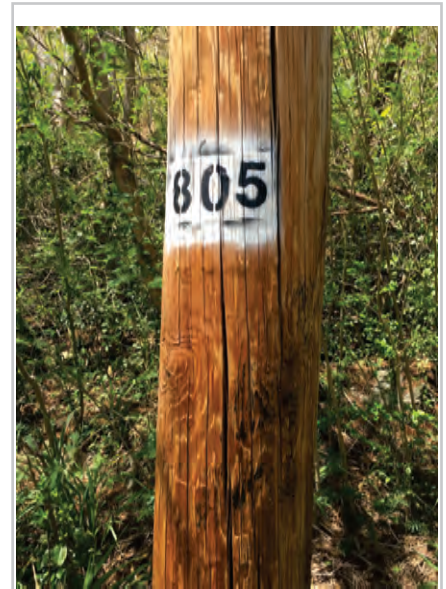
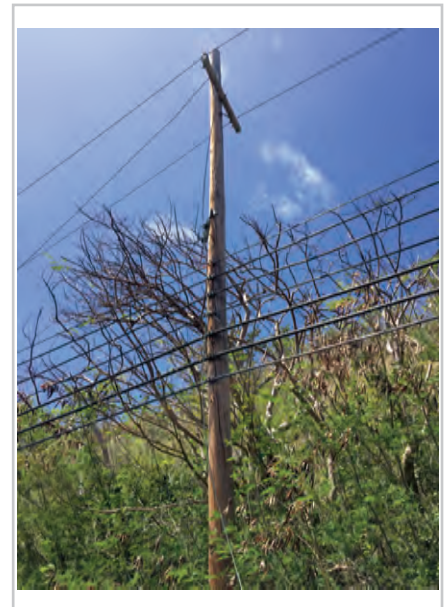
Comments: ^{CROSS ARM MIS ALIGNED, ONE CONDUCTOR FALLEN}_____
N/A

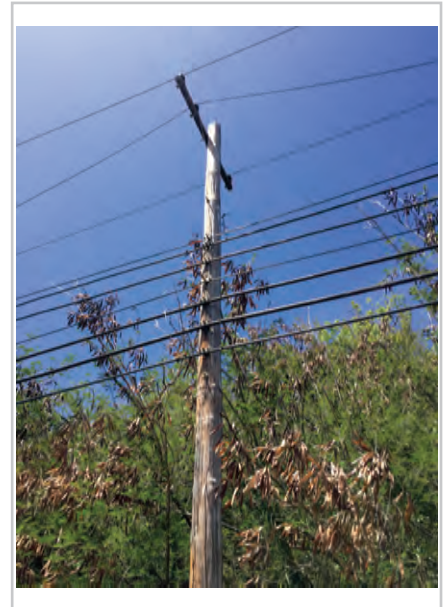
Photo 2: Pole Constr. Standards

Comments: CONDUCTORS ARE LOOSED

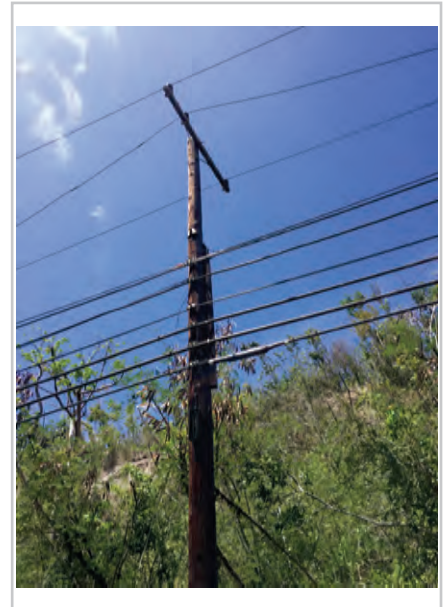
Photo 2: Pole Constr. Standards

Comments: ^{CONDUCTORS ARE LOOSED} _____
N/A

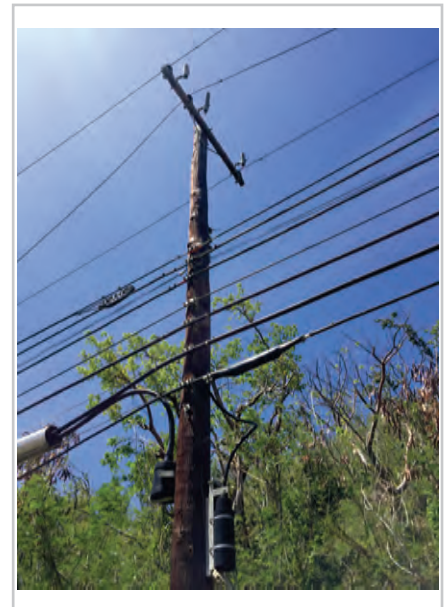
Photo 2: Pole Constr. Standards

Comments: ^{CONDUCTORS ARE LOOSED AND LIGHTNING ARRESTER ON WOOD} _____
^{CROSS ARM} _____

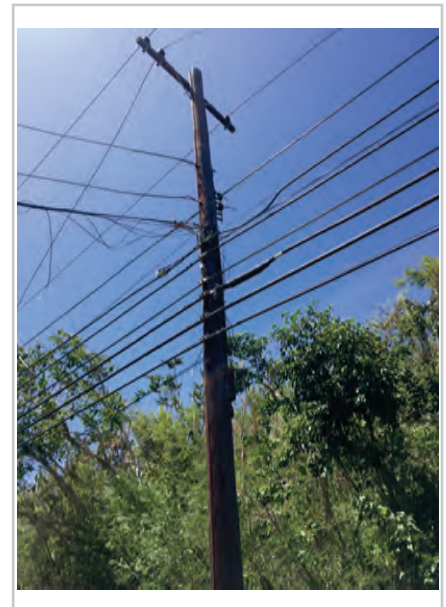
Photo 2: Pole Constr. Standards

Comments: ^{CONDUCTORS ARE LOOSED} _____
N/A

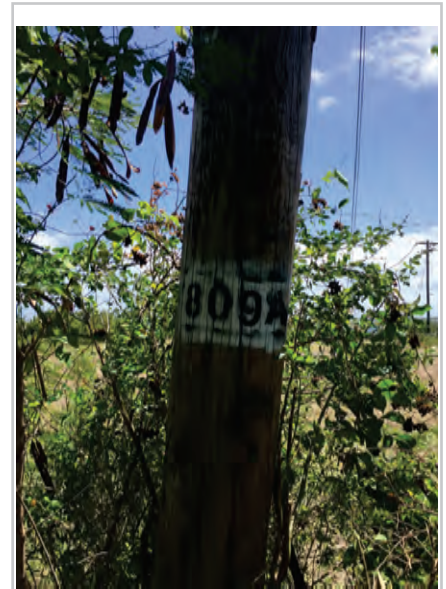
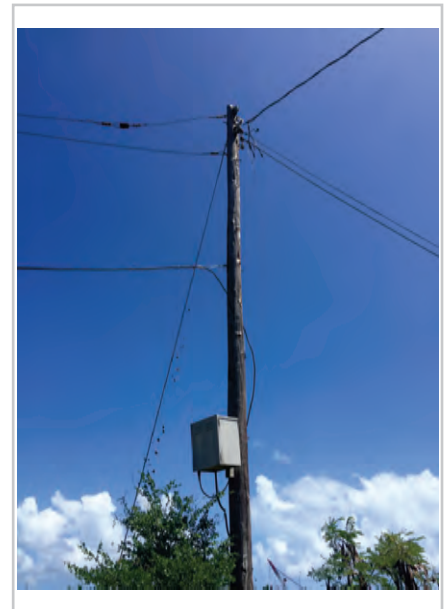
Comments: STUB POLE FOR POLE 809

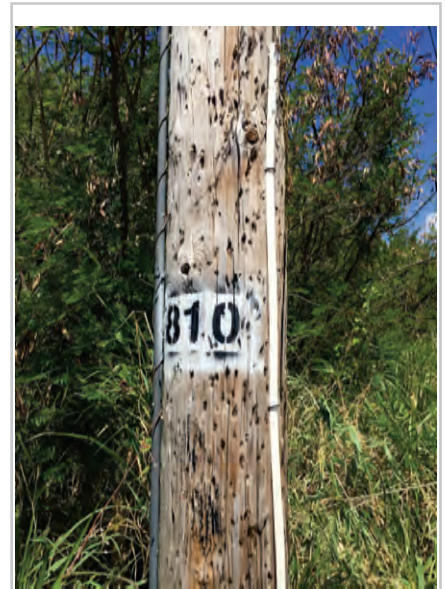
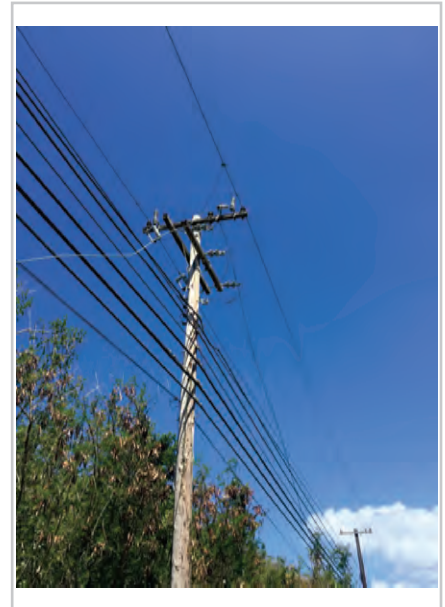
Comments: ^{ANCHORED PRIMARY TAP WITH FUSED CUT OUT AND LIGHTNING} _____

ARRESTER ON WOOD CROSS ARM, ONE PHASE CONDUCTOR ON GROUND

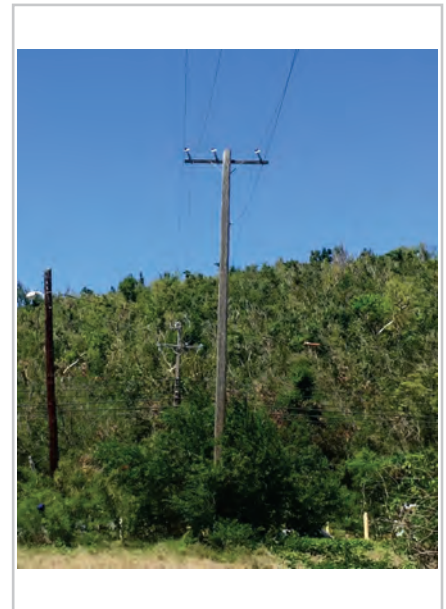
Photo 2: Pole Constr. Standards

Comments: ^{CONDUCTORS LOOSED AND OUT OF POSITION} _____
N/A

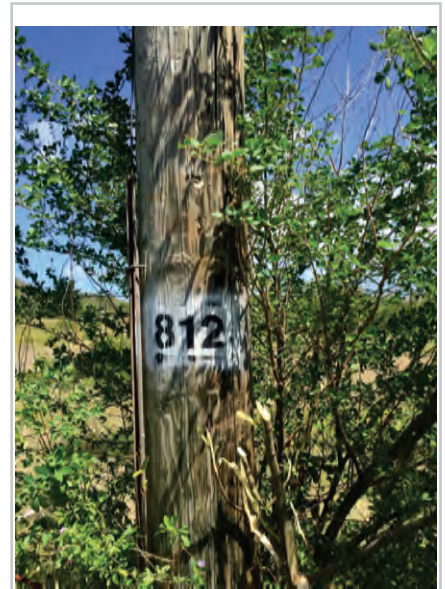
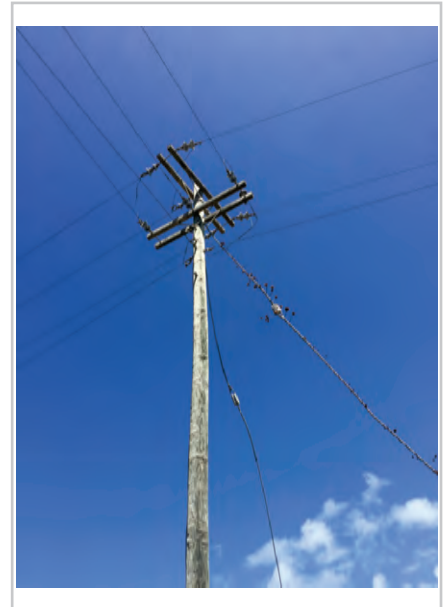
Comments: ANCHORED WITH WOOD CROSS ARM PRIMARY TAP FOR CONNECTION
OF POLE 812A

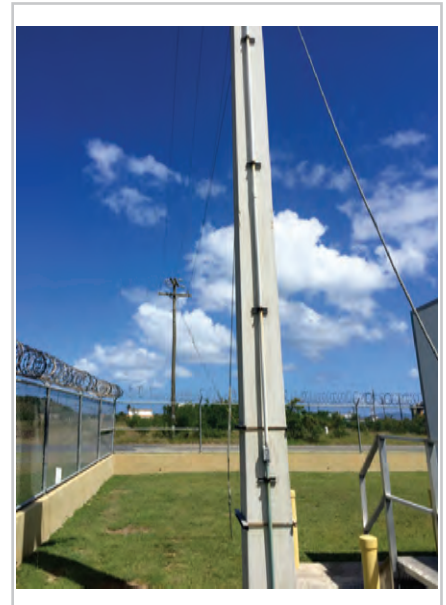
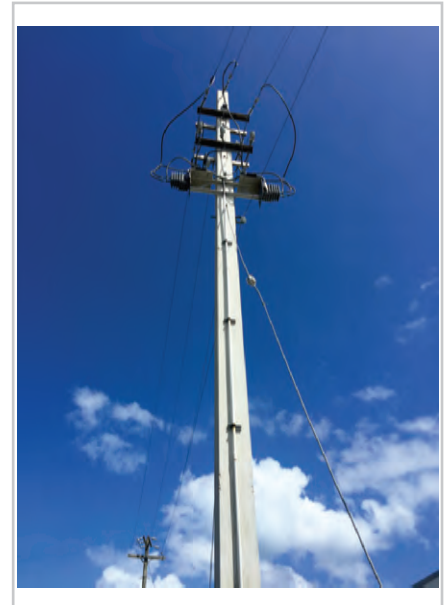
Comments: FUSED CUT OUT AND LIGHTNING ARRESTER FOR PRIMARY METERING
SYSTEM INSTALLED ON STEEL CROSS ARMS

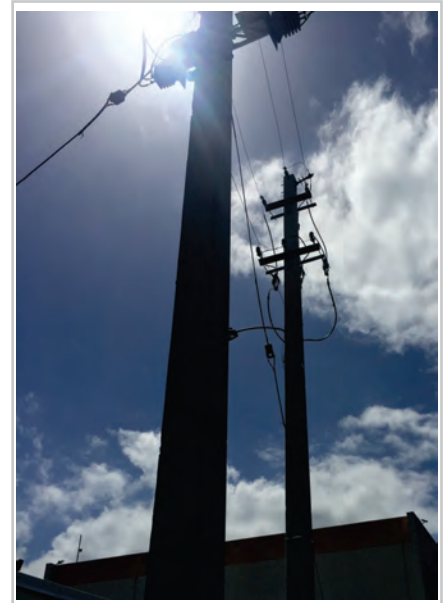
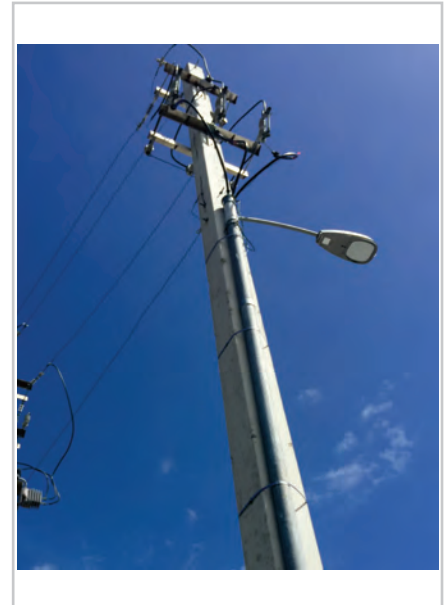
Comments: FUSED CUT OUT AND LIGHTNING ARRESTER FOR PRIMARY RISER

INSTALLED ON STEEL CROSS ARMS

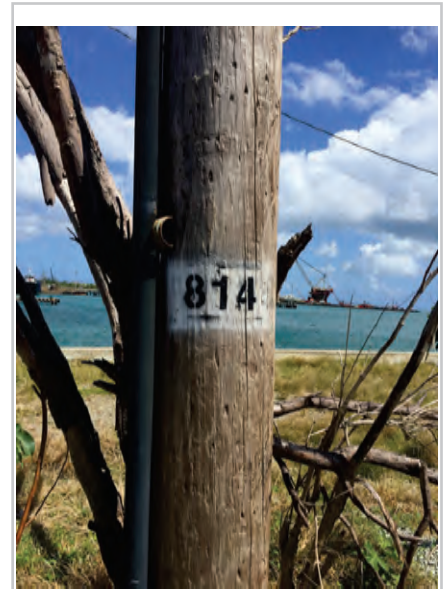
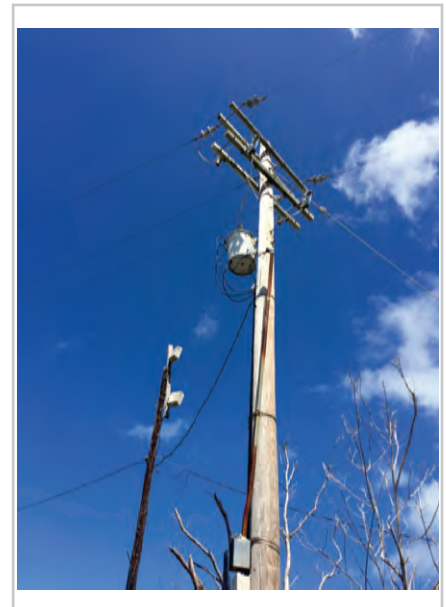
Comments: FUSED CUT OUT AND LIGHTNING ARRESTER FOR TRANSFORMER

INSTALLED ON WOOD CROSS ARMS

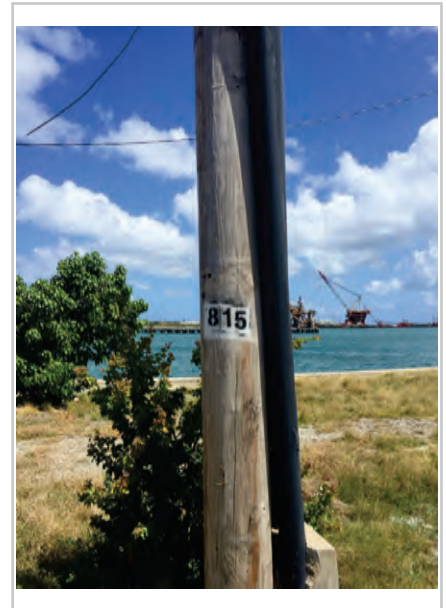
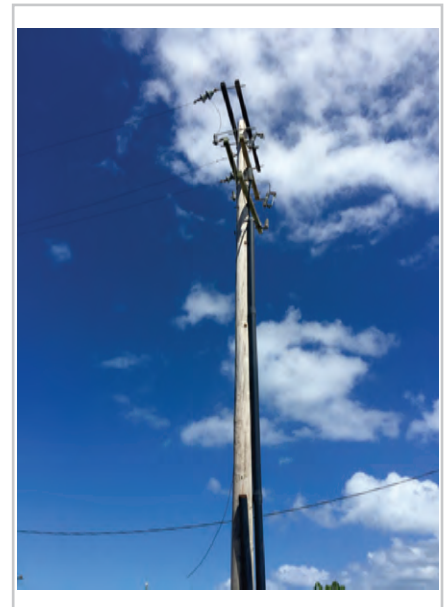
Comments: FUSED CUT OUT AND LIGHTNING ARRESTER FOR PRIMARY RISER
INSTALLED ON WOOD CROSS ARMS

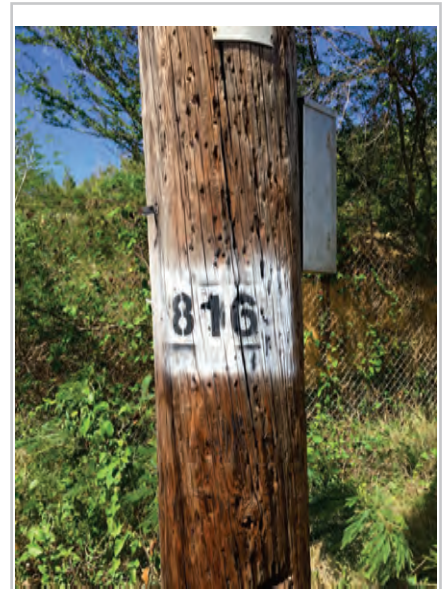
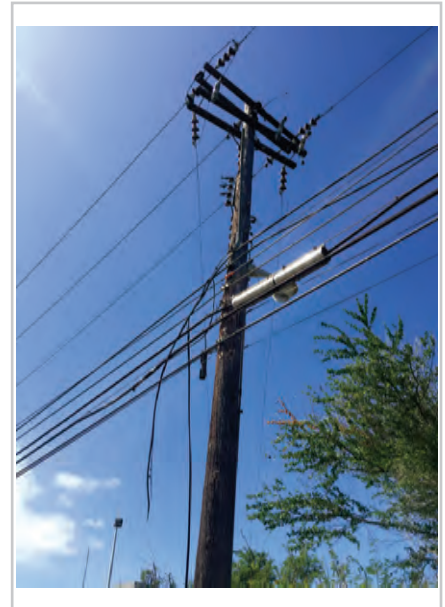
Luminaire: ^{1, OUT OF SERVICE} _____

Comments: ^{CONDUCTORS ON GROUND AND FUSED CUT OUT ON WOOD CROSS} _____
^{ARMS FOR PRIMARY TAP}

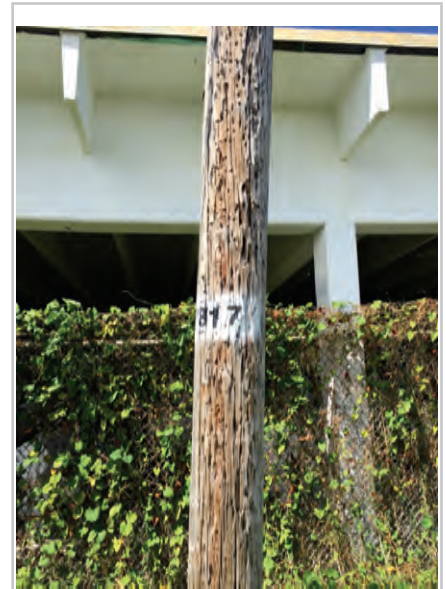
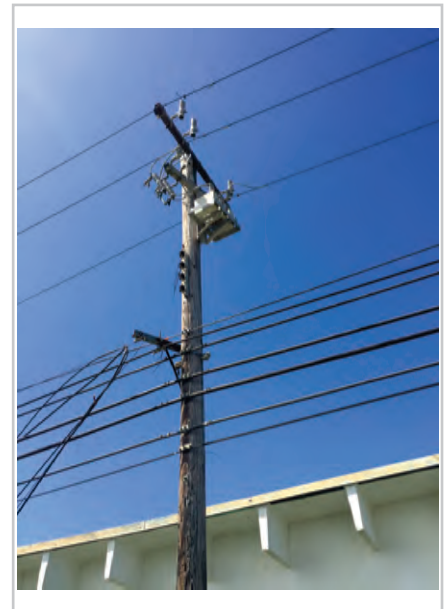
Comments: ^{FUSED CUT OUT AND LIGHTNING ARRESTERS ON WOOD CROSS ARMS} _____
^{FOR CAPACITOR BANK} _____

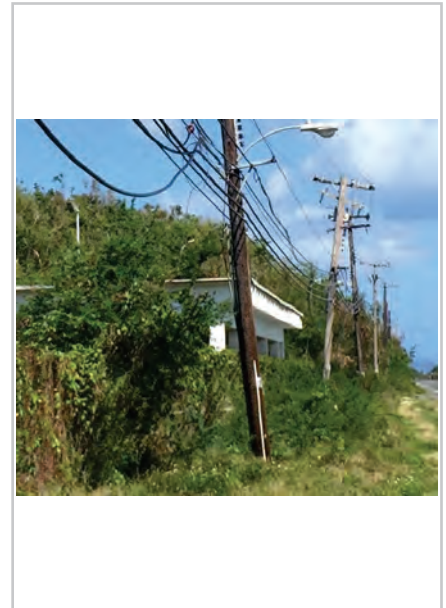
Luminaire: 1, OUT OF SERVICE

Comments: FUSED CUT OUT AND LIGHTNING ARRESTERS ON WOOD CROSS ARMS
FOR PRIMARY RISER

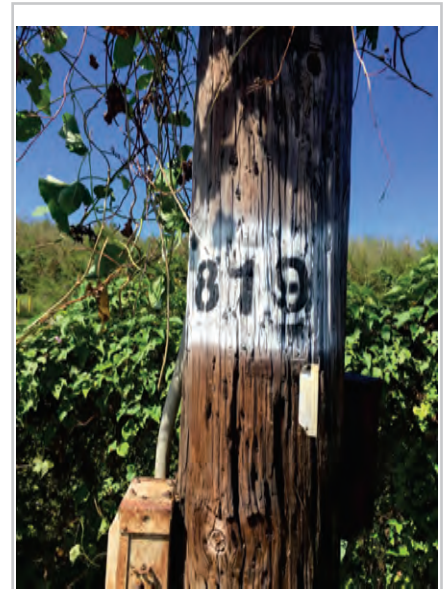
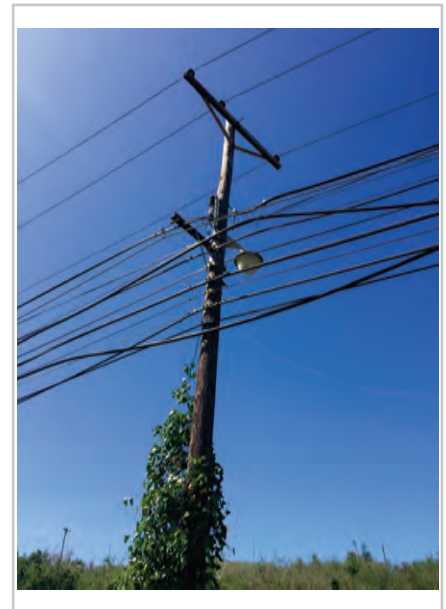
Luminaire: ^{1, OUT OF SERVICE} _____

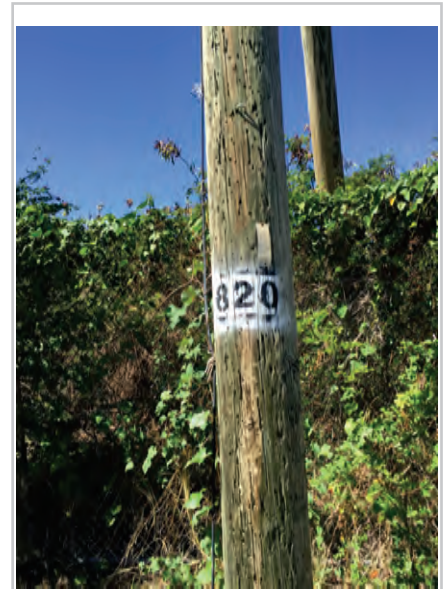
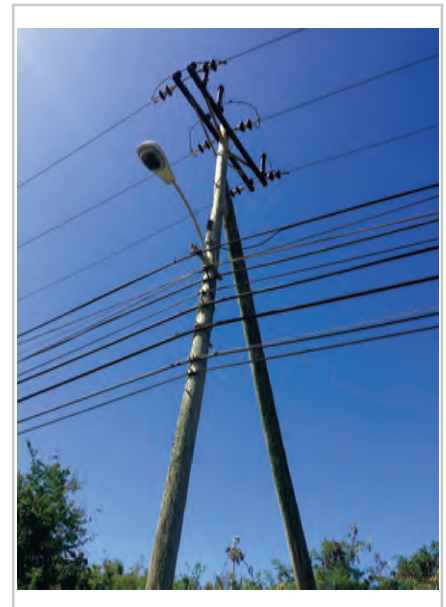
Comments: LIGHTNING ARRESTER ON WOOD CROSS AND A SIDE WOOD POLE

USED FOR MAIN POLE SUPPORT

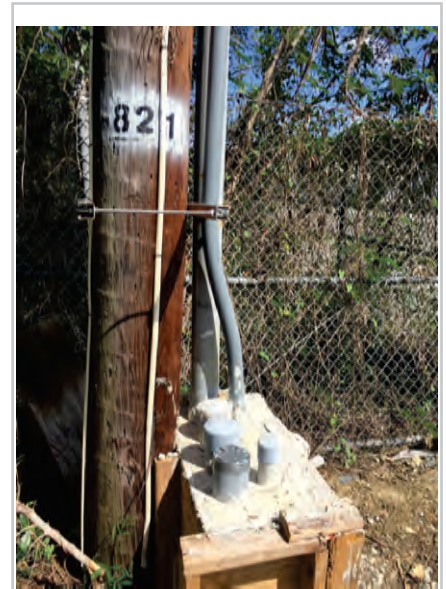
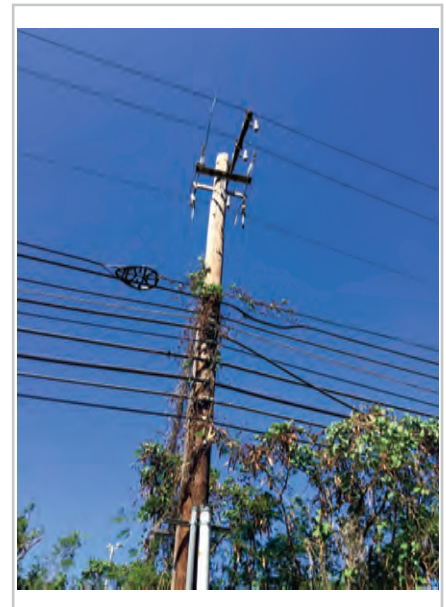
Comments: ^{LIGHTNING ARRESTER ON WOOD CROSS AND FUSED CUT OUT ON} _____
^{STEEL CROSS ARM TO CONNECT POLE 821A}

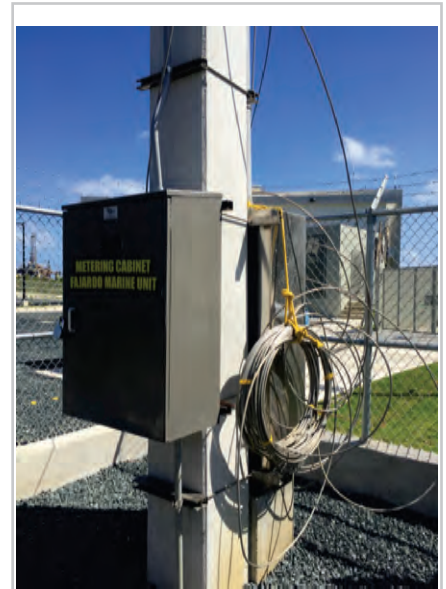
Photo 1: Pole Identification

Comments: FUSED CUT OUT, METERING EQUIPMENT AND LIGHTNING ARRESTER
FOR SUBSTATION INSTALLED ON STEEL CROSS ARMS, PRIVATE POLE

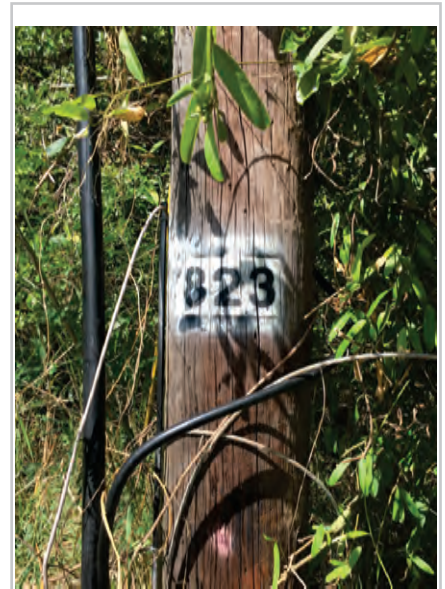
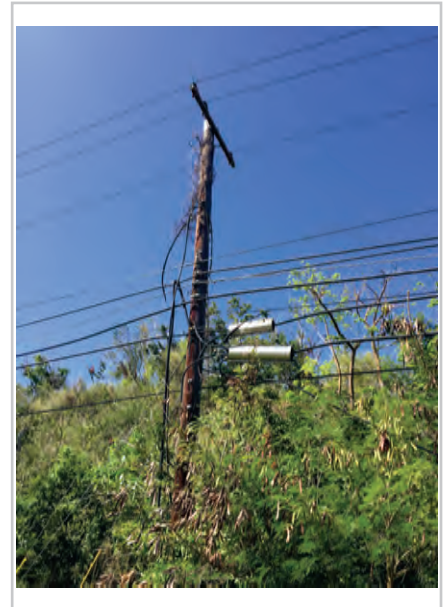
Condition: ^{GOOD}_____

Comments: ^{FUSED CUT OUT AND LIGHTNING ARRESTERS ON WOOD CROSS ARMS}_____

FOR CAPACITOR BANK
