POLES CONDITION ASSESSMENT REPORT

PROJECT: HURRICANE MARIA DAMAGES REPAIRS
TO ROOSEVELT ROADS ELECTRICAL
SYSTEM (19-1741)

LOCATION: Roosevelt Roads,
Ceiba, PR

DATE: May 17, 2018

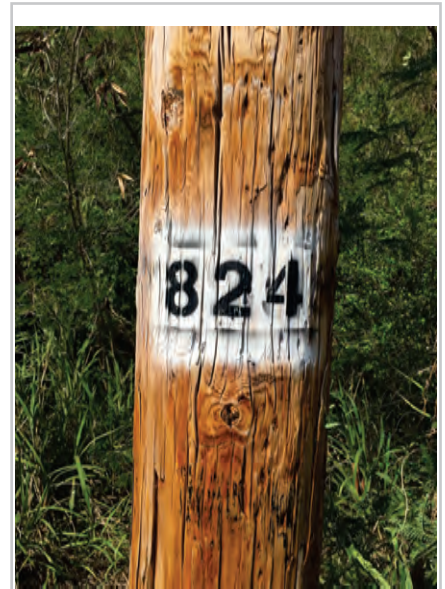
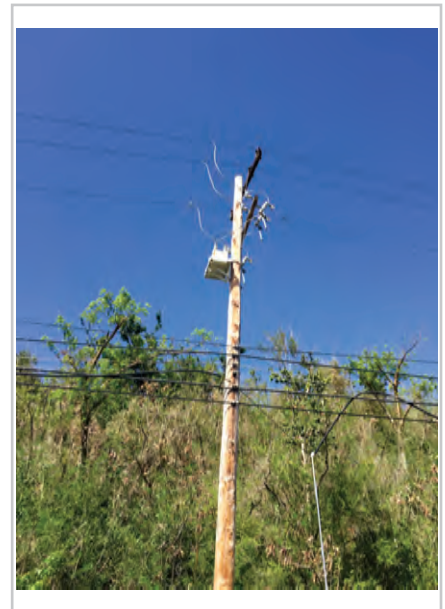
Condition: ^{GOOD} _____

Luminaire: ^{1, OUT OF SERVICE} _____

Comments: ^{TWO SIDES POLES FOR MAIN POLE SUPPORT} _____
N/A

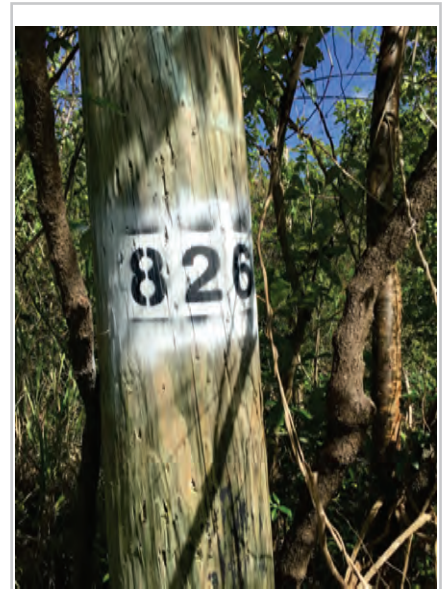
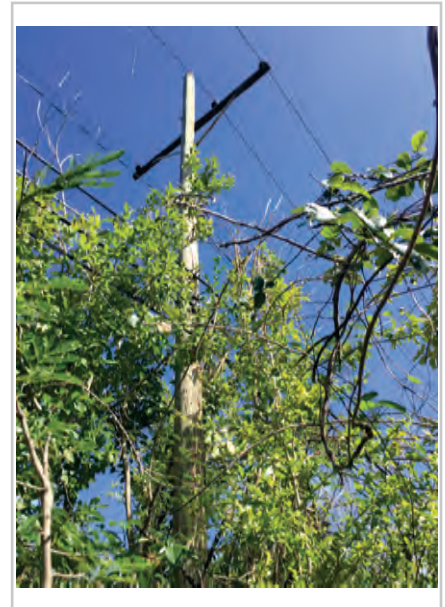
Condition: ^{GOOD} _____

Comments: ^{ALL CONDUCTORS AND CROSS ARM ON GROUND} _____

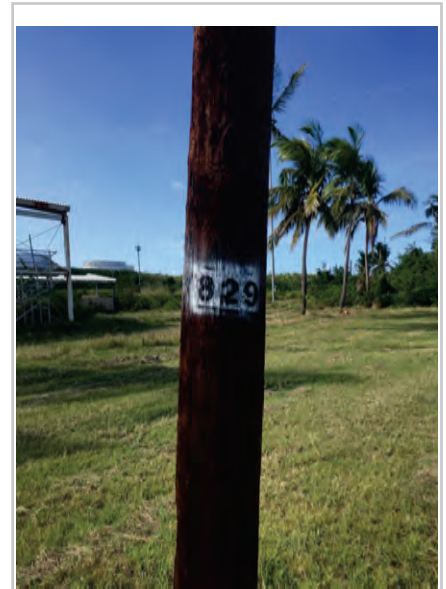
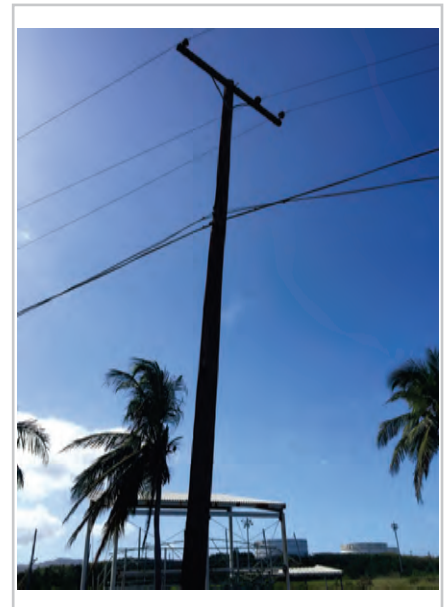
Condition: ^{INCLINED} _____

Comments: ^{FUSED CUT OUT AND LIGHTNING ARRESTERS INSTALLED ON WOOD} _____
^{CROSS ARMS FOR PRIMARY RISER, AT ONE SIDE PRIMARY LINES ON GROUND}

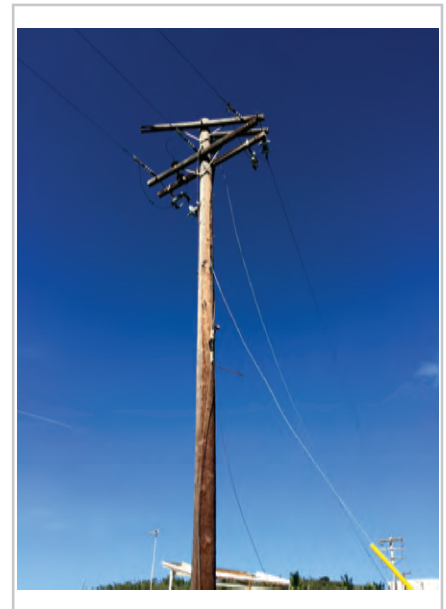
Comments: FUSED CUT OUT INSTALLED ON WOOD CROSS ARM FOR PRIMARY
LINE, AT ONE SIDE PRIMARY LINES ON GROUND, CROSS ARMS DAMAGED

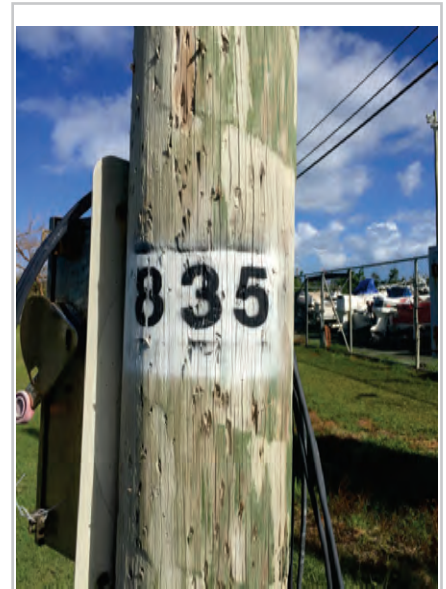
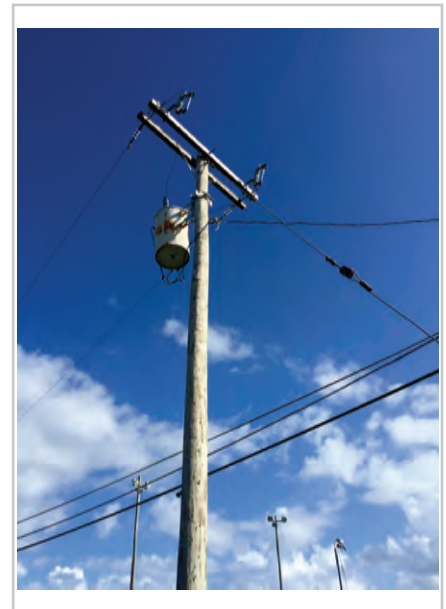
Comments: FUSED CUT OUT INSTALLED ON WOOD CROSS ARM FOR POLE

MOUNTED TRANSFORMER, SECONDARY SAFETY SWITCH IS DISCONNECTED

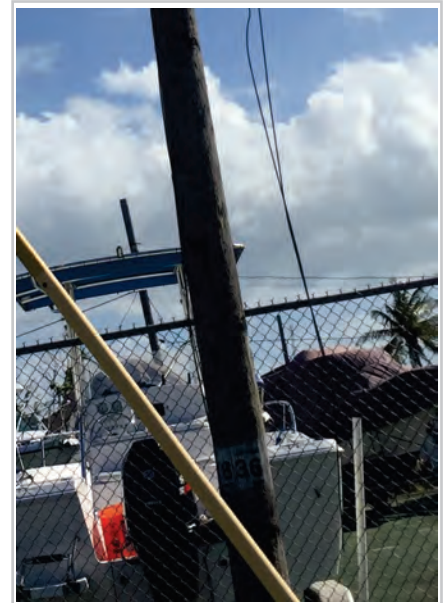
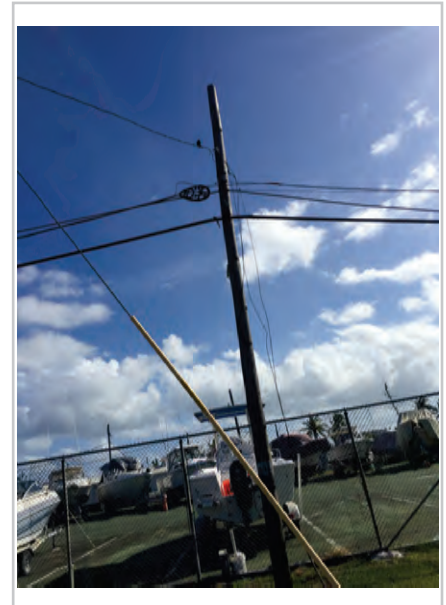
Comments: ^{SECONDARY CONDUCTORS AT ONE SIDE ARE ON GROUND} _____
N/A

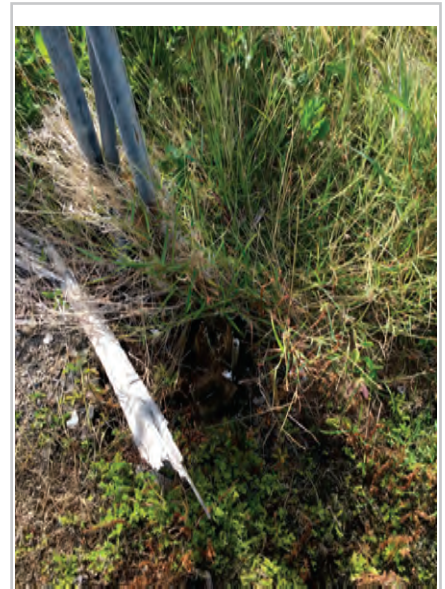
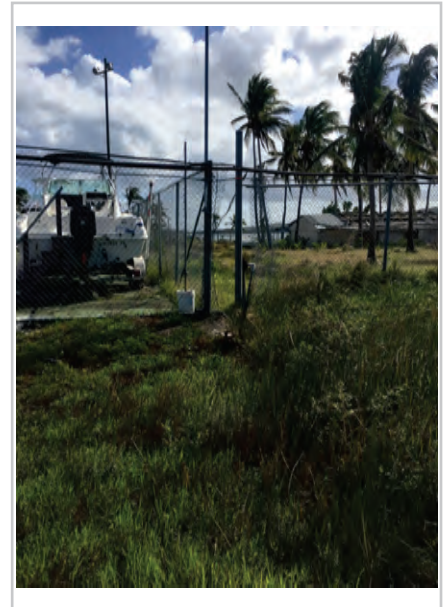
Condition: BROKEN, POLE NOT EXIST

Comments: POLE NOT EXIST, HEIGHT DETERMINED SIMILAR TO THE SIDE POLES,

ALL CONDUCTORS ON GROUND

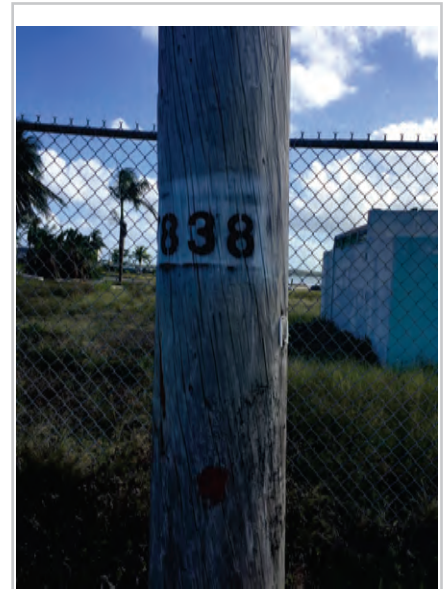
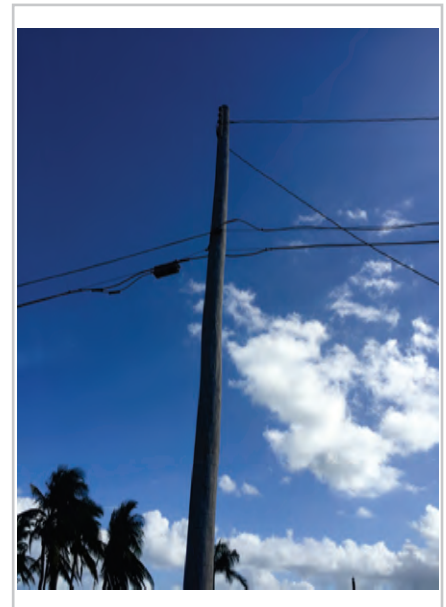
Comments: ^{ONE SIDE OF SECONDARY CONDUCTORS ON GROUND} _____

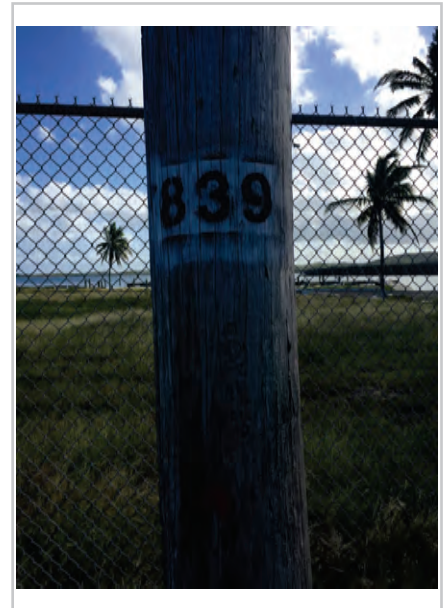
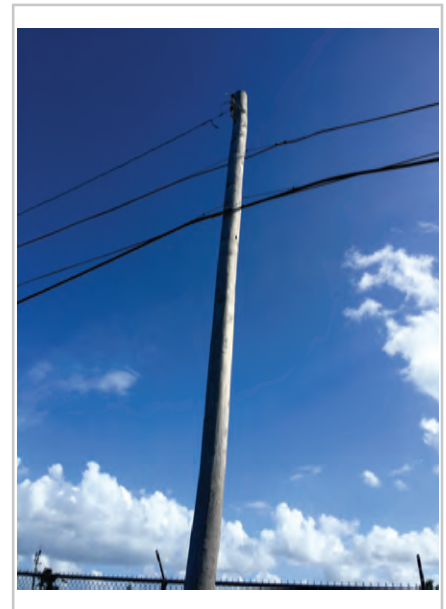
Comments: ONE SIDE OF SECONDARY CONDUCTORS ON GROUND

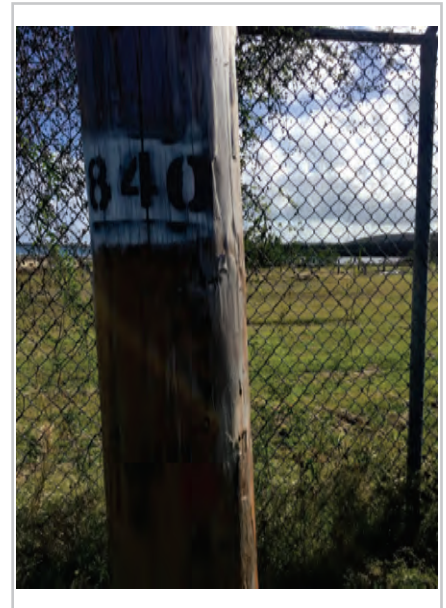
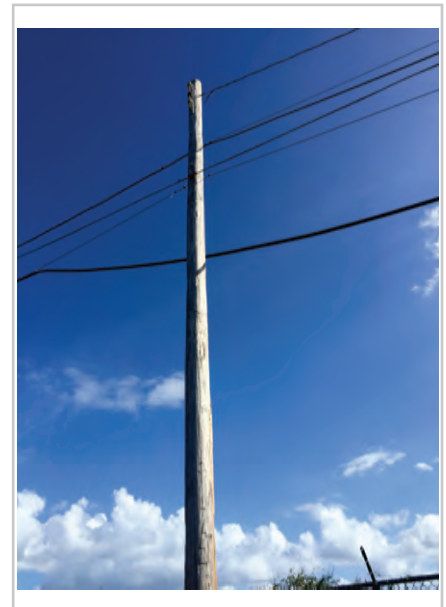
Comments: ^{ONE SIDE OF SECONDARY CONDUCTORS ON GROUND} _____
N/A

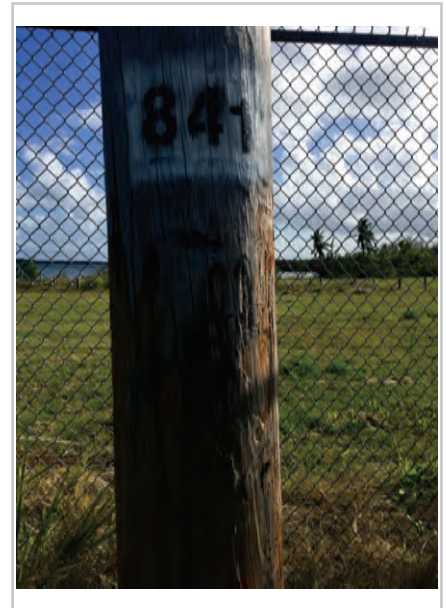
Comments: ONE SIDE OF SECONDARY CONDUCTORS ON GROUND
N/A

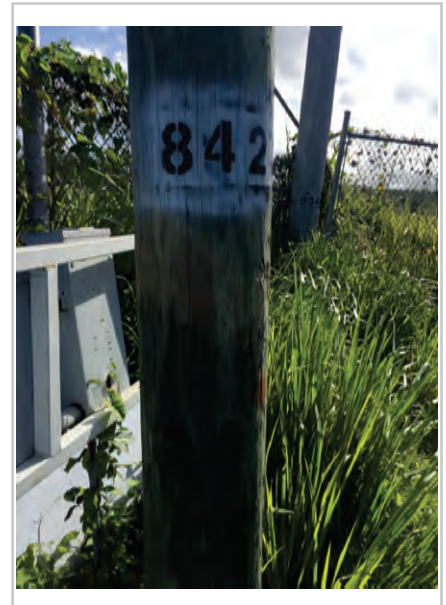
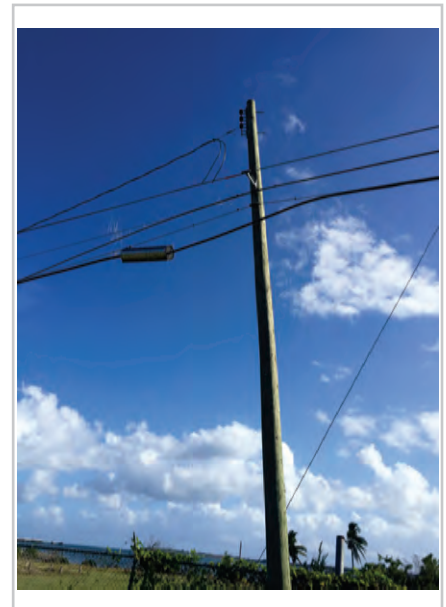
Comments: ^{ONE SIDE OF SECONDARY CONDUCTORS ON GROUND} _____
N/A

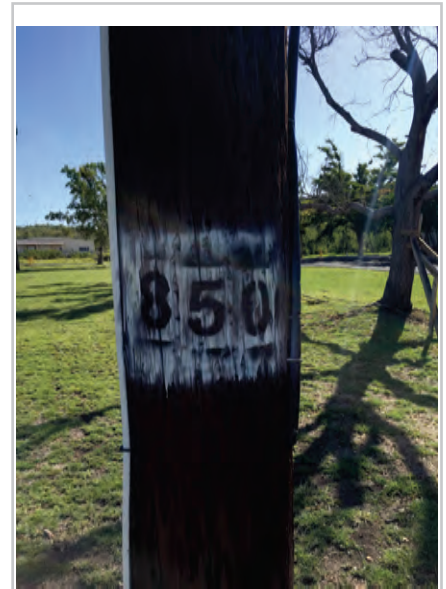
Condition: BROKEN

Comments: CROSS CONNECTION WITH DOUBLE ANCHORED CONDUCTORS

ALL CONDUCTORS AT GROUND

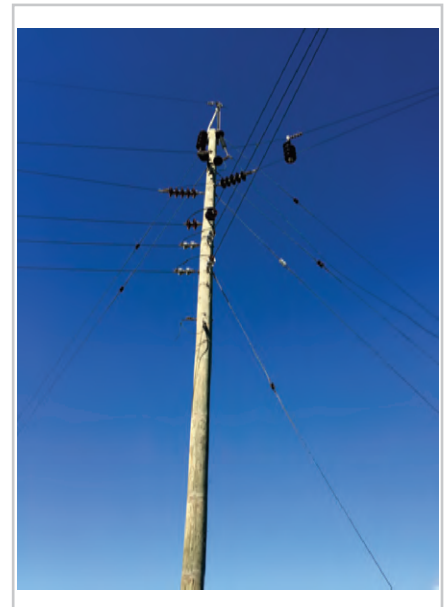
Photo 2: Pole Constr. Standards

Comments: ^{38 KV INSULATOR DAMAGED, SOME CONDUCTORS FALLEN} _____

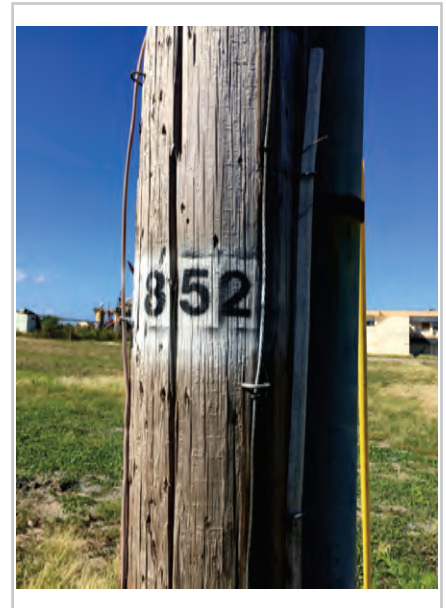
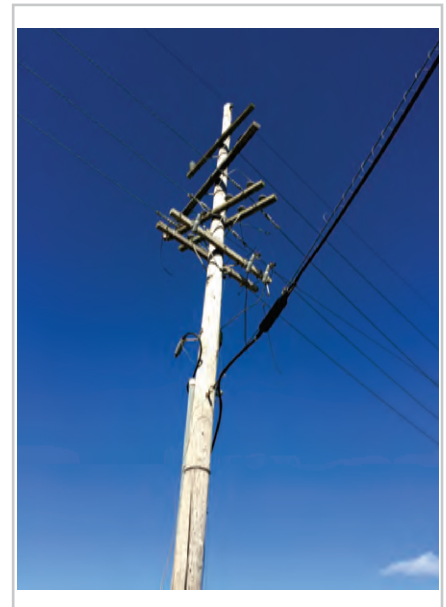
Comments: FUSED CUT OUT AND LIGHTING ARRESTER INSTALLED ON WOOD

CROSS ARMS FOR PRIMARY RISER

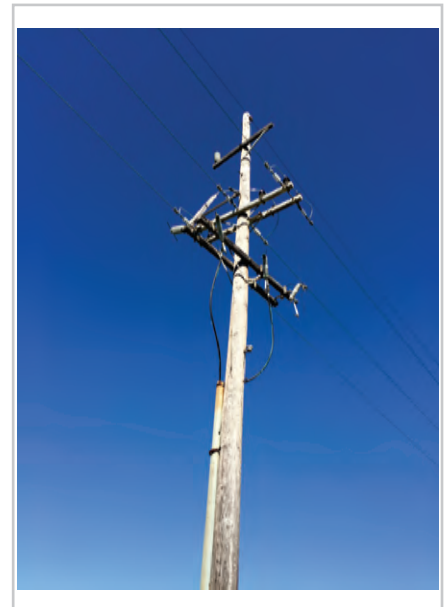
Photo 2: Pole Constr. Standards

CROSS ARMS FOR PRIMARY RISER, 38 KV CROSS AMRS DAMAGED

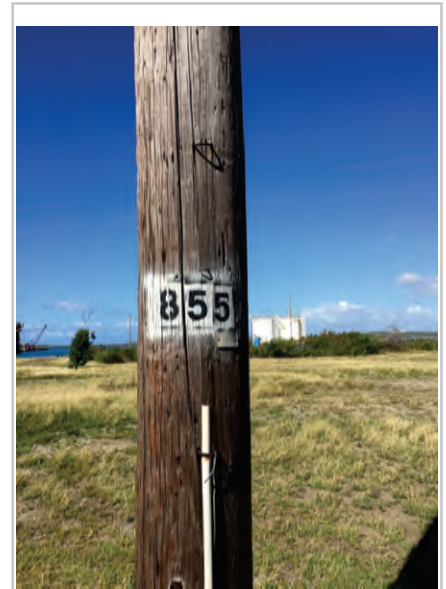
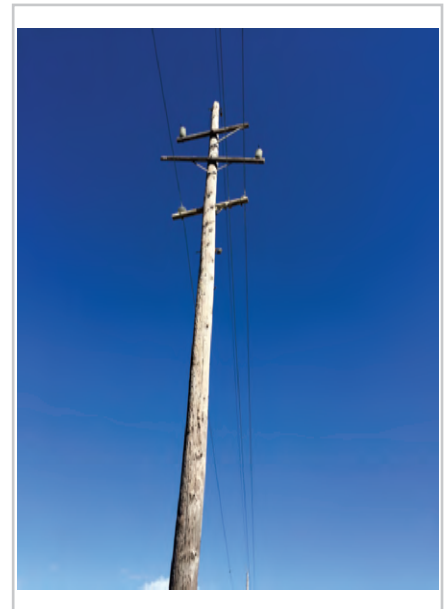
Comments: ^{CROSS ARMS MIS ALIGNED} _____

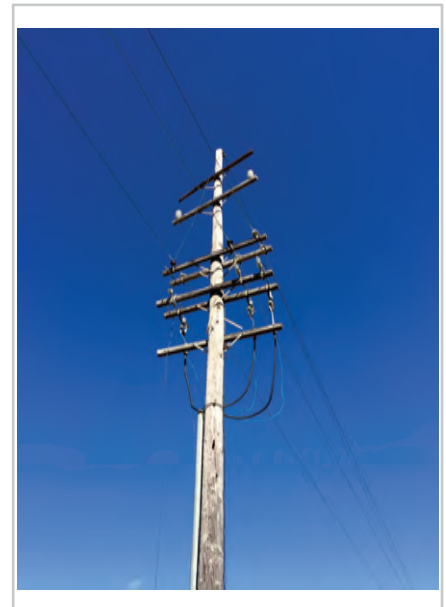
Photo 2: Pole Constr. Standards

CROSS ARMS FOR PRIMARY RISER, CROSS AMRS AND CONDUCTORS DAMAGED

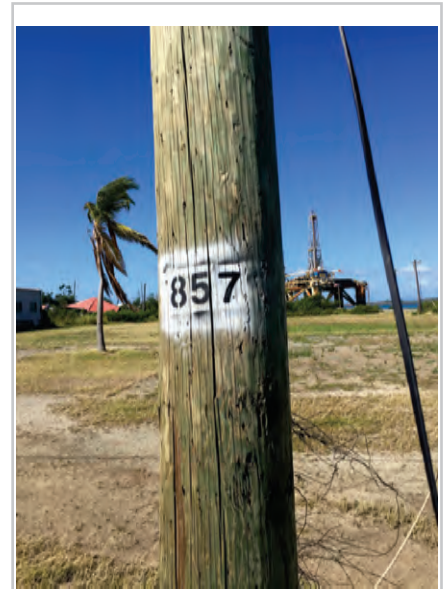
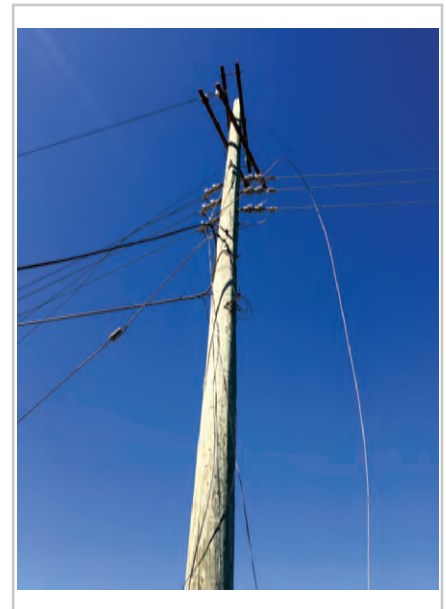
Condition: INCLINED

Comments: 38 KV CONDUCTORS ON GROUND

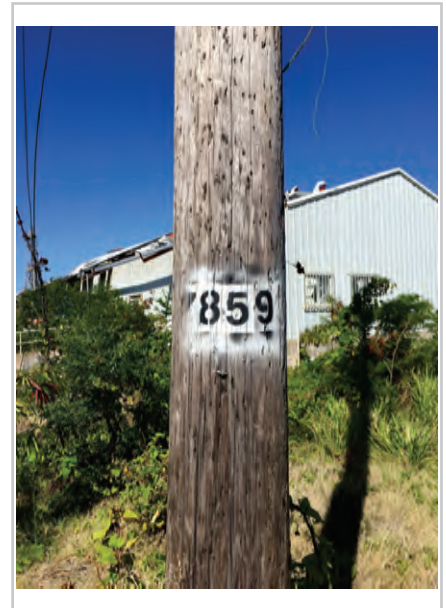
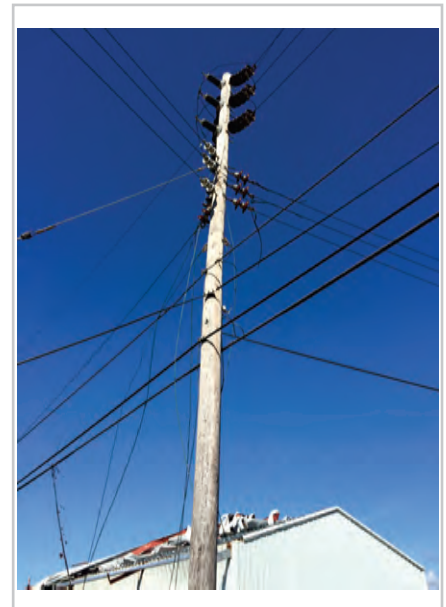
Comments: 13.2 KV TRIPLE ANCHORED CONNECTION, SOME CONDUCTORS

FALLEN

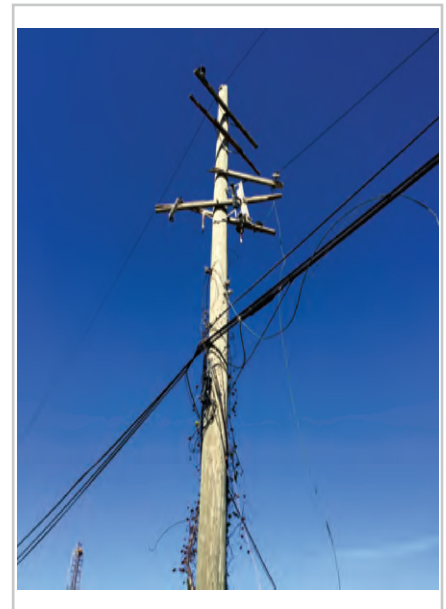
Photo 2: Pole Constr. Standards

CROSS ARMS, CONDUCTORS FALLEN AND WOOD CROSS ARMS DAMAGED

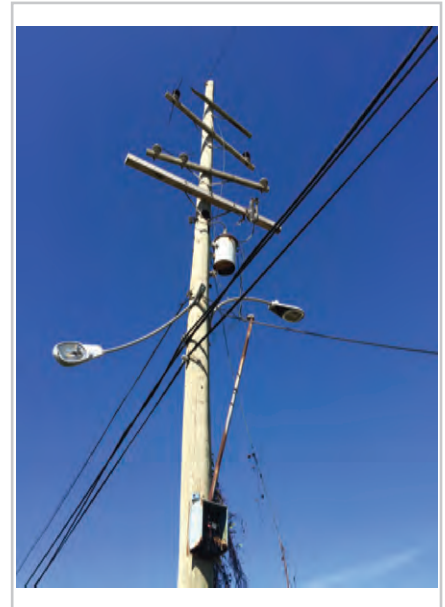
Photo 2: Pole Constr. Standards

Condition: BROKEN

TRANSFORMER, POLE BURNED AT CROSS ARMS HEIGHT, CONDUCTORS FALLEN

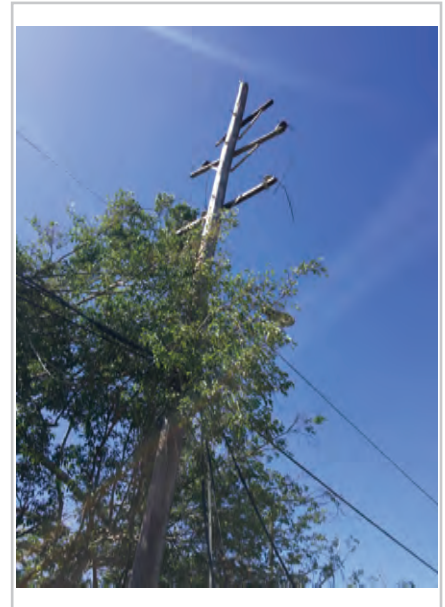
Photo 2: Pole Constr. Standards

Condition: BROKEN

Comments: DAMAGED AND MIS ALIGNED WOOD CROSS ARM AND CONDUCTORS

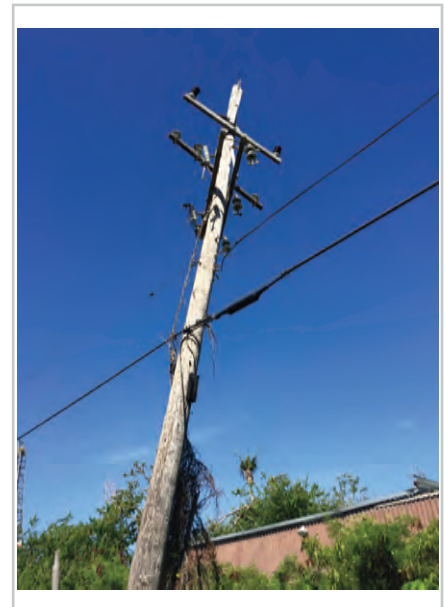
Photo 2: Pole Constr. Standards

Condition: INCLINED

Comments: DAMAGED AND MIS ALIGNED WOOD CROSS ARM AND CONDUCTORS

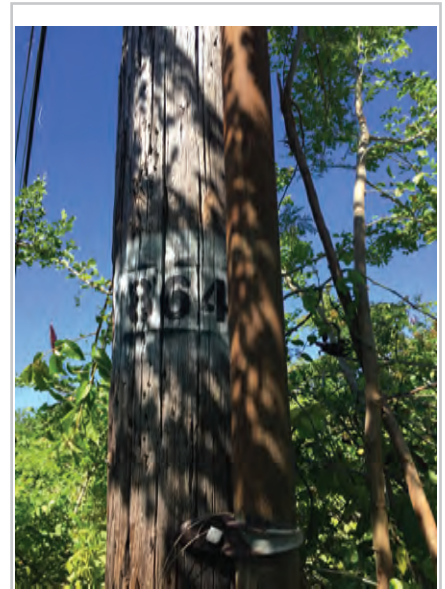
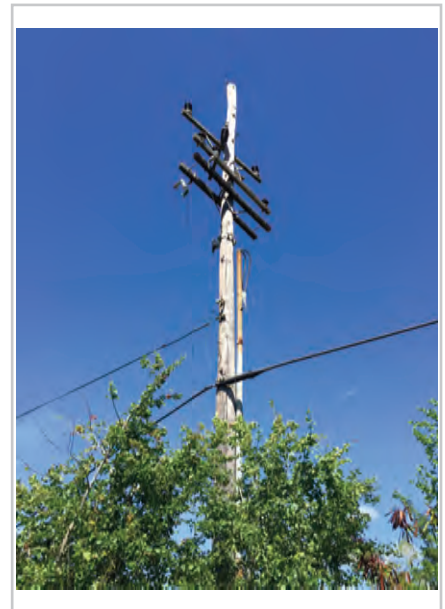
Comments: OUT OF SERVICE FUSED CUT OUT AND LIGHTING ARRESTER

INSTALLED ON WOOD CROSS ARMS FOR PRIMARY RISER

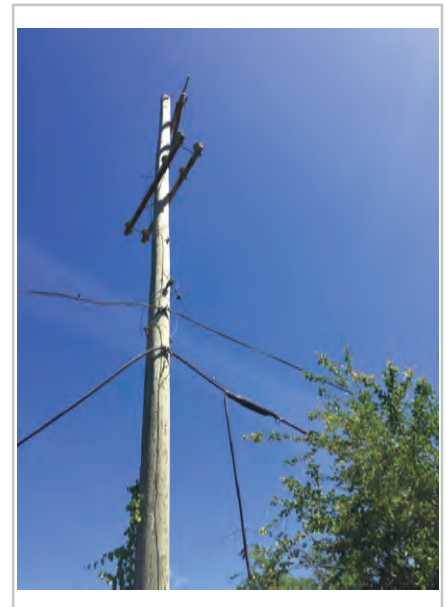
Photo 2: Pole Constr. Standards

Comments: ^{DAMAGED AND MIS ALIGNED CROSS ARMS, ALL CONDUCTORS} _____

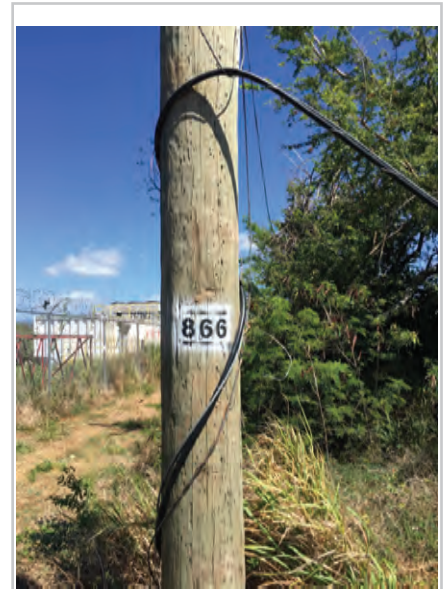
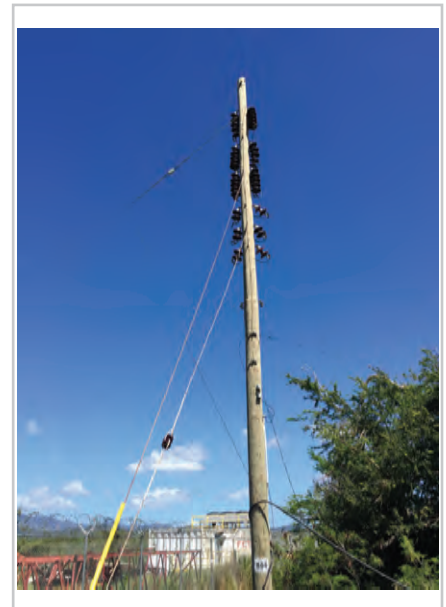
Comments: ALL CONDUCTORS FALLEN OR REMOVED

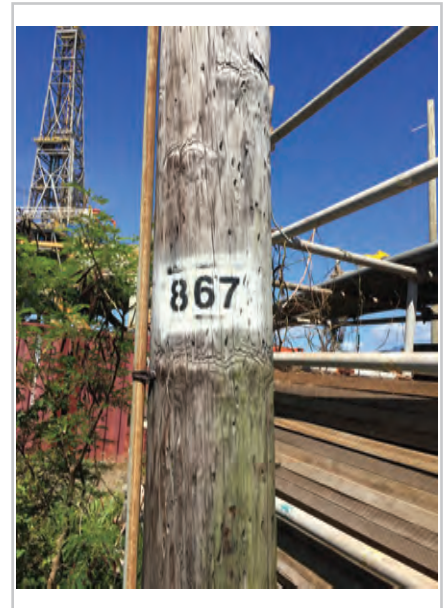
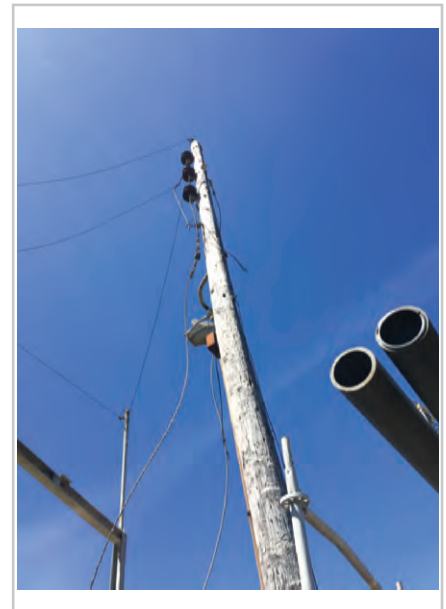
Comments: ALL CONDUCTORS FALLEN OR REMOVED

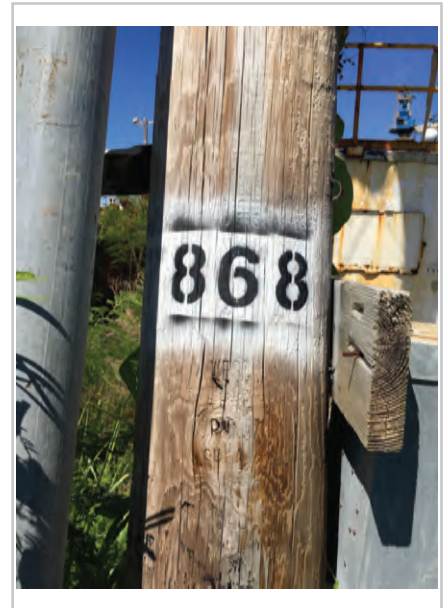
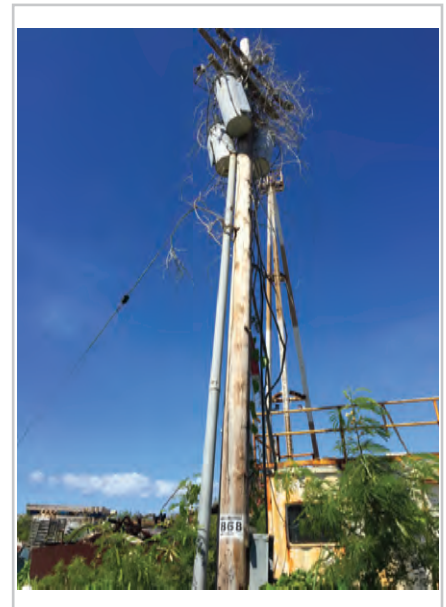
Condition: VERY INCLINED

Comments: ALL CONDUCTORS FALLEN OR REMOVED, ALL SUBSTATION
COMPONENTS ARE OUT OF SERVICE

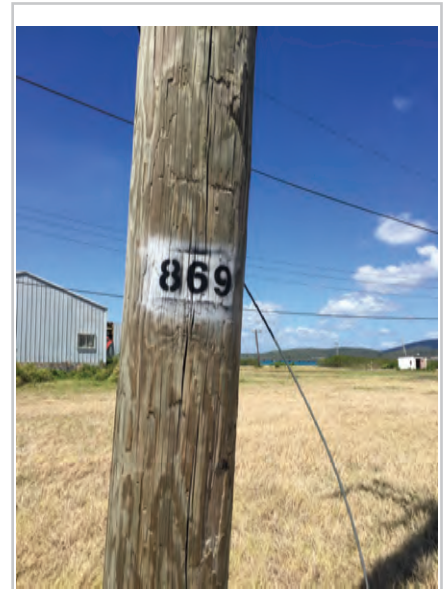
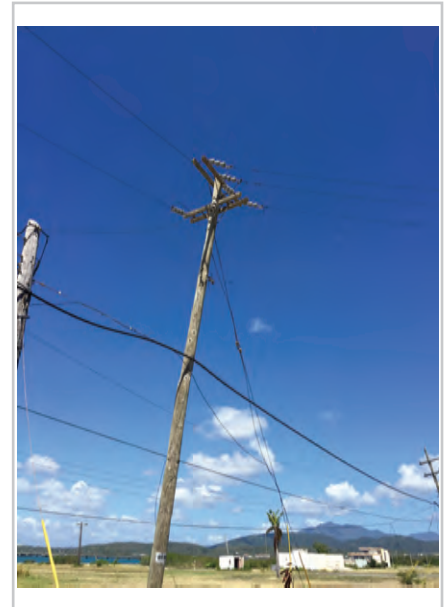
Comments: ONE PHASE CONDUCTOR FALLEN

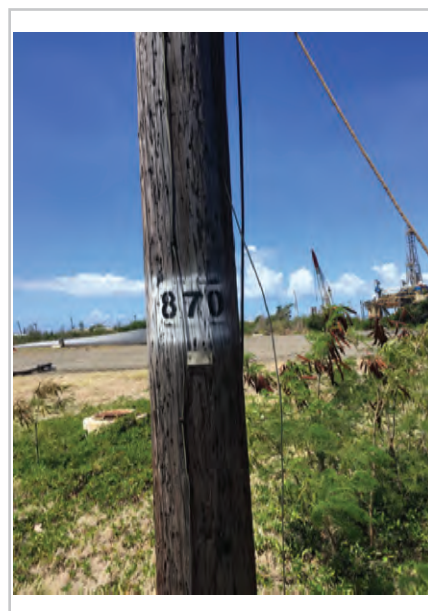
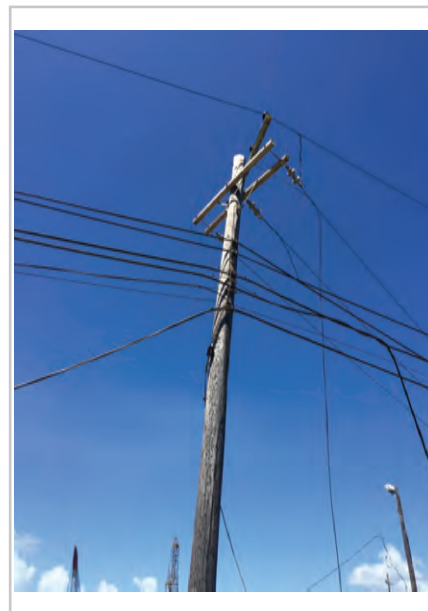
Comments: ^{SOME CONDUCTORS FALLEN OR REMOVED, TWO PRIMARY LINES} _____
^{ON THIS POLE} _____

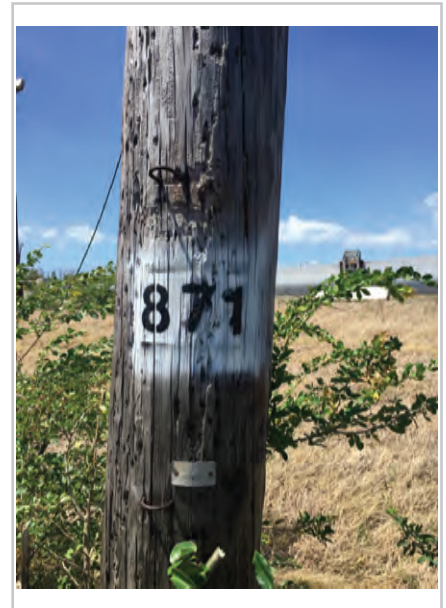
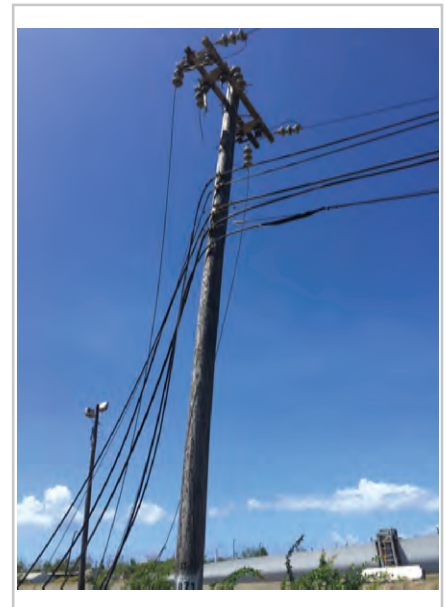
Comments: POLE MOUNTED IN LINE LOAD BREAK, ALMOST ALL CONDUCTORS

FALLEN OR REMOVED

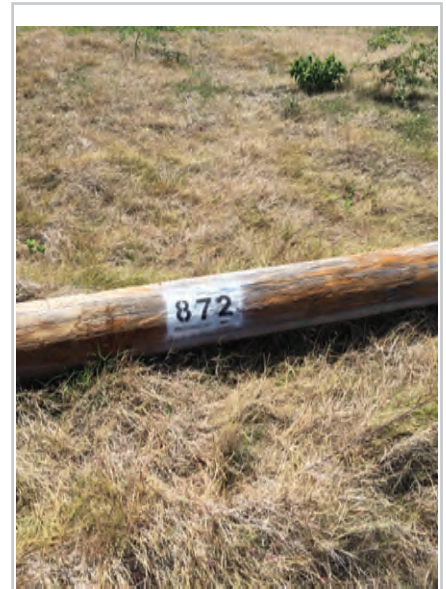
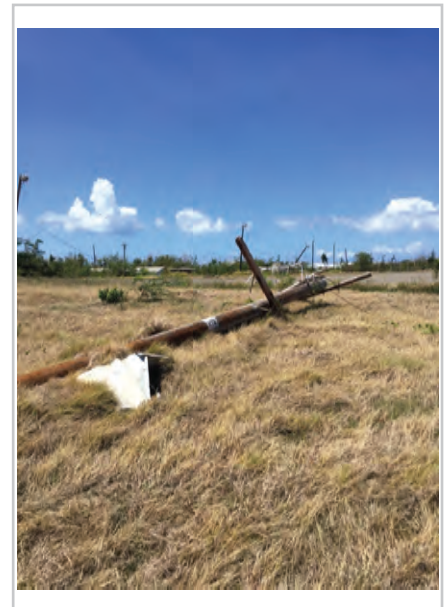
Condition: BROKEN

Comments: POLE AND ALL LINES ON GROUND

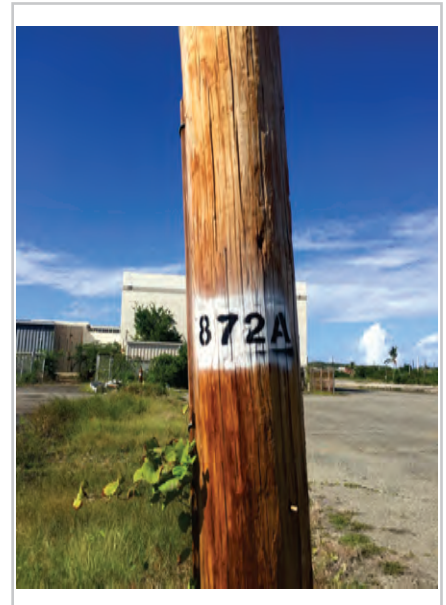
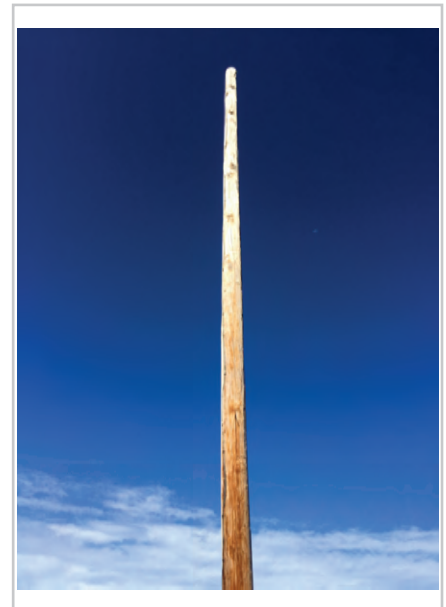
Condition: INCLINED

NOT ANCHORED, WITH WOOD CROSS ARMS, STANDARD BROKEN ON GROUND

Comments: ALL CONDUCTORS AND CONSTRUCTION STANDARDS ON GROUND OR

REMOVED

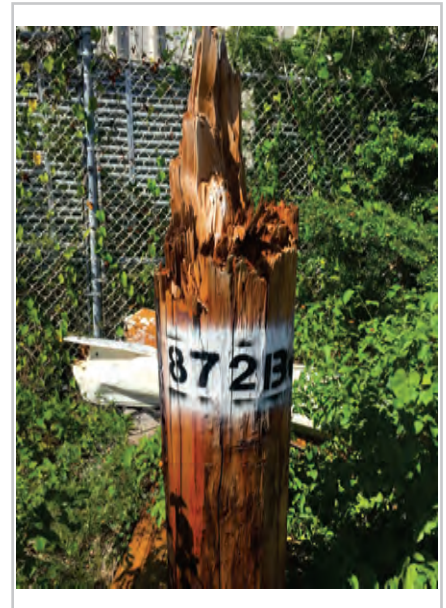
Photo 1: Pole Identification

Condition: BROKEN

Comments: POLE, ALL CONDUCTORS AND RISER CONSTRUCTION STANDARDS
WITH WOOD CROSS ARMS ON GROUND OR REMOVED

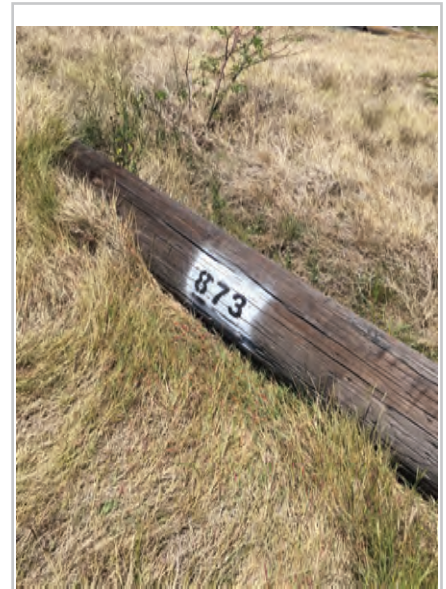
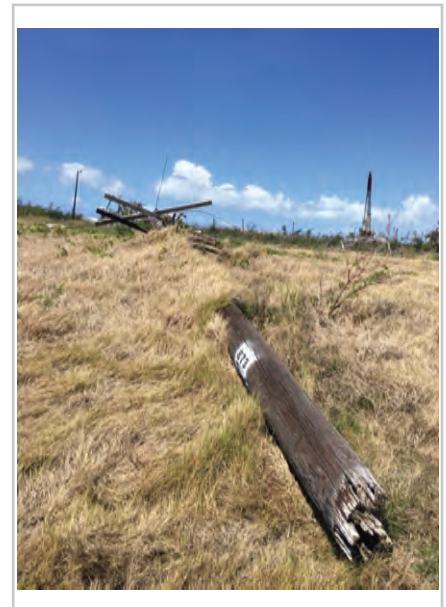
Condition: BROKEN

Comments: POLE AND ALL LINES ON GROUND
N/A

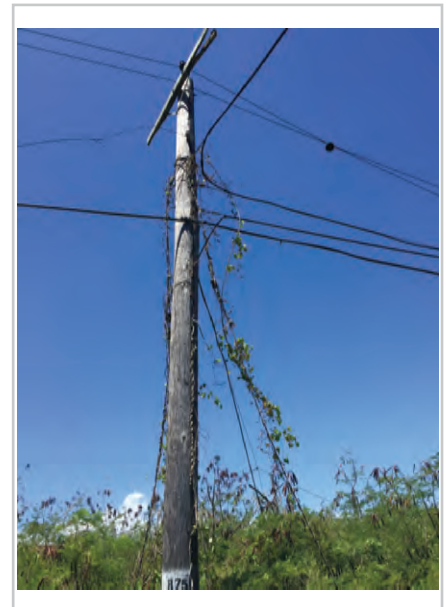
Photo 2: Pole Constr. Standards

Comments: CROSS ARMS BROKEN, ALMOST ALL CONDUCTORS ON GROUND
N/A

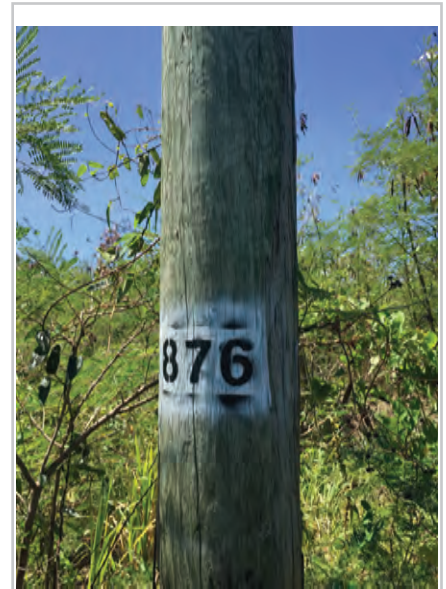
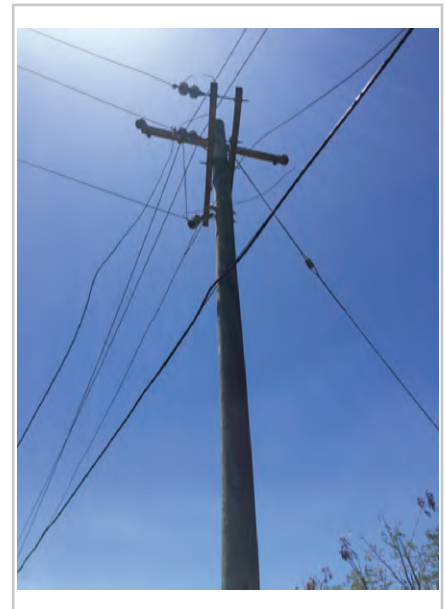
Comments: NOT ANCHORED CONDUCTORS ARE OUT OF POSITION AND AT ONE

SIDE SOME ARE FALLEN

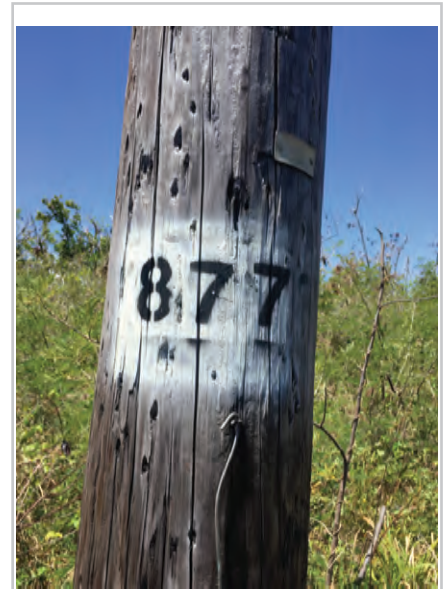
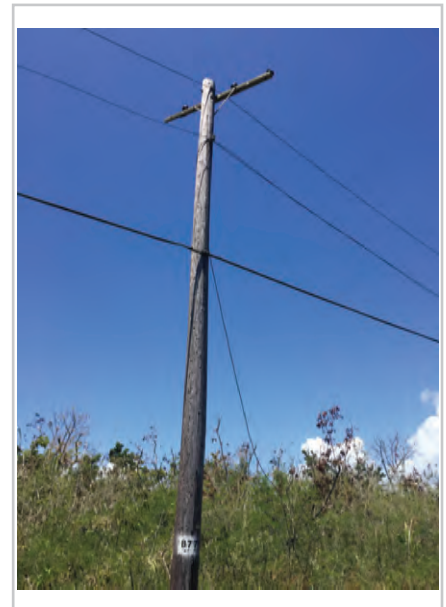
Comments: CONDUCTORS OUT OF POSITION OR FALLEN

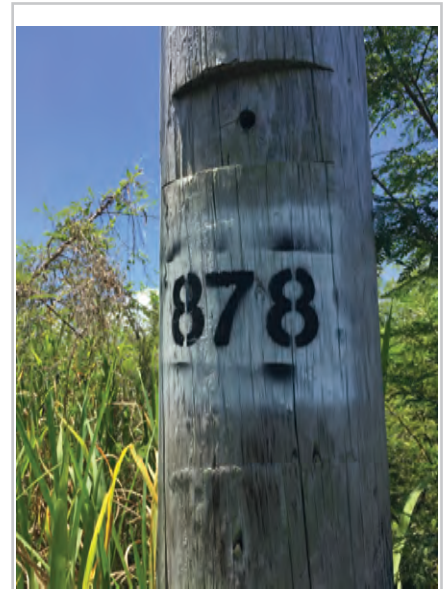
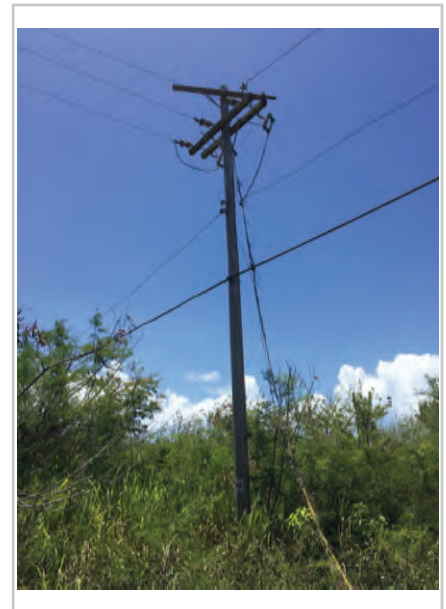
Comments: NOT ANCHORED CONDUCTORS ARE FALLEN, FUSED CUT OUTS ARE
INSTALLED ON WOOD CROSS ARMS FOR PRIMARY TAP

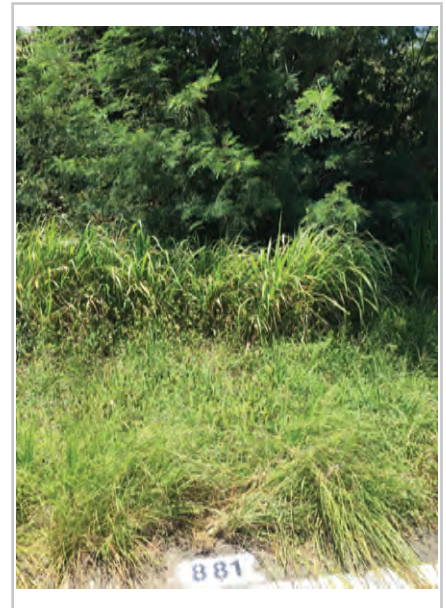
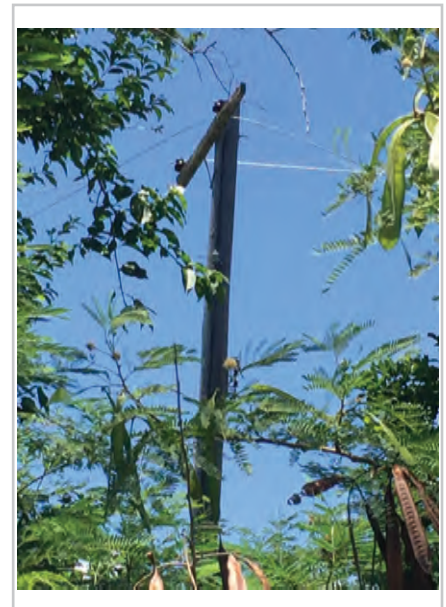
Comments: CONDUCTORS ARE OUT OF POSITION OR FALLEN, INDICATED
COORDINATES ARE OF ROAD IN THE FRONT OF POLE DUE TO LIMITED ACCESS

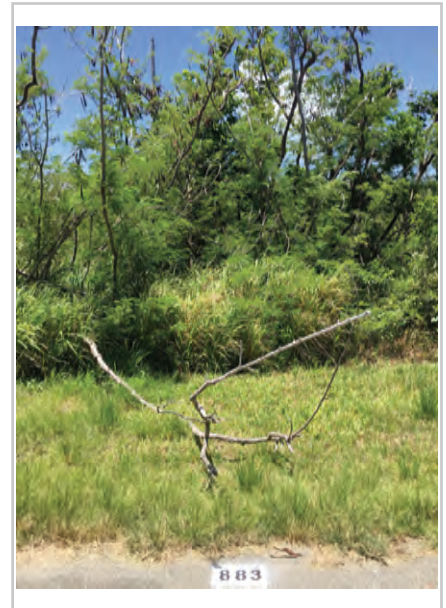
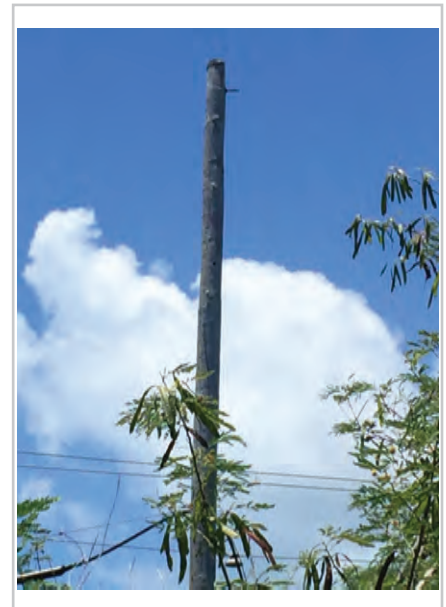
Comments: ALL CROSS ARMS AND CONDUCTORS ARE ON GROUND, INDICATED

COORDINATES ARE OF ROAD IN THE FRONT OF POLE DUE TO LIMITED ACCESS

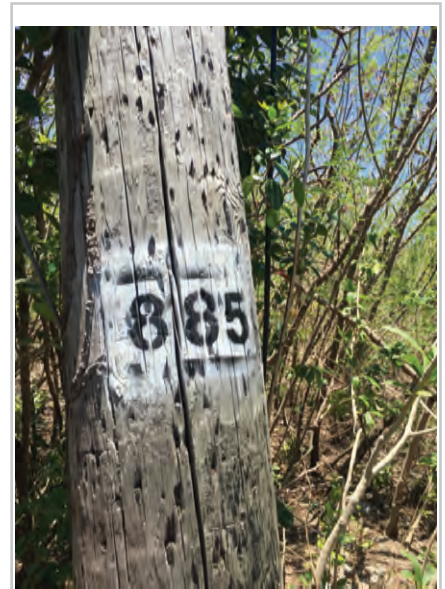
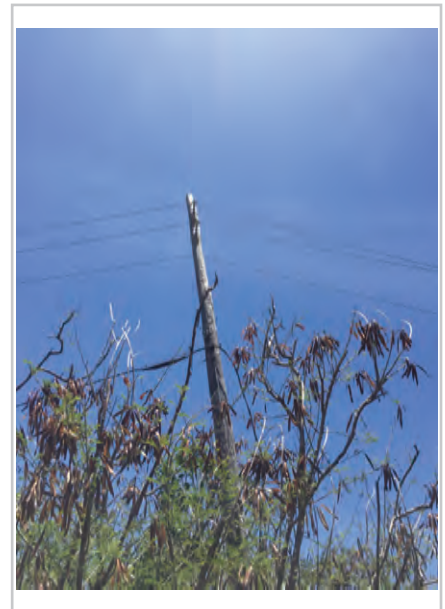
Condition: INCLINED

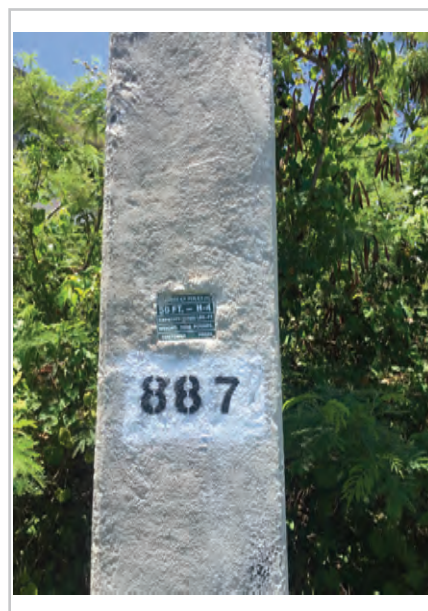
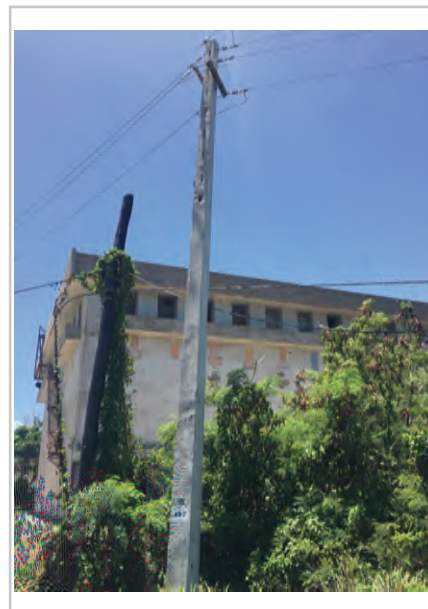
Condition: INCLINED

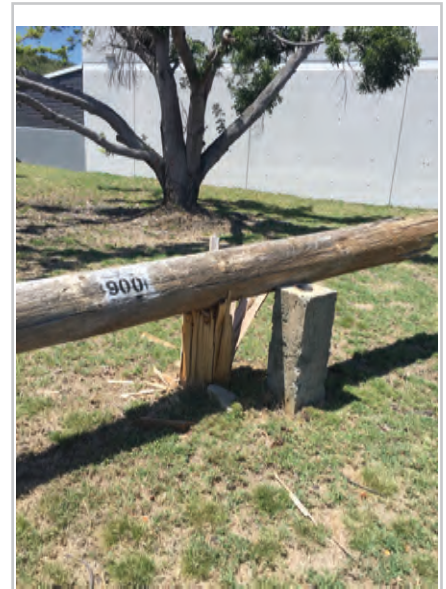
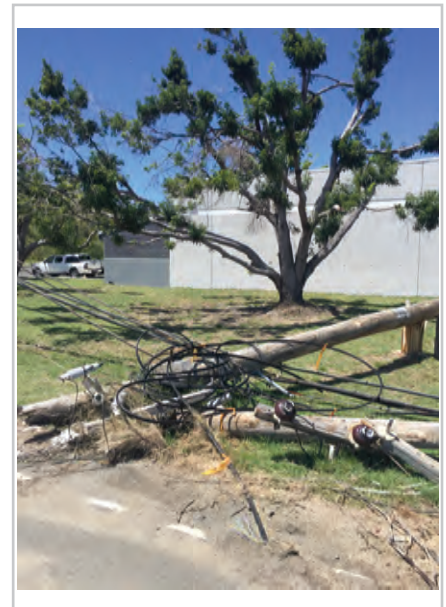
Condition: BROKEN

Comments: FUSED CUT OUT AND LIGHTNING ARRESTER FOR OUT OF SERVICE
RISER INSTALLED ON WOOD CROSS ARM, POLE AND ALL COMPONENTS AT GROUND

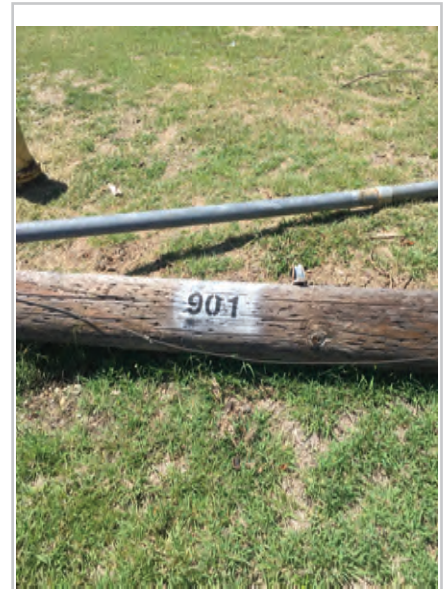
Photo 1: Pole Identification

Condition: BROKEN

Comments: FUSED CUT OUT AND LIGHTNING ARRESTER FOR PRIMARY RISER
INSTALLED ON WOOD CROSS ARM, POLE AND ALL COMPONENTS AT GROUND

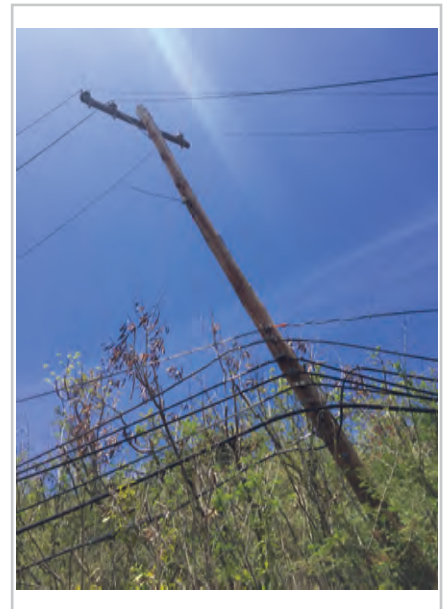
Photo 2: Pole Constr. Standards

Condition: BROKEN

Comments: POLE CRACKED AT BASE
N/A

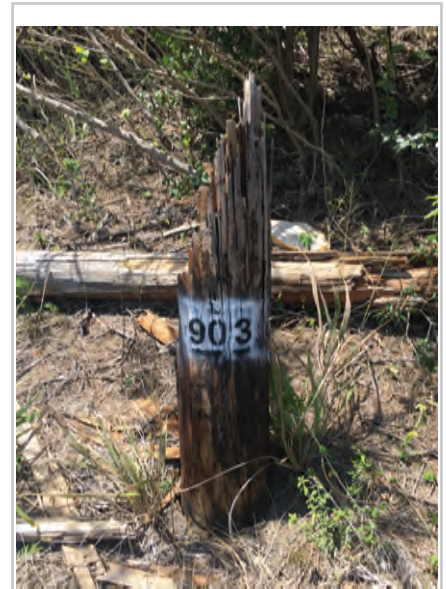
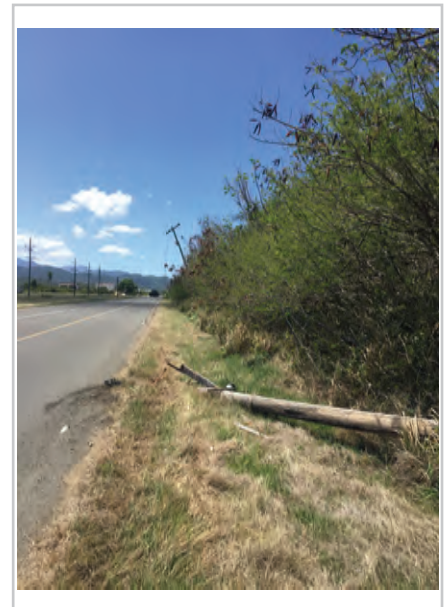
Condition: BROKEN

Comments: POLE, LINES AND ALL COMPONENTS AT GROUND
N/A
