POLES CONDITION ASSESSMENT REPORT

PROJECT: HURRICANE MARIA DAMAGES REPAIRS
TO ROOSEVELT ROADS ELECTRICAL
SYSTEM (19-1741)

LOCATION: Roosevelt Roads,
Ceiba, PR

DATE: May 17, 2018

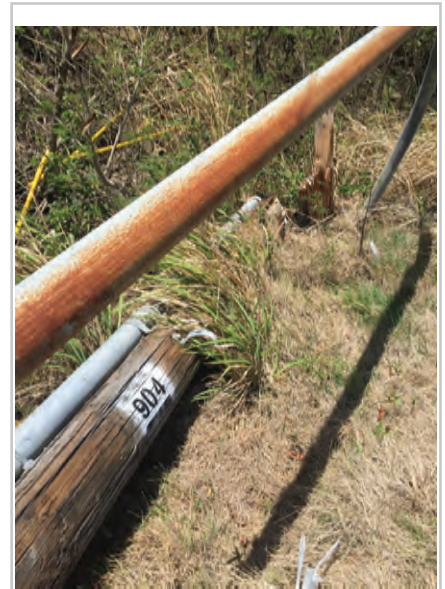
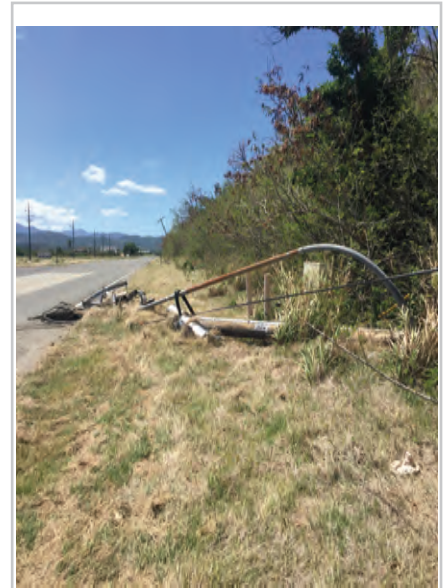
Condition: BROKEN

Comments: FUSED CUT OUT AND LIGHTNING ARRESTER FOR PRIMARY RISER
INSTALLED ON WOOD CROSS ARM, POLE AND ALL COMPONENTS AT GROUND

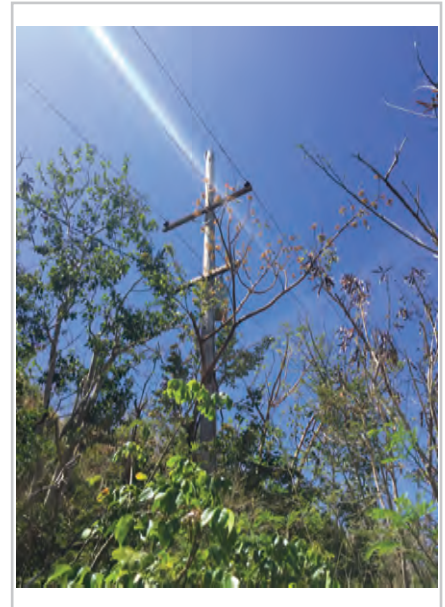
Photo 2: Pole Constr. Standards

Comments: FUSED CUT OUT AND LIGHTNING ARRESTER FOR TRANSFORMER
INSTALLED ON WOOD CROSS ARM, SECONDARY CABLES DAMAGED

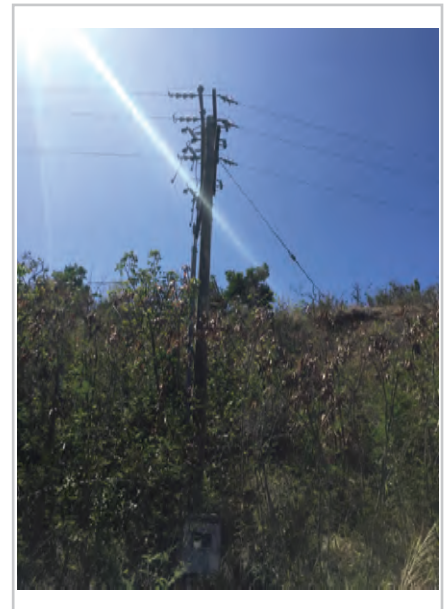
Photo 2: Pole Constr. Standards

INSTALLED ON WOOD CROSS ARM, SECONDARY CABLES DAMAGED

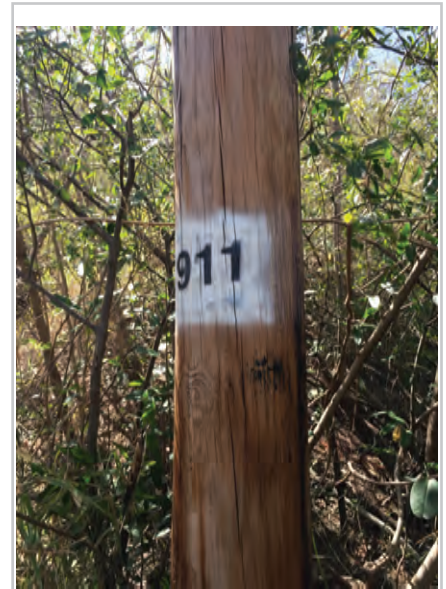
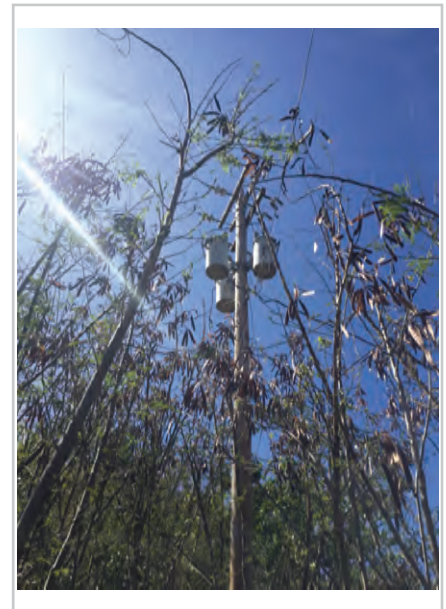
Comments: FUSED CUT OUT AND LIGHTNING ARRESTER FOR SUBSTATION
INSTALLED ON WOOD CROSS ARM

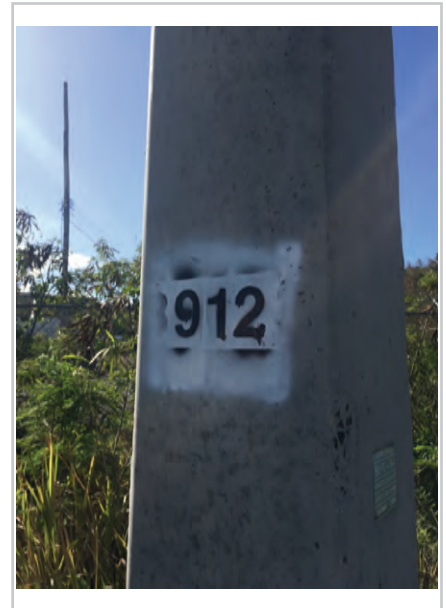
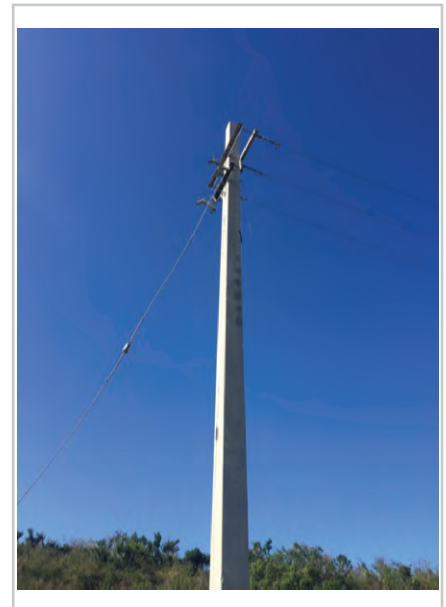
Comments: FUSED CUT OUTS AND LIGHTNING ARRESTERS INSTALLED ON
STEEL CROSS ARM THAT SUPPLY NOTHING

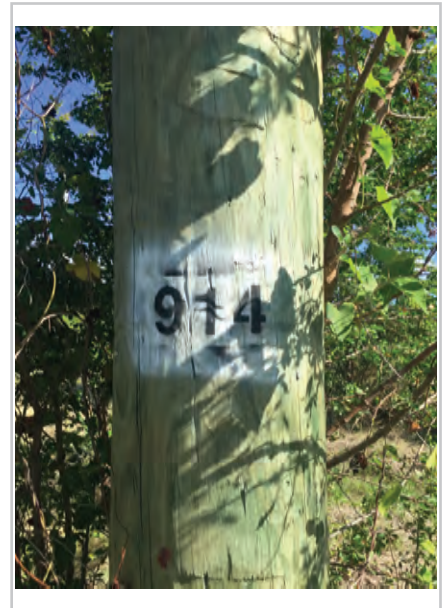
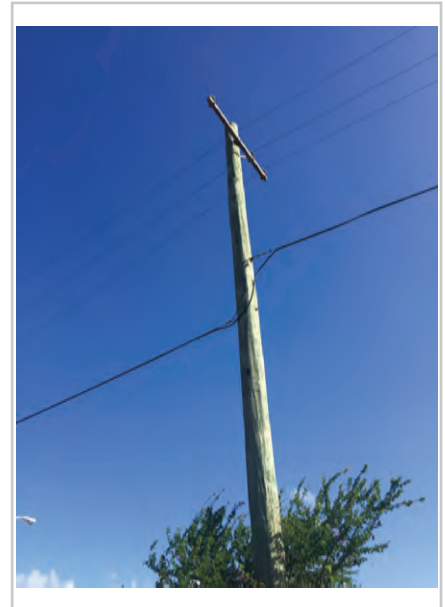
Comments: CONDUCTORS OUT OF POSITION

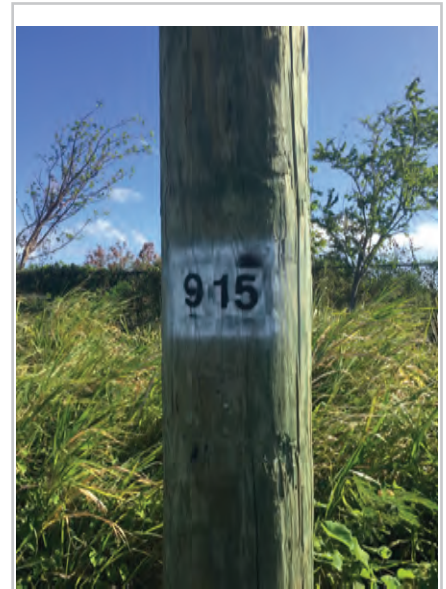
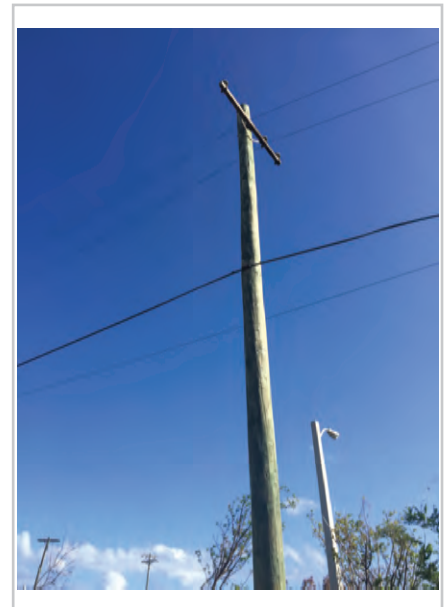
Comments: CONDUCTORS OUT OF POSITION

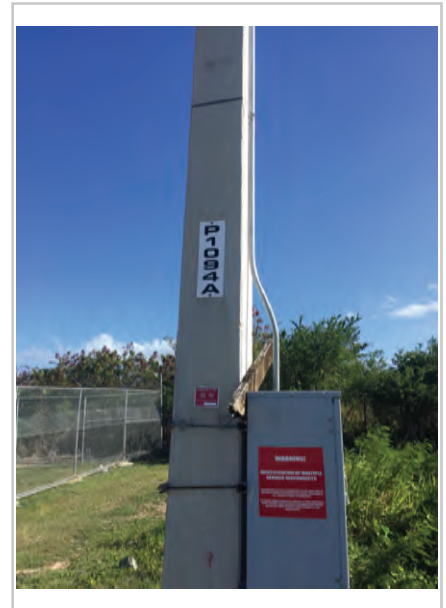
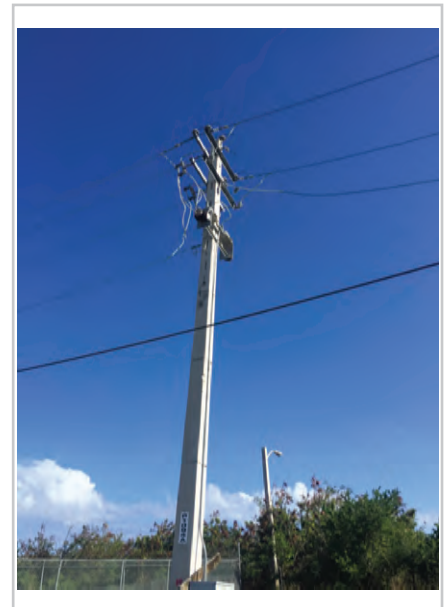
Comments: PRIVATE POLE, FUSED CUT OUTS AND LIGHTNING ARRESTER
INTALLED ON STEEL POLE AND PRIMARY METERING EQUIPMENT

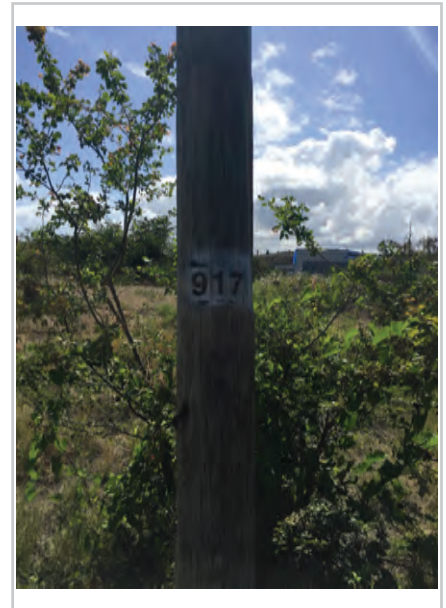
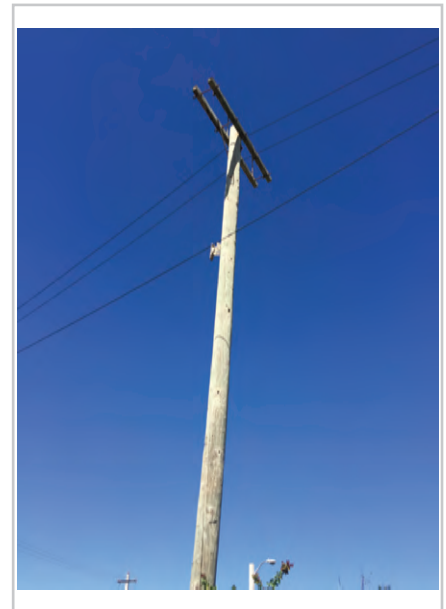
Comments: CONDUCTORS OUT OF POSITION AND FALLEN

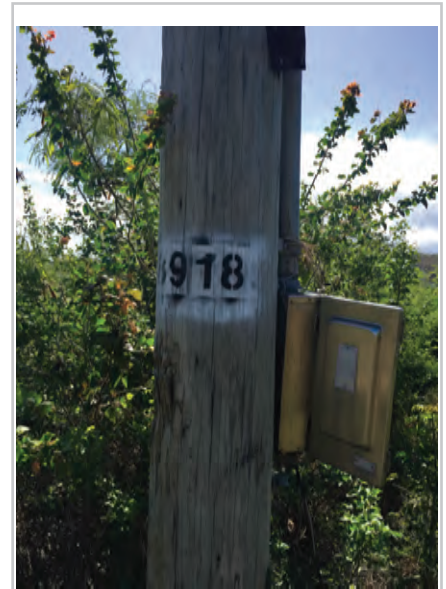
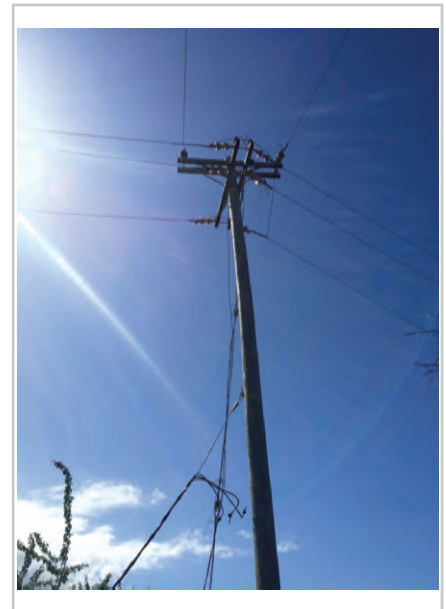
Comments: SECONDARY CONDUCTORS FALLEN
N/A

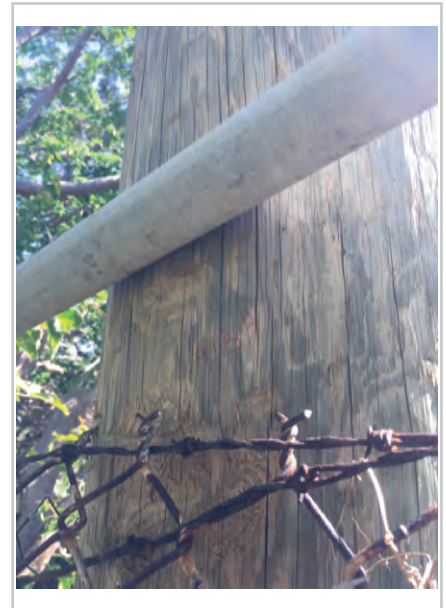
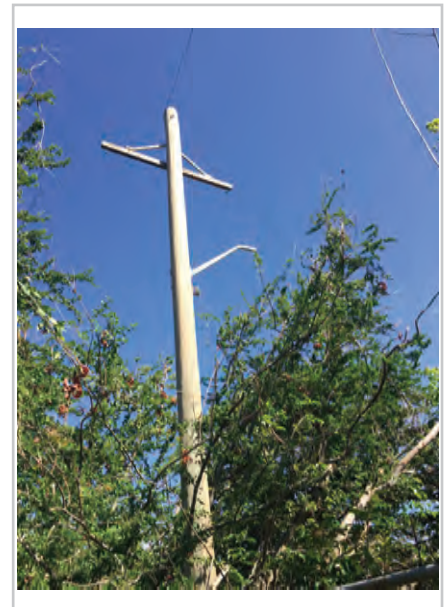
Comments: ALMOST ALL CONDUCTORS FALLEN

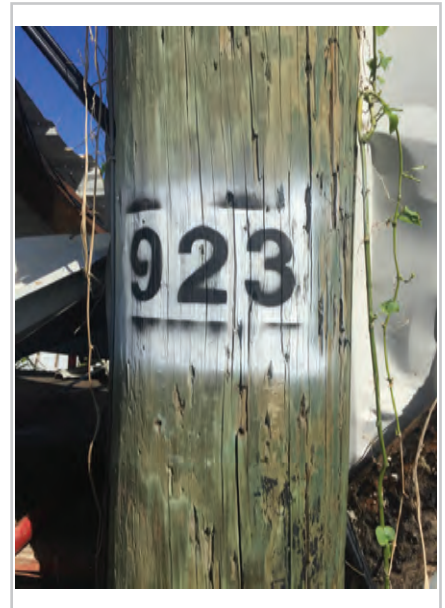
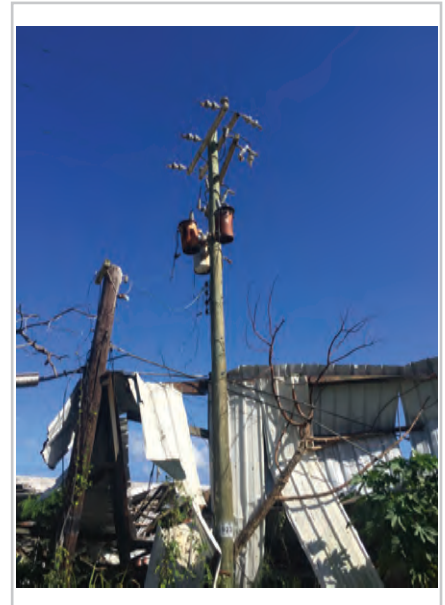
Comments: FUSED CUT OUTS AND LIGHTNING ARRESTER FOR OUT OF SERVICE
SUBSTATION INSTALLED ON WOOD CROSS ARMS, NO SECONDARY CONDUCTORS

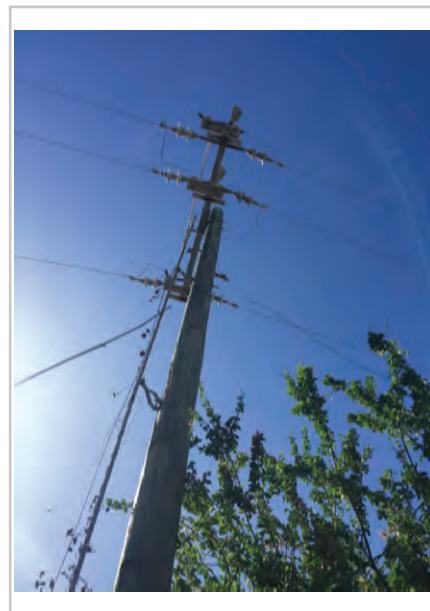
Photo 2: Pole Constr. Standards

Comments: LOOSEN CONDUCTORS, NO LABEL, LIMITED ACCESS
N/A

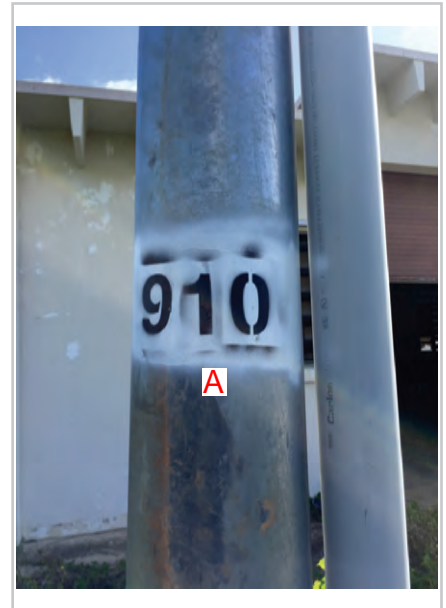
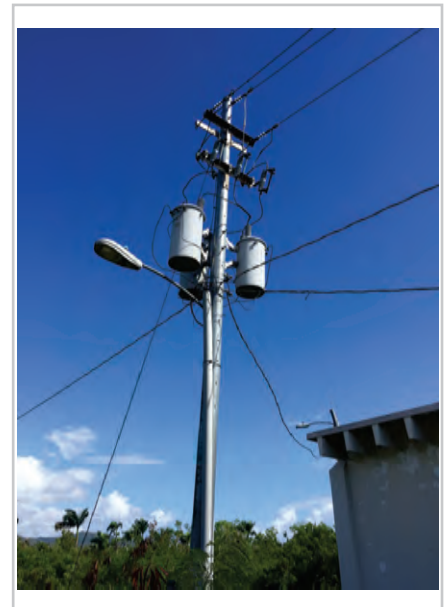
Comments: POLE MOUNTED SUBSTATION, FUSED CUT OUT AND LIGHTNING
ARRESTERS INSTALLED ON STEEL CROSS ARMS

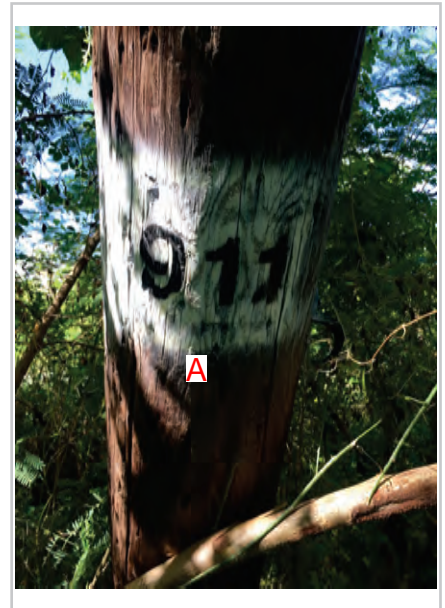
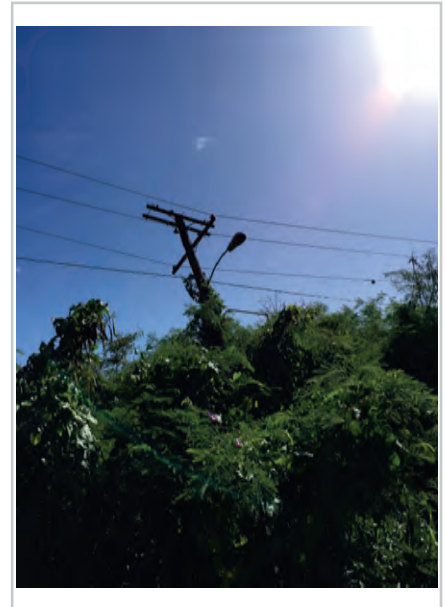
Condition: INCLINED

Comments: POLE CONTAINS OUT OF SERVICE WOOD CROSS ARMS
N/A

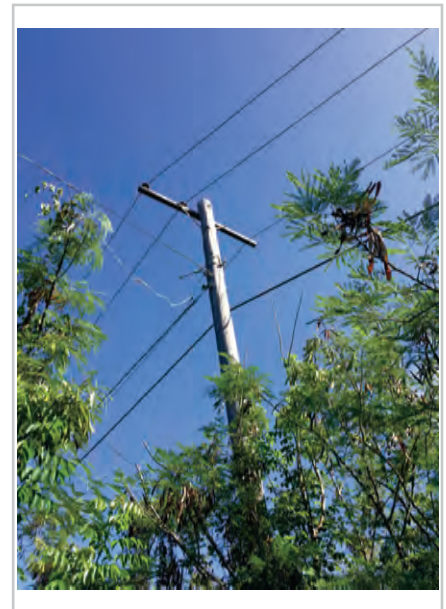
Photo 2: Pole Constr. Standards

Condition: INCLINED

Comments: INSULATOR DAMAGED

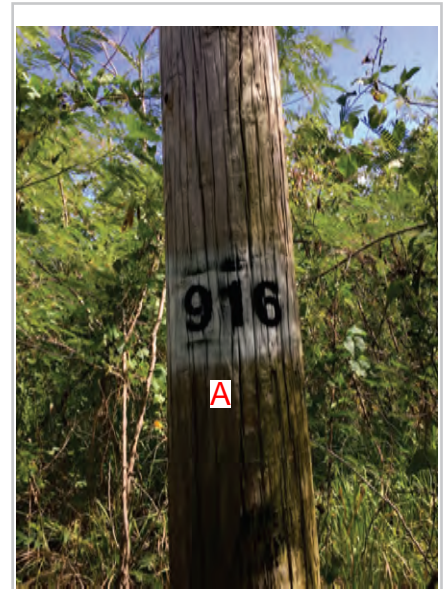
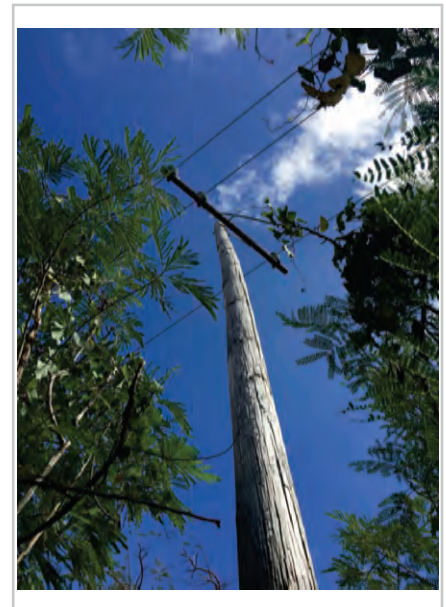
Condition: INCLINED

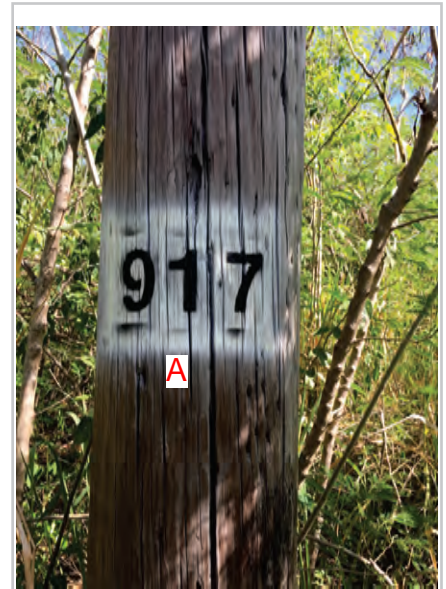
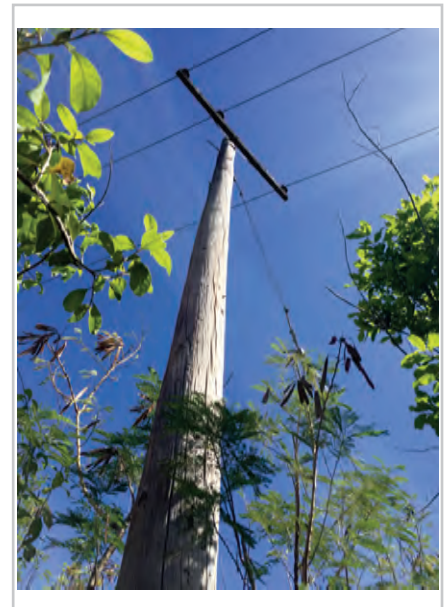
Condition: INCLINED

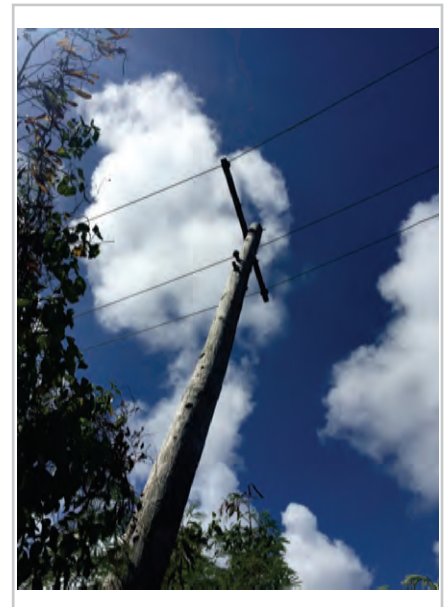
Photo 2: Pole Constr. Standards

Condition: ^{BROKEN} _____

Comments: ^{INCLINED AND CRACKED AT BASE} _____
N/A

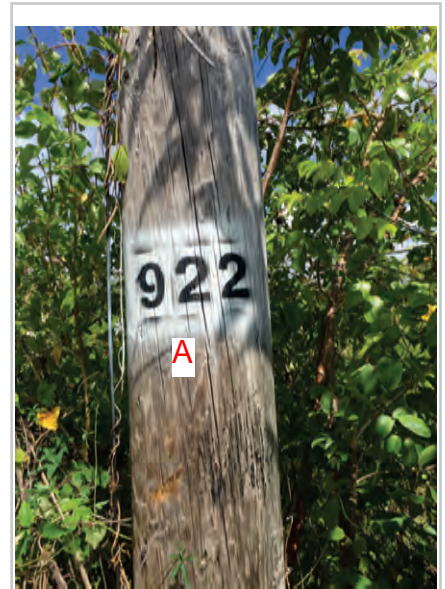
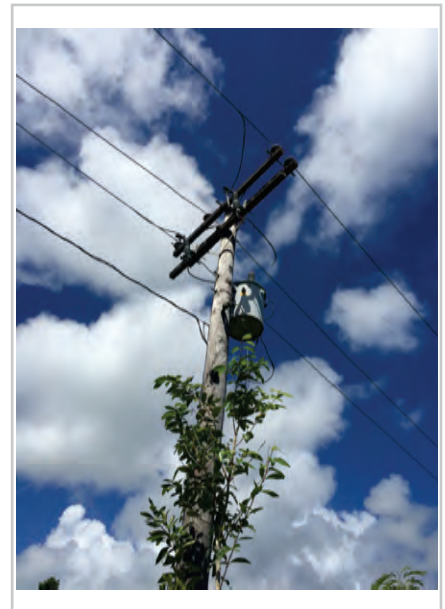
Comments: FUSED CUT OUT FOR TRANSFORMER INSTALLED ON WOOD

CROSS ARM

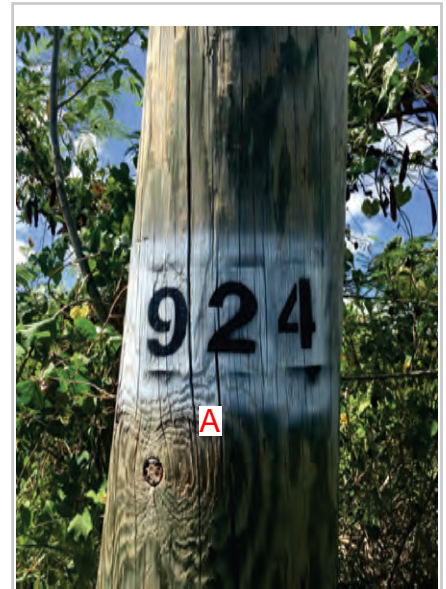
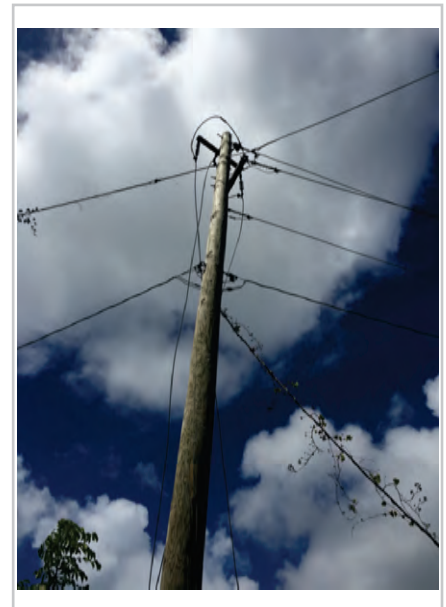
Comments: FOR ONE SIDE OF POLE, LINES ON GROUND OR REMOVED

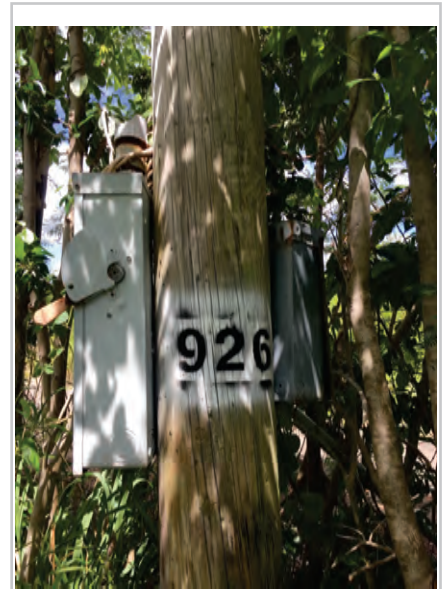
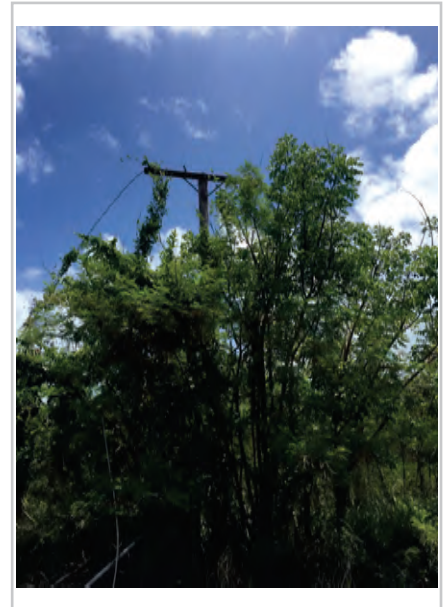
Comments: ^{OUT OF SERVICE DISCONNECT SWITCHES AT POLE BASE, ALL} _____

CONDUCTORS ON GROUND

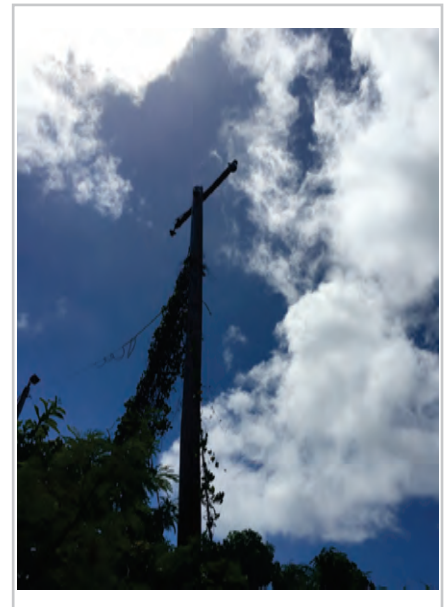
Photo 2: Pole Constr. Standards

Condition: ^{INCLINED} _____

Comments: ^{ALL CONDUCTORS ON GROUND, CROSS ARM AND INSULATORS} _____
^{DAMAGED} _____

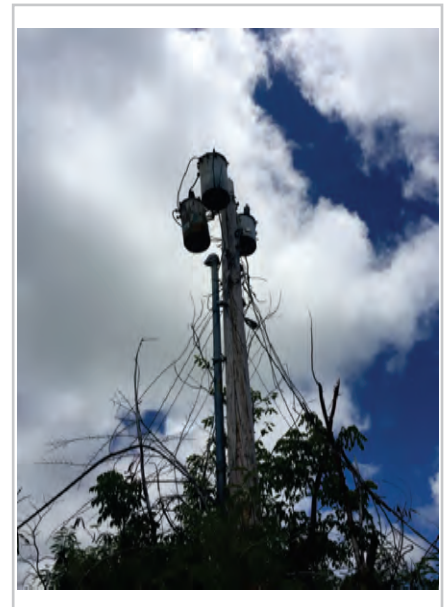
Photo 2: Pole Constr. Standards

Condition: BROKEN

Primary line voltage and standards: 13.2 KV
ANCHORED, WITH WOOD CROSS ARMS, BROKEN ON GROUND

Comments: POLE BROKEN AT TOP, POLE MOUNTED SUBSTATION AND
SECONDARY INSTALLATION OUT OF SERVICE, ALL CONDUCTORS ON GROUND

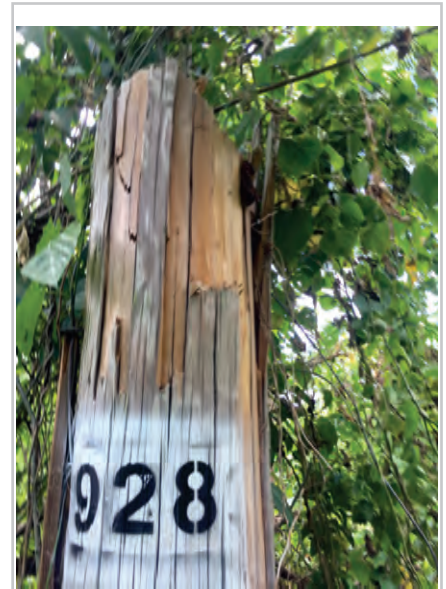
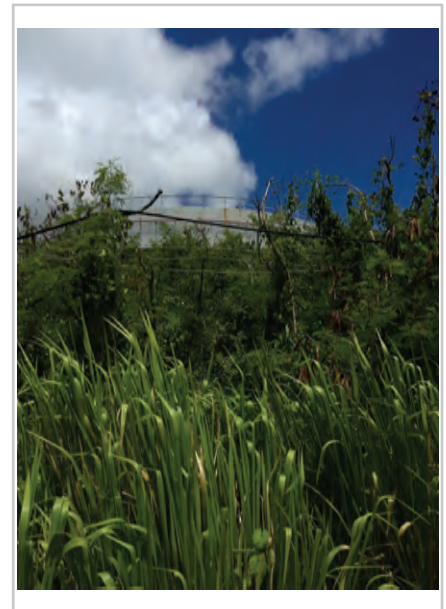
Condition: ^{BROKEN} _____

Primary line voltage and standards: ^{13.2 KV} _____
NOT ANCHORED, WITH WOOD CROSS ARMS, BROKEN ON GROUND

Comments: ^{POLE AND ALL CONDUCTORS ON GROUND} _____
N/A
